Phase I Environmental Site Assessment

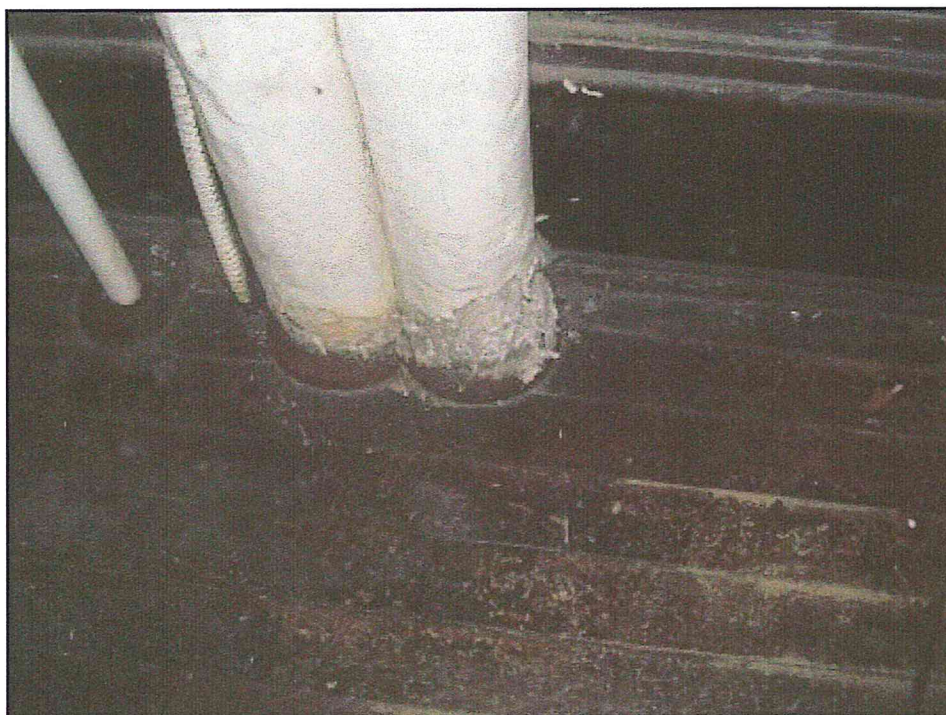
210 Bernard Court.  
Looking at possible asbestos wrapped pipes in front entry way.

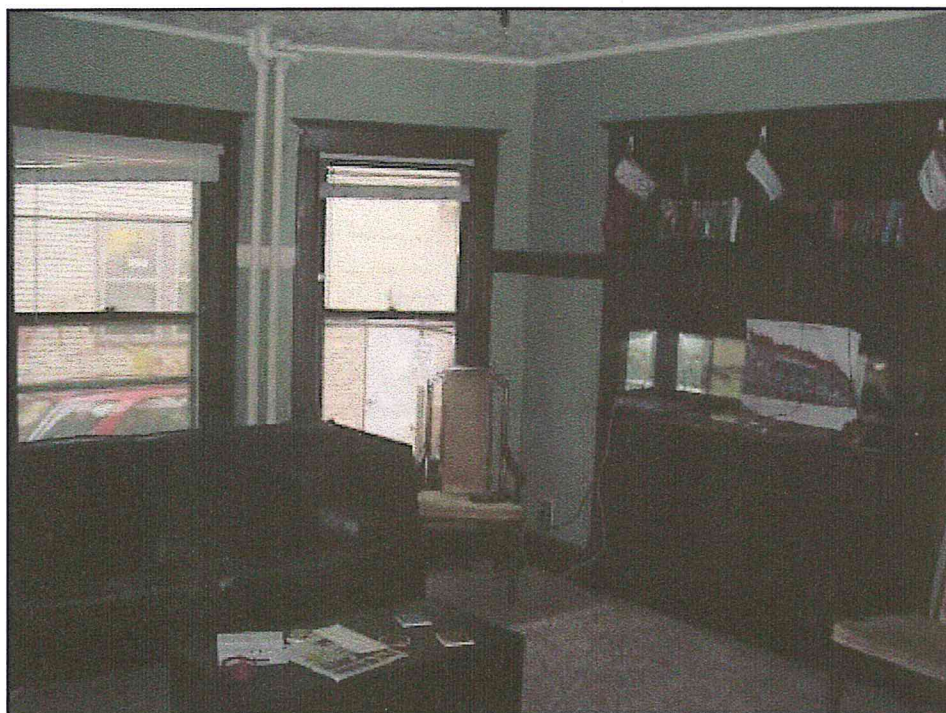
210 Bernard Court.  
Typical common area. Pipes in background are painted steel with no wrapping material.

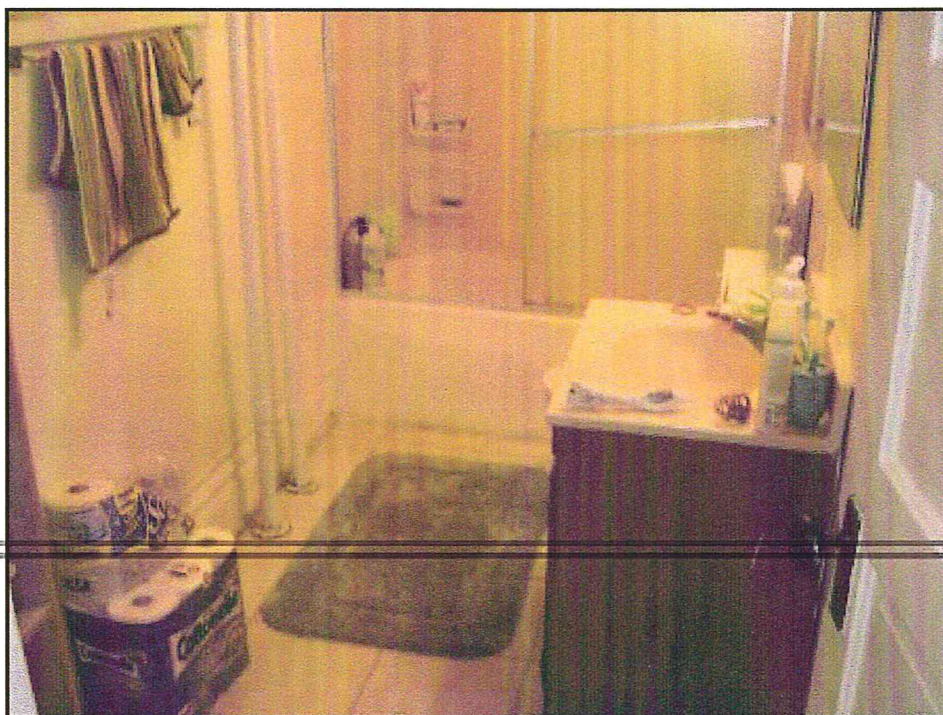
210 Bernard Court.  
Typical bathroom, pipes running along wall are painted with no wrapping.

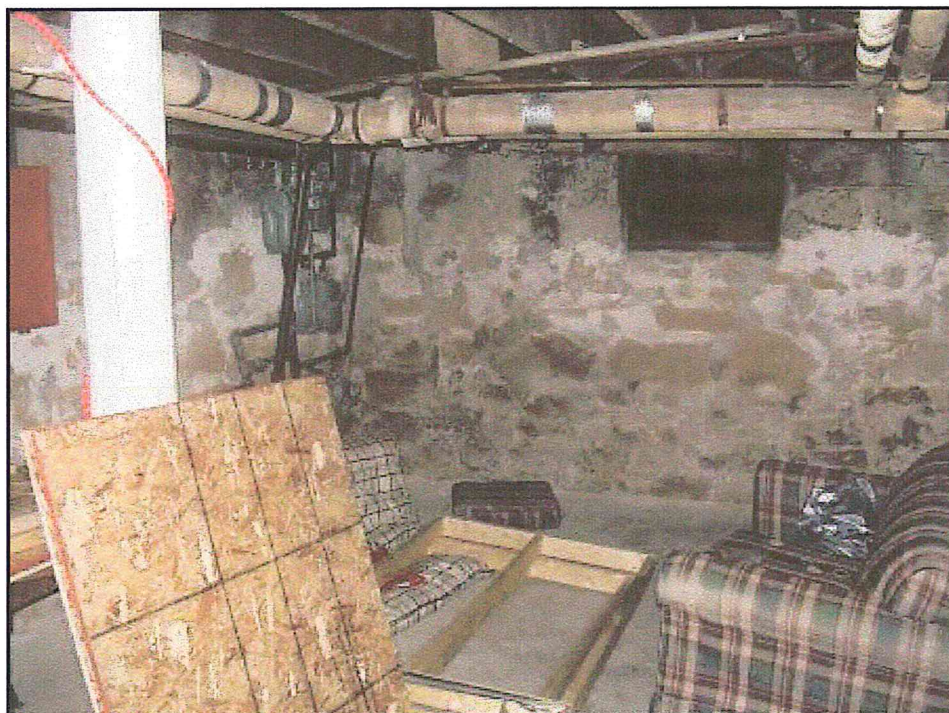
210 Bernard Court.  
Basement area showing stone foundation and wrapped pipes along ceiling.

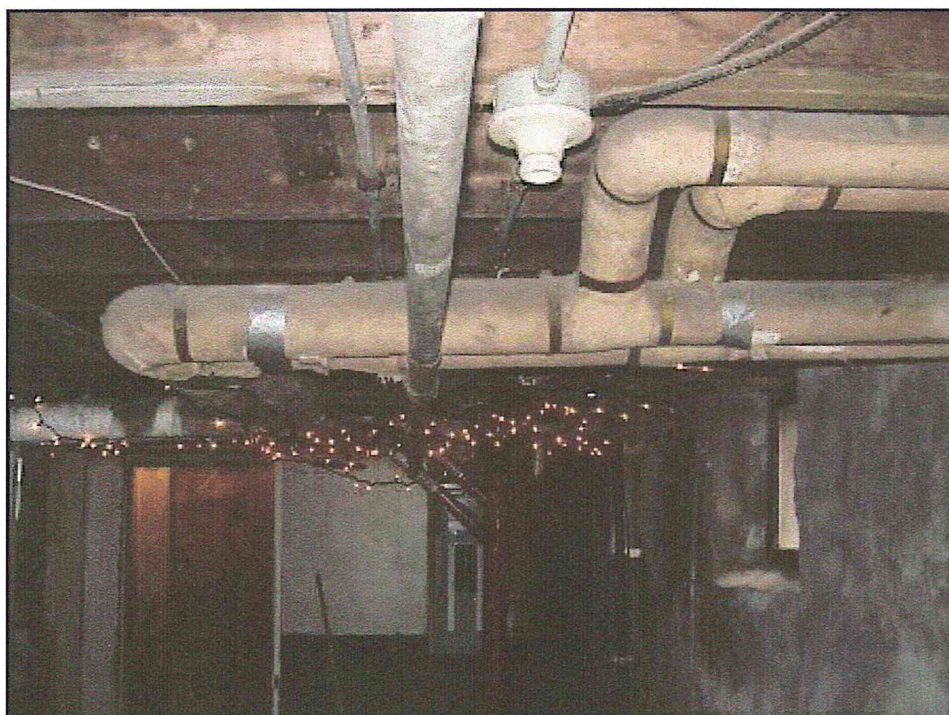
201 Bernard Court.  
Basement area showing more wrapped pipes along ceiling.
