City of Madison Planning Division
215 Martin Luther King Jr. Blvd. | Room LL.100 | P.O. Box 2985 | Madison, WI 53701-2985

Madison Landmarks Commission APPLICATION

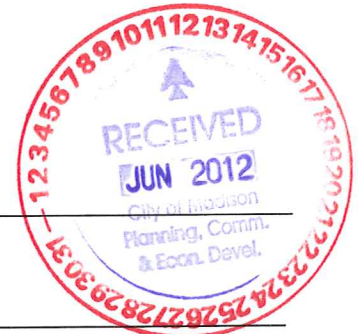
- Alteration / Addition to a Designated Madison Landmark Schubert Building
- Alteration / Addition to a building adjacent to a Designated Madison Landmark Castle and Doyle
- Alteration / Addition to a building in a Local Historic District (specify):
 - Mansion Hill Third Lake Ridge First Settlement
 - University Heights Marquette Bungalows
- New Construction in a Local Historic District (specify):
 - Mansion Hill Third Lake Ridge First Settlement
 - University Heights Marquette Bungalows
- Demolition
- Variance from the Landmarks Ordinance
- Referral from Common Council, Plan Commission, or other referral
- Other (specify): _____

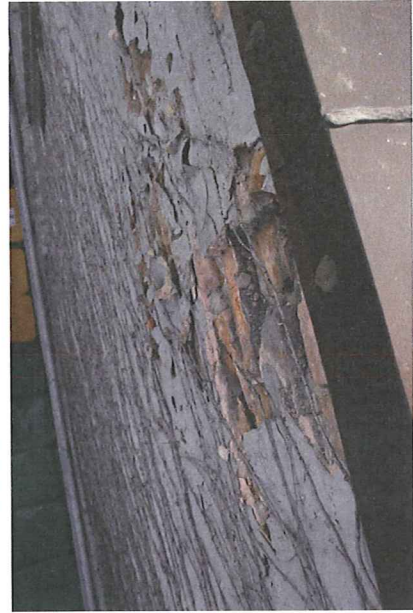
View from roof looking at condition of brick and parged wall

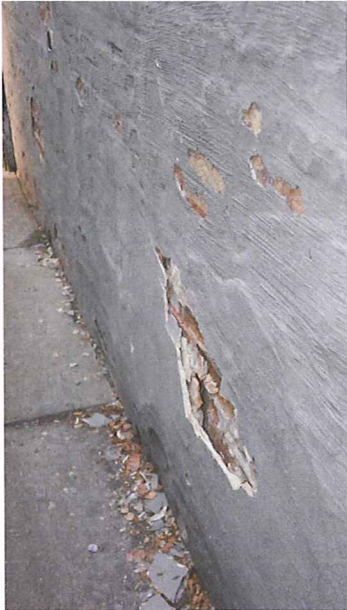
Exterior: View in the alley showing a section of delaminated parging

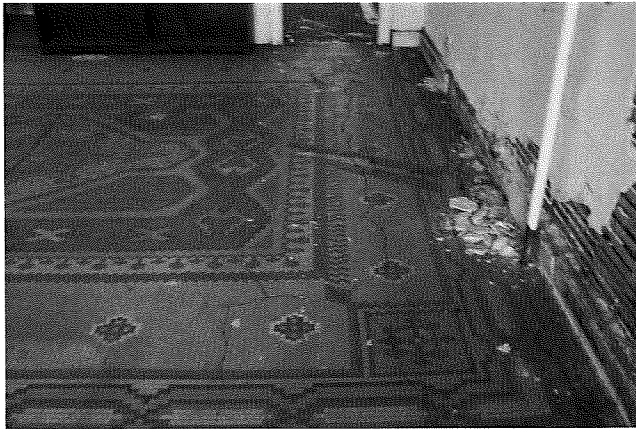
First Floor: View toward back exit showing multiple cracks in floor tile

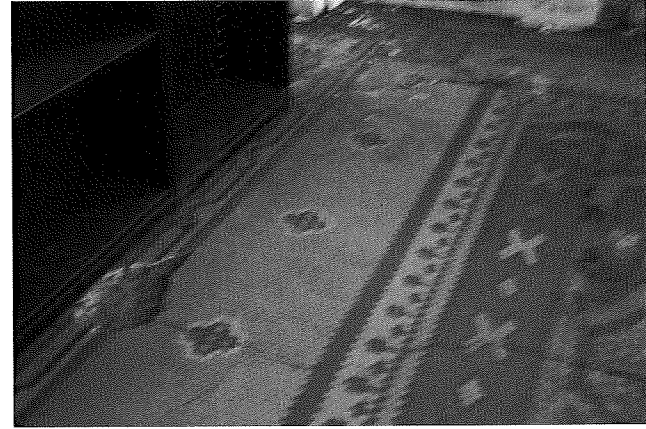
First Floor: View at back of room showing areas where tile floor has been removed

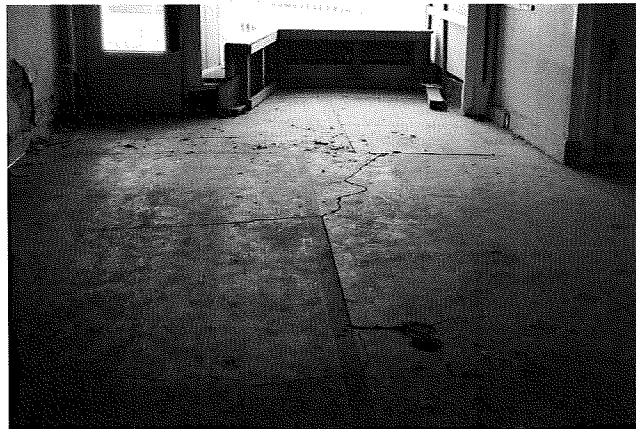
First Floor: View toward Mifflin Street entry showing multiple cracks in floor tiles

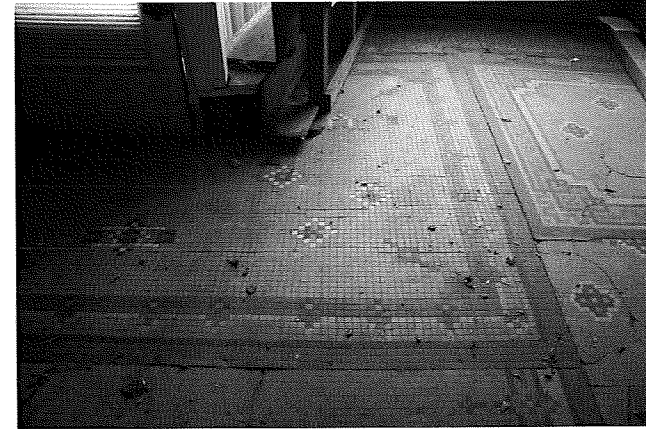
First Floor: View at entry off Mifflin Street showing three flooring surfaces. 1) Original 3/4" square tiles 2) 1" square tiles at entry 3) composite flooring at window

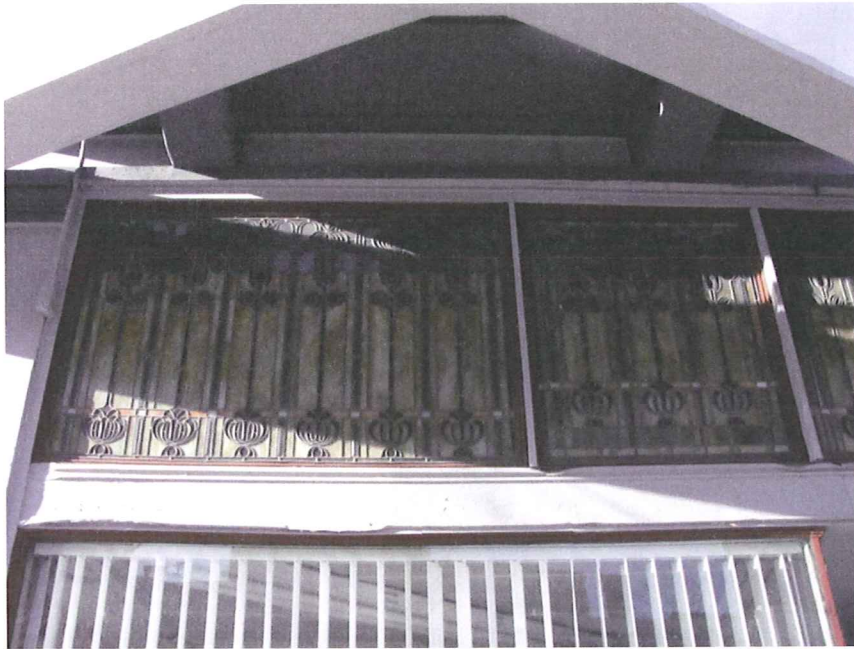
Figure 4. The first floor storefront includes a three-part leaded art glass transom.

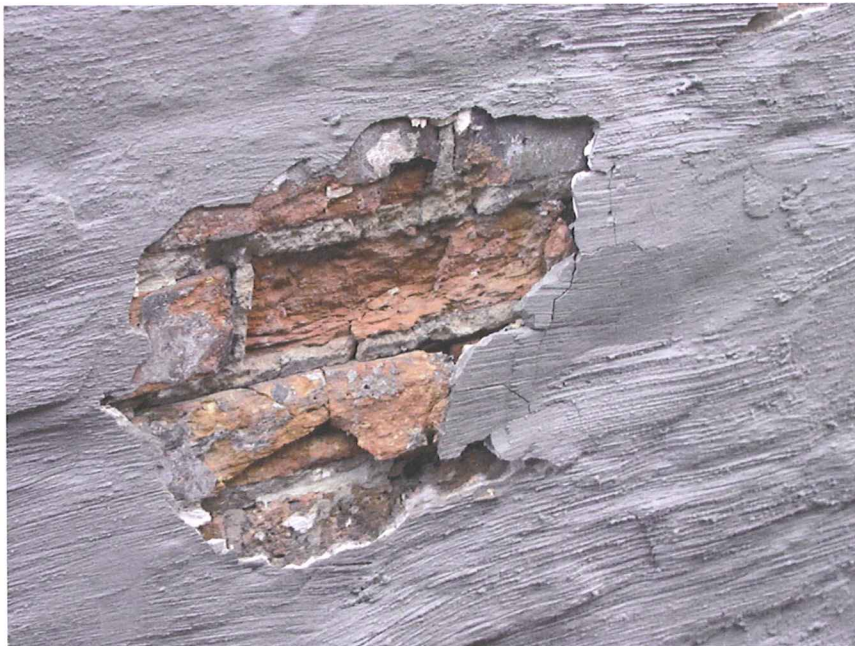
Figure 5. Failure of cementitious parge coat, revealing deteriorated brick masonry.

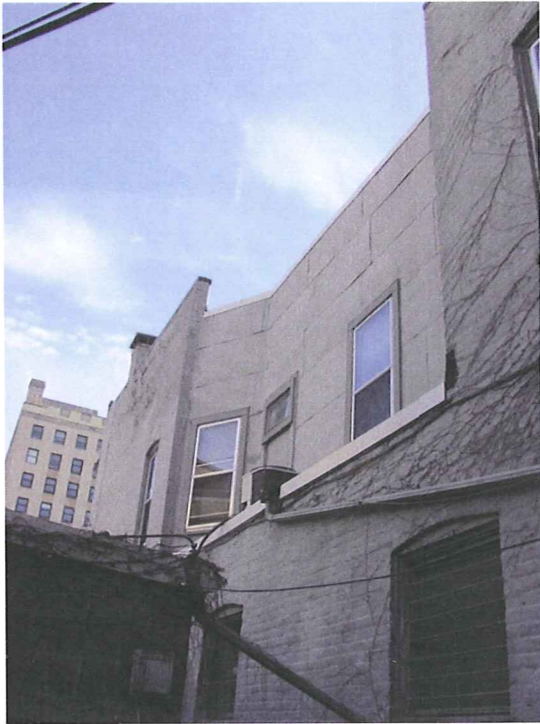
Figure 9. A portion of the side wall is recessed at the second floor and is clad with painted sheet metal.

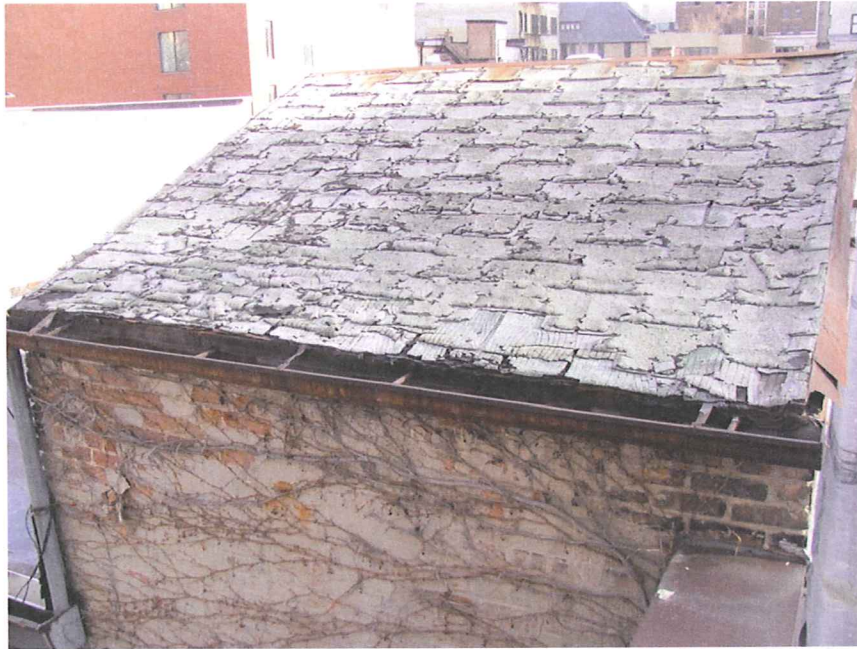
Figure 13. The penthouse roof is covered with asphalt shingles in deteriorated condition.

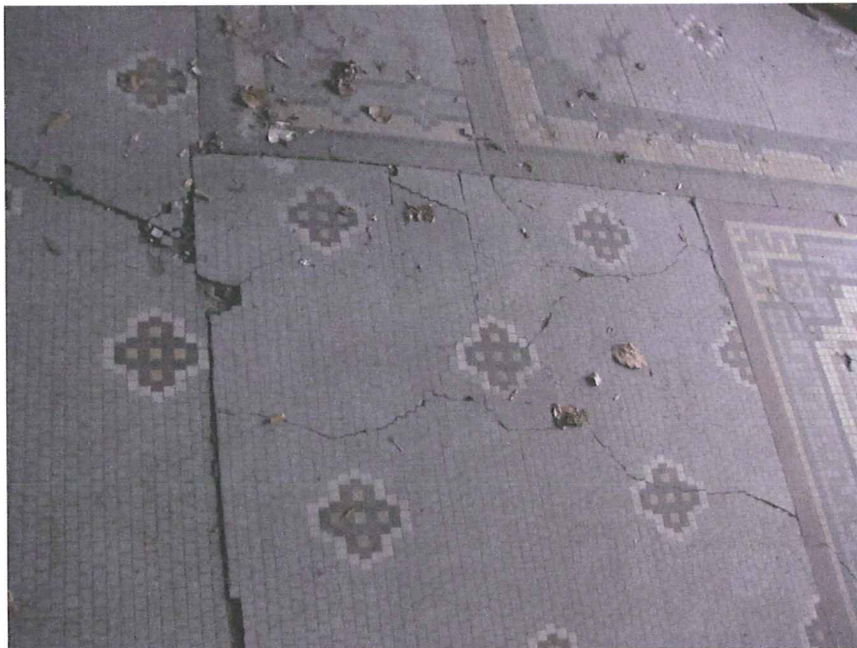
Figure 14. There is elaborate mosaic tile flooring at the first floor; the flooring has suffered extensive cracking and displacement.

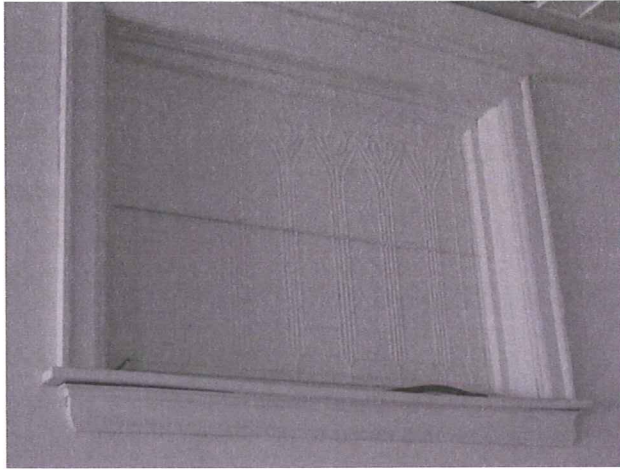
Figure 17. Leaded glass window, which has been painted over, at the southwest party wall.

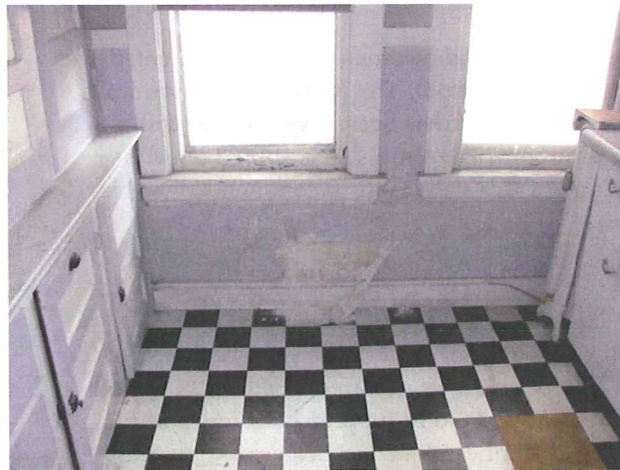
Figure 18. Plaster damage at the rear wall at the second floor of the building.

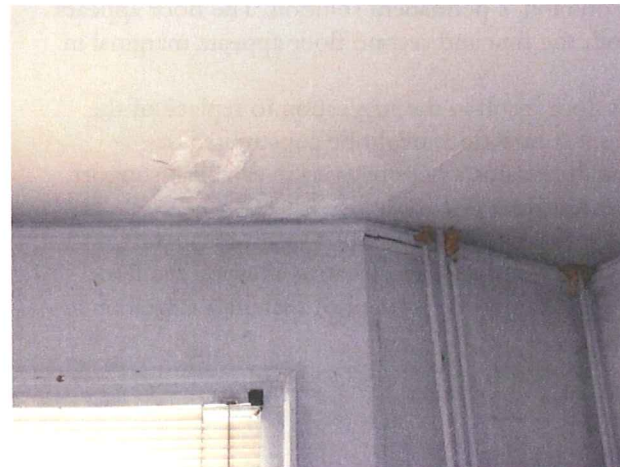
Figure 19. Moisture damage to plaster finishes at the second floor.

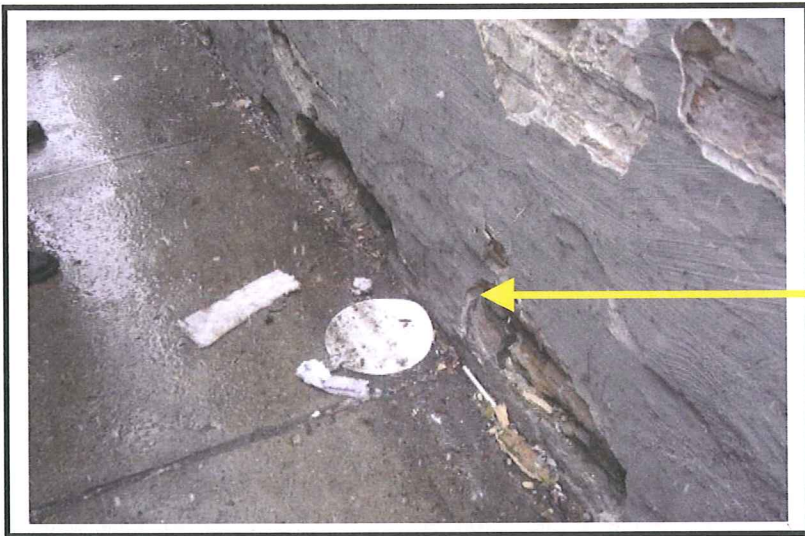
Figure 4 – Spalling brick face-east exterior wall.

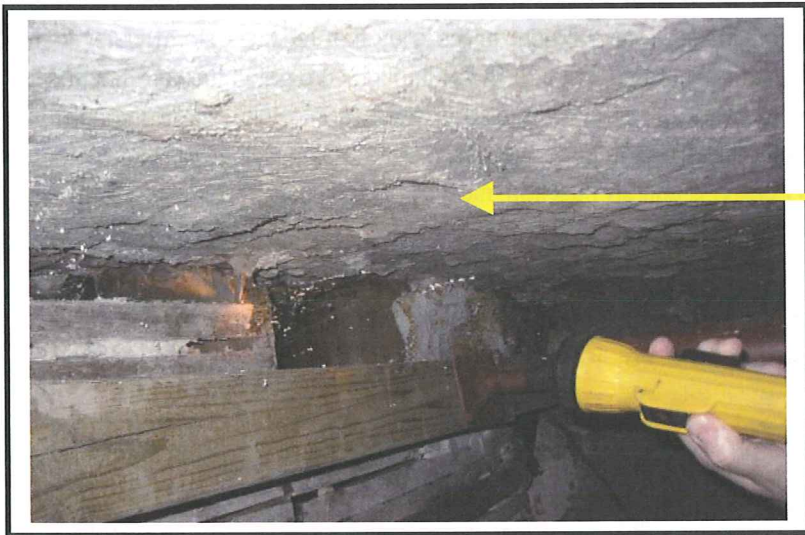
Figure 5 – Picture of rotted end of wood floor joist at first floor.

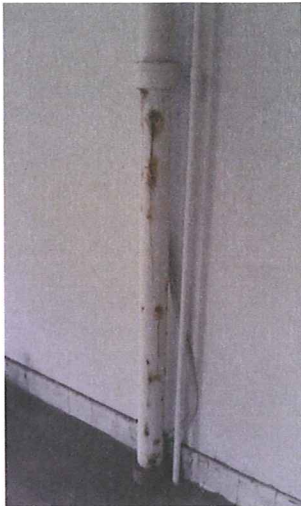
Leaking sanitary pipe

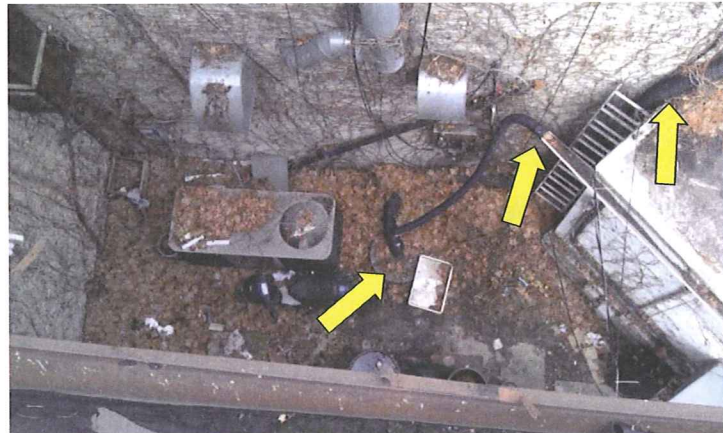
Roof drains into cistern that discharges through basement

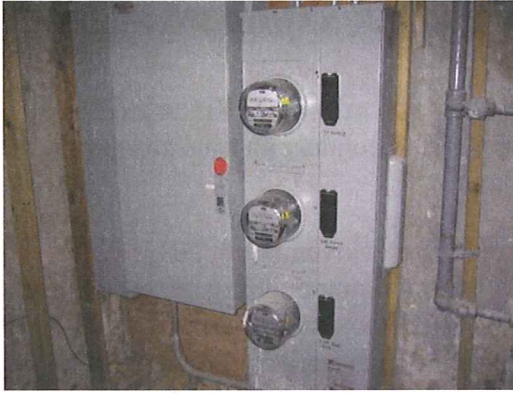
Electrical service in the basement.
