LANDMARKS COMMISSION APPLICATION

Project Title/Description: Replace remainder of old windows in house to match addition windows

Re: 2122 Chadbourne Ave, Madison, WI 53726 Window Replacement Plant Property

Initial Window Condition Assessment

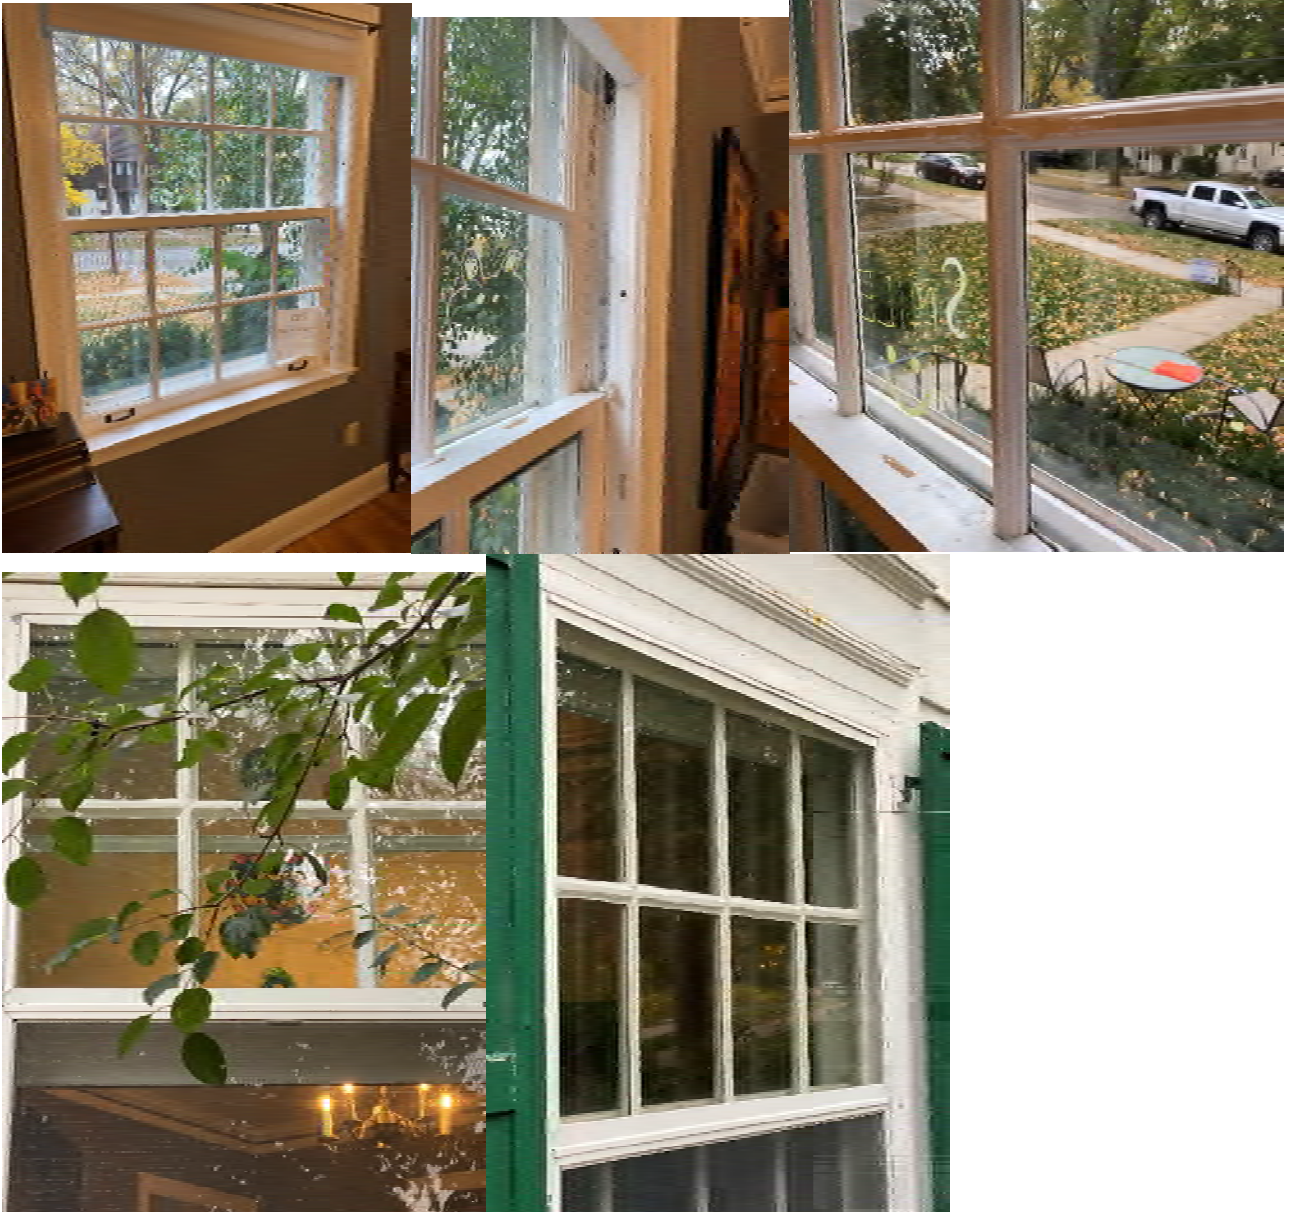
- Window 1 – Dining Room Front Facade
 - Existing condition –Original to the house. The sash cords are broken, there are no locks on the window for security, paint is peeling from inside and outside of window. Bad exterior lite repair. Does not seal properly.

Sill and jamb condition: Paint failure, no observed defects to wood surface

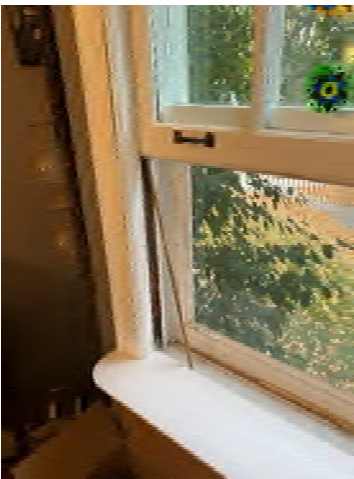
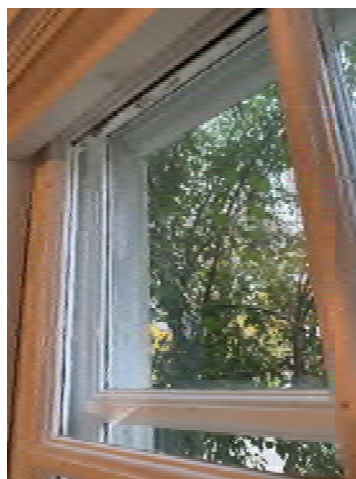
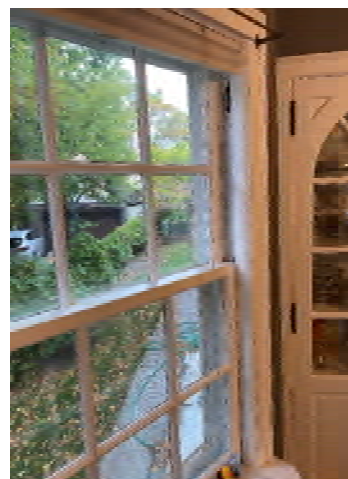
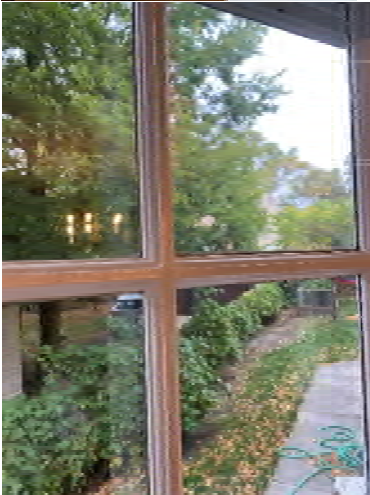
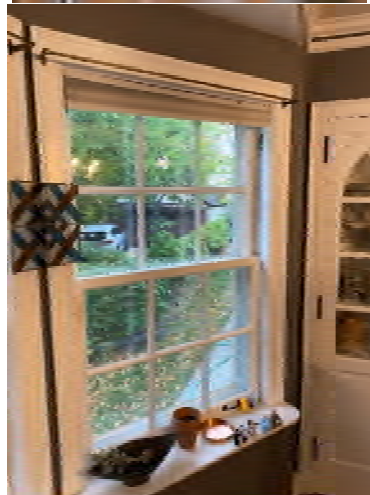
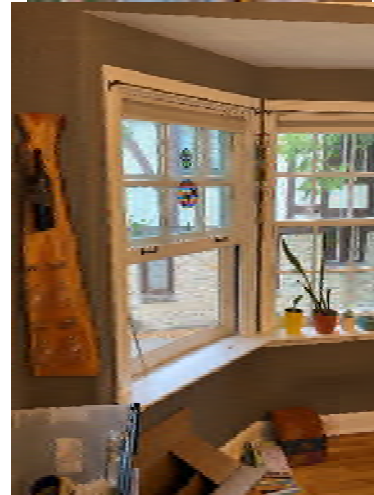
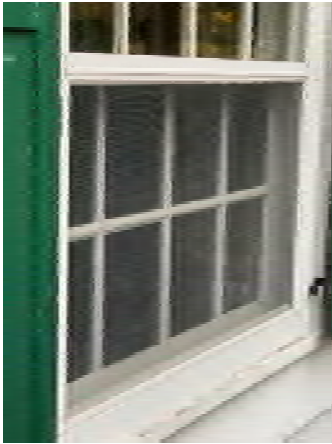
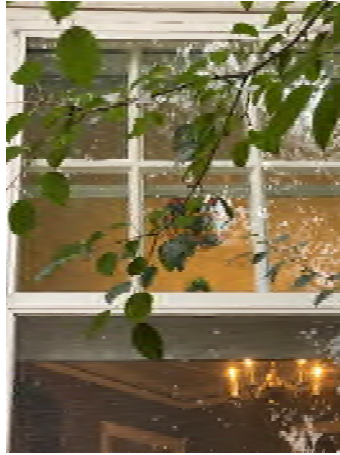
- Window 2/3/4 - Dining Room Bay Windows
 - Existing condition -Original to the house. The sash cords are all broken, there are no locks on the window for security, paint is peeling from inside and outside of window. Bad exterior lite repair. Does not seal properly.
 - Repair Quote
 - Replacement \$\$

Glass condition: Cracked upper lite

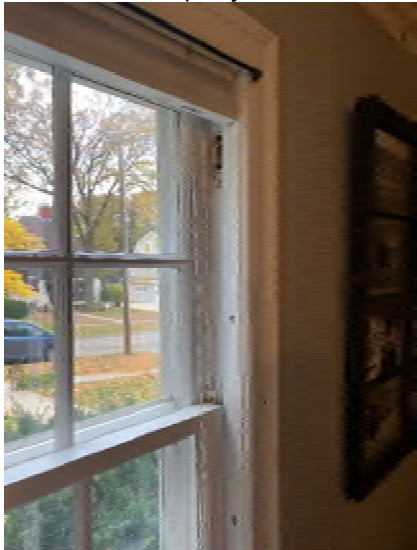
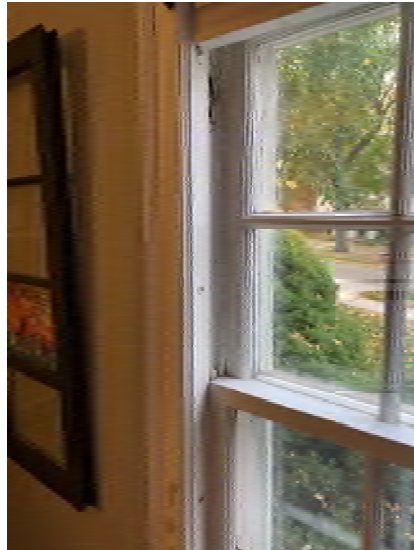
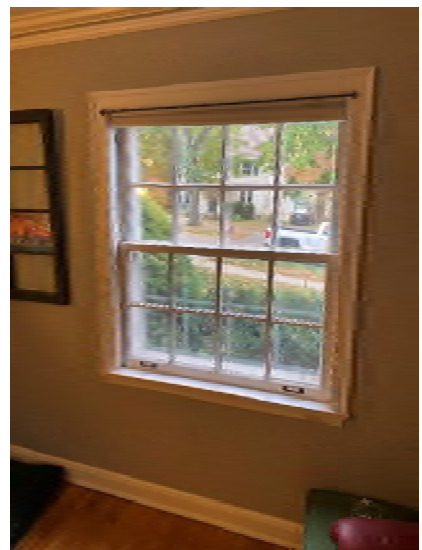
- Window 5 will be removed during addition project.
- Window 6 – First Floor Front Façade - Living Room South Window
 - Existing condition—Original to the house. The sash cords are broken, there are no locks on the window for security, paint is peeling from inside and outside of window. Bad exterior lite repair. Does not seal properly.
 - See 3rd party assessment attached.

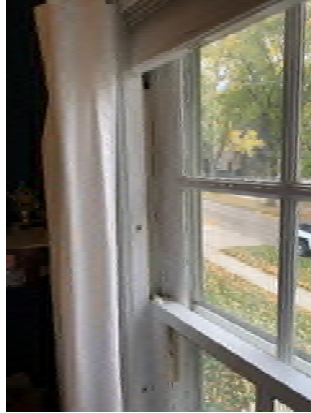
- Window 7- Front Façade Center – Small Bedroom
 - Existing condition – Original to house, sash cord broken, paint peeling inside and out, does not seal properly.

Notes: Interlocking weatherstripping present

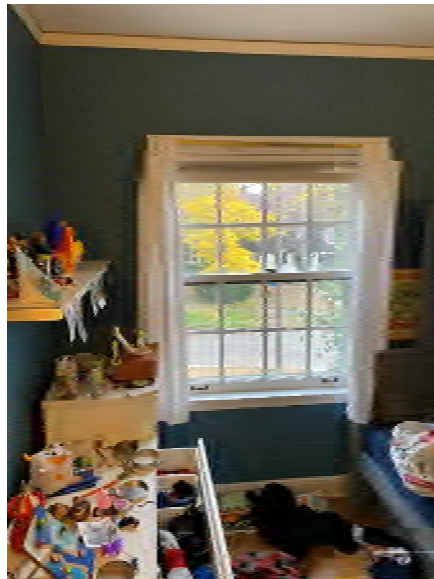
- Window 8 – Front Façade Left – Bedroom 2
 - Existing condition- One sash cords is broken, there are no locks on the window for security, paint is peeling from inside and outside of window. Bad exterior lite repair. Does not seal properly.

Notes: Interlocking weatherstripping present, Top sash has dropped 1/2" and is painted in place

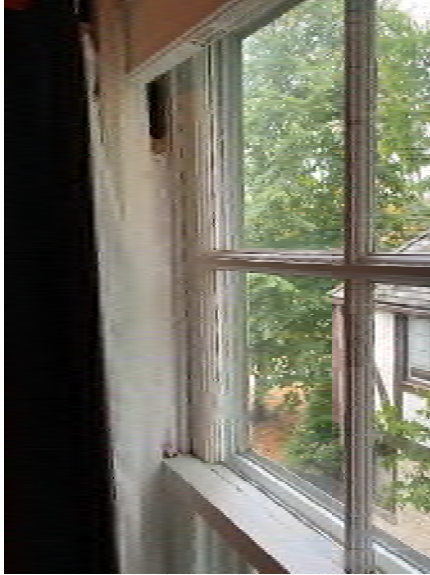
- Window 9 – Second floor west façade – Bedroom 2
 - Existing Condition – Sash cord broken, doesn't seal properly, chipped paint interior and exterior.

Notes: Jamb liner balances have been retrofitted- recommend removal and revert to original pulley balance system salvaged from windows to be removed for addition, Top sash has dropped 1/2" and is painted in place

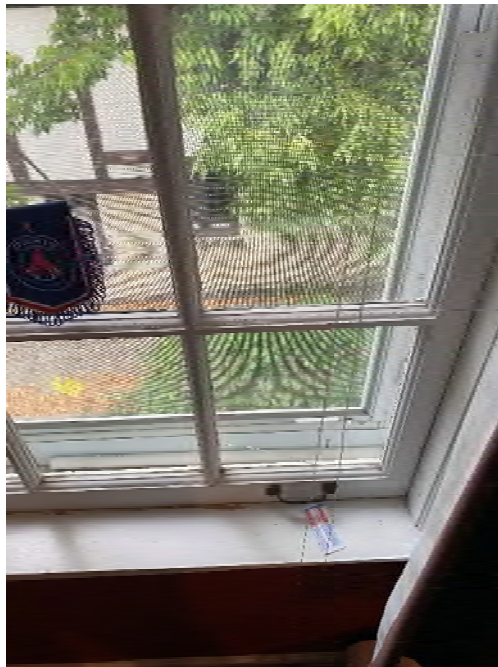
- Window 10 – Second Floor West Façade – Bedroom 3 –
 - Existing Condition – Chipped paint inside and outside, broken window pane, sash cords broken. Doesn't seal properly.

Glass condition: Cracked single lite

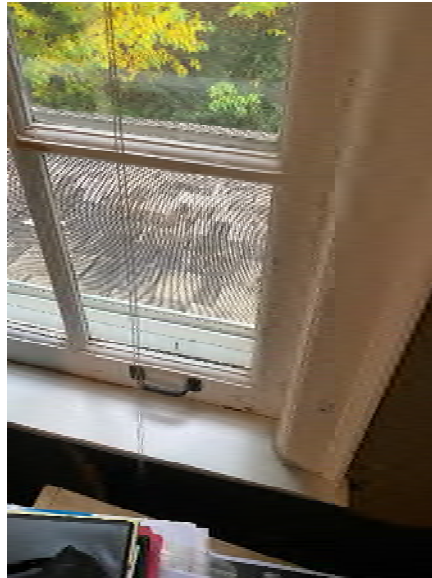
- Window 11 – Second floor rear façade – will be removed during addition
- Window 12 – Second floor rear façade – will be removed during addition
- Window 13 – Second floor east façade – Master bathroom
 - Existing condition – chipped paint inside and outside, doesn't seal properly, no locks

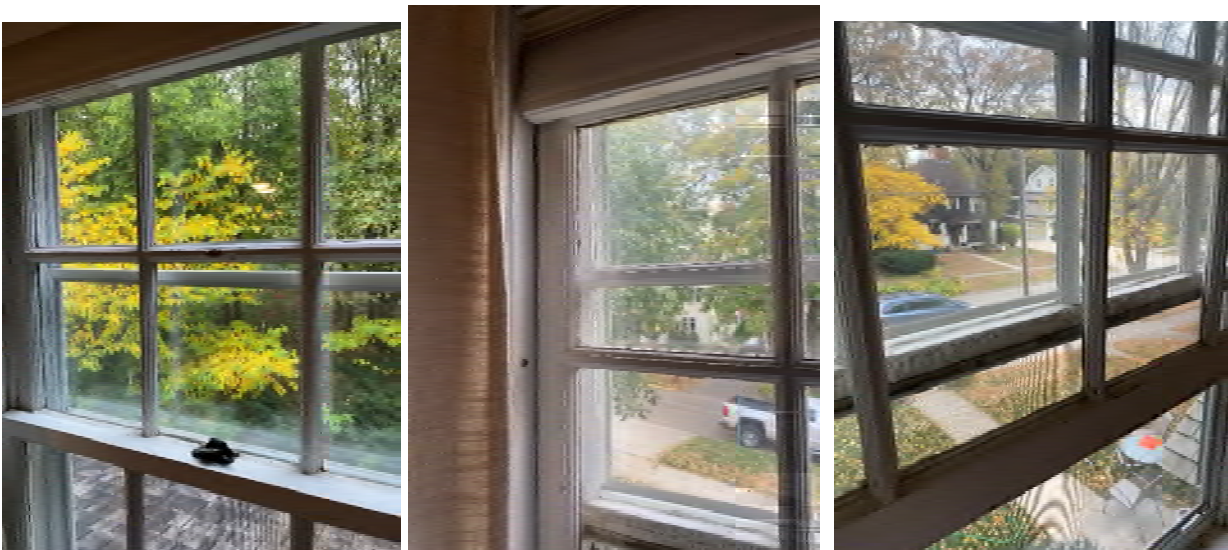
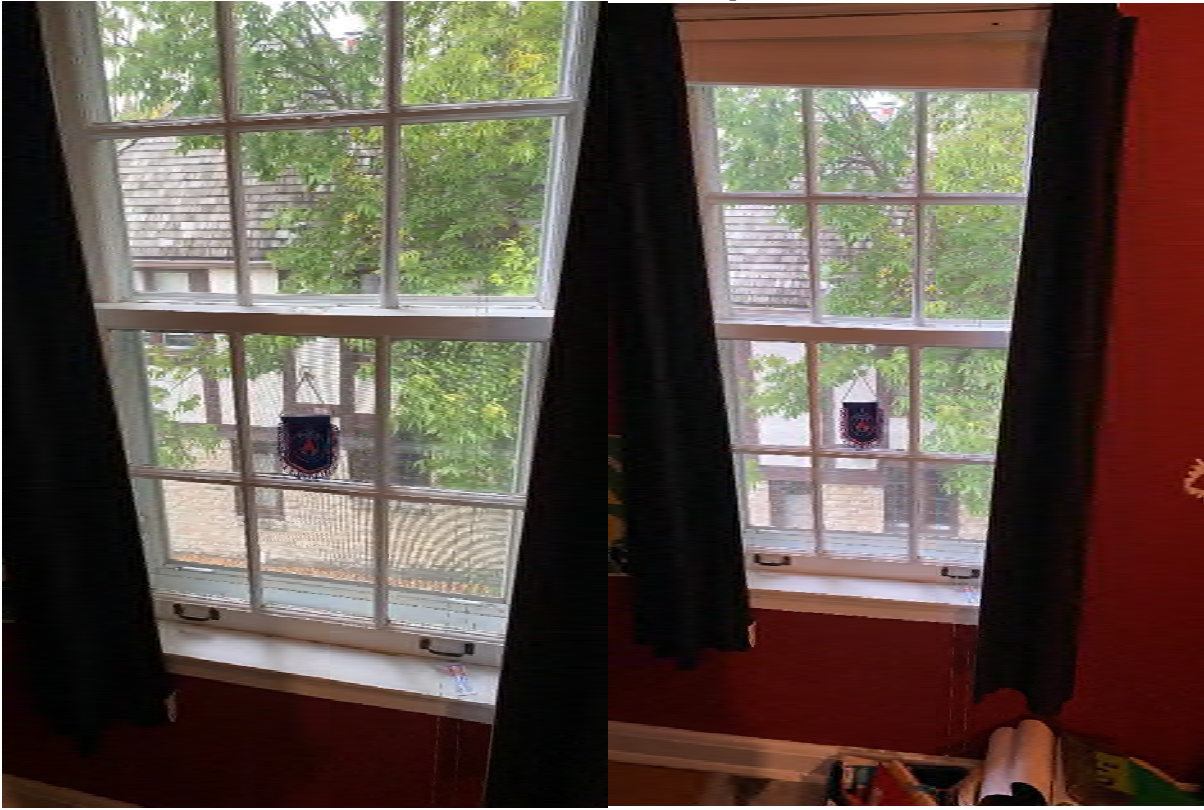
- Window 14/15– Second floor east façade – master bedroom
 - Existing condition -Original to the house. The sash cords are broken, there are no locks on the window for security, paint is peeling from inside and outside of window. Bad exterior lite repair. Does not seal properly.

Notes: Inner jamb separation from sill, repairable
