Re: Agenda Item 8, Legistar File #85527
Appeal of the Plan Commission action on the demolition permit for 2121 Jefferson St. and
1007 Edgewood Ave.
October 29 Common Council Meeting

AmeriSpec Inspection Service

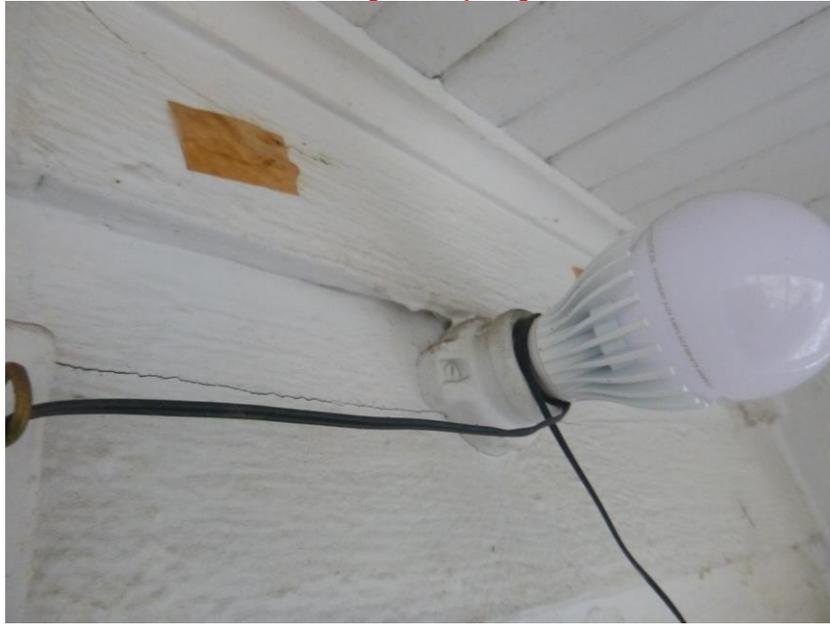
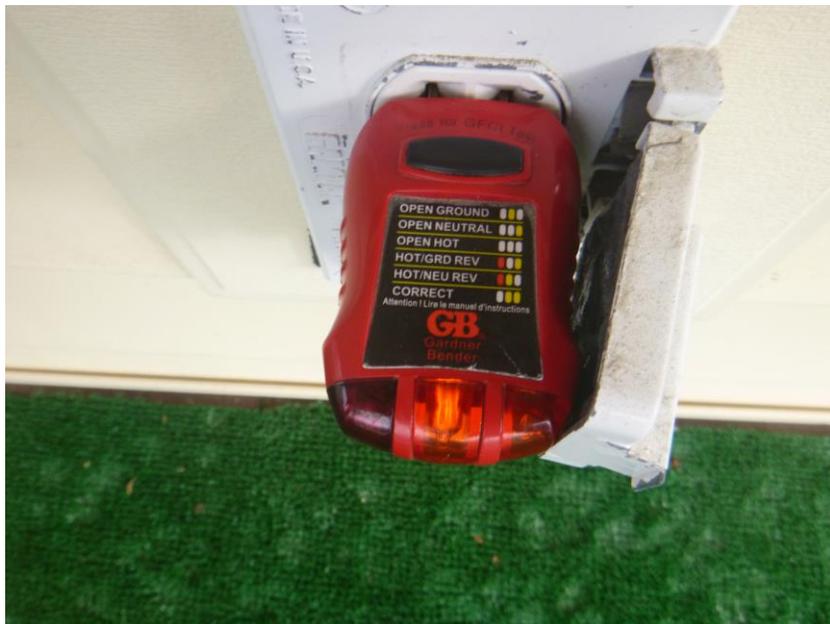
Defect. No weatherproof cover or GFCI noted at the rear porch receptacle. The wiring of the fixture at the rear porch may pose a safety concern. Ungrounded three-prong receptacle and no GFCI noted at the front porch. Recommend review and repairs by a qualified electrician.

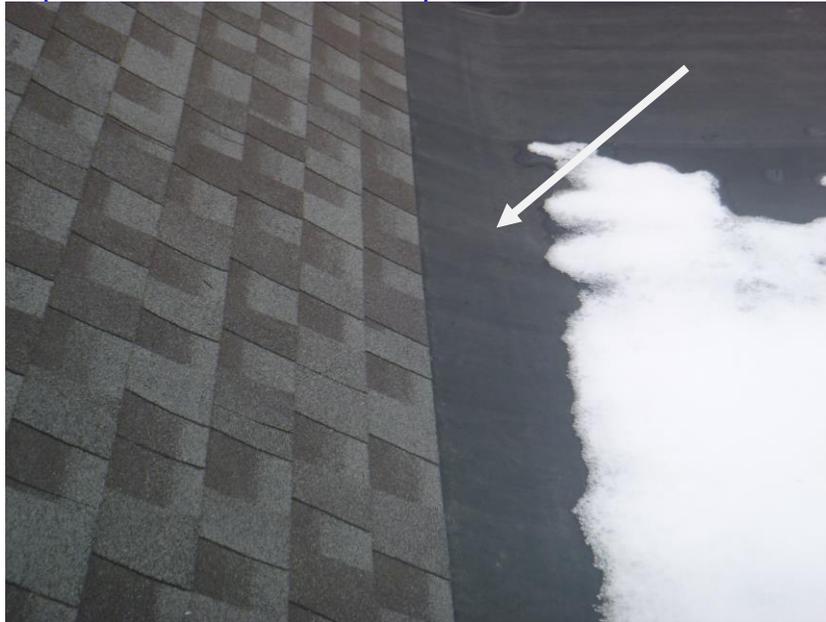
1209. Conditions

Maintenance. The rubber membrane is bridging at the change of slope. Recommend review for repairs.

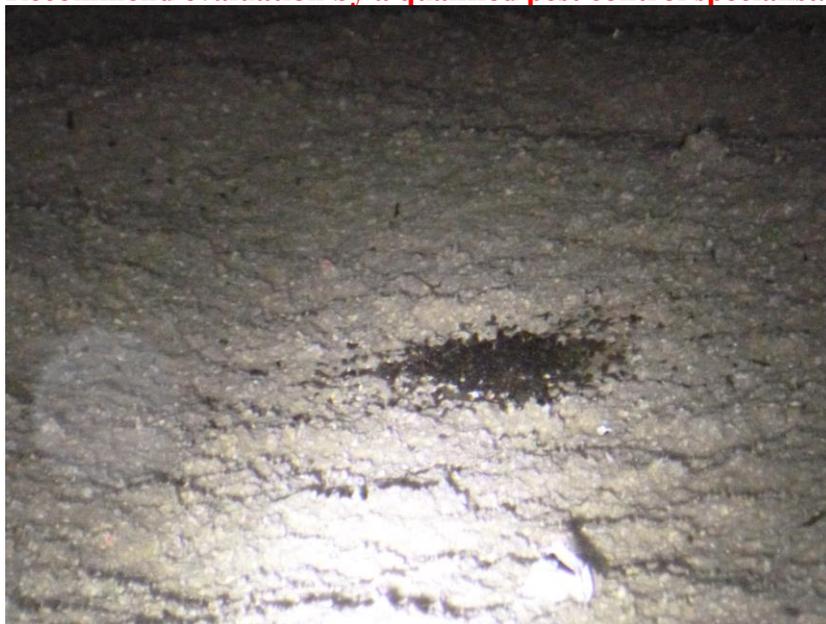
1360.	Chimneys	Not Present.
1361.	Maintenance	No.
1362.	Attic Comments	Defect. Rodent droppings observed in the insulation. Recommend evaluation by a qualified pest control specialist.

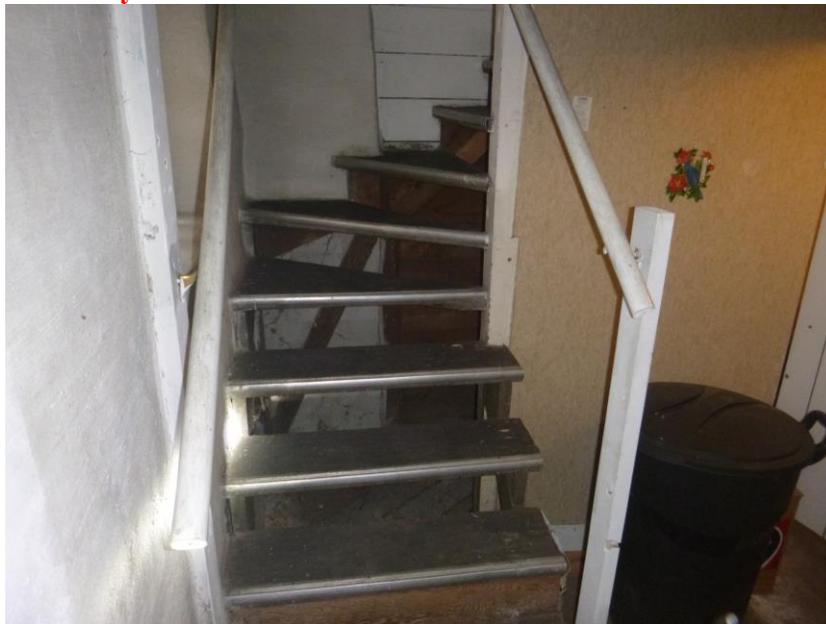
Step #	Component	Comment
1601.	Access	The basement was accessed from the kitchen and exterior right.
1602.	Stairs	Defect. Open risers noted. Weak and improper guardrail noted. Uneven risers noted posing a trip hazard. The window is not tempered/safety glass. Recommend review by a qualified professional for repair or replacement, as necessary.

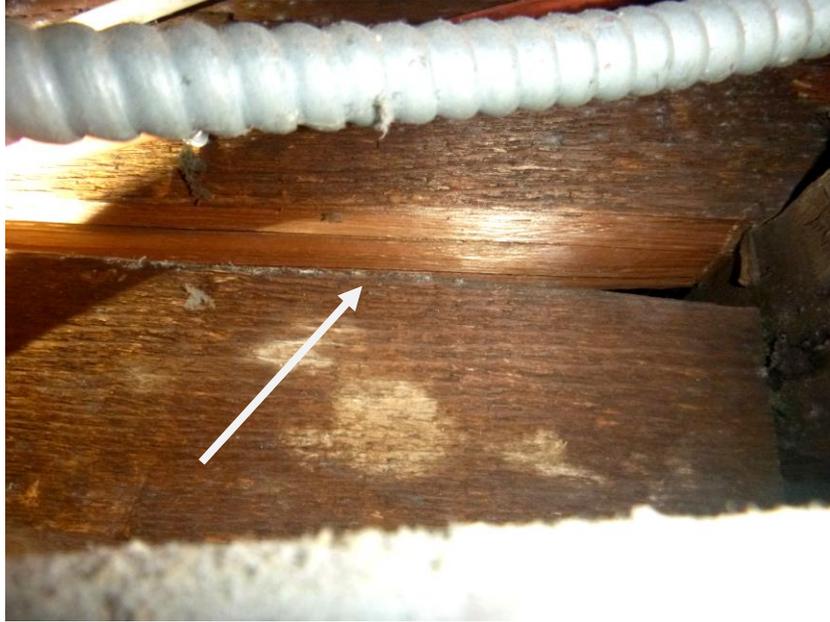
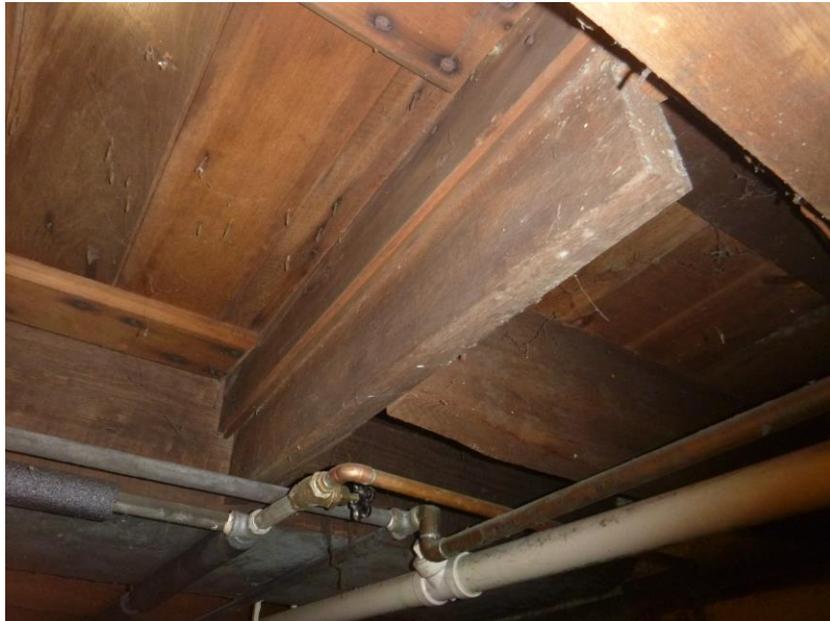
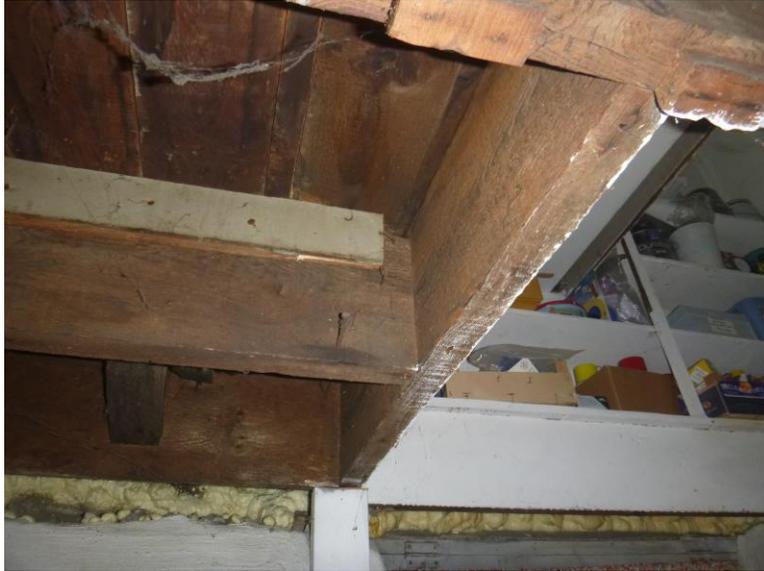
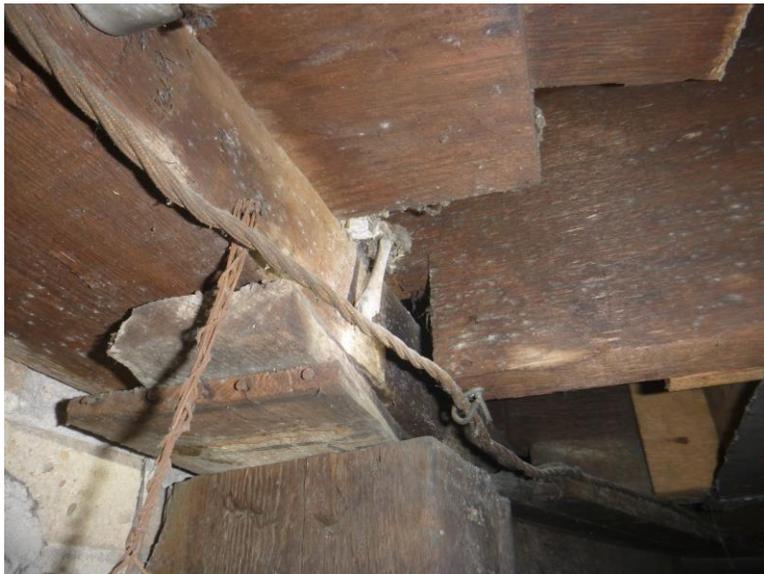
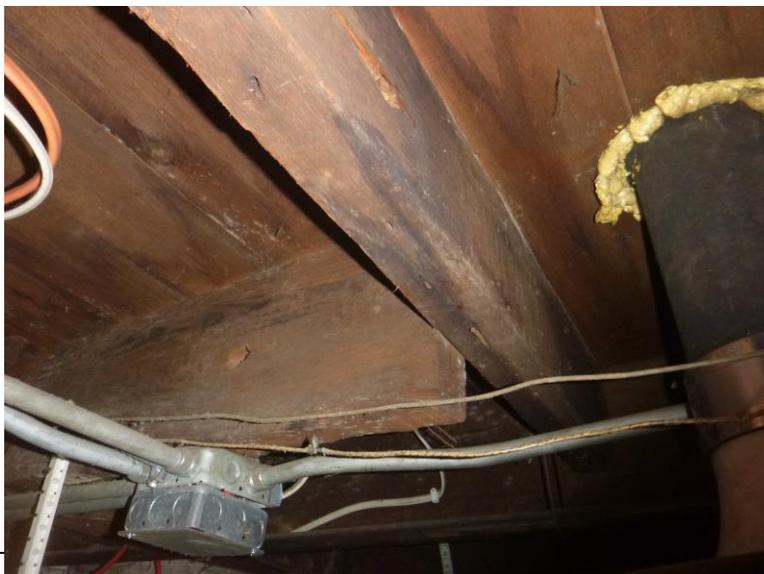
Defect. Conventional 2 X 6, 2 x 8 framing; Conventional 2 X 10 framing. Cracked/split joist noted. Improper headers noted. Joists noted which have moved out from the nailers/beams. Recommend review by a qualified professional for repair or replacement, as necessary.

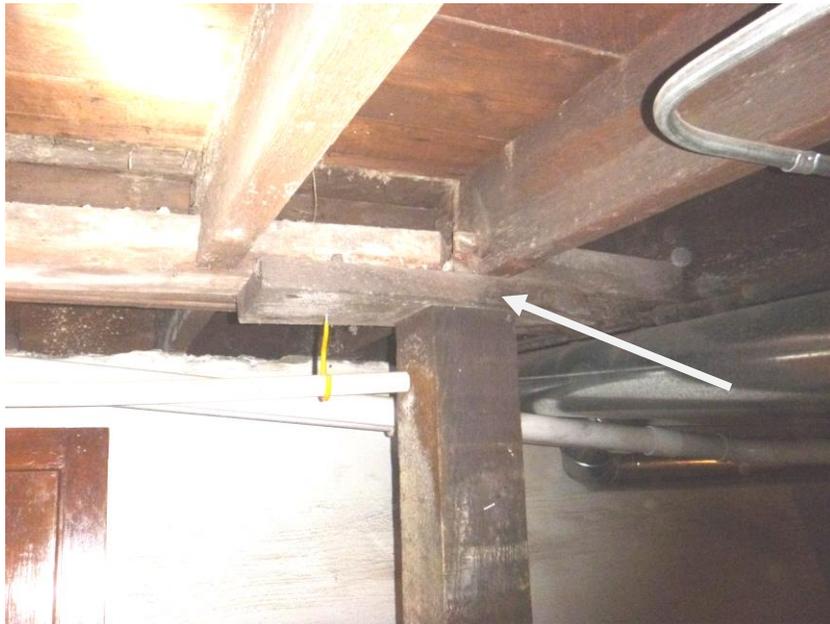
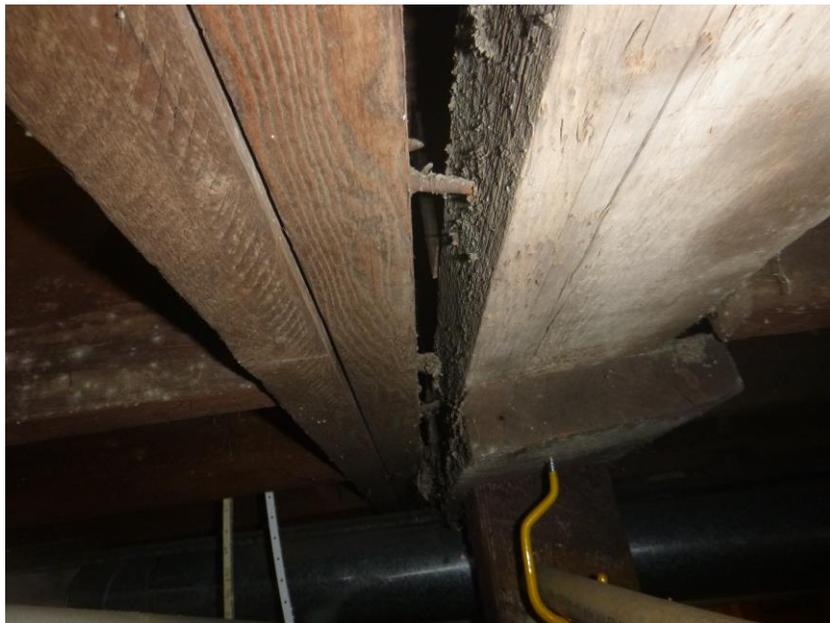
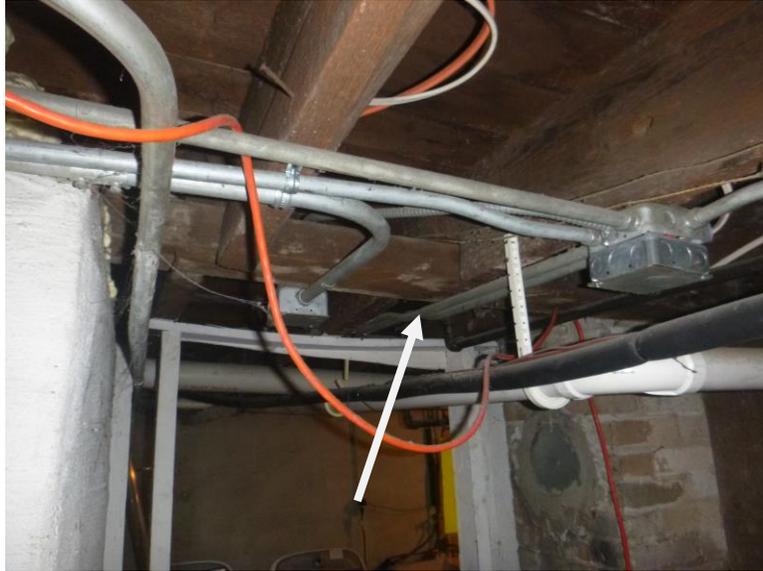
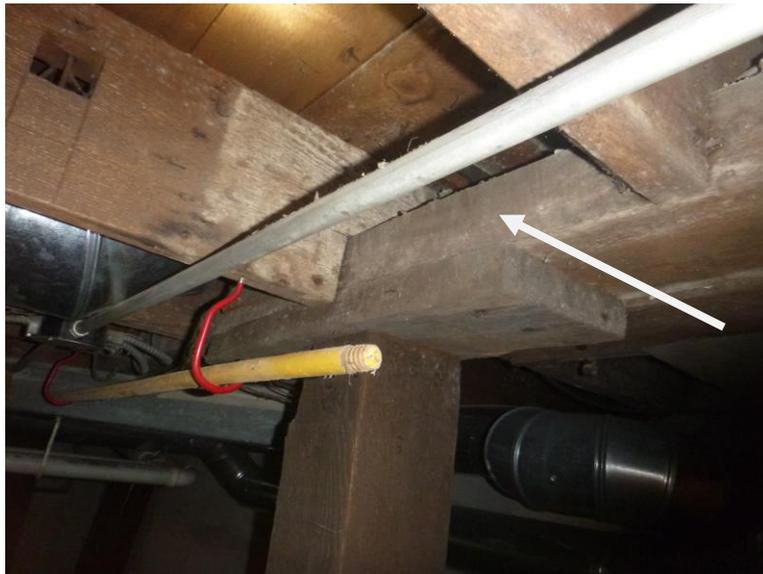
Defect. Wood. The beams do not appear to be adequate for support of the joists. Beams noted out of level and improperly supported. Recommend review by a qualified professional for repair or replacement, as necessary, prior to close.

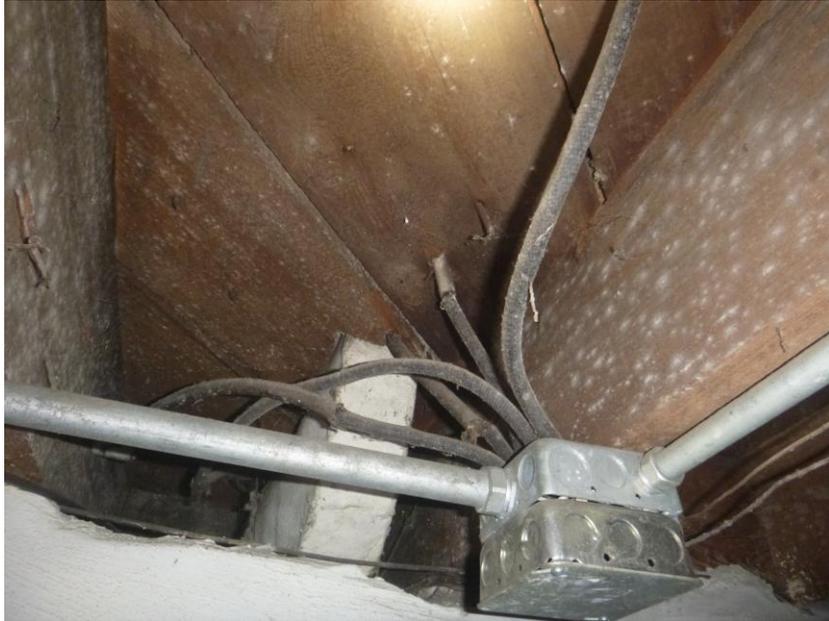
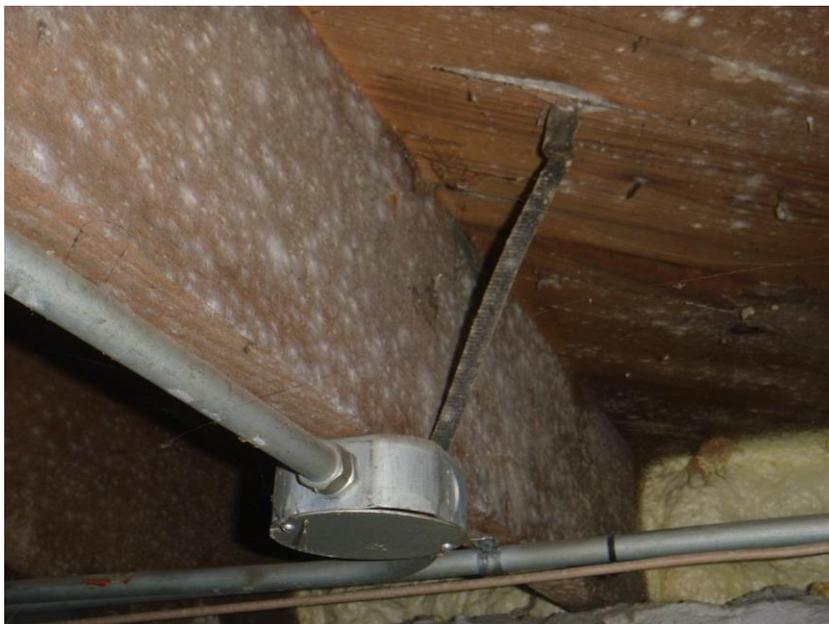
Defect. Knob and tube wiring was observed. This is a "Safety Concern". Suggest review by licensed electrician prior to closing for replacement and removal of all knob and tube wiring. No GFCI protection noted. Suggest client consider upgrading with GFCI's at all basement receptacles to enhance safety. Upgrades should be performed by a licensed electrician.

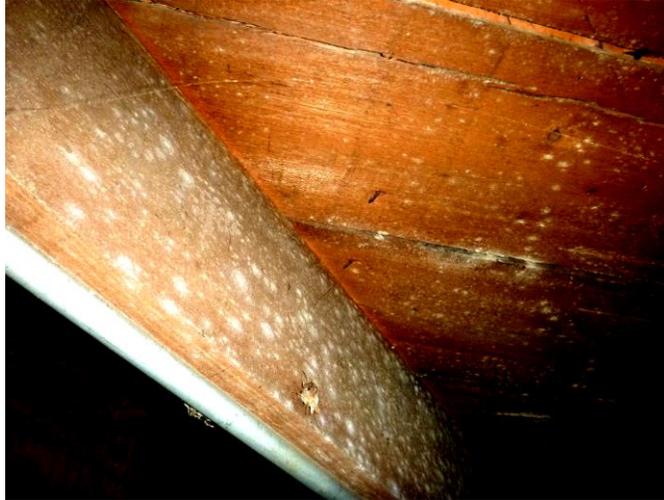
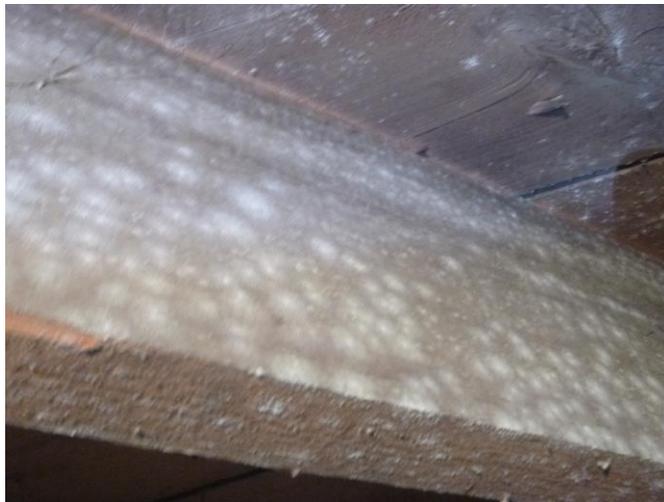
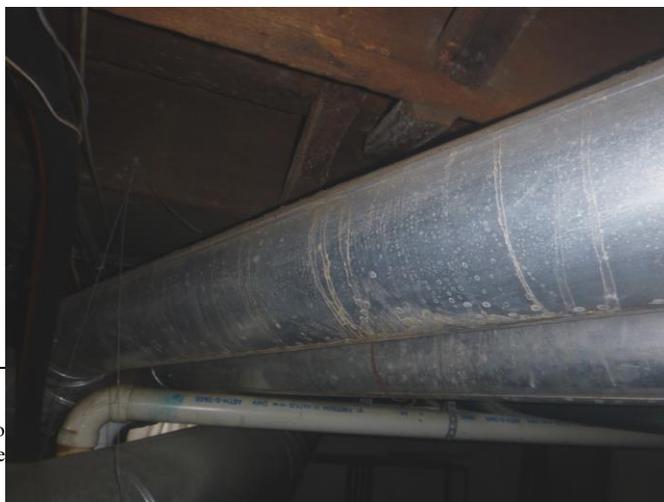
Defect. Stains, discoloration, growth and/or evidence of moisture observed on framing. These conditions may indicate mold and/or fungus growth and were discovered during the home inspection. Because certain types of mold may be toxic and result in adverse health effects, we recommend further review by a specialist so proper repairs and clean-up are made. Water stains not on ducts may indicate a past moisture issue in the basement. Recommend evaluation by a qualified contractor.

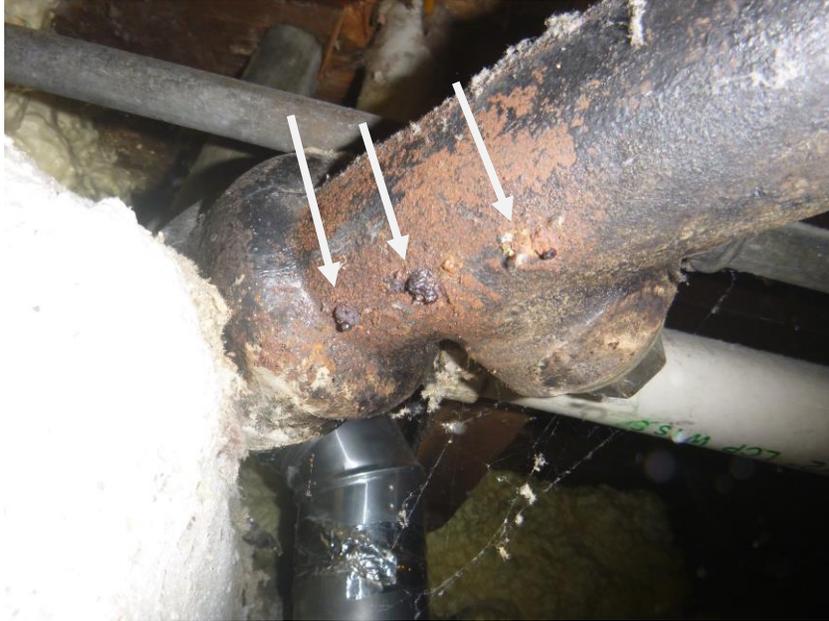
1705. Drain Waste Lines & Vent Pipes
Defect. Rust nodes and evidence of leakage noted on the kitchen sink drain pipe in the basement. Recommend review by a licensed plumber for repair or replacement, as necessary.

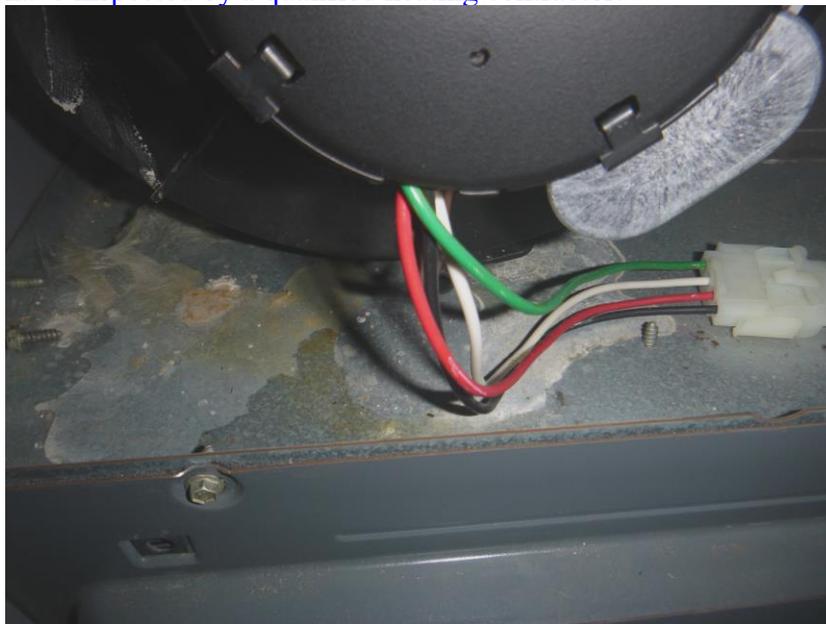
Step #	Component	Comment
1901.	Location of unit	The heating system is located in the basement.
1902.	Heating Design Type/Brand & Age	Gas forced air; High efficiency furnace. Manufactured by Armstrong in approximately 2012.
1903.	Energy Source	Natural gas with shutoff valve provided.
1904.	Burner Chambers	Serviceable. Only a small area of the heat exchanger was visible without disassembling the unit. This is a limited review.
1905.	General Conditions	Maintenance. Evidence of past condensate leakage noted in the cabinet. The area was dry at the time of the inspection. Recommend contacting the seller(s) for more information, or have inspected by a qualified heating contractor.

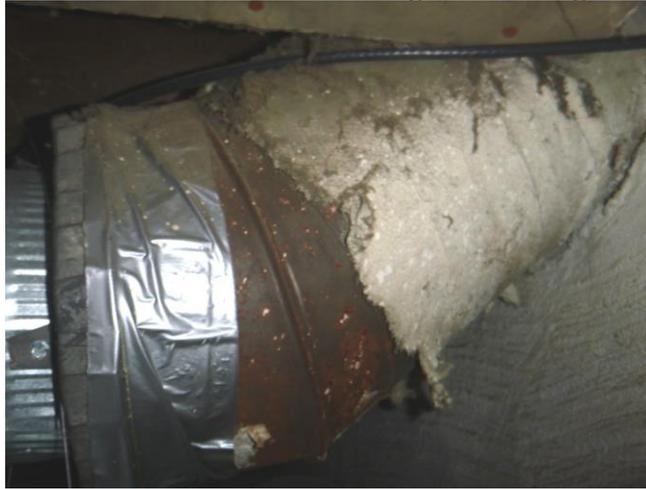
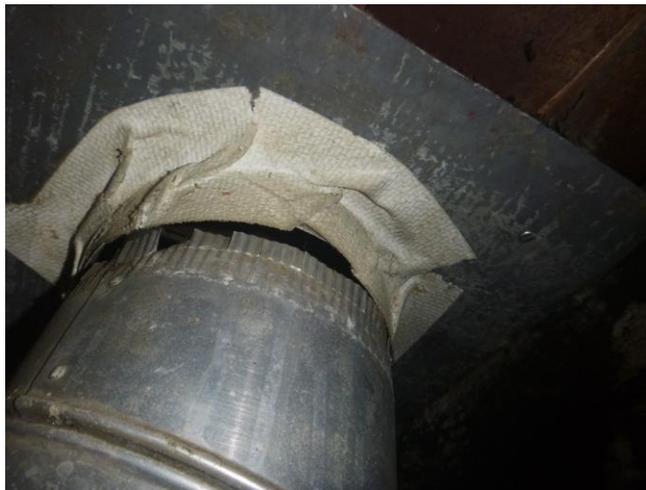
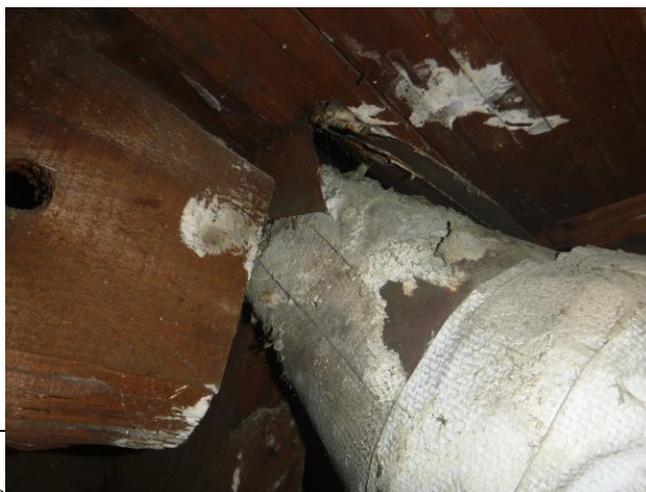
Defect. Ducts/Registers. Possible asbestos materials observed. The materials were torn, ripped, or damaged at the time of inspection. This is a possible safety hazard. Suggest further review by a licensed asbestos testing lab be performed prior to closing for repairs/replacement needed to ensure safety. Loose and disconnected ducts noted. Recommend review and repairs by a qualified heating contractor for efficient heating and cooling of the house.

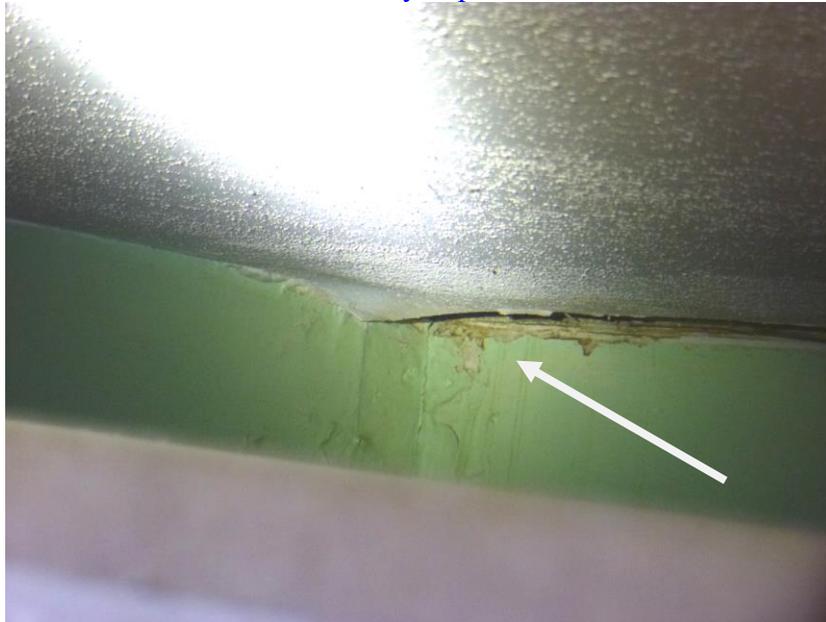
Step #	Component	Comment
2201.	Floor	Serviceable. Sheet vinyl.
2202.	Walls	Serviceable.
2203.	Ceiling	Maintenance. Stains observed at the front right corner of the eating area. Recommend contacting the sellers for more information or further review by a qualified contractor.

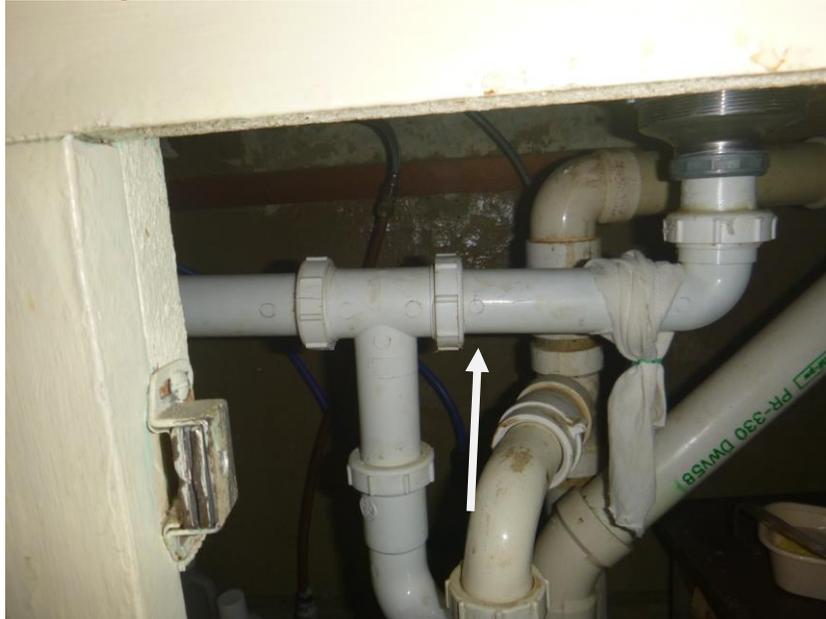
2213. Traps / Drains / Supply **Defect. Negative slope and improper Tee noted. Recommend review by a licensed plumber for repair or replacement, as necessary.**

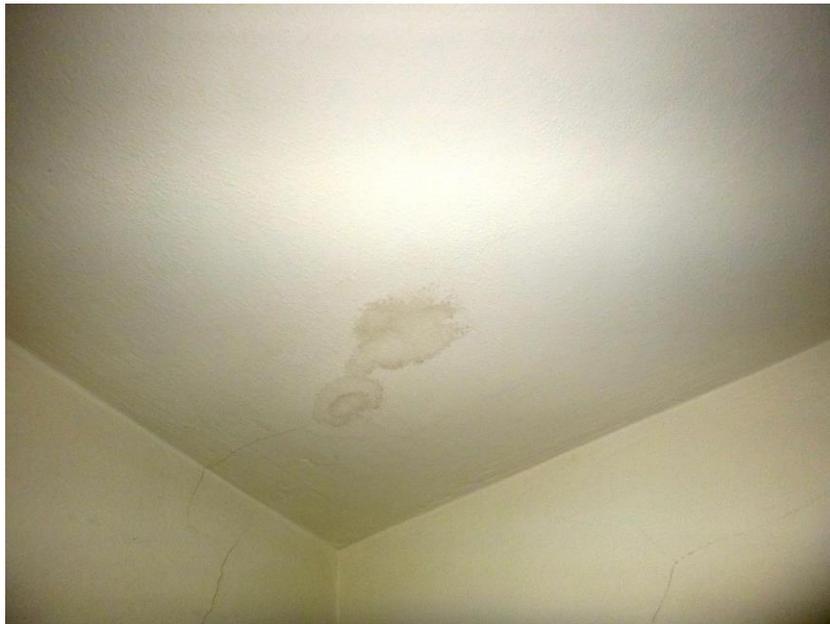
Step #	Component	Comment
2681.3.	Location	Second floor; Rear; Right side.
2682.3.	Floors	Serviceable. Carpet.
2683.3.	Walls	Serviceable.
2684.3.	Ceilings	Maintenance. Stains observed in the closet ceiling. A qualified contractor is needed for further review and to perform necessary corrections.

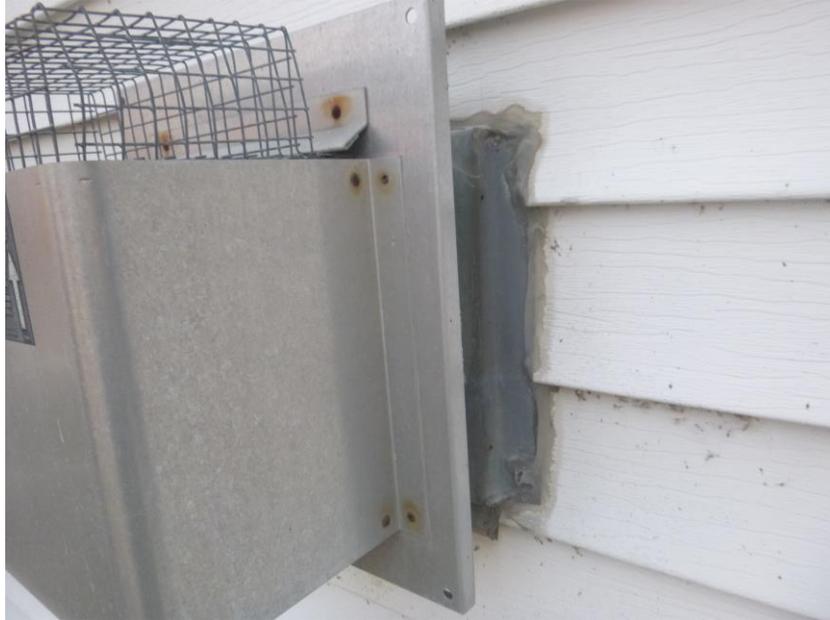
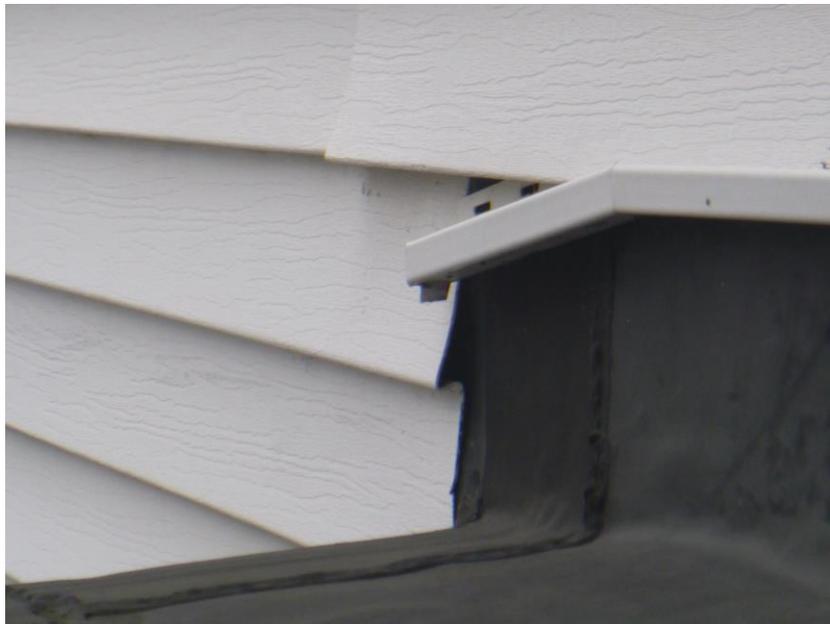
Defect. Vinyl siding. The fireplace vent is not properly flashed. Loose siding and improper flashing noted between the flat roof systems and siding. Recommend review by a qualified professional for repair or replacement, as necessary. Caulking should be applied at all joints and penetrations as part of normal maintenance.

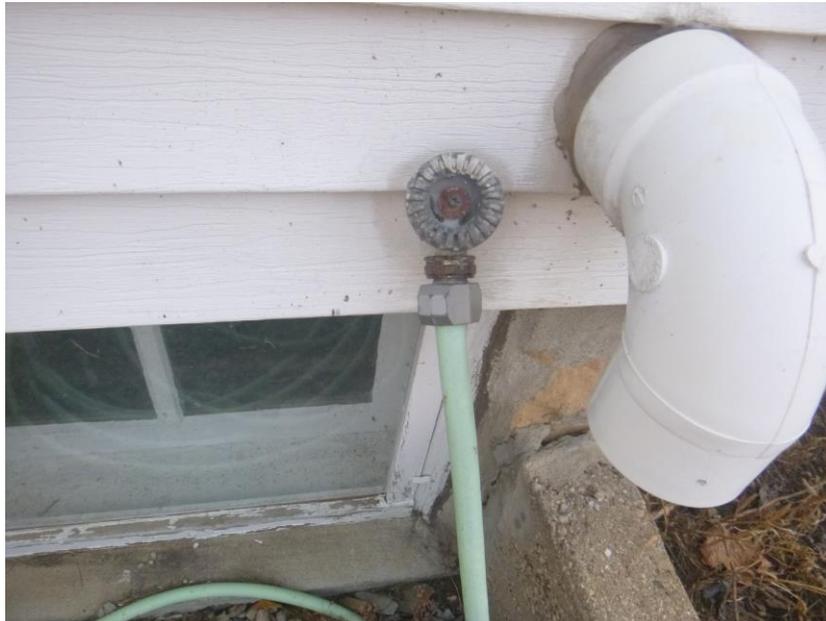
1106. Exterior Door(s) Serviceable. Wood; Storm door. Doors with glass that are near the floor level could be dangerous. Suggest that the Client consider upgrading to safety/tempered glass to enhance safety. A qualified glass company should be consulted for a complete review of all windows and doors that may require upgrades to ensure safety.
1107. Gutters / Downspouts Serviceable. Metal.
1108. Fences / Gates Not Present.
1109. Electrical **Defect. The GFCI at the rear porch does not trip when tested and does not have a weatherproof cover. Recommend repairs by a qualified electrician for safety.**
1110. Electric Meter(s) Serviceable. The electric meter is located at the right side.
1111. Gas Meter(s) Serviceable. The gas meter is located at the right side. The main gas shut off valve is located at the meter.
1112. Exterior Faucets **Maintenance. A hose is attached to the right faucet. This may cause freezing and damage to the pipe. The faucet was not operated. Recommend verifying operation with the sellers and inspection for leakage prior to close. Suggest upgrading the exterior faucets to frost-free with an air gap to prevent freezing and water siphoning water back into the house from a garden hose.**

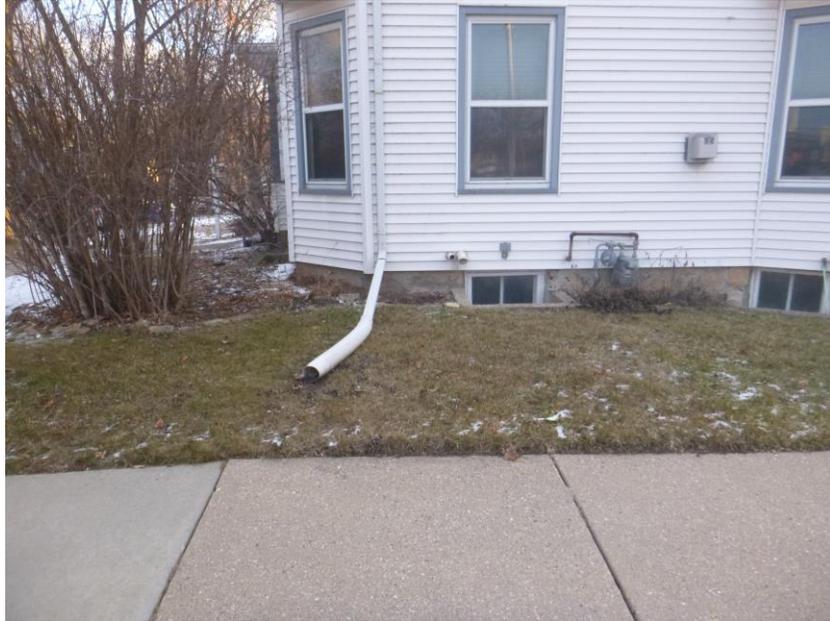
1115. Lot / Grade Drainage **Defect. Flat lot; Minor slope. Inadequate grade noted at several areas. Recommend review by licensed contractor for corrections as needed. We suggest maintaining a positive grade away from the foundation walls around the entire house, wherever possible, to further channel water away from the foundation walls and to reduce the potential for possible water infiltration into the home.**

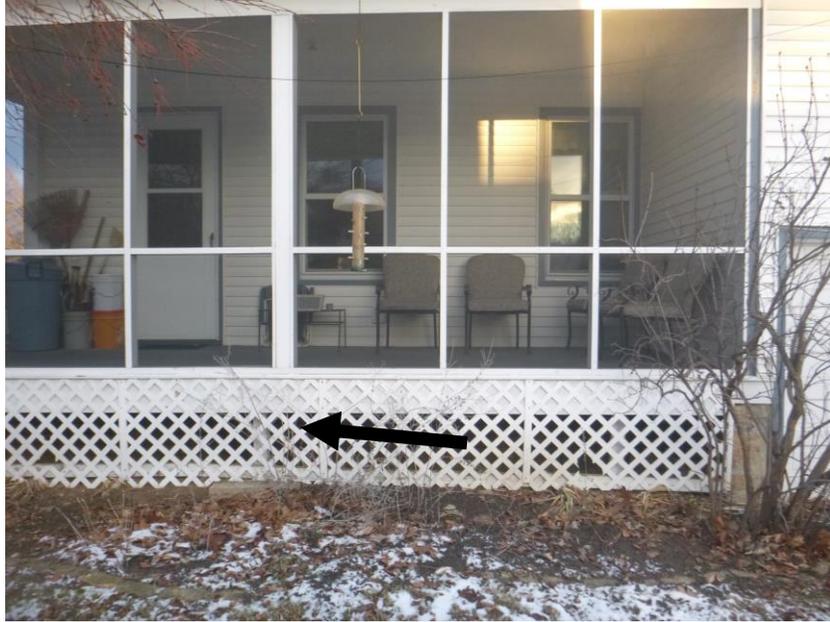
Defect. Wood; Screened. No guardrails noted. Recommend review for installing guardrails for safety. The middle roof support post is not installed directly above the post below. The outed joist is bolted onto the post, not set on top. Recommend evaluation by a qualified contractor.

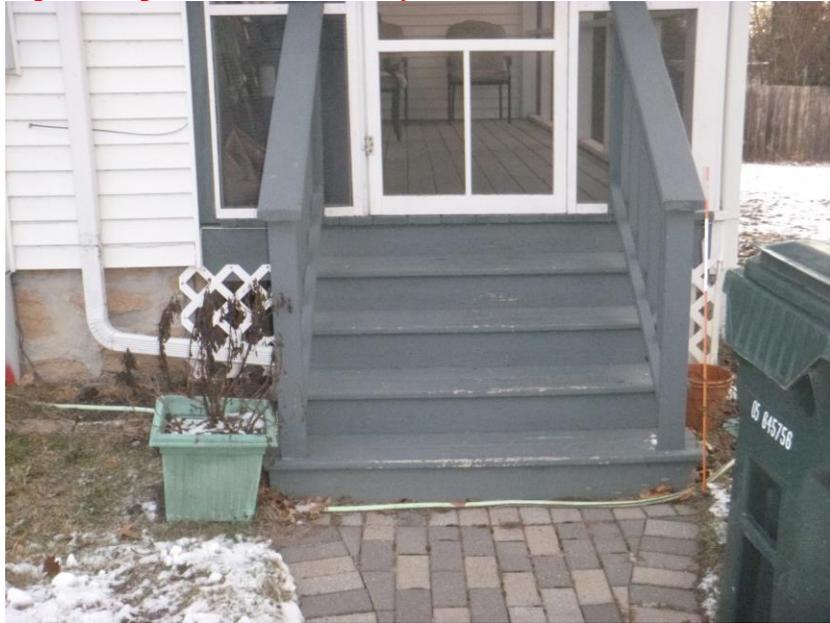
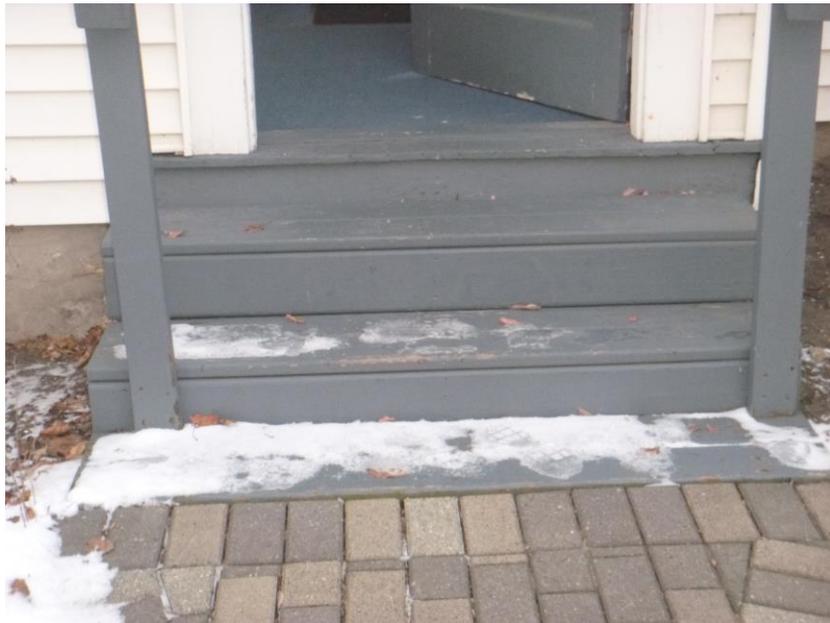
Defect. Wood. Uneven risers noted posing trip hazards. The wood tread at grade level at the front steps poses a slip concern. Recommend review by a qualified contractor for repairs/replacement for safety.

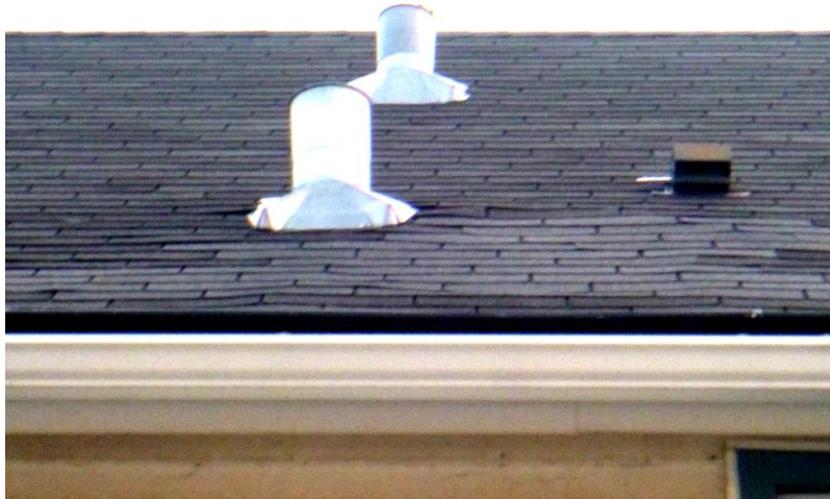
Shingles are curling. Some granule erosion noted. Wavy and uneven shingles noted. Repairs noted. Recommend further review by a qualified roofer.

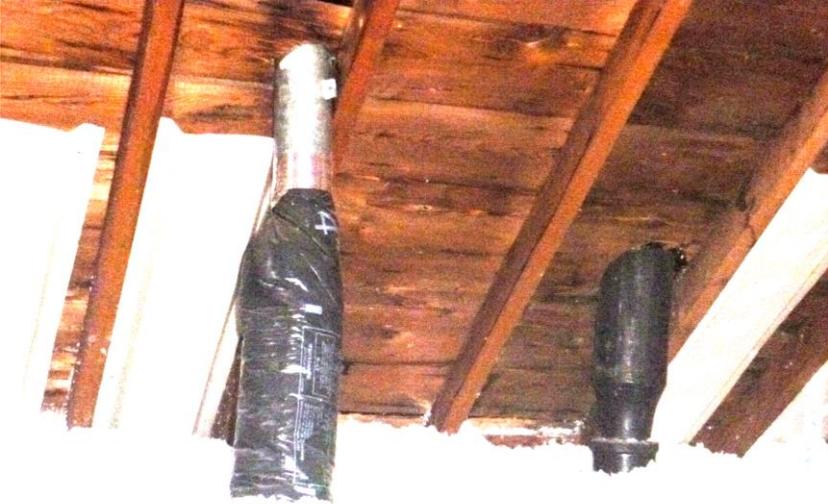
Step #	Component	Comment
1351.	Access location / Inspection method	The attic was inspected from the access.
1352.	Framing	Serviceable. Rafters; 2X4.
1353.	Sheathing	Serviceable. Spaced wood plank. Spaced planking may need to be upgraded to a solid sheathing when a new roof is installed. This will add to the cost of a new roof.
1354.	Evidence of Leaking	Yes. Stains observed on the roof decking. No moisture was present at time of inspection. Recommend monitoring.

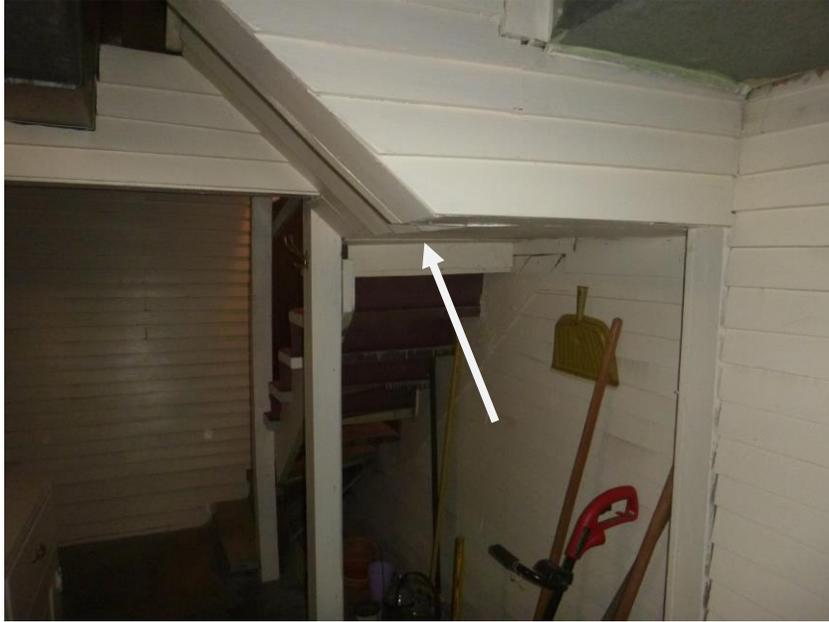
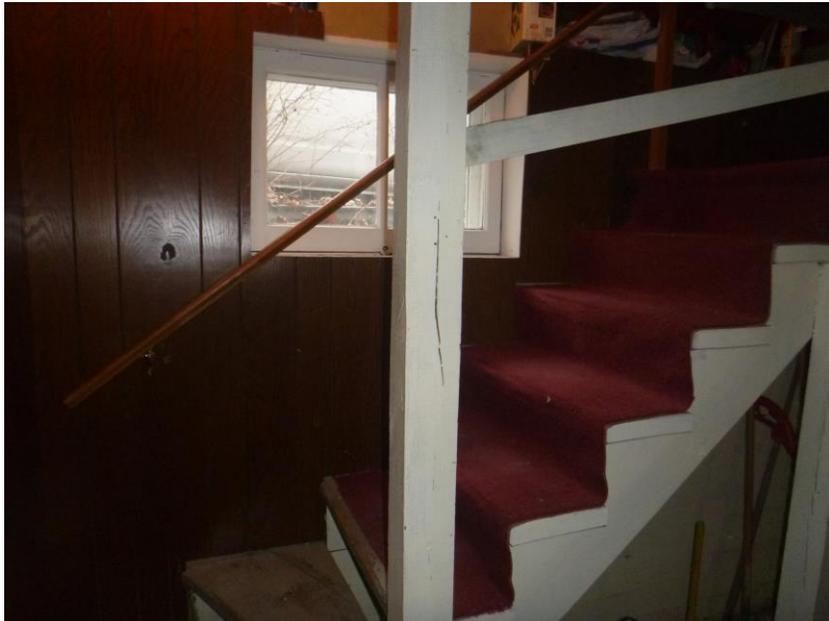
Defect. The landing is not properly supported. No guardrails noted. Uneven and open risers noted. The window in the stairs is not tempered/safety glass. Inadequate headroom noted. Recommend review by a qualified professional for repair or replacement, as necessary.

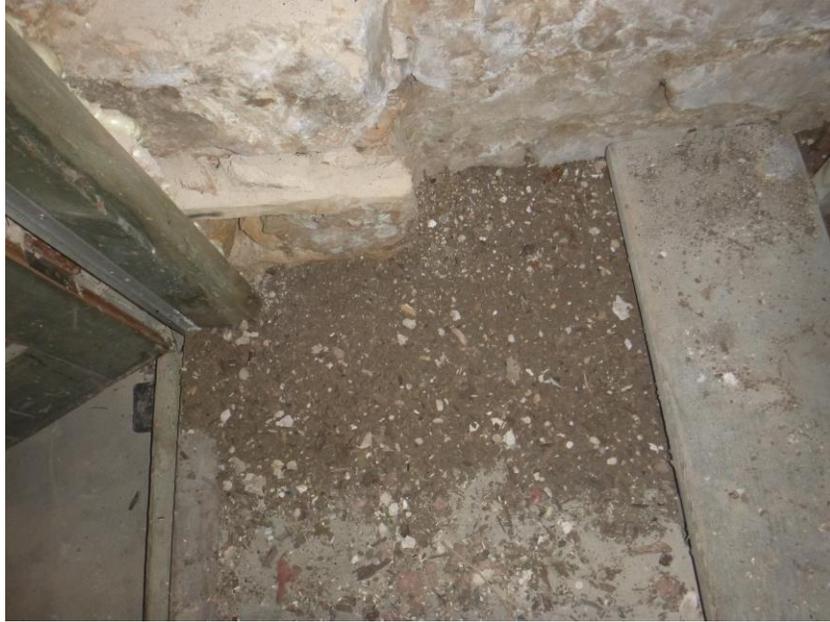
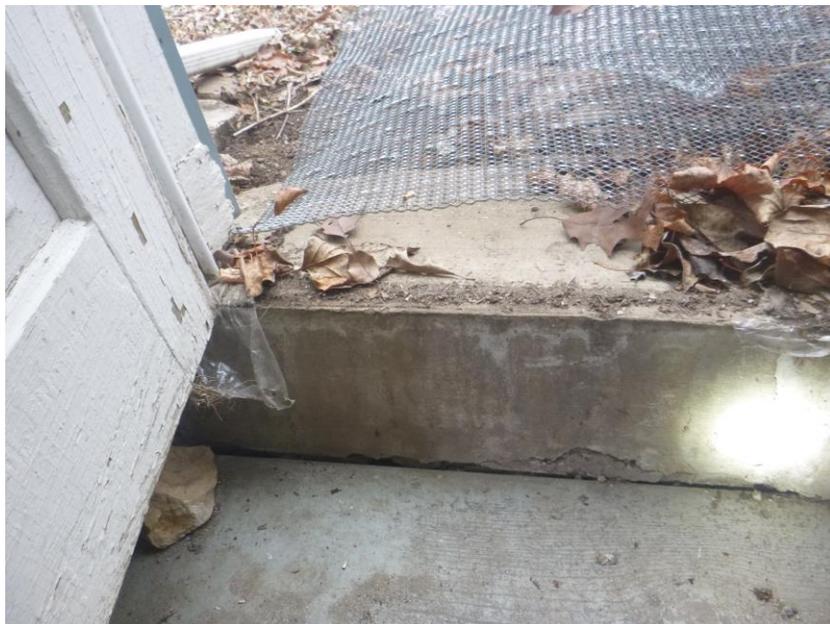
Defect. Open risers, uneven risers and inadequate headroom noted. The door opens over the stairs posing a safety issue. Evidence of water and pest entry noted. Recommend review by a qualified professional for repair or replacement, as necessary.

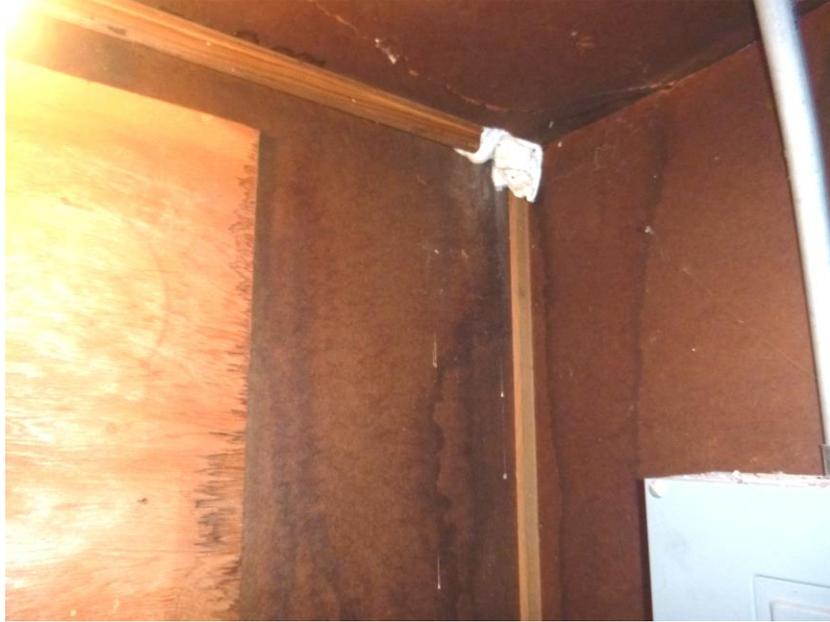
Maintenance. Stone. Water stains noted near the electric panel. Recommend contacting the sellers for more information and monitoring or have reviewed by a qualified contractor. The foundation walls are mostly covered and not visible for inspection.
