Re: Agenda Item 8, Legistar File #85527
Appeal of the Plan Commission action on the demolition permit for 2121 Jefferson St. and
1007 Edgewood Ave.
October 29 Common Council Meeting

AmeriSpec Inspection Service

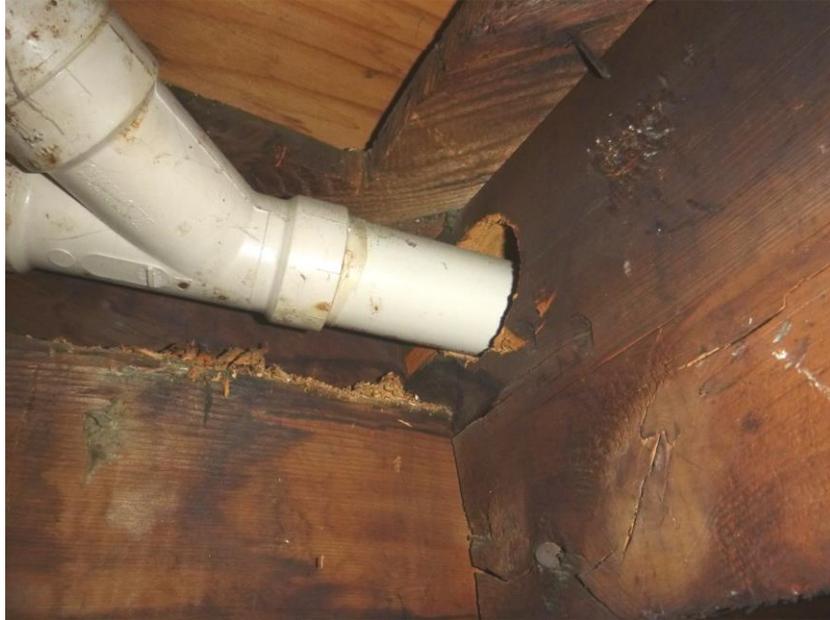
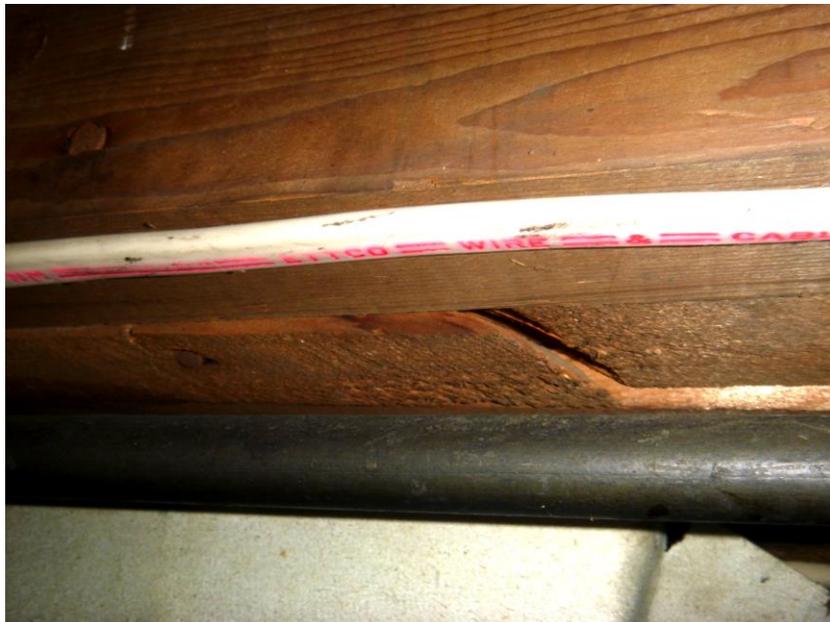
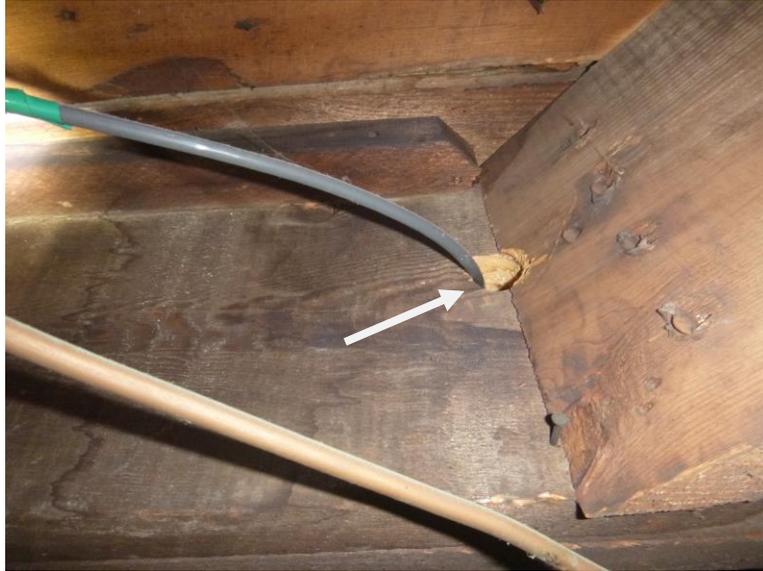
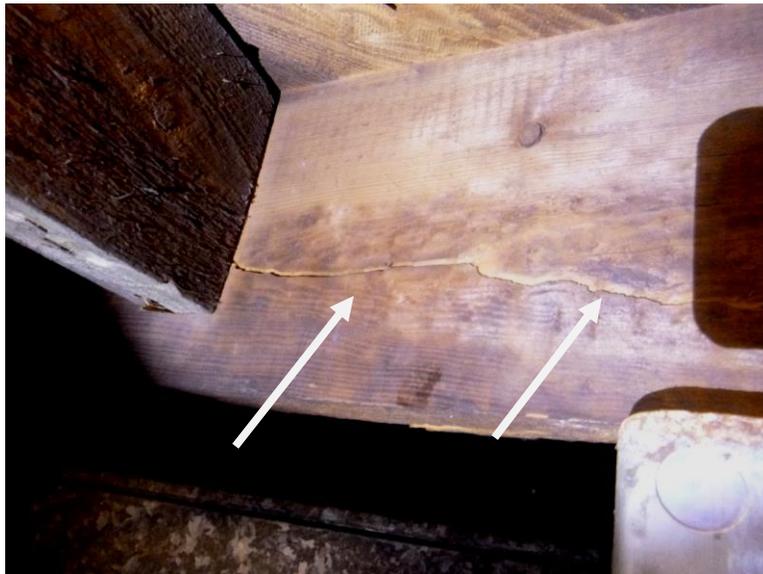
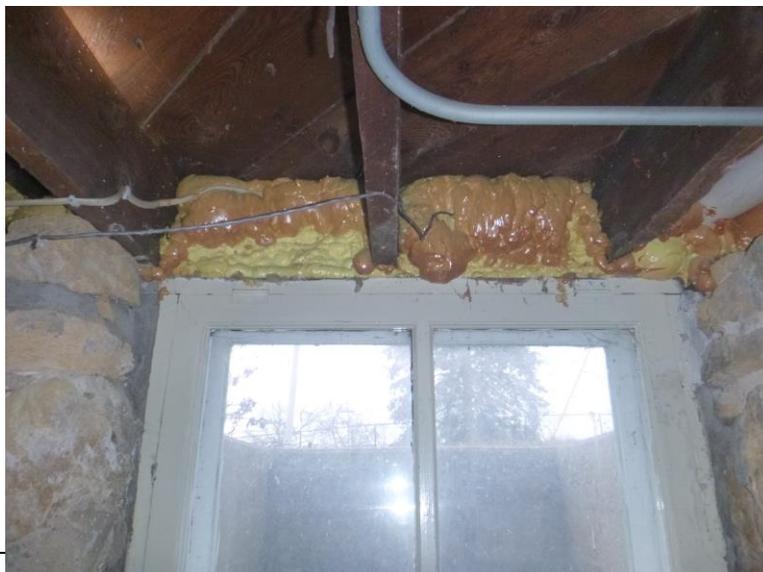
Defect. Conventional 2 X 8 framing. Improperly bored holes noted. Cracked/split joists noted. Joists are notched to seat on the beam nailers weakening the joists. Joists are improperly supported by window frames. Recommend review by a qualified professional for repair or replacement, as necessary, prior to close.

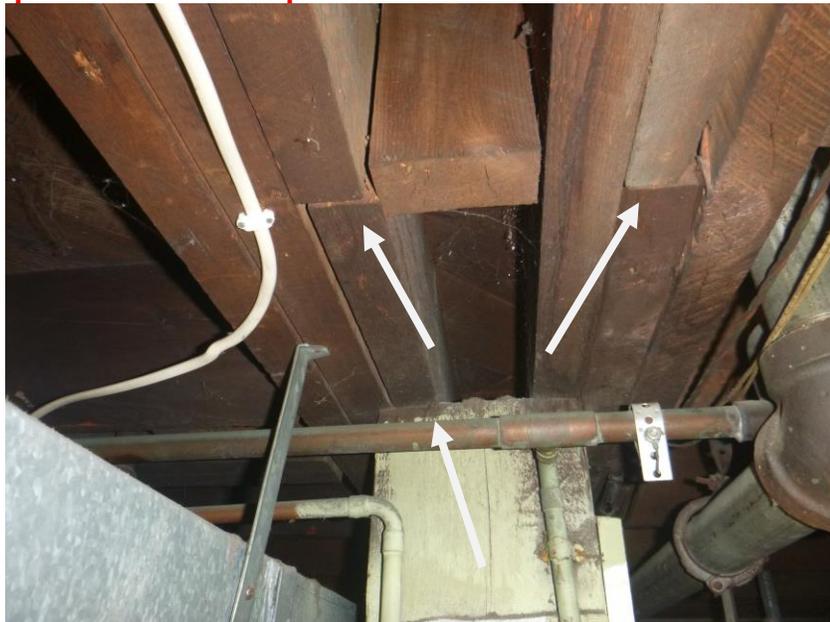
Defect. Wood. The split beam system is not properly supported at the posts. The beam is crushing onto the posts. Splices in the beam noted not installed over posts. Cracked beam noted. Recommend evaluation and repairs by a qualified contractor prior to close.

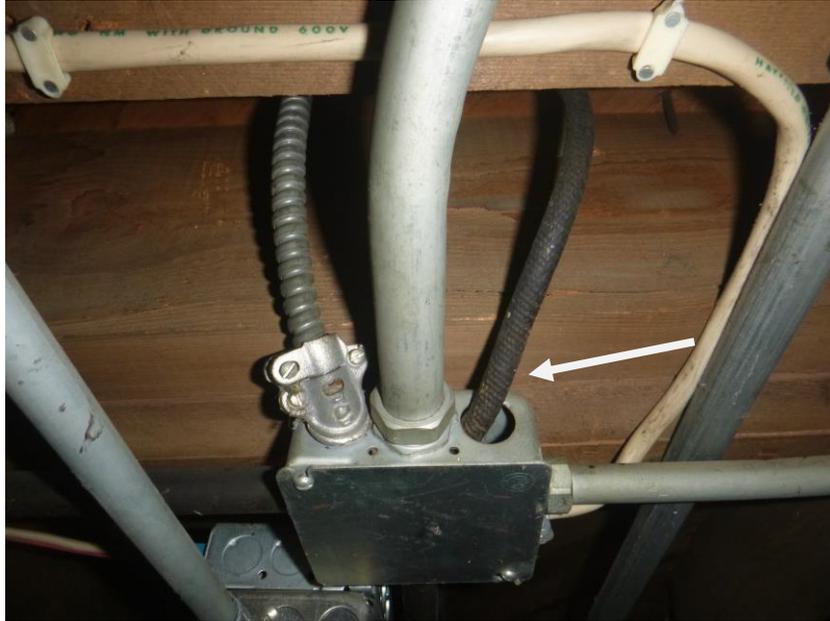
Defect. Knob and tube wiring was observed. This is a "Safety Concern". Suggest review by licensed electrician prior to closing for inspection and replacement of knob and tube wiring. No GFCI protection noted. Suggest client consider upgrading with GFCI's at all basement receptacles to enhance safety. Ungrounded receptacle noted. Recommend review and repairs by a qualified electrician.

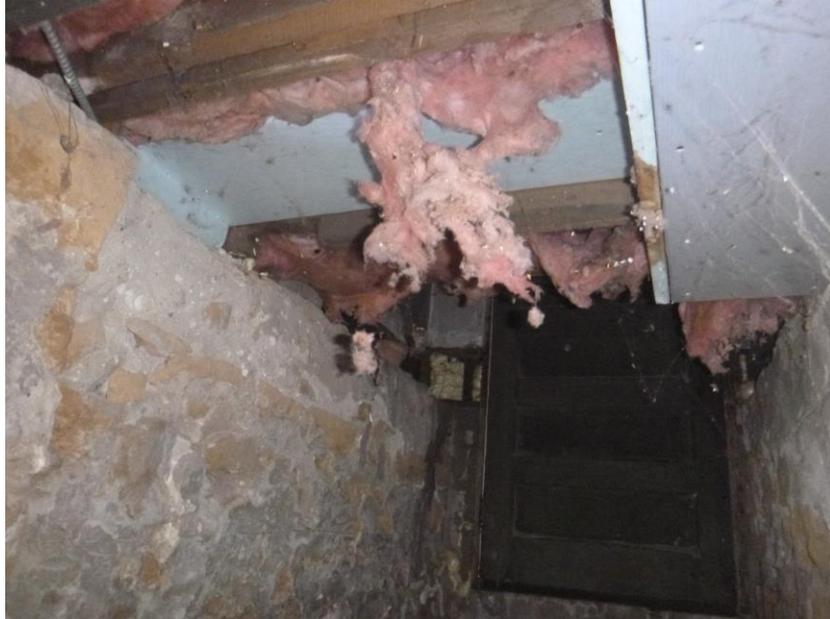
Defect. Fiberglass; Spray Foam Insulation. The kitchen pantry is not properly insulated. Recommend review for repairs for efficiency.

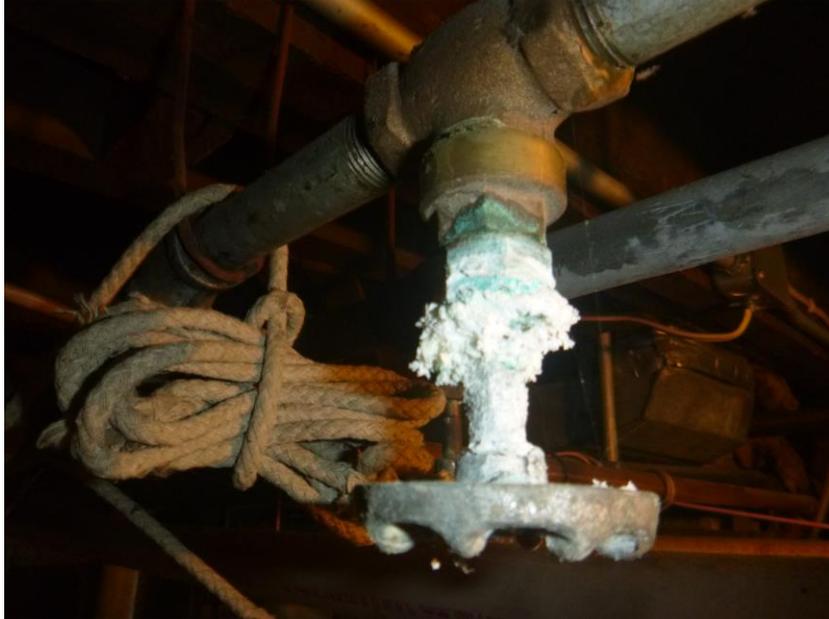
Defect. Evidence of leakage noted on a valve near the water softener. Recommend review by a licensed plumber for repair or replacement, as necessary.

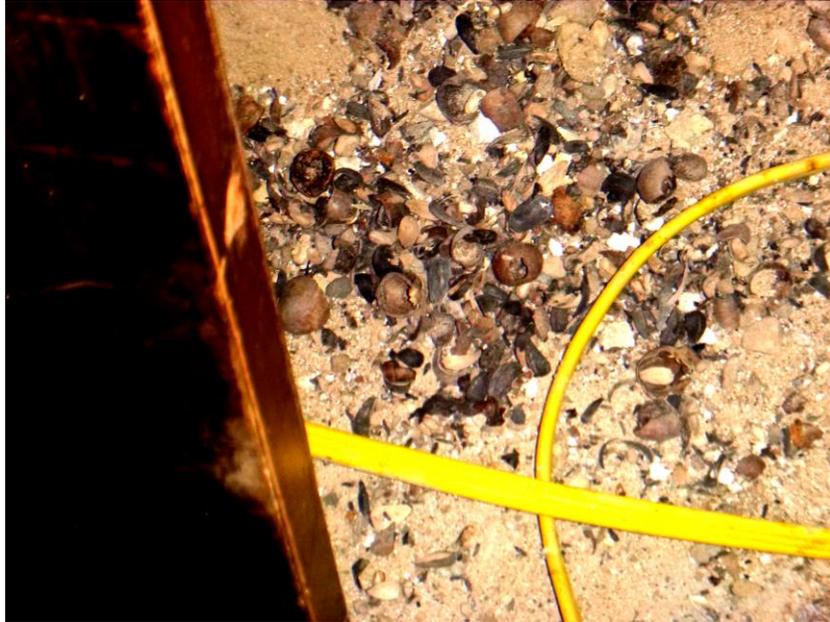
Yes. Evidence of rodents noted. Recommend review by a qualified pest control specialist.
