EXISTING BUILDING REVIEW

120 W. Mifflin Street

Name: Andrew Schubert Building

120 West Mifflin Street – Architectural Review

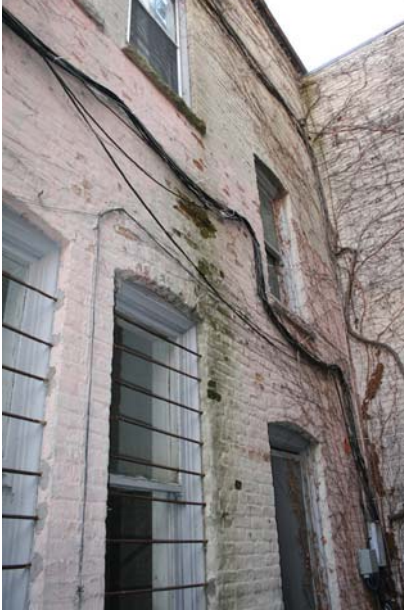
Exterior: View of the back of building showing eroding brick veneer

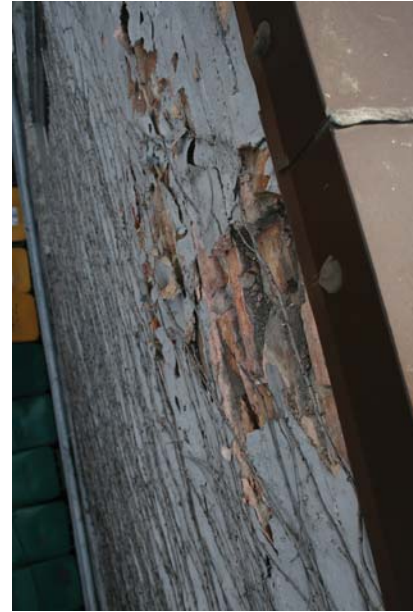
View from roof looking at condition of brick and parged wall

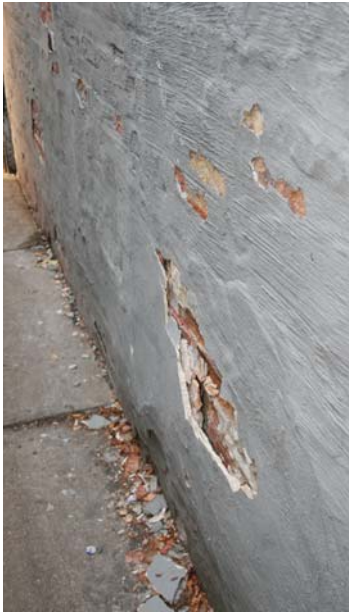
Exterior: View in the alley showing a section of delaminated parging

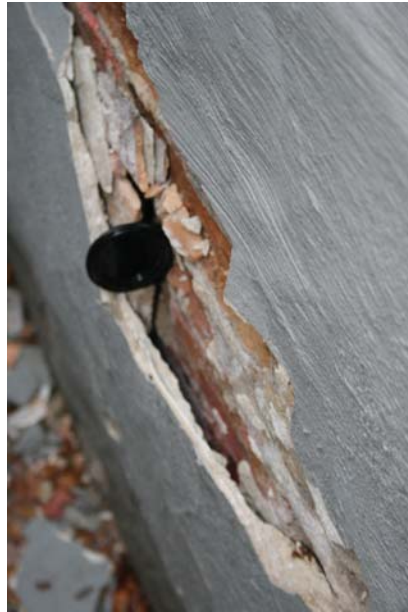
Exterior: View in the alley showing the delamination of the parging system from the brick veneer

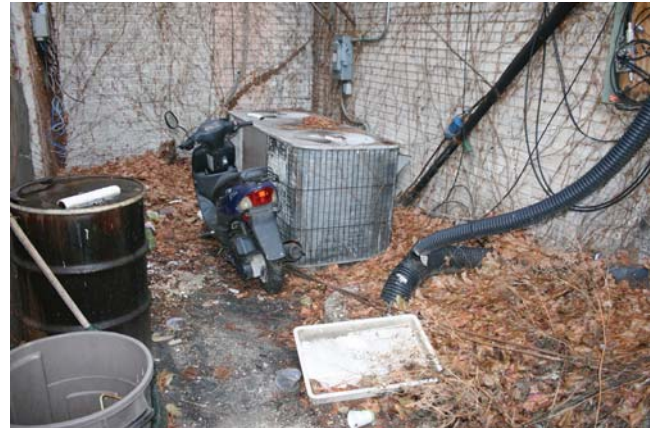
View of space behind existing building showing storm basin collecting water from adjacent buildings

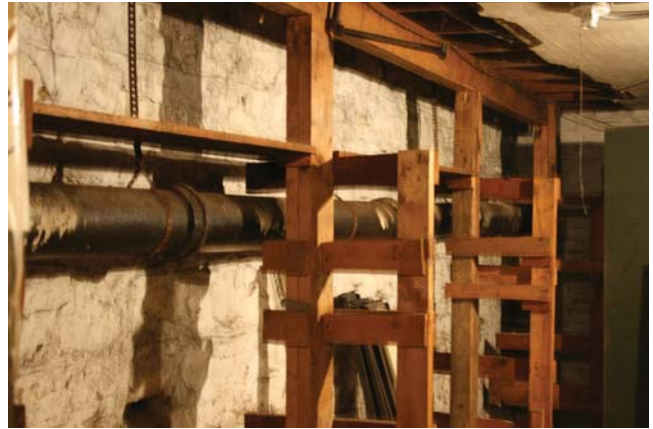
Basement view showing stormline routing storm water from adjacent building(s) through the basement of 120 West Mifflin Street

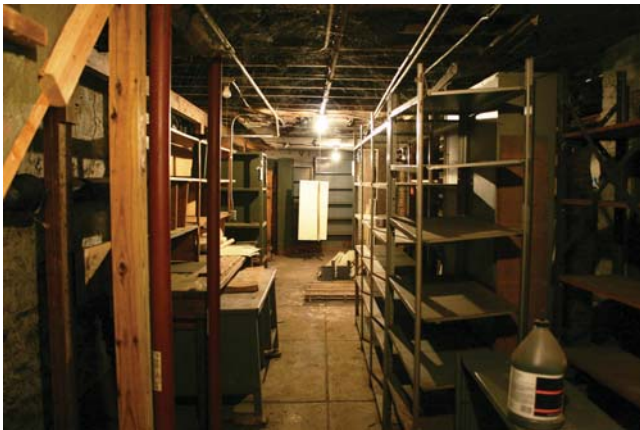
Basement: Temporary shoring to support first floor

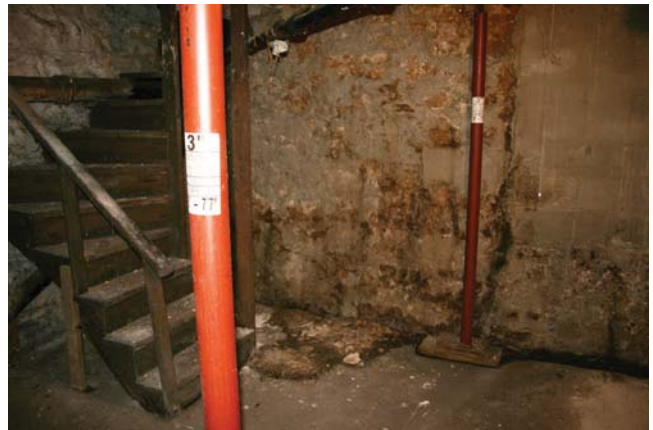
Basement: Temporary shoring to support first floor

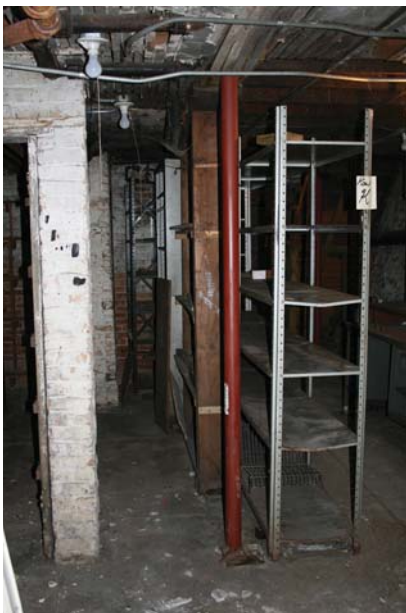
Basement: View of one temporary column supporting the first floor

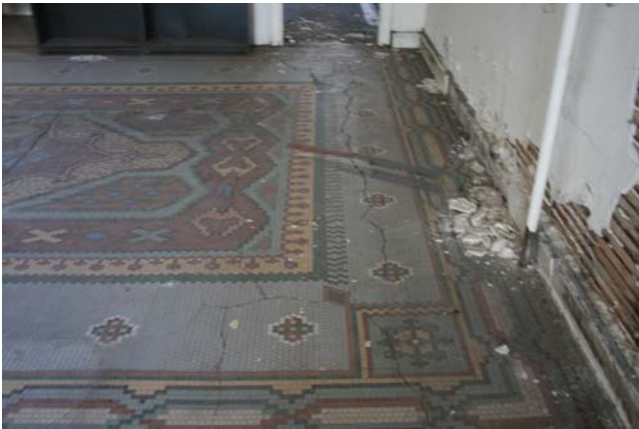
First Floor: View toward back exit showing multiple cracks in floor tile

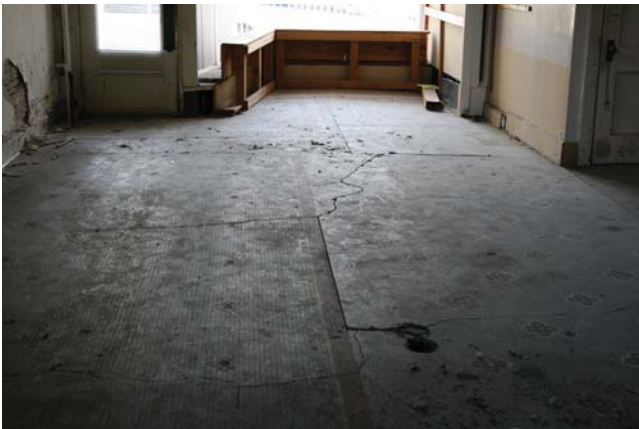
First Floor: View toward Mifflin Street entry showing multiple cracks in floor tiles

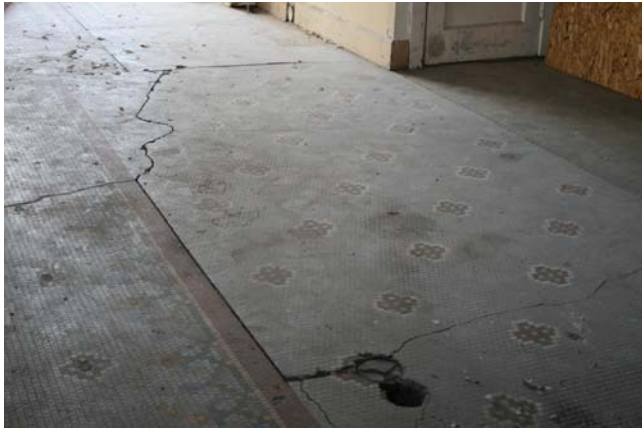
First Floor: View toward basement stair showing multiple cracks in tile floor

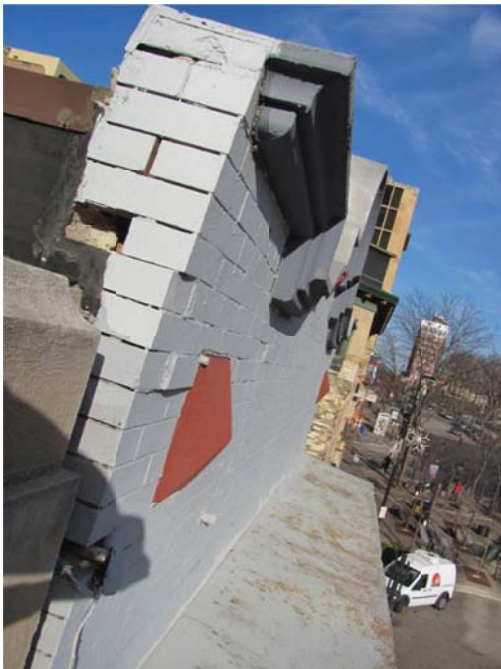
The top west (left hand, as viewed from the street) corner of the parapet wall is displaced outward, with dislodged brick units and open mortar joints at this location (Figure 2). At the limestone masonry of the first floor, some areas of coating have debonded, revealing the stone below (Figure 3). Open mortar joints were observed in the limestone portion of the facade. Although coated, the limestone and face brick masonry at the street facade appears to be in fair to good condition.

Figure 2. Left. View of displaced masonry at the top corner of the parapet wall.

The Mifflin Street facade is generally in good condition. Appropriate repair would begin with removal of the existing coating from all masonry using chemical strippers, followed by a more detailed assessment of repair needs. The extent of repointing of the brick and limestone masonry can be determined following removal of the coating. At the west (left hand) top of the parapet wall at the street facade, an approximately three foot by three foot area of displaced brick masonry will likely require dismantling and reconstruction.

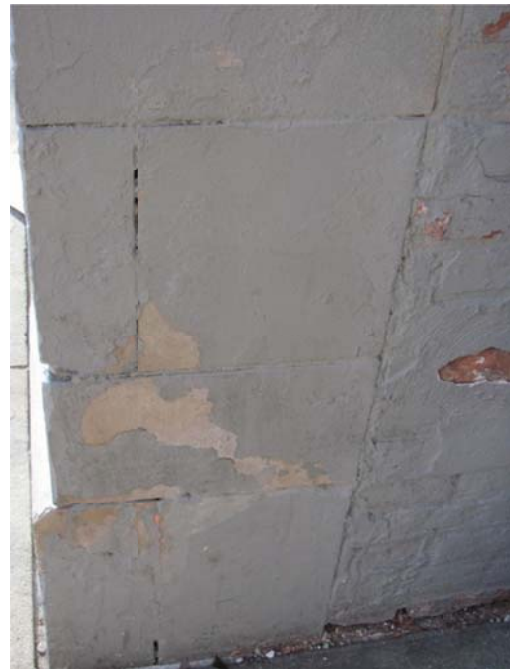
Figure 3. Right. At the limestone masonry of the first floor, some areas of coating have debonded.

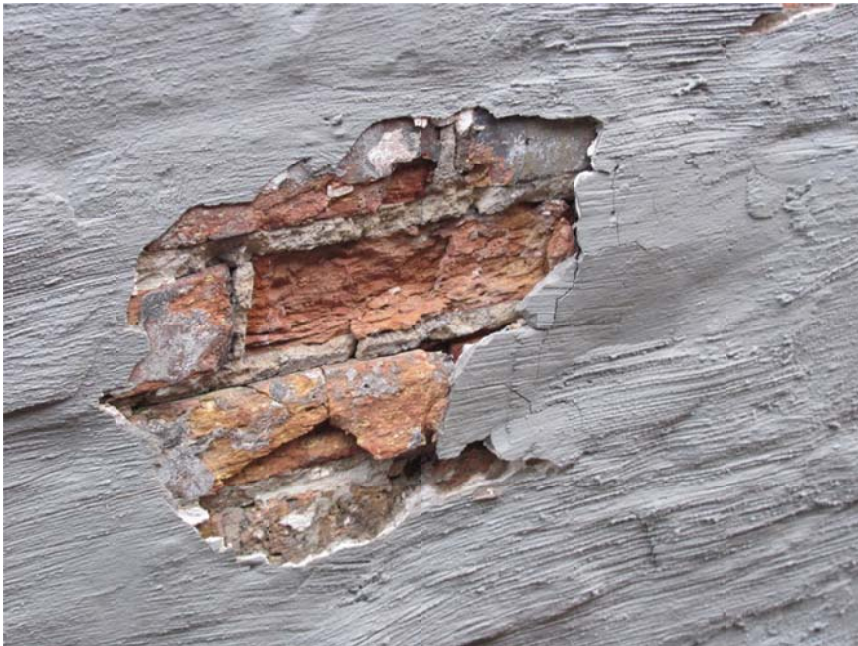
The northeast-facing side wall and northwest-facing rear wall are common brick masonry that has been variously parged and coated. Portions within 6 feet of grade have a build-up of multiple layers of cementitious parging and coating. These layers are now debonding, exposing the original brick masonry. The common brick masonry is in poor condition, with open joints and deep face spalling of the brick units. Examples of this distress are shown in Figure 5 through Figure 8. The deterioration is most severe near grade and below the coping at the top of the wall. The ongoing deterioration of this masonry wall has resulted in detached fragments of brick, mortar, or parging.

Figure 5. Failure of cementitious parge coat, revealing deteriorated brick masonry.

In contrast to the street facade, the side and rear walls are in very poor condition. Appropriate repair would include removal of existing coatings and parge materials, followed by selective replacement of the outer wythe of brick with new masonry. Replacement required is likely extensive, based on conditions observed. Based on this limited survey, the majority of the outer wythe of brick on the alley side and rear walls may require replacement, including extensive areas at grade and at the top of the walls. The condition of the backup wythes of brick masonry is not known at this time. Further investigation of the brick backup masonry, especially at grade and the parapet walls, is needed to determine if the existing deterioration extends beyond the exposed face wythe of brick and whether repair or replacement of backup masonry is required.

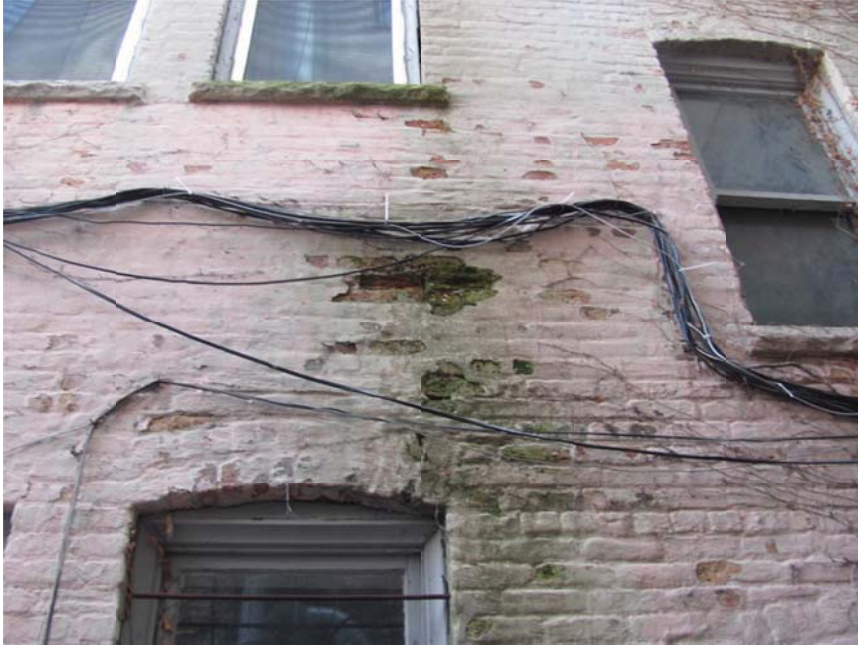
Figure 6. Deterioration of brick masonry at the rear facade.

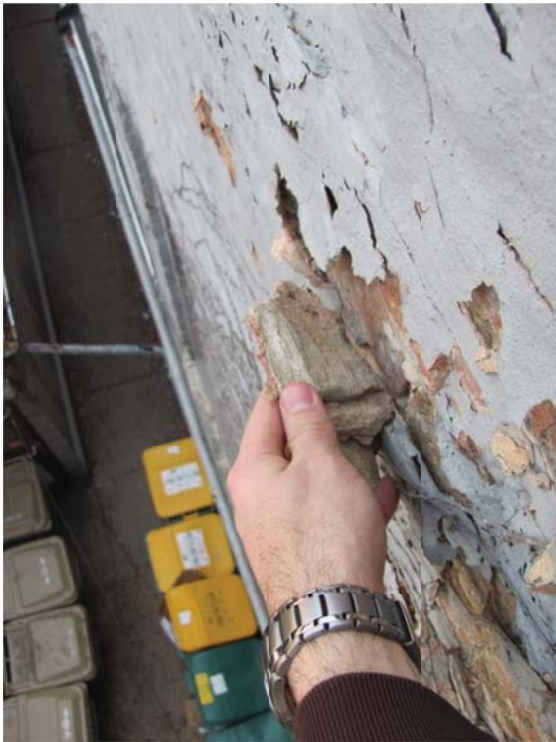
Figure 7. Left. Loose fragments of brick/mortar/parging were removed by hand from the side wall.

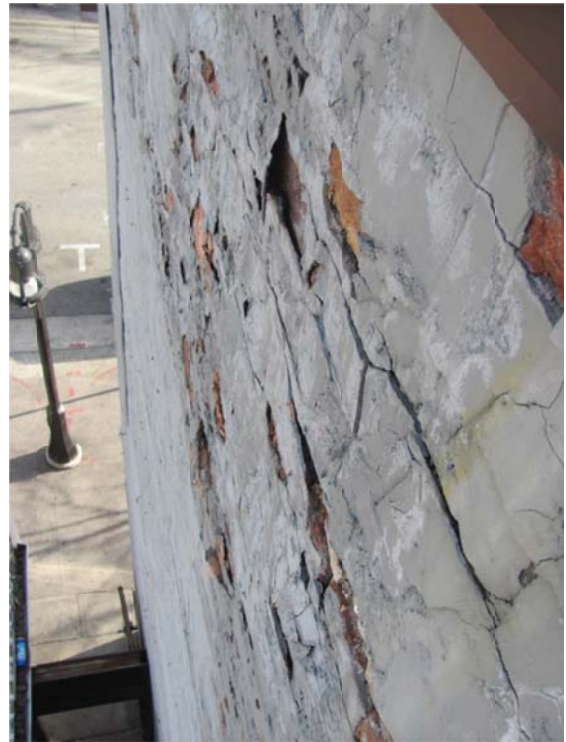
Figure 8. Right. Deterioration of brick and parging near the top of the side wall.

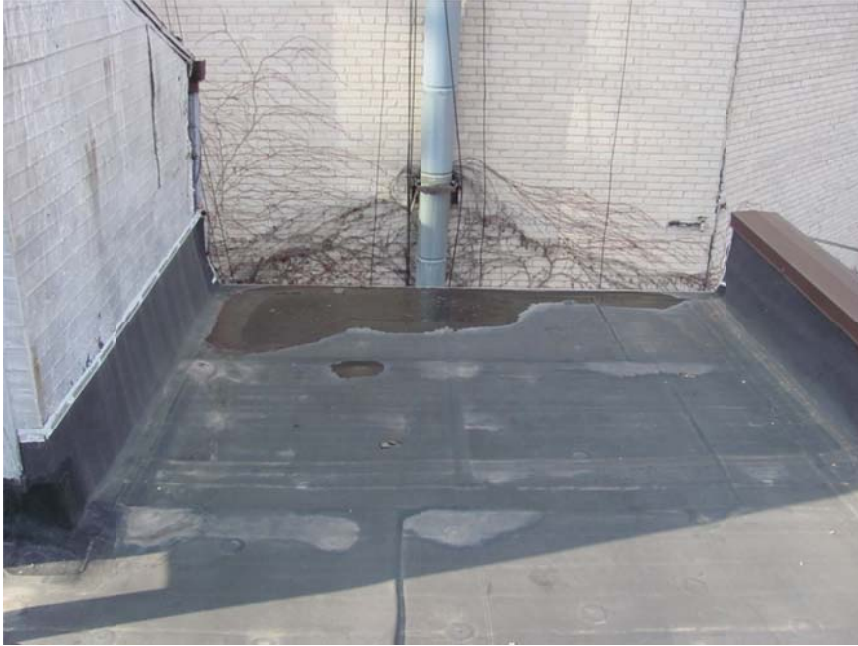
The roof is covered with a relatively new EPDM rubber membrane (Figure 10). The membrane is extended up the rear face of the parapet walls. The membrane intersects a sheet metal coping. Five circular attic vents are located near the south end of the roof. The roof slopes from south to north and is drained to a continuous galvanized metal gutter along the north wall. Ponded water was observed on the roof surface near the gutter (Figure 11). The gutter itself is in poor condition, with open seams, accumulated debris, and broken support brackets.

Figure 11. Ponding on the roof near the gutter.

The penthouse roof and wall cladding requires repair or replacement to create a watertight building envelope. The main roof appears generally watertight, but further investigation is needed to ensure that perimeter flashing details are appropriately integrated with the coping and that appropriate slope for drainage is provided. The existing gutters and downspouts along the rear wall should be replaced.

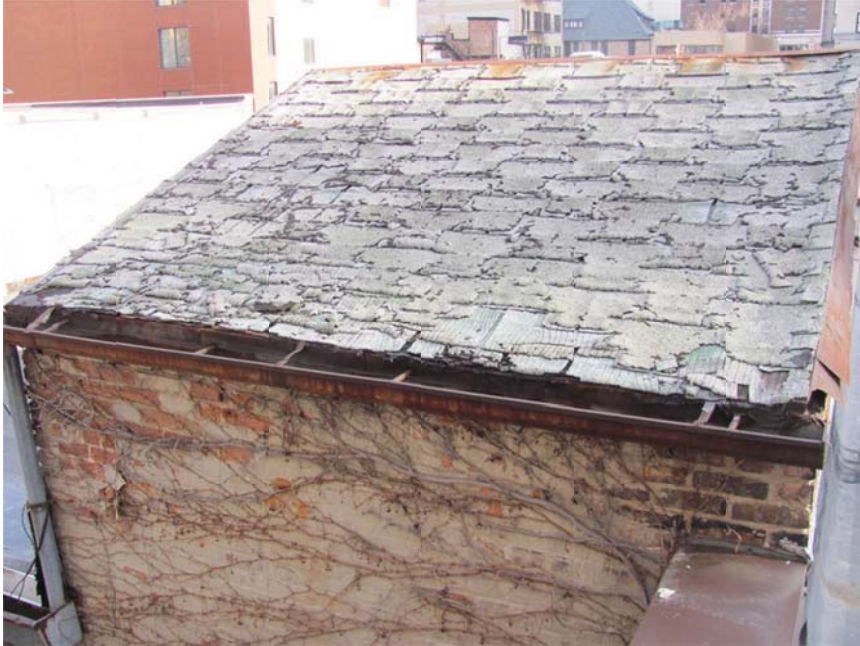
The roof is accessed through a small penthouse over the rear stairwell (Figure 12). The roof of the penthouse is covered with asphalt shingles that are in extremely poor condition (Figure 13). The walls of the stairwell are brick masonry and wood framing covered with painted sheet metal. Water infiltration through the walls and roof of the penthouse has occurred in the past, as the interior plaster in the stairwell is severely deteriorated.

Figure 13. The penthouse roof is covered with asphalt shingles in deteriorated condition.

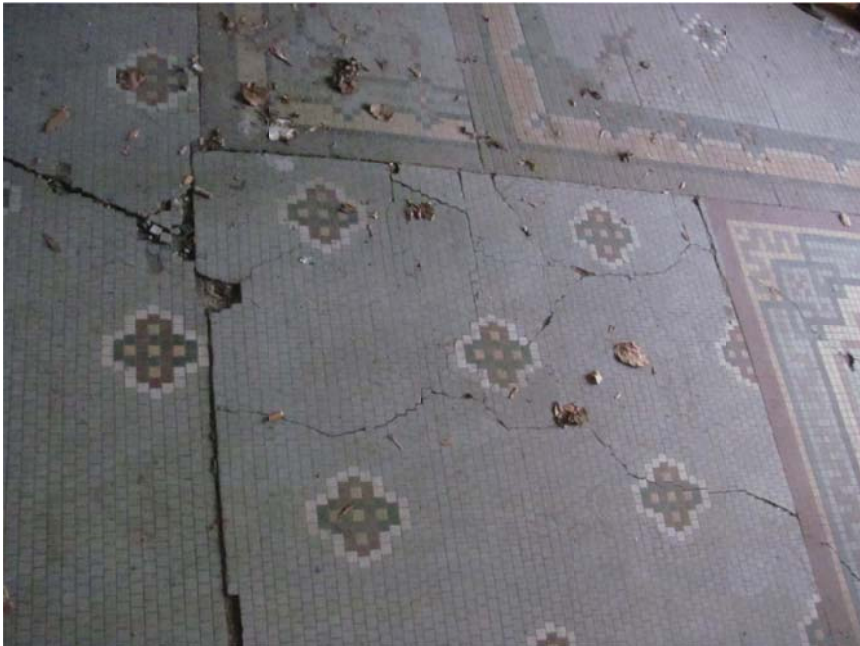
The first floor main interior room has four different areas of flooring consisting of elaborate decorative mosaic tile floor composed of various colors of 3/4 inch square tiles in a running bond. A portion of the ceramic tile flooring near the front door has been replaced with 1 inch square tiles with rounded edges. A second area of non-original flooring is located adjacent to the storefront at the southeast end of the space. Localized individual ceramic tiles throughout the flooring are missing and have been replaced with concrete patching. Extensive cracking, displacement, and settlement have occurred at this flooring (Figure 14). The distress in the flooring is apparently the result of significant and widespread deterioration of the basement-level wood columns, wood beams, and wood joists that support the floor. A detailed assessment of the first floor framing was beyond the scope of this study, but obvious signs of decay as well as previously installed temporary shoring were observed in the basement.

Figure 14. There is elaborate mosaic tile flooring at the first floor; the flooring has suffered extensive cracking and displacement.

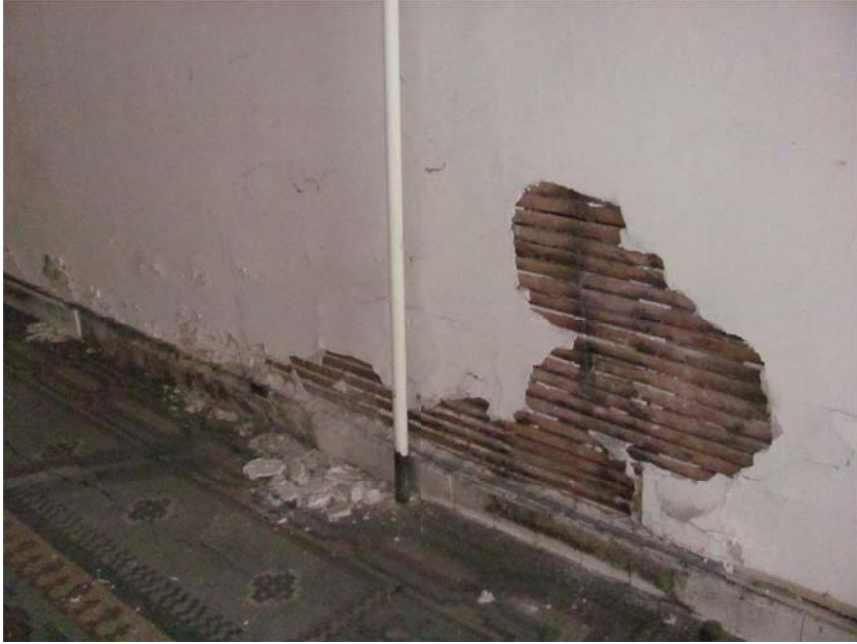
The first floor walls and ceiling are painted plaster on wood lath. Portions of the plaster have detached from the lath, likely due to water infiltration (Figure 15). Water staining and bubbling of the plaster were also observed (Figure 16).

Figure 15. Damage to interior plaster wall finish.

Interior plaster finishes have suffered deterioration apparently related to water infiltration through roofing and the side and rear brick masonry walls and may require replacement.

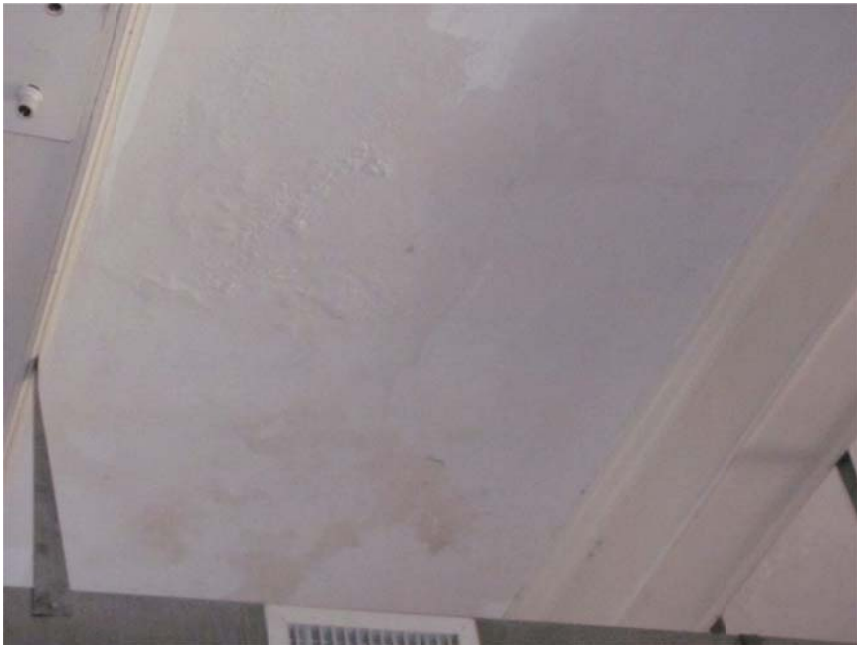
Figure 16. Water staining and bubbling of interior plaster ceiling.

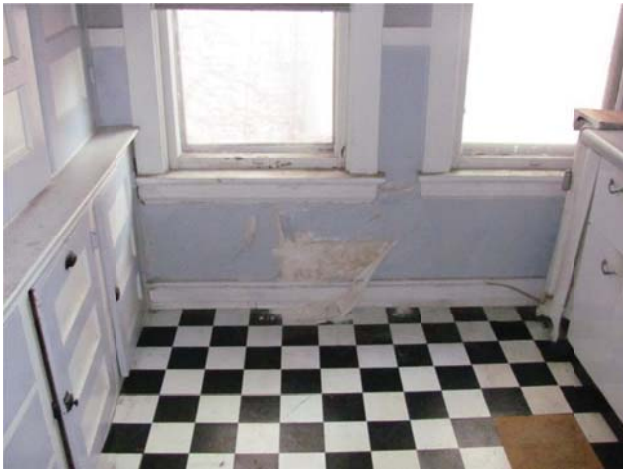
Figure 18. Plaster damage at the rear wall at the second floor of the building.

The second floor interior is in poor condition overall. Much of the interior plaster at or adjacent to the exterior walls has evidence of water infiltration damage and may require replacement. Consideration should be given to salvaging intact original elements such as interior doors and trim.

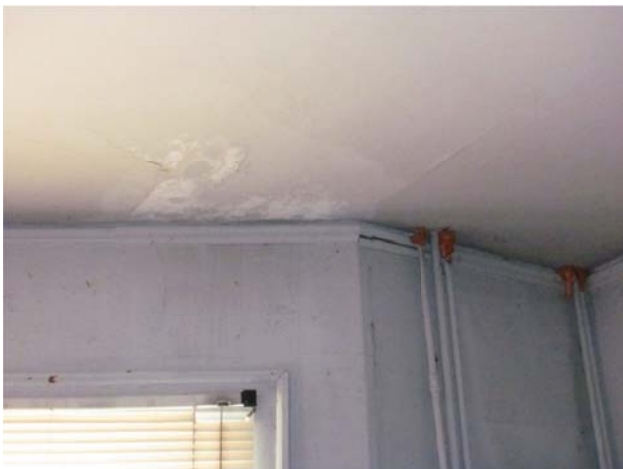
Figure 19. Moisture damage to plaster finishes at the second floor.

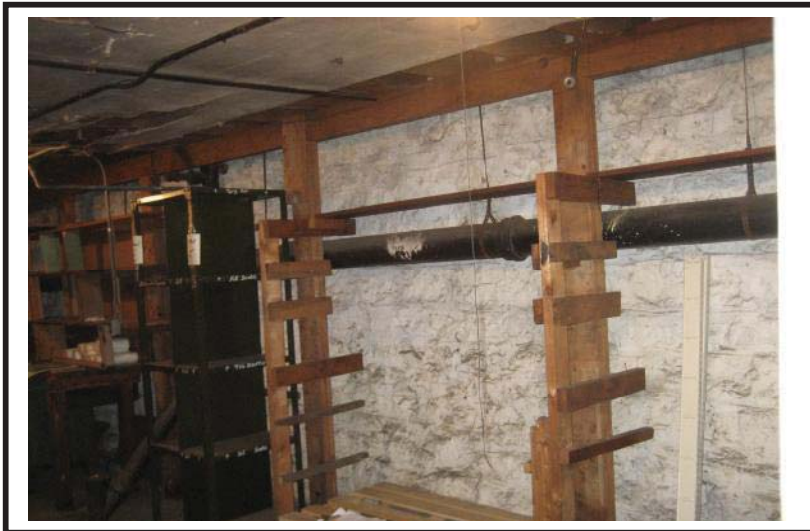
Figure 1 – Shoring along basement wall –also used as shelving.

The quantity of defects and the deflection in the first floor result in the suggestion to replace of the entire floor system as the most logical course of action. A new floor might be constructed of concrete fill on metal form deck on sheet metal joists. It remains a possibility to re-establish support for the existing floor, but the deflection would largely remain.

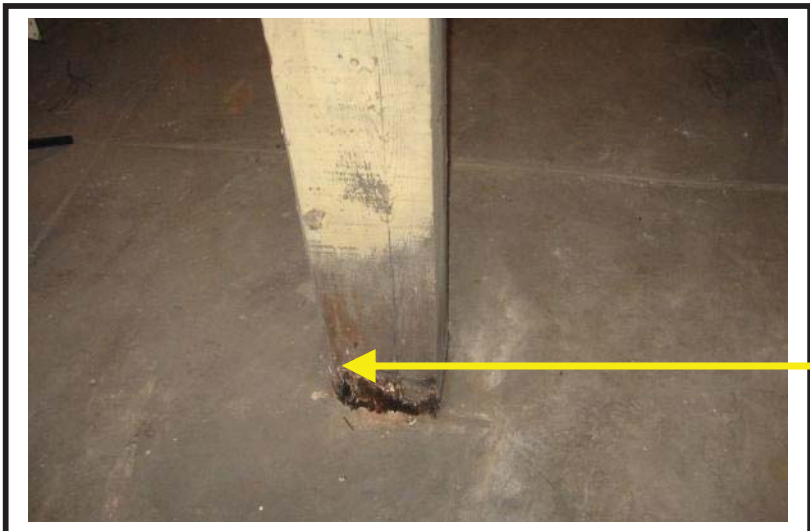
Floor is cast in place concrete on grade. Stains on bottom of wood columns indicate water entry over a period of time. Column bases to the north are rotting at the bottom. The rubble foundation walls appear in good condition. Basement access thru the sidewalk vault has been covered over with a concrete slab. The electrical and water service are in this room. The vault slab is shored up with wood cribbing on east /west faces. Repair to the bearing of this slab is thus recommended which would necessitate removal of a sidewalk panel or two.

Figure 2 – Rooted column base in basement.

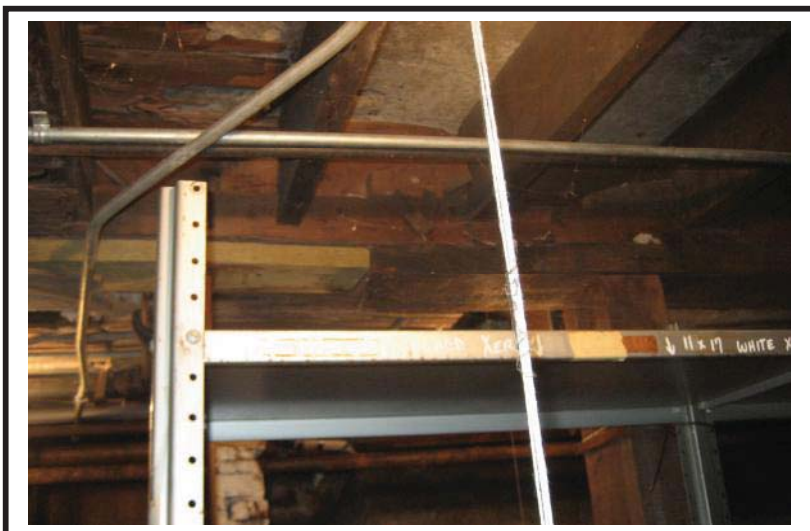
Figure 3 – Wood materials added to aid in support of the joists and the center beam line.

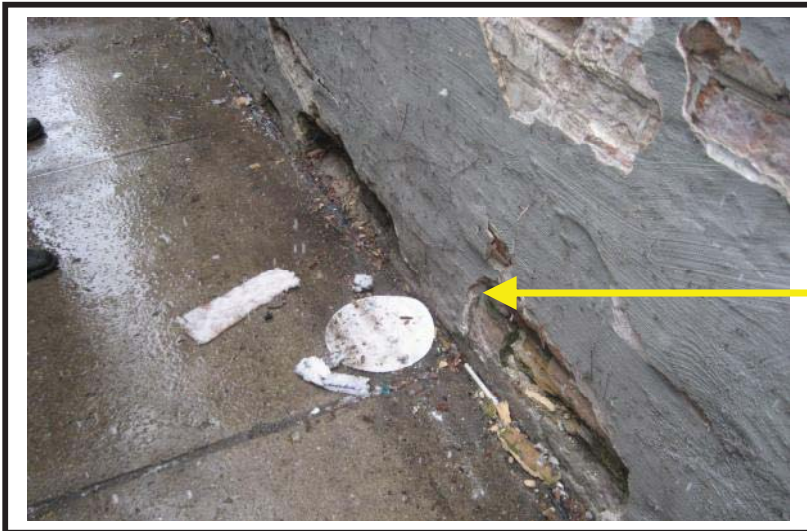
The walls on the east and west sides were observed from the alleyway running along the east side. The grade level walls appear to be a porous brick with a painted parging at the surface. The pargings are usually placed to cover defects in the brick- which appears to be the case here. Areas where the faces of the brick have fallen off were observed. The east wall steps back at the second level. At this location sheet metal siding is used. The west wall was not observed but is probably a party wall with the adjacent property.

Figure 4 – Spalling brick face-east exterior wall.

The observed walls were judged to be structurally stable but in need of repair to maintain water tightness. One option might be to cover the existing brick with an exterior insulation and finish system to economically reestablish the water barrier. Any repair system chosen should be investigated for its own tendency to trap moisture in the wall. Any projection beyond the existing wall line would have to be verified with property rights.

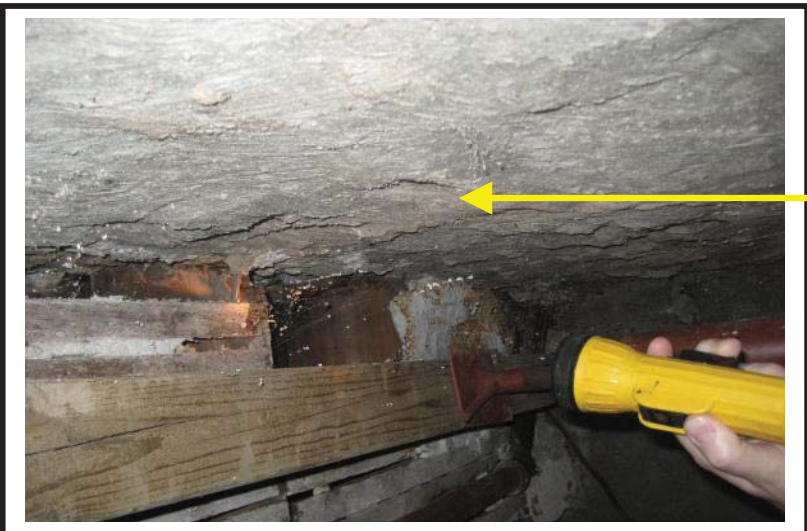
Figure 5 – Picture of rotted end of wood floor joist at first floor.

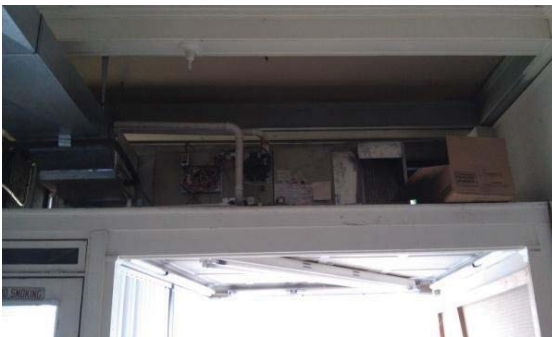
Furnace above entrance

The furnace appears to be operational but has signs of incomplete repairs from many years ago. Exact functionality is unknown. The support of the storm main is weak and the last several feet pitches upward, indicating a deteriorating system. The lead piping is an obvious health issue. A portion of the gas piping is badly deteriorated and has the potential to fail. Several sections of sanitary piping has either completely failed or is leaking. The storm main through the building is inappropriate since it doesn't directly serve the building.

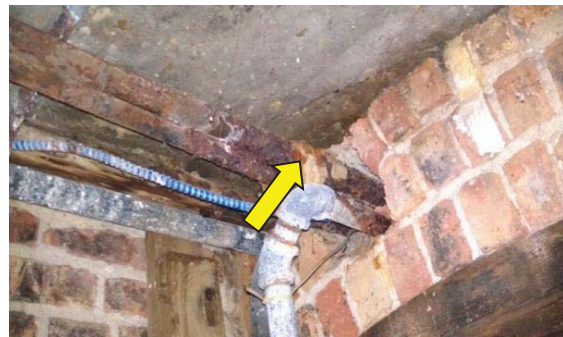
Deteriorated gas pipe

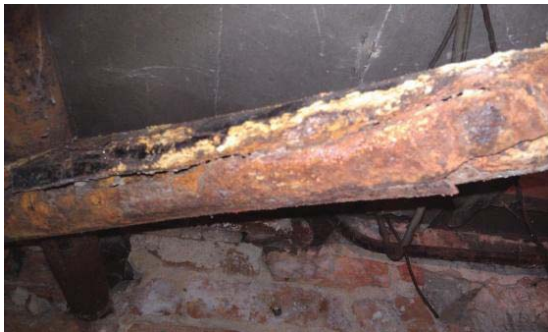
Deteriorated sanitary pipe

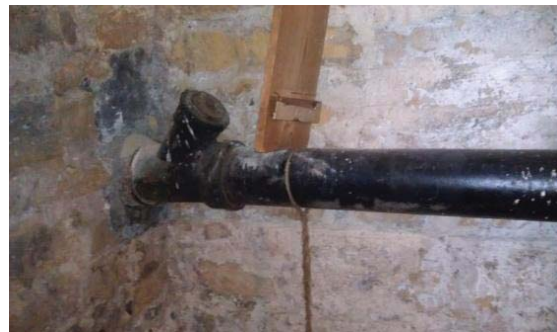
Storm main support/pitch

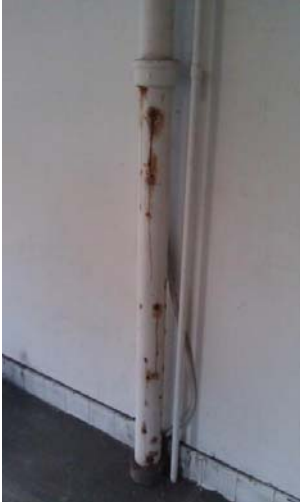
Leaking sanitary pipe

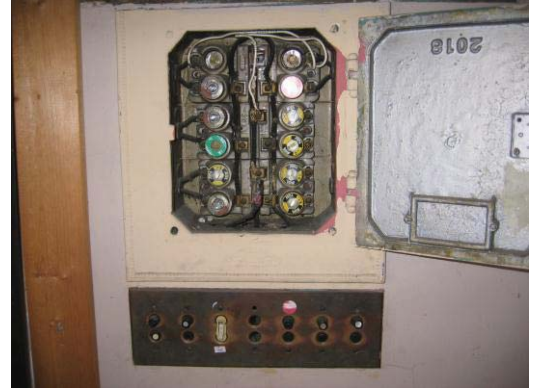
The fuse panel on the 1st floor is past its reliable life, and the panel on the 2nd floor is at the end of its useable life. The fusible panel on the 1st does not meet current code requirements. The current wiring device locations in the apartment do not comply with accessibility requirements. Receptacle quantity and locations in the apartment do not comply with current NEC requirements. Compliance with current codes for these items would require branch circuit, receptacle and fuse panel replacement.

Electrical fuse panel on 1st floor.

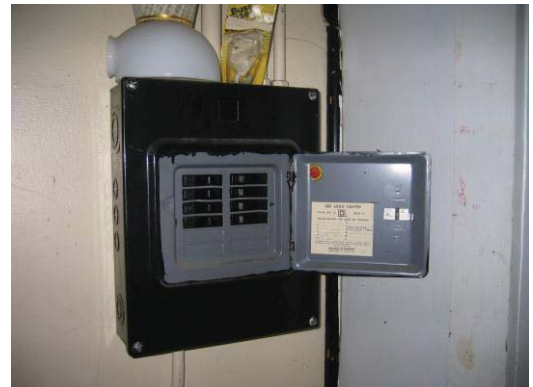
Electrical panel on 2nd floor.
