STRATEGIC STRUCTURAL DESIGN, LLC

Subject: 126 Langdon Street Madison, WI Building Condition Report

Per your request, Strategic Structural Design has completed the scope of our work outlined in our agreement, Contract Number 170231, to prepare a building condition report of the Wisconsin Hall Men's Dormitory on 126 Langdon Street in Madison, Wisconsin. On December 7, 2017 we walked through the existing building.

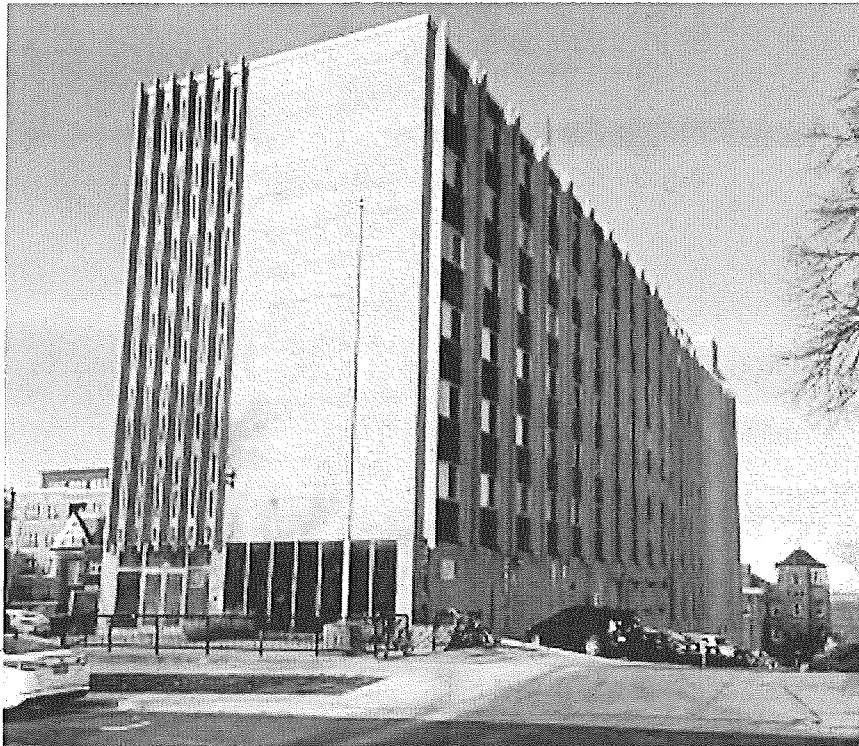
Brick veneer, precast concrete panels, and glass punched openings represent a majority of the exterior cladding of the building (Figure 1). Large glass curtain walls are located on the first floor south elevation for the main lobby and on the north elevation for the basement level dining room. On the southeast and northeast corners of the building, large brick masses are broken up by long vertical precast concrete panels. Between concrete panels are punched window openings and smaller sections of brick veneer.

*Figure 1: Southeast Corner.*

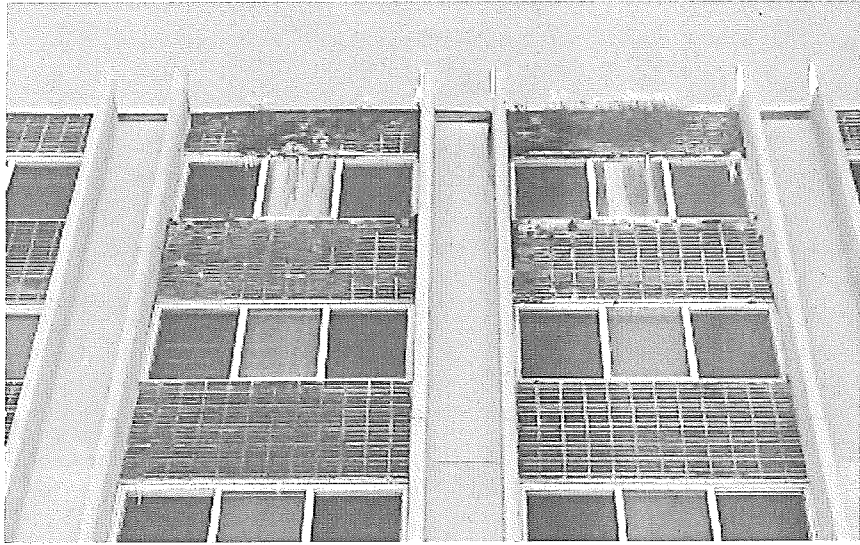
Overall, the exterior cladding was observed to be in good condition. Vegetation was observed to be growing on the roof of the east side of the building (Figure 2). In general, precast concrete panels were in good condition with broken sections noted on the bottom of a pair of sections on the west side of the building (Figure 3). Exterior brick veneer was in good condition with the exception of some spalled sections on the west side of the building (Figure 4). Eroded mortar joints were observed along the basement level just above the existing asphalt pavement. On the northwest and northeast corners of the building, vertical cracks in the brick veneer were observed to extend from the basement to third floor level (Figure 5).

*Figure 2: East Elevation Roof Level Vegetation.*

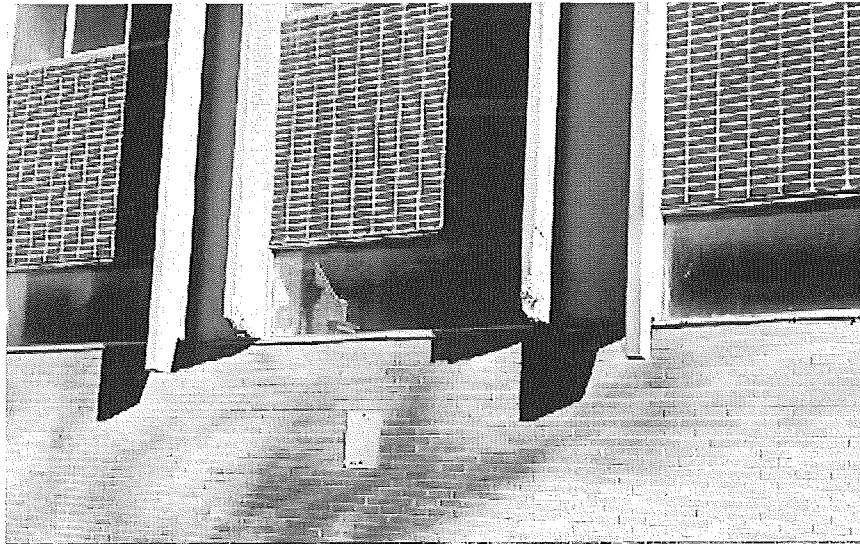
*Figure 3: West Elevation Broken Precast Cladding.*

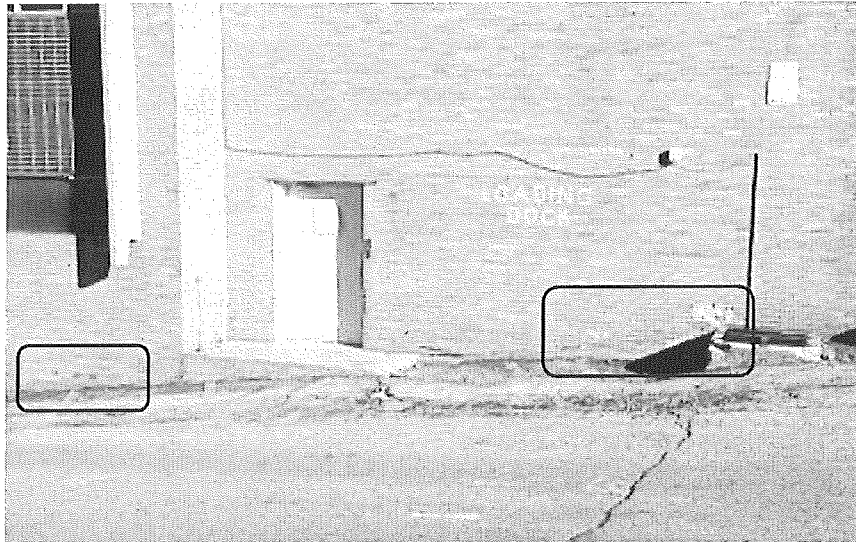
*Figure 4: West Elevation Spalled Brick Veneer.*

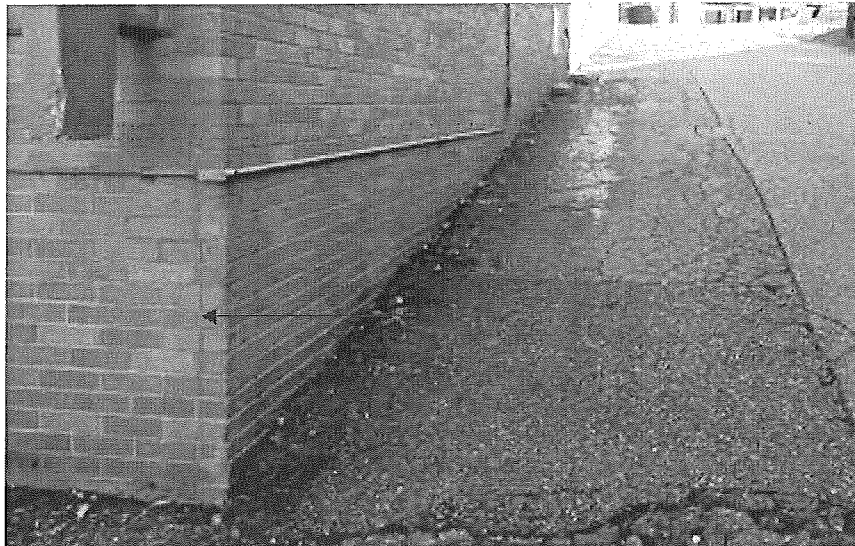
*Figure 5: Northwest Corner Brick Veneer Cracking.*

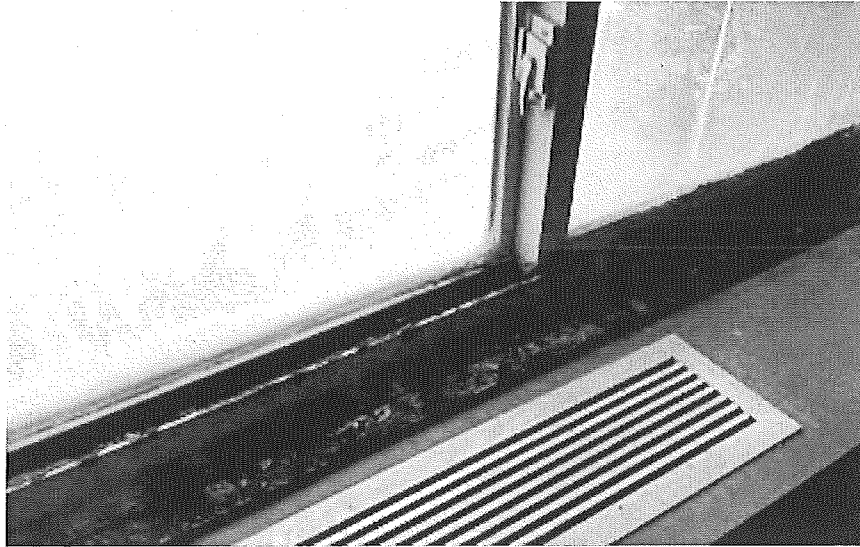
In general, the structural frame of the building was in good condition. Where structural concrete was exposed, it was typically observed to be free of cracks and spalls. Finished floors were observed to be unlevel with a combination of ridges and valleys that could be sensed walking along the corridors of the supported floors. CMU partition walls were in good condition with some visibly patched areas. Several exterior windows had been replaced with temporary glass or displayed failed window seals (Figure 6).

*Figure 6: Seventh Floor Damaged Window Seal.*

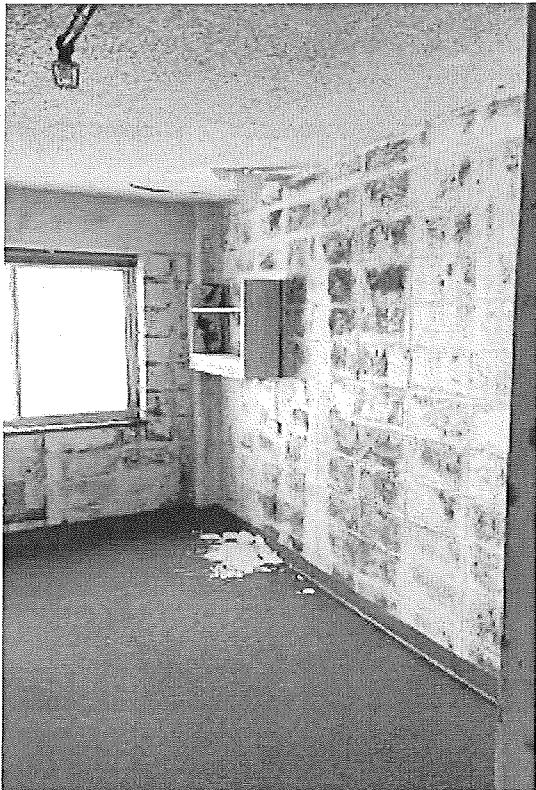
Water damage and mold growth was observed on the fifth through seventh floor walls, floors, and corridor ceiling tiles (Figures 7 and 8). A broken window was observed in Unit 407 on the fourth floor (Figure 9).

*Figure 7: Fifth Floor Wall Mold.*

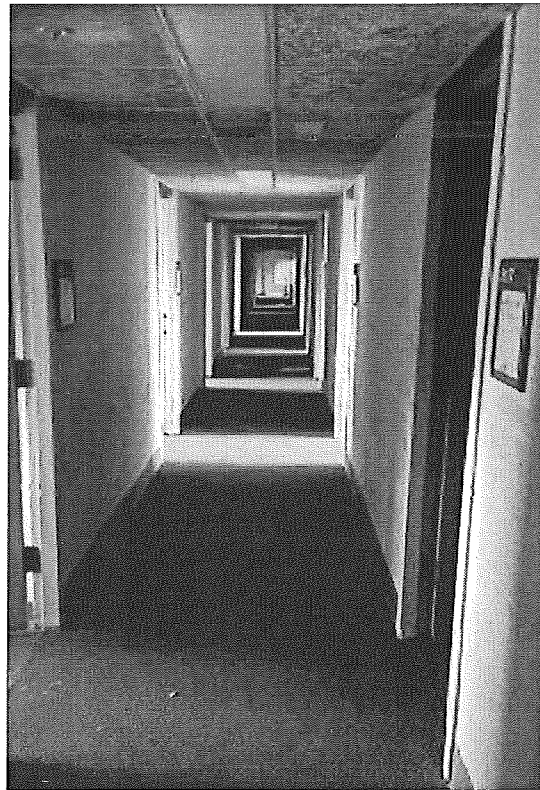
*Figure 8: Fifth Floor Mold on Ceiling Tiles.*

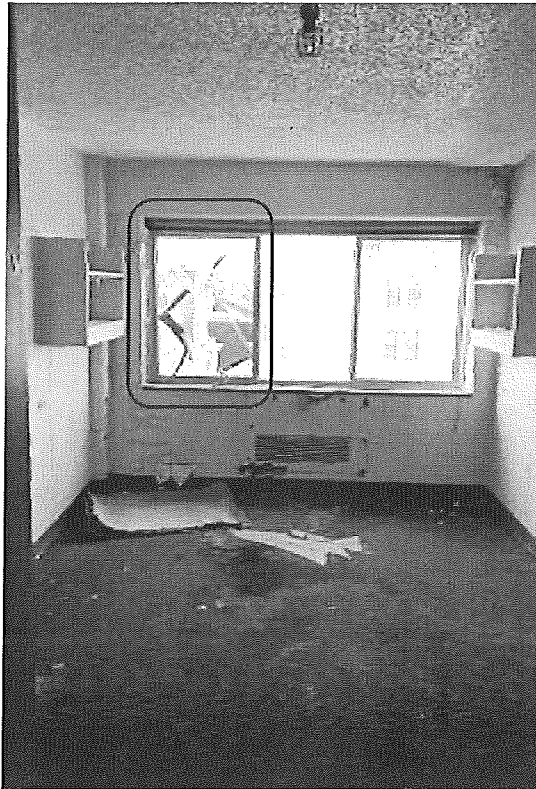
*Figure 9: Fourth Floor Broken Window.*

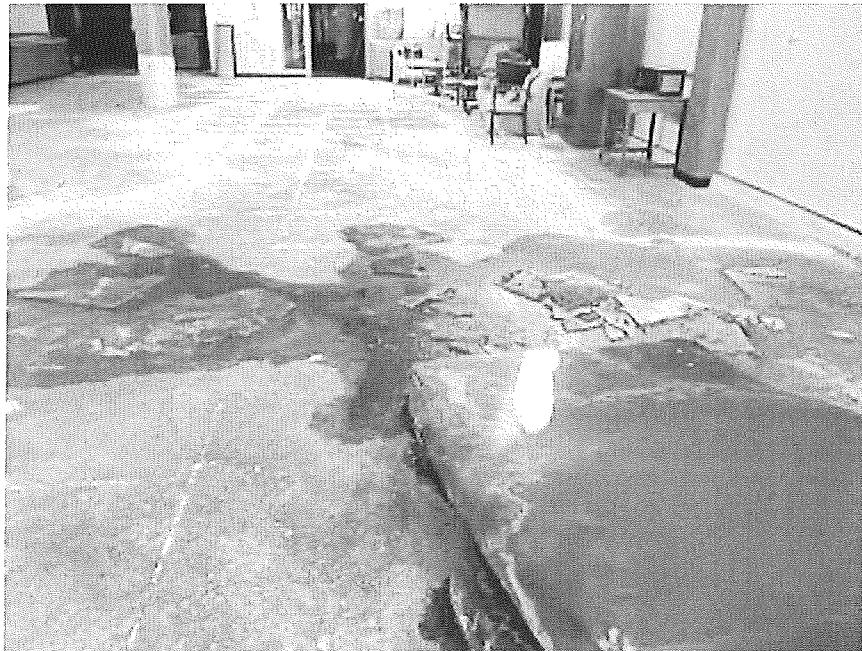
Second through fourth floor had less water damage and mold growth when compared to the above floors. An active water leak was observed in the dining room on west side basement level exterior wall. Standing water was observed during the site visit along with floor stains that appeared to indicate larger ponding had occurred in the past (Figure 10). Water stains were observed on the north wall of the sub-basement fitness room (Figure 11). The area was dry, so it was unclear whether this was an active water leak. In general, sub-basement plumbing piping and fittings had visible surface corrosion (Figure 12).

*Figure 10: Basement Level Active Water Leak.*

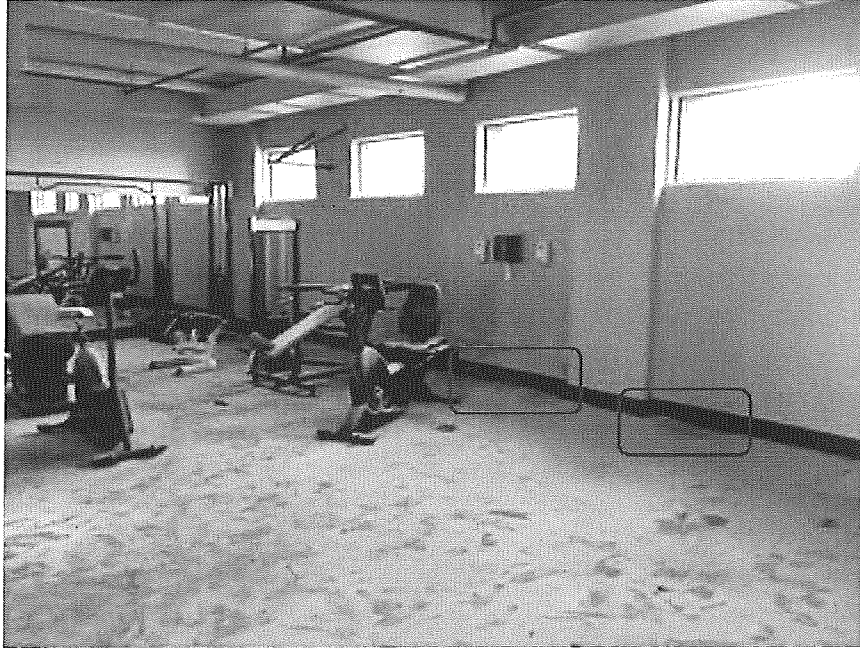
*Figure 11: Sub-Basement Water Stain.*

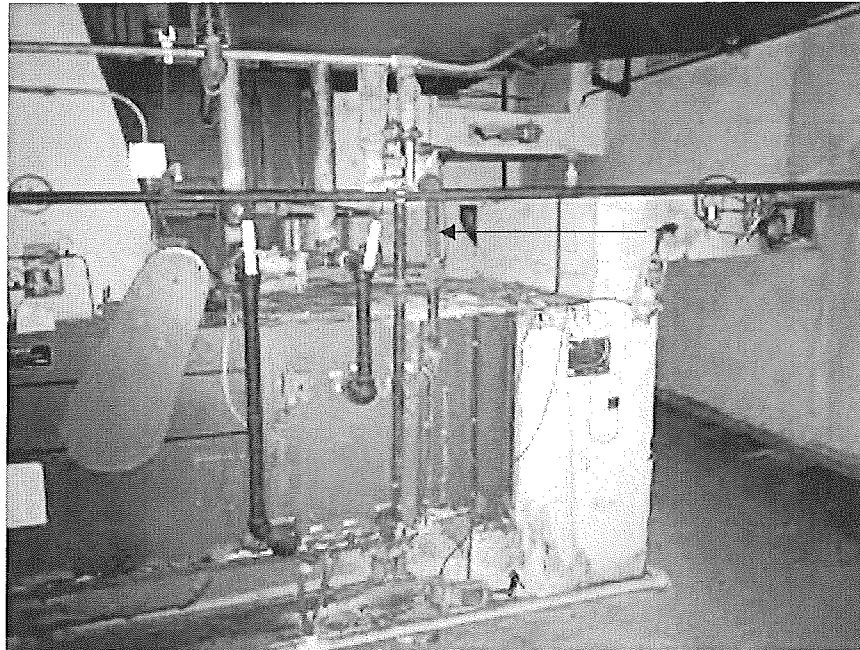
*Figure 12: Sub-Basement Plumbing Piping and Fitting Corrosion.*
