**RE: OVERTURE CENTER
FACILITY ASSESSMENT VERIFICATION
MADISON, WISCONSIN**

Mortenson Construction is very pleased to present the assessment verification for Overture Center located in Madison, Wisconsin.

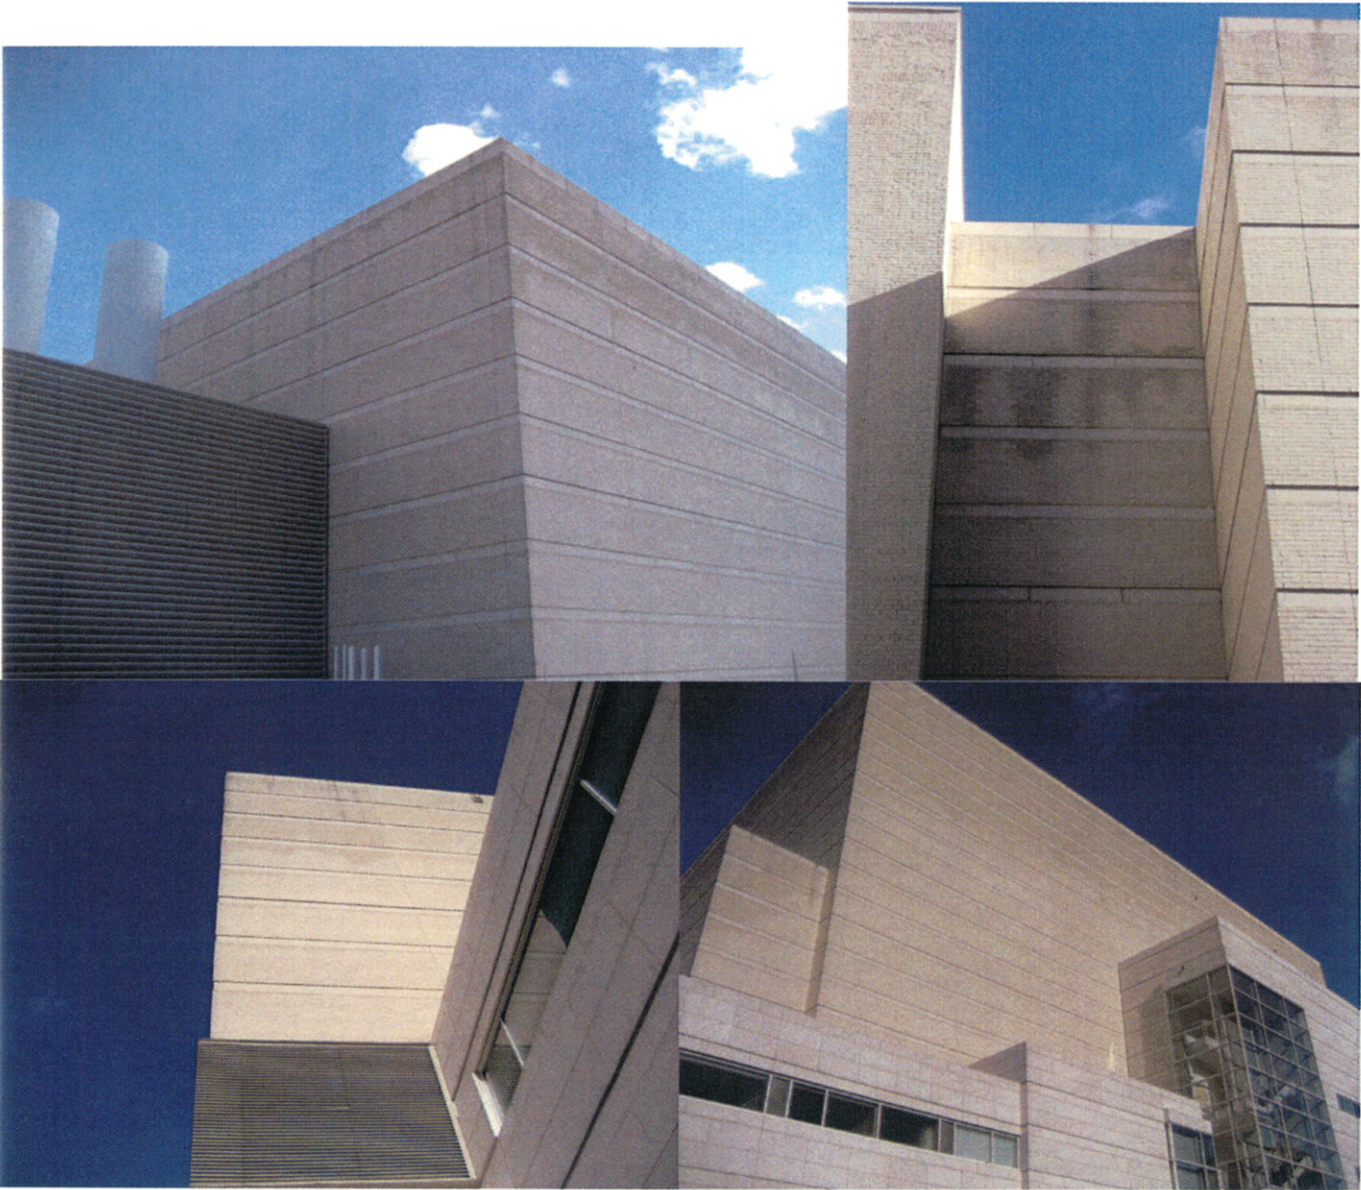
PHOTO PAGE #2 – EXTERIOR CLEANING / RESTAINING

6	2	Exterior Building Cleaning/Re-staining/Minor Repairs	\$300,000	\$300,000	\$0	Mortenson has validated the pricing and concurs with the assessment.
7	3	Granite Base	\$0	\$0	\$0	Mortenson concurs with the assessment.
8	4	Caulking/Tuck pointing (exterior)	\$700,000	\$700,000	\$0	Mortenson has validated the pricing and concurs with the assessment.
9		Curtain Wall	\$0	\$0	\$0	Mortenson agrees with the assessment of the curtain wall healing system. Repairs are ready to be made and should be made prior to the 2010 heating season. Contractors are lined up and ready to perform the work and the scope is understood by the center's Director of Facility Operations. Once this work is complete this system will be good.
10		Window Replacement	\$850,000	\$200,000	\$0	Maintenance of the seals for the windows is important. With proper maintenance, the replacement of any windows during the next 15 years should not be expected or required.

Upon completion of this, a cleaning of the masonry wall would be appropriate, and Mortenson feels would be covered by the budget established in Item 6, where \$300,000 has been allocated for exterior cleaning and re-staining of the masonry walls.

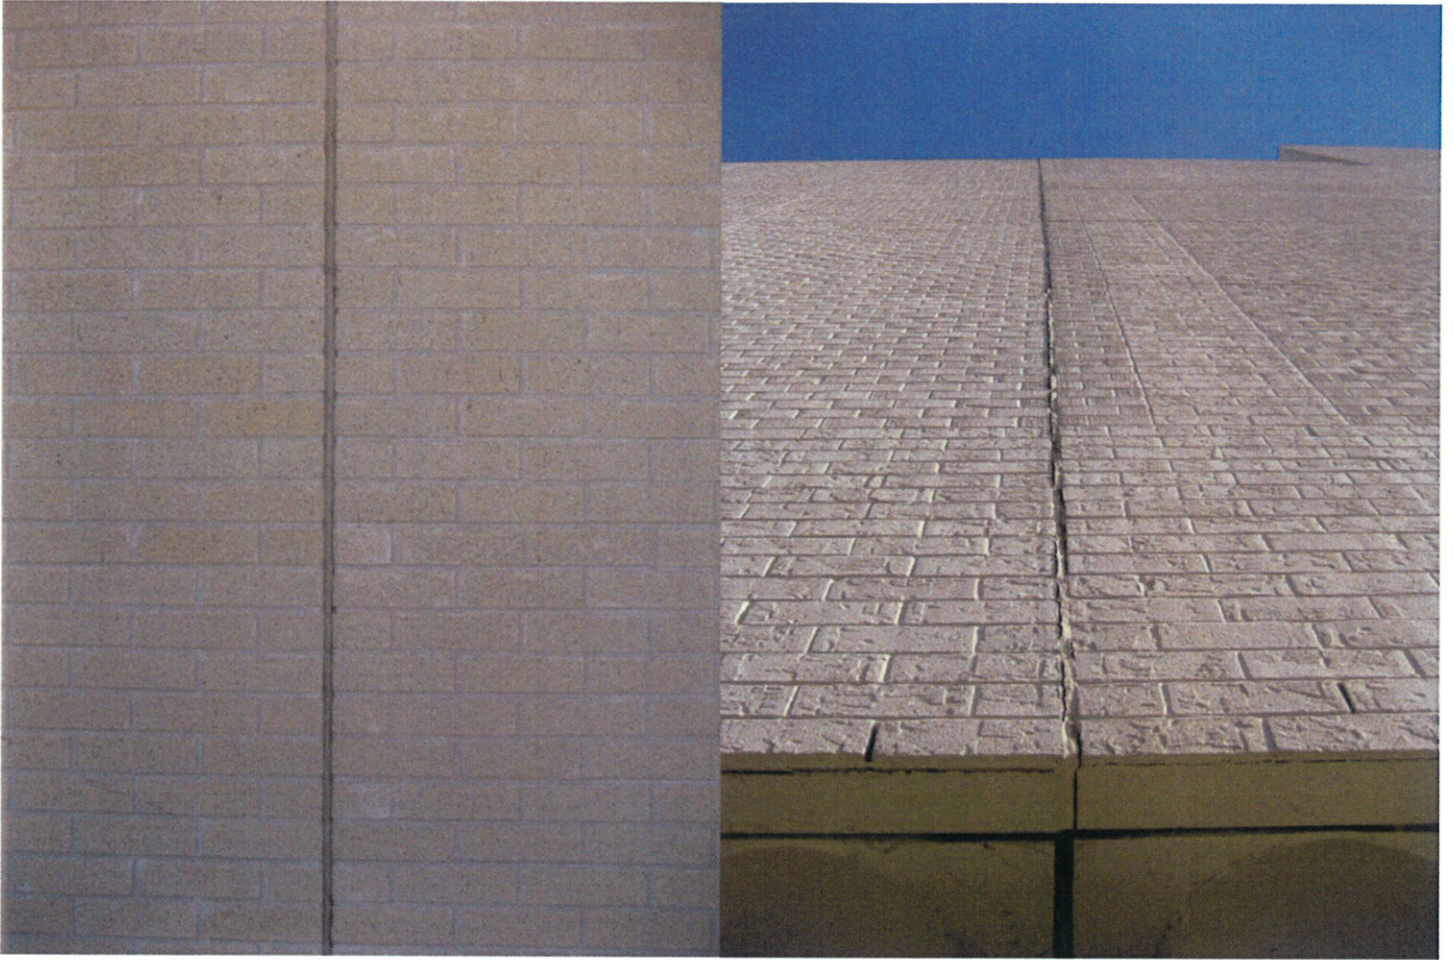
PHOTO PAGE #4 – CAULKING & TUCKPOINTING

Items 1-10 within the Expenditure Log are attributable to the enclosure and roofing systems, for the majority of these items, Mortenson Construction concurs with the previous assessment and estimated costs for major maintenance and capital replacement for the next 15 years. During our review of the enclosure it appears that the need for a re-caulking of the masonry systems is in need in the next year, which is already covered in Item 8.

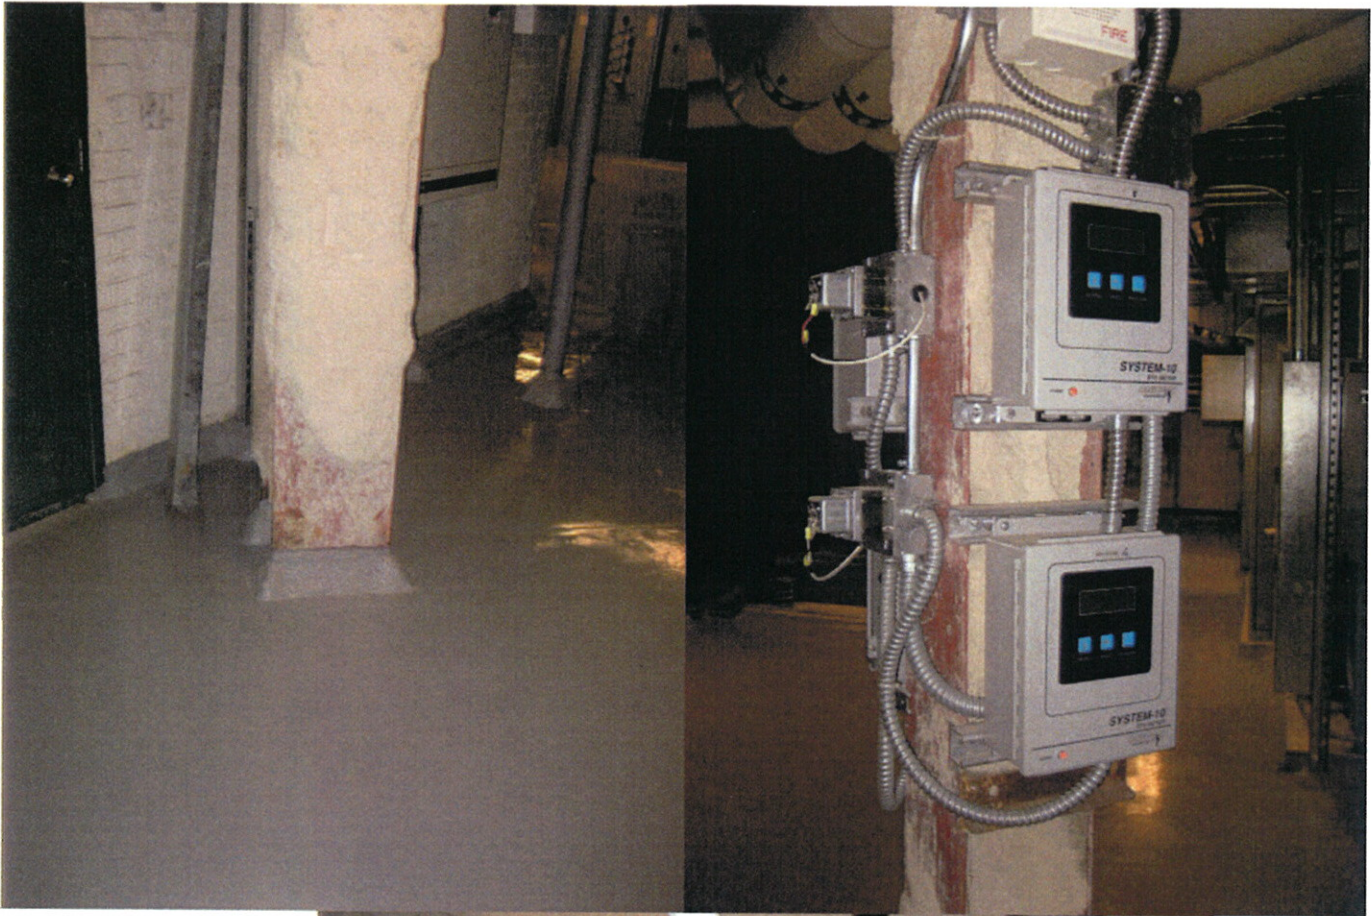
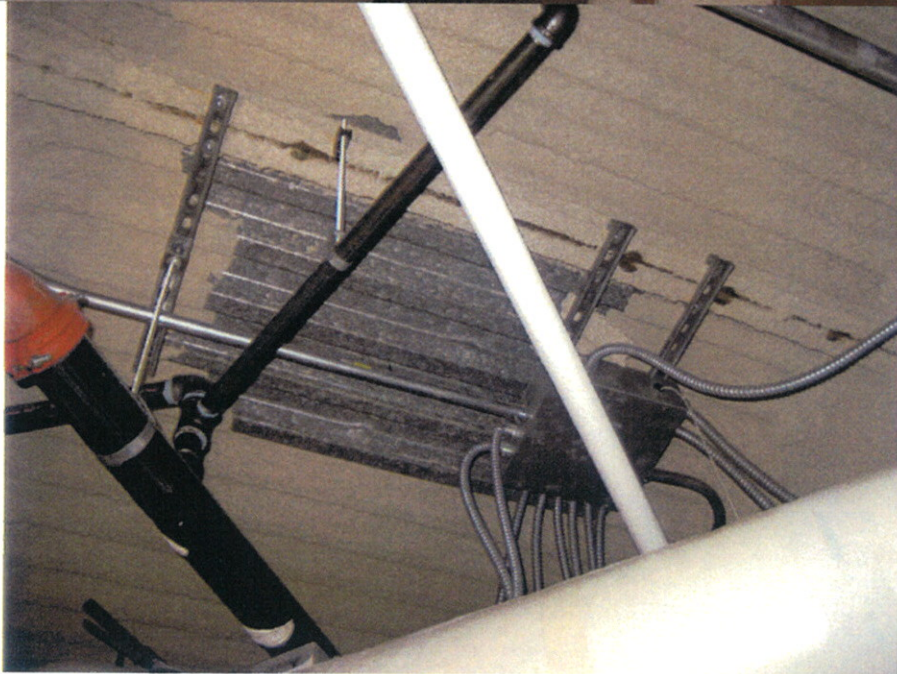
PHOTO PAGE #5 – SPRAYED FIREPROOF PATCHING

NEW ITEM 1 – Cementitious Fireproof Patching - At the Mechanical Penthouse of the Capital Theater - part of the existing structure from the previous building - there are steel columns and metal decking that is exposed, where the fireproofing has been removed to facilitate equipment installation. This fireproofing requires patching to maintain the required levels of fire protection on the structure in these areas. Mortenson Construction recommends a full inspection of the existing structure in the Capital Theater building areas and patching of fireproofing as required. We have included an allowance for this effort in the Expenditure Log in Section C. Photo page #5 of Section D provides a visual reference.

ITEM	PHOTO PAGE	ITEM	ESTIMATED COST - ORIGINAL REPORT	ESTIMATED COST - MAJOR MAINTENANCE	ESTIMATED COST - CAPITAL REPLACEMENT	COMMENTS
NI 1						
5		Sprayed Cementitious Fireproof Patching	\$0	\$20,000	\$0	Expected Year of Expenditure - 2011. The mechanical room serving the Capital Theater contains structural steel which has spray fireproofing missing from columns and metal deck. Patching can be done to cover the exposed steel.
NI 2		EIFS Artwork on Brick Façade	\$0	\$27,000	\$0	Expected Year of Expenditure - 2018. The south façade of the building contains artwork applied to the brick facing that is constructed out of EIFS. EIFS can have a short life span if the top coating is not maintained properly.
NI 3		Parapet Sheet Metal Gap Repair	\$0	\$30,000	\$0	Expected Year of Expenditure - 2011. Sheet metal cap flashing located on top of exterior brick and stone clad walls appears to have a gap in which water can access the wall cavity. This water infiltration appears to be causing discoloration of the brick and stone. A line of backer rod and joint sealant could be added immediately to stop the infiltration.

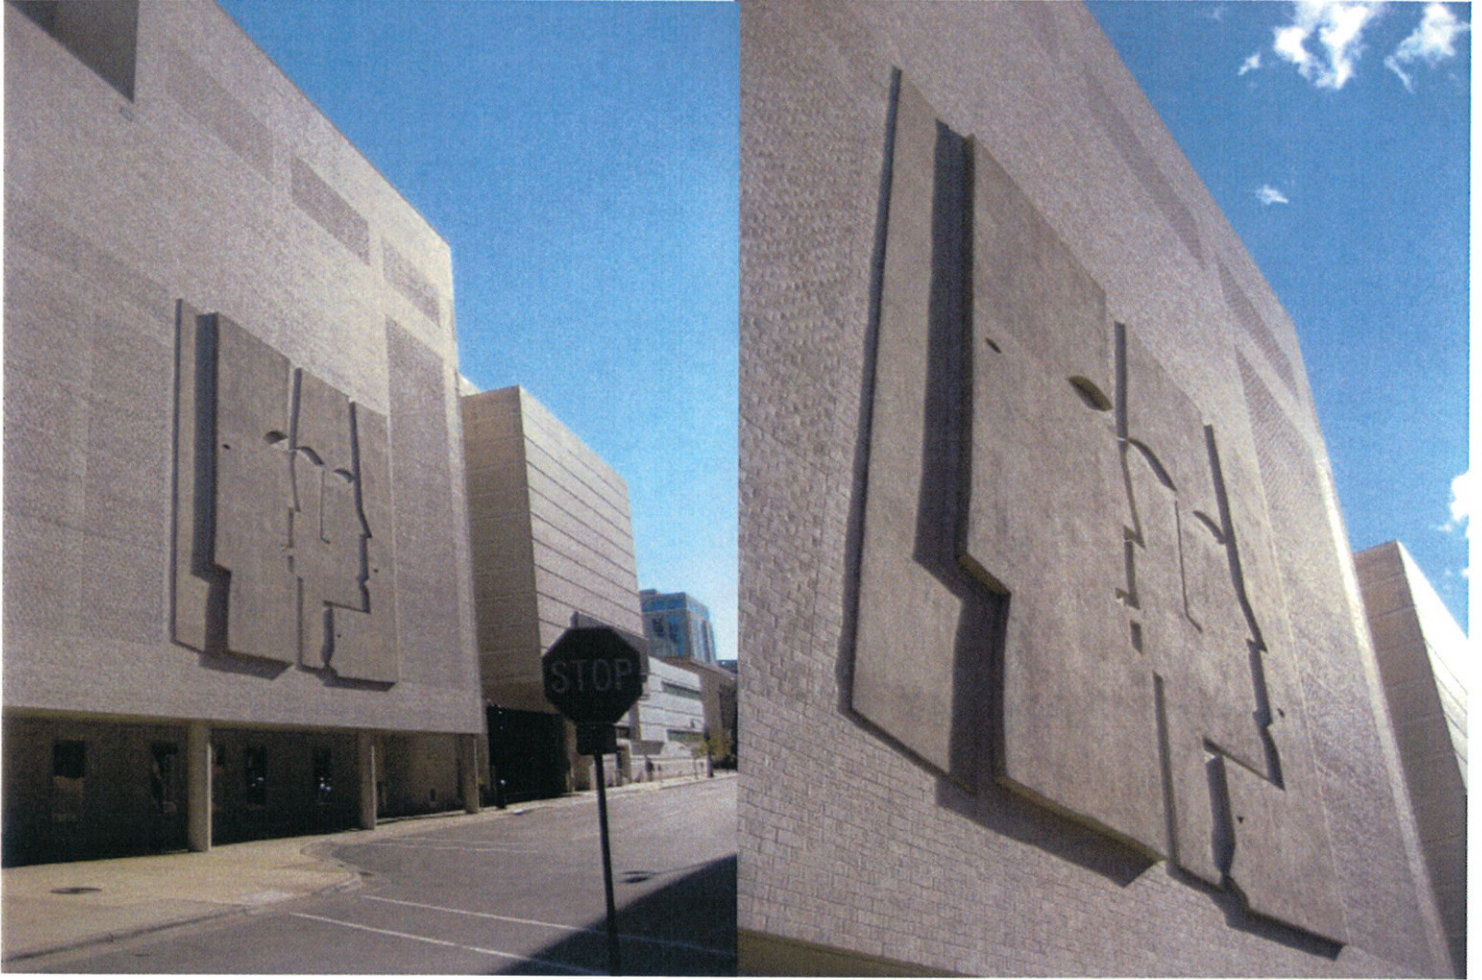
PHOTO PAGE #6 – EIFS ARTWORK

NEW ITEM 2 – EIFS artwork – There is a direct-applied EIFS artwork on the south façade of the building that is adhered directly to the brick facing. This artwork was part of the existing building and with the limited life span of EIFS material, Mortenson has included an allowance to recoat this EIFS artwork to prevent water damage on the artwork and/

or delamination from the brick facing. This is purely a cosmetic issue and does not affect the integrity of the enclosure wall. The allowance for major maintenance on this issue is estimated at \$27,000. Photo page #6 of Section D provides a visual reference.

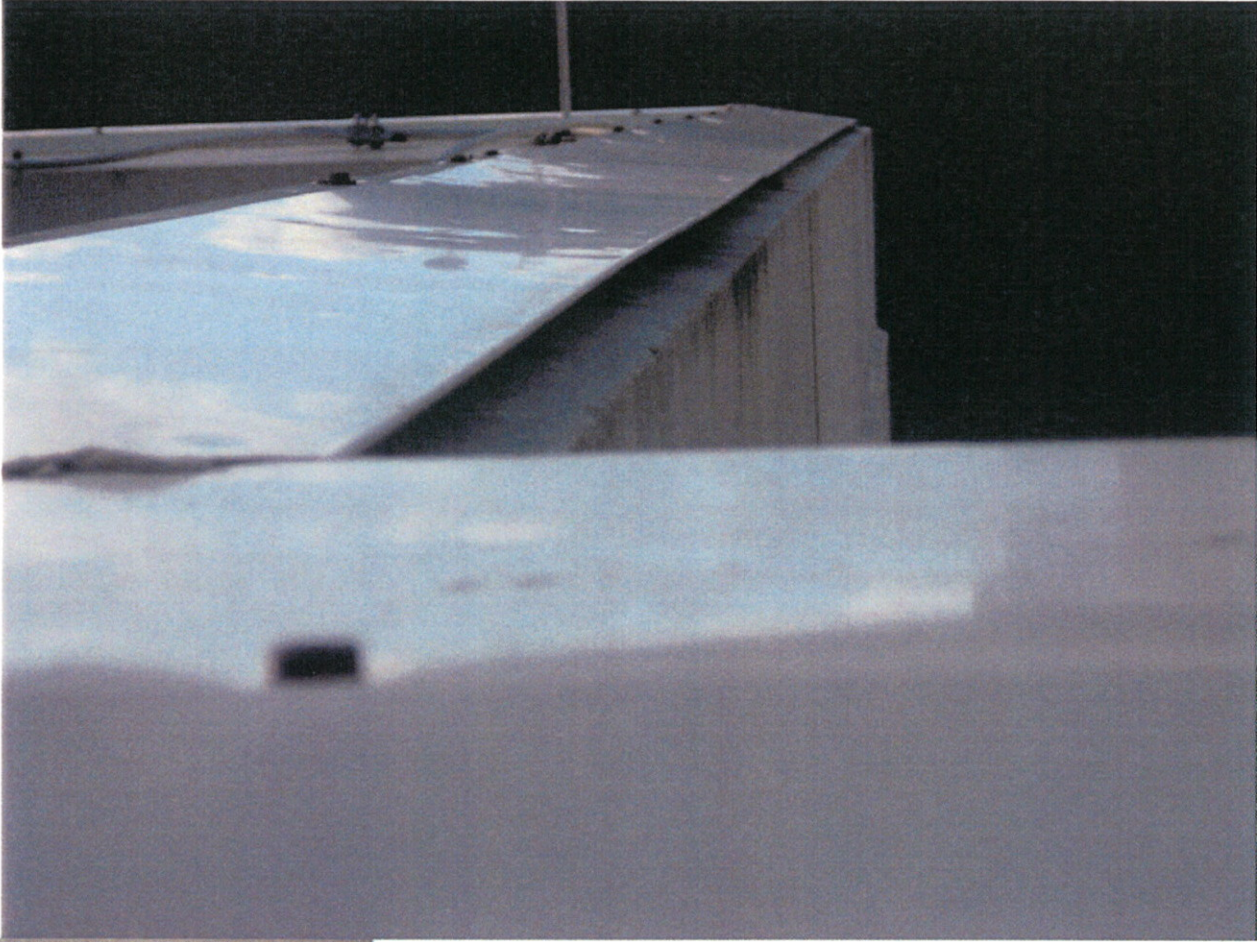
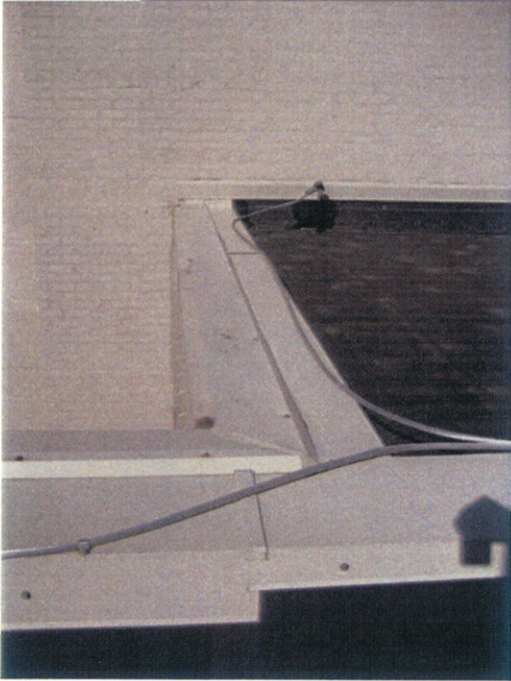
PHOTO PAGE #7 – PARAPET SHEETMETAL GAP

NEW ITEM 3 – Parapet Coping Repair – The parapet at the top of the main Overture Building masonry walls a gap has developed between the masonry wall and the cap flashing which appears to be allowing water infiltration into the masonry cavity of that exterior wall. The current result of this water infiltration is a discoloration of the brick in streaks running down periodically along the top 4-6' of the masonry wall. If this issue is not resolved, eventually the freeze/thaw of the water infiltrating the masonry wall will cause a breakdown and spalling of the brick mortar and the integrity of that wall would be compromised. Mortenson recommends further review of this detail in order to determine the optimal treatment to resolve this issue. Mortenson Construction has included an estimated major maintenance cost of \$30,000 to treat this detail with a line of backer rod and joint sealant to prevent future water infiltration. Another approach to resolving this issue could be to completely replace the sheet metal cap flashing which has an estimated cost of \$100,000. Photo page #7 of Section D provides a visual reference.

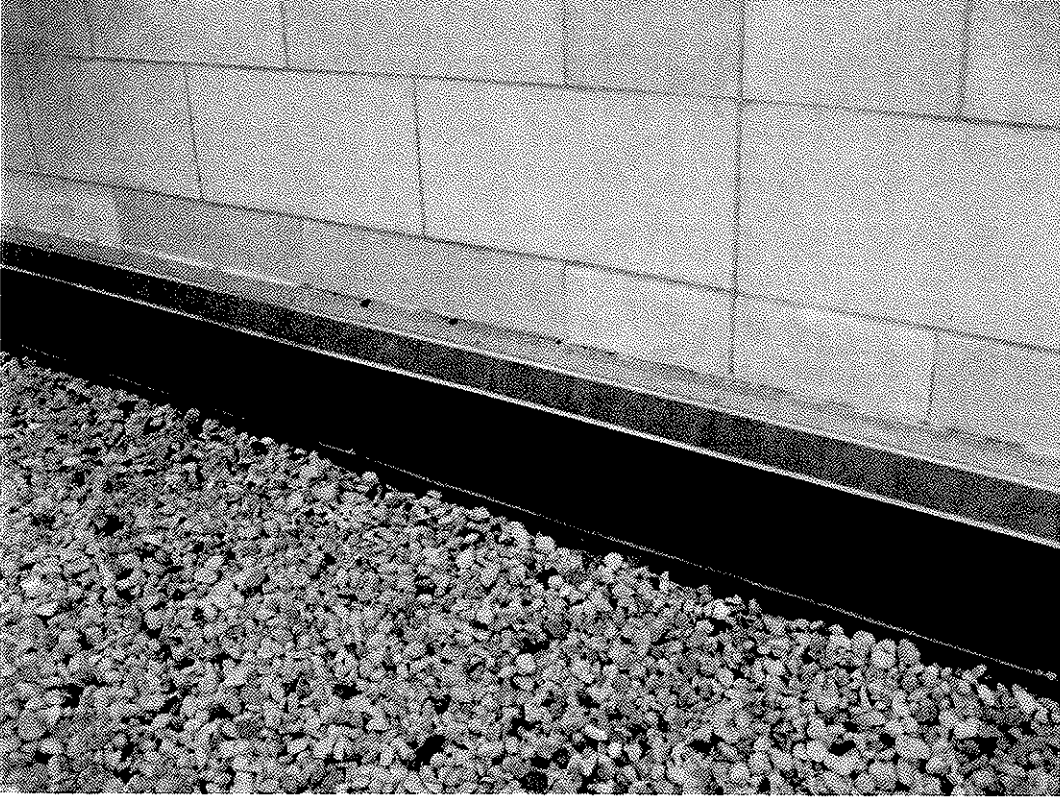
PHOTO PAGE #8 – BALLAST ROOF TO EXTERIOR WALL

NEW ITEM 4 – Administrative office roof leak – There is an on-going, unresolved, roof leak at the administrative office roof. As this area was reviewed it was noted that the adjacent vertical wall has a weep flashing that has been treated with a joint sealant, which is preventing from the moisture in the stone masonry wall to weep through the intended system. This soft joint and resulting trapped moisture could be a contributing factor to this leak, however, requires additional review and study. As a base measure, Mortenson recommends the removal of this joint sealant to allow the weeping of moisture from this wall as intended. An allowance of \$20,000 for major maintenance has been included to address this issue. Photo page #8 of Section D provides a visual reference.

NI 4		Roof Leak Above Administration Offices	\$0	\$20,000	\$0	Expected Year of Expenditure - 2011. A known leak located above the administration offices has not been located or repaired.
NI 5		Smoke Evacuation Sequence Test	\$0	\$10,000	\$0	Expected Year of Expenditure - 2011. Smoke evacuation systems require complex sequencing between multiple items and systems. The smoke evacuation system has been tested one time at the opening of the facility. The city may want to perform a sequencing test of the system to ensure proper working requirements. Exercising of all components should be done as part of annual maintenance.
NI 6		Motors - Hydroid Systems, Air Handling Units.	\$0	\$75,000	\$0	Expected Year of Expenditure - 2018. Vibration analysis is performed on all motors 10hp and up every 6 months. Bearings are changed out in-house and should be considered an operating maintenance item. Life expectancy of an average motor run on a 100% duty cycle within conditions it was built for should be 10-15 years. Cost ranges vary. A 100 hp motor will cost around \$5,000, a 150hp motor around \$8,000 and a 200hp motor around \$10,000 installed. As motors are changed out they should be changed out with high efficiency motors with a grounding brush on the rotor shaft when driven by a VFD. An ungrounded rotor shaft causes stray voltages within VFD units.

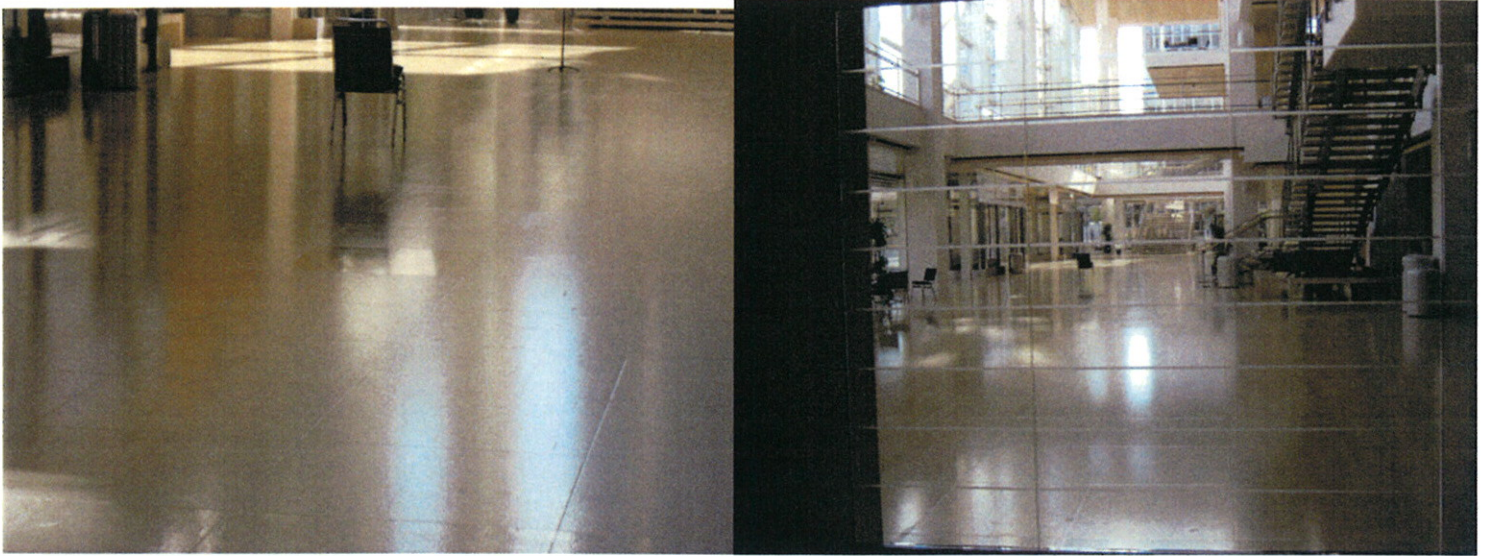
PHOTO PAGE #9 – TRAVERTINE TILES

Item 45 - Travertine floors – Mortenson spent a considerable amount of time to understand the maintenance plan for the main Overture Center lobby travertine flooring. The Overture Center maintenance team has been trained and have a proactive plan in place to maintain the new sealing system treatment at the lobby floor. With this system continued, Mortenson advocates that this floor should be expected to withstand the next 15 years and beyond without a major replacement. The major maintenance estimated budget of \$600,000 has been carried to allow for a reseal at 2016 and complete strip and reseal in 2024.
