Steven R. Bassett, INC

August 20, 2007

34 Schroeder Ct. Madison, WI - Tree Inspection Report

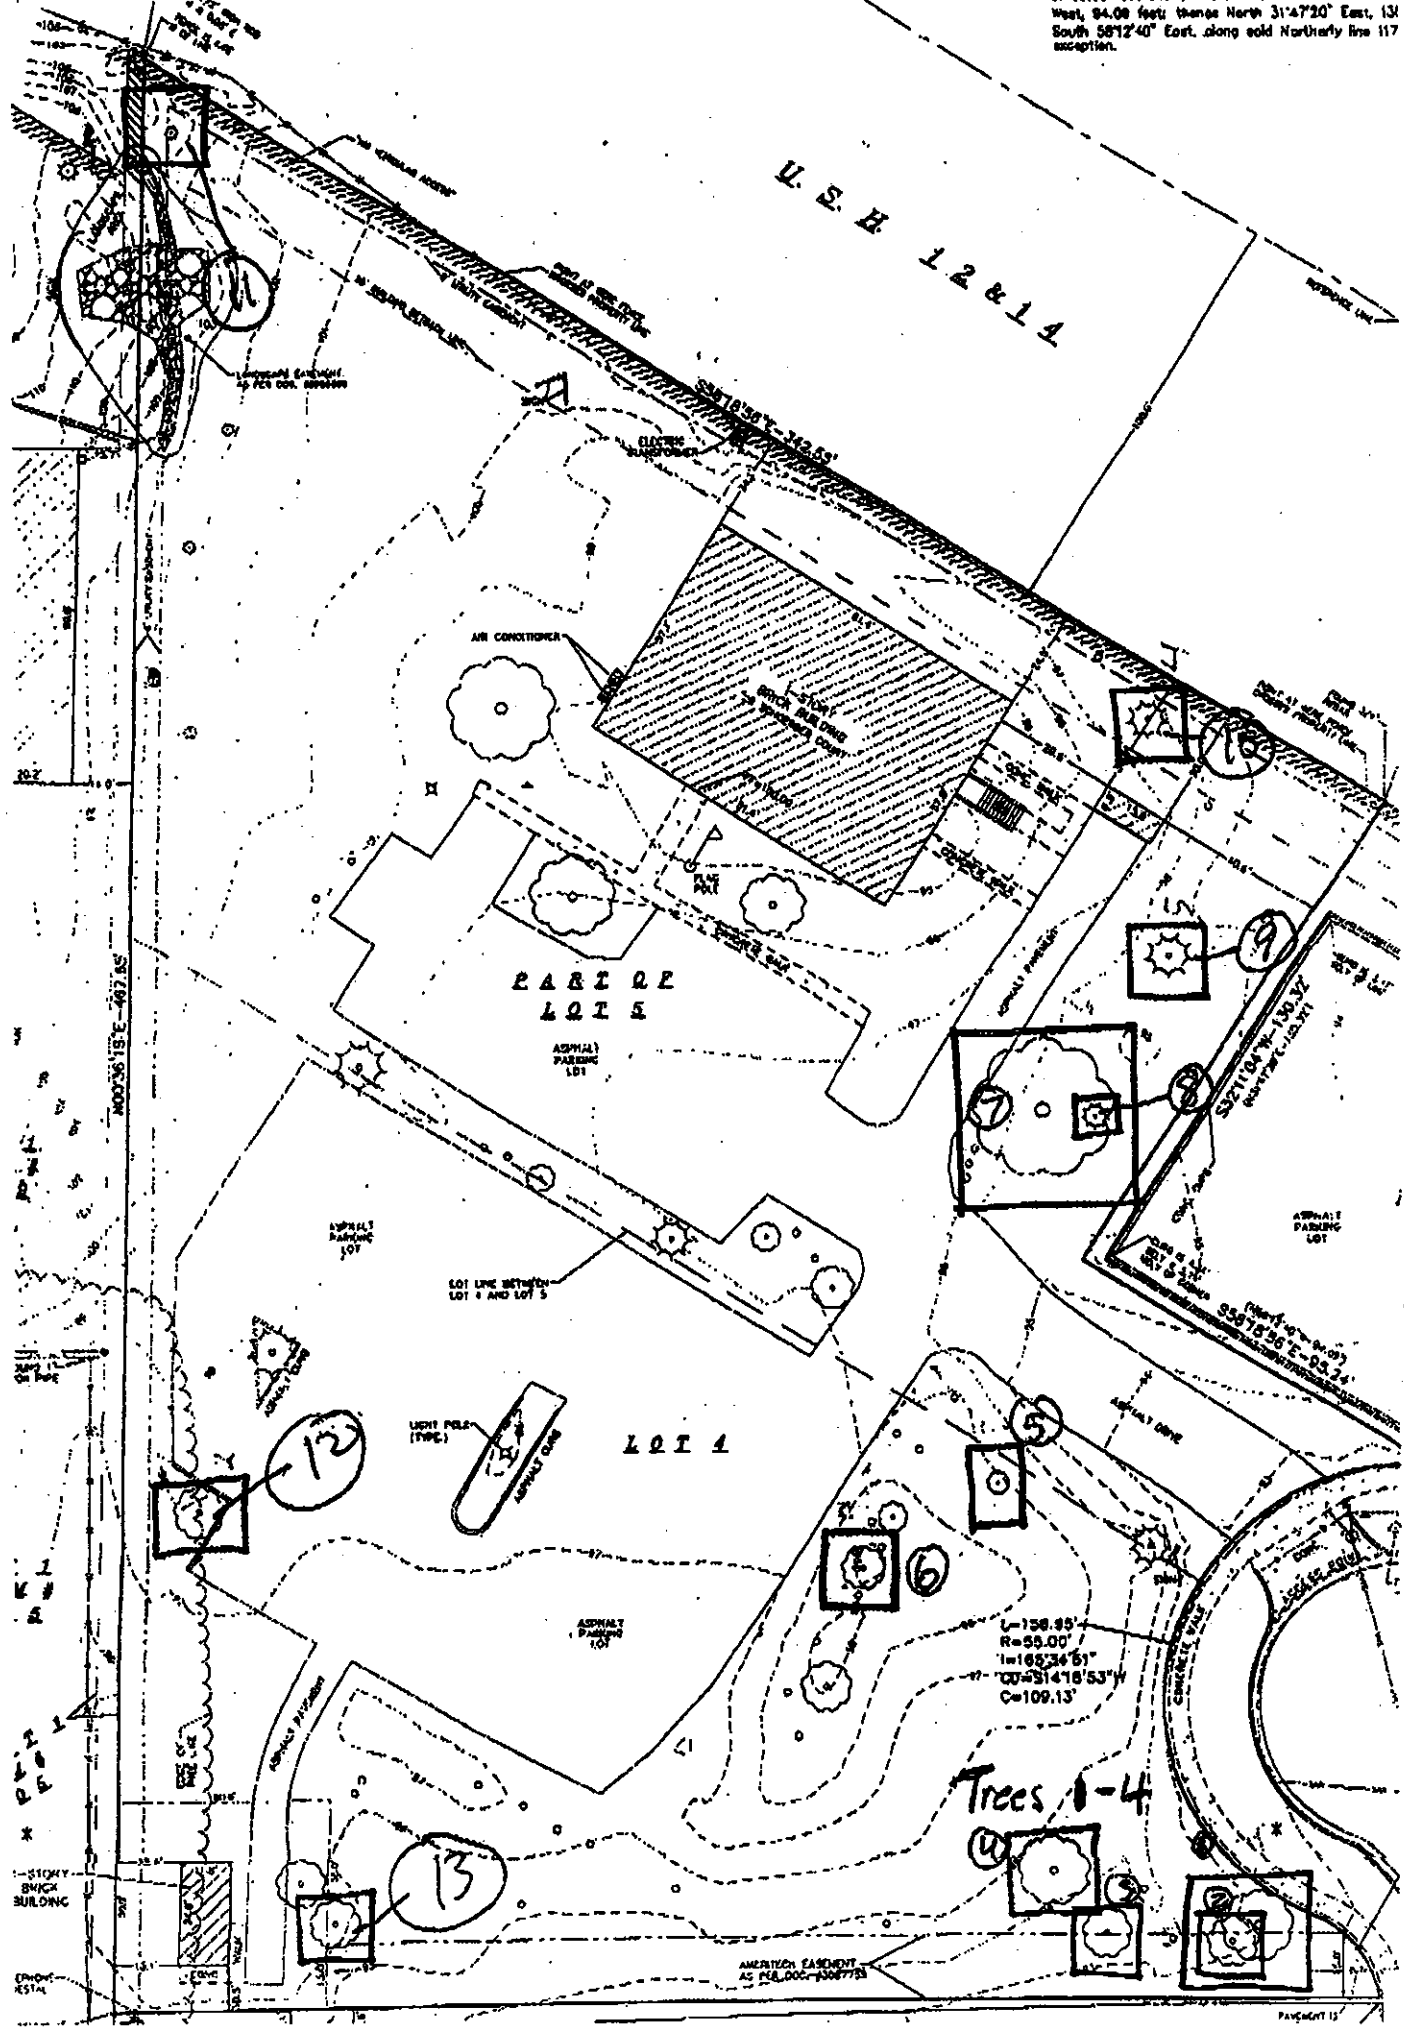
- The 4 eastern most Boxelders could potentially be saved if fencing is used to protect the roots. Fencing with a 12' radius is recommended.(TREES MARKED 1-4)
- The northern Boxelder should be fine with appropriate fencing around roots.(TREE #5)
- Removal of the Ash tree should be considered due to the restraints of island size/construction and because of the potential for pest problems in the future.(TREE #6)

- To save the River Birch, a minimum of a 3 stall island should be created.(TREE#7)
- The Arborvitae nearest the River Birch should be removed due to plant placement. It is too close to and underneath the River Birch.(TREE #8)
- The large Blue Spruce north of the River Birch should be removed due to constraints of island size.(TREE #9)
- The Arborvitae near the highway can be saved if protective fencing with a minimum 8' radius is used. (TREE #10)

- The small spruce next to the highway should be fine provided fence protection is installed. (TREE #11)
- The Ash in the existing island should be removed due to the constraints of the island size/construction and because of the potential for future pest problems.(TREE#12)
- The Boxelder next to the brick building should be removed because the island size is too small. A more desirable species should be planted in the island instead.(TREE #13)
