# **Edgewater Tree Inventory**

## and Waterfront Vegetation Survey

January 22, 2010

Prepared by : Allison Tree Care, Inc.

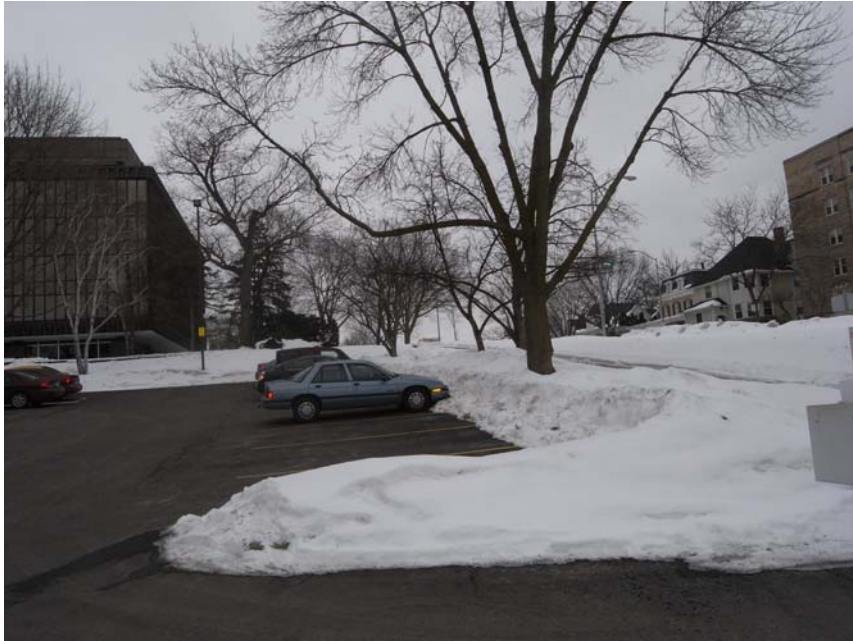
Photo 1 Parking lot trees

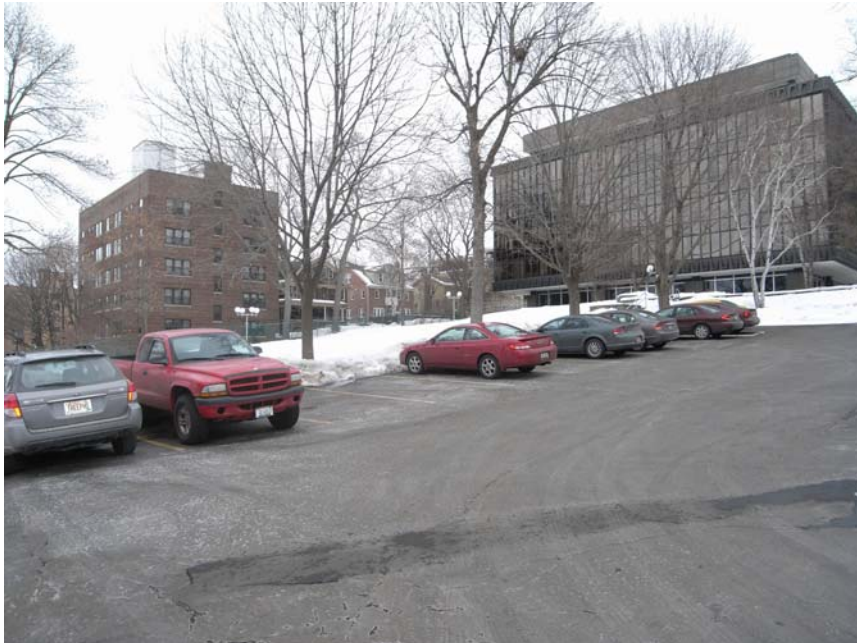
Photo 2 Parking Lot trees

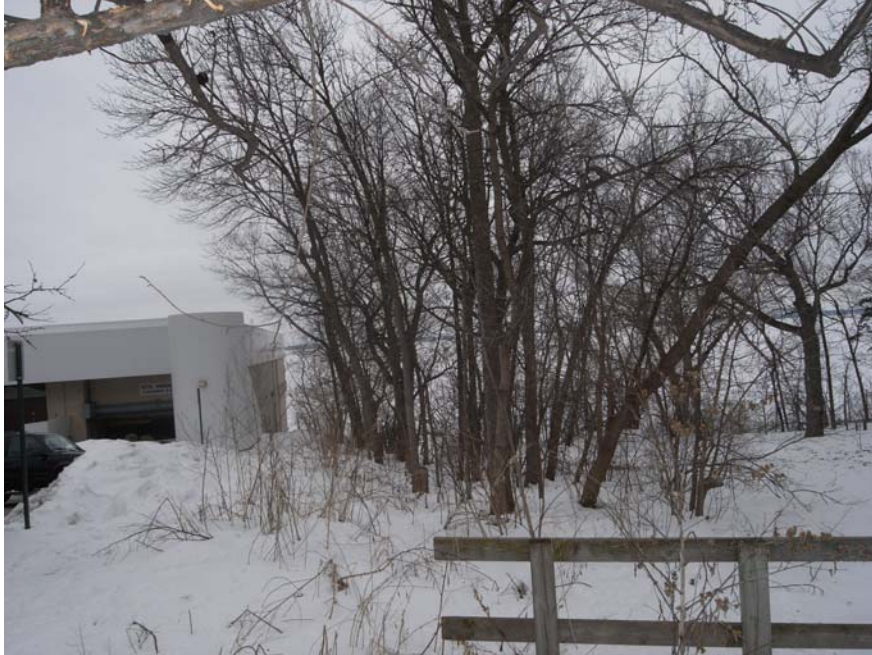
**Photo 3 Parcel 4 South End**

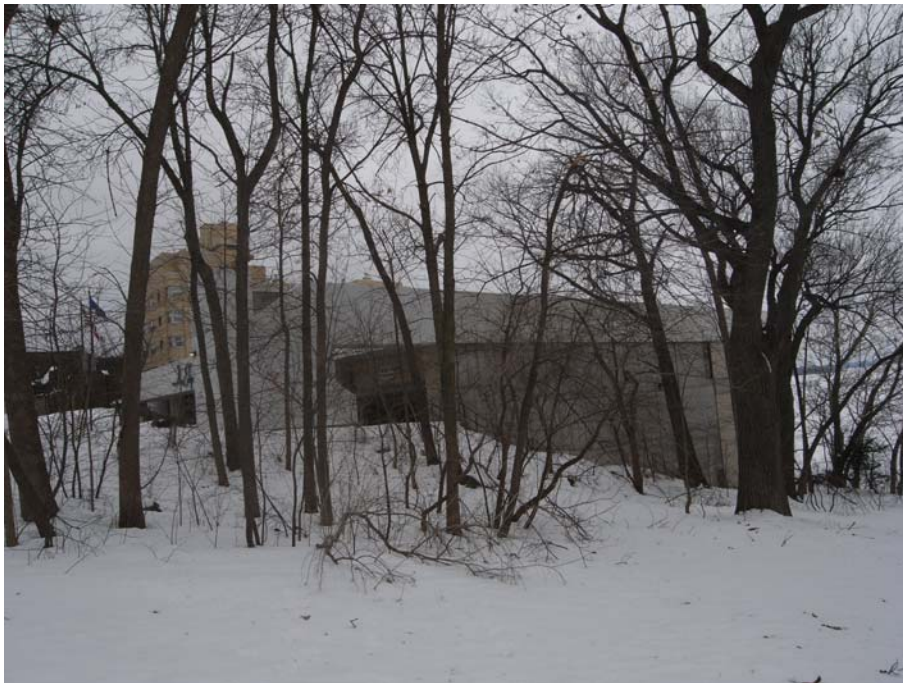
**Photo 4 Parcel 4 Middle area including Red Oaks**

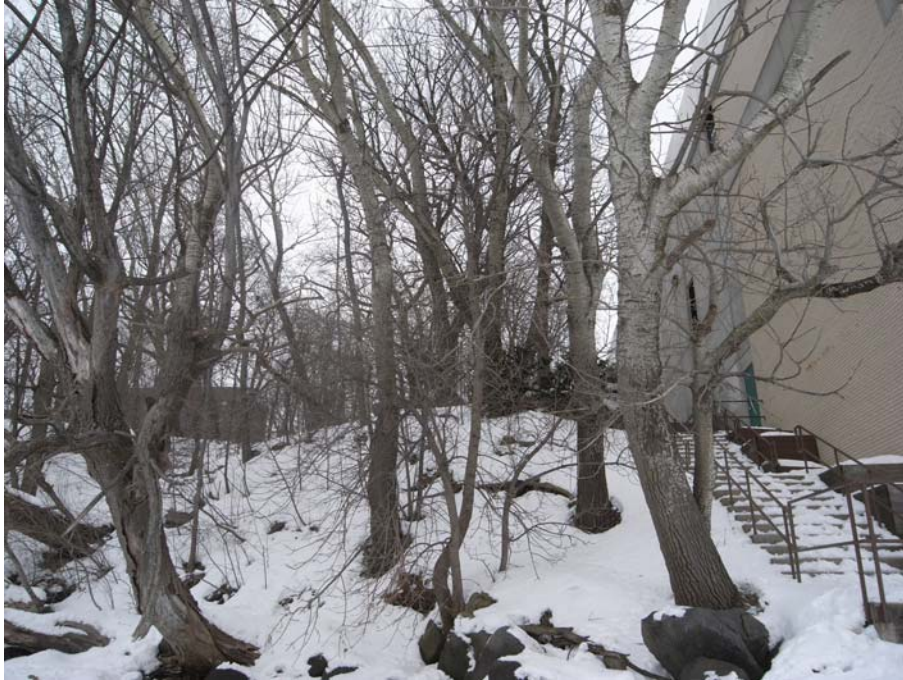
Photo 5 Parcel 4 lake end with poplars

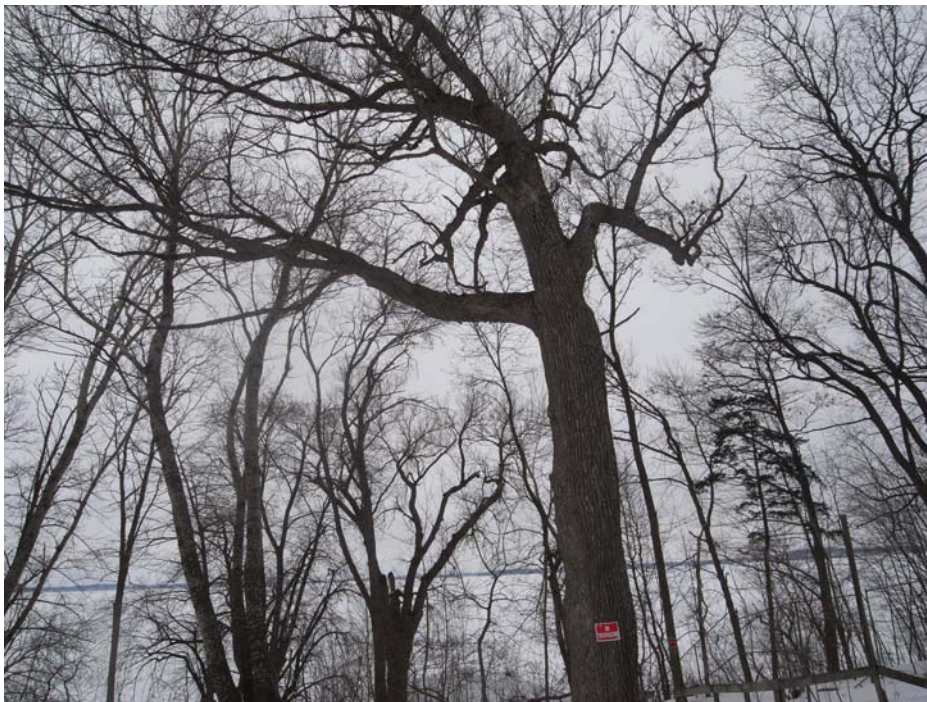
The bulging at the trunk base of the white oak is suggestive of internal decay. A micro-drill resistance test to measure the internal condition of the trunk is recommended prior to making a decision regarding efforts to protect that tree. As always on proposed construction sites, a tree protection plan including fencing and equipment access restrictions is recommended to protect those trees designated for preservation in and around the proposed building zone.

Photo 6 White Oak in group of trees east of Parcel 4
