Re: Gilman Street Development
Evaluation of two properties
Madison, WI

The following is my report on the properties at 123 and 127 West Gillman Street.

127 W. Gilman St.
Madison, WI 53703

Conceptual Budget/Recommendations Report

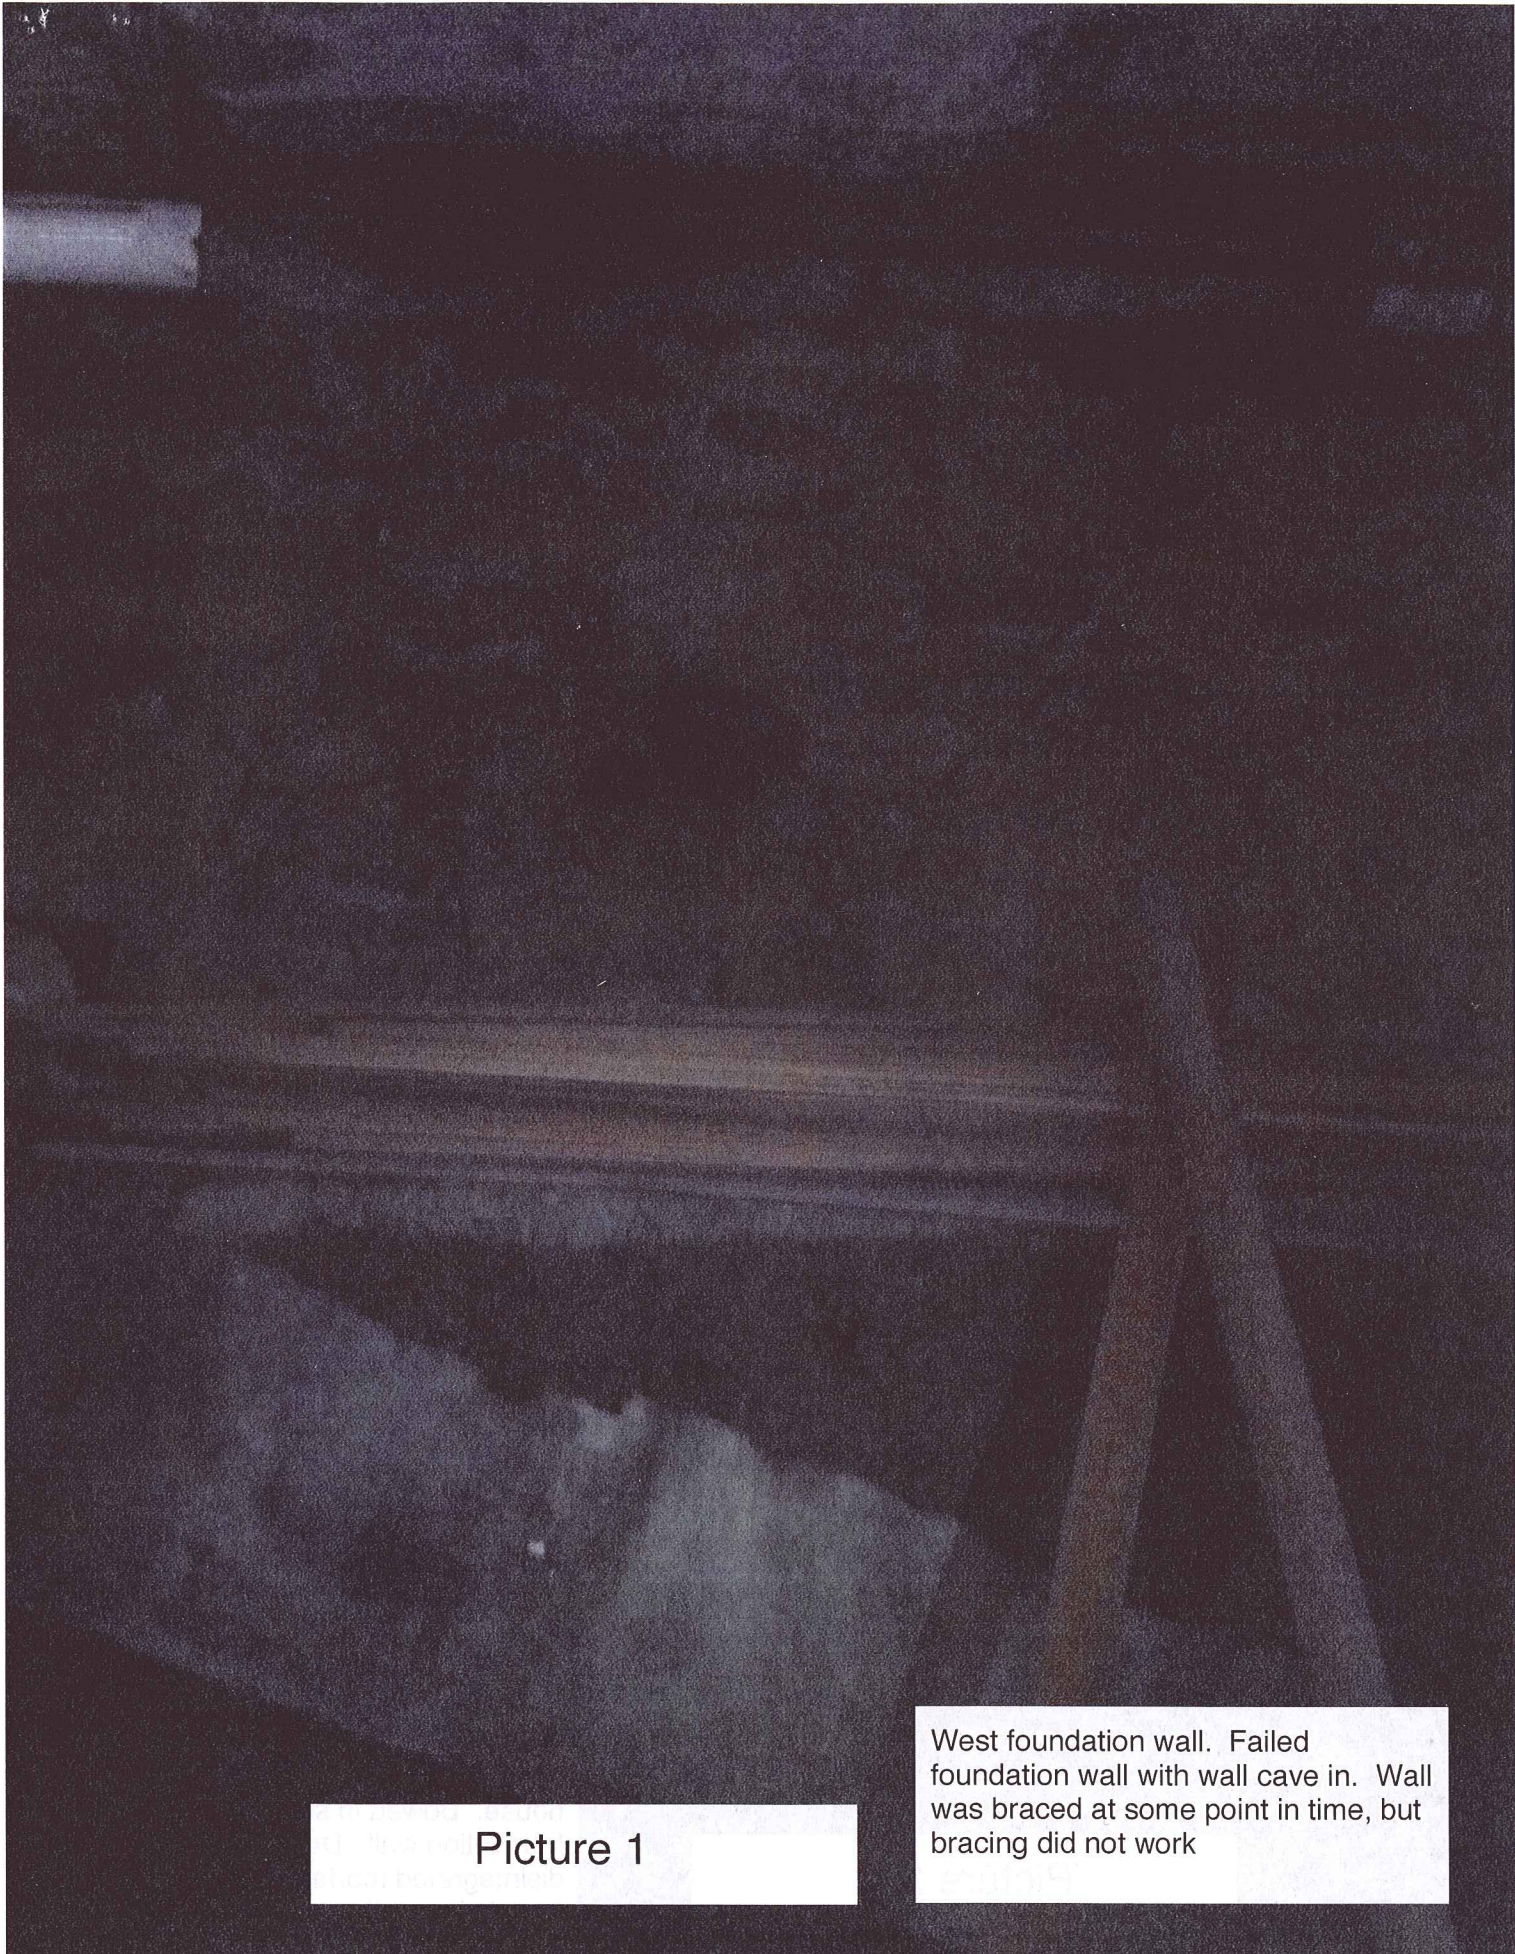
Picture 1

- a. Complete failure of the north foundation wall (See Picture 1). It is my understanding this wall has been previously shored once or twice previously and repairs made. It is also my understanding that this shoring and repairs were made prior to the purchase of the property by the current owner. The primary distressed condition related to deteriorated extreme distressed areas primarily consisted of in a state of severe distress and / or failure in some areas.

West foundation wall. Failed foundation wall with wall cave in. Wall was braced at some point in time, but bracing did not work

1. Complete replacement of the foundation.
2. Removal and replacement; including improving the foundation bearing for the deteriorated wood posts in the basement.

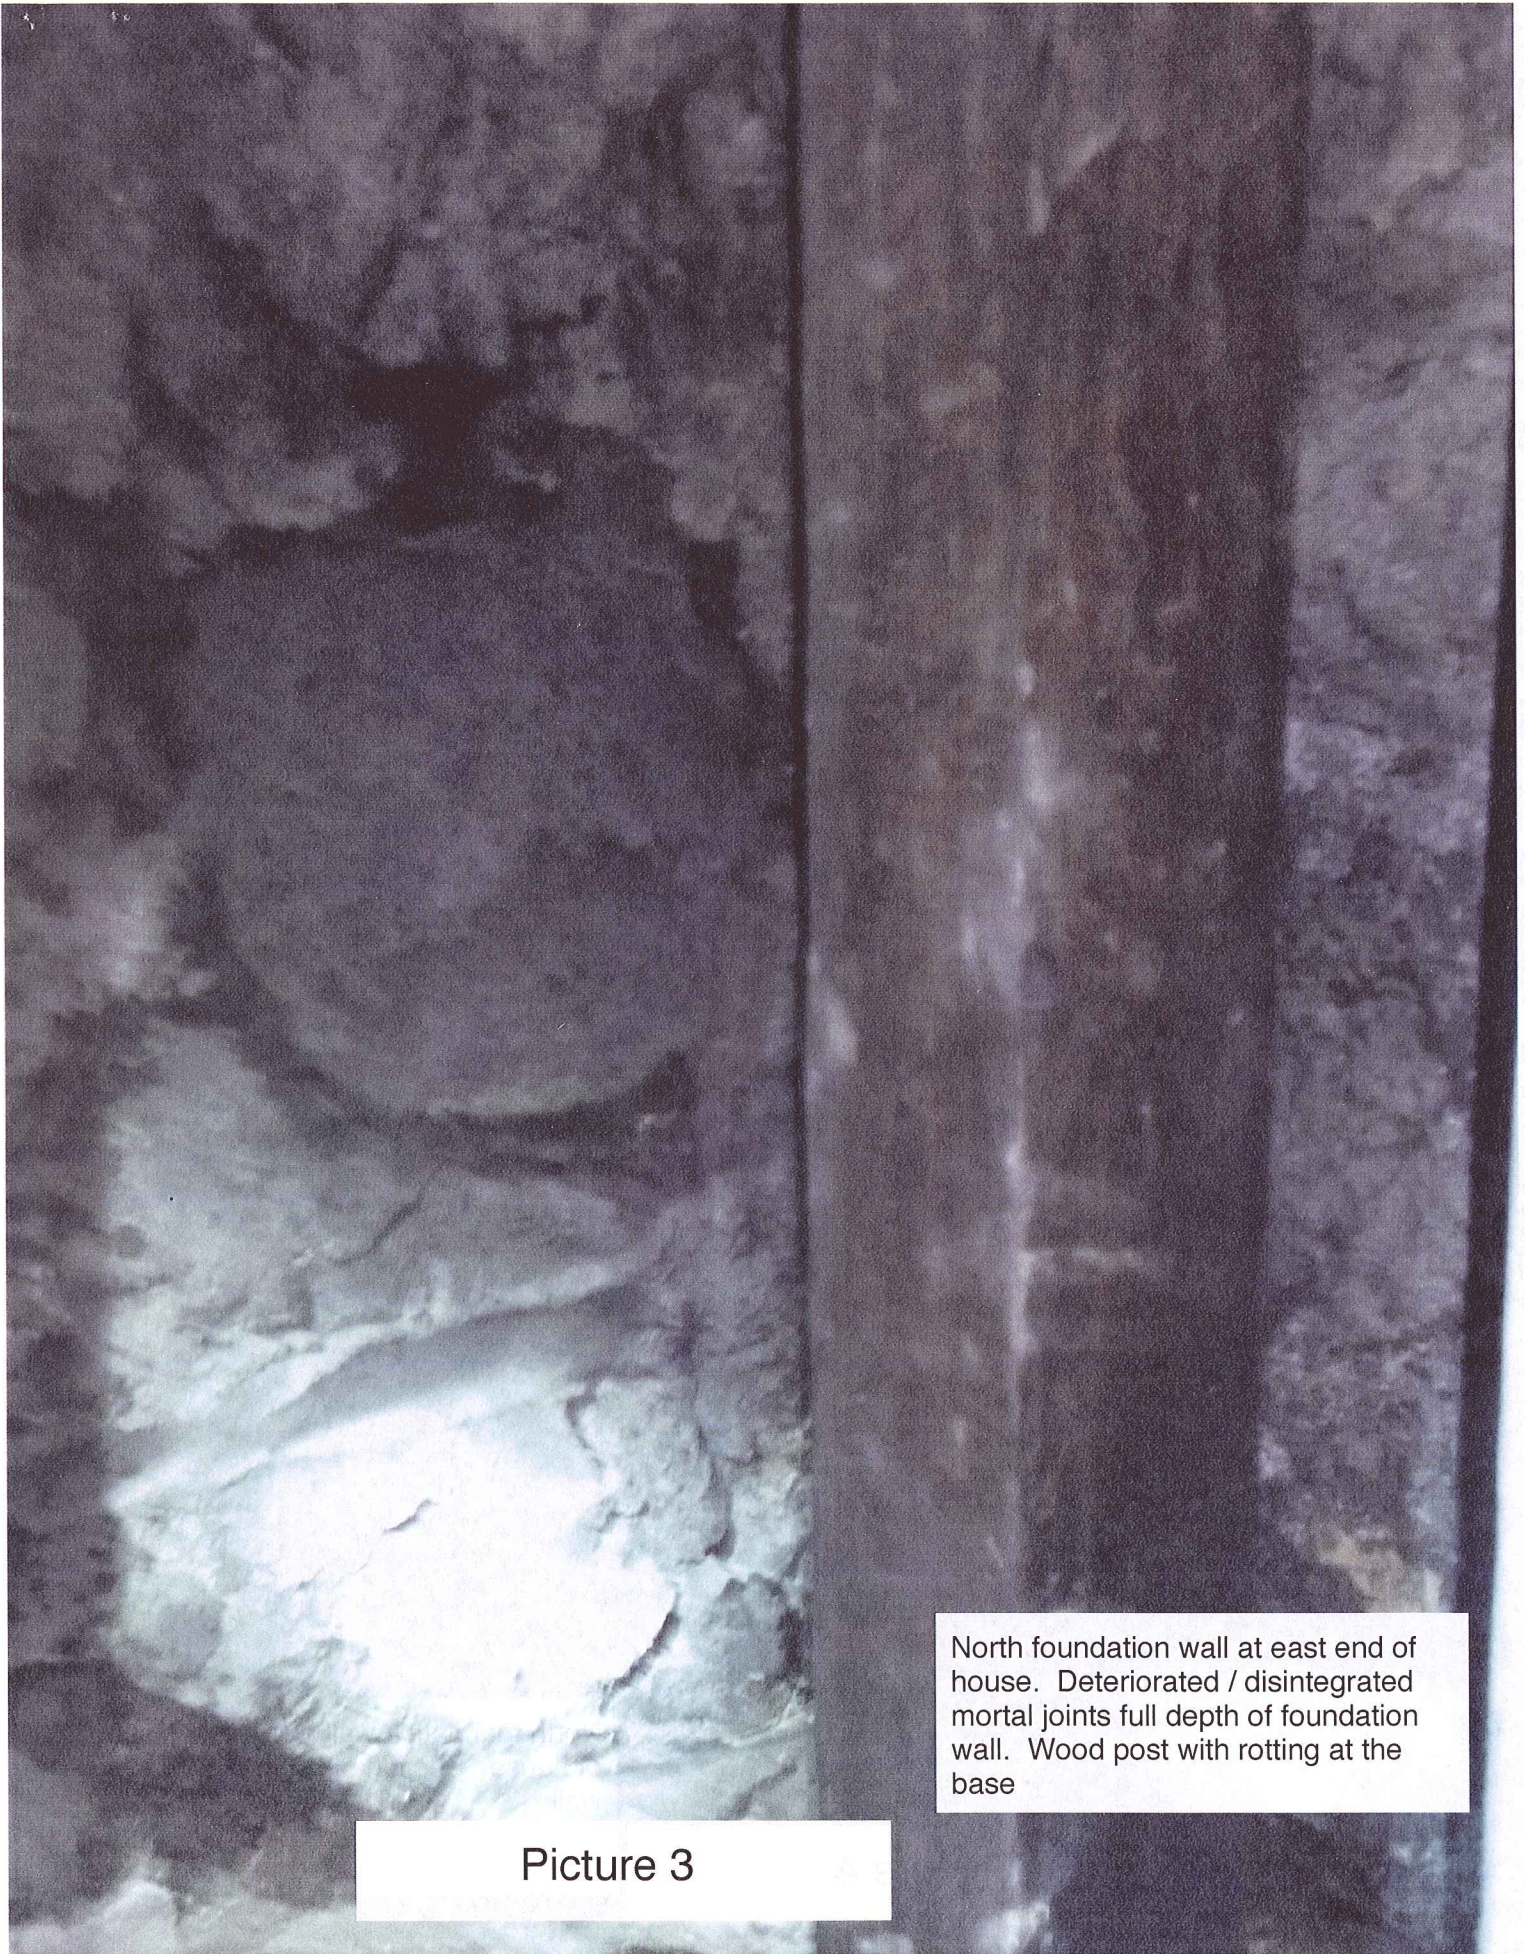
Picture 3

North foundation wall at east end of house. Deteriorated / disintegrated mortal joints full depth of foundation wall. Wood post with rotting at the base

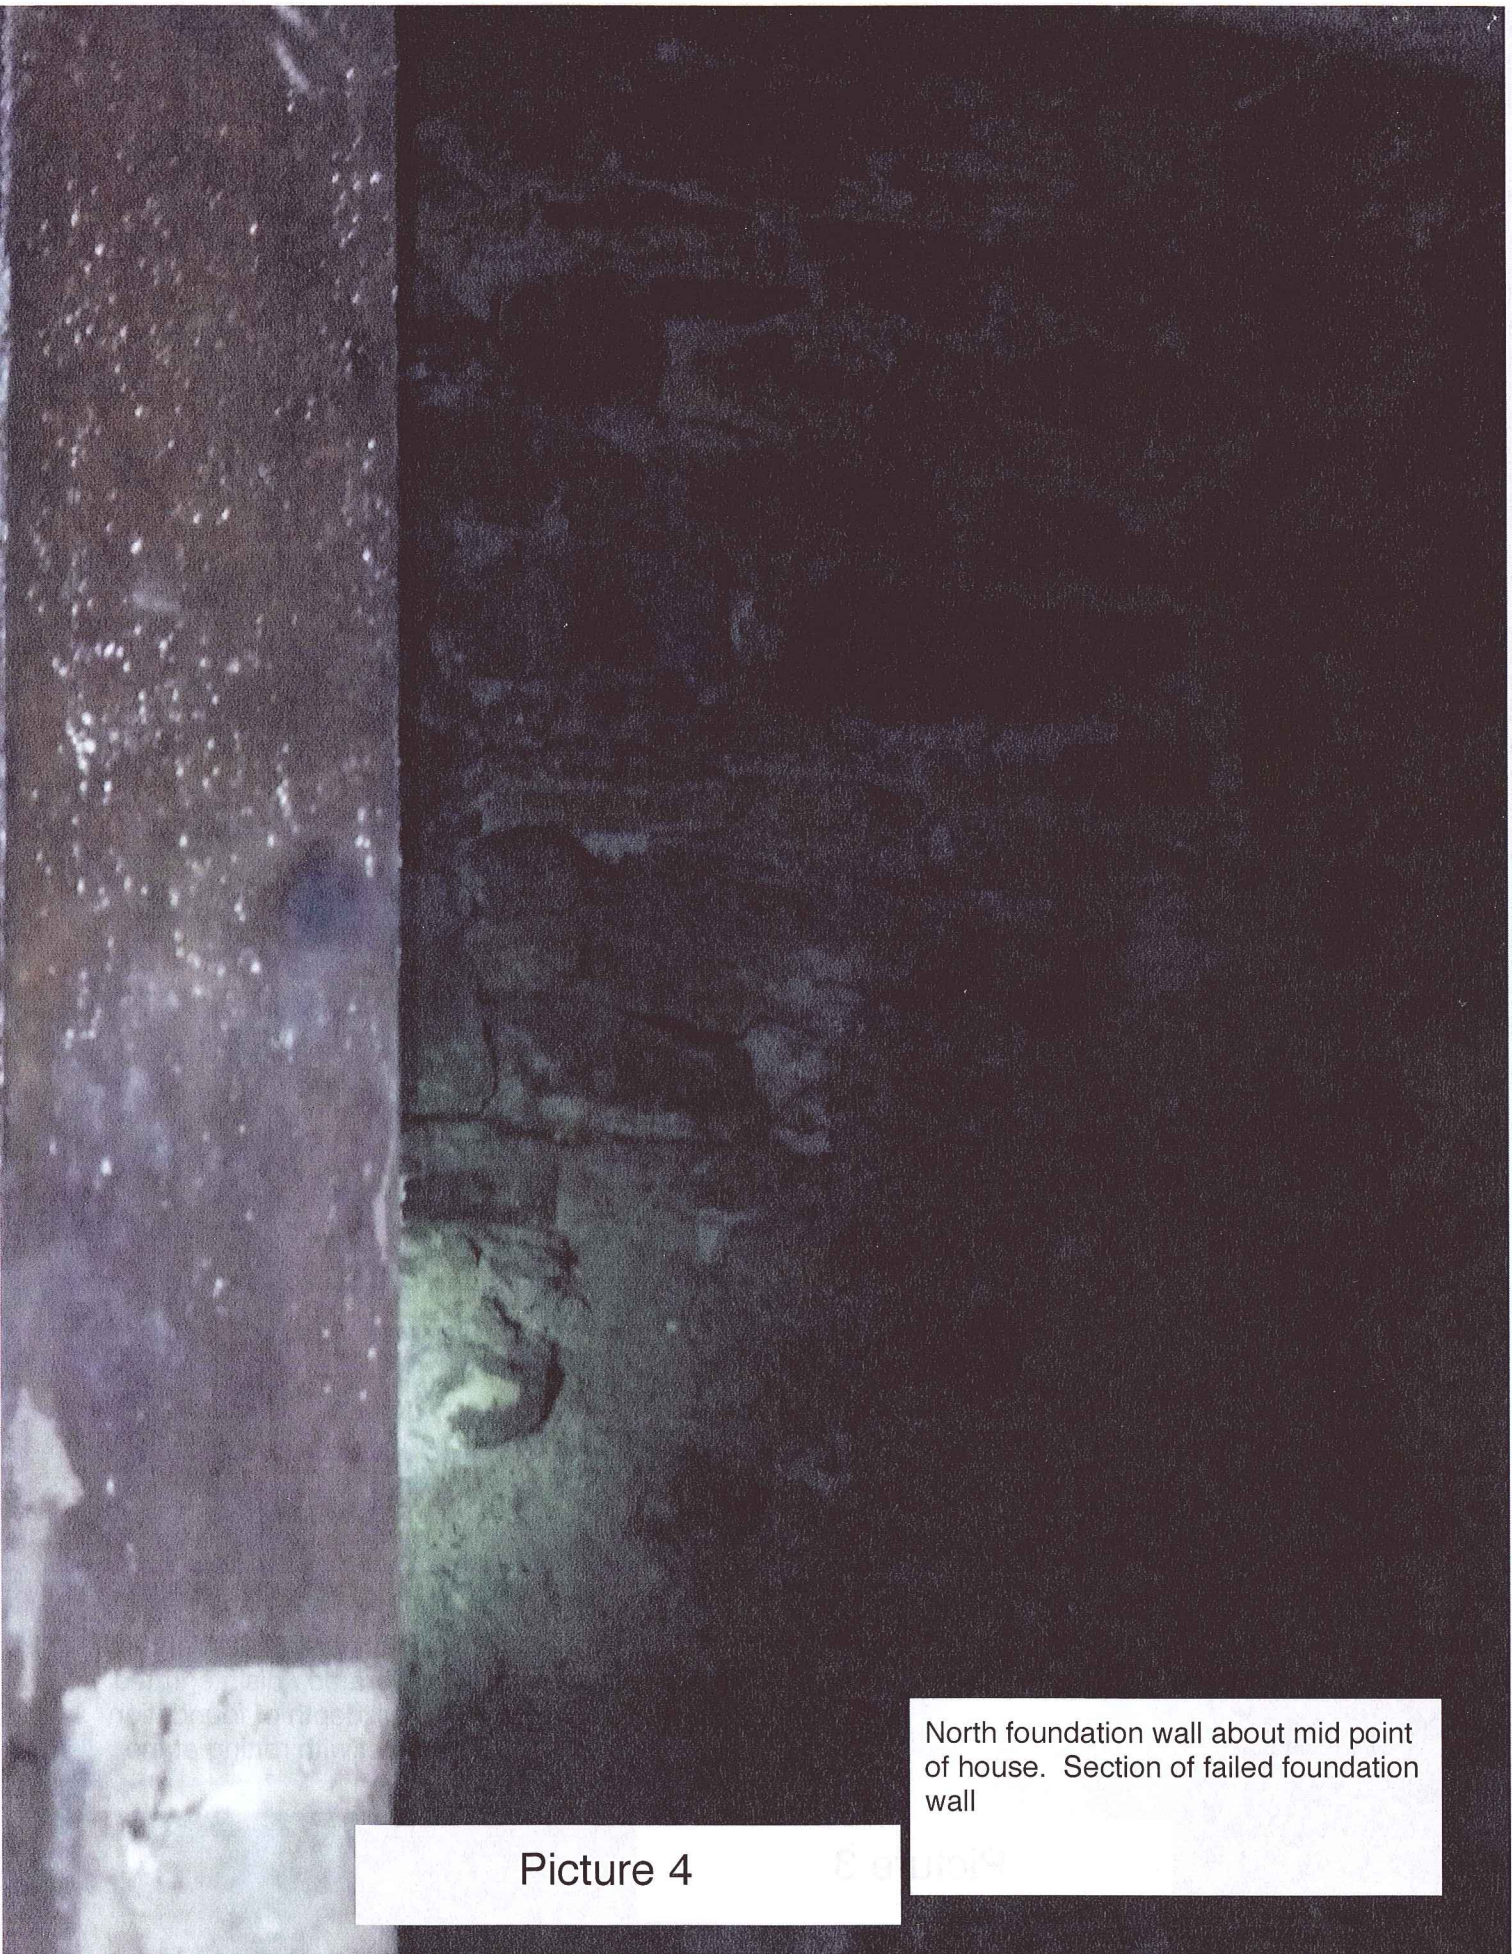
Picture 4

North foundation wall about mid point of house. Section of failed foundation wall

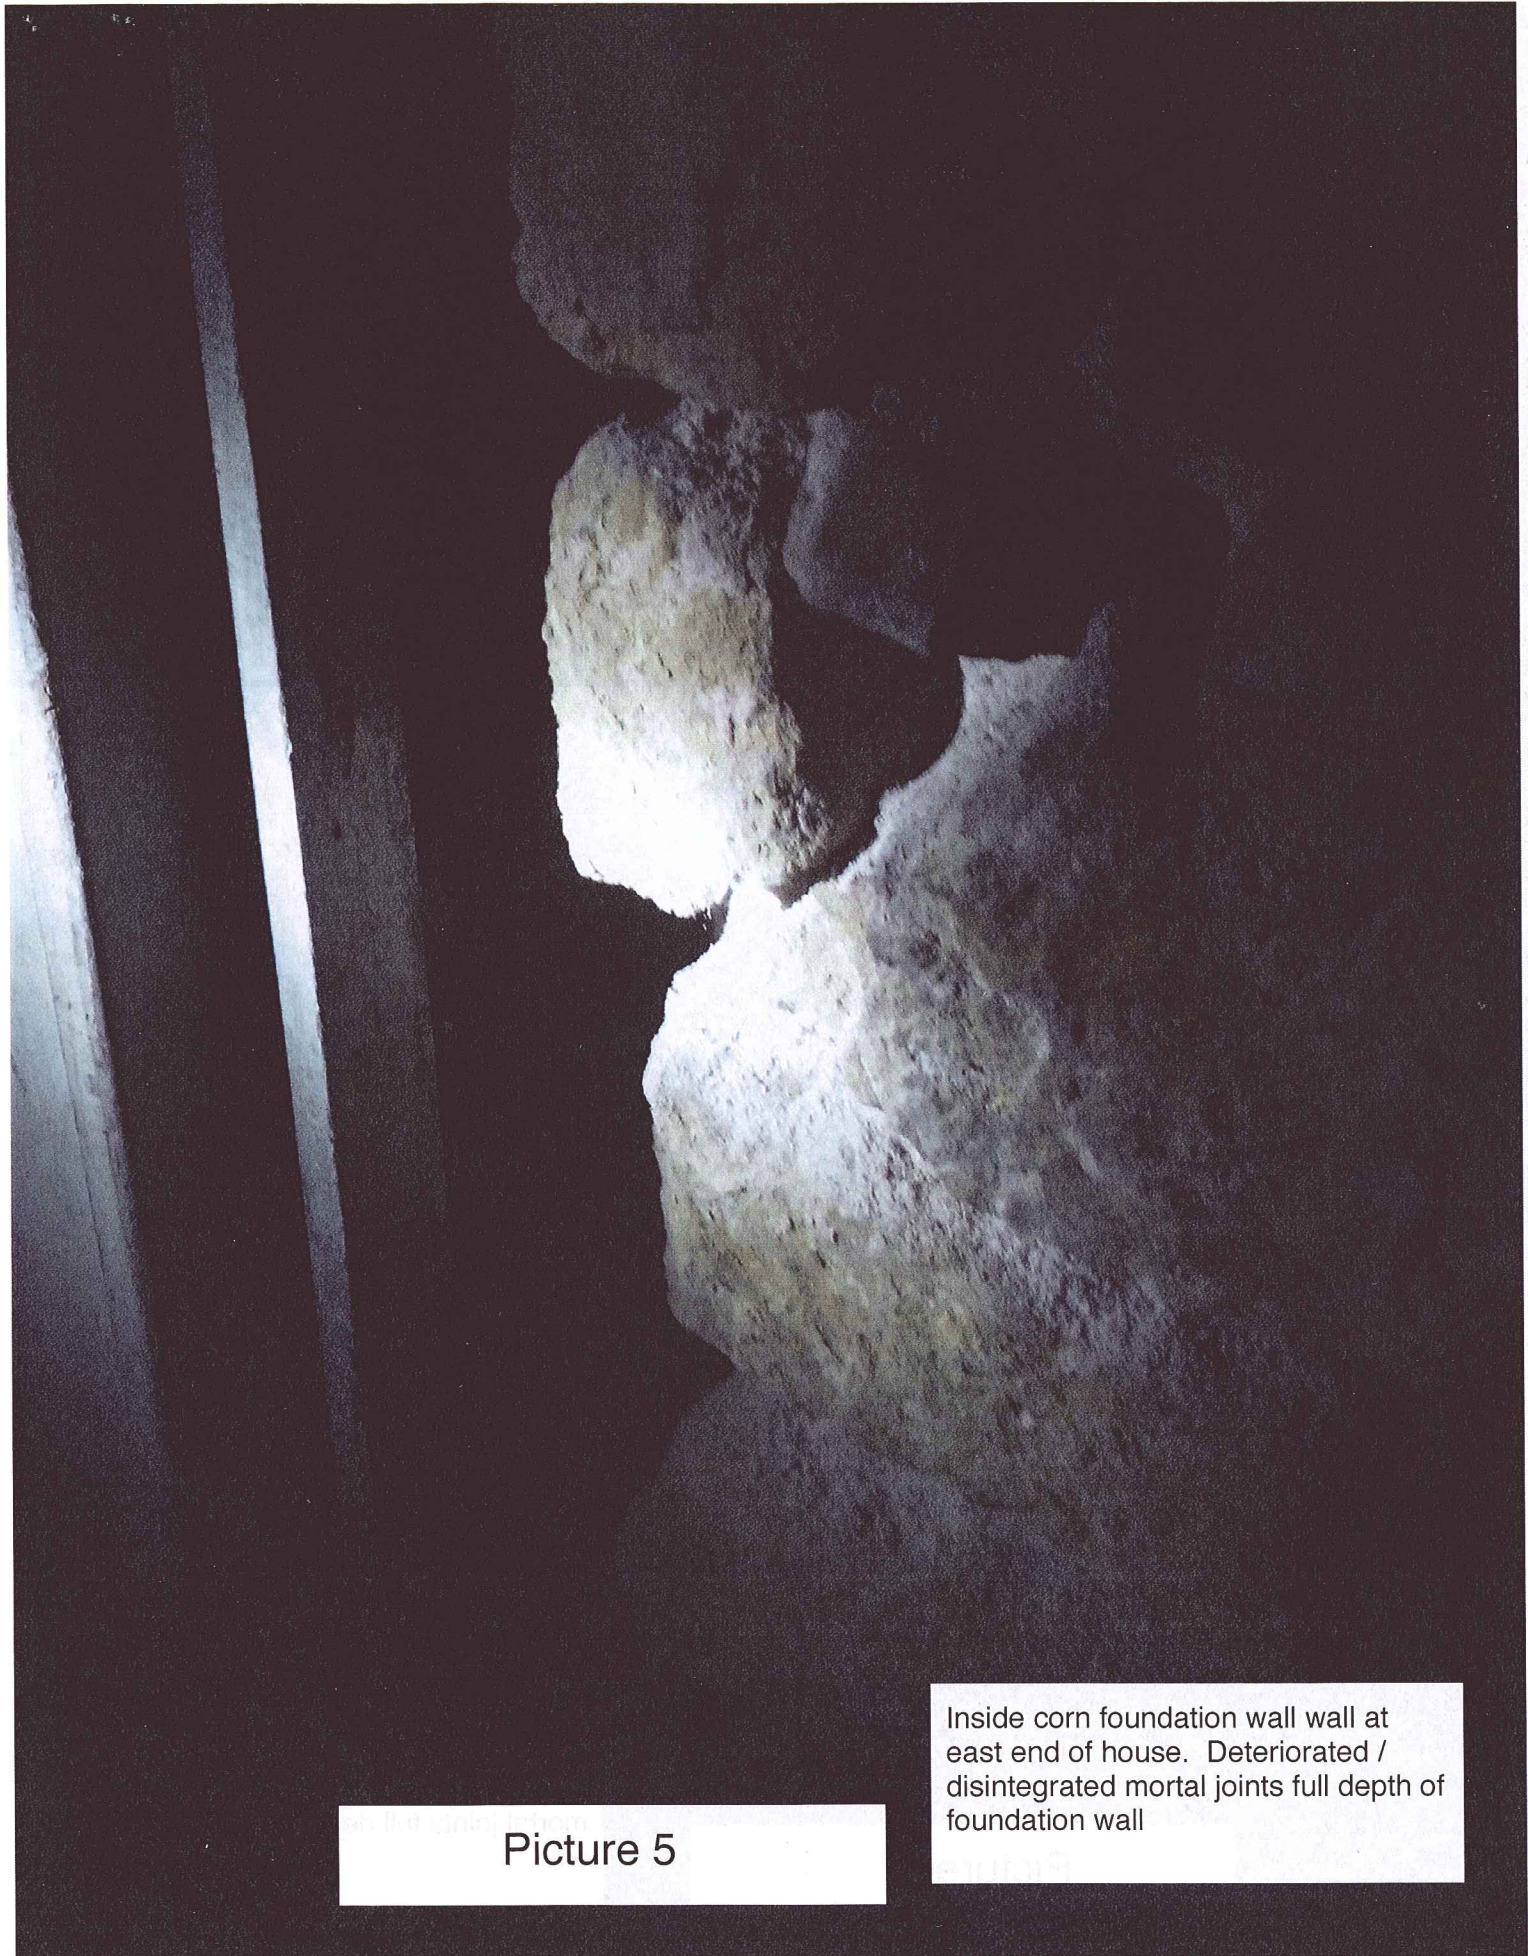
Picture 5

Inside corn foundation wall wall at east end of house. Deteriorated / disintegrated mortal joints full depth of foundation wall

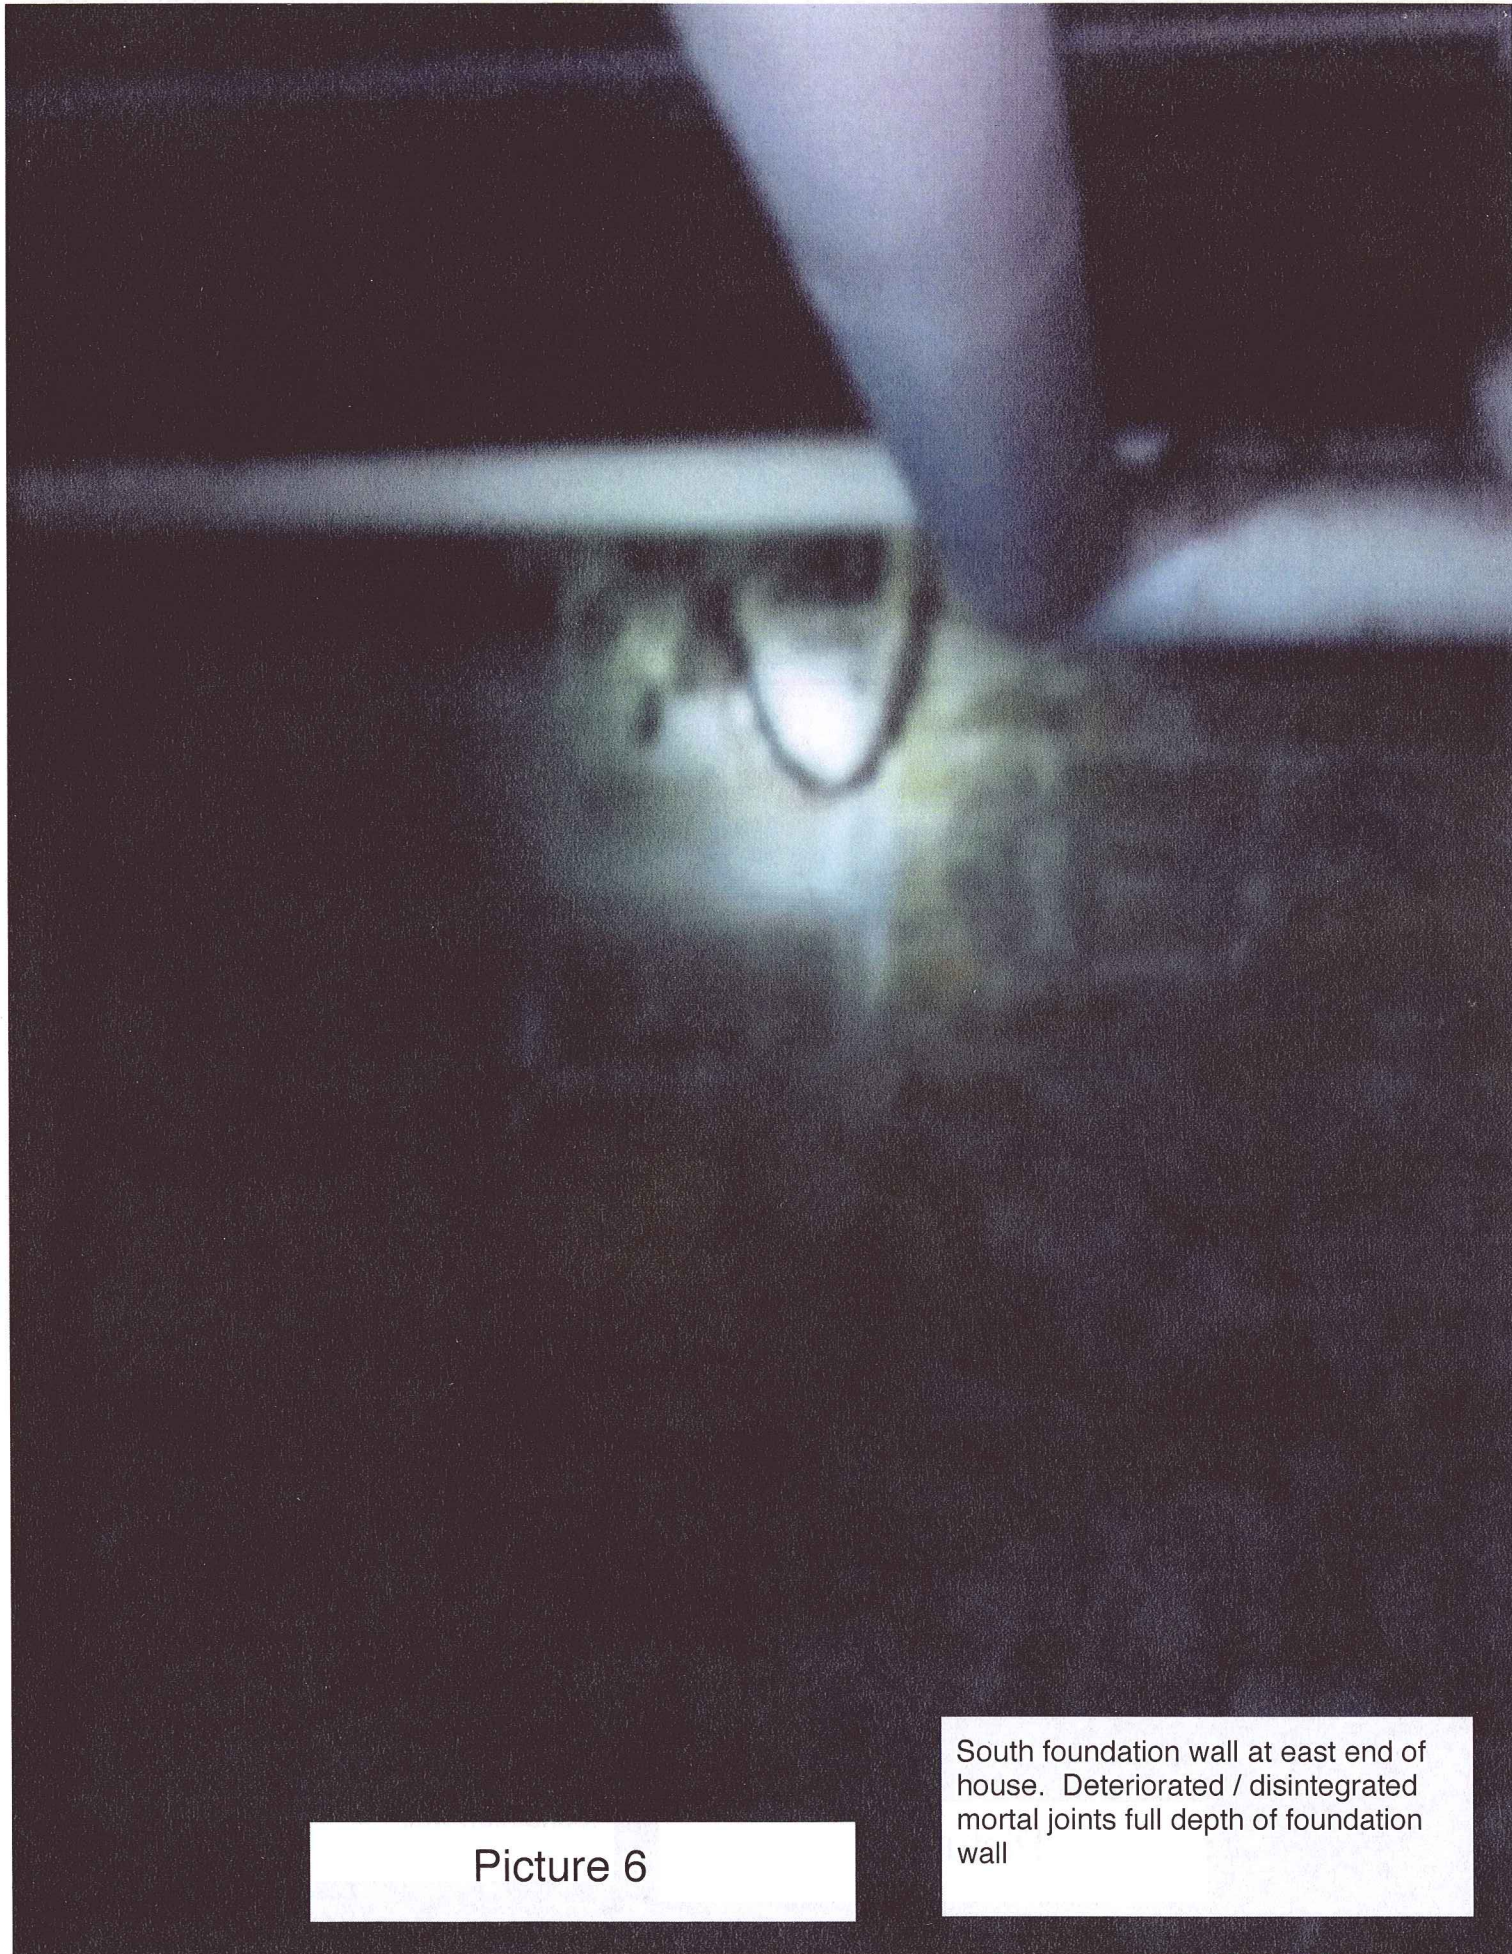
Picture 6

South foundation wall at east end of house. Deteriorated / disintegrated mortal joints full depth of foundation wall

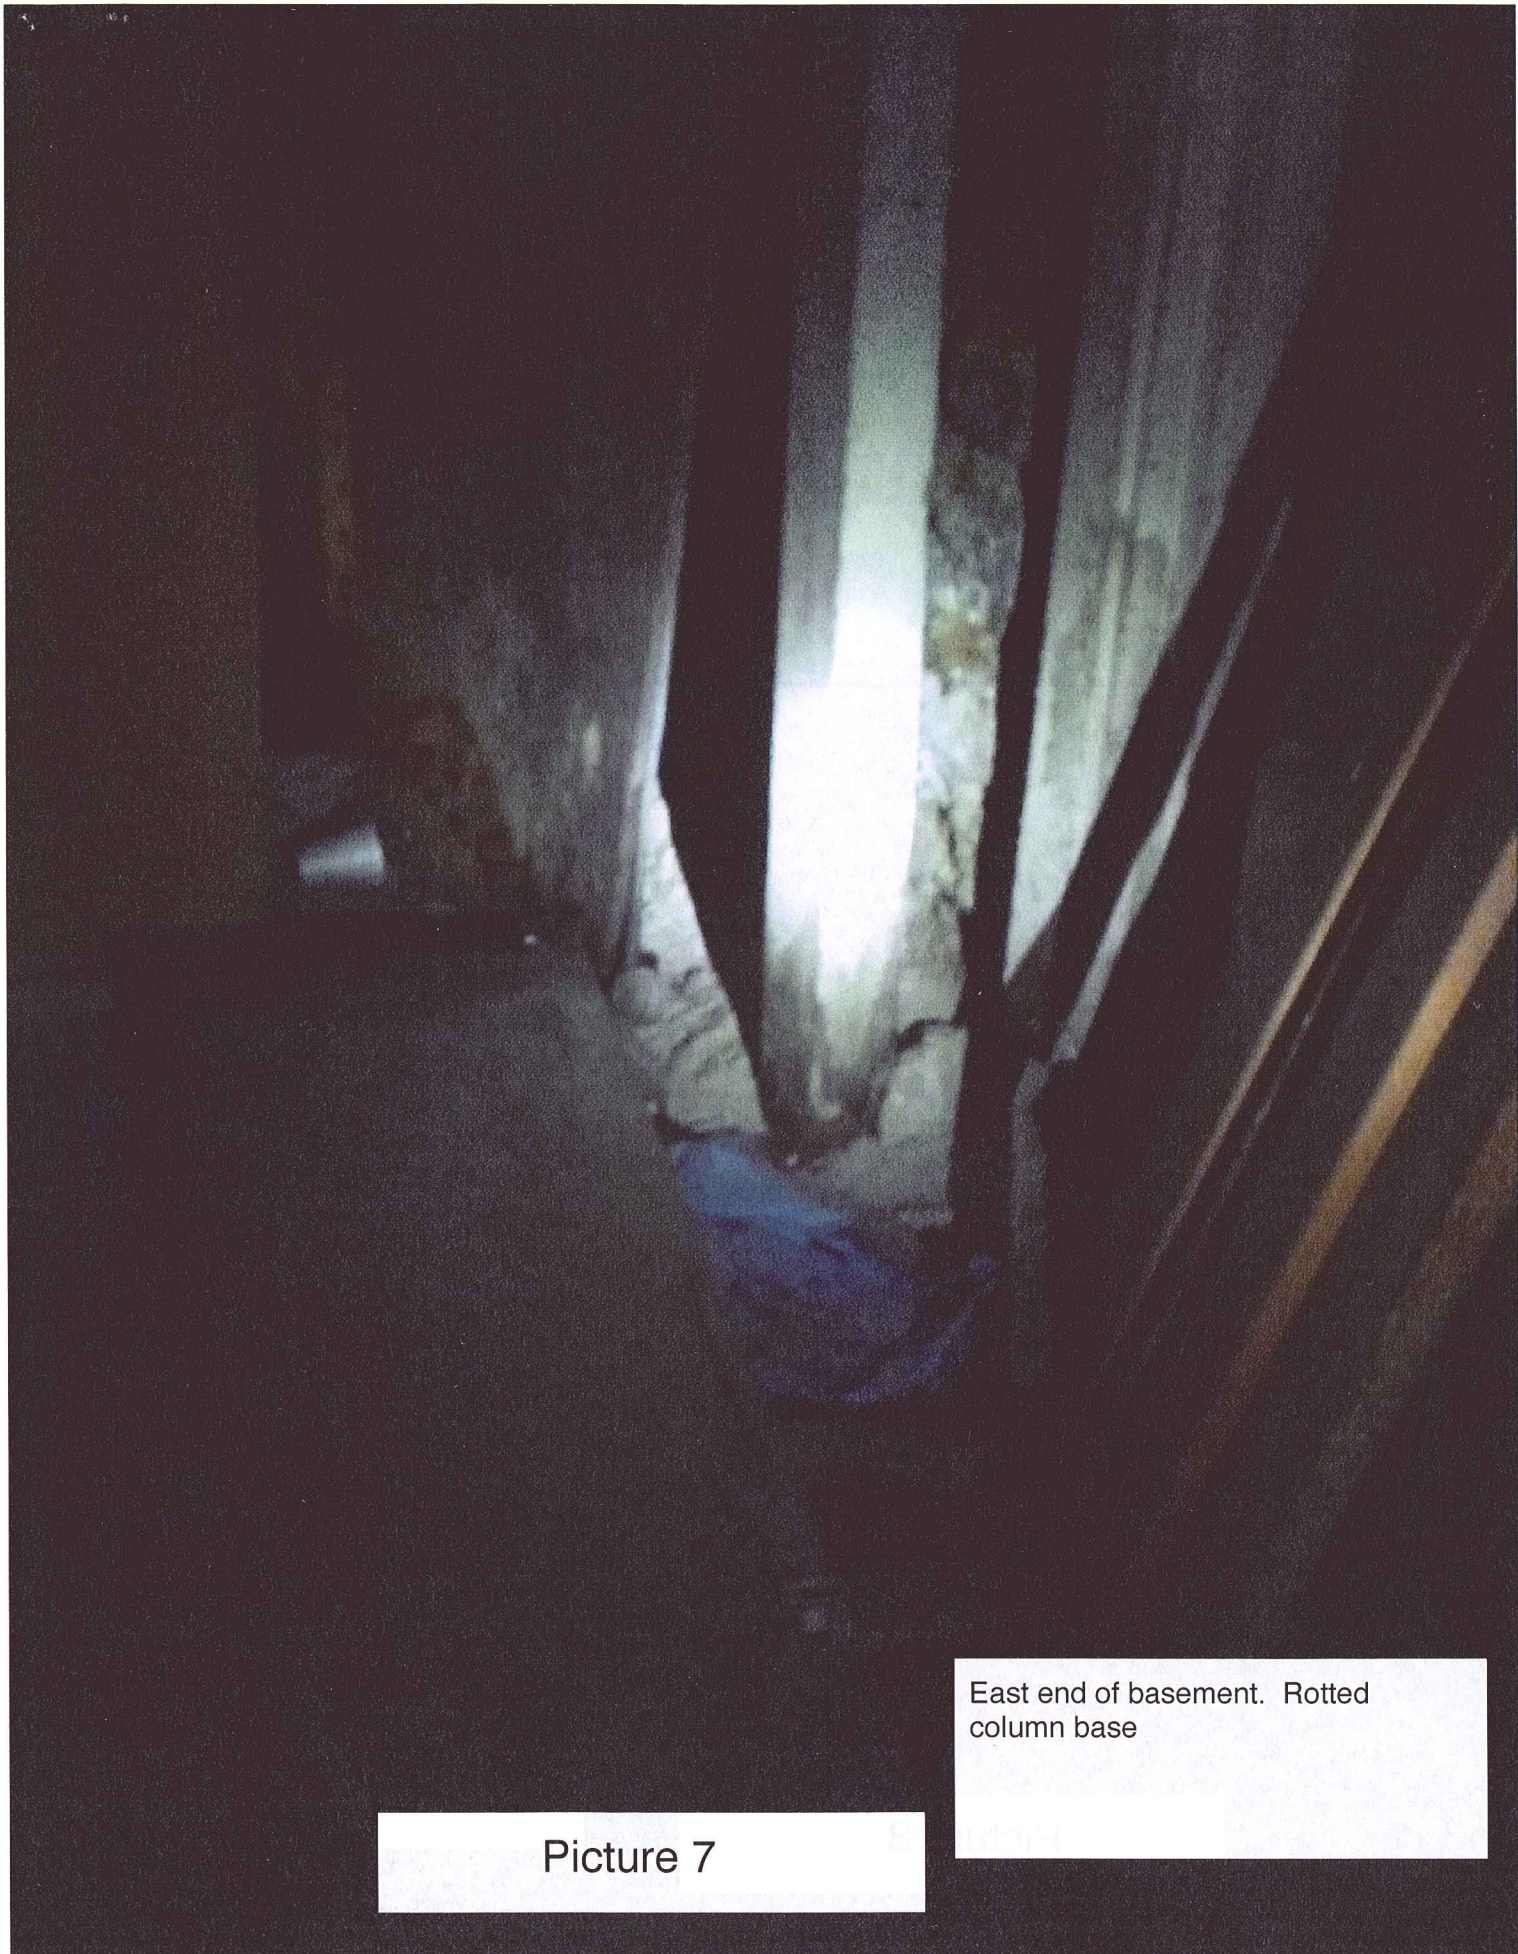
Picture 7

2. There are several wood posts in the basement which support the first floor beams, and these first floor beams are under bearing walls above. The bearing walls above support the second, third, and attic floor framing. Over time due to moisture, the bases of these columns have rotted. Some have been repaired, but many have not and significant rotting has occurred at the base. This degree of rotting has significantly diminished the structural capacity of the post. Pictures 7 thru 9 show typical rotted base conditions.

East end of basement. Rotted column base

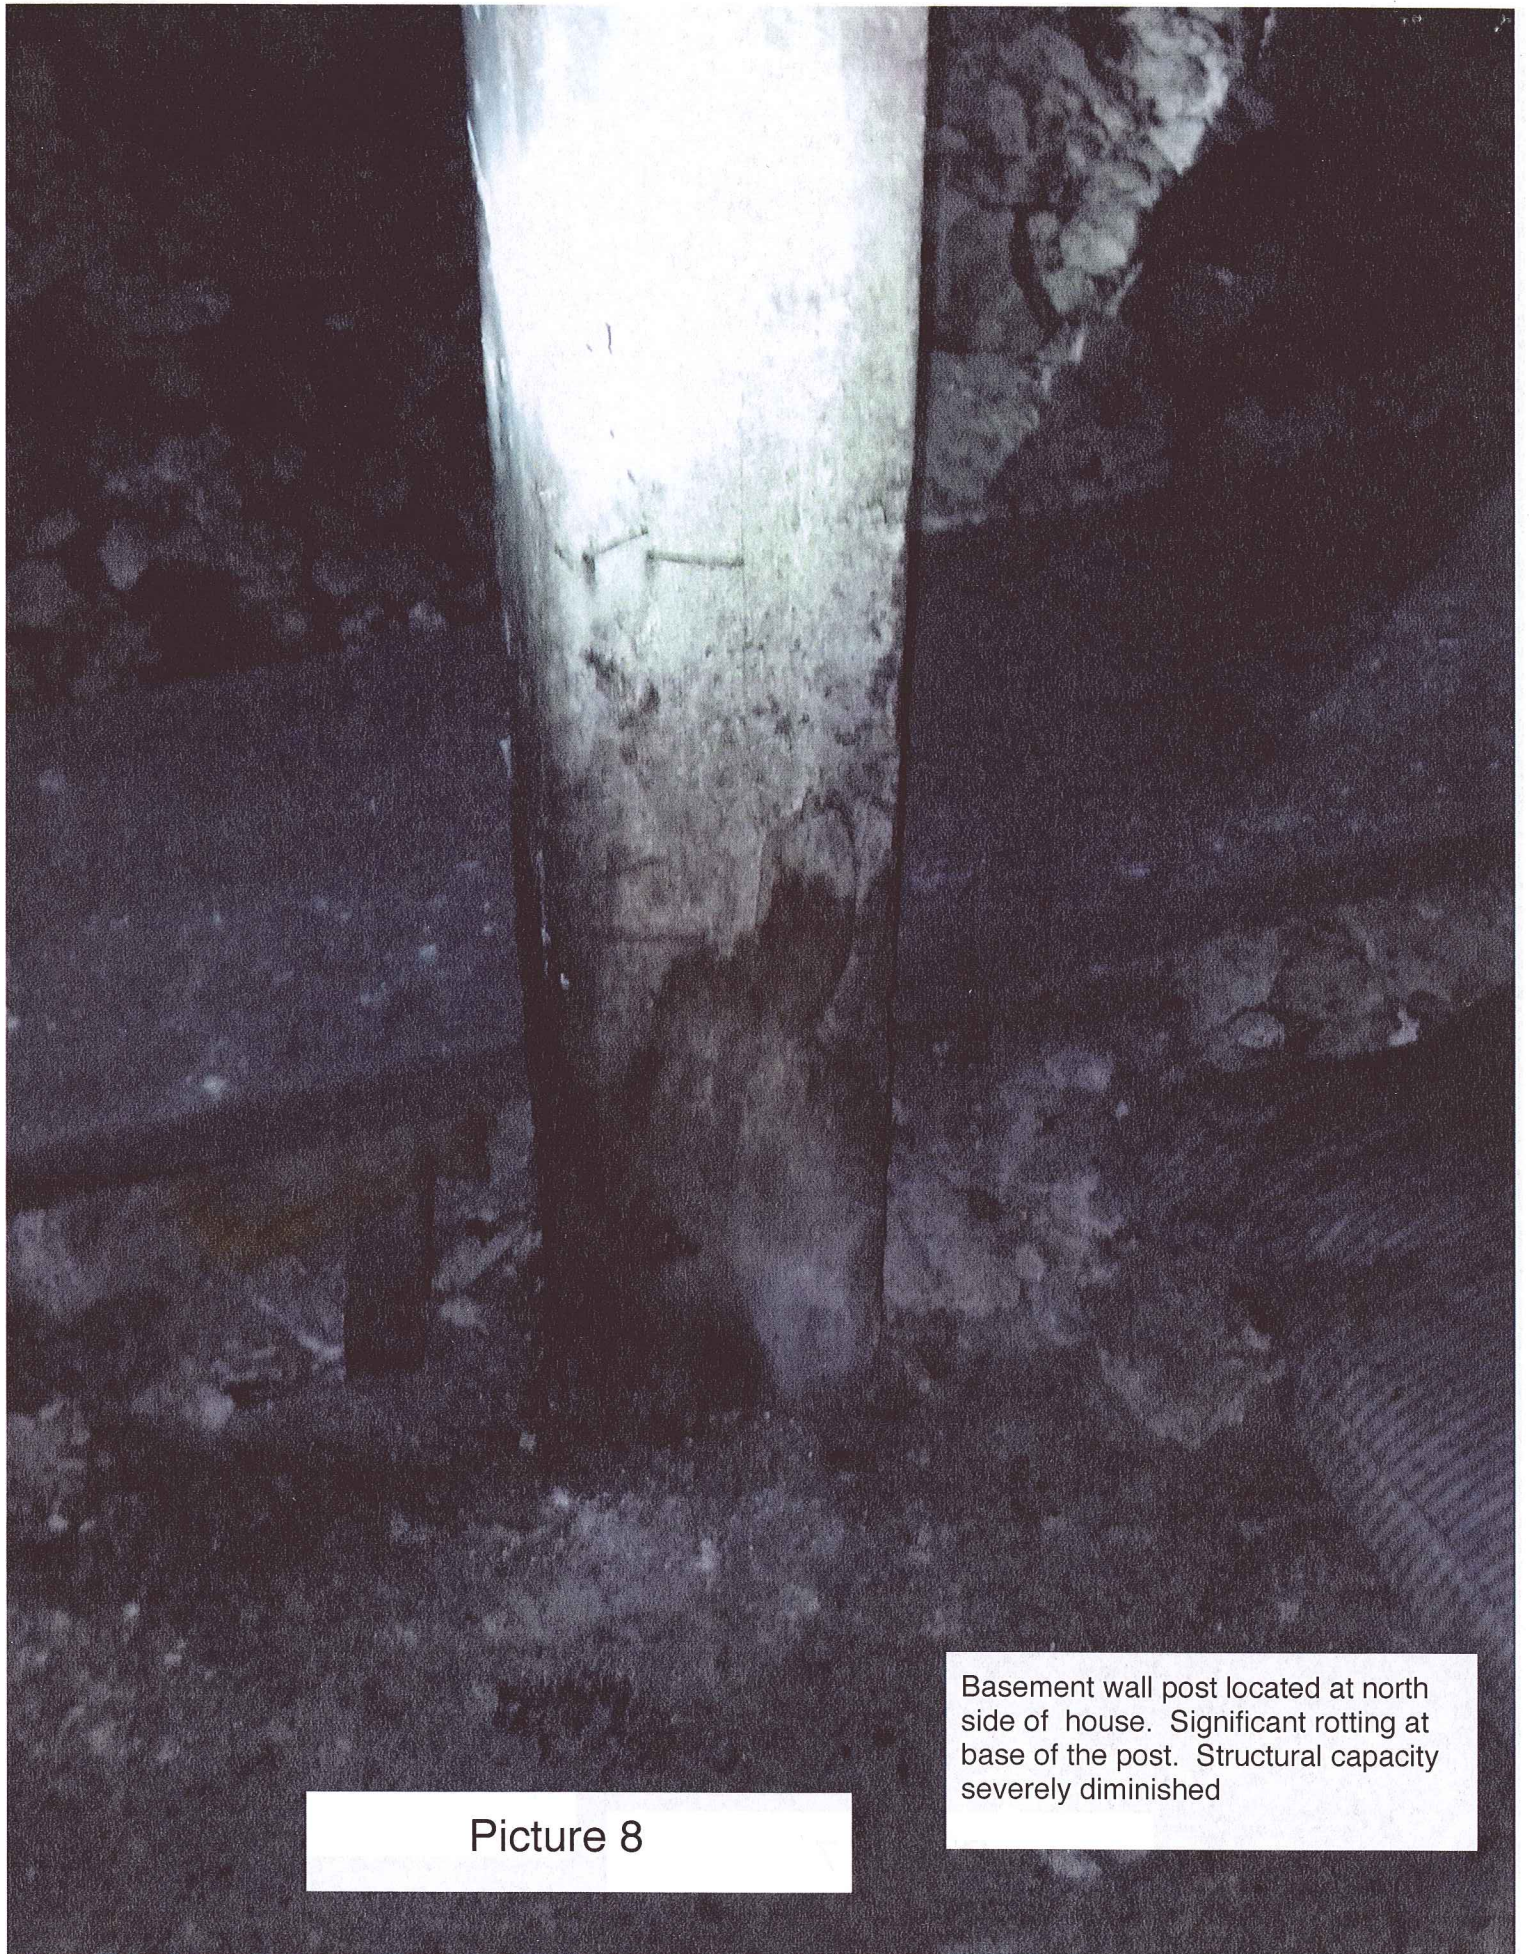
Picture 8

Basement wall post located at north side of house. Significant rotting at base of the post. Structural capacity severely diminished
