Re: Gilman Street Development
Evaluation of two properties
Madison, WI

The following is my report on the properties at 123 and 127 West Gillman Street.

127 W. Gilman St.
Madison, WI 53703

Conceptual Budget/Recommendations Report

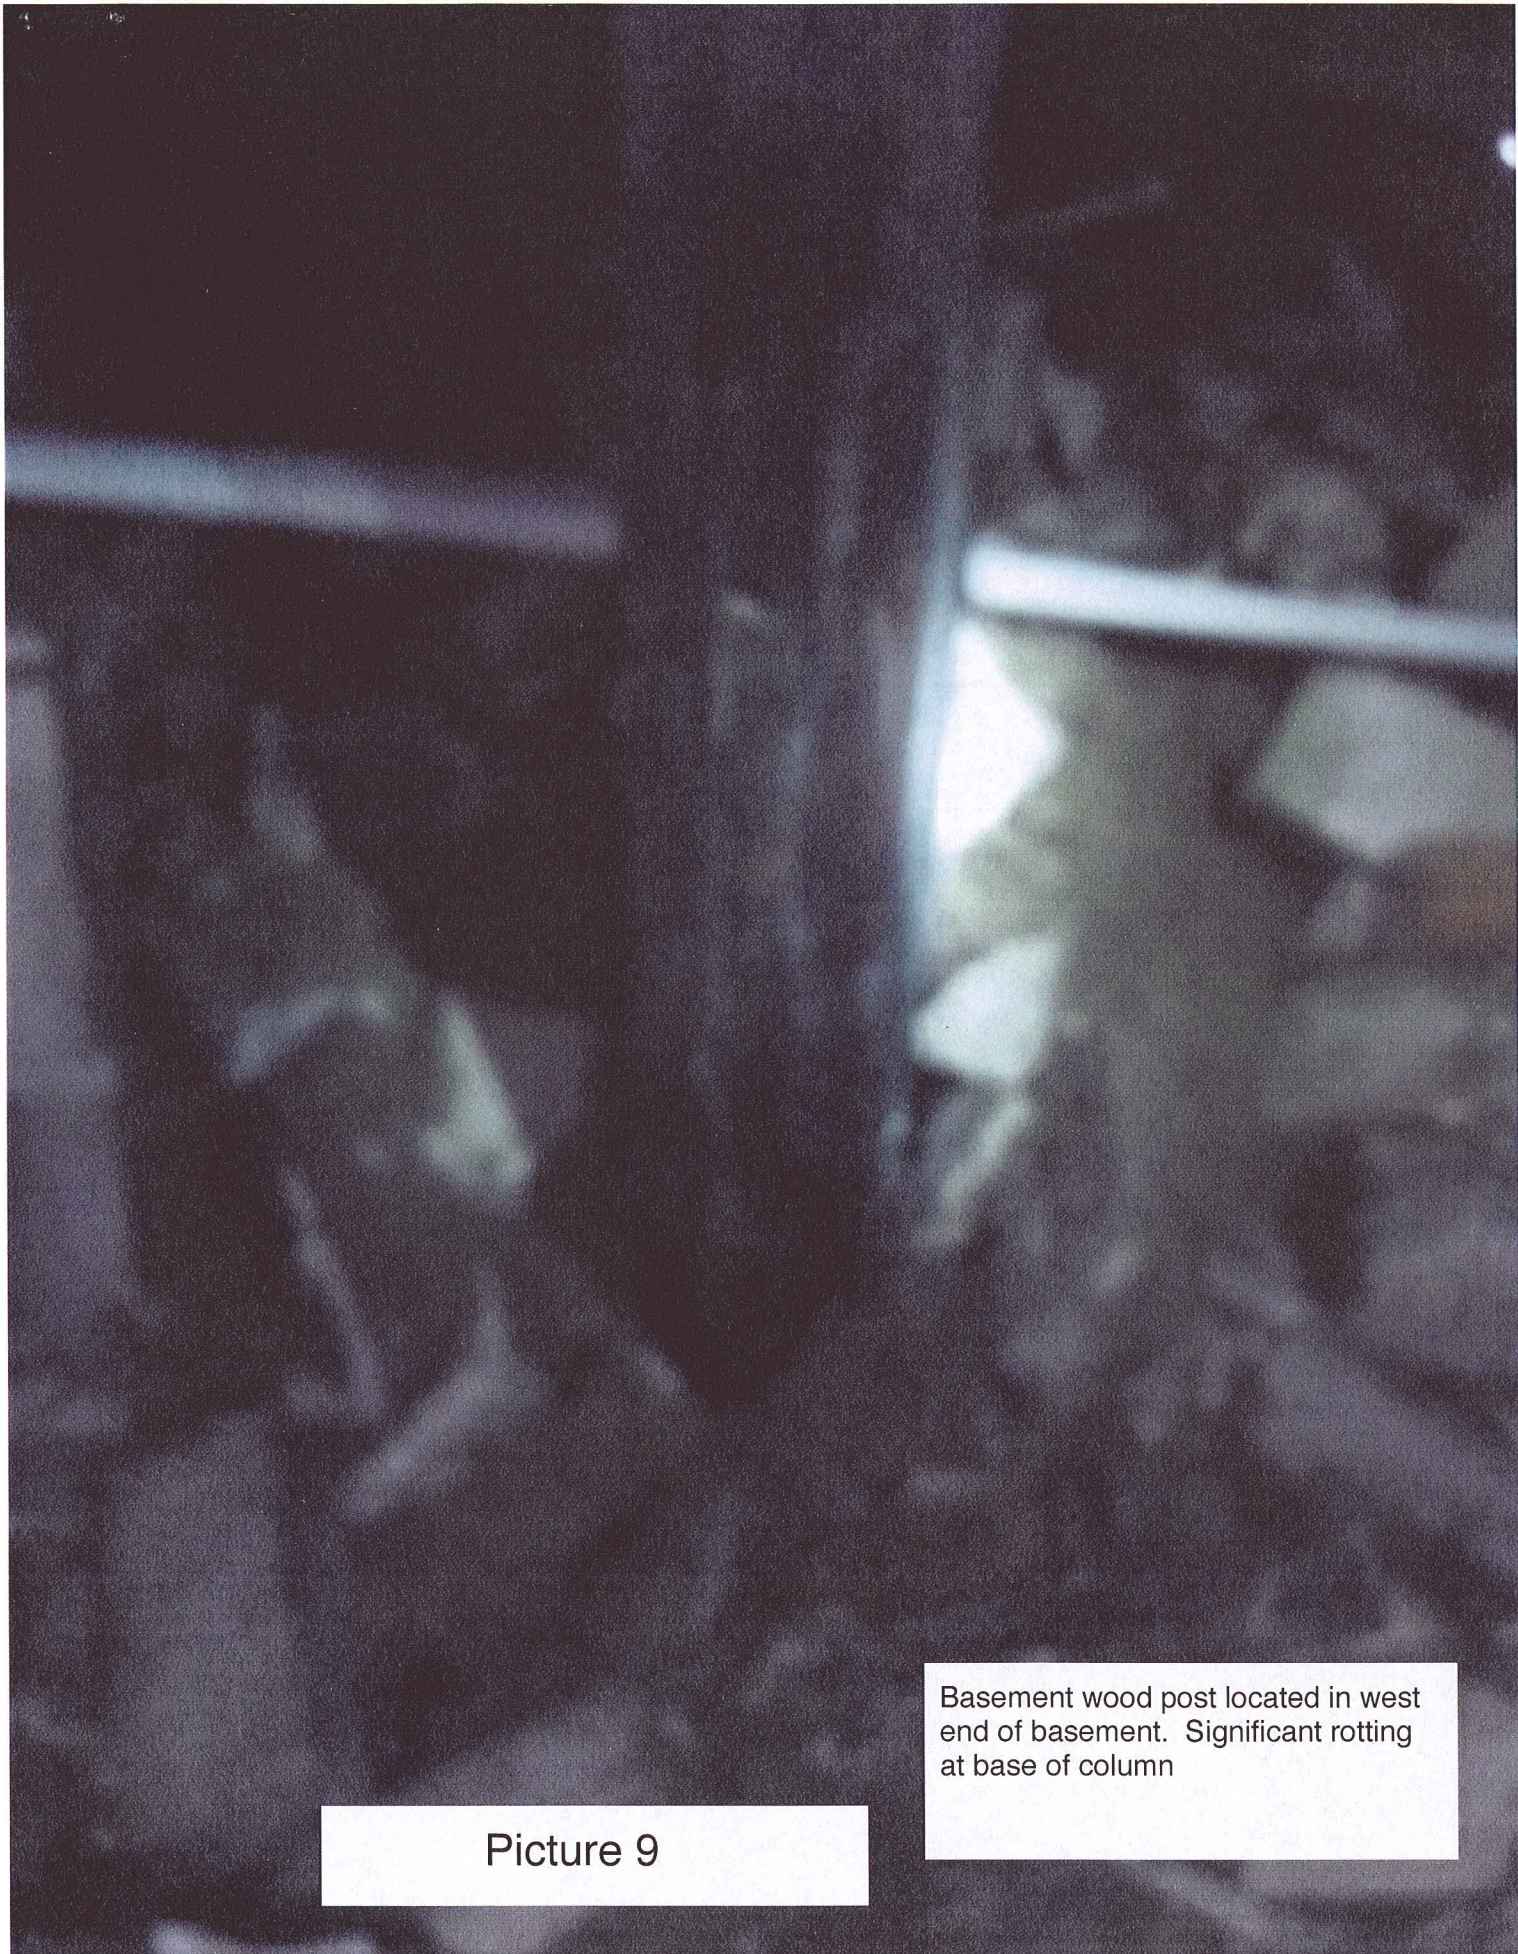
Picture 9

2. There are several wood posts in the basement which support the first floor beams, and these first floor beams are under bearing walls above. The bearing walls above support the second, third, and attic floor framing. Over time due to moisture, the bases of these columns have rotted. Some have been repaired, but many have not and significant rotting has occurred at the base. This degree of rotting has significantly diminished the structural capacity of the post. Pictures 7 thru 9 show typical rotted base conditions.

Basement wood post located in west end of basement. Significant rotting at base of column

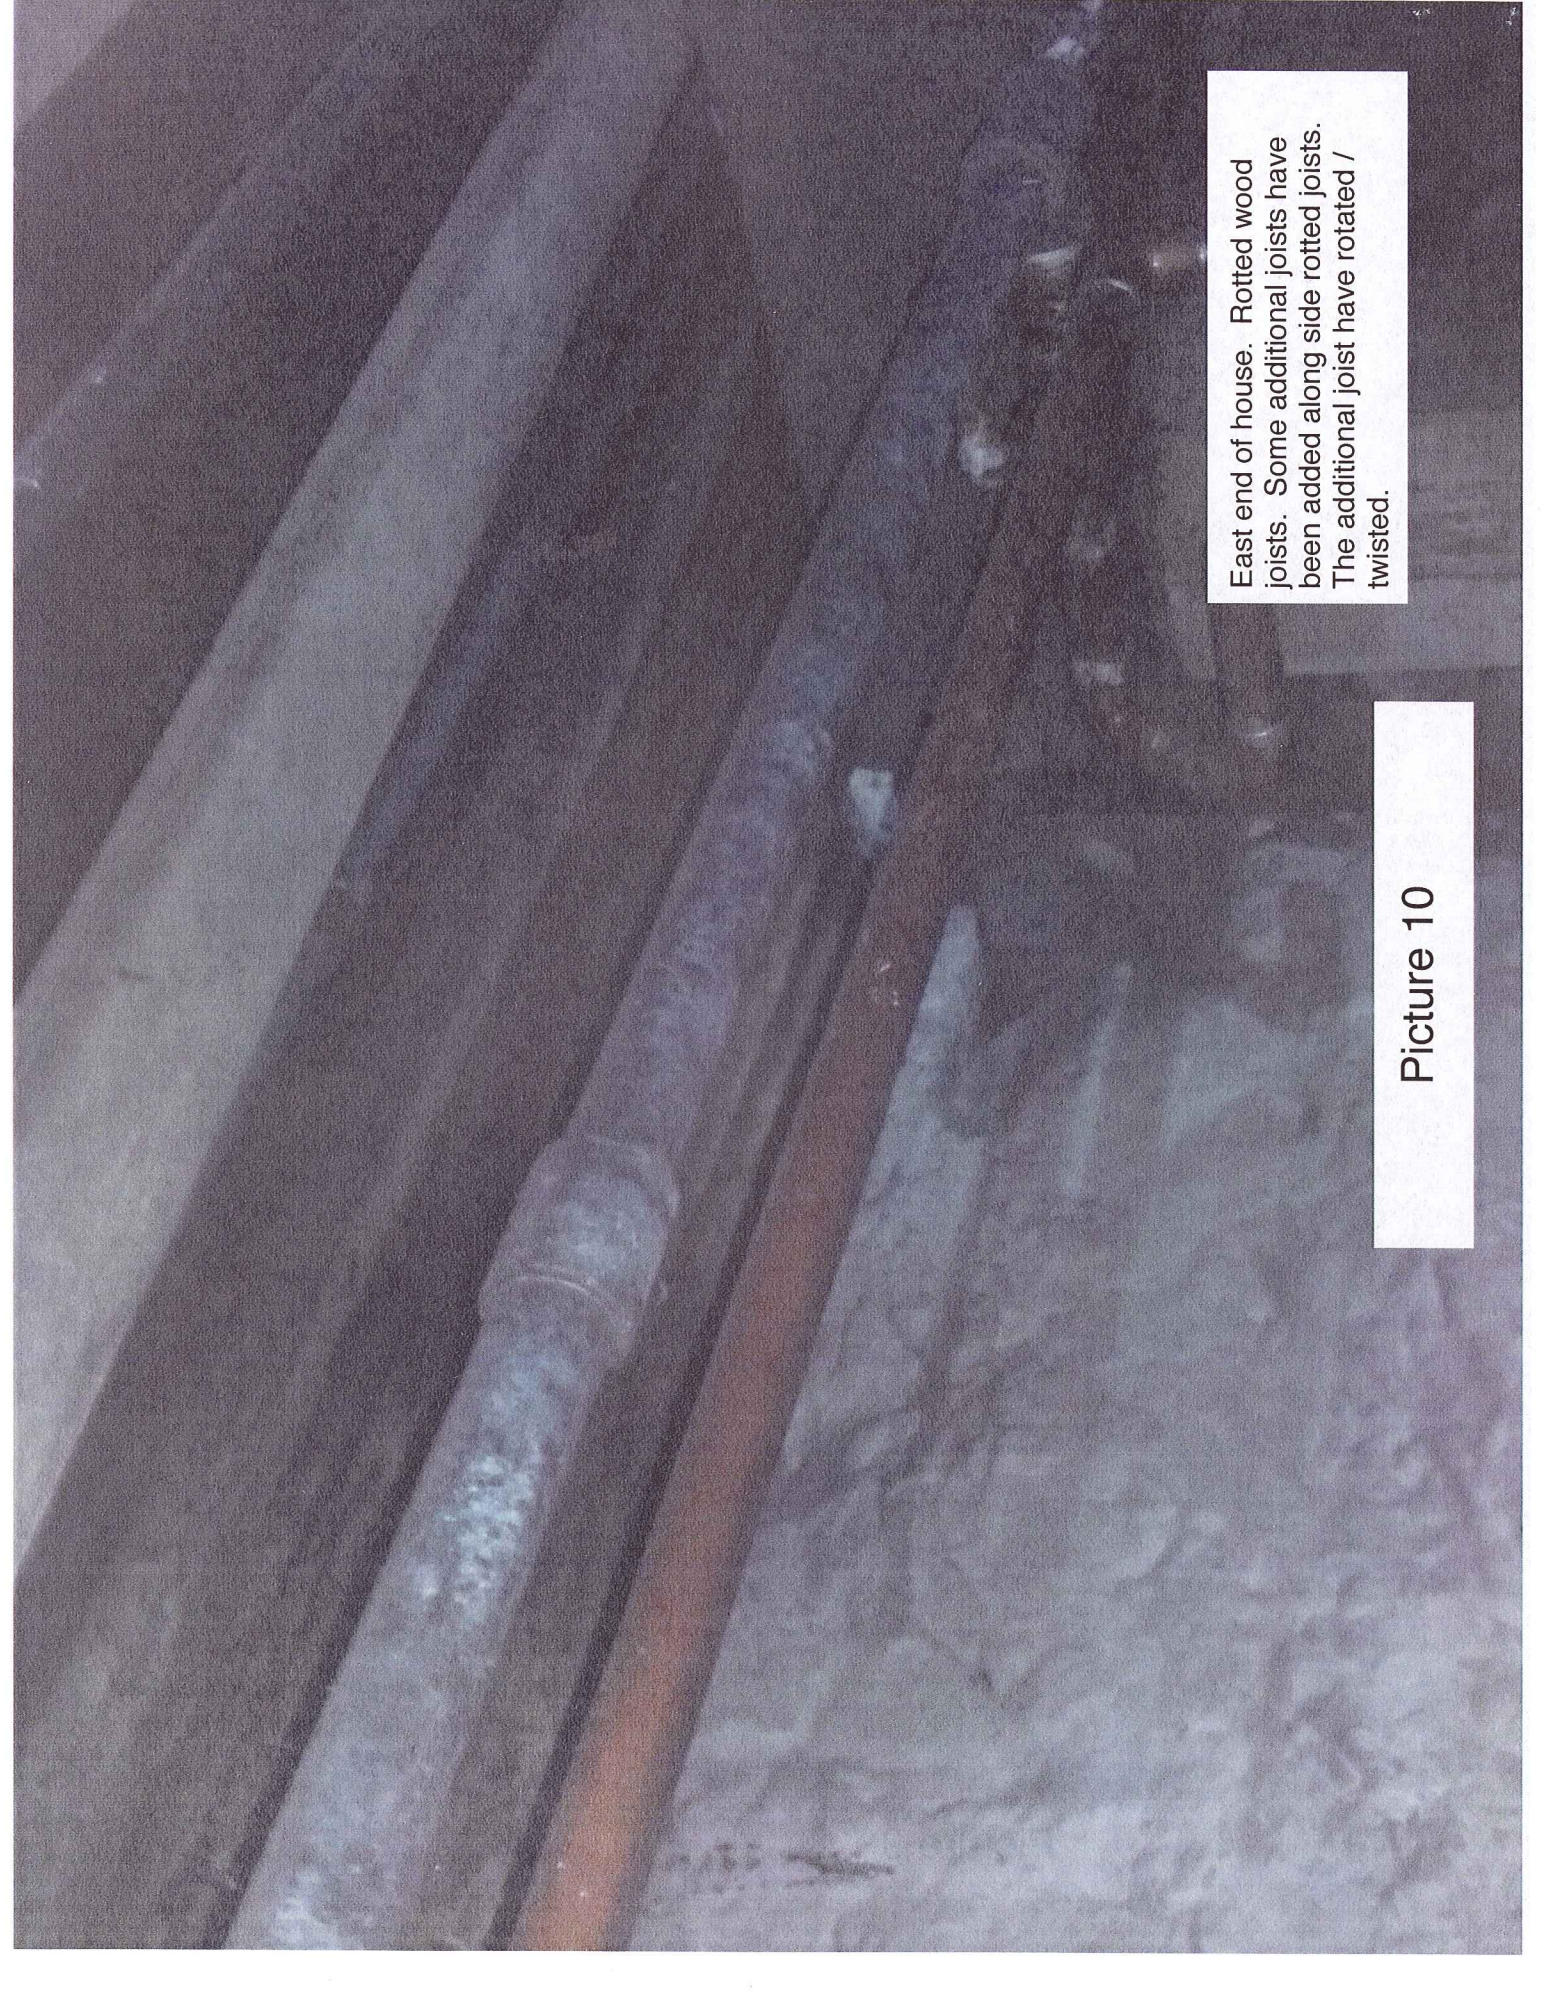
Picture 10

East end of house. Rotted wood joists. Some additional joists have been added along side rotted joists. The additional joist have rotated / twisted.

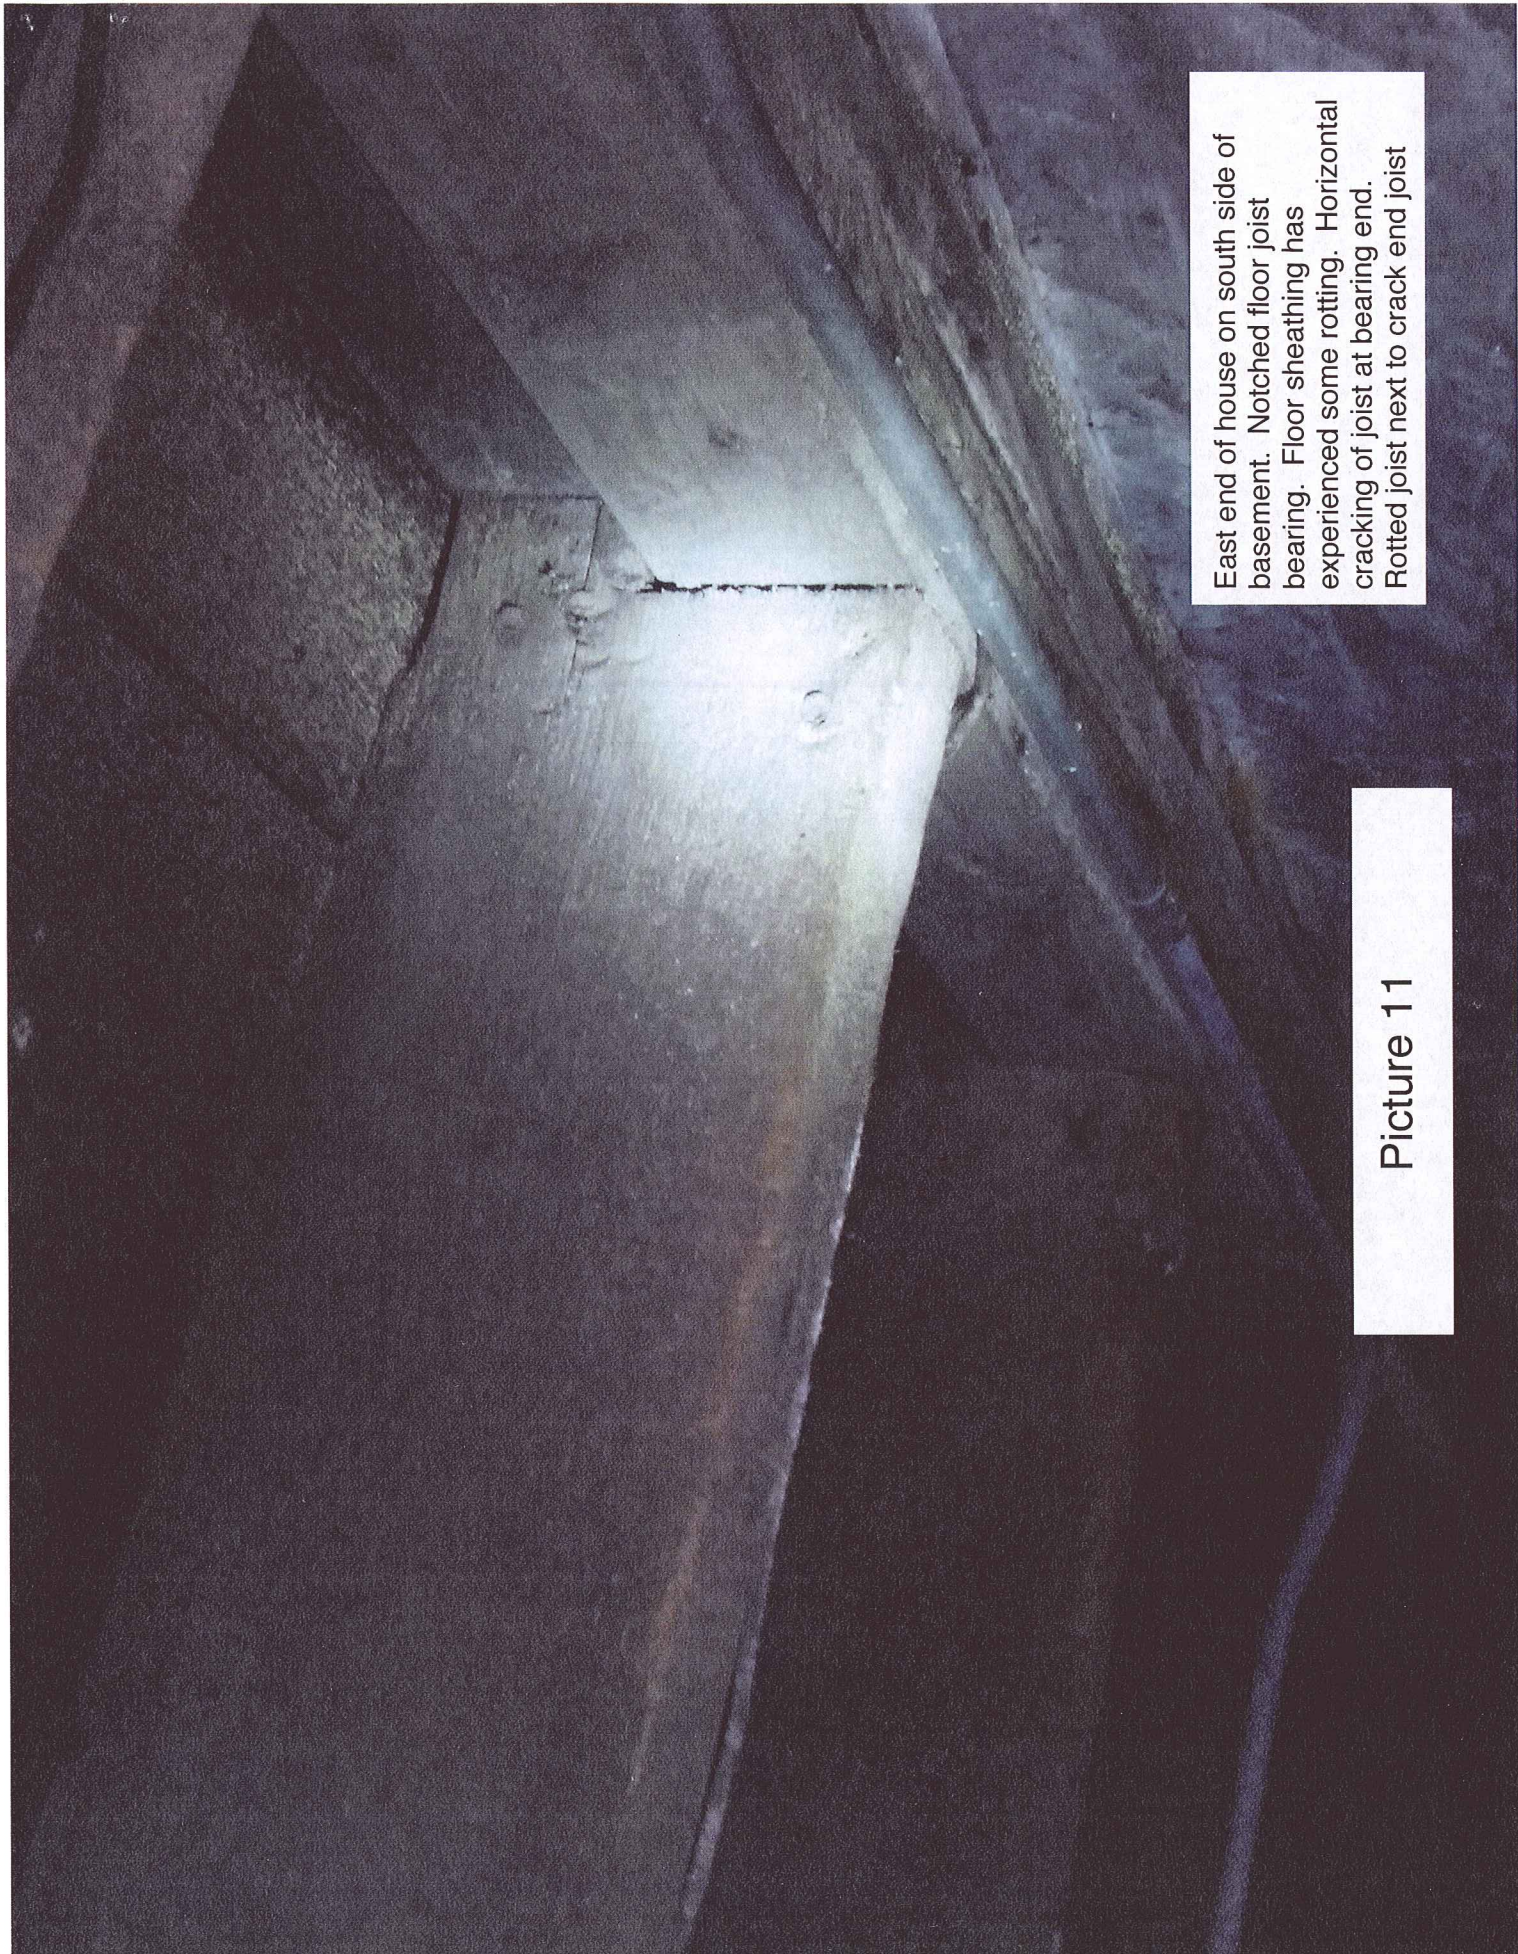
Picture 11

East end of house on south side of basement. Notched floor joist bearing. Floor sheathing has experienced some rotting. Horizontal cracking of joist at bearing end. Rotted joist next to crack end joist

3. Reinforcement or replacement of rotted and compromised framing members (Pictures 11 and 12) at the first floor framing level. It is estimated that the majority of the first floor framing would need to be corrected in some manner by either; removal and replacement of the structure or reinforcement of the existing structure.
4. Replace the fire damaged structure.
5. Further exploration of the structure at the water leaking areas to check for additional structure deterioration due to rotting.

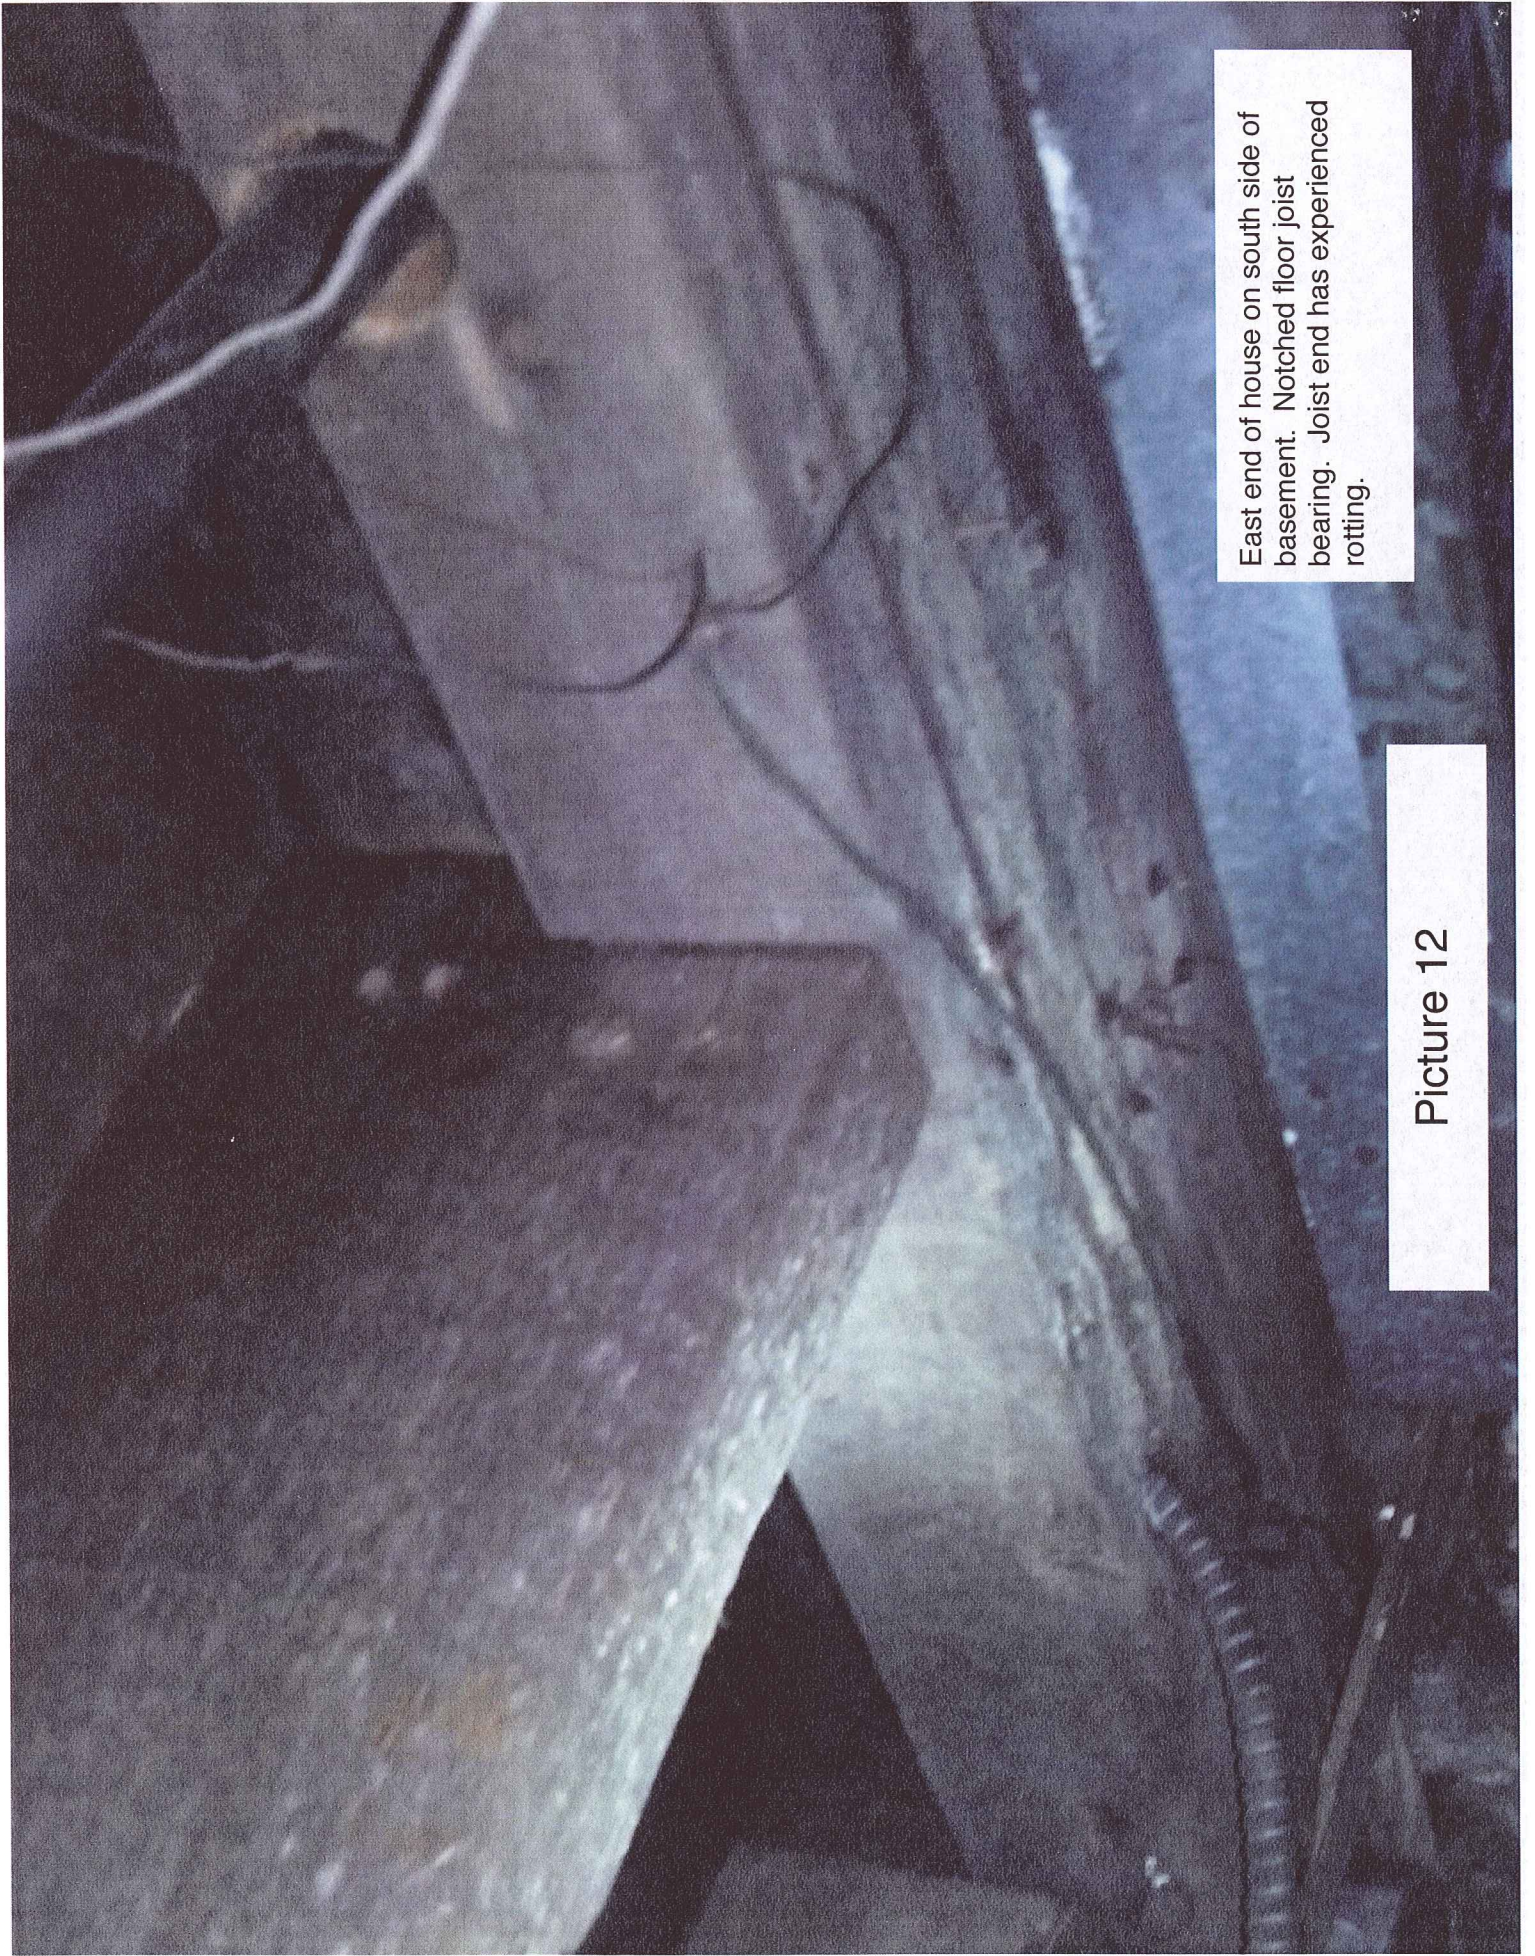
Picture 12

East end of house on south side of basement. Notched floor joist bearing. Joist end has experienced rotting.

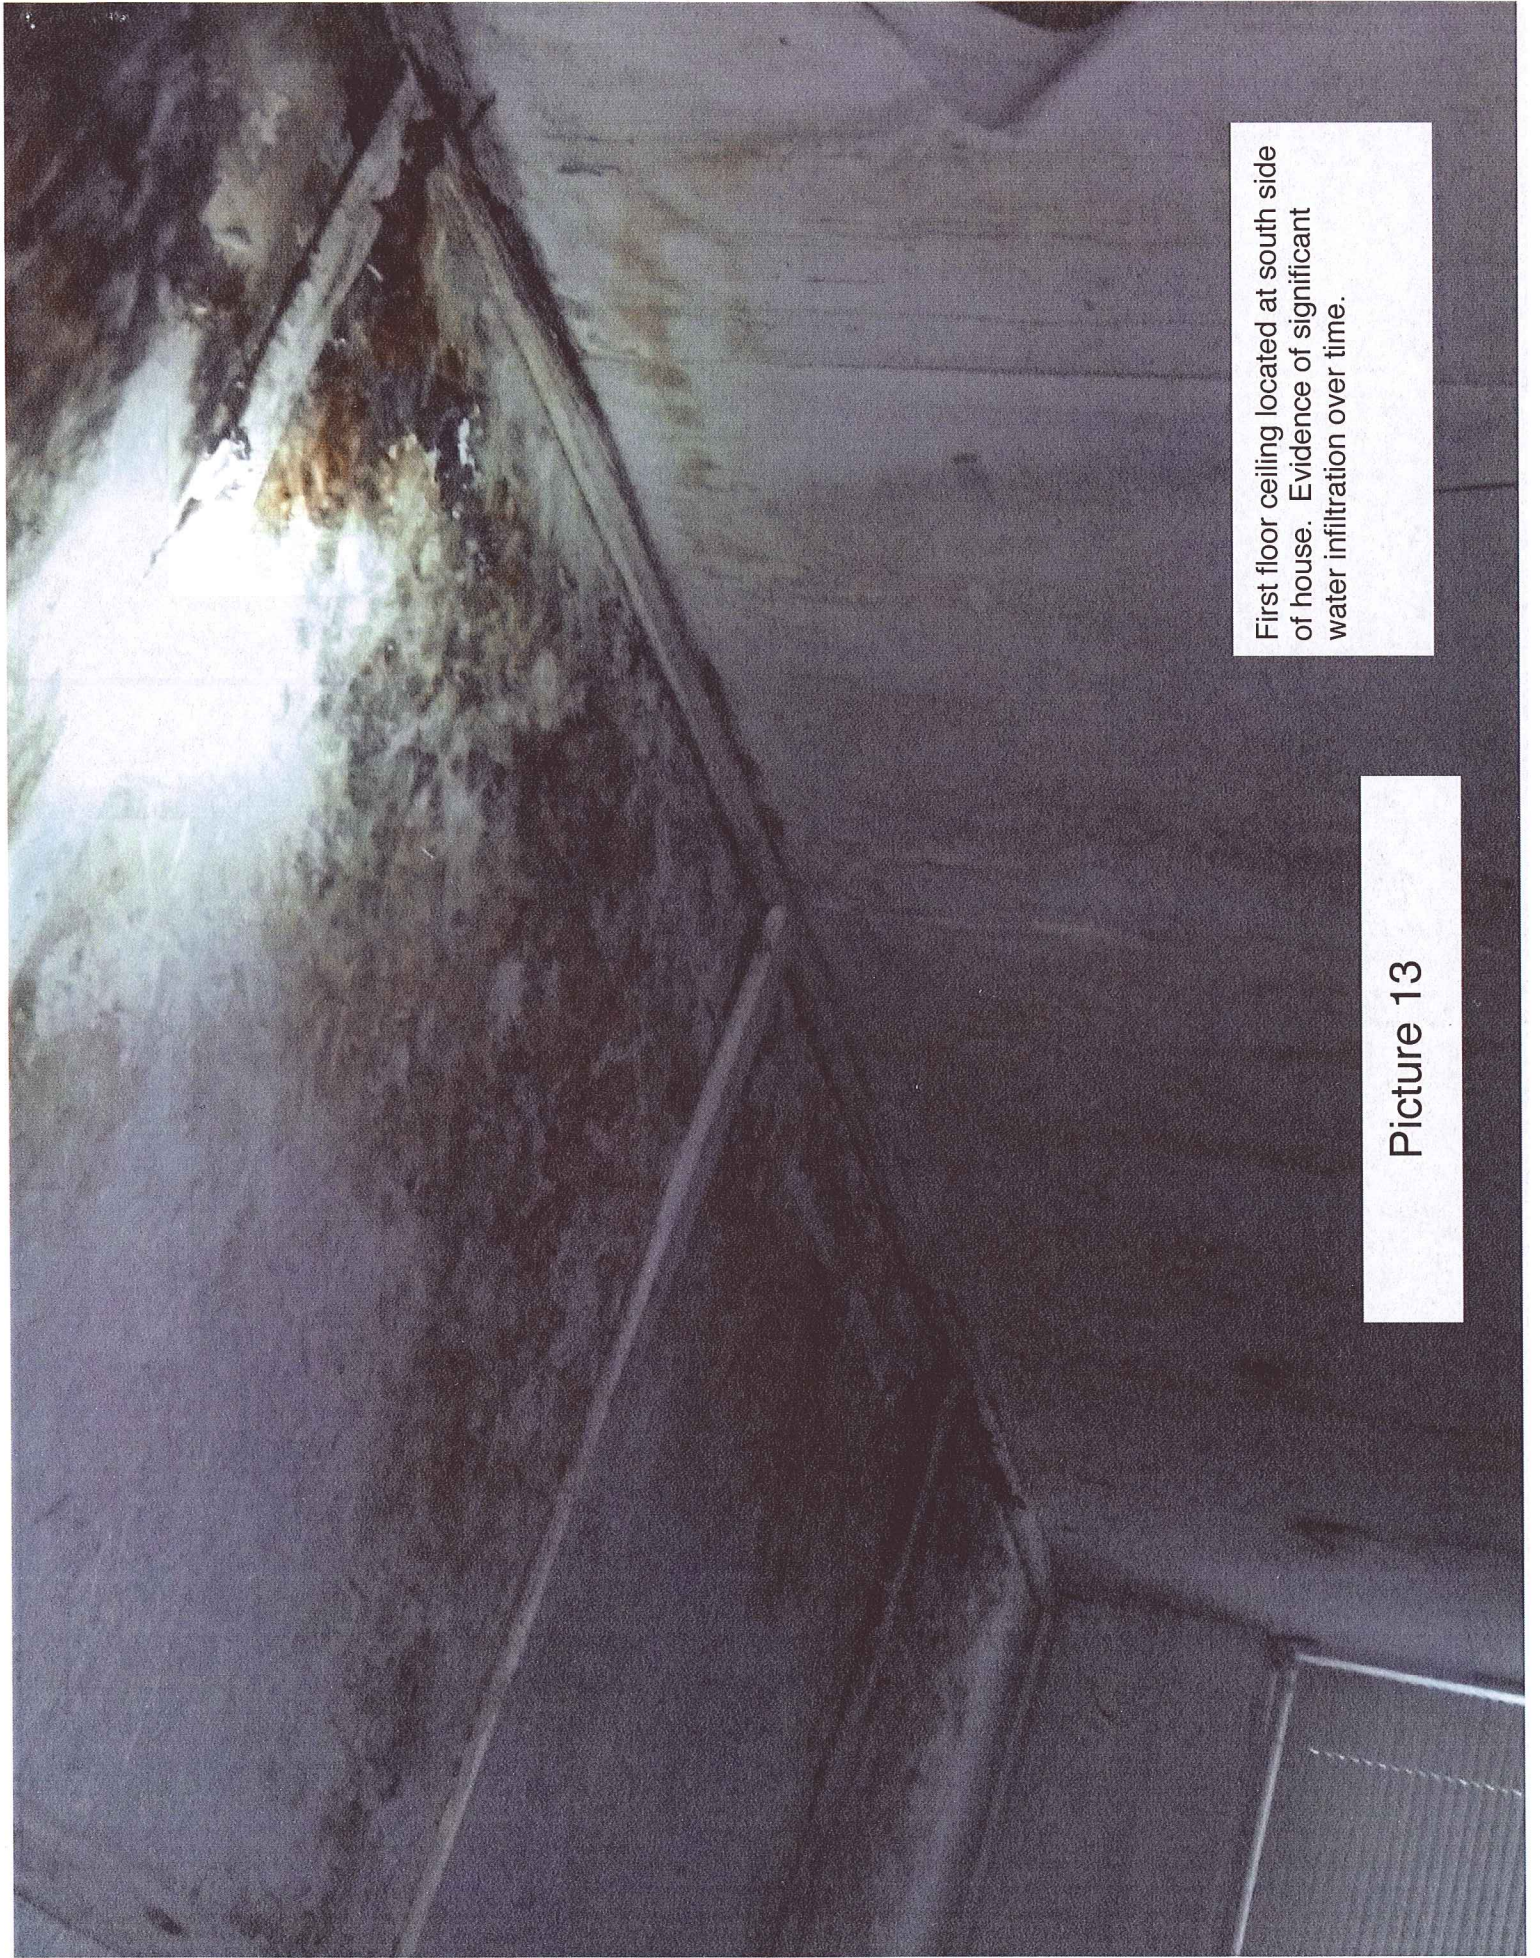
Picture 13

First floor ceiling located at south side of house. Evidence of significant water infiltration over time.

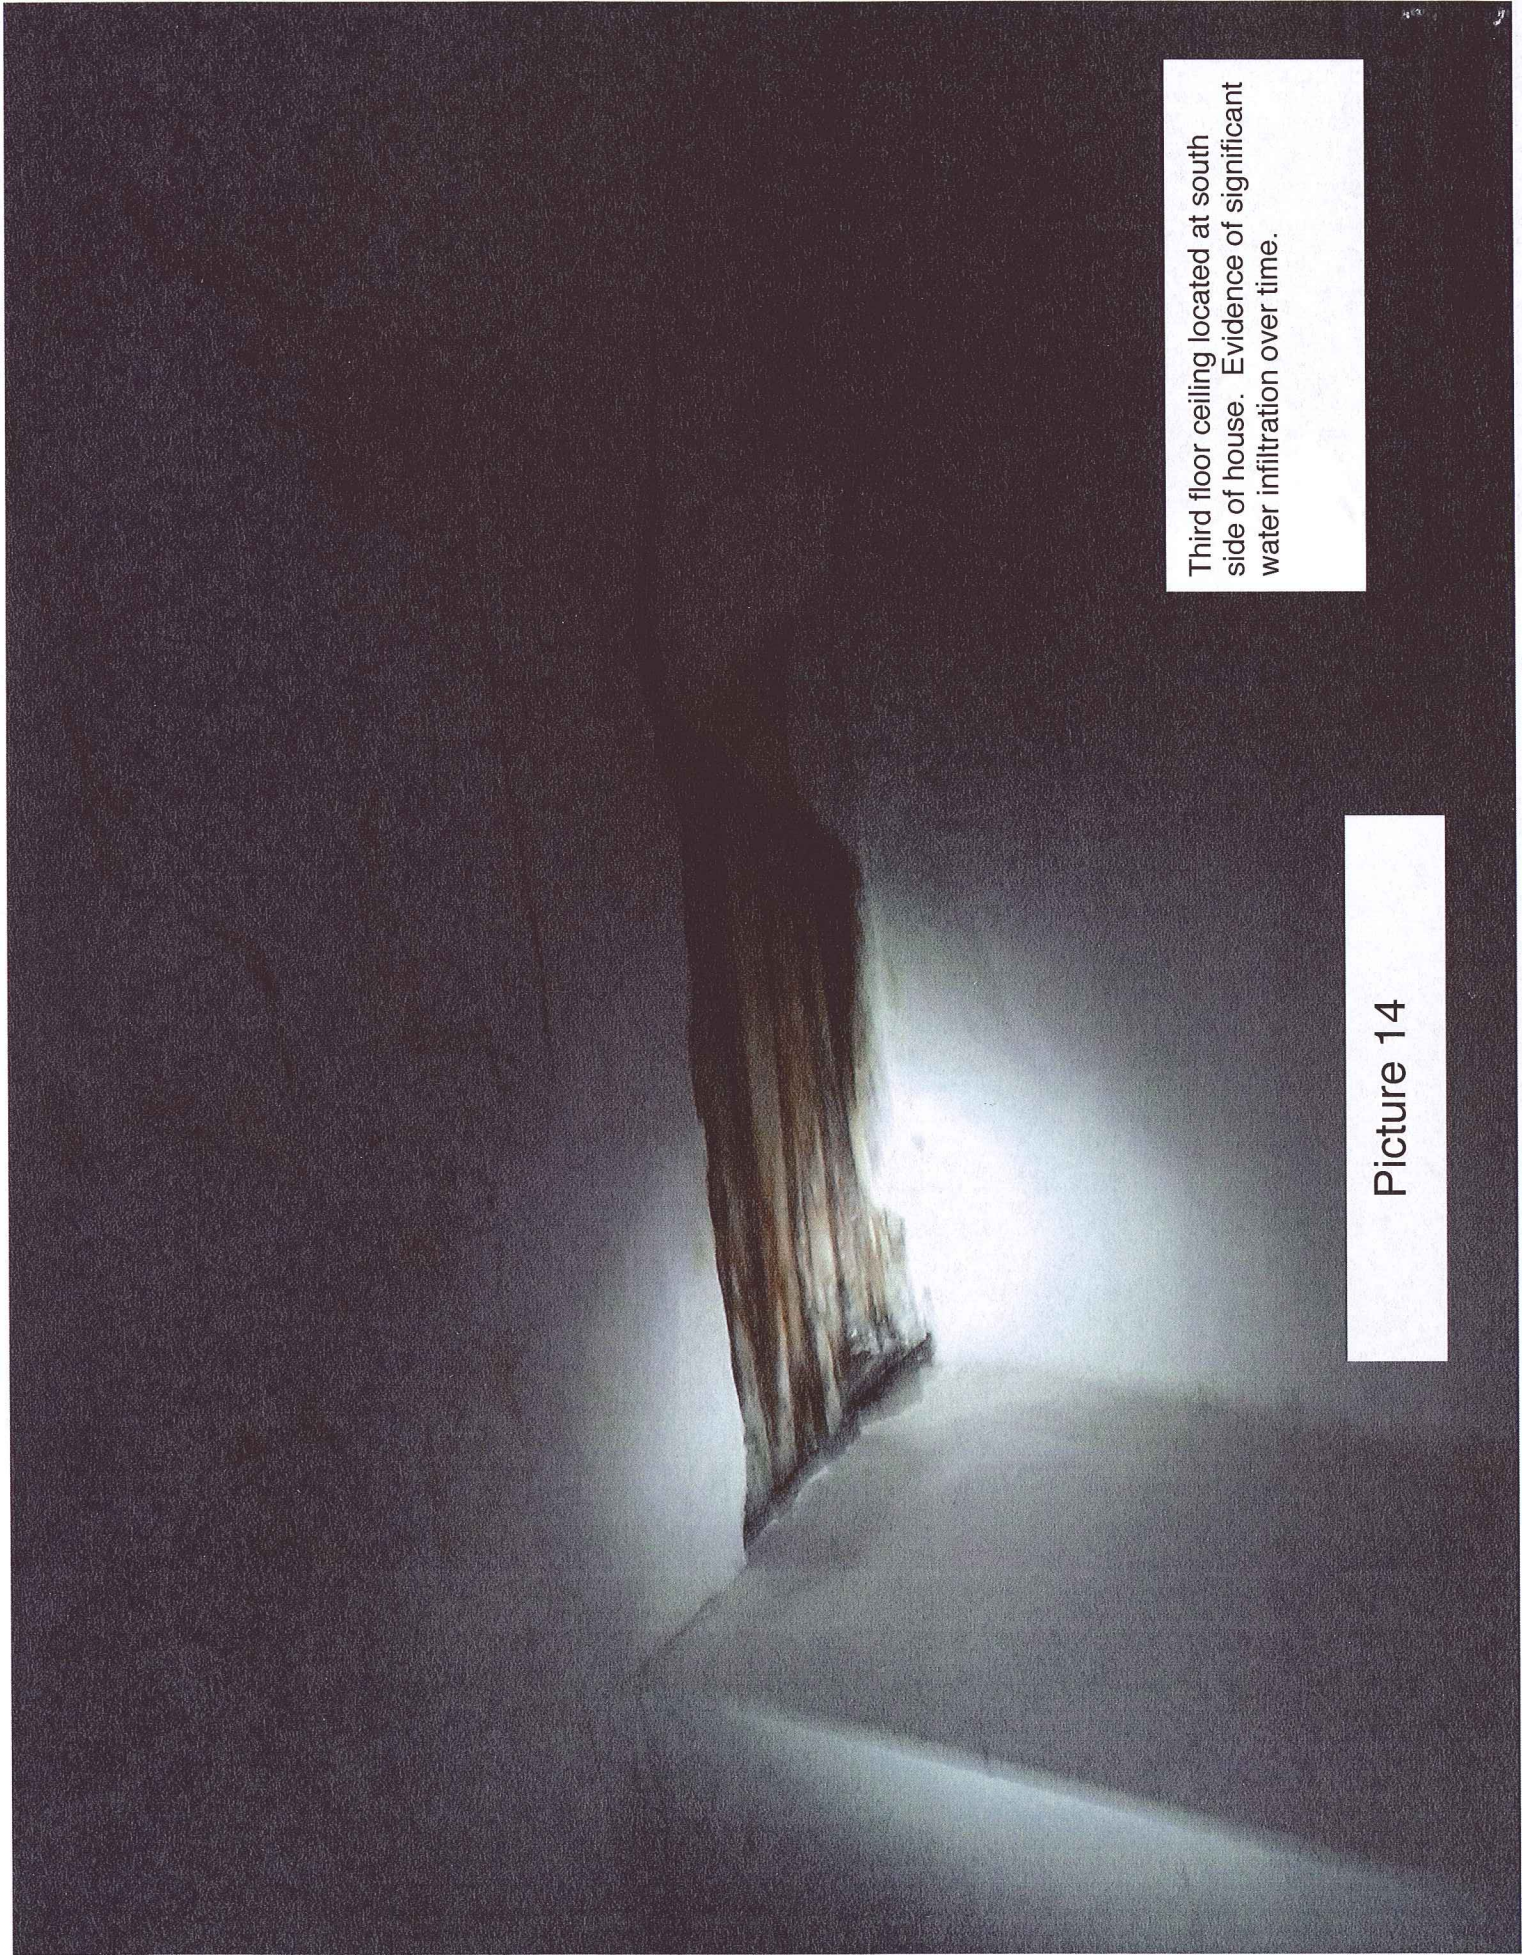
Picture 14

Third floor ceiling located at south side of house. Evidence of significant water infiltration over time.

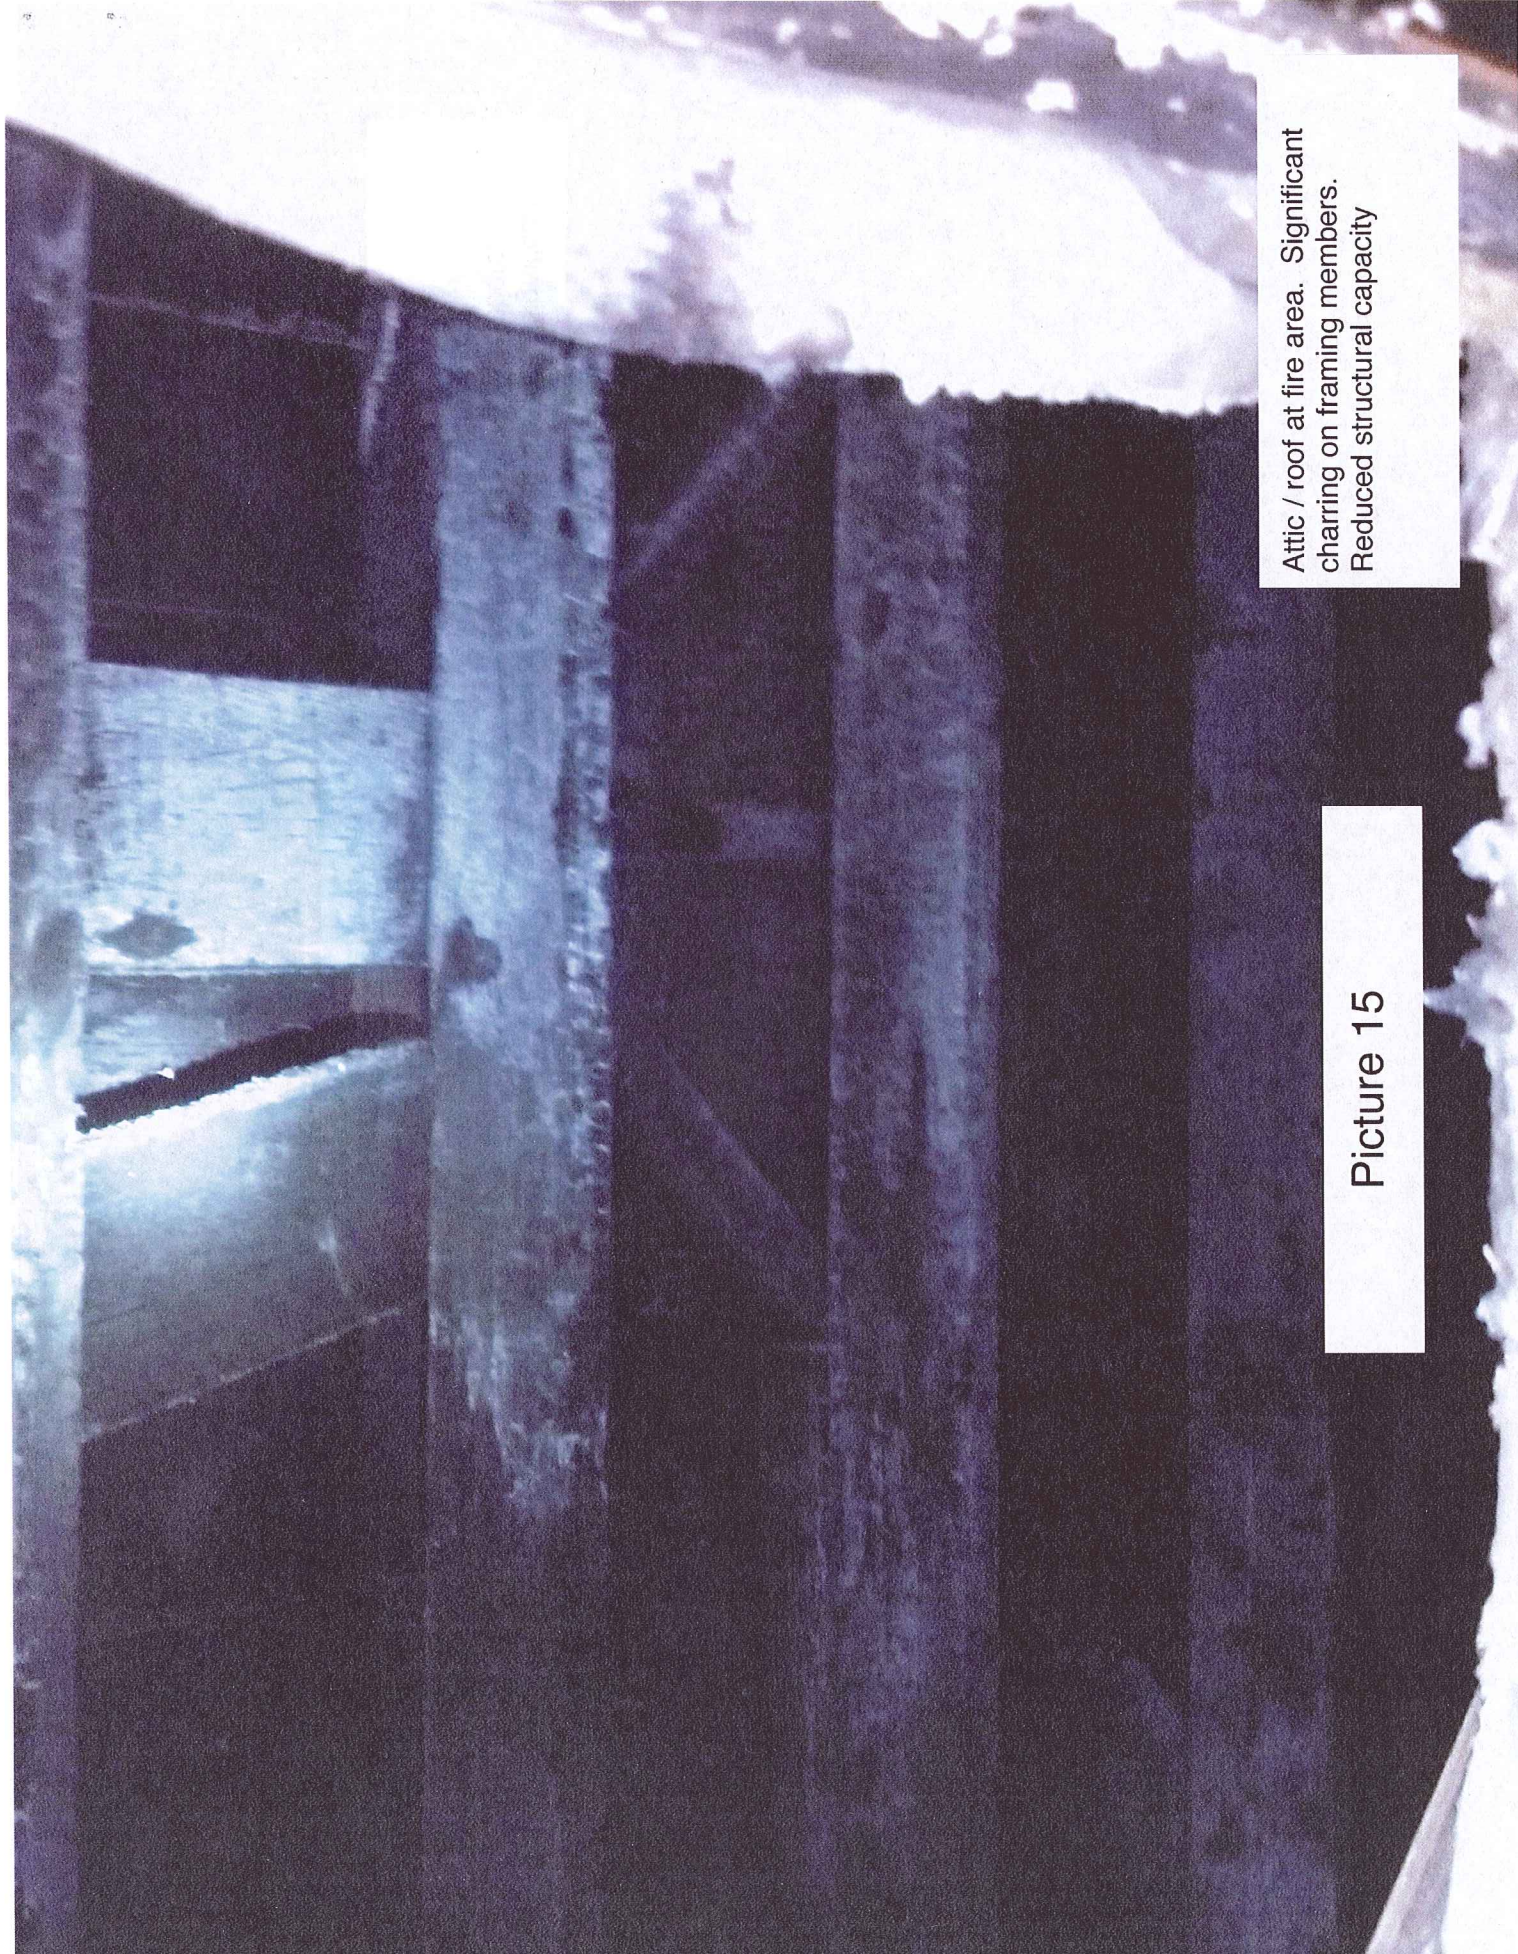
Picture 15

Attic / roof at fire area. Significant charring on framing members. Reduced structural capacity
