Re: Gilman Street Development
Evaluation of two properties
Madison, WI

The following is my report on the properties at 123 and 127 West Gillman Street.

127 W. Gilman St.
Madison, WI 53703

Conceptual Budget/Recommendations Report

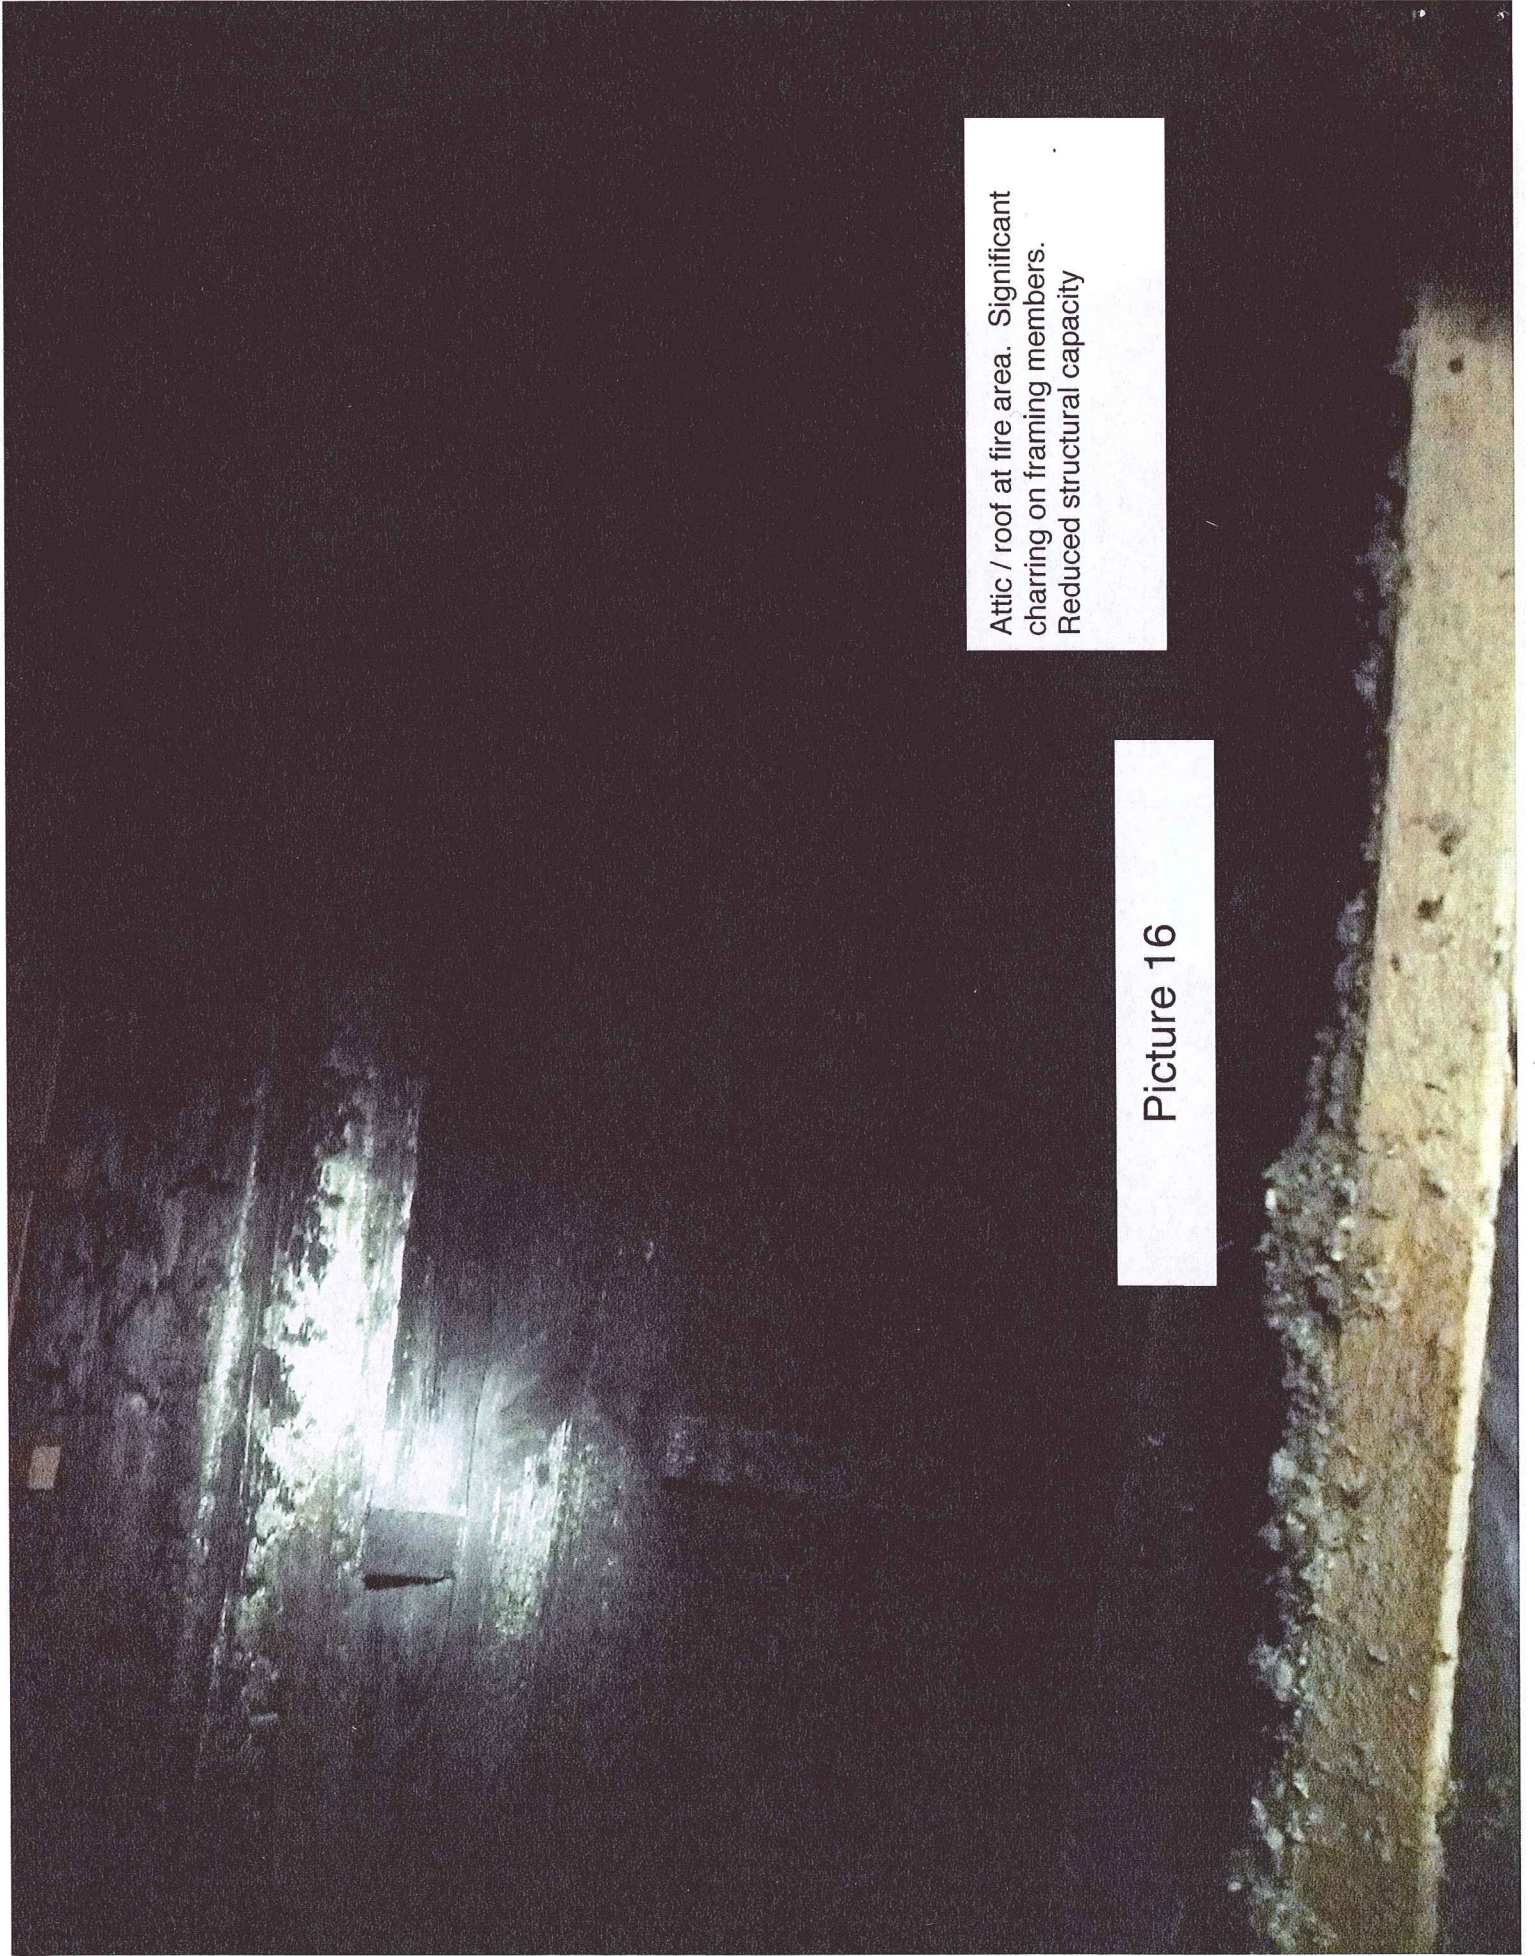
Picture 16

16 are of the attic / roof structure where fire damage has occurred. The fire was of significant intensity that severe charring has occurred to some of the attic / roof framing members reducing their structural capacity. Picture 17 is of the fire damage at the second floor bathroom. The intensity of the this fire does not appear to have been as damaging as the attic fire, but charring of the framing members has occurred, and it is suspected the structural capacity of the charred framing members has been reduced.

Attic / roof at fire area. Significant charring on framing members. Reduced structural capacity

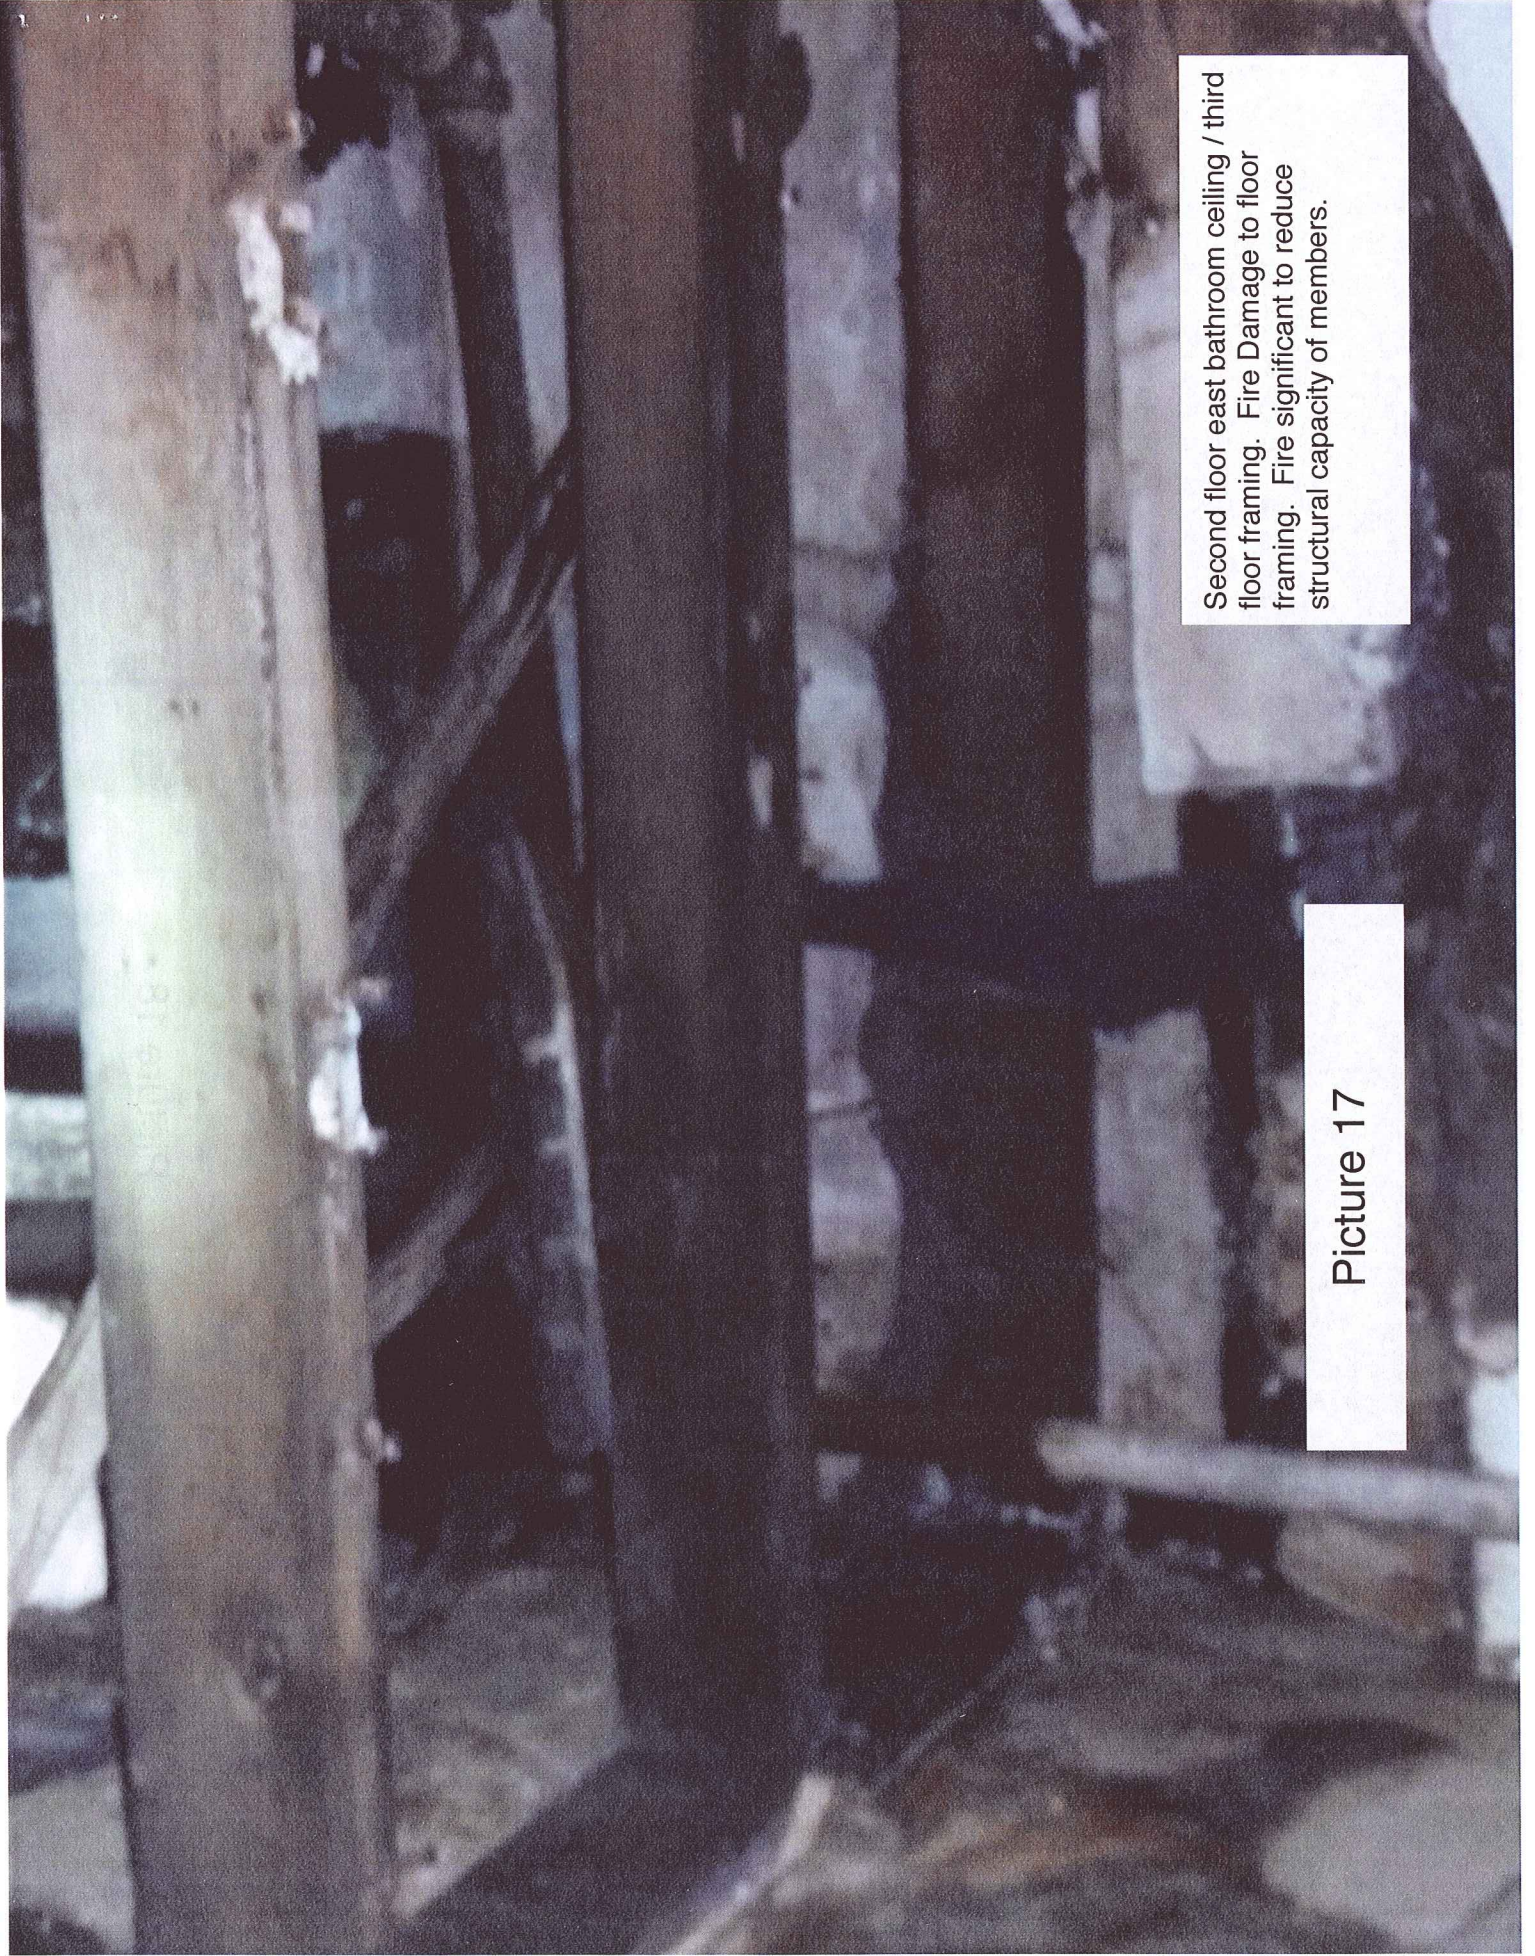
Picture 17

Second floor east bathroom ceiling / third floor framing. Fire Damage to floor framing. Fire significant to reduce structural capacity of members.

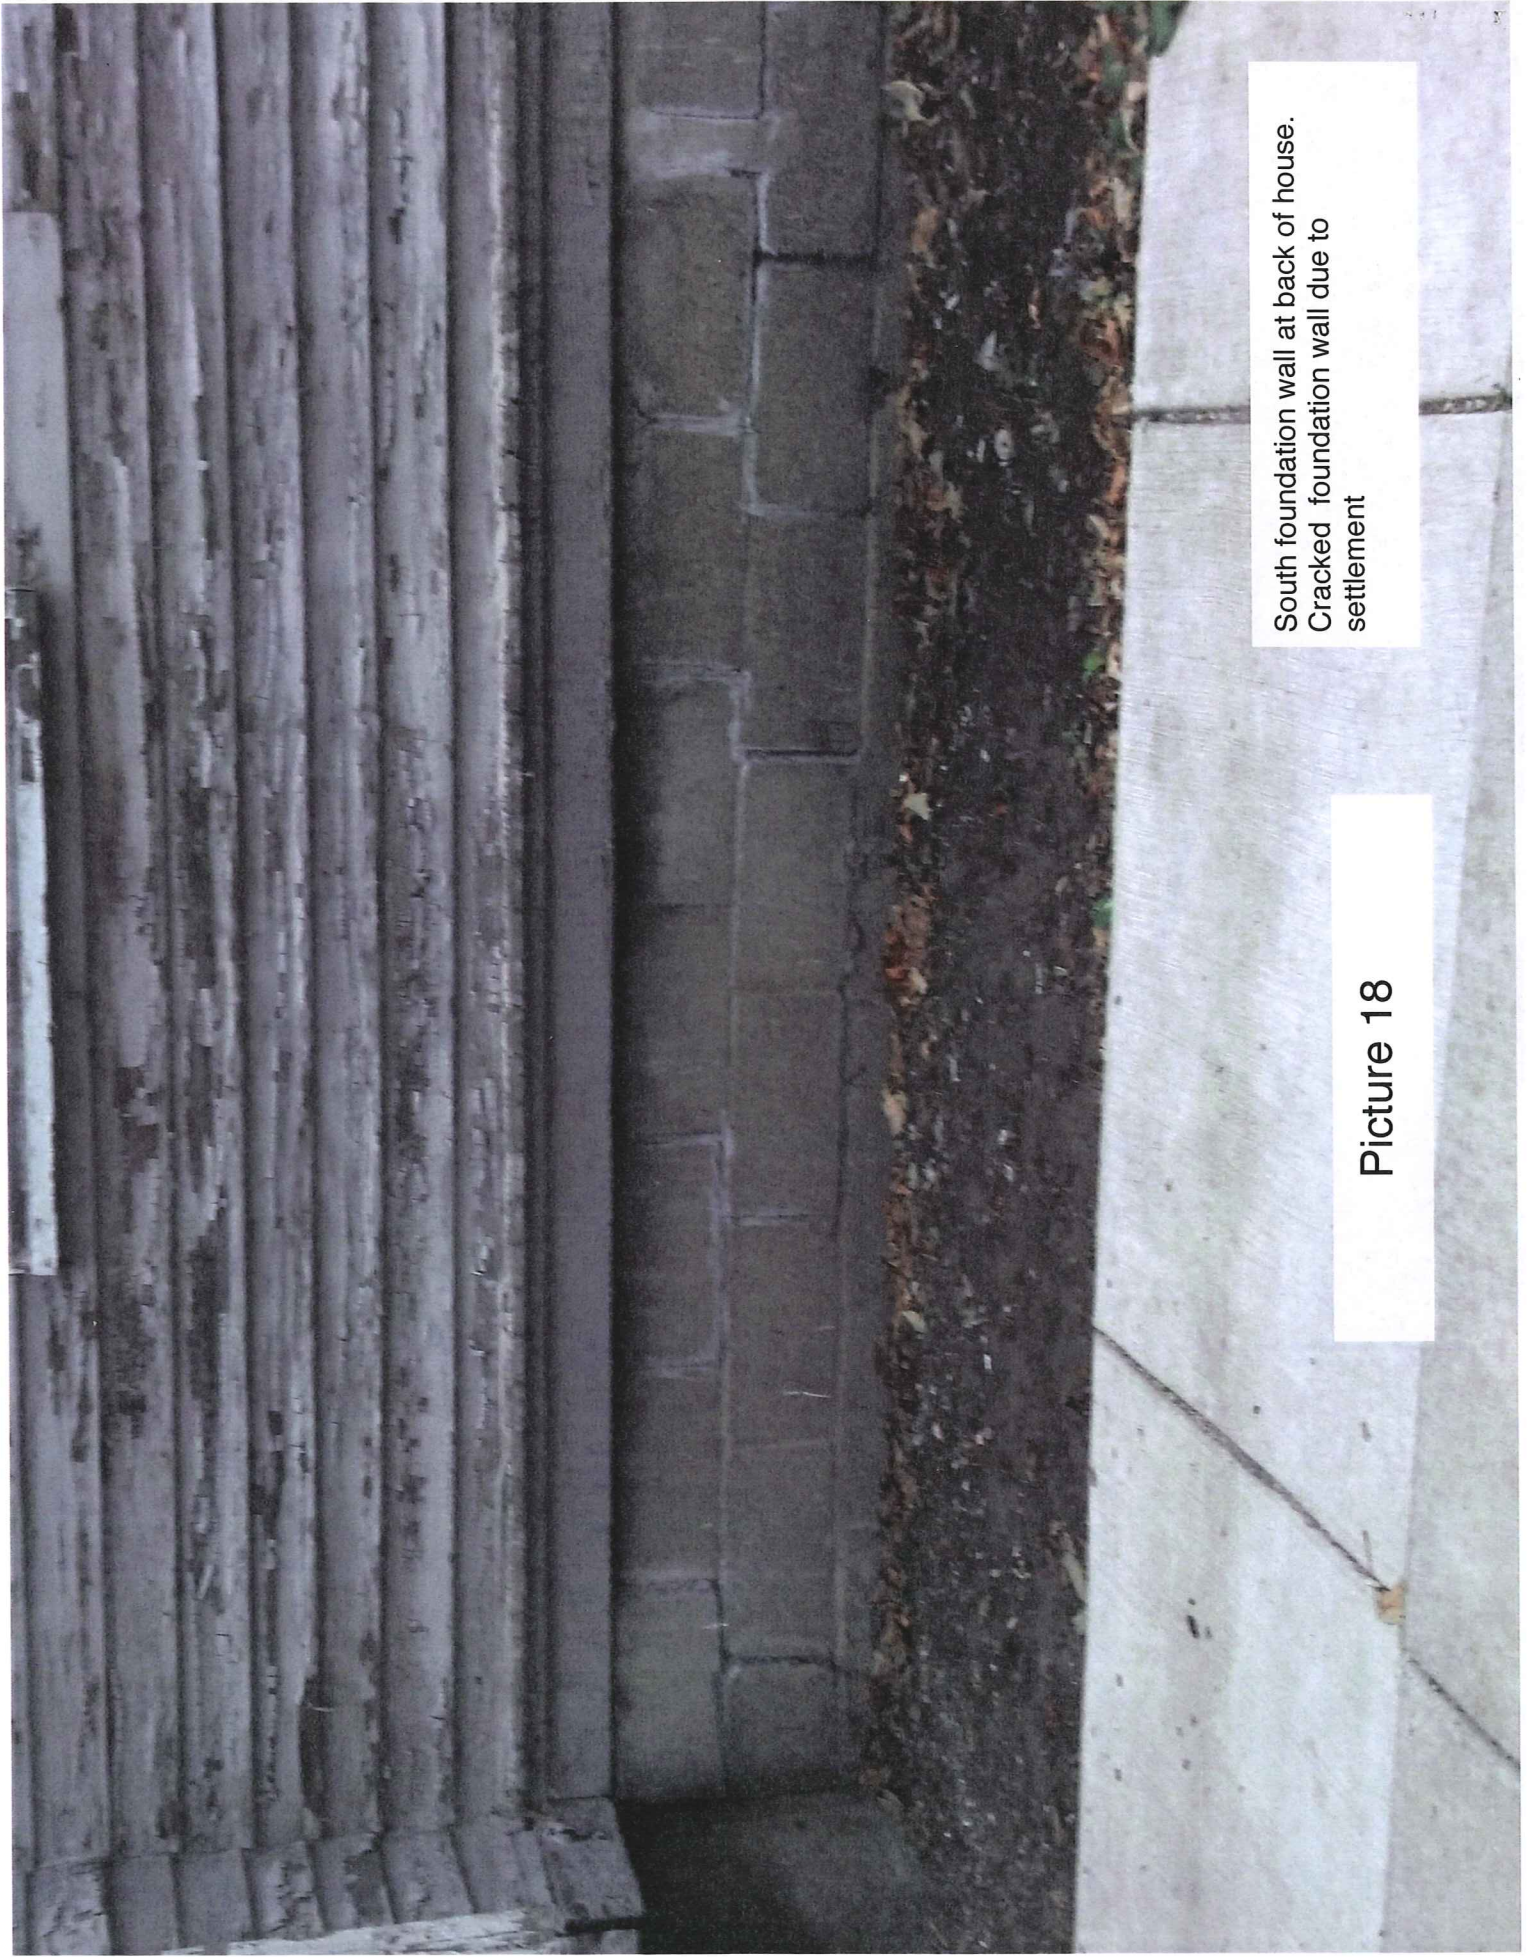
Picture 18

6. The house has also experienced some movement and settlement over time. It is believed this movement has not reduced the structural integrity of the framing, but is one of serviceability of the structure. Pictures 18 thru 20 show evidence of building movement. Sloping of the floor framing has also occurred and this is noticeable when walking the floors. This movement has caused diagonal cracking in the walls, Picture 20, which leads to mis-aligned doors and window. Other affects as a result of the movement are buckled flooring and sloped floors.

South foundation wall at back of house.
Cracked foundation wall due to
settlement

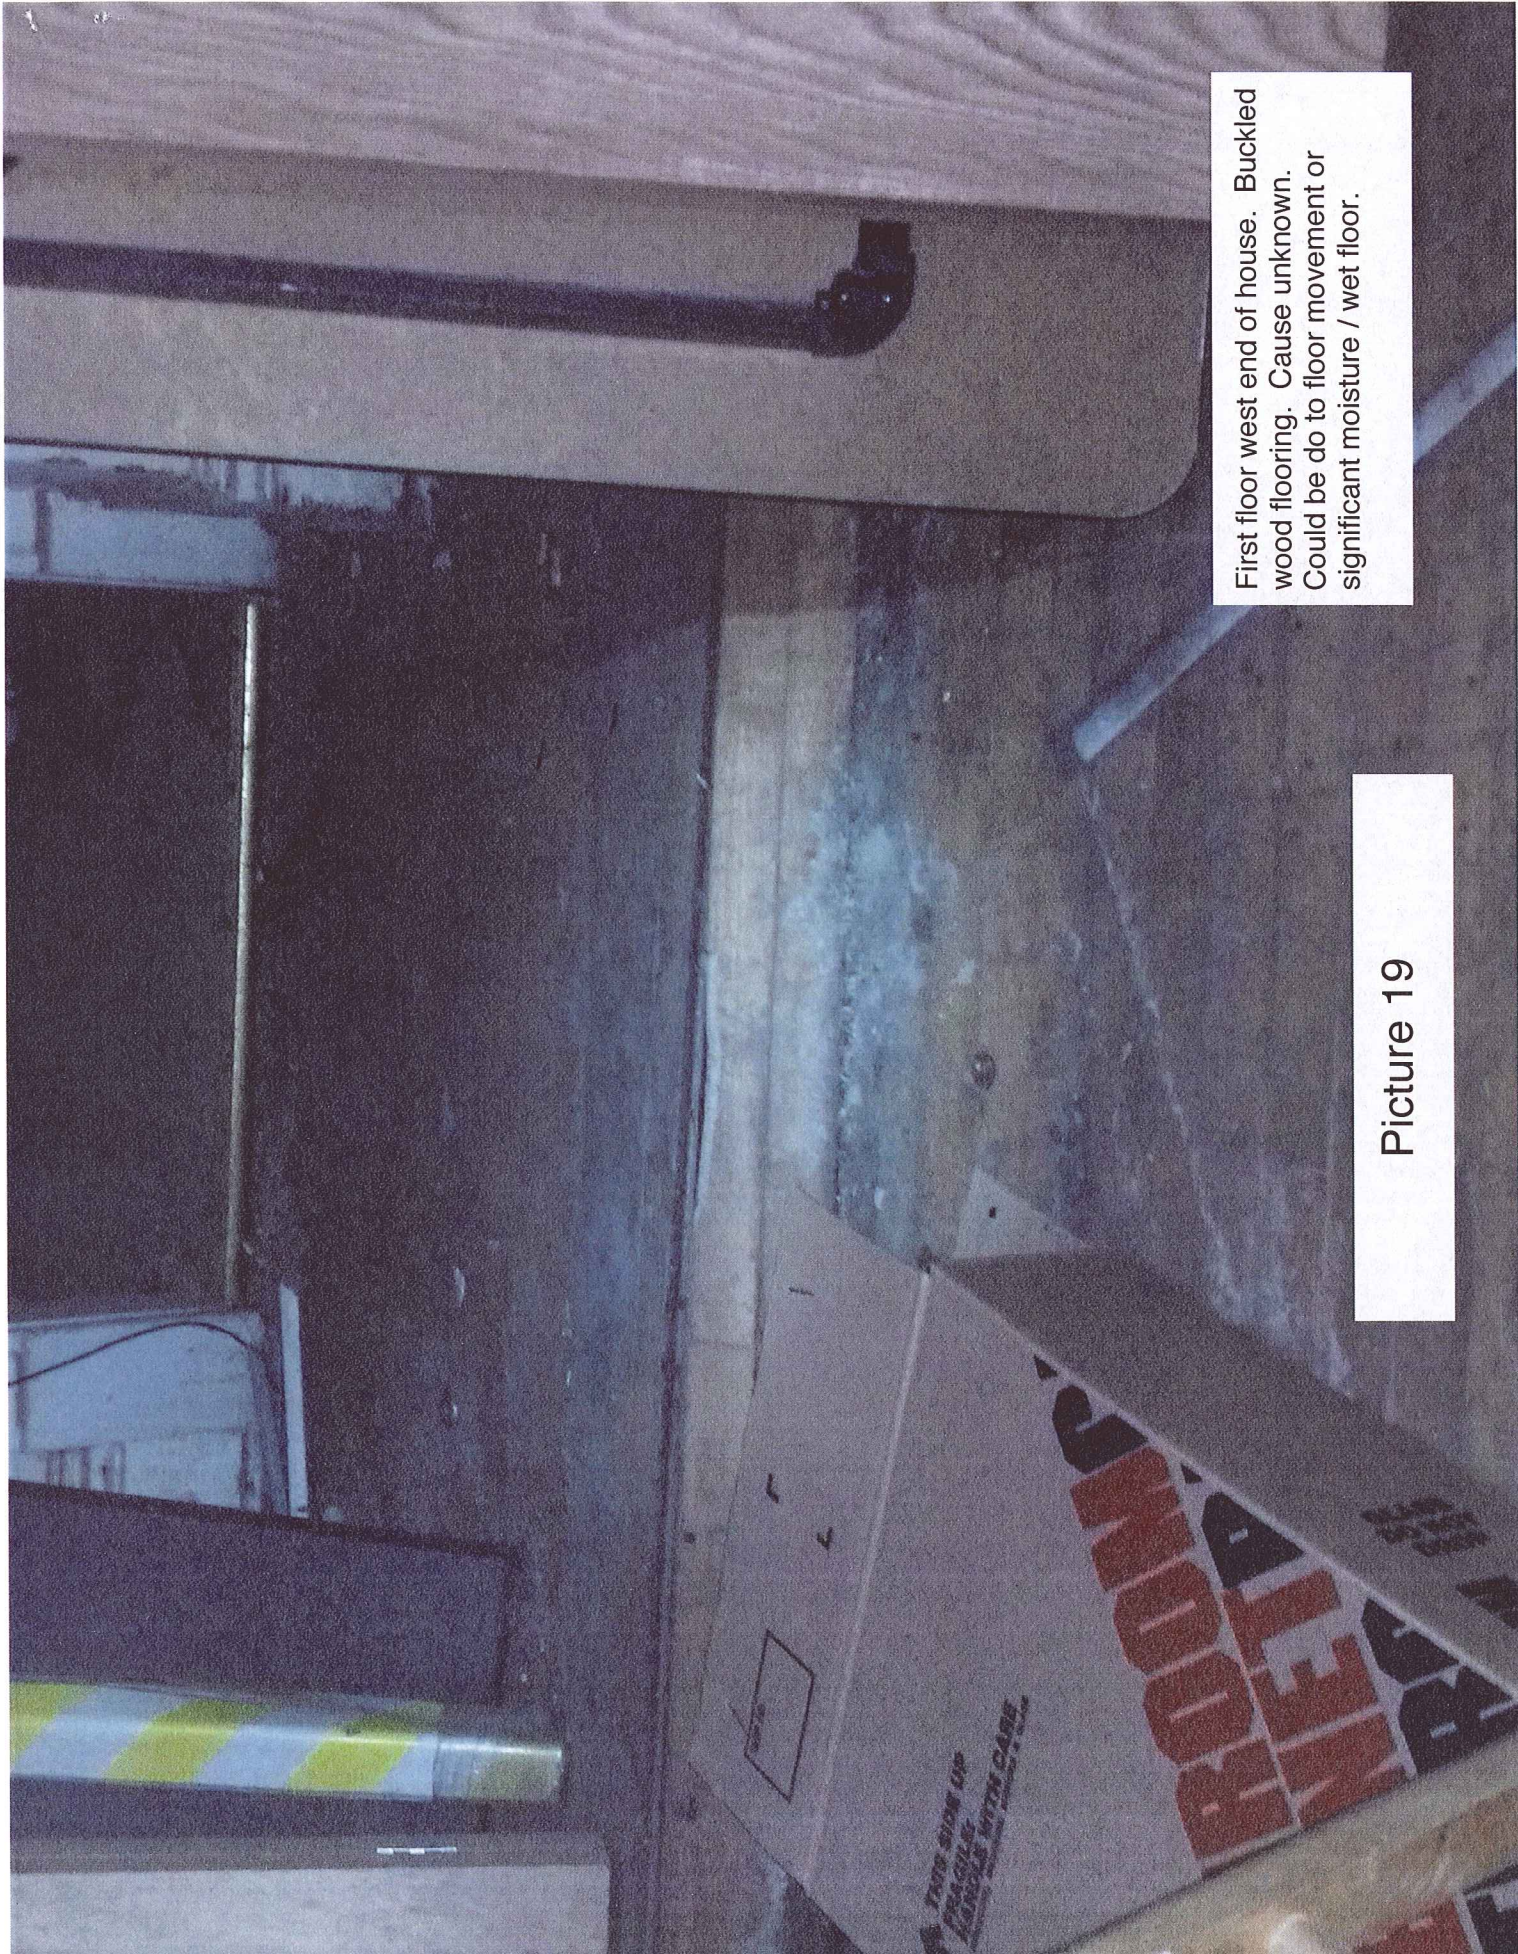
Picture 19

First floor west end of house. Buckled wood flooring. Cause unknown. Could be do to floor movement or significant moisture / wet floor.

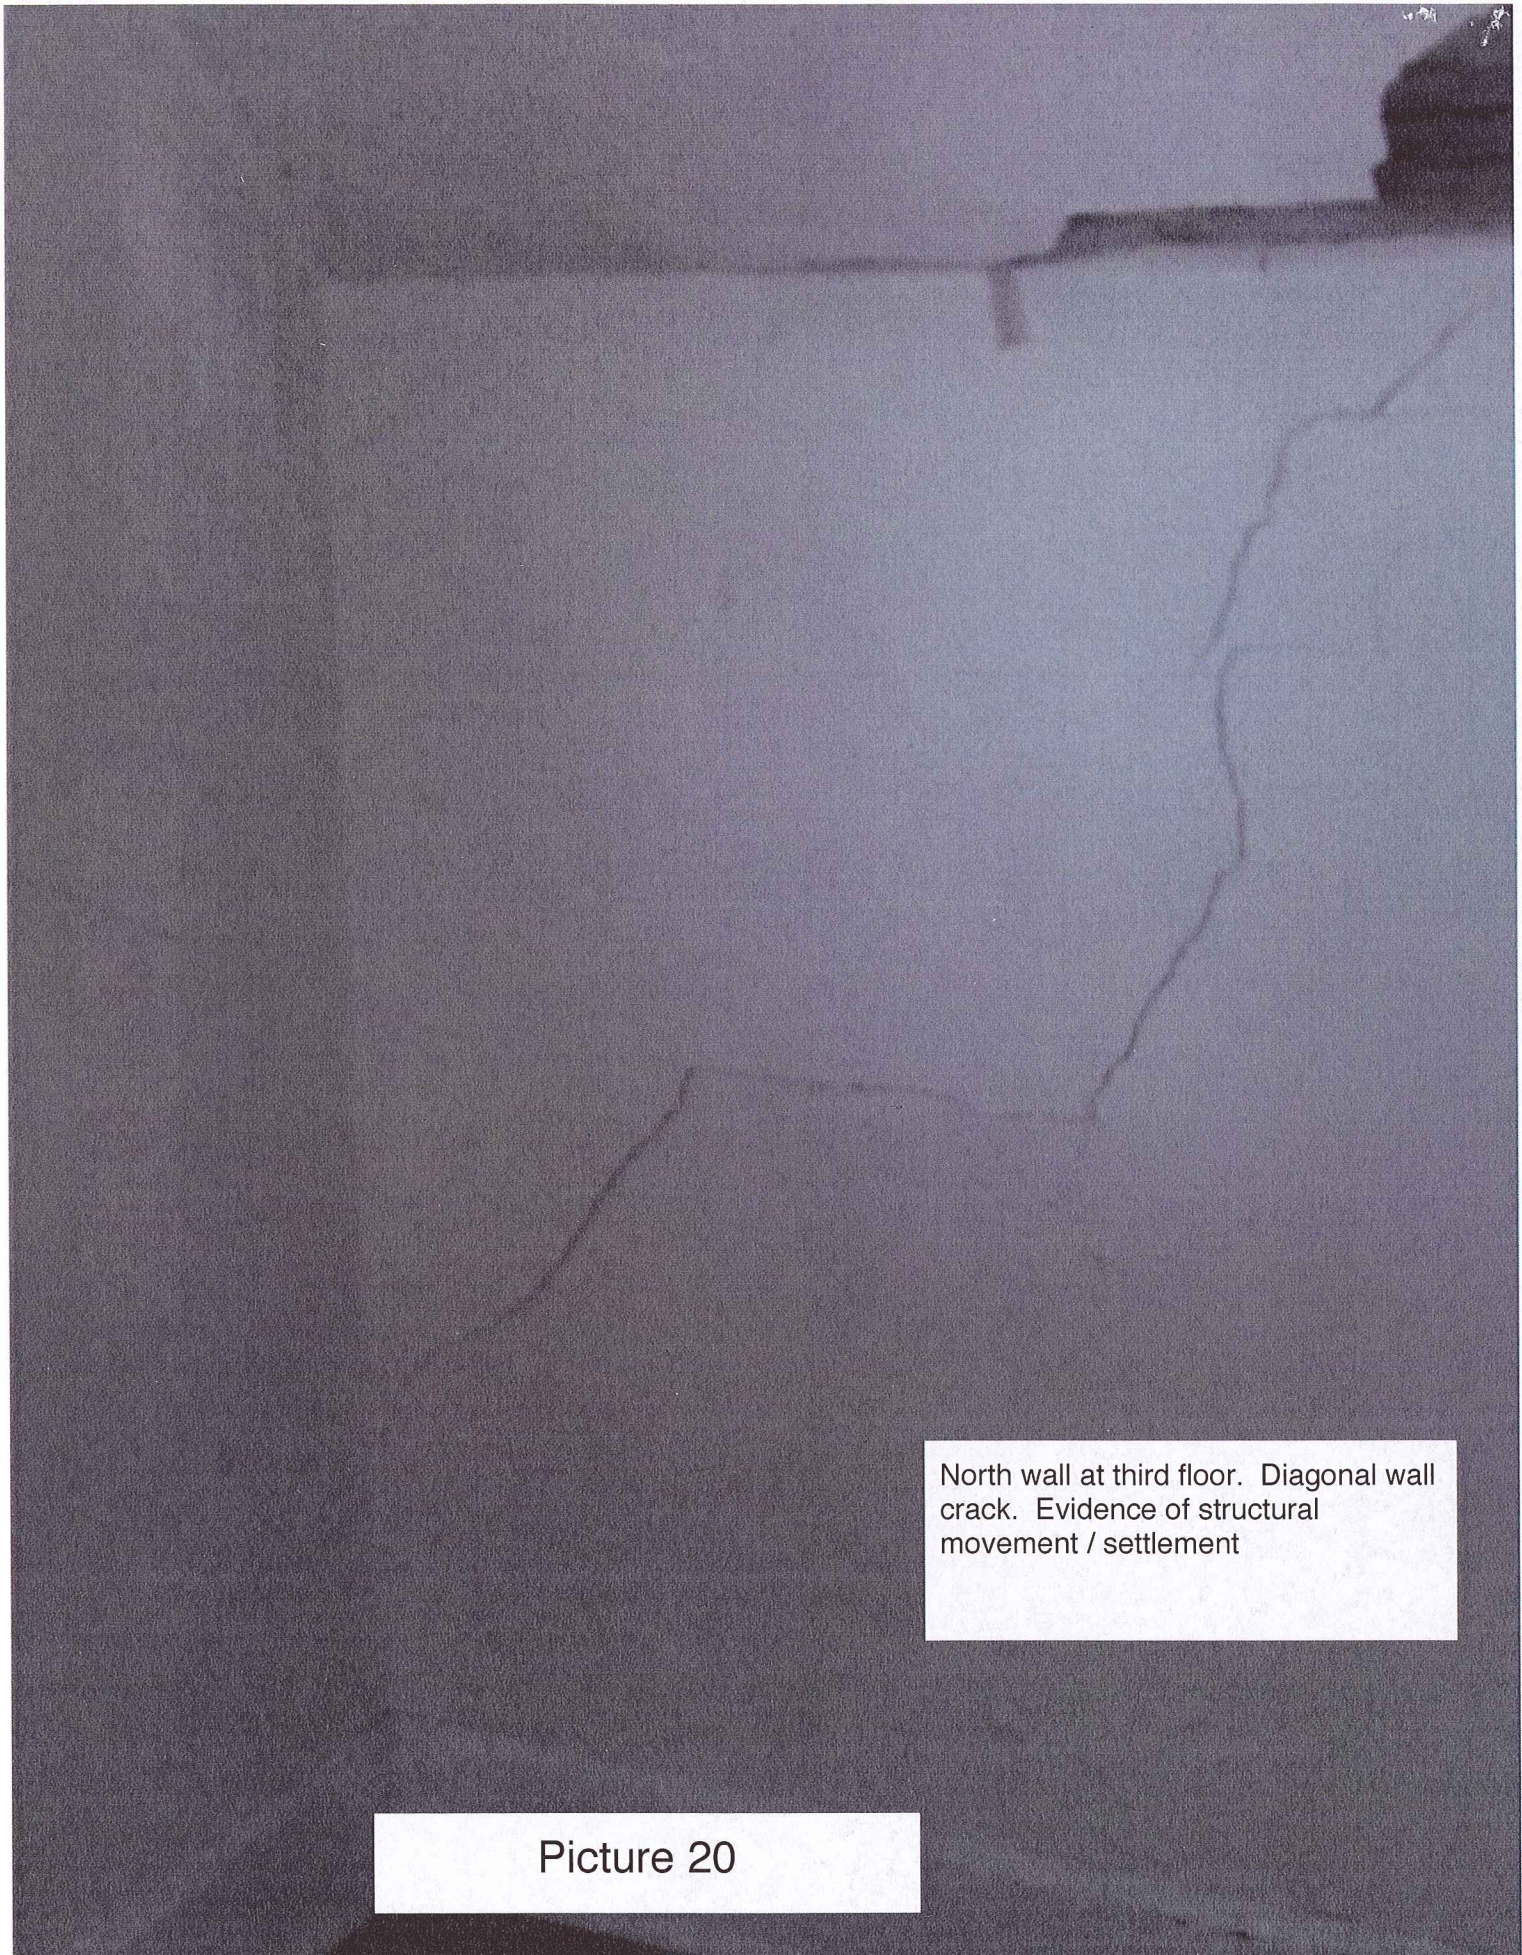
Picture 20

North wall at third floor. Diagonal wall crack. Evidence of structural movement / settlement
