HOVDEPROPERTIES

June 13, 2019

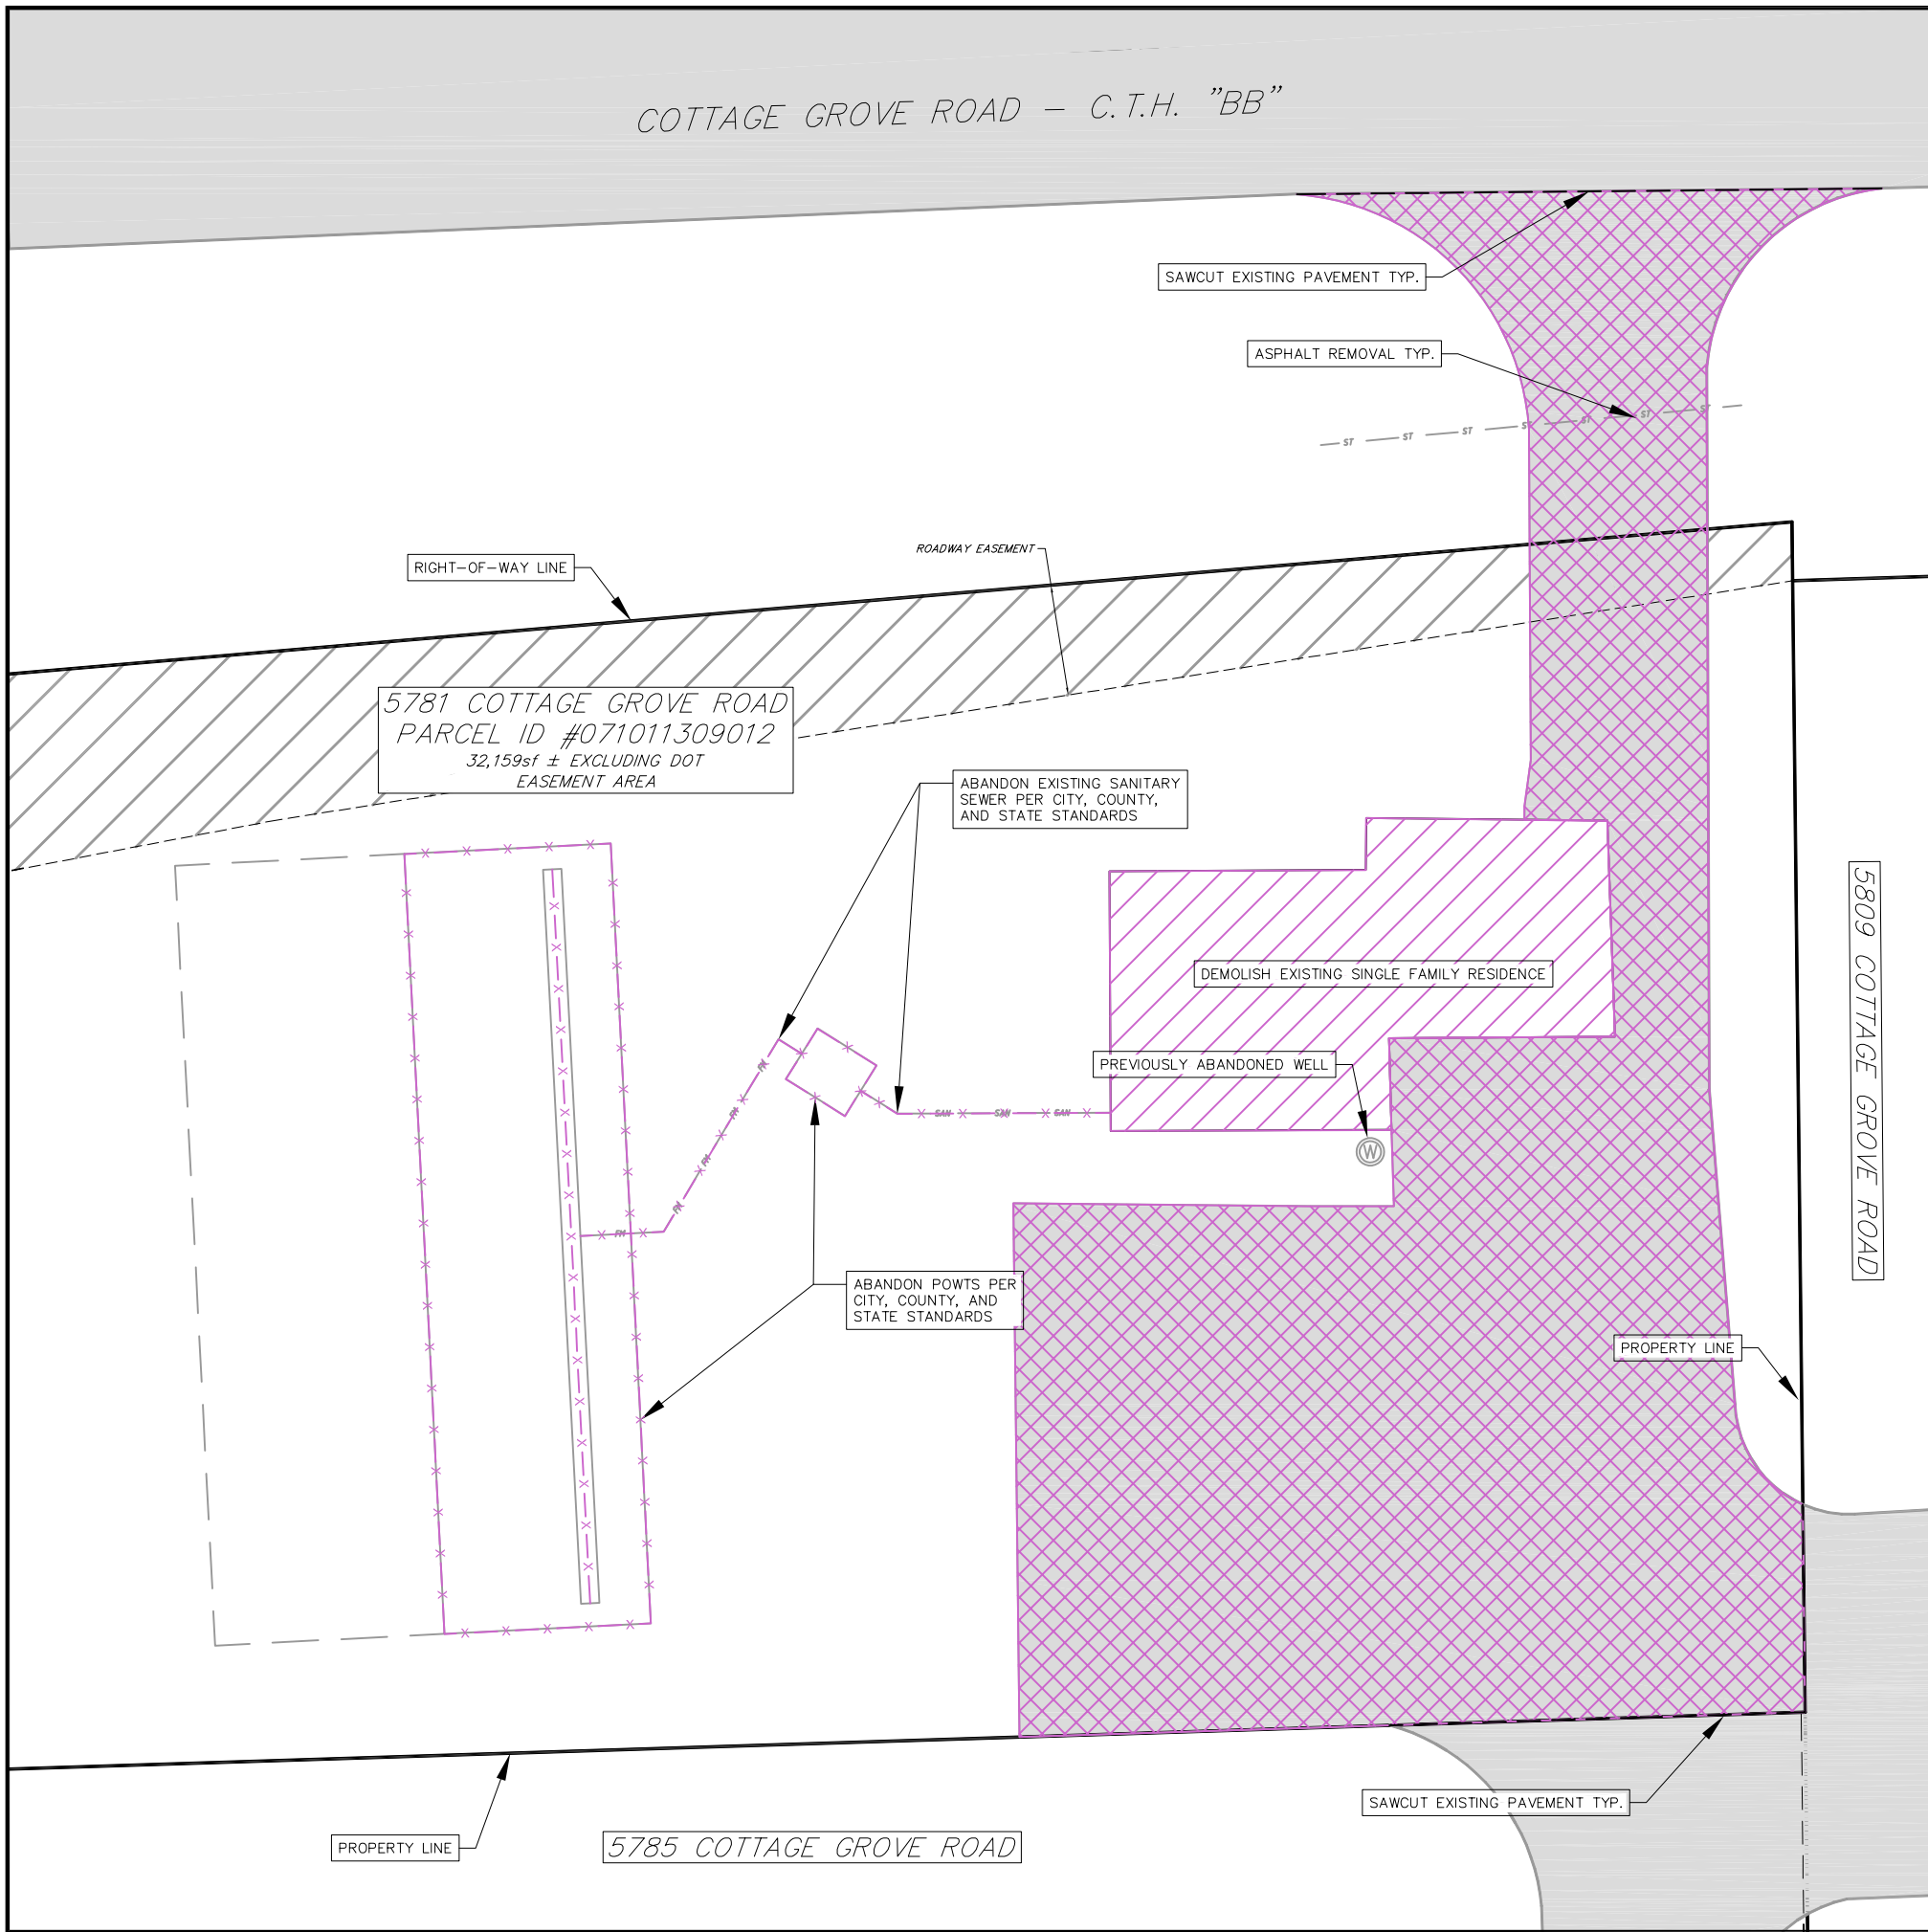
DEMOLITION PLAN LEGEND

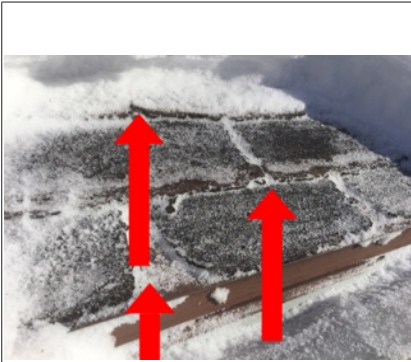
Shingles have broken corners, missing granulars and cracking. Recommend replacing soon

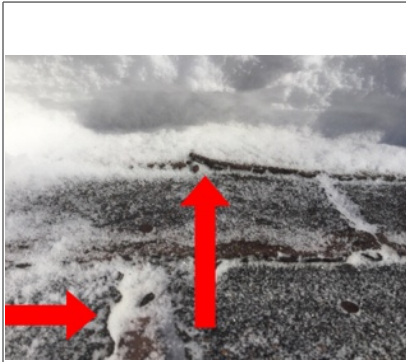
Shingles are curling. Recommend replacing roof soon

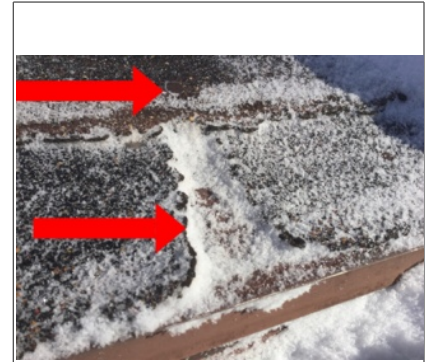
Shingles have broken corners, missing granulars and cracking. Recommend replacing soon

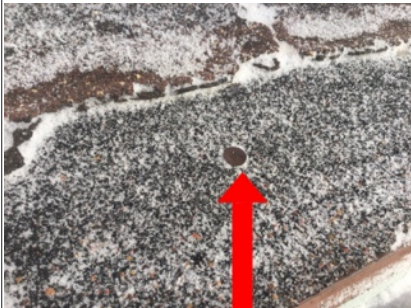
Face nailing present in many areas of roof. Recommend repair

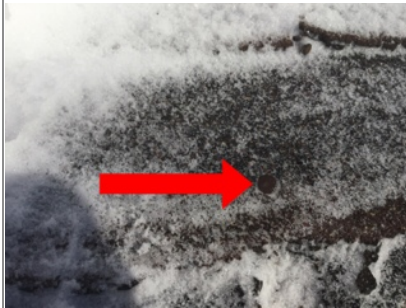
Face nailing present

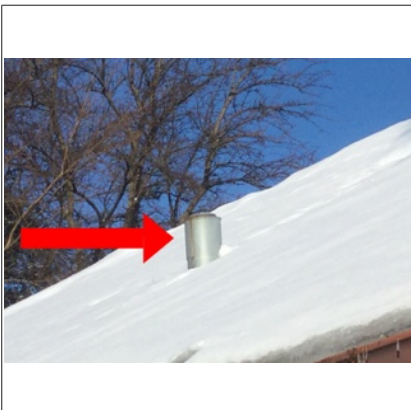
Condition
Comments
Photos

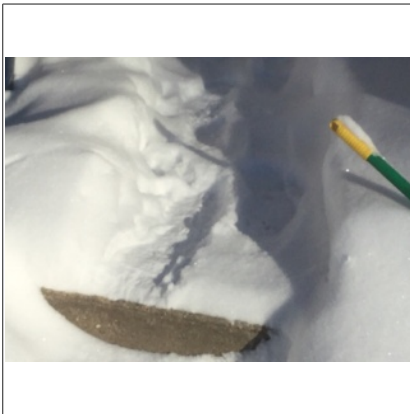
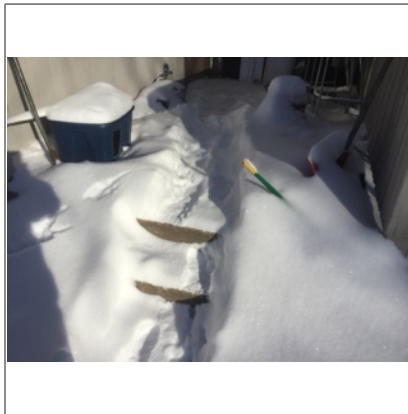
None
Material Concrete Wood Other: _____ Railing/Balusters recommended
Condition Satisfactory Marginal Poor Safety Hazard Uneven risers Rotted/Damaged
 Cracked Settled
Comments Limited visibility due to snow cover
Photos

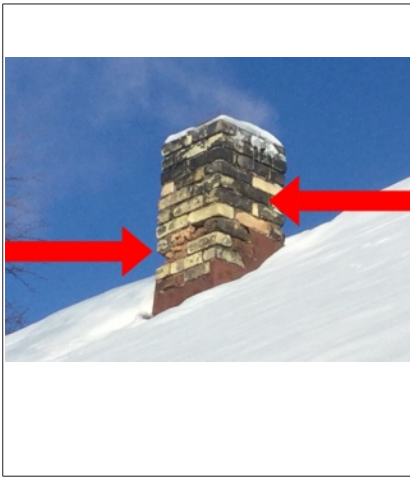
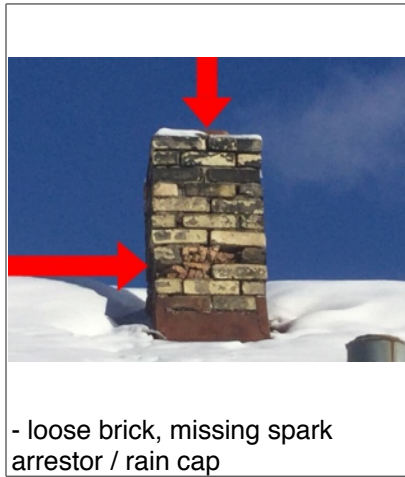
- loose brick, missing spark
arrestor / rain cap

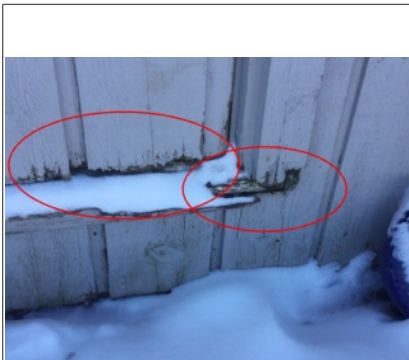
- Siding had some damage under north side door and at end of beam at west end of gable , recommend repairing/replacing damaged sections

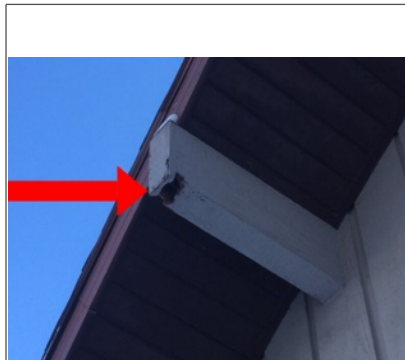
- Siding had some damage under north side door and at end of beam at west end of gable , recommend repairing/replacing damaged sections

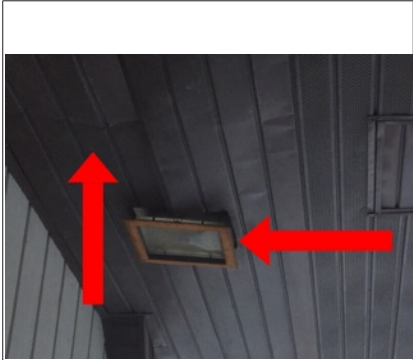
- Soffit has some damaged panels under canopy Recommend repair
 - Light fixtures in soffit are falling out or severely rusted. Appear to not work. Recommend repair

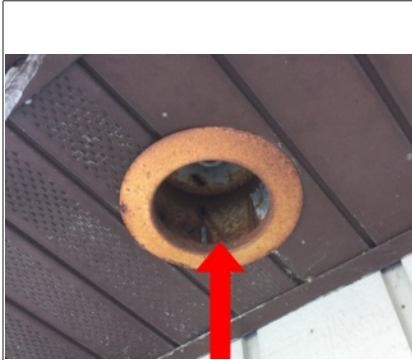
- Light fixtures in soffit are falling out or severely rusted. Appear to not work. Recommend repair

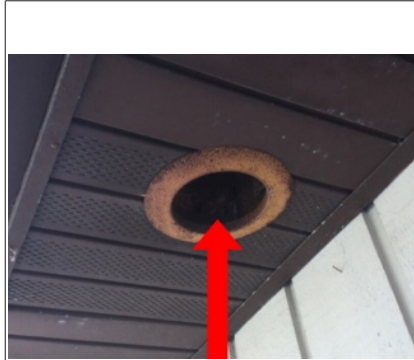
- Light fixtures in soffit are falling out or severely rusted. Appear to not work. Recommend repair

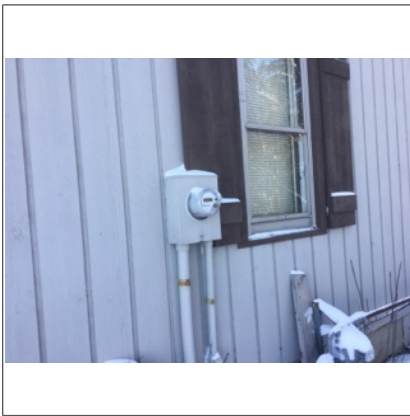
Building(s) Exterior Wall Construction

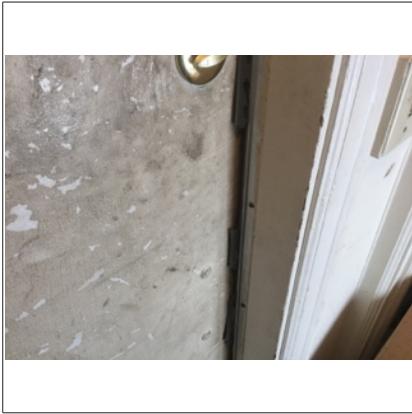
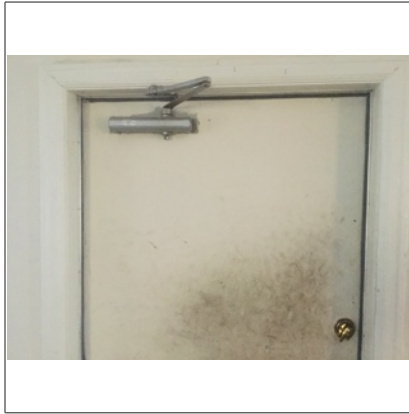
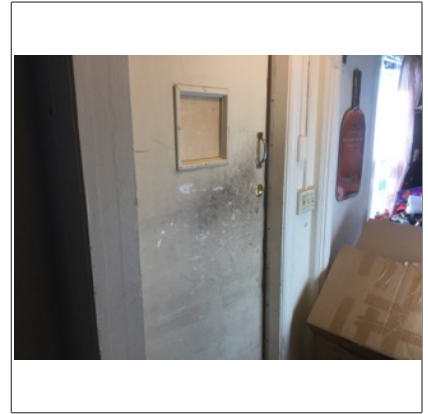
Exterior A/C - Heat pump #1

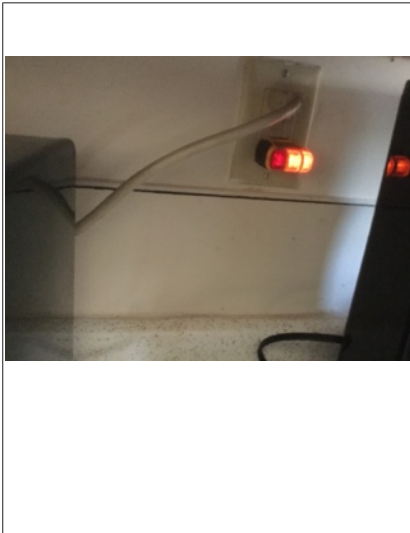
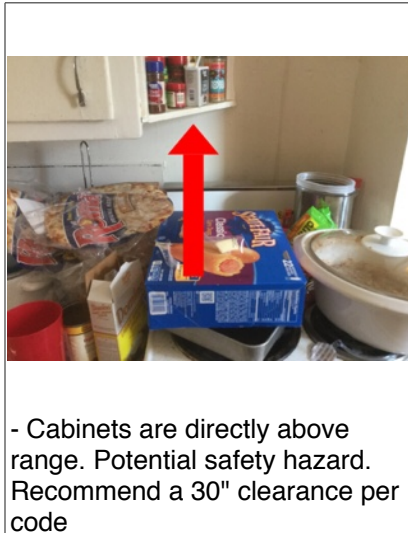
- Cabinets are directly above range. Potential safety hazard. Recommend a 30" clearance per code

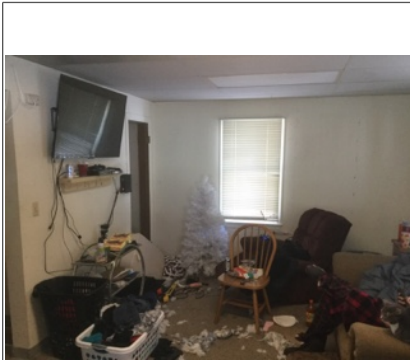
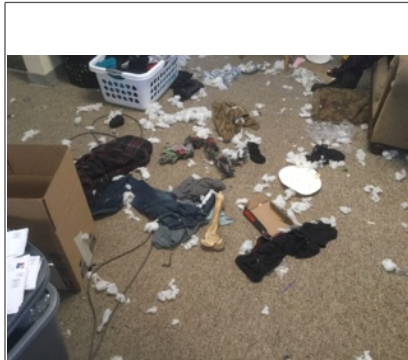
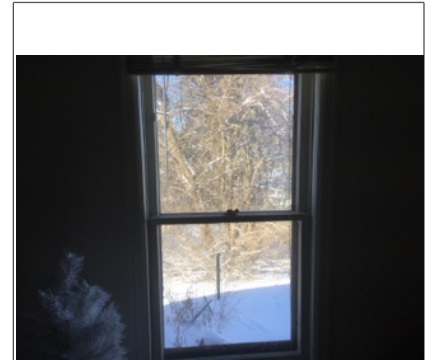
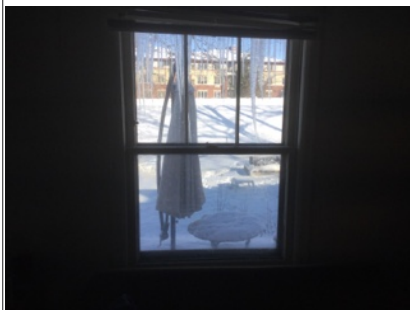
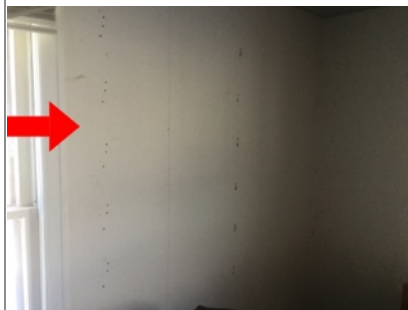
- walls in living room have damage, Recommend repair

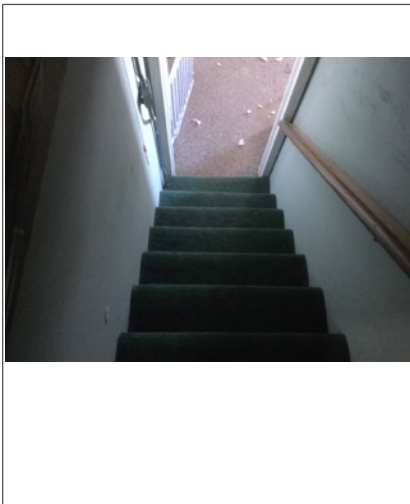
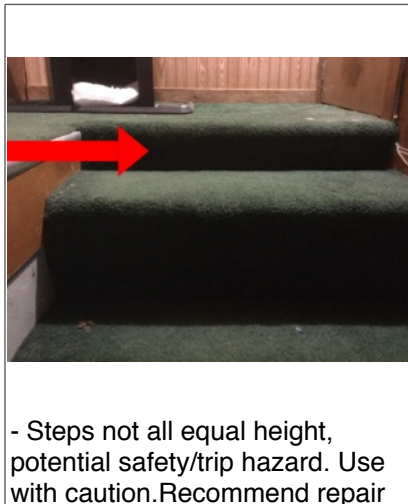
Smoke/Carbon Monoxide detectors

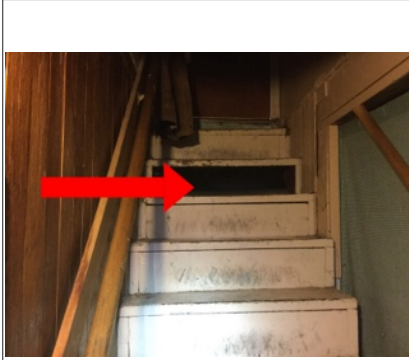
Risers are missing on basement steps

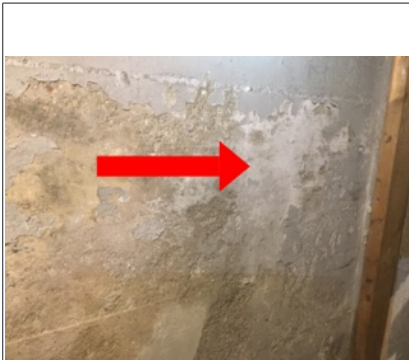
- Foundation has signs of Efflorescence. Recommend keeping water away from foundation wall on exterior.

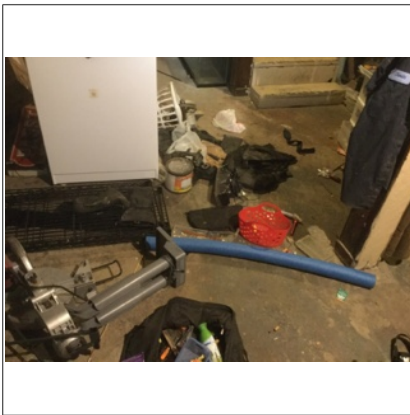
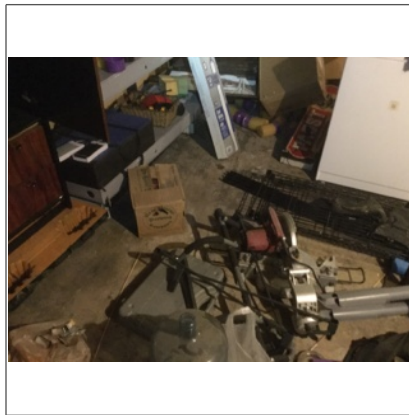
Material Concrete Dirt/Gravel Not Visible Other:
Condition Satisfactory Marginal Poor Typical cracks Not Visible
Comments
Photos

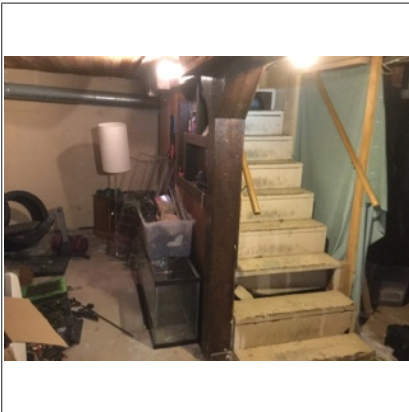
Not Visible
 Satisfactory Marginal Poor Stained/Rusted
 Steel Wood Concrete Block Not Visible
Comments
Photos

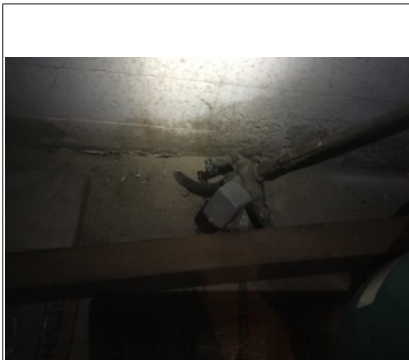
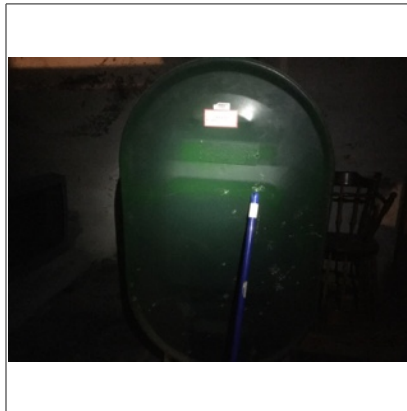
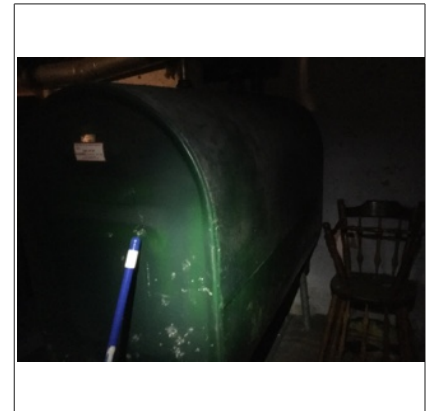
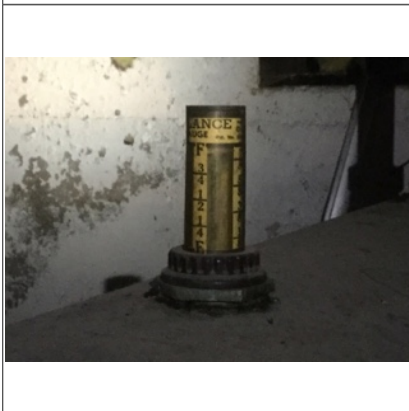
Main fuel shut-off location

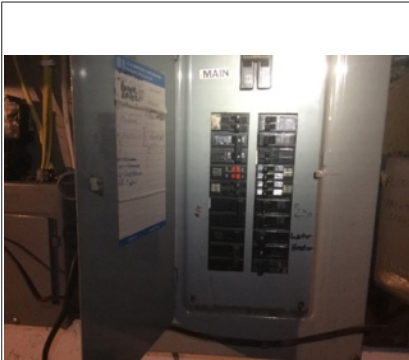
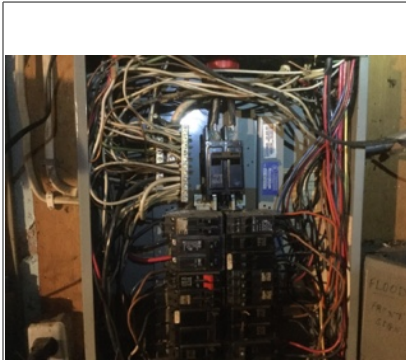
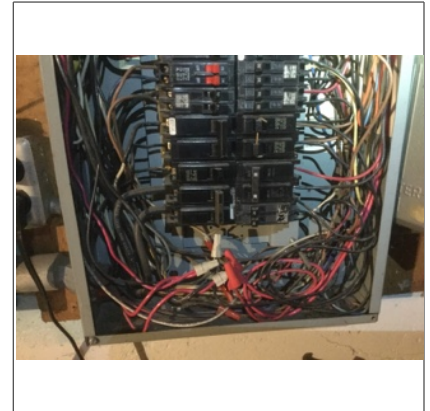
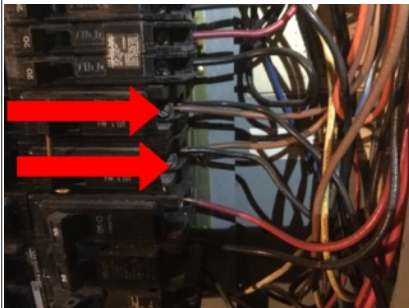
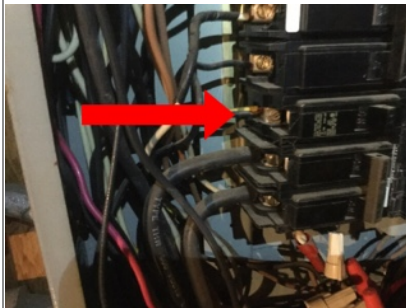
- Electrical panel has double tapping present on several breakers recommend a licensed electrician repair.
