EXISTING BUILDING REVIEW

120 W. Mifflin Street

Name: Andrew Schubert Building

120 West Mifflin Street – Architectural Review

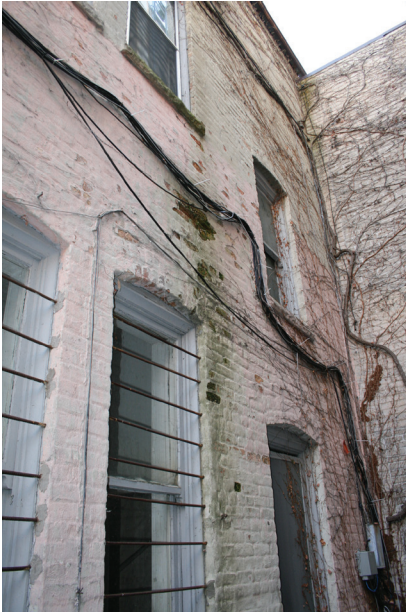
Exterior: View of the back of building showing eroding brick veneer

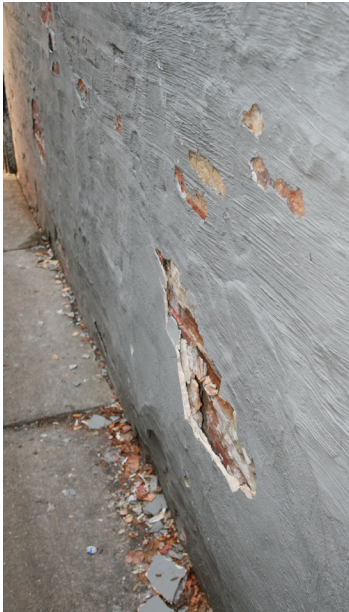
Exterior: View in the alley showing a section of delaminated parging

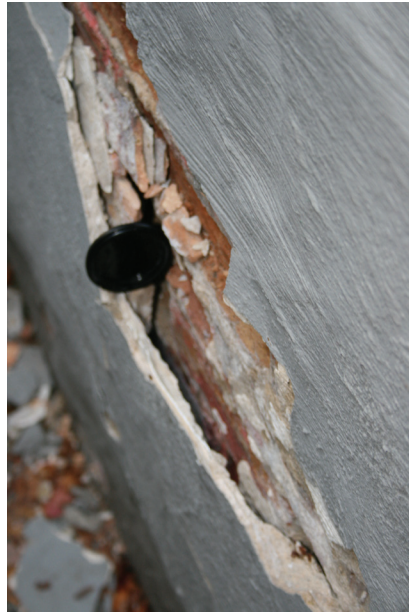
Exterior: View in the alley showing the delamination of the parging system from the brick veneer

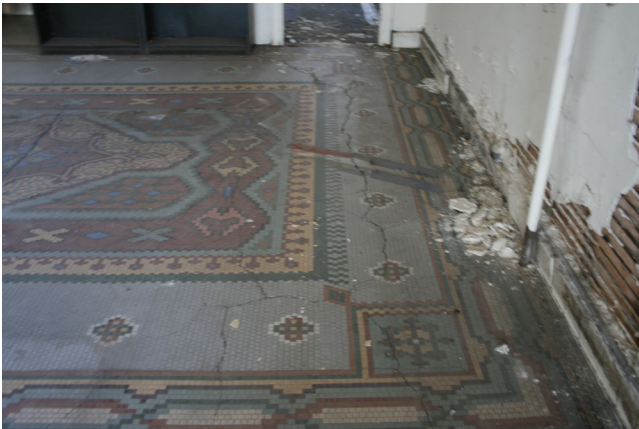
First Floor: View toward back exit showing multiple cracks in floor tile

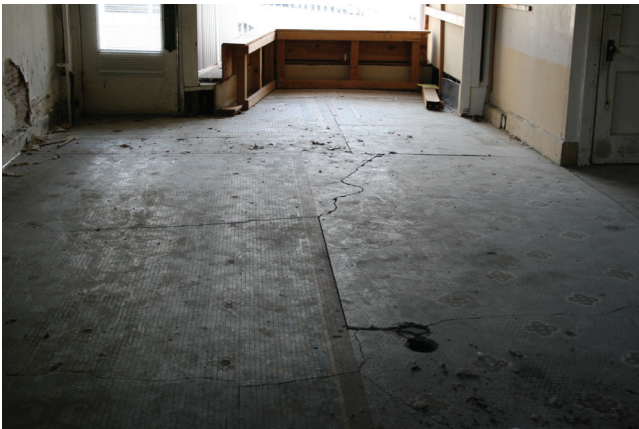
First Floor: View toward Mifflin Street entry showing multiple cracks in floor tiles

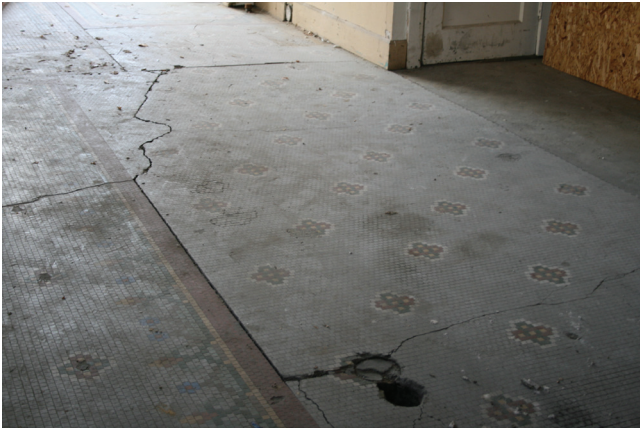
First Floor: View toward basement stair showing multiple cracks in tile floor

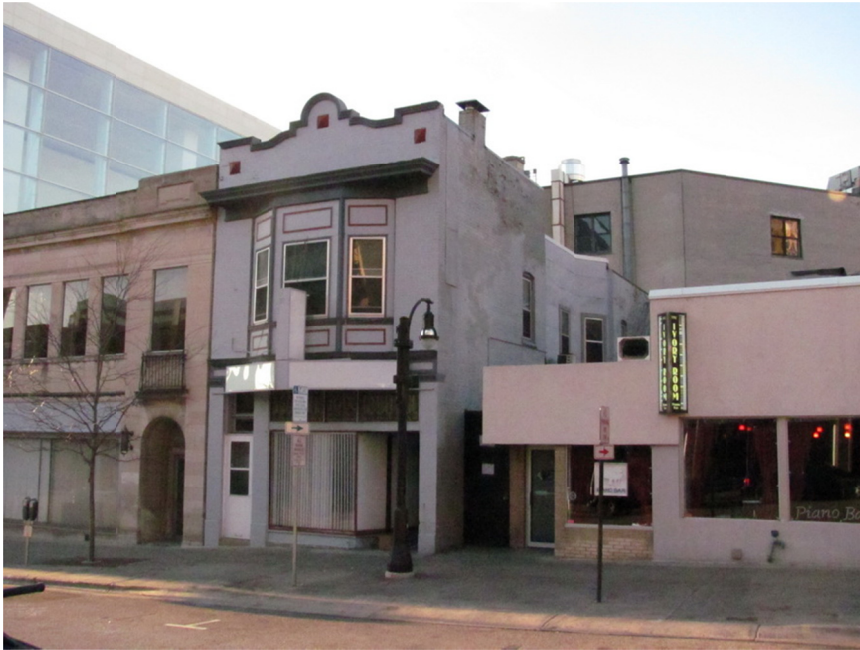
The front facade consists of limestone at the first floor and face brick at the second floor and parapet (Figure 1). All of the masonry has been painted. There is a projecting bay window and cornice at the second floor that is clad with painted sheet metal. The sheet metal appeared intact and well anchored to the underlying framing. Some areas of the sheet metal exhibit surface corrosion.

Figure 1. Overview of the building from the south. The Mifflin Street facade is at left.

The Mifflin Street facade is generally in good condition. Appropriate repair would begin with removal of the existing coating from all masonry using chemical strippers, followed by a more detailed assessment of repair needs. The extent of repointing of the brick and limestone masonry can be determined following removal of the coating. At the west (left hand) top of the parapet wall at the street facade, an approximately three foot by three foot area of displaced brick masonry will likely require dismantling and reconstruction.

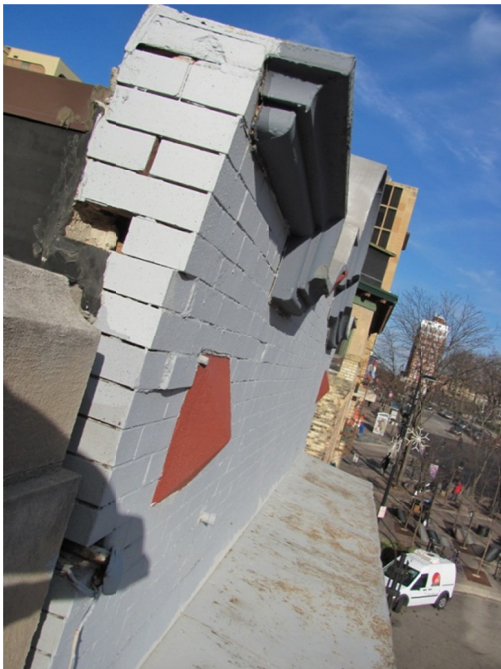
The top west (left hand, as viewed from the street) corner of the parapet wall is displaced outward, with dislodged brick units and open mortar joints at this location (Figure 2). At the limestone masonry of the first floor, some areas of coating have debonded, revealing the stone below (Figure 3). Open mortar joints were observed in the limestone portion of the facade. Although coated, the limestone and face brick masonry at the street facade appears to be in fair to good condition.

Figure 2. Left. View of displaced masonry at the top corner of the parapet wall.

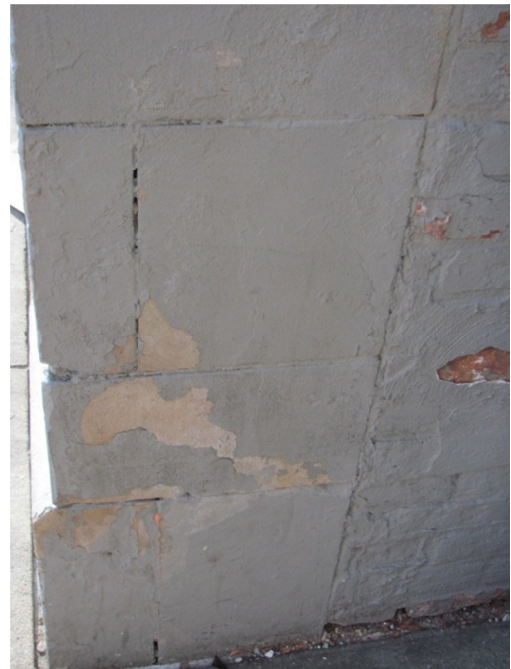
Figure 3. Right. At the limestone masonry of the first floor, some areas of coating have debonded.

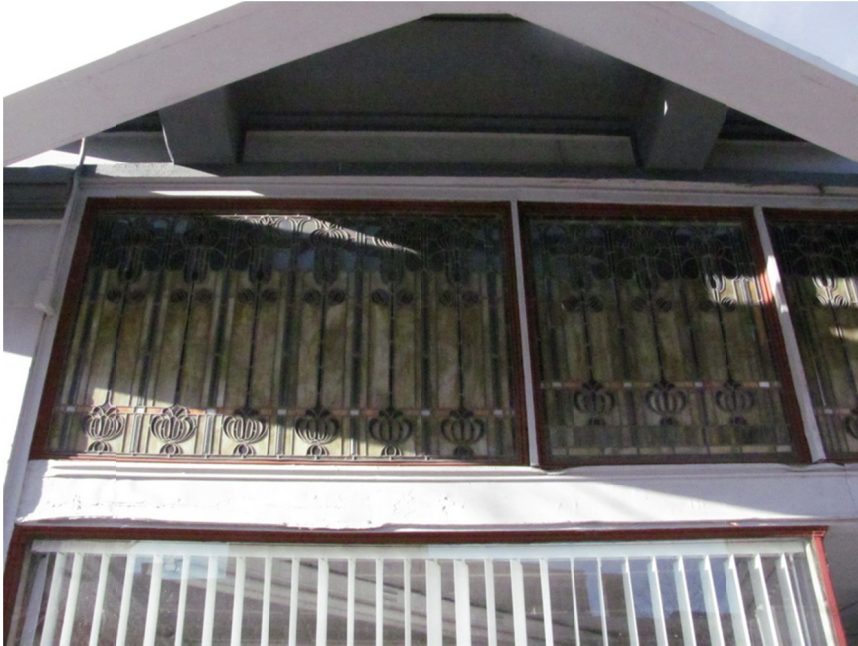
The first floor storefront includes a three-part leaded art glass transom in good condition (Figure 4). The area of the storefront below the transom appears to have been altered following original construction, based on comparison with historic photographs included in the city landmark nomination.

Figure 4. The first floor storefront includes a three-part leaded art glass transom.

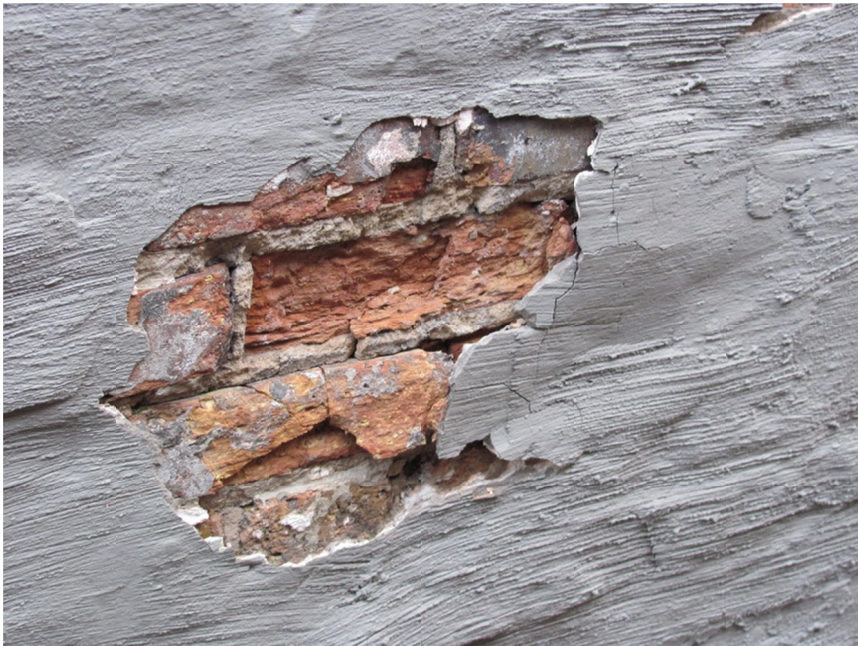
The northeast-facing side wall and northwest-facing rear wall are common brick masonry that has been variously parged and coated. Portions within 6 feet of grade have a build-up of multiple layers of cementitious parging and coating. These layers are now debonding, exposing the original brick masonry. The common brick masonry is in poor condition, with open joints and deep face spalling of the brick units. Examples of this distress are shown in Figure 5 through Figure 8. The deterioration is most severe near grade and below the coping at the top of the wall. The ongoing deterioration of this masonry wall has resulted in detached fragments of brick, mortar, or parging.

Figure 5. Failure of cementitious parge coat, revealing deteriorated brick masonry.

In contrast to the street facade, the side and rear walls are in very poor condition. Appropriate repair would include removal of existing coatings and parge materials, followed by selective replacement of the outer wythe of brick with new masonry. Replacement required is likely extensive, based on conditions observed. Based on this limited survey, the majority of the outer wythe of brick on the alley side and rear walls may require replacement, including extensive areas at grade and at the top of the walls. The condition of the backup wythes of brick masonry is not known at this time. Further investigation of the brick backup masonry, especially at grade and the parapet walls, is needed to determine if the existing deterioration extends beyond the exposed face wythe of brick and whether repair or replacement of backup masonry is required.

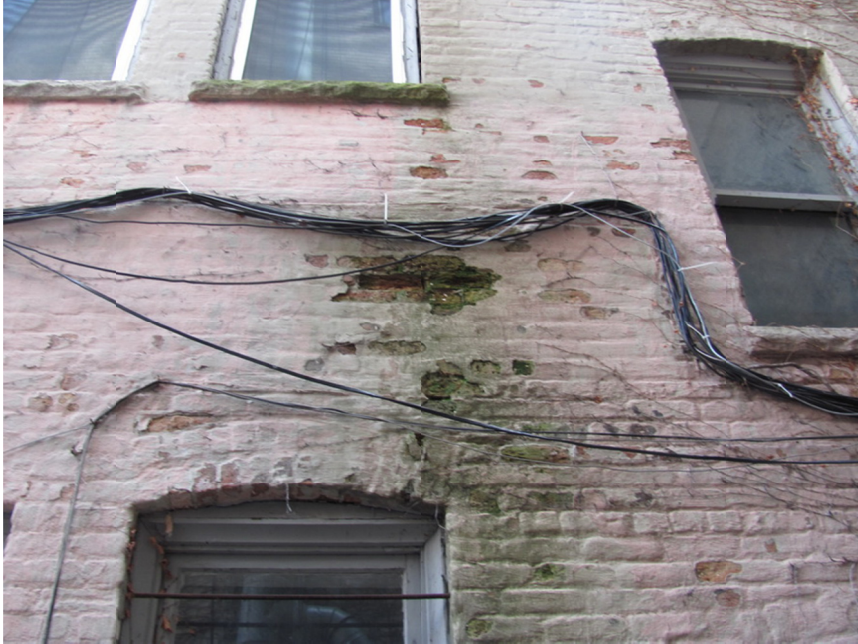
Figure 6. Deterioration of brick masonry at the rear facade.

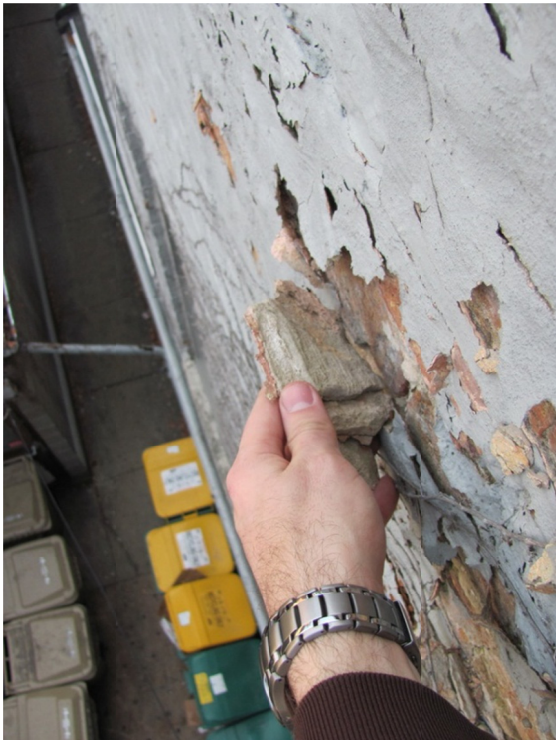
Figure 7. Left. Loose fragments of brick/mortar/parging were removed by hand from the side wall.

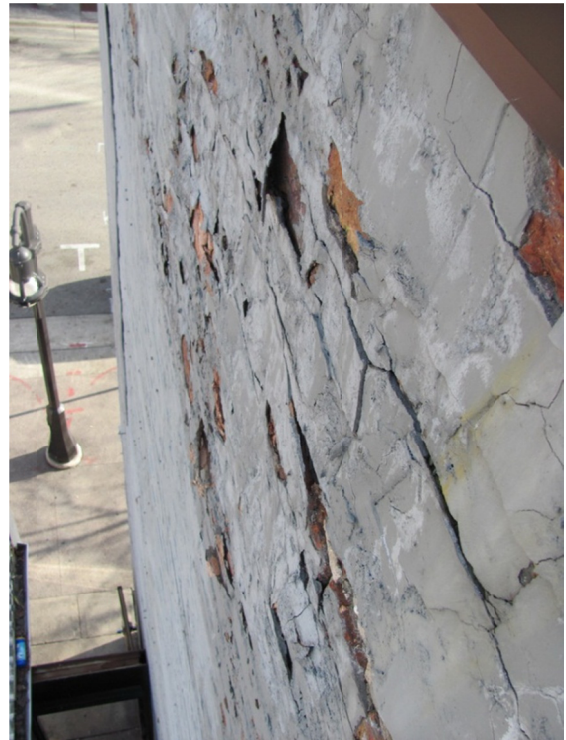
Figure 8. Right. Deterioration of brick and parging near the top of the side wall.

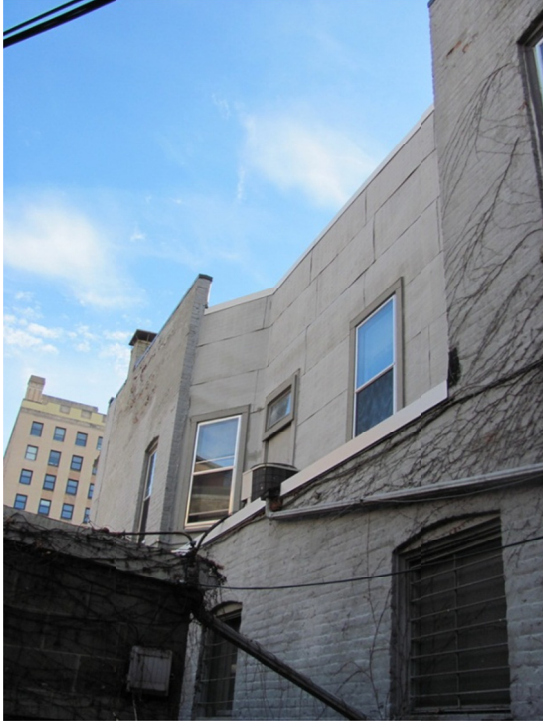
There is a recessed area at the second floor of the building along the northeast side. The walls of this area are clad with painted sheet metal (Figure 9).

Figure 9. A portion of the side wall is recessed at the second floor and is clad with painted sheet metal.

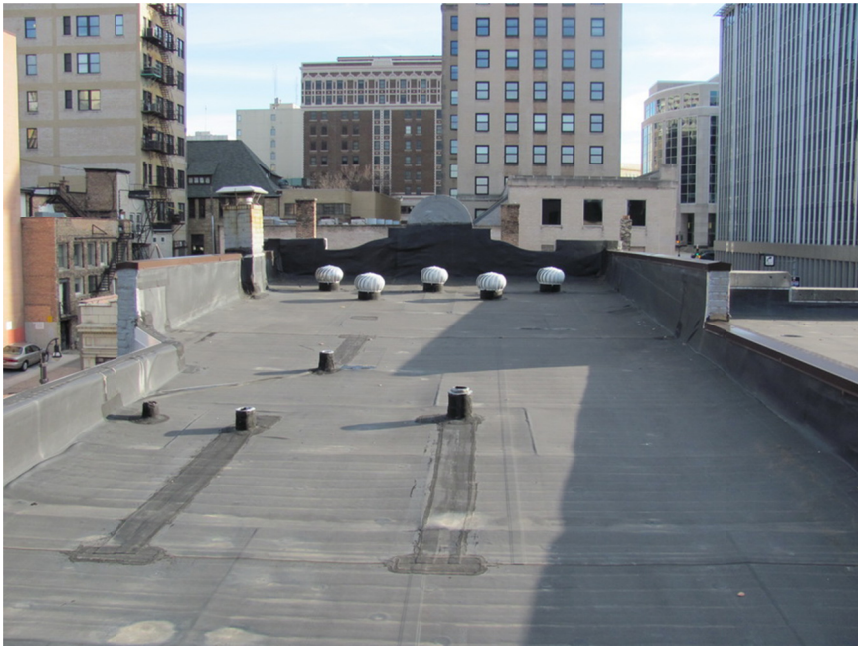
The roof is covered with a relatively new EPDM rubber membrane (Figure 10). The membrane is extended up the rear face of the parapet walls. The membrane intersects a sheet metal coping. Five circular attic vents are located near the south end of the roof. The roof slopes from south to north and is drained to a continuous galvanized metal gutter along the north wall. Ponded water was observed on the roof surface near the gutter (Figure 11). The gutter itself is in poor condition, with open seams, accumulated debris, and broken support brackets.

Figure 10. Overview of the roof.

The penthouse roof and wall cladding requires repair or replacement to create a watertight building envelope. The main roof appears generally watertight, but further investigation is needed to ensure that perimeter flashing details are appropriately integrated with the coping and that appropriate slope for drainage is provided. The existing gutters and downspouts along the rear wall should be replaced.

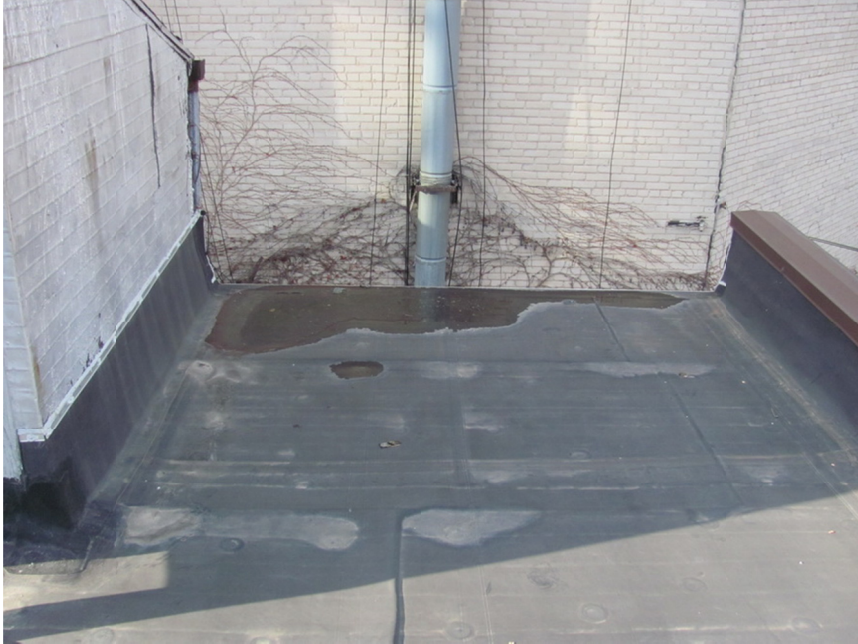
Figure 11. Ponding on the roof near the gutter.

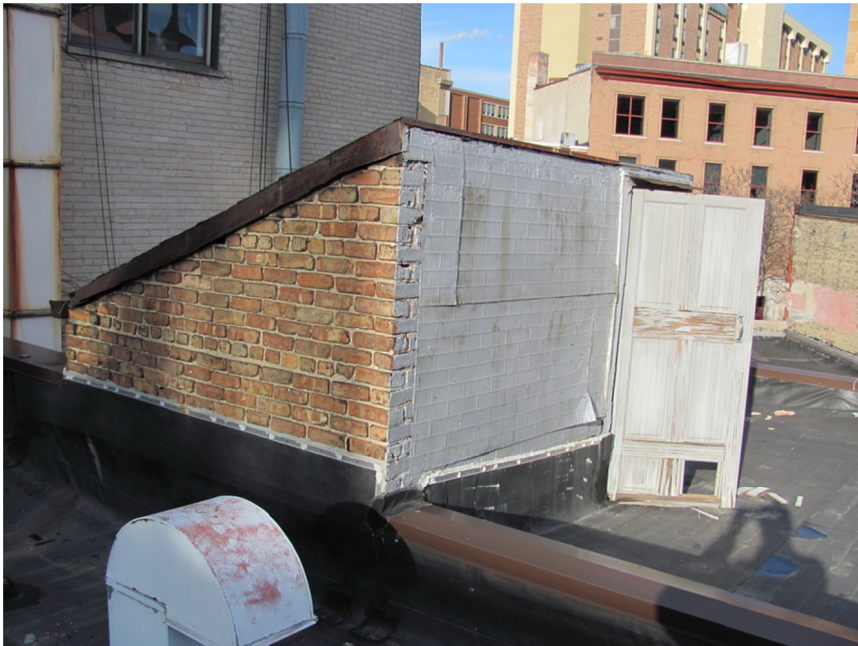
The roof is accessed through a small penthouse over the rear stairwell (Figure 12). The roof of the penthouse is covered with asphalt shingles that are in extremely poor condition (Figure 13). The walls of the stairwell are brick masonry and wood framing covered with painted sheet metal. Water infiltration through the walls and roof of the penthouse has occurred in the past, as the interior plaster in the stairwell is severely deteriorated.

Figure 12. View of the penthouse walls constructed of brick masonry and painted sheet metal.

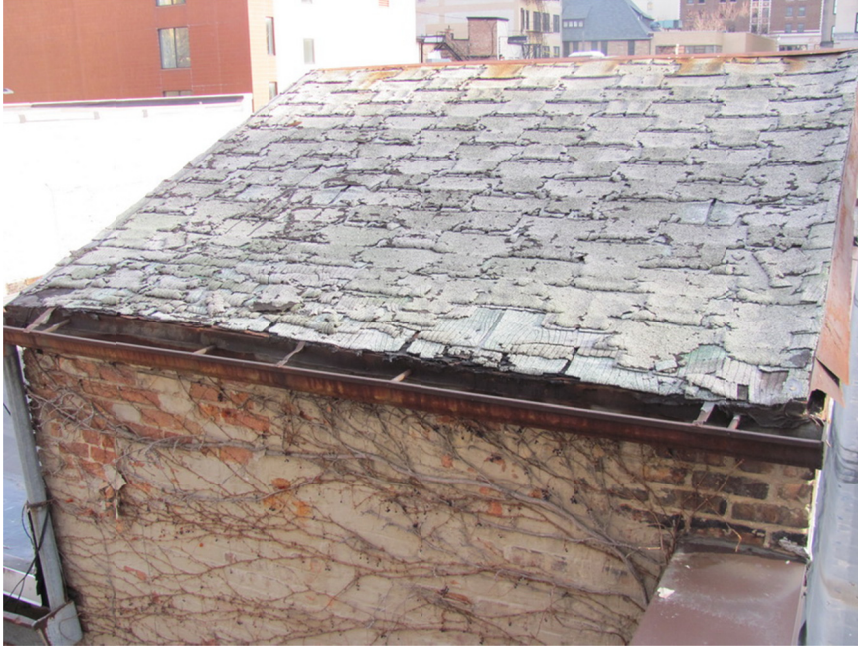
Figure 13. The penthouse roof is covered with asphalt shingles in deteriorated condition.

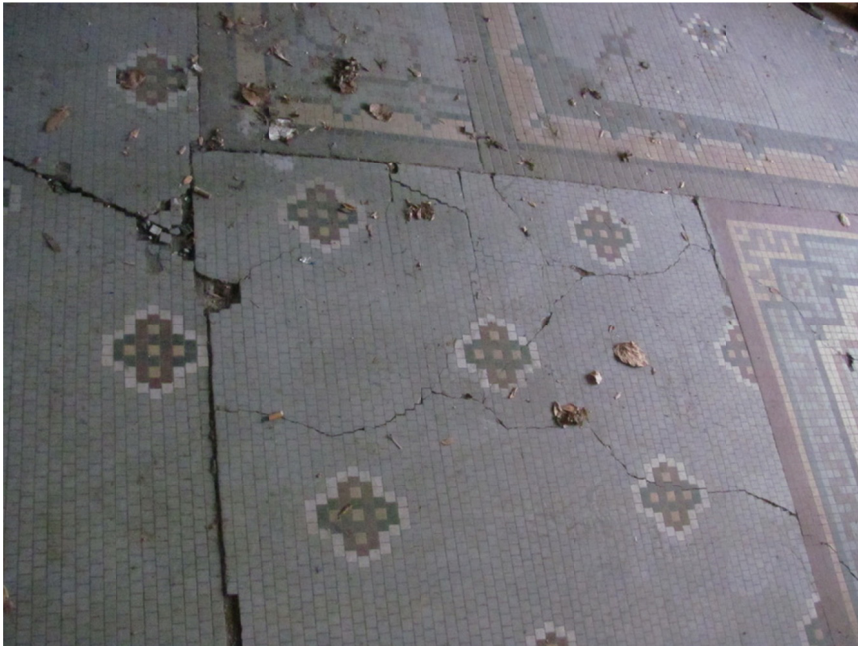
The first floor main interior room has four different areas of flooring consisting of elaborate decorative mosaic tile floor composed of various colors of 3/4 inch square tiles in a running bond. A portion of the ceramic tile flooring near the front door has been replaced with 1 inch square tiles with rounded edges. A second area of non-original flooring is located adjacent to the storefront at the southeast end of the space. Localized individual ceramic tiles throughout the flooring are missing and have been replaced with concrete patching. Extensive cracking, displacement, and settlement have occurred at this flooring (Figure 14). The distress in the flooring is apparently the result of significant and widespread deterioration of the basement-level wood columns, wood beams, and wood joists that support the floor. A detailed assessment of the first floor framing was beyond the scope of this study, but obvious signs of decay as well as previously installed temporary shoring were observed in the basement.

Figure 14. There is elaborate mosaic tile flooring at the first floor; the flooring has suffered extensive cracking and displacement.

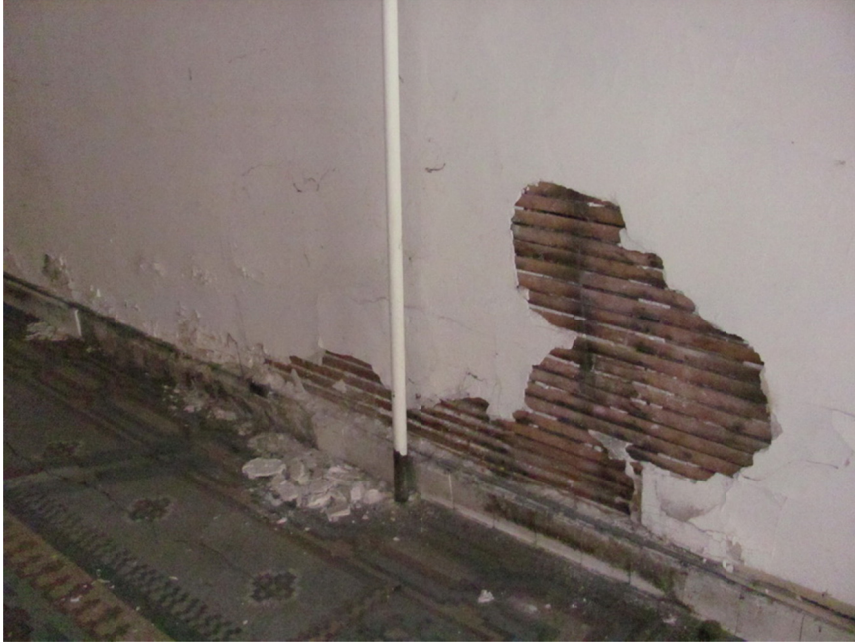
The first floor walls and ceiling are painted plaster on wood lath. Portions of the plaster have detached from the lath, likely due to water infiltration (Figure 15). Water staining and bubbling of the plaster were also observed (Figure 16).

Figure 15. Damage to interior plaster wall finish.

Interior plaster finishes have suffered deterioration apparently related to water infiltration through roofing and the side and rear brick masonry walls and may require replacement.

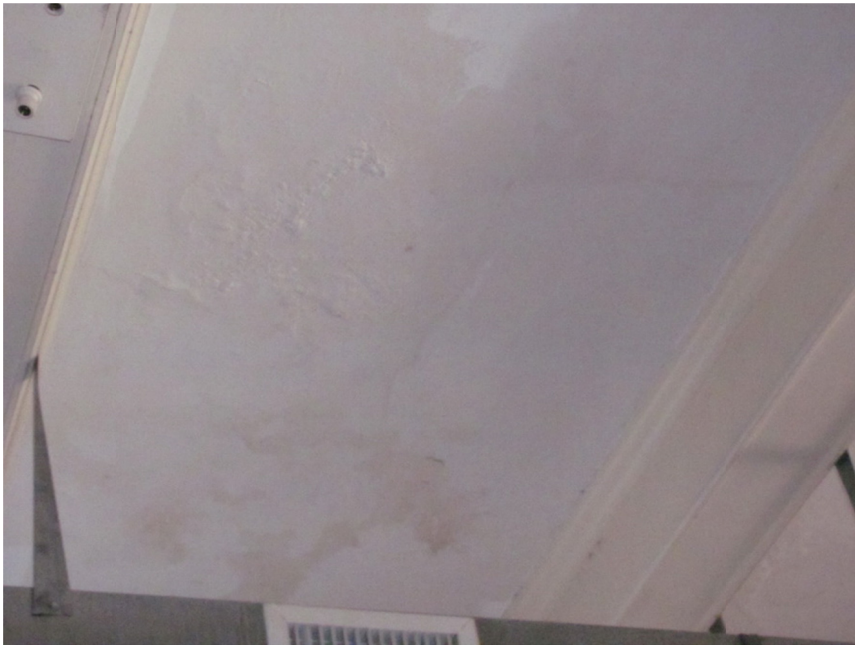
Figure 16. Water staining and bubbling of interior plaster ceiling.

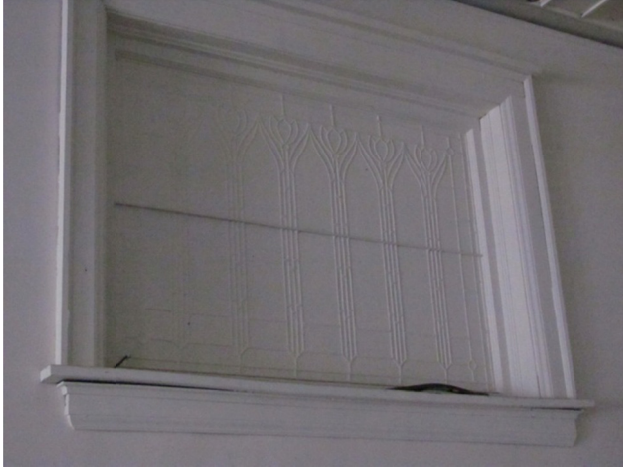
In addition to the storefront, a notable feature of the interior first floor is one leaded glass window at the southwest party wall; the glass has been painted over (Figure 17).

Figure 17. Leaded glass window, which has been painted over, at the southwest party wall.

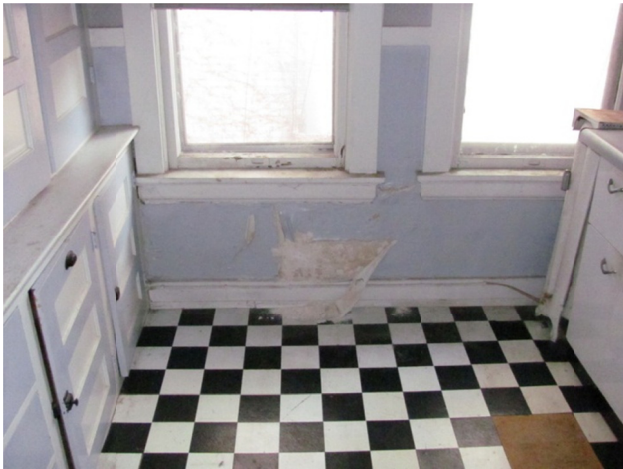
Figure 18. Plaster damage at the rear wall at the second floor of the building.

The second floor interior is in poor condition overall. Much of the interior plaster at or adjacent to the exterior walls has evidence of water infiltration damage and may require replacement. Consideration should be given to salvaging intact original elements such as interior doors and trim.

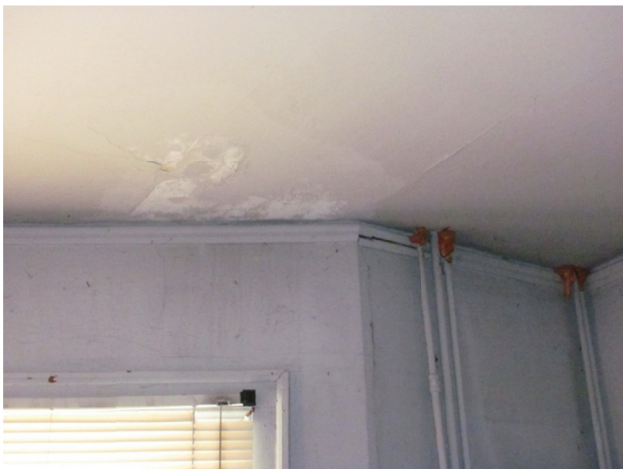
Figure 19. Moisture damage to plaster finishes at the second floor.

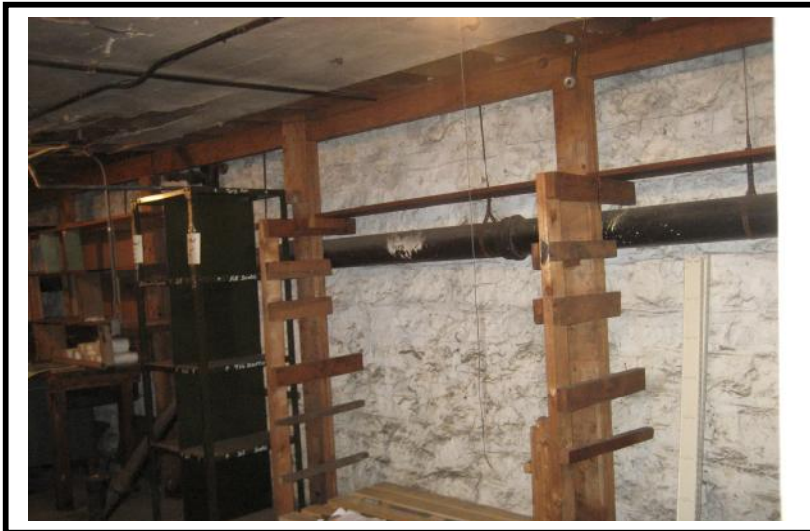
Figure 1 – Shoring along basement wall –also used a s shelving.

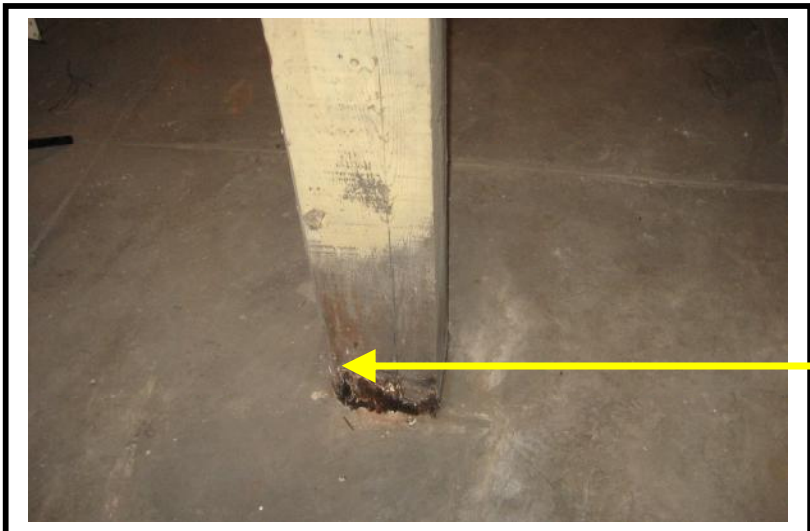
Floor is cast in place concrete on grade. Stains on bottom of wood columns indicate water entry over a period of time. Column bases to the north are rotting at the bottom. The rubble foundation walls appear in good condition. Basement access thru the sidewalk vault has been covered over with a concrete slab. The electrical and water service are in this room. The vault slab is shored up with wood cribbing on east /west faces. Repair to the bearing of this slab is thus recommended which would necessitate removal of a sidewalk panel or two.

Figure 2 – Rooted column base in basement.

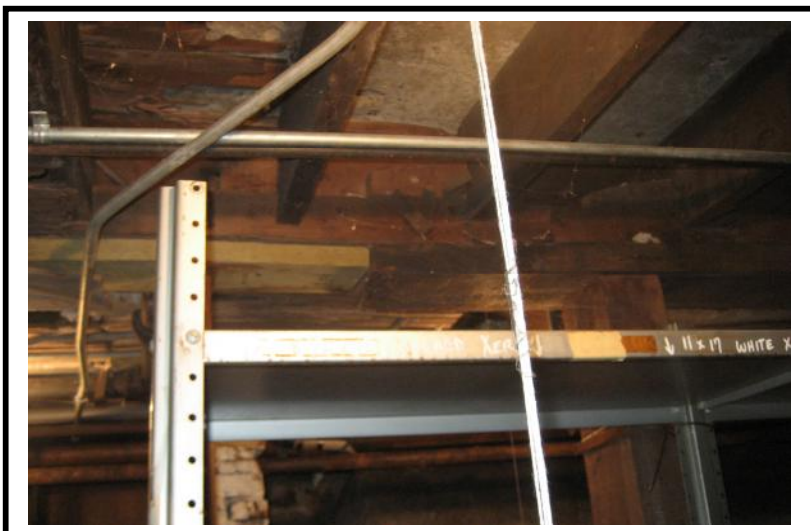
Figure 3 – Wood materials added to aid in support of the joists and the center beam line.

The quantity of defects and the deflection in the first floor result in the suggestion to replace of the entire floor system as the most logical course of action. A new floor might be constructed of concrete fill on metal form deck on sheet metal joists. It remains a possibility to re-establish support for the existing floor, but the deflection would largely remain.

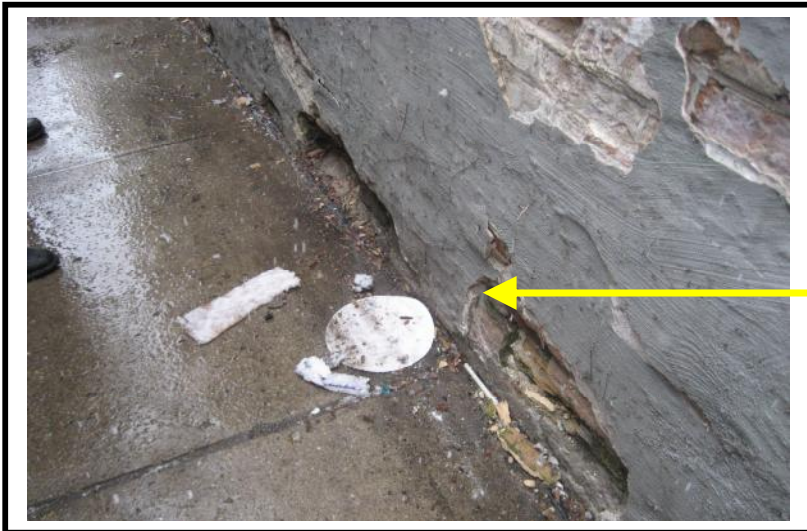
The walls on the east and west sides were observed from the alleyway running along the east side. The grade level walls appear to be a porous brick with a painted parging at the surface. The pargings are usually placed to cover defects in the brick- which appears to be the case here. Areas where the faces of the brick have fallen off were observed. The east wall steps back at the second level. At this location sheet metal siding is used. The west wall was not observed but is probably a party wall with the adjacent property.

Figure 4 – Spalling brick face-east exterior wall.

The observed walls were judged to be structurally stable but in need of repair to maintain water tightness. One option might be to cover the existing brick with an exterior insulation and finish system to economically reestablish the water barrier. Any repair system chosen should be investigated for its own tendency to trap moisture in the wall. Any projection beyond the existing wall line would have to be verified with property rights.

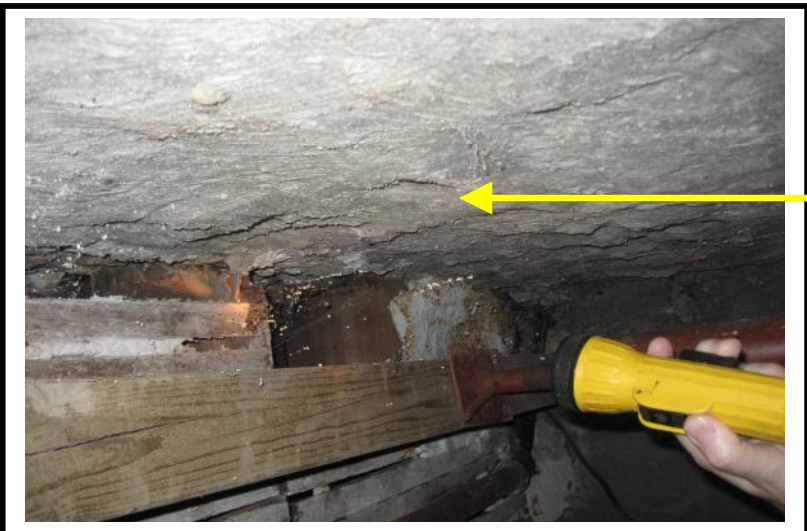
The first floor is roughly 3" concrete/tile topping on wood decking on 2x10 wood joists at 16" o/c. Floor joists span east/ west to a center support line. The floor shows significant deflection. Wood shoring has been placed along both east and west basement walls to re-support floor joists where they have rotted at their bearing in the rubble wall. The center beam line has been re-supported by metal posts to deal with rotted original wood columns. In certain areas of the center beam line the joists are pulling away from the support ledger. There have been wood materials added to deal with the ledger condition but they are not, in the writer's opinion, a permanent solution. The floor appears to sag toward the southwest stair. The support of both the first and second floor appears marginal in this area.

Figure 5 – Picture of rotted end of wood floor joist at first floor.

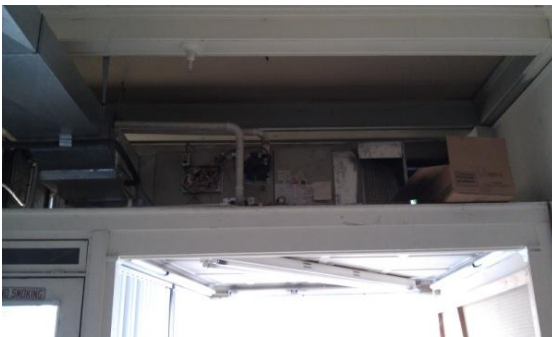
Furnace above entrance

The furnace appears to be operational but has signs of incomplete repairs from many years ago. Exact functionality is unknown. The support of the storm main is weak and the last several feet pitches upward, indicating a deteriorating system. The lead piping is an obvious health issue. A portion of the gas piping is badly deteriorated and has the potential to fail. Several sections of sanitary piping has either completely failed or is leaking. The storm main through the building is inappropriate since it doesn't directly serve the building.

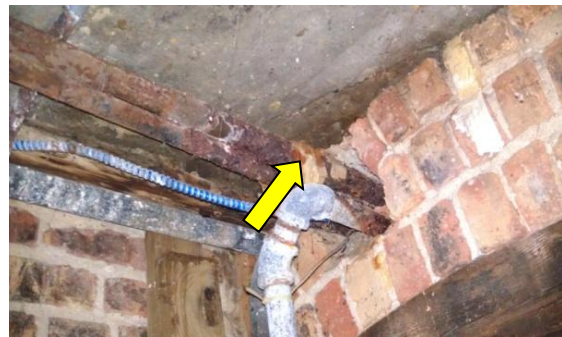
Deteriorated gas pipe

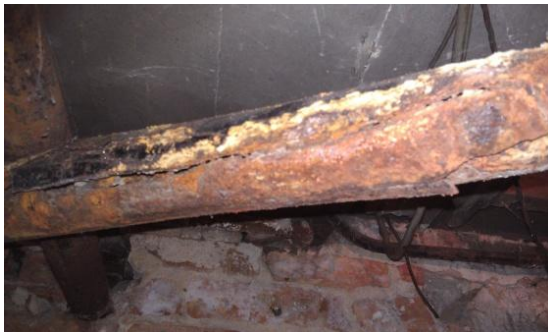
Deteriorated sanitary pipe

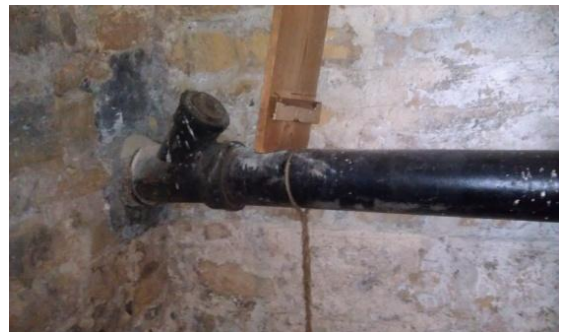
Storm main support/pitch

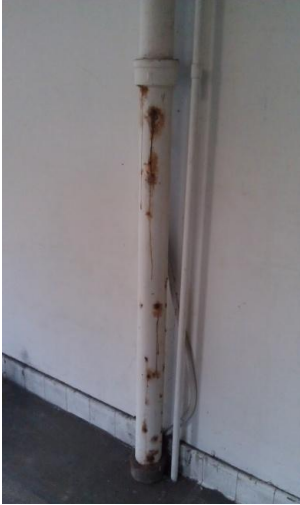
Leaking sanitary pipe

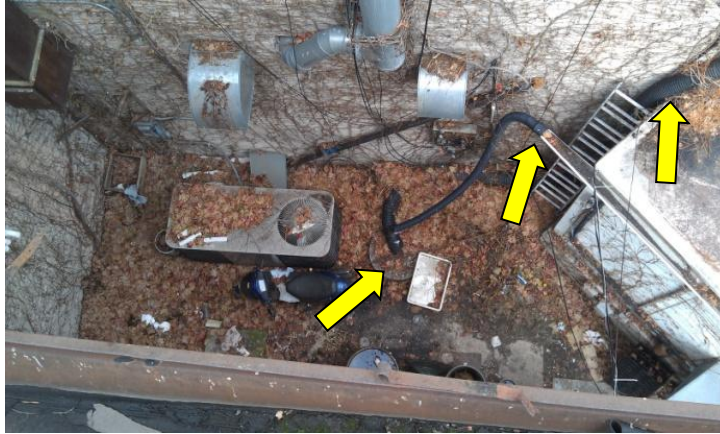
Roof drains into cistern that discharges through basement

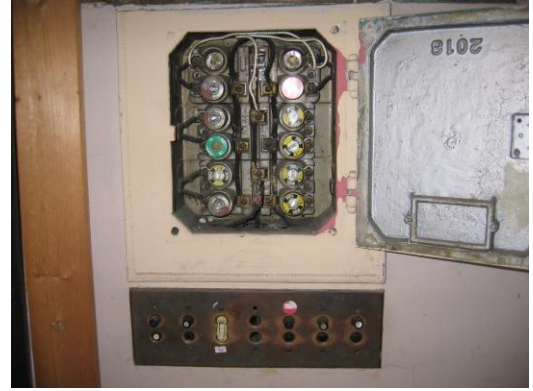
The fuse panel on the 1st floor is past its reliable life, and the panel on the 2nd floor is at the end of its useable life. The fusible panel on the 1st does not meet current code requirements. The current wiring device locations in the apartment do not comply with accessibility requirements. Receptacle quantity and locations in the apartment do not comply with current NEC requirements. Compliance with current codes for these items would require branch circuit, receptacle and fuse panel replacement.

Electrical fuse panel on 1st floor.

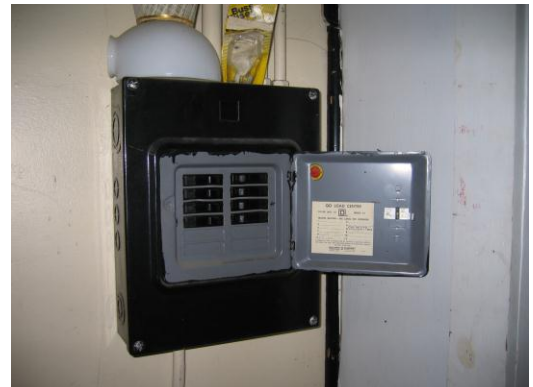
Electrical panel on 2nd floor.
