APPLICATION FOR DEMOLITION OF PRINCIPAL BUILDINGS

City of Madison

Building Inspection Division

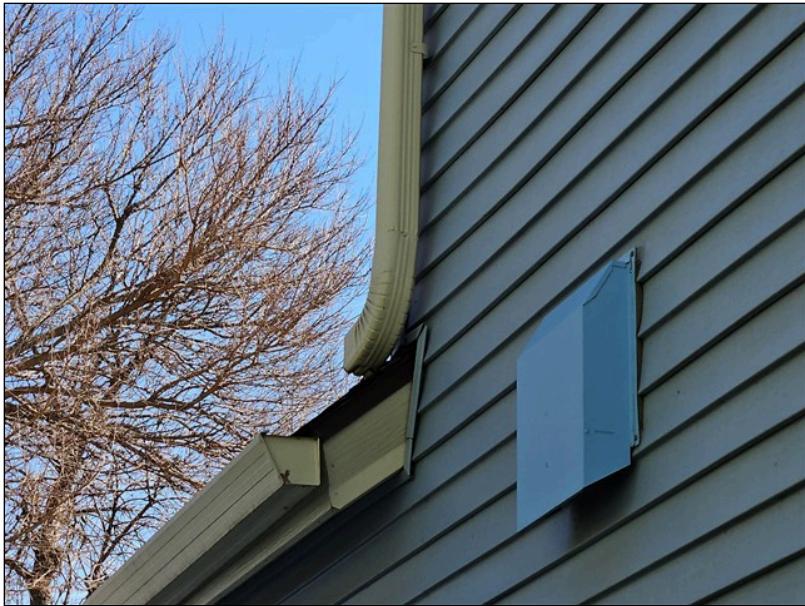
1.1 (1) Repair: Downspout discharged directly onto the lower roof covering. Over time the concentrated draining of water over this section of the roof can result in a reduced shingle life and/or leaking. If it is draining next to a sidewall or valley, there is the increased potential of moisture intrusion in the area.

Recommend a qualified contractor install a downspout to take water to the gutter on the lower roof.

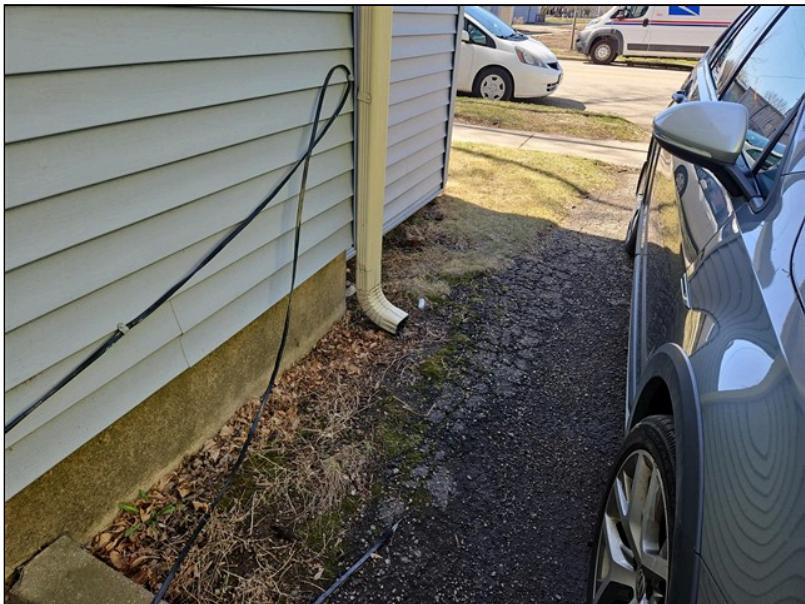
1.1 (2) Repair: Downspouts discharged roof drainage next to the foundation. This condition can result in excessively high moisture levels in the soil at the foundation and can cause damage to the foundation and moisture intrusion into the basement.

example of one location

Recommend installation of downspout extensions to discharge roof drainage a minimum of (6) feet from the foundation.

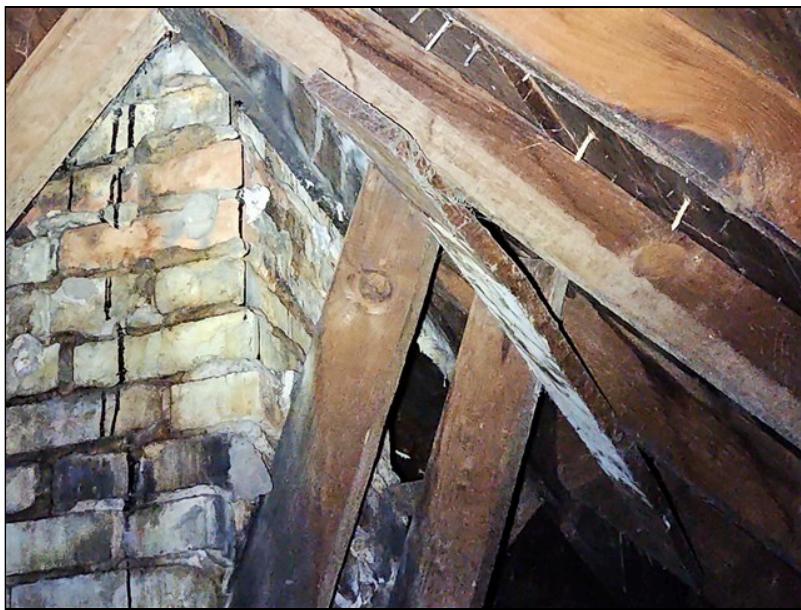
1.4 Defect: Chimney structure was deteriorated. In the basement, cracks were present. Chimney was leaning on the exterior. Moisture stains are indicative of a current or past leak in the flashing.

Recommend further evaluation and repair/remove as necessary by qualified chimney contractor.

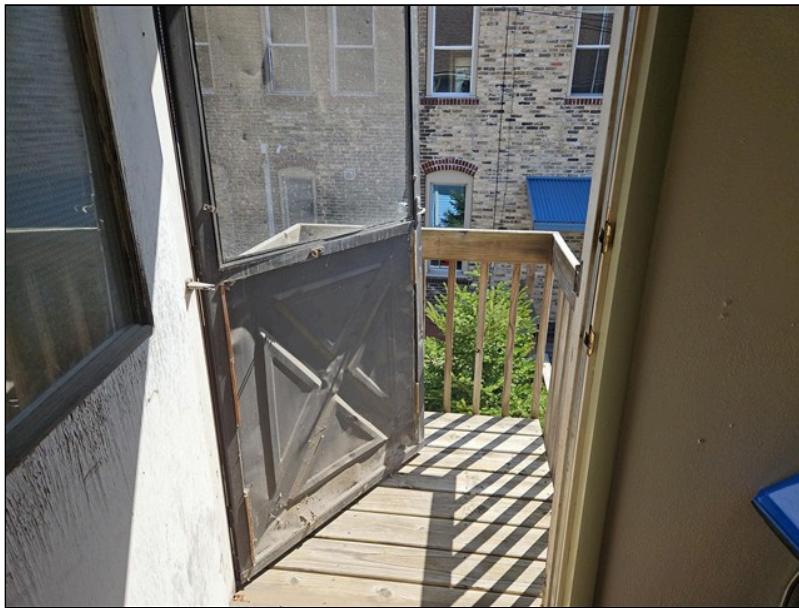
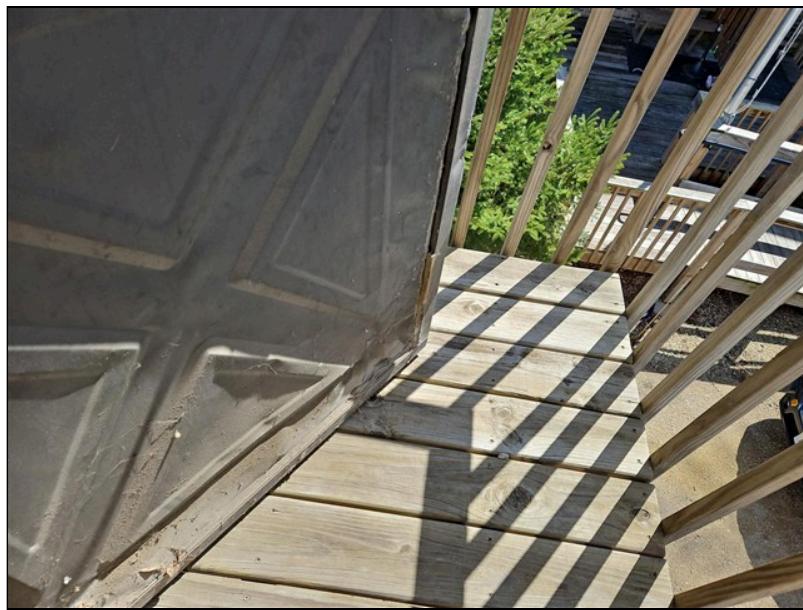
2.2 (2) Repair: Storm door to balcony was damaged.

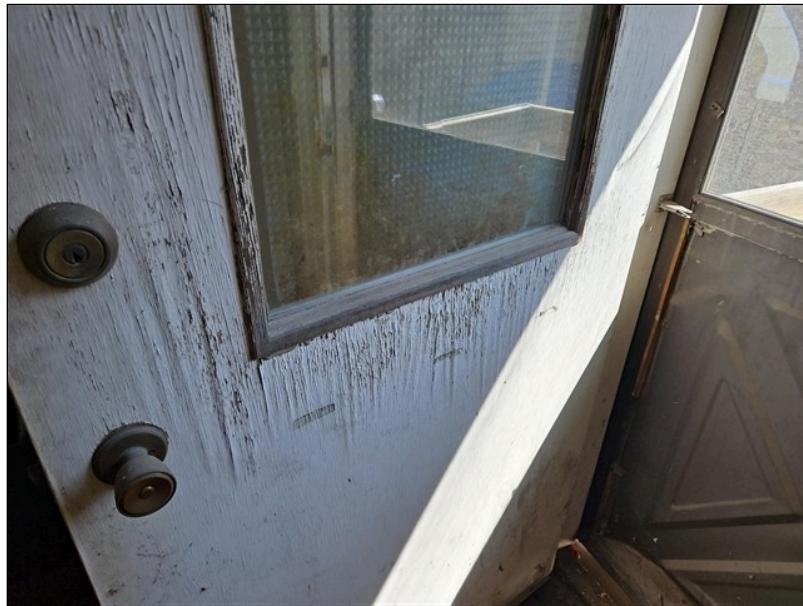
2.2 (3) Repair: Door to balcony was deteriorated.

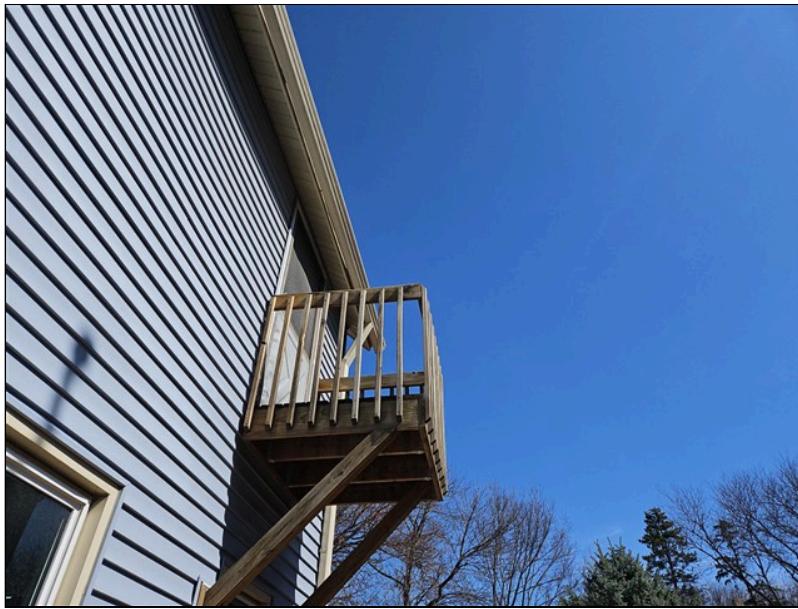
2.4 (2) Defect: The balusters on the guardrail on the balcony were spaced in excess of 4". This is a choking hazard for children.

Recommend further evaluation and repair as necessary by a qualified contractor.

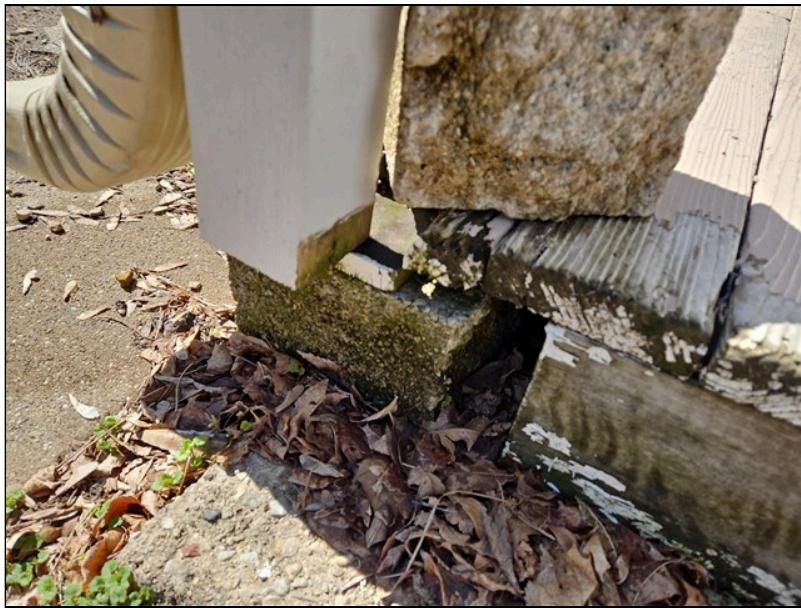
2.4 (3) Defect: Post supporting porch roof was not centered on footing. Footing was not set below the frost line and may move with frost heave.

Recommend further evaluation and repair as necessary by qualified contractor.

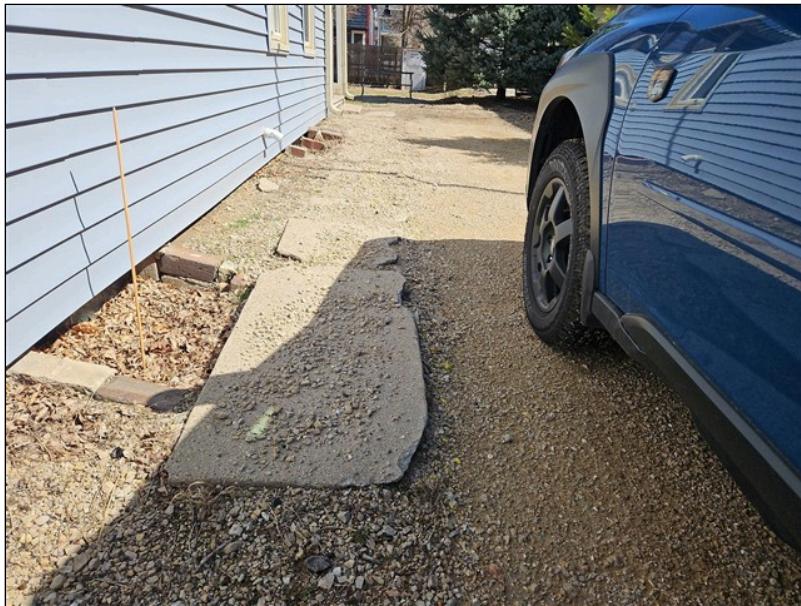
2.5 Defect: The heaving, settling and cracking of the sidewalk has created trip hazards.

Recommend further evaluation and repair/replace as necessary by a qualified contractor.

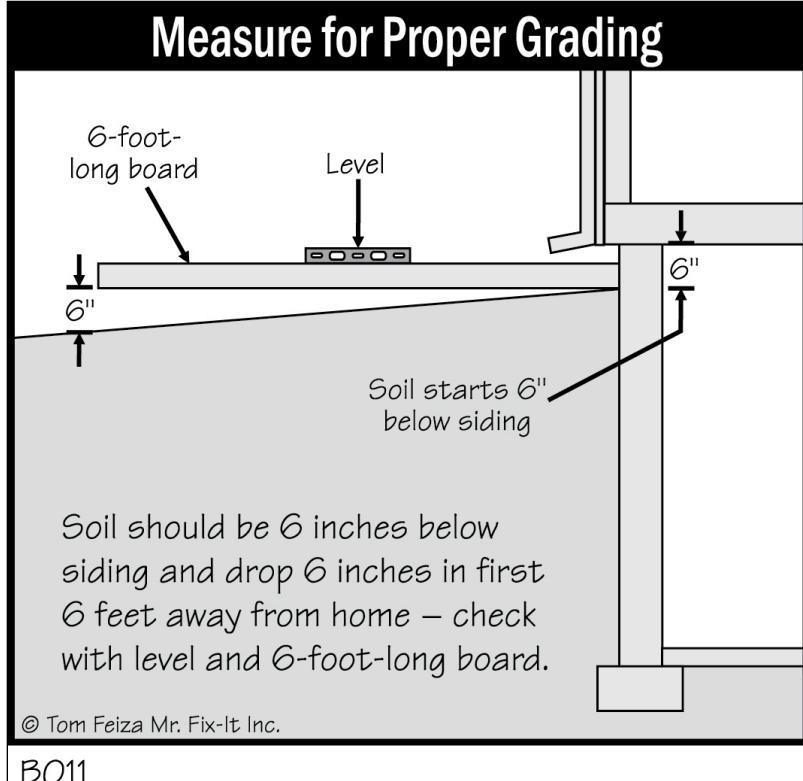
2.6 Repair: The landscaping was insufficiently sloped away from the home in multiple locations. This can cause excessively high levels of moisture at the foundation and cause damage to the foundation and moisture intrusion into the basement. Recommend correcting landscape to drain water away from home.

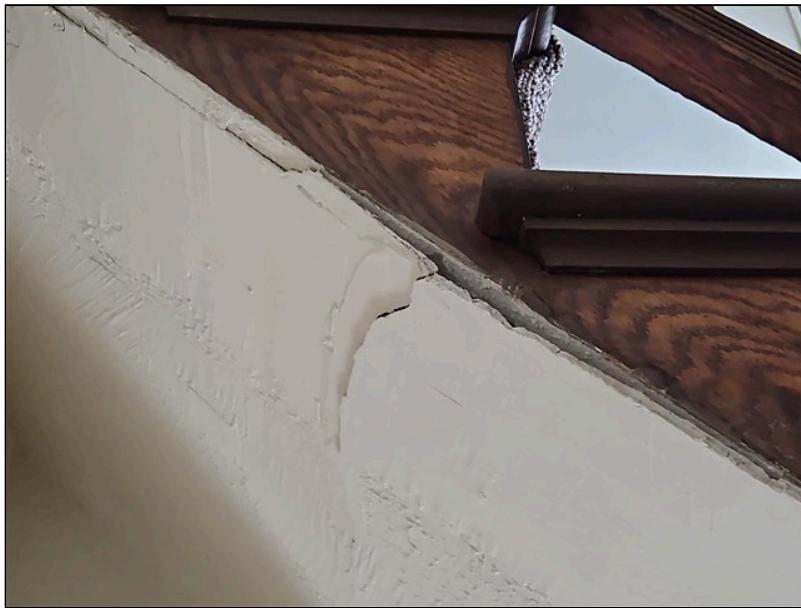
3.0 (1) Repair: The plaster was disengaged/cracked in multiple locations.

example of one location

Recommend further evaluation and repair as necessary by a qualified contractor.

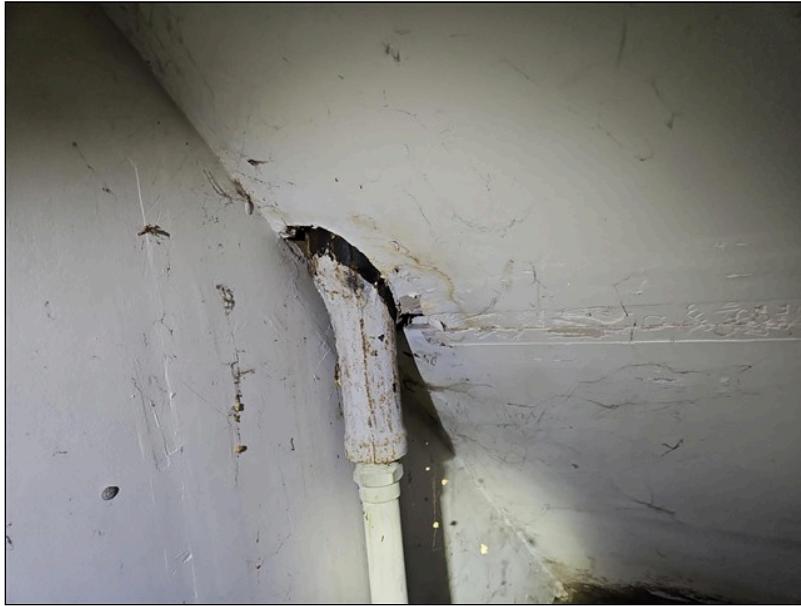
3.0 (2) Moisture stains were present on the ceiling in the attic space - at the time of the inspection, no moisture was present.

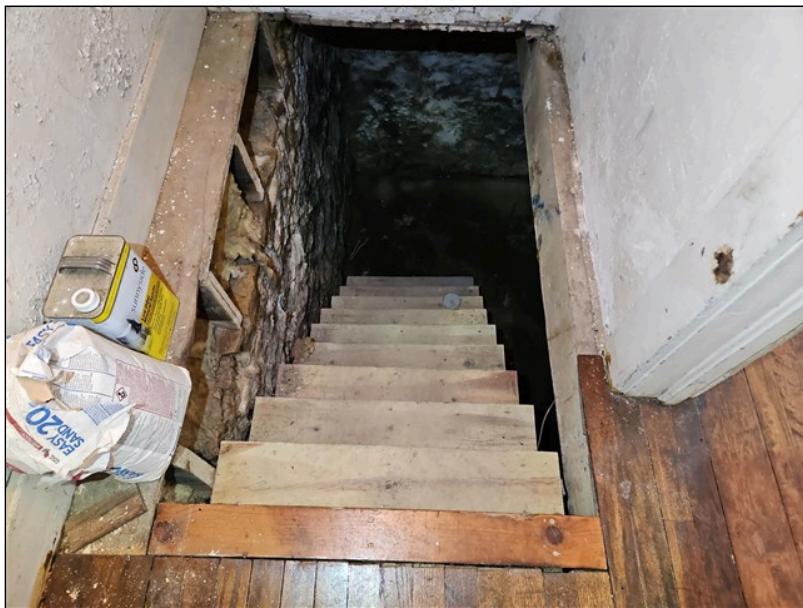
3.2 Defect: The stairs to the basement and upper level were not constructed in a manner that are consistent with today's safety standards. This can be a fall hazard.

Recommend further evaluation and repair by a qualified contractor.

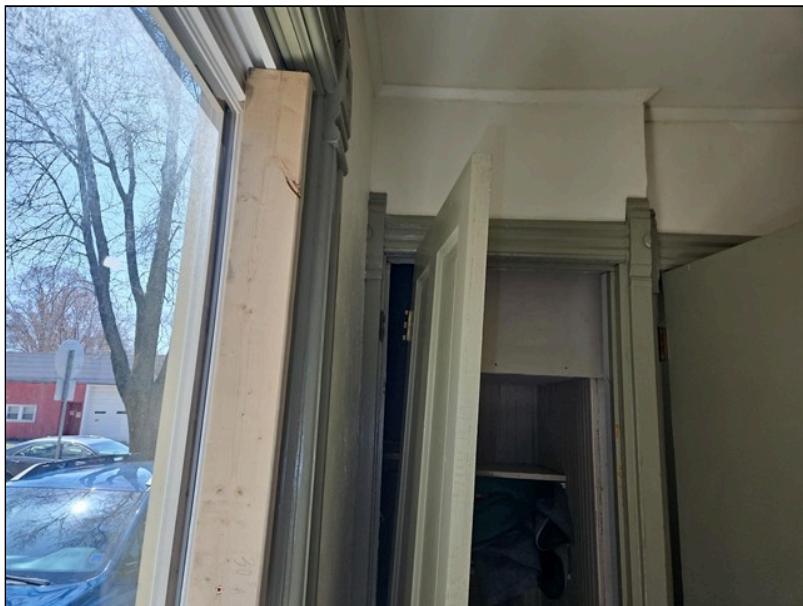
3.3 Repair: Door was not connected to the frame.

Recommend further evaluation and repair by a qualified contractor.

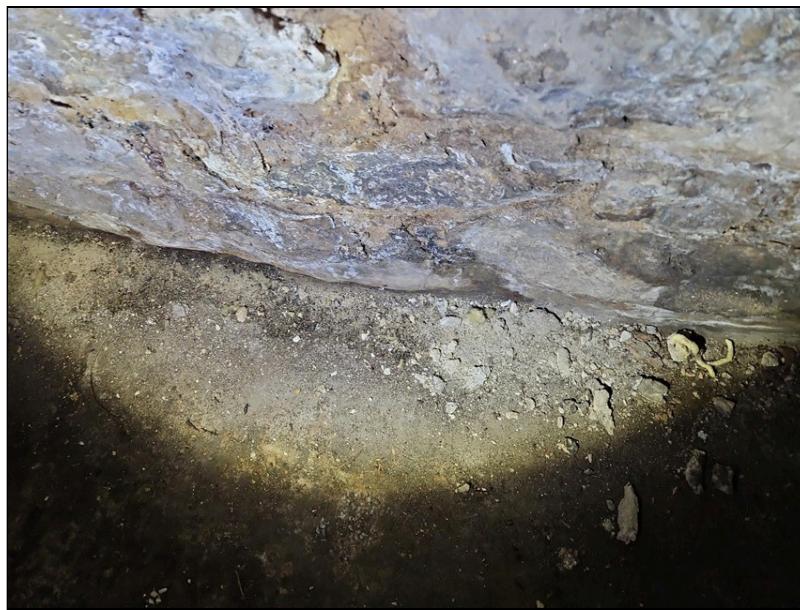
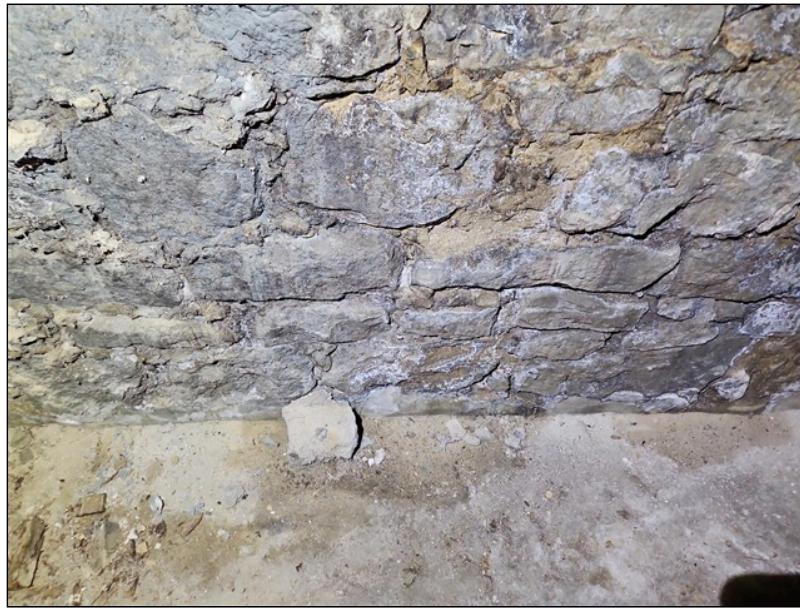
4.0 Defect: Pooling water and moisture stains were present in the basement. The mortar was deteriorated between the rocks/stones in the foundation wall in areas. The deterioration of the mortar in a rock/stone foundation wall makes it vulnerable to moisture intrusion and may result in the structural integrity of the wall being compromised.

Recommend further evaluation and repair as necessary by a qualified foundation specialist.

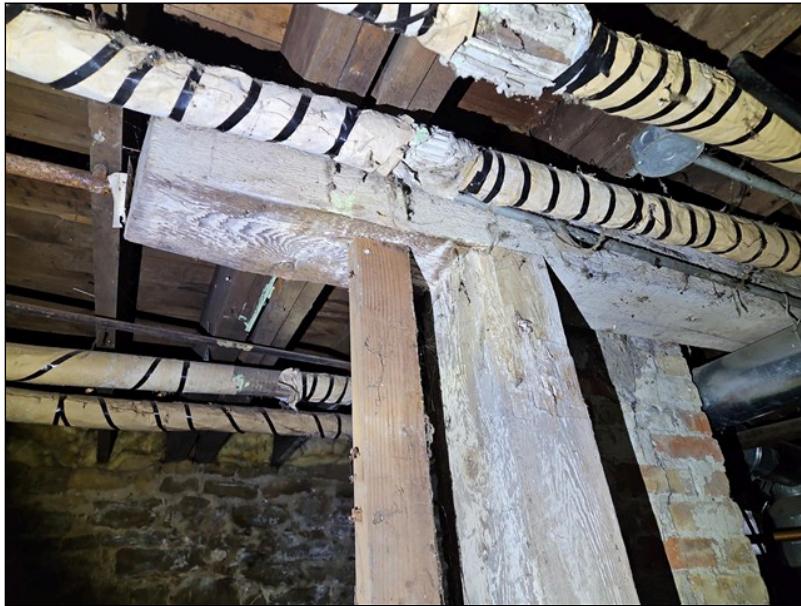
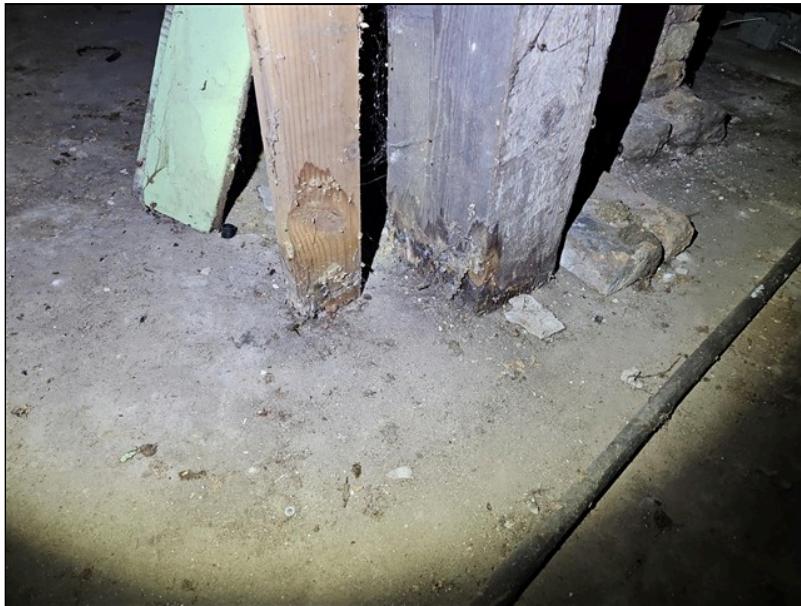
4.2 (1) Defect: Columns were not constructed in a manner or in a condition to adequately support the floor structure.

Recommend further evaluation and repair as necessary by a qualified professional.

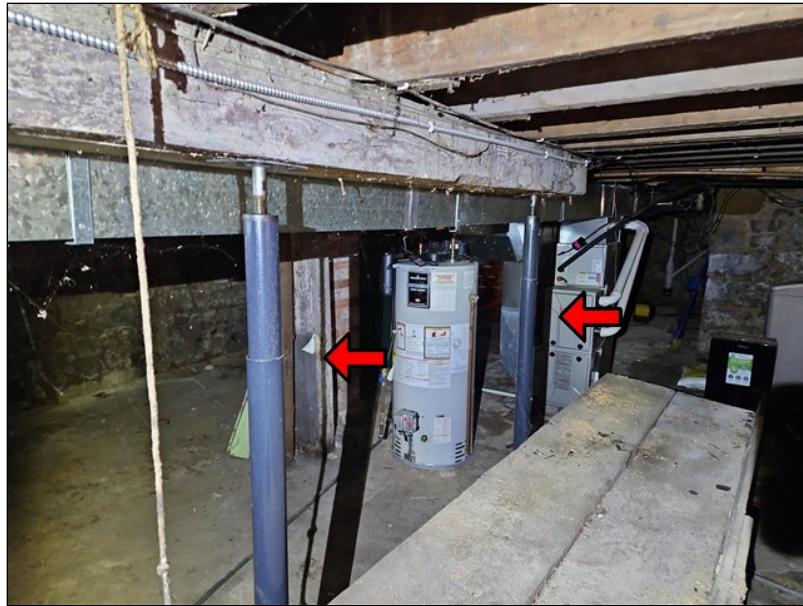
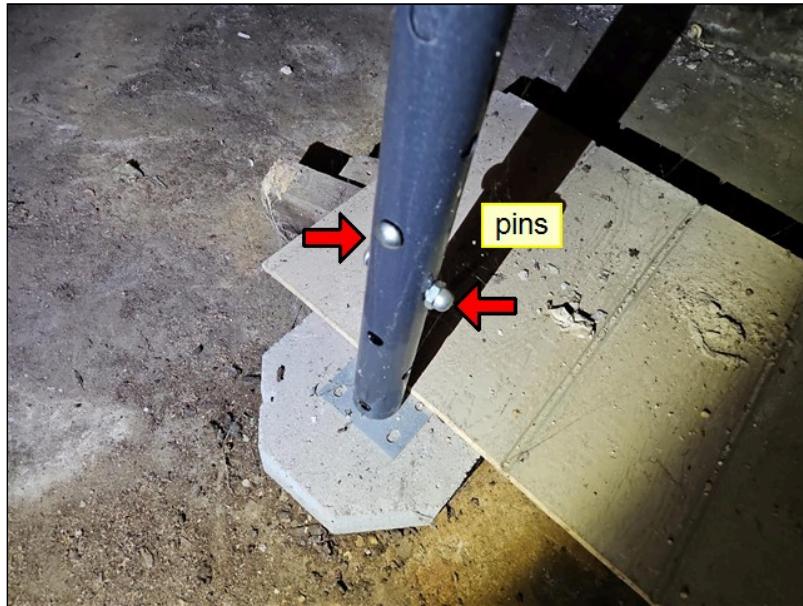
4.2 (2) Defect: Steel screw jacks were installed as columns supporting a main beam. Screw jacks are intended for temporary use only and not approved for permanent support. The pins only are supporting the floor structure.

Recommend further evaluation and repair as necessary by a qualified professional.

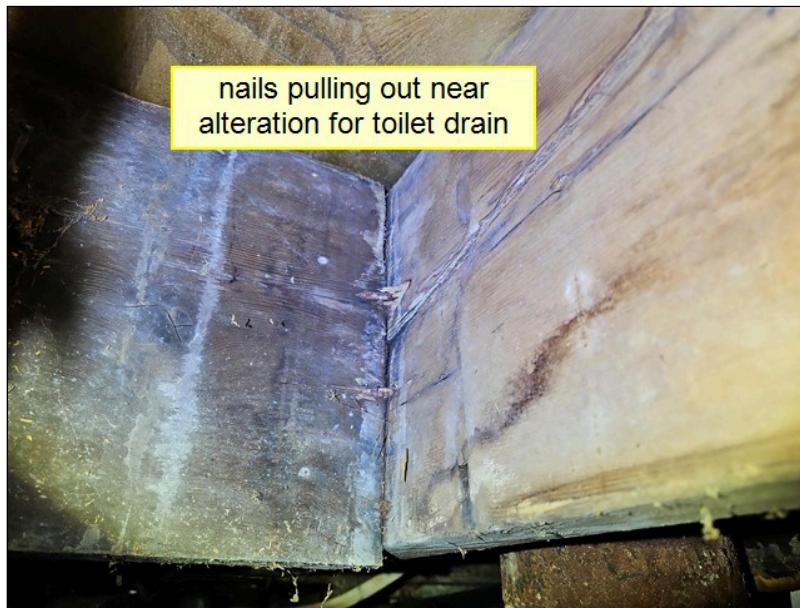
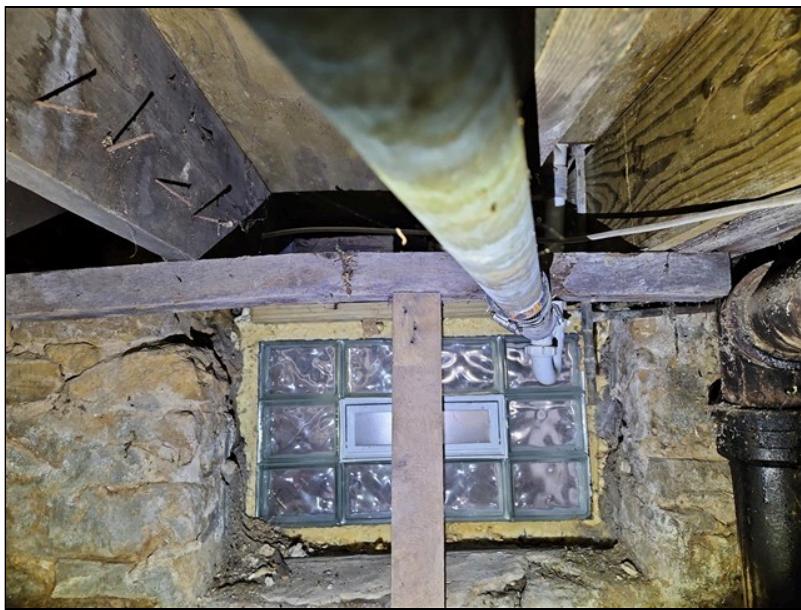
4.3 Defect: Joist(s) were altered in a manner that impact their structural integrity. Beam was sagging.

Recommend further evaluation and repair as necessary by a qualified professional.

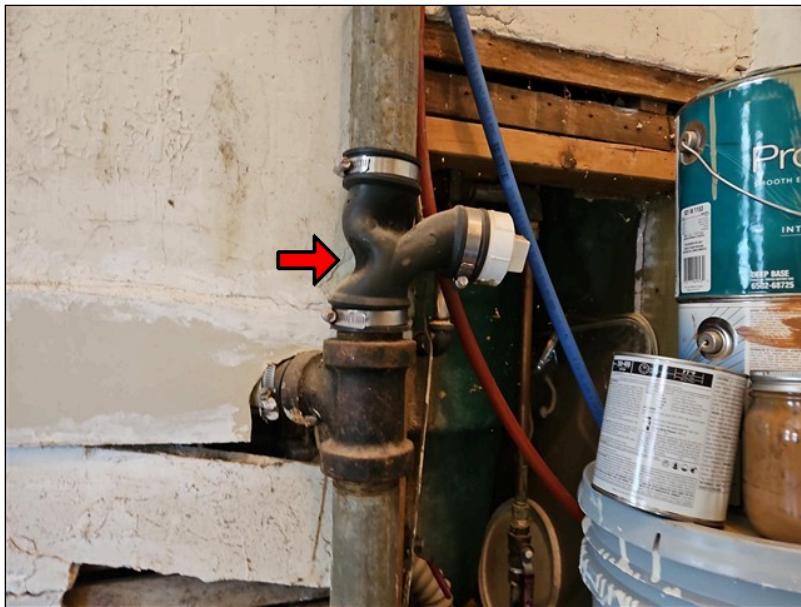
5.0 (2) Repair: Junction was deformed and may prevent proper drainage.

Recommend further evaluation and repair as necessary by licensed plumber.

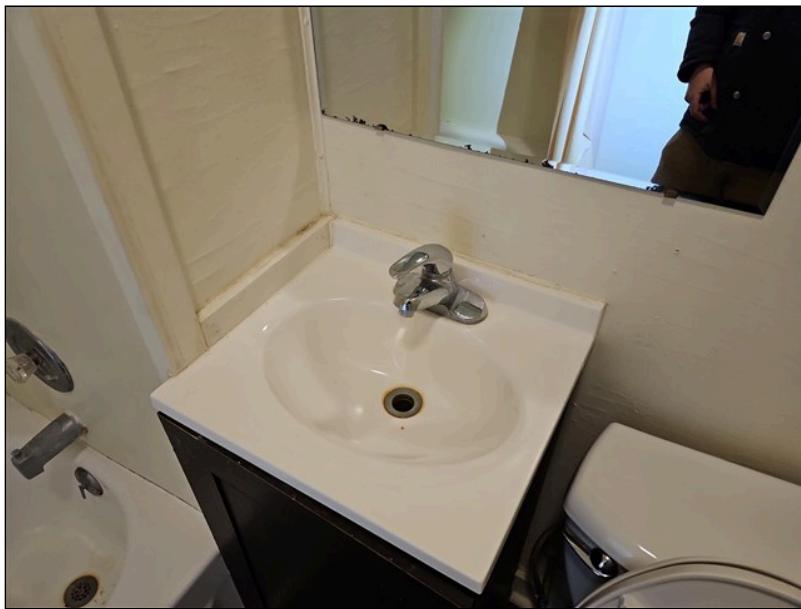
5.0 (4) Repair: In the upper level shared bath, the sink did not have a functional drain stopper. The sink would not hold water.

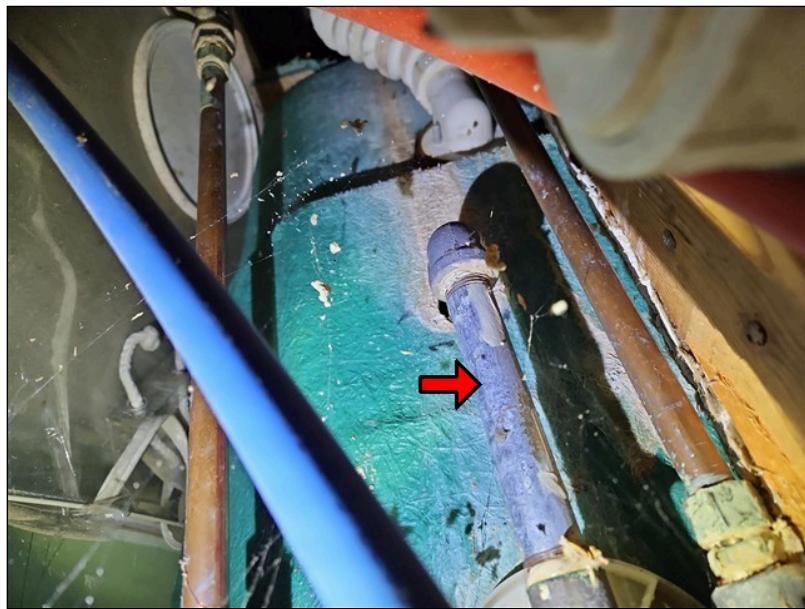
5.1 (2) Monitor: Galvanized steel pipe was in use for the water distribution lines. This style of pipe will rust from the inside out. The accumulation of rust/minerals on the inside of the pipe may restrict water flow. Recommend monitoring condition.

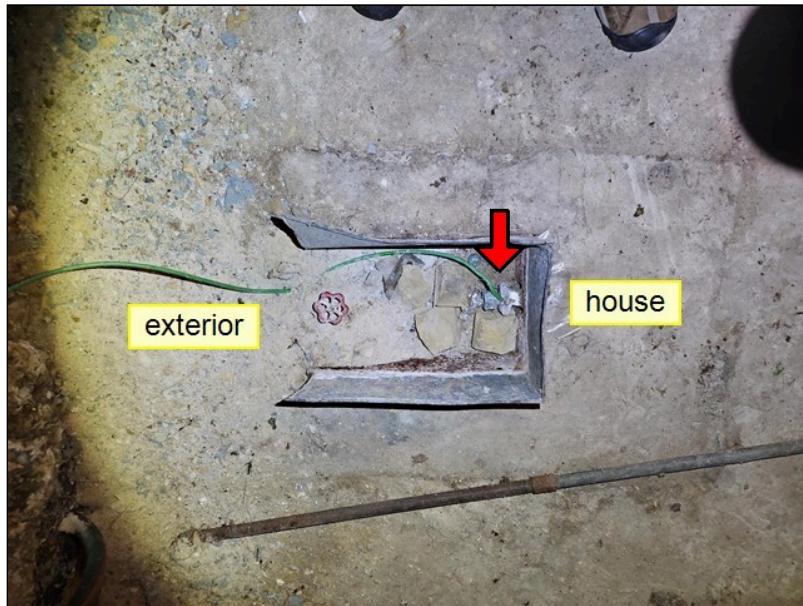
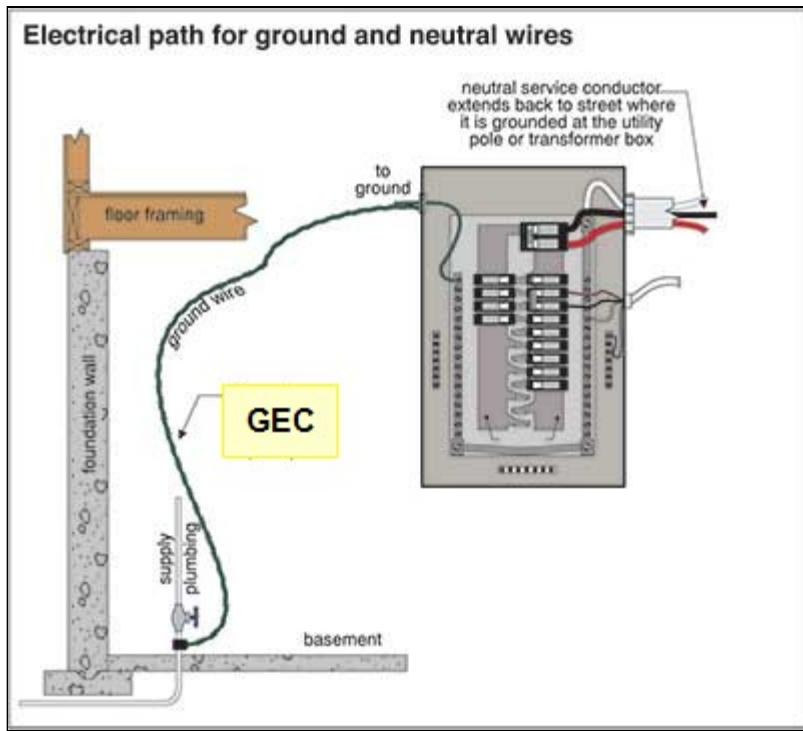
6.2 (2) Defect: A grounding electrode conductor (GEC) is the wire used to connect the grounding system of the home's electrical service to the grounding electrode (rod driven into the ground on the outside, main water supply pipe...).

Recommend connecting the clamp for the GEC to the current main water supply line by a licensed electrician.

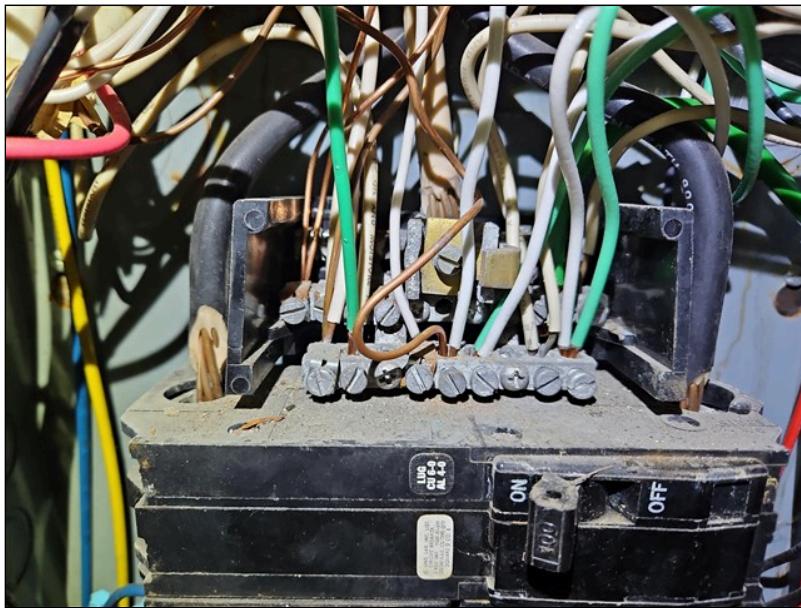
6.3 (1) Repair: Double lugged neutral and grounding conductors and double lugged neutral conductors were installed on the bus bar inside the main panel.

Recommend further evaluation of the panel and repair as necessary by licensed electrician.

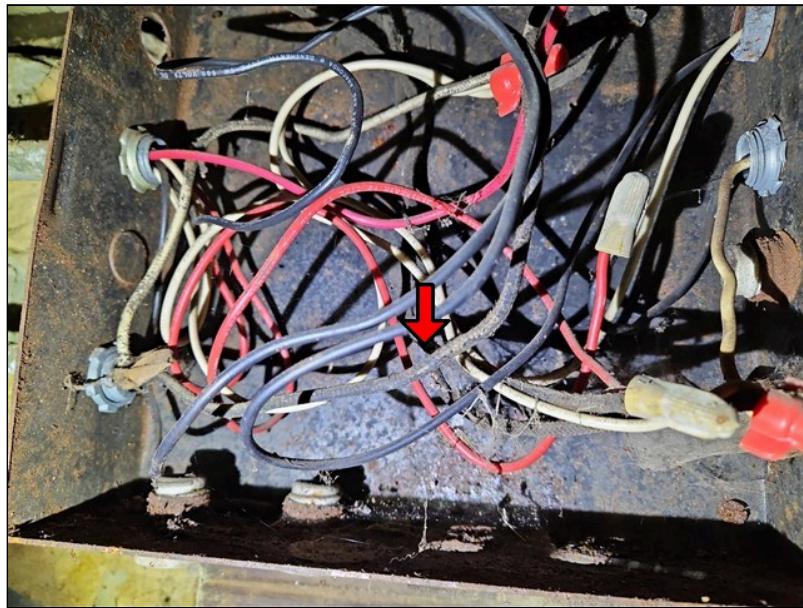
6.3 (2) Further Evaluation: Cloth wiring was present.

Recommend further evaluation by a licensed electrician.

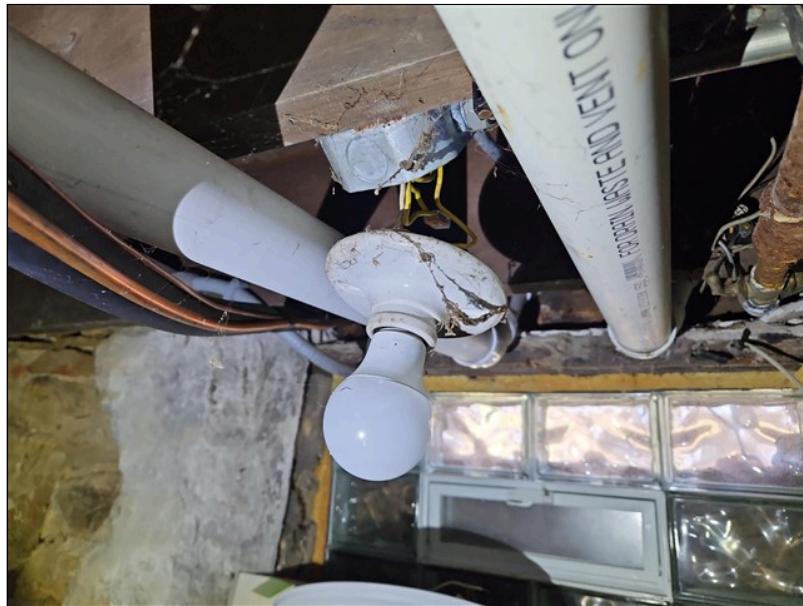
6.4 (1) Defect: Light fixture was not securely attached to the structure in the basement.

Recommend further evaluation and repair by a licensed electrician.

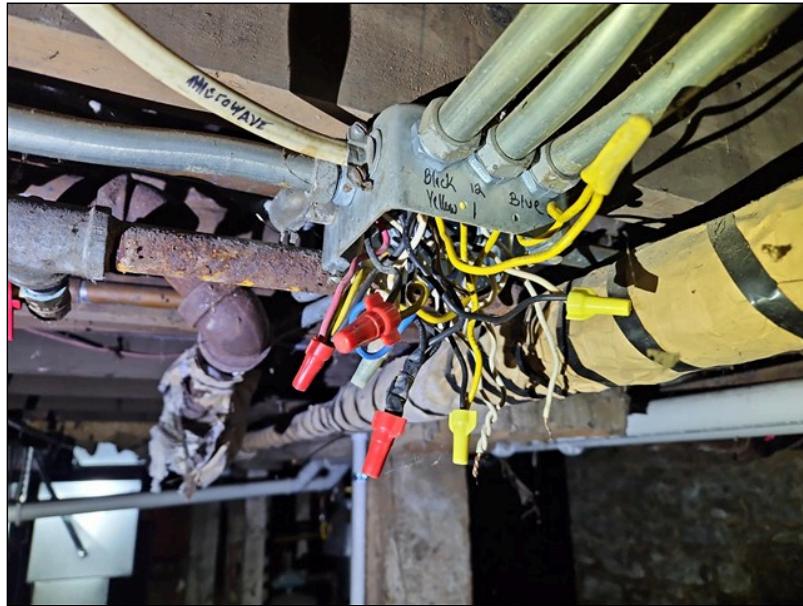
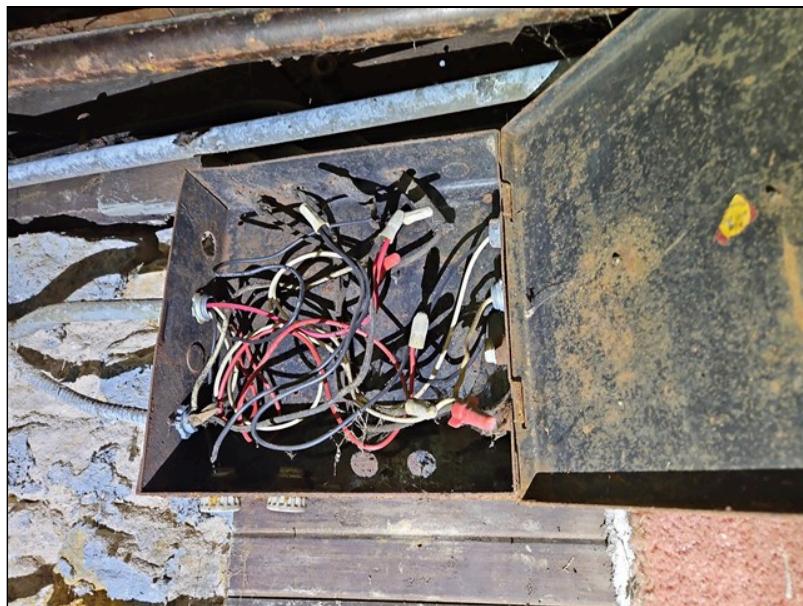
6.4 (2) Defect: Cover plates were missing. This condition leaves energized electrical components exposed to touch and is a shock/electrocution hazard.

Recommend further evaluation and repair as necessary by licensed electrician.

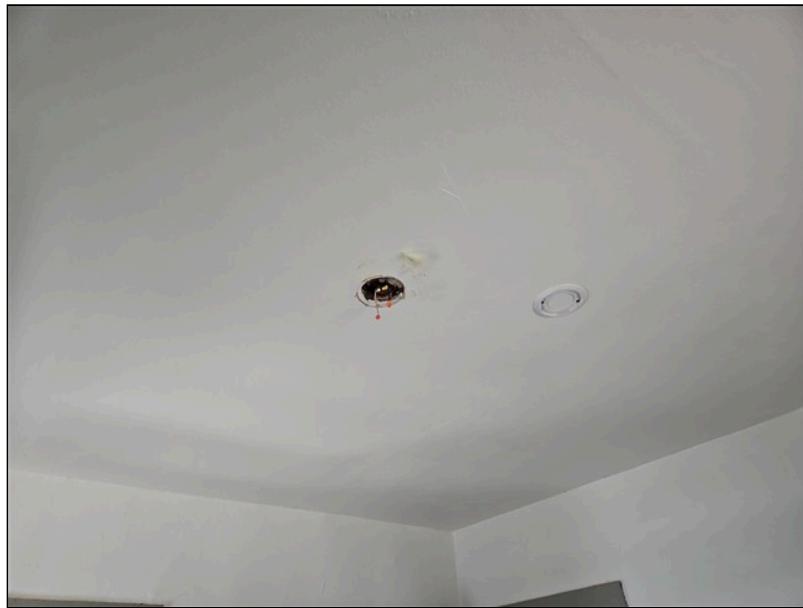
6.4 (3) Repair: There was no light fixture in the kitchen.

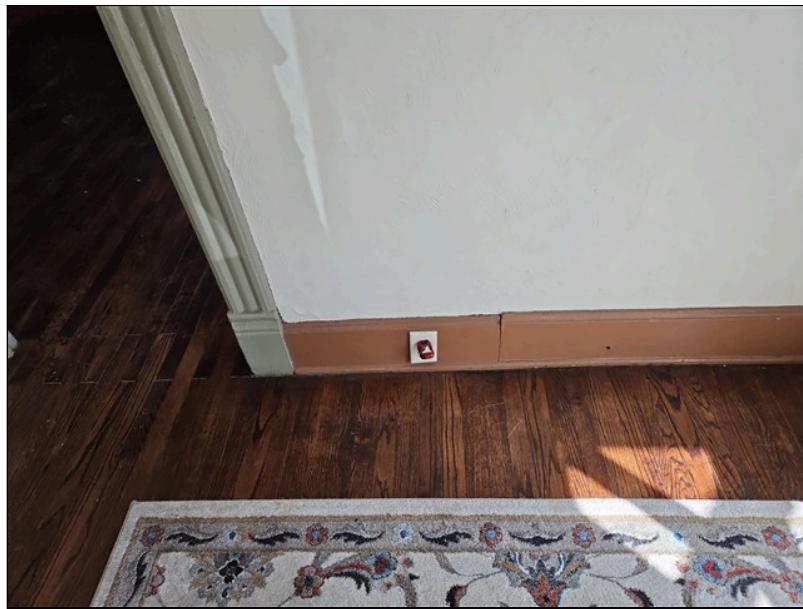
6.4 (4) Defect: Receptacle that was not energized was present in the dining room.

Recommend further evaluation and repair as necessary by a licensed electrician.

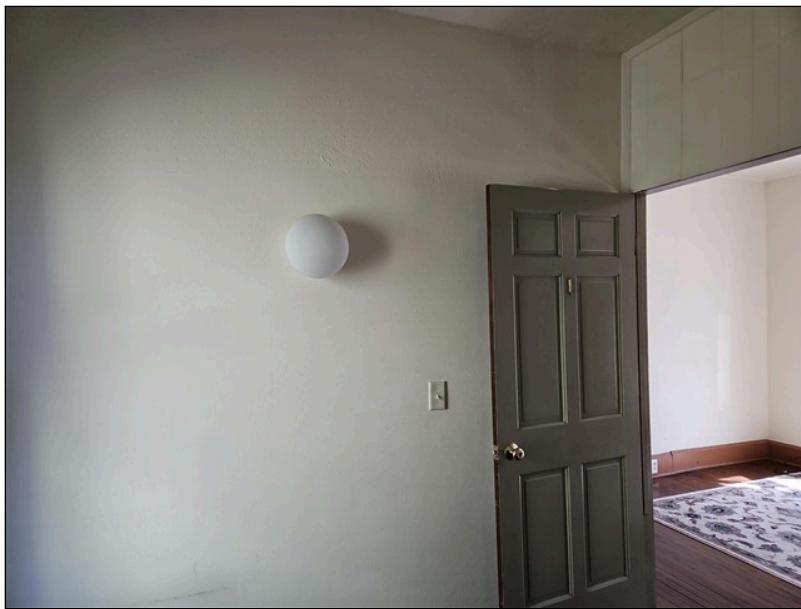
6.4 (5) Further Evaluation: Light fixture(s) did not respond to the switch. The bulb may need to be replaced or there may be a problem with the switch, fixture or wiring. If after the light bulb is replaced, the fixture does not respond to the switch, recommend further evaluation and repair as necessary by licensed electrician.

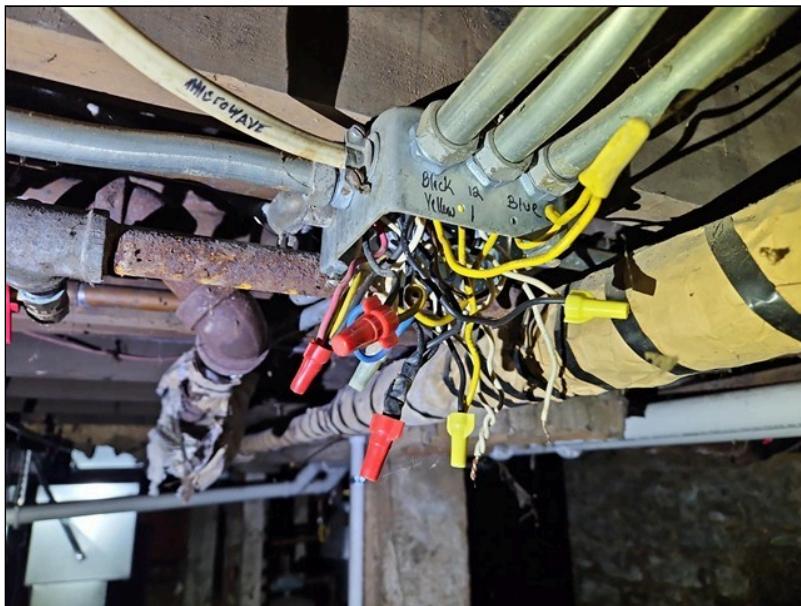
6.4 (6) Further Evaluation: There is a limit to the number of wires that can be in a junction box. An excessive number may cause overheating and can be a fire hazard.

Recommend further evaluation of all junction boxes by licensed electrician.

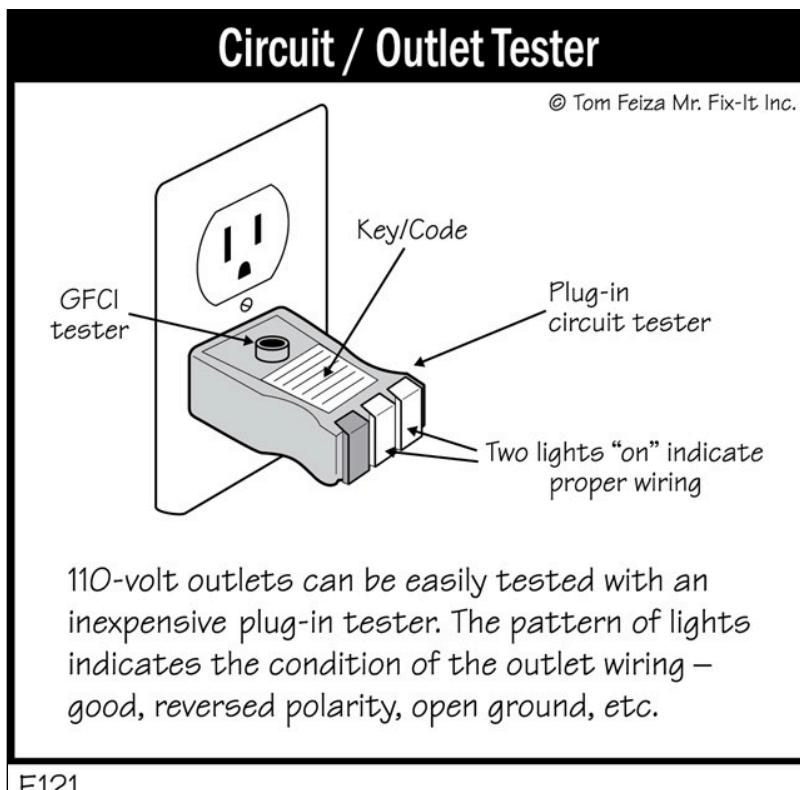
E121

6.5 (1) Defect: Non-grounded, 2-prong electrical receptacles were present. The lack of a grounding conductor will limit the use of items that require a ground. If there is an electrical surge in the home, items not plugged into a grounded receptacle will be damaged. The use of grounded receptacles increases the safety of the electrical system for the occupants of the home.

example of one location

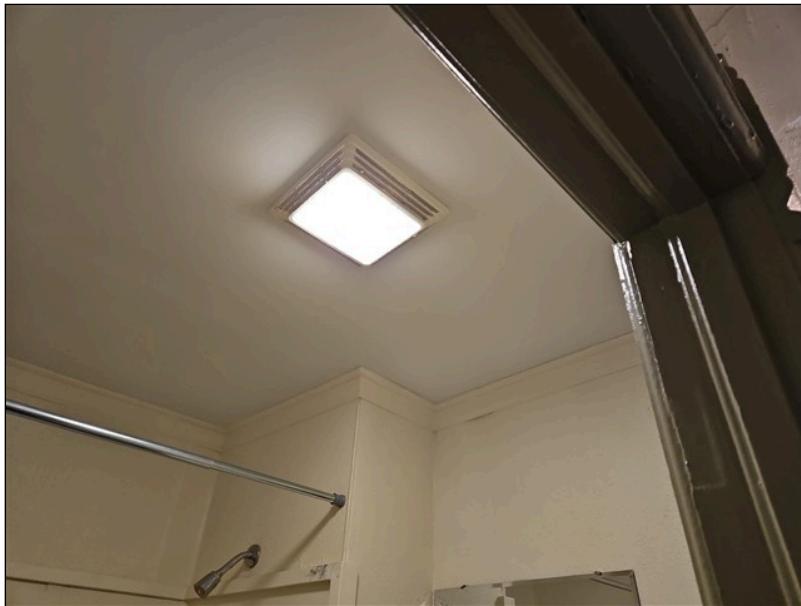
8.3 (1) Repair: A gable vent that would be used to vent the attic space was in use for the bathroom fan.

Recommend further evaluation and repair as necessary by a qualified contractor.

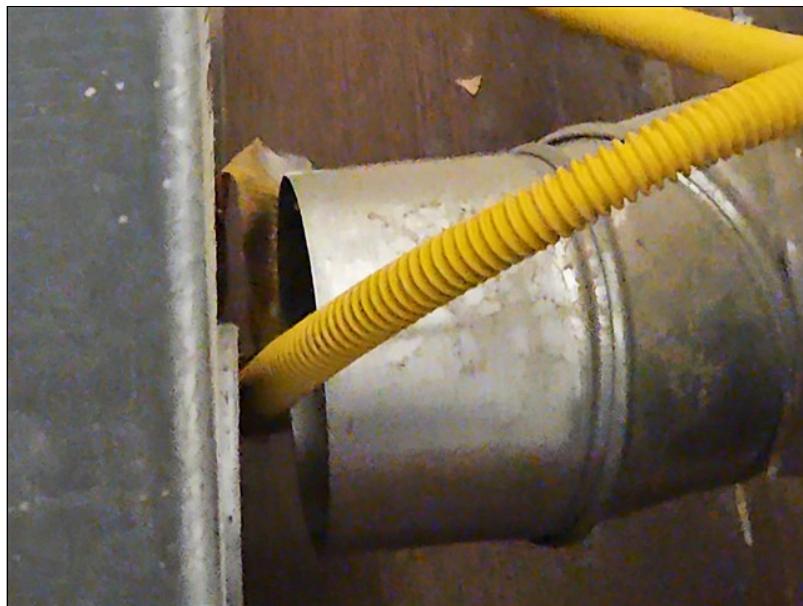
8.3 (2) Repair: The dryer vent was disengaged and not venting to the outside. This can create high levels of humidity in the home and introduce lint into the air.

Recommend further evaluation and repair as necessary by a qualified individual.

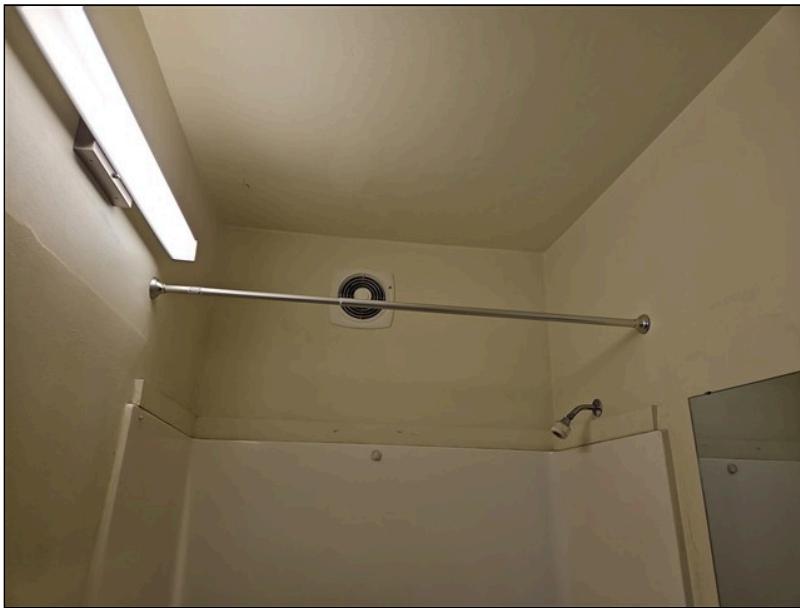
8.3 (3) Defect: Bathroom fan did not turn on with the switch on the wall.

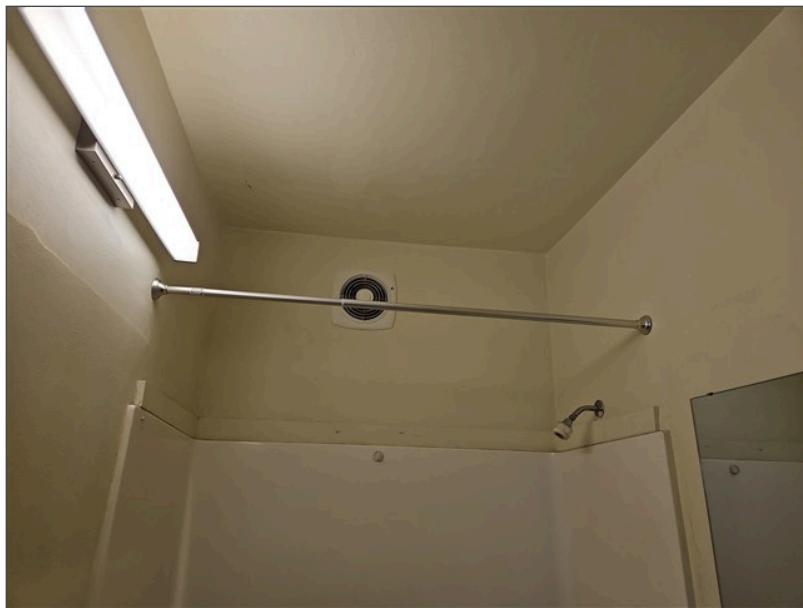
- (3) **Defect:** Bathroom fan did not turn on with the switch on the wall.

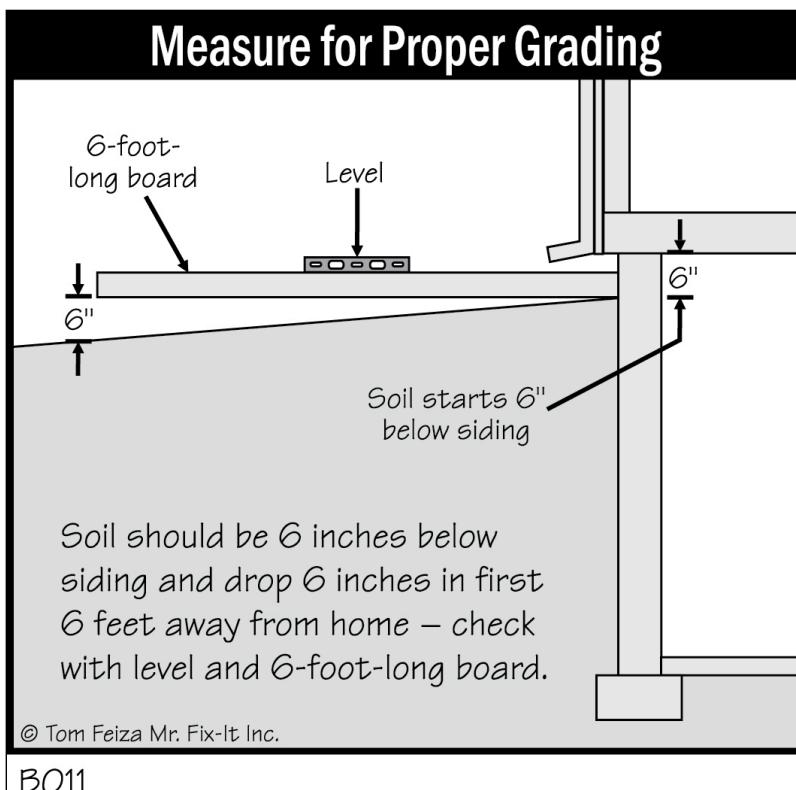
Repair: The landscaping was insufficiently sloped away from the home in multiple locations. This can cause excessively high levels of moisture at the foundation and cause damage to the foundation and moisture intrusion into the basement. Recommend correcting landscape to drain water away from home.
