APPLICATION FOR DEMOLITION OF PRINCIPAL BUILDINGS

City of Madison

Building Inspection Division

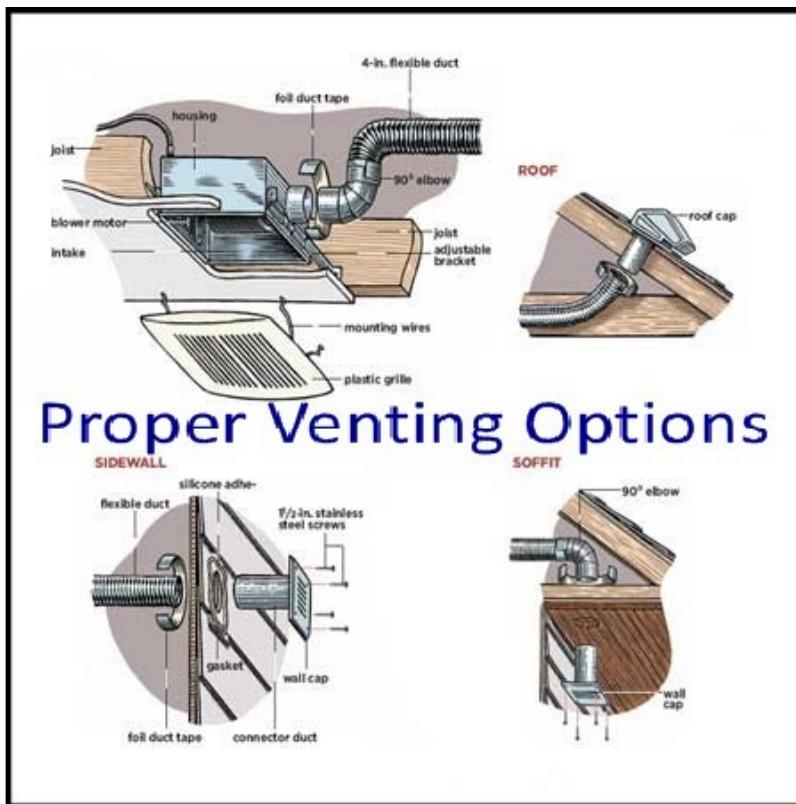
(2) **Repair:** The dryer vent was disengaged and not venting to the outside. This can create high levels of humidity in the home and introduce lint into the air.
