Charles J. Quagliana, AIA
Preservation Architect
5641 Willoughby Road
Mazomanie, WI 53560

May 31st, 2019

Re: Essen Haus Property
506/508, 510, 514/516 & 518 East Wilson Street

The following is my report on the properties at 506/508, 510, 514/516 & 518 East Wilson Street, Madison, Wisconsin.

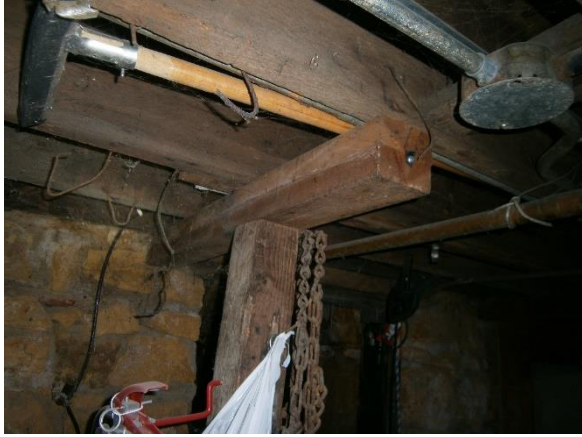
View of added support column and partial beam in basement.

The floor framing consists of 2x12 at 12-inch centers. The framing appeared generally in good condition. There were a couple instances where framing is being “helped” by added supports. The floor framing spans the complete width of the building without an intermediate beam in the basement. A portion of the floor in this building at the rear has been replaced with new 2x12 framing with plywood decking over it. The joist framing bears in masonry wall pockets at ends. It appears that the flooring is placed directly on original joists without a subfloor.

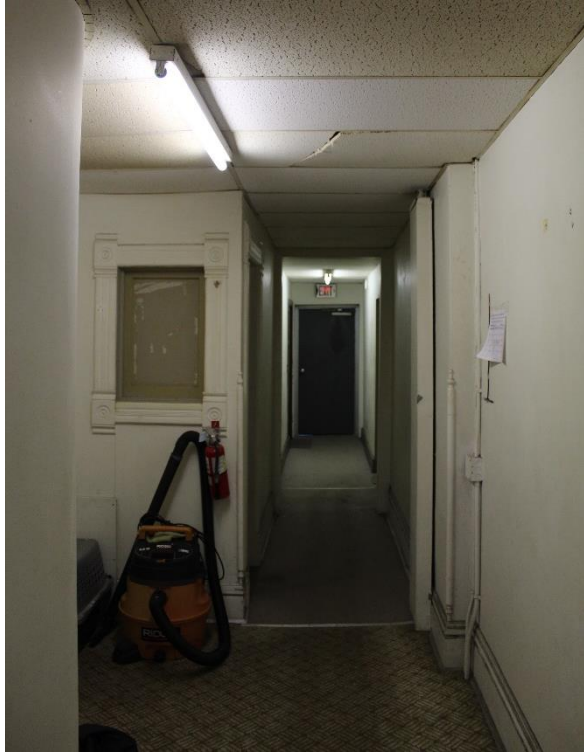
Interior view of second floor corridor 506

The existing second floor rooms are worn, outdated and deteriorated. They are very substandard in terms of condition. The state of condition does warrant a very significant extent of repair and rehabilitation to bring these spaces into contemporary standards.

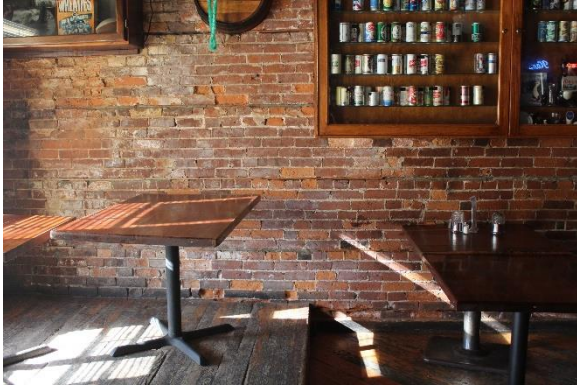
Interior view of west wall of 506

The west wall of 506 is an exterior wall. This common brick wall is absorbing water from the adjacent ground and this is causing deterioration of the brick. Freeze thaw action is delaminating the face of the brick and water intrusion is facilitating efflorescence. Efflorescence is a fine, white, powdery deposit of water-soluble salts left on the surface of masonry as the water evaporates.

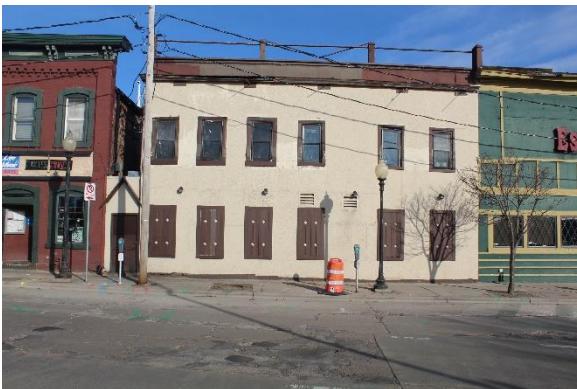
Front façade view of 510

The original façade has been partially removed at the first floor and both first and second floor exterior covered with stucco. The current second floor window locations are approximate to original locations but have been scaled down from original size. All original character defining features have been removed from the front façade.

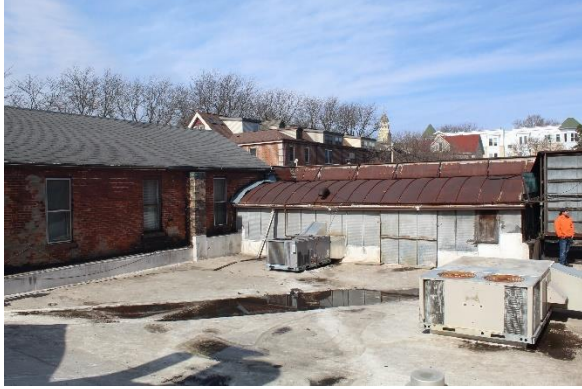
The roof area of 510 is a complex layout of original roofs and added components. The roof of the two-story area is a three-tab fiberglass asphalt shingles on a gable configuration. Over the one-story area is a white PVC roof system. A metal barrel-vaulted roof Trachte building sits on top of this roof at the rear of the building. The rear screen wall is made of metal structural supports and galvanized metal panels.

Roof of 510

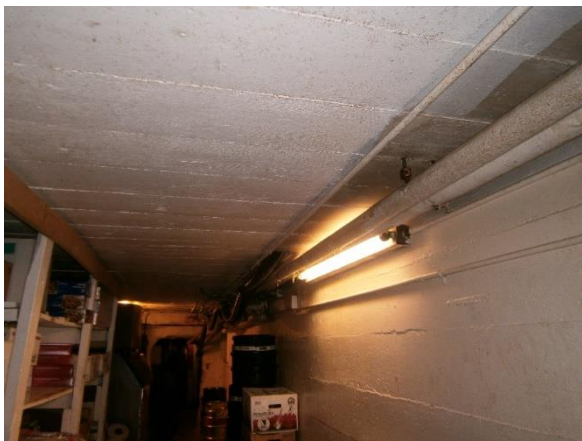
Concrete floor slab of first floor viewed from basement

The foundations are a combination of concrete and rubble limestone. The walls were covered with stored materials, equipment and utilities and not completely accessible to view. Portions that were visible had some holes punched through but otherwise appeared to be in fair condition. The headroom is low in the space, in this building; the foundation walls are only approximately 6 feet tall. Some standing water was noted in this area.

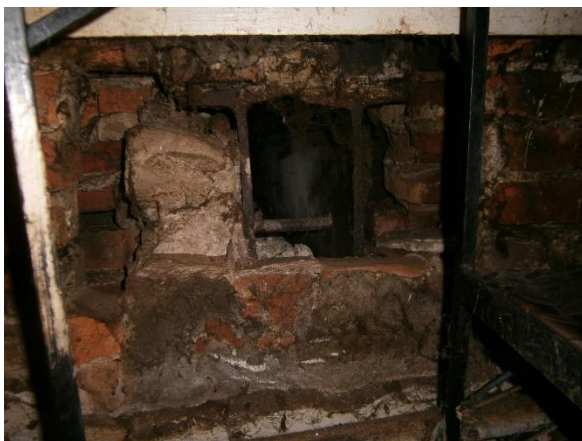
Steel beams supporting portions of second floor.

The second-floor framing was concealed. The back walls of the front structures hidden behind the front parapet appear to be supported with black painted steel. A beam end was present in the stairway to the second floor southwest structure.

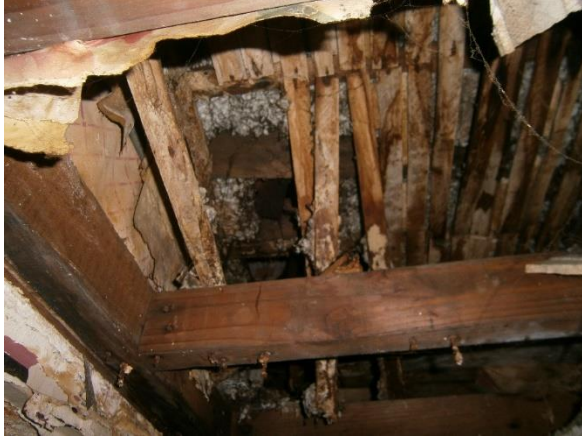
View of deteriorated ceilings and roof in second floor of 510.

The roof at the second floor was concealed from view. A portion of the roof over the front portion is visible from the office areas on the second floor. The nature of the roof framing is difficult to see due to the presence of insulation and other materials. The framing is believed to be 2x framing. This framing is likely to have some water damaged areas since the ceilings and other areas have significant water damage.

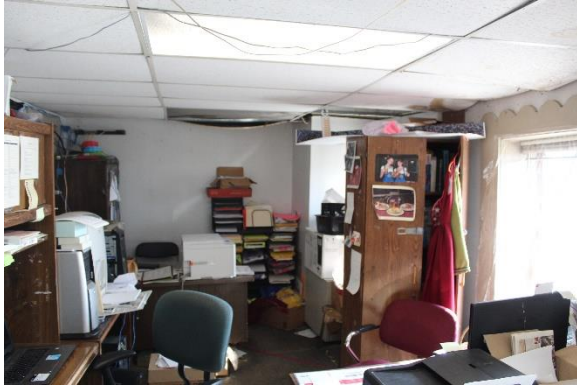
View of second floor office space 510

The second floor currently houses a labyrinth of office space, storage and dressing rooms for the restaurant below. The corridor is extremely narrow as are the office doors. Access is by way of a spiral stair from the restaurant first floor kitchen or by access from the adjacent building second floor level. Many remodeling projects have altered this second floor.

There are multiple layers of ceilings and a wide variety of materials and finishes from different eras. All are in poor condition with deterioration and water damage apparent. No original fabric was identified.

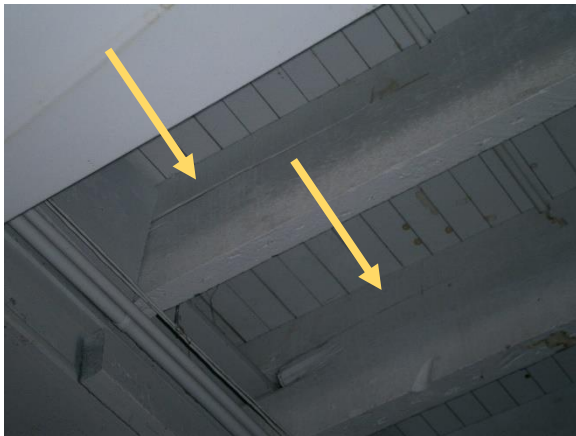
View of cracked joists at intersection with steel beam.

In the case of 516 Wilson Street, second floor joists were coped to allow them to rest on a steel angle riveted to the side of the girder. Approximately 1/3 to half of the joists are cracked and failing. This room is only occasionally occupied and is used mostly for storage.

There is a significant concern that the stored materials present on second floor could be enough to cause portions or all the floor in this building section to collapse onto the first floor dining space below.

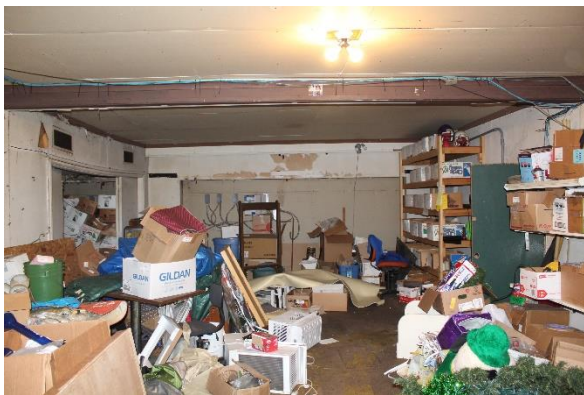
Second floor of 514/516

The second floor is presently used as storage and has been extensively altered over time. It once housed apartments, small business and later a dinner theatre. There are multiple layers of materials and finishes from numerous remodeling campaigns. Many of the rooms are piled high with stored artifacts, collectables and general supplies.

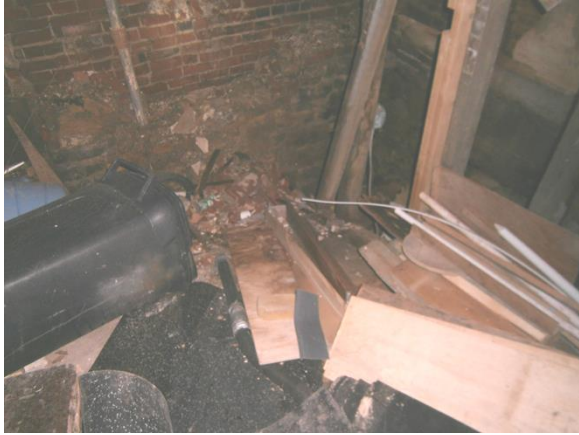
The framing at first floor (not accessible by guests) at the back of the building has collapsed. We suspect that the framing at the front of the building is on the same course if not corrected with intervention soon.

View of collapsed first floor at rear of building.

The first-floor framing at the back half of the building has collapsed into the basement. The progression of the floor collapse has damaged the brick masonry rear wall of the building. In addition, without the attachment to a first floor, the exterior masonry walls of the back of the building are now much taller and slender, taken with the damage, portions may be unstable. The front portion of the building's first floor are showing similar signs of deterioration.

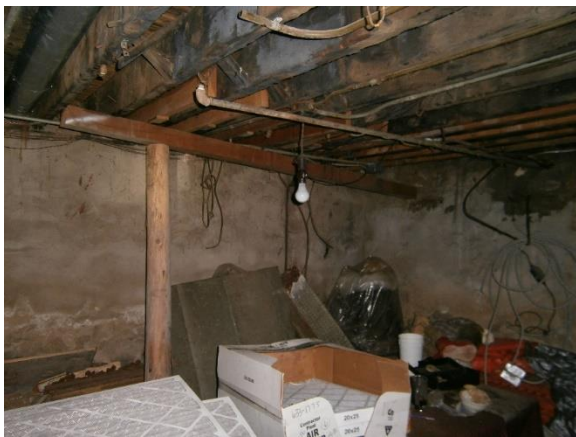
The framing of the floor is 2x12 at 16" centers. The framing had several additional supports likely added to resupport the framing at damaged bearing ends at the masonry walls. The space is very dirty, wet and some concealed deterioration in floor joists is likely.
