WARNER PARK CUNETTE REPLACEMENT

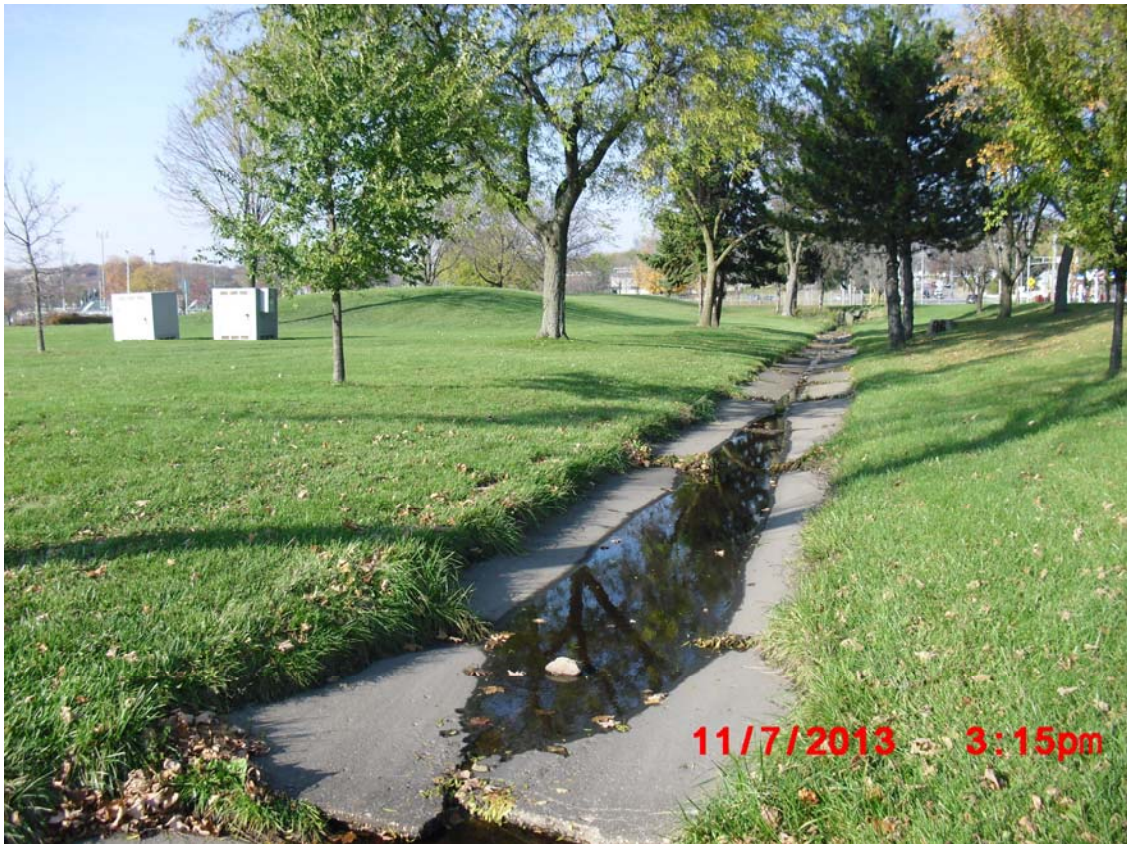
Photograph 2: Existing condition of the channel. This photo was taken along Sherman Avenue.

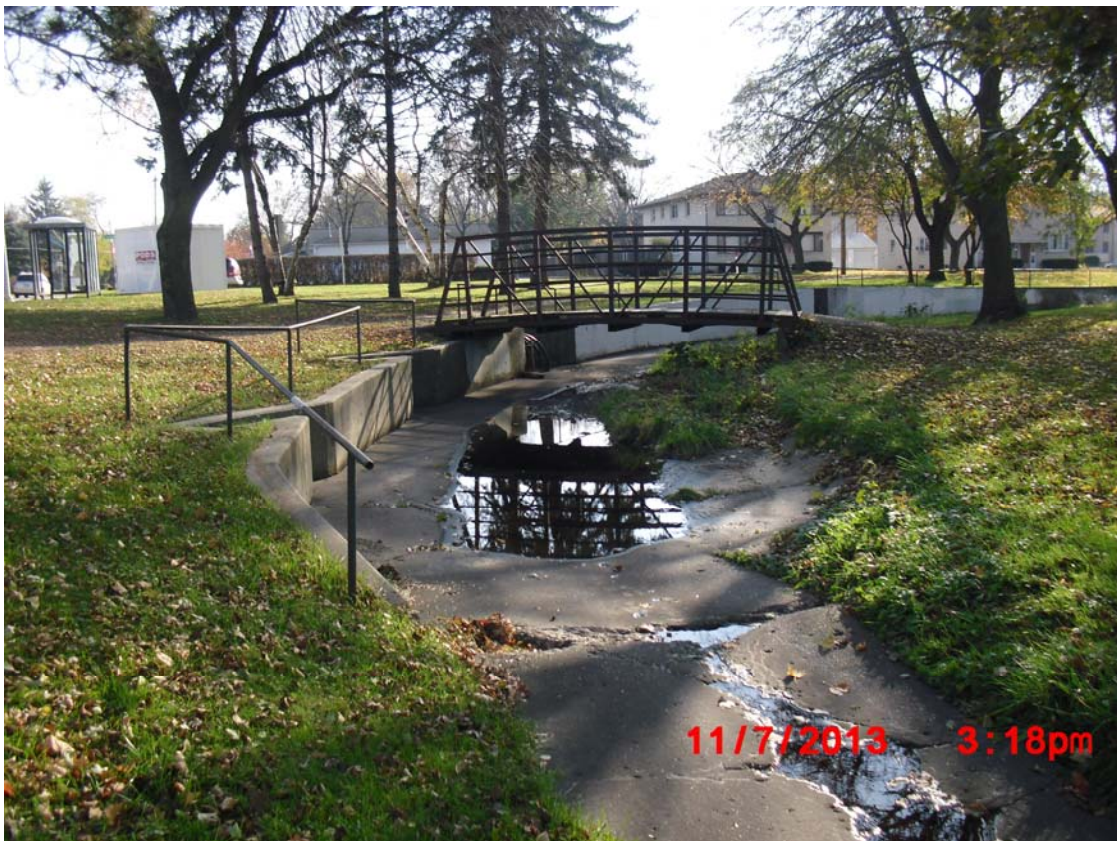
Photograph 3: Existing conditions of the channel. Degraded concrete and sediment deposition are both visible in this photo, which was taken at the 90 degree turn at Sherman Avenue and Trailway intersection.

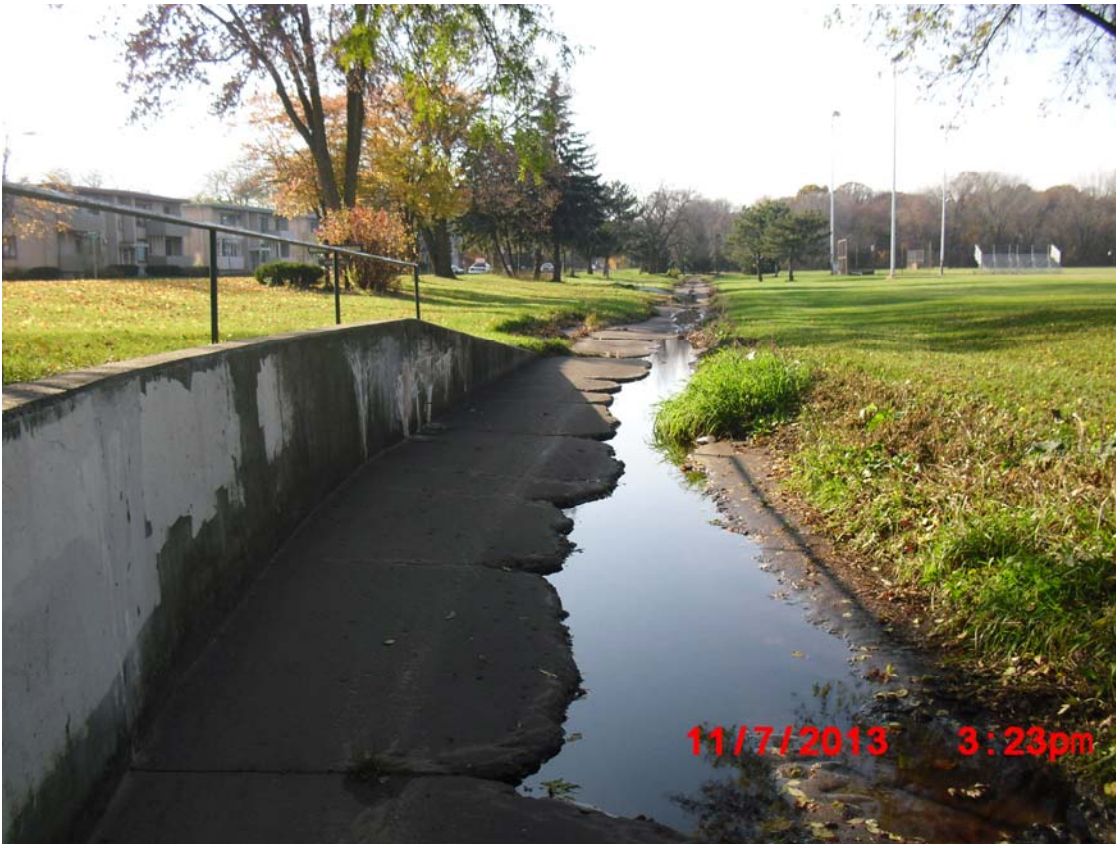
Photograph 4: Existing conditions of the channel. The concrete channel shows significant degradation along Trailsway.

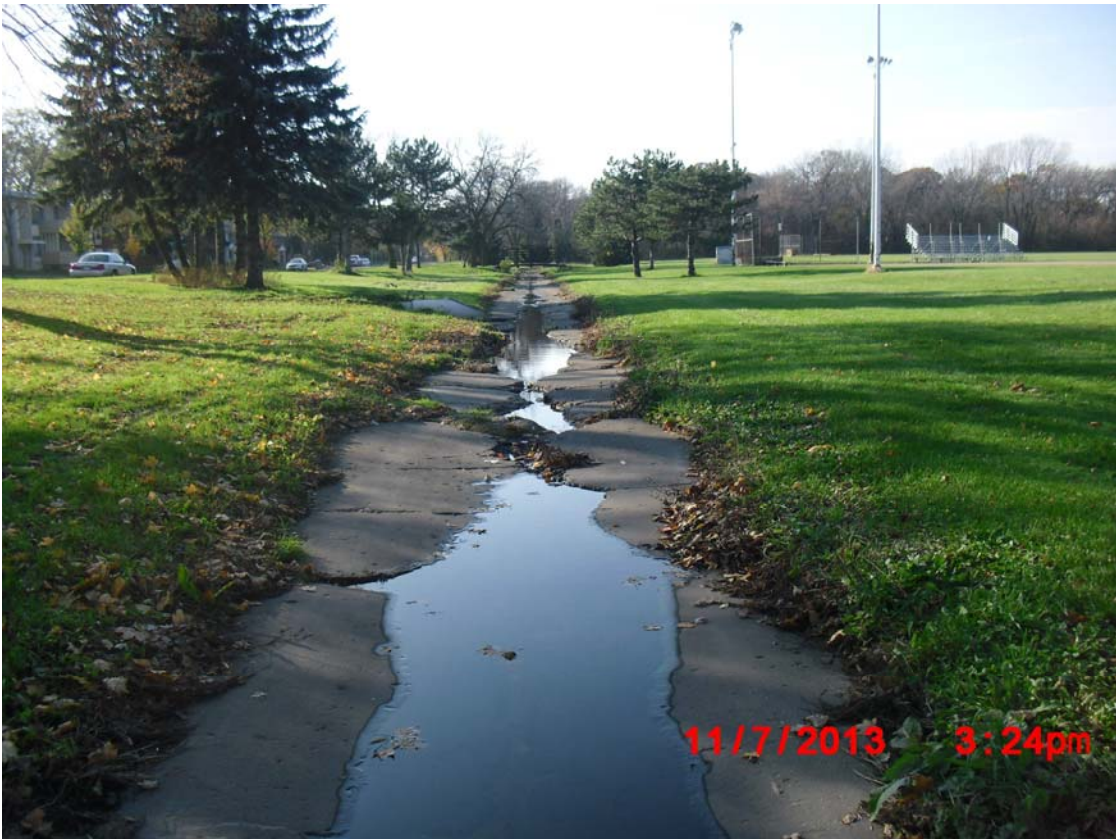
Photograph 5: Existing conditions of the channel. The concrete channel shows significant degradation along Trailsway. Cunette replacement will extend to the wooded area in the background of the photo.
