Photos

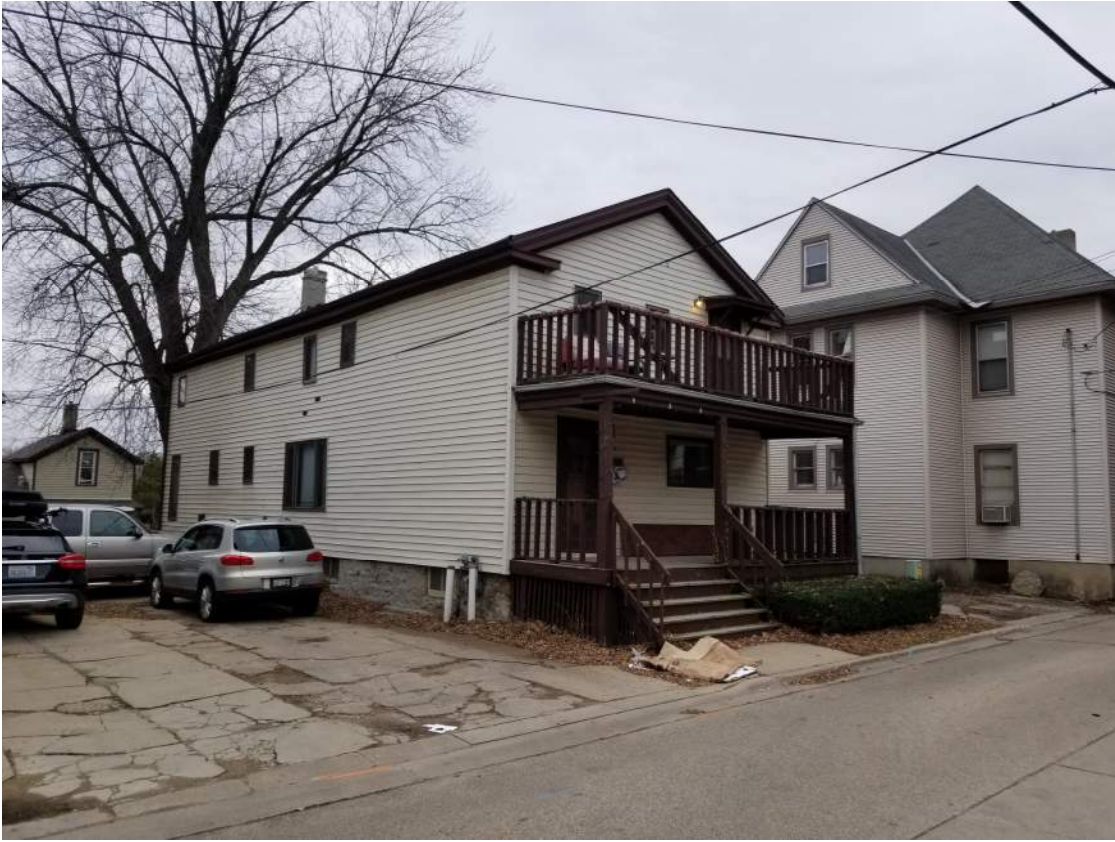
Figure 1. North east corner of the building.

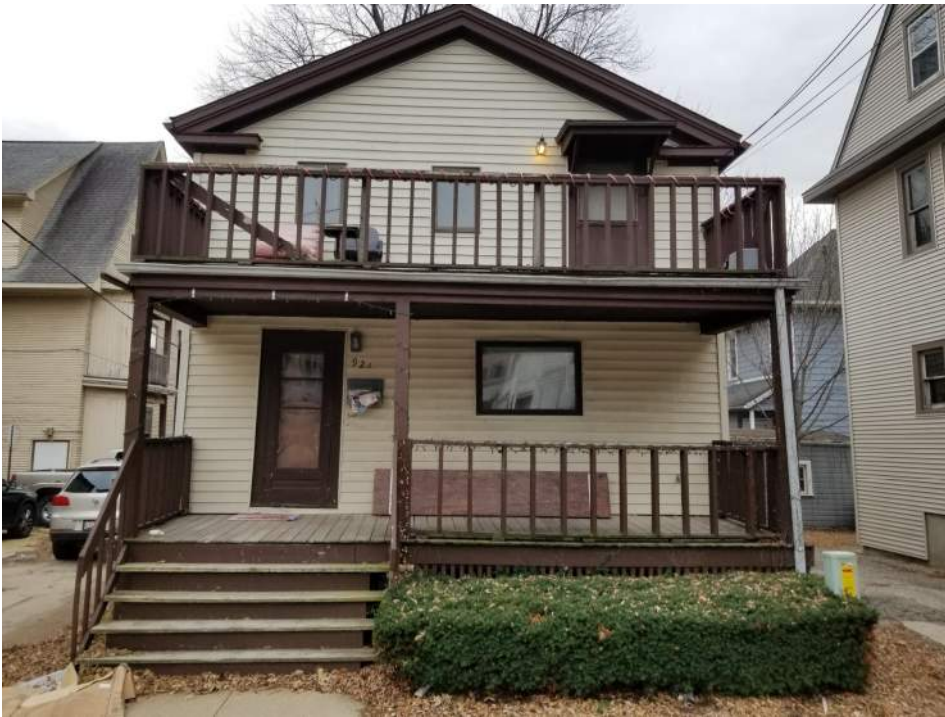
Figure 2. North elevation of 923 Clymer. Original materials have been replaced or covered with vinyl siding and windows infilled. The porch has been rebuilt.

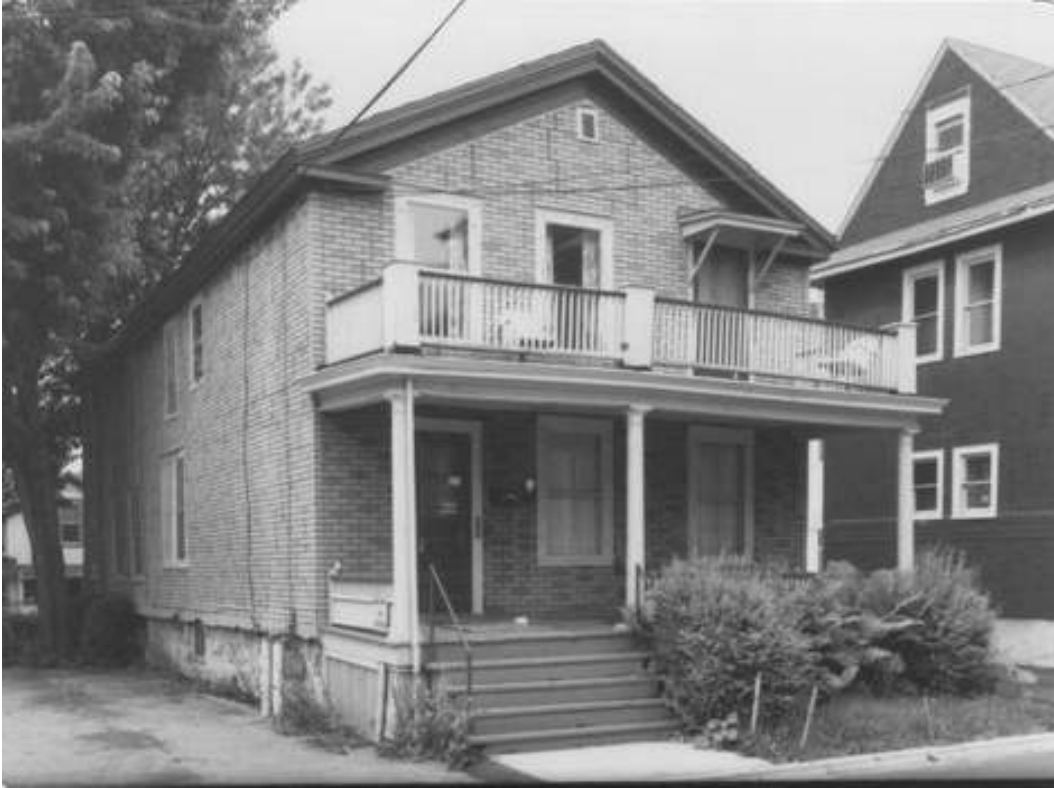
Figure 3. Historic image of 923 Clymer from AHI website.

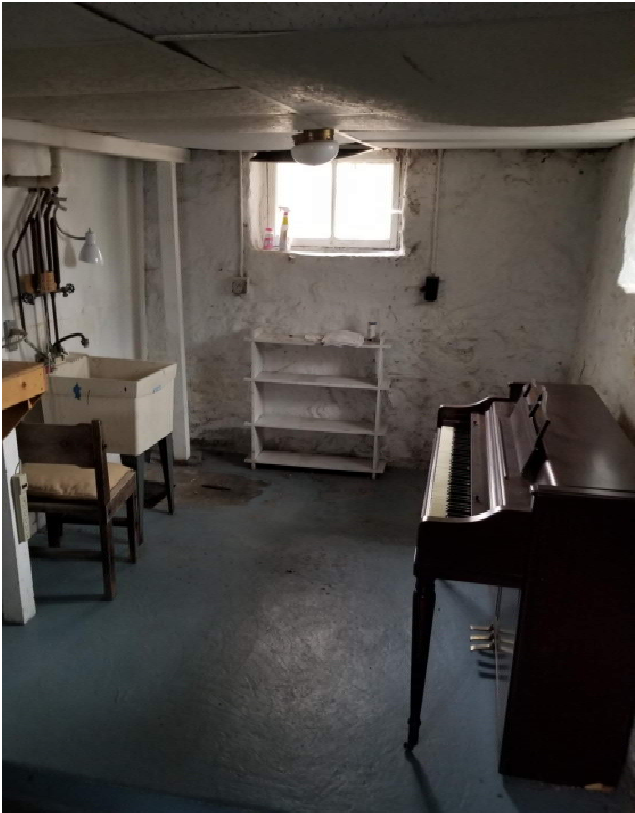
Figure 4. Basement Utility Room.

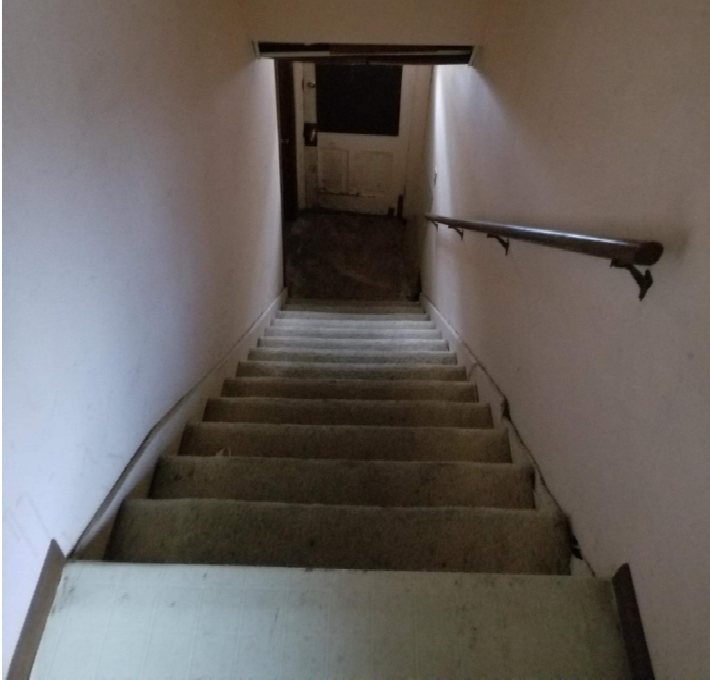
Figure 5. Basement access stairs.

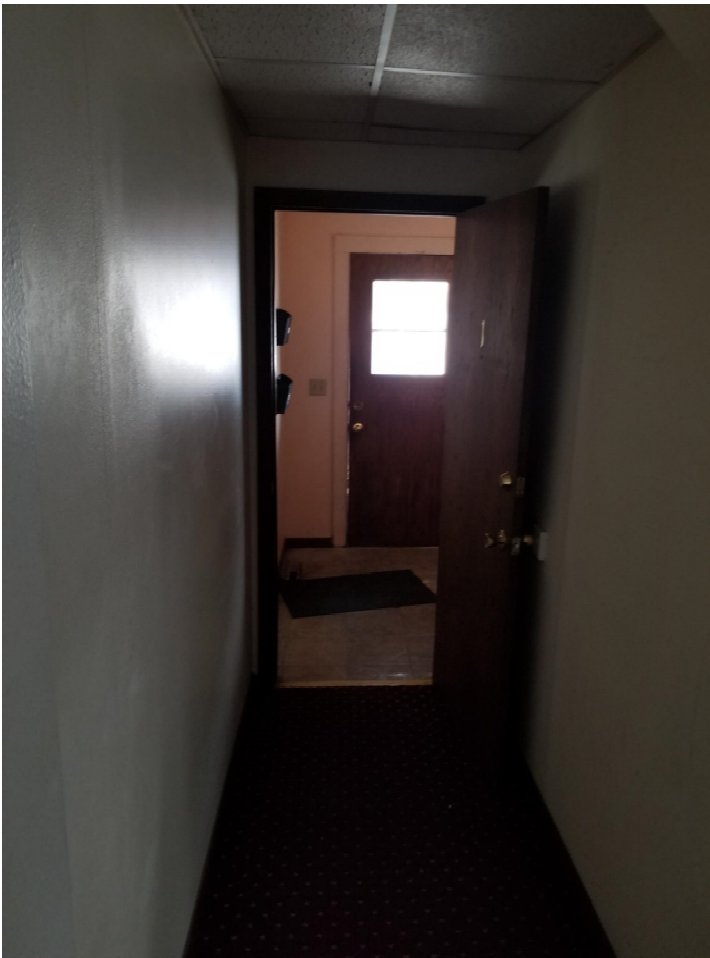
Figure 6. North entrance door.

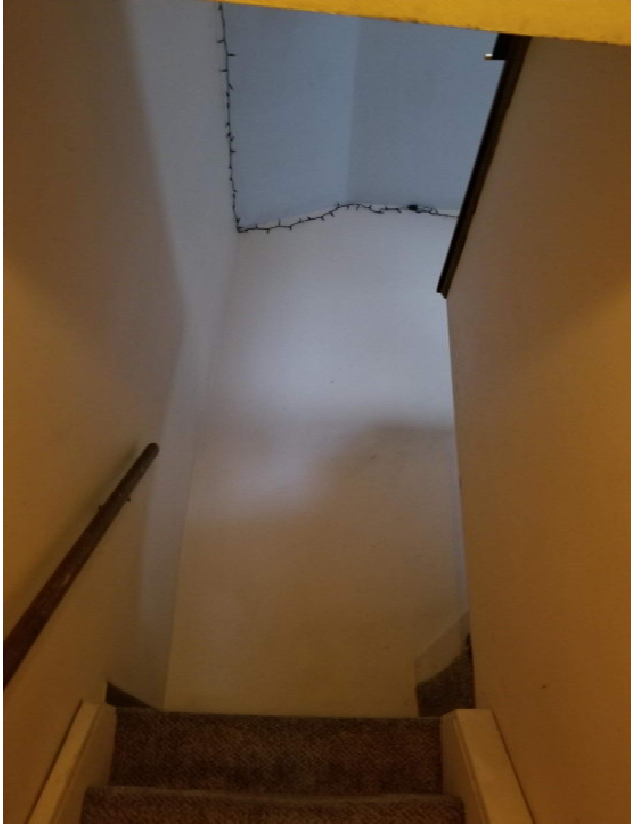
Figure 7. Primary stair to second floor.

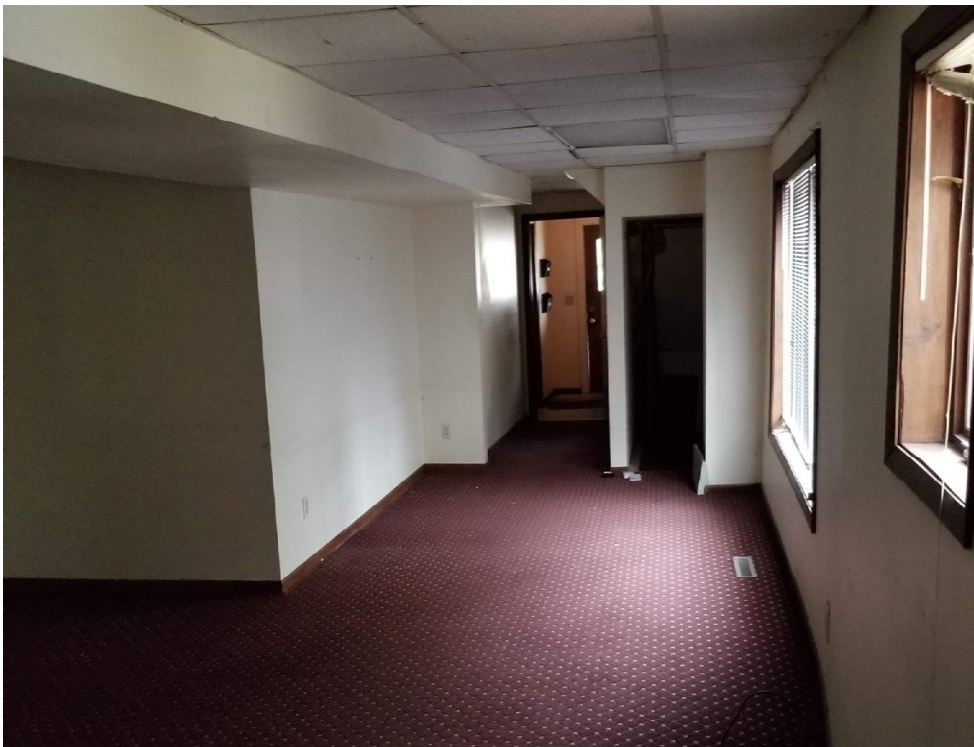
Figure 8. First floor living room.

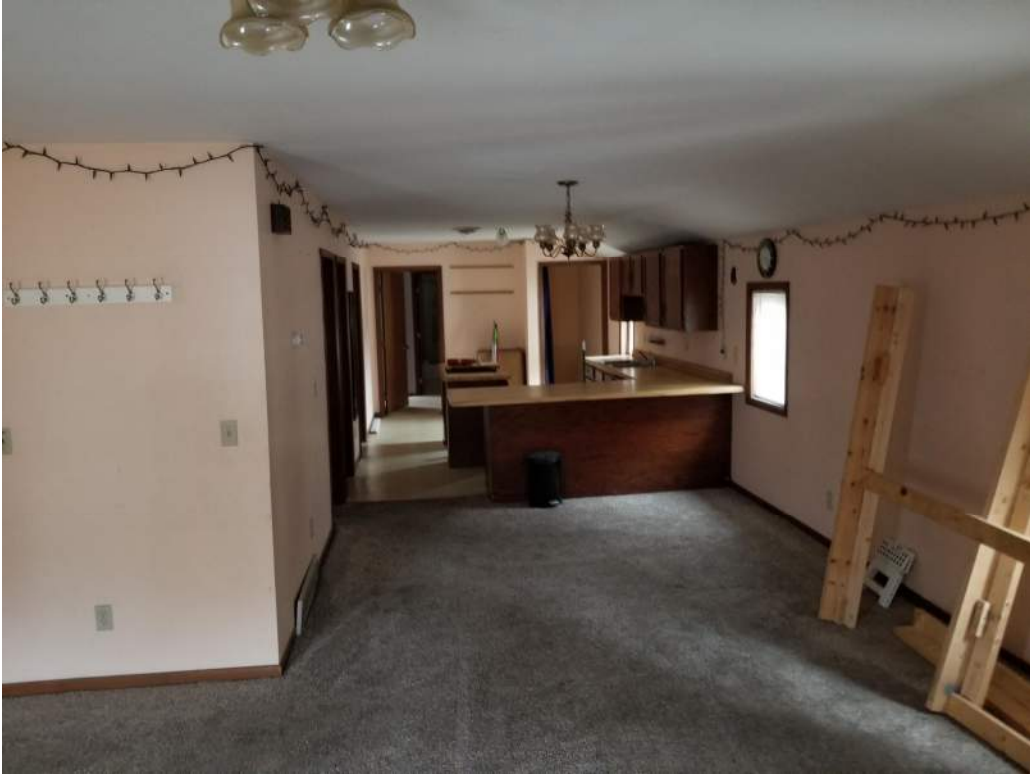
Figure 9. Second floor living room and kitchen.

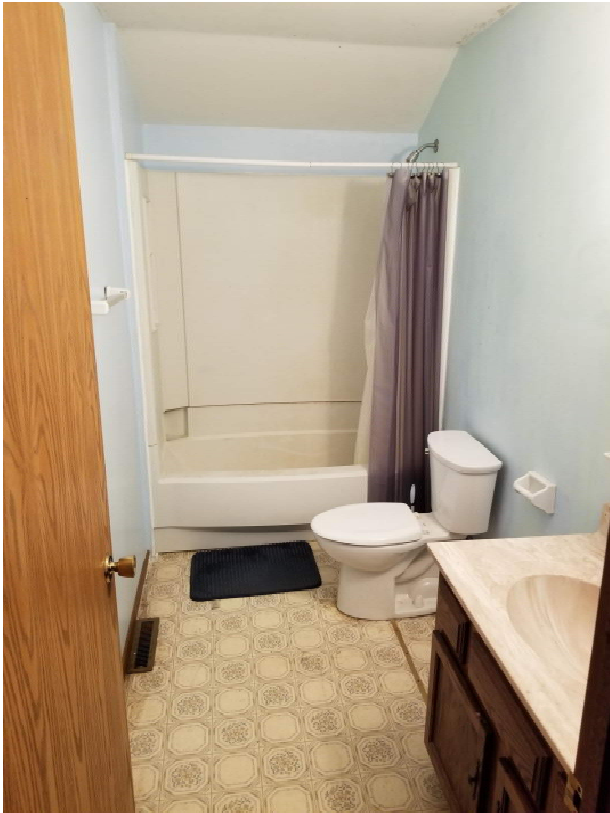
Figure 10. Second floor bathroom.
