EXISTING BUILDING REVIEW

125 State Street

Name: Madison Fire Engine House No. 2/ Castle & Doyle Building

125 State Street – Architectural Review

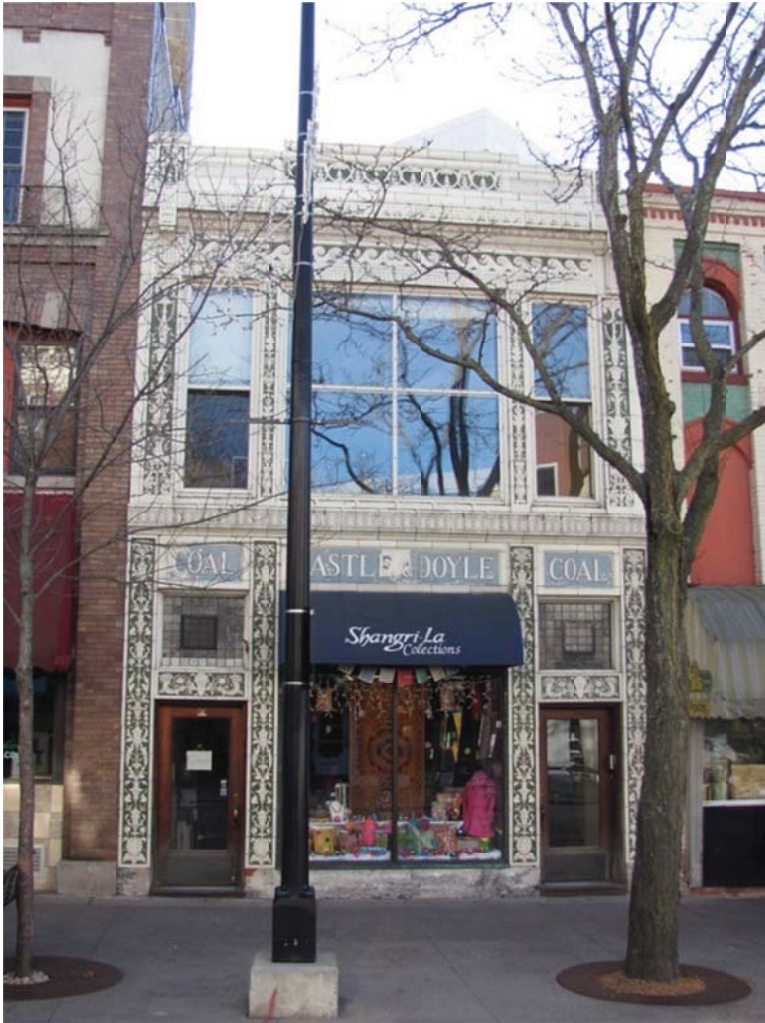
The State Street facade is clad with white and green glazed terra cotta masonry (Figure 1). At the base of the facade, the masonry veneer appears to have been altered after 1921; this area includes marbled cast stone panels as well as exposed common brick masonry (Figure 2). The terra cotta masonry is generally in very good condition, with a few individual damaged units, including one cracked window sill, one unit with a hole, one spalled unit, and one displaced unit above the first floor storefront (Figure 3 through Figure 5). At two locations, terra cotta coping units have been removed and set on the roof surface. Mortar joints in the terra cotta masonry are generally eroded. One inspection opening through the interior finishes at the second floor had been created by others prior to the site visit. At this opening, the back side of two terra cotta units are visible, as well as two wythes of brick backup masonry. One steel tie wire connecting the terra cotta to the brick backup was observed at this opening.

Figure 1. Overall view of the State Street facade.

Appropriate repairs to the terra cotta State Street facade may include repair of individual damaged units; re-setting of coping units, perhaps to include a through-wall flashing integrated with the roof membrane and counterflashing; and repointing of mortar joints. At grade, a new masonry veneer may be desirable to

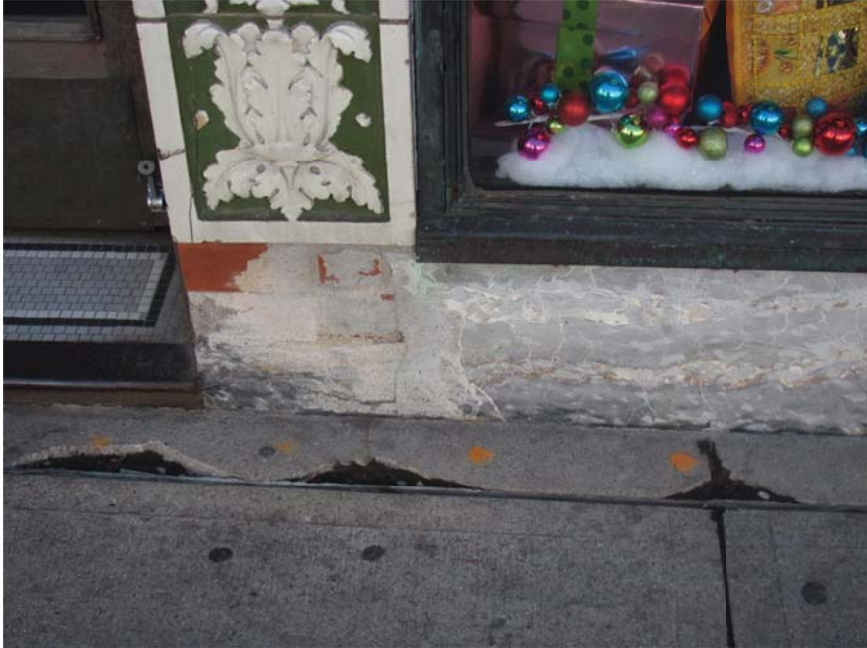
Figure 2. Marbleized cast stone and brick masonry at the base of the State Street facade.

replace the existing mixture of common brick and faux marble cladding with a material more compatible with the historic 1921 design of the facade.

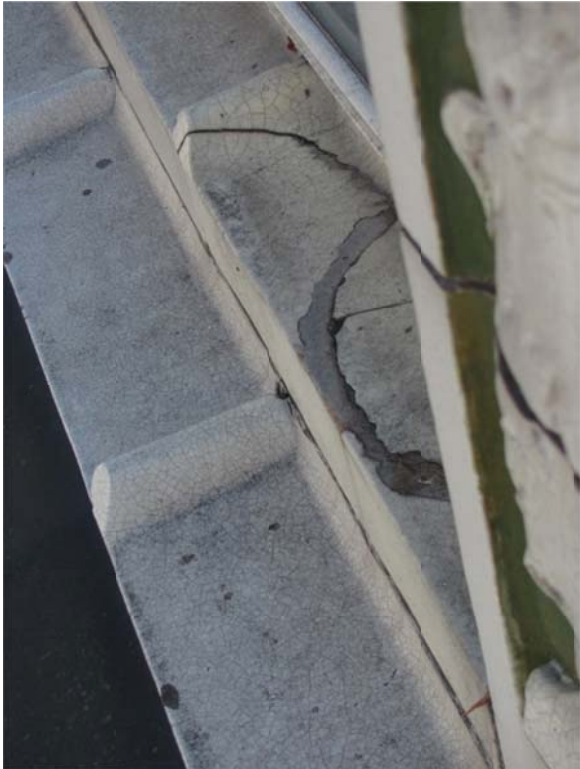
Figure 3. One cracked terra cotta window sill.

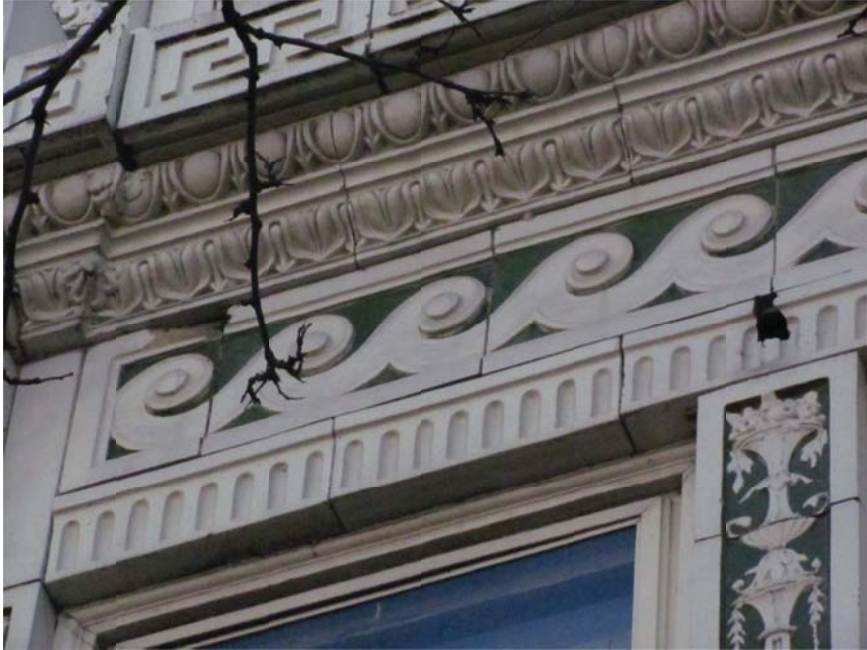
Figure 4. One unit with a hole and one spalled unit.

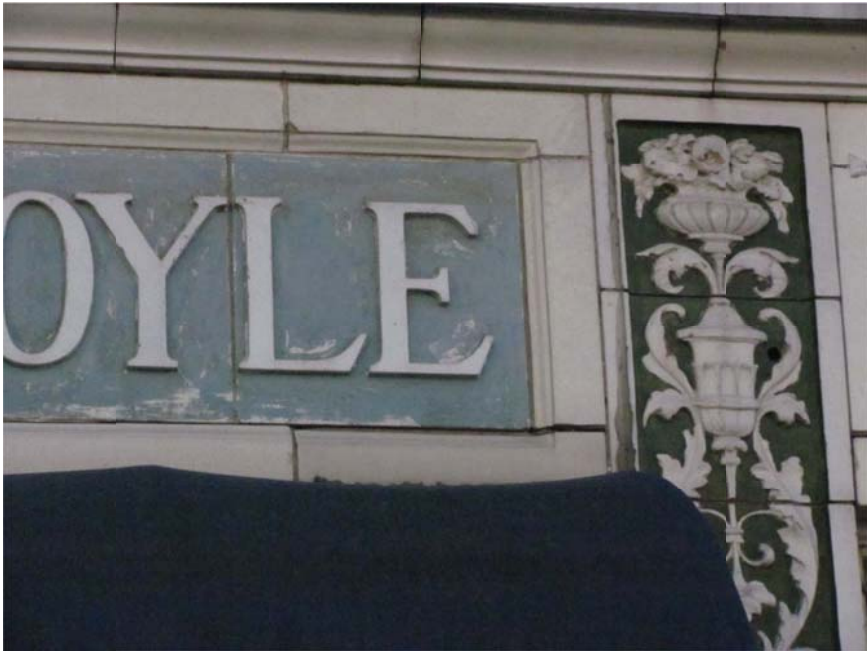
Figure 5. One displaced unit above the first floor storefront.

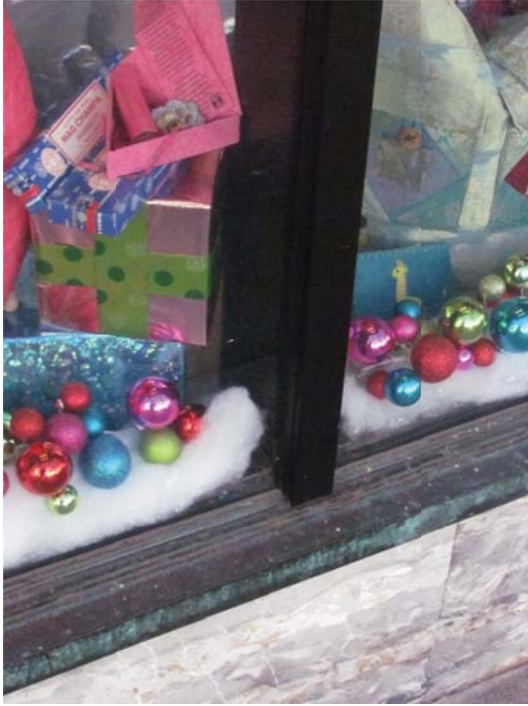
The central storefront at the first floor is a bronze-framed window. Previously, the storefront appears to have been a single large glass unit; an aluminum mullion has been added at the center of the opening, dividing it into two panes (Figure 6). Above the storefront and entrance doors are prism glass transoms incorporating operable sash. The first floor exterior entrance doors are stained and varnished wood stile-and-rail doors with brass hardware and ceramic tile thresholds. The doors are intact, although the finish is worn.

Figure 6. An aluminum mullion has been added at the center of the storefront at the first floor of the State Street facade.

At the first floor storefront on State Street, consideration could be given to removing the added center mullion and installing a single pane of glass to match the 1921 design. The exterior entrance doors should be refinished to match the historic appearance. At the second floor, the center window on the State Street facade should be replaced with a new window system matching the 1921 design.

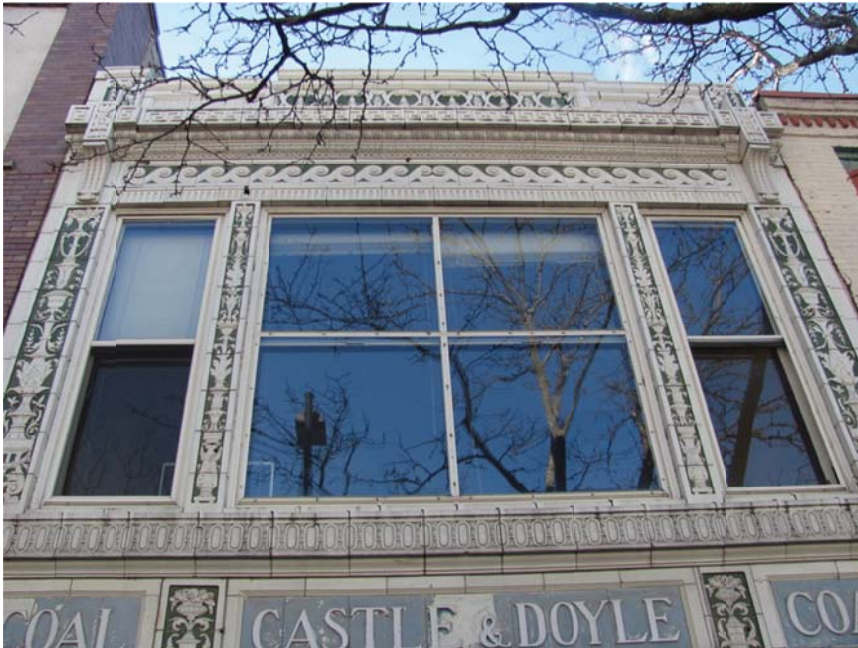
The central second floor window is a non-original assembly consisting of painted 2x wood framing supporting four panes of glass and a separate, similarly divided storm window (Figure 7). The smaller windows at either side are one-over-one wood double hung windows dating to the 1921 renovation. These windows are covered by exterior aluminum triple track storm windows, although some of the storm

Figure 7. The central second floor window is a non-original assembly consisting of painted 2x wood framing supporting four panes of glass and a separate, similarly divided storm window.

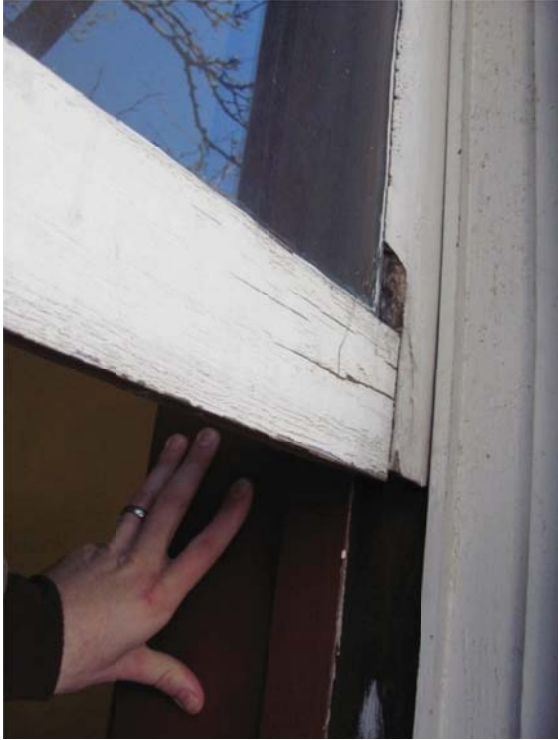
window sash have been removed. The wood windows are in fair condition, with missing components such as the parting stop, loss of paint and glazing putty, and some wood decay and displacement of window sash joinery (Figure 8).

Figure 8. The wood windows are in fair condition, with some wood decay and displacement of window sash joinery.

The double hung wood windows throughout the building should be restored, including stripping and repainting, repairing the wood frame and sash as needed, reglazing, and repairing the pulley and counterweight balance system. If desired, new interior or exterior storm windows can be provided to improve the thermal efficiency of the windows.

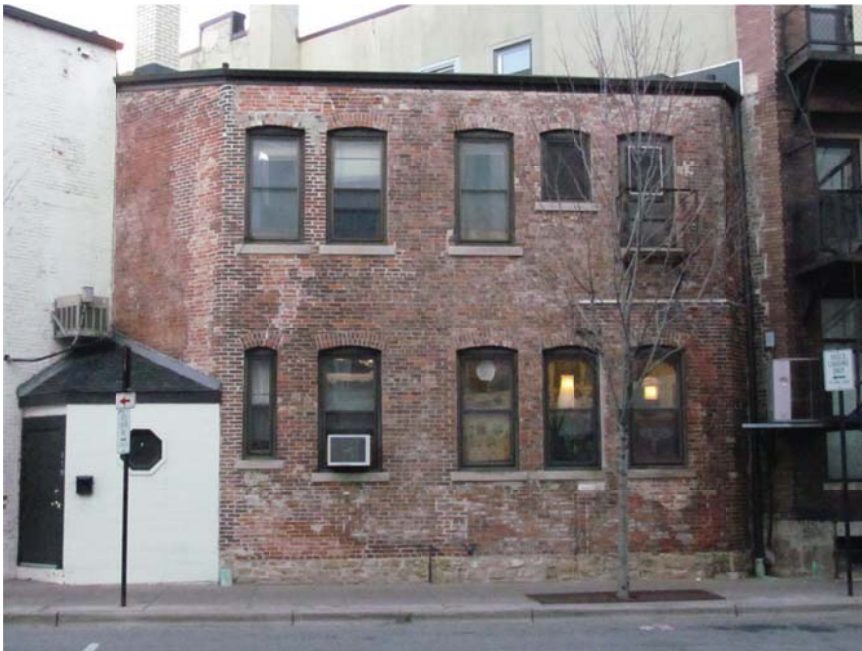
The Fairchild Street facade, which apparently dates to the original construction of the building circa 1856, has a stone foundation at grade (Figure 9). Above the foundation, the walls are load-bearing red brick masonry in a common bond with headers every seventh course. Limestone is used for window sills. Window openings are formed with two-course rowlock brick arches.

Figure 9. The Fairchild Street facade.

The brick masonry on the Fairchild Street facade requires more extensive repairs, likely including replacement of individual spalled brick units, repointing, removal of remnant coatings, and pinning of previously rebuilt areas to connect the face wythe to the backup masonry. Further investigation is needed to quantify the extent of these repairs. The fire escape platform should be removed and repaired or replaced as necessary.

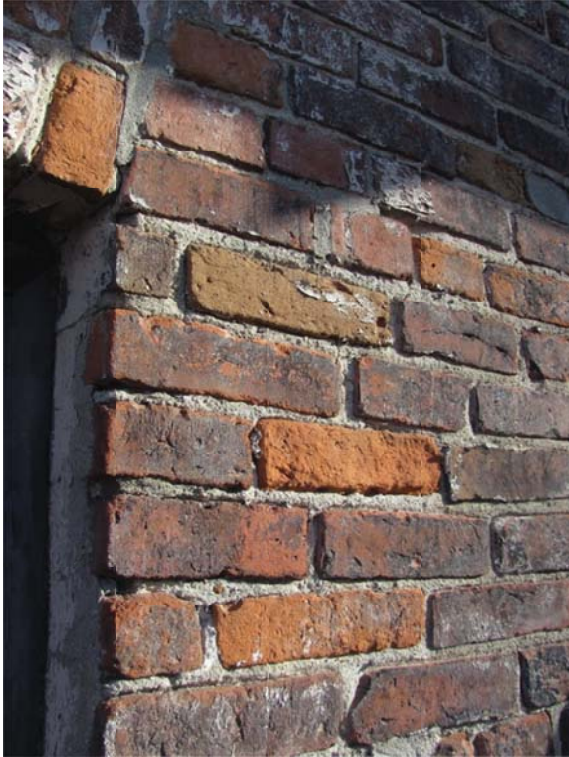
Throughout this facade, individual brick units were observed to have erosion or spalling of the face of the brick (Figure 10). Cracks and spalls that have been previously filled with mortar were observed (Figure 11). Also, localized areas of brick masonry appear to have been rebuilt previously (Figure 12). These rebuilt areas were sounded with a hammer and seemed hollow, indicating that the newer outer wythe of masonry may not be well integrated with the original backup masonry.

Figure 10. Left: Individual brick units were observed to have erosion or spalling of the face.

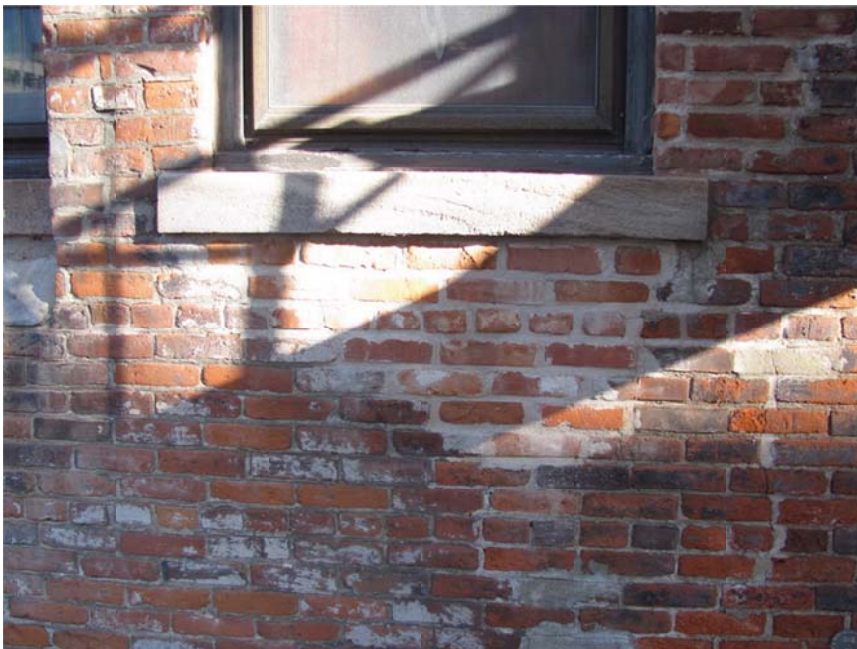
Figure 12. Localized areas of brick masonry appear to have been rebuilt previously.

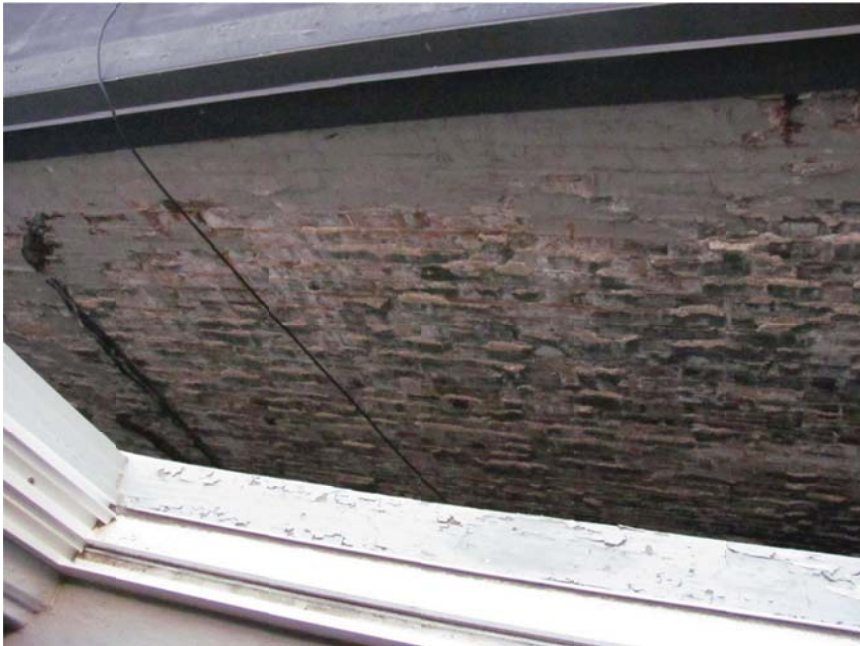
The east and west walls of the building are common brick party walls. A small portion of the party wall is exposed at the light well of the adjacent building at 121–123 State Street. Where observed, the masonry appeared to be in fair condition, with some erosion of brick units and extensive mortar parging on the surface (Figure 14).

Figure 14. The masonry party wall as viewed from the adjacent building appeared to be in fair condition.

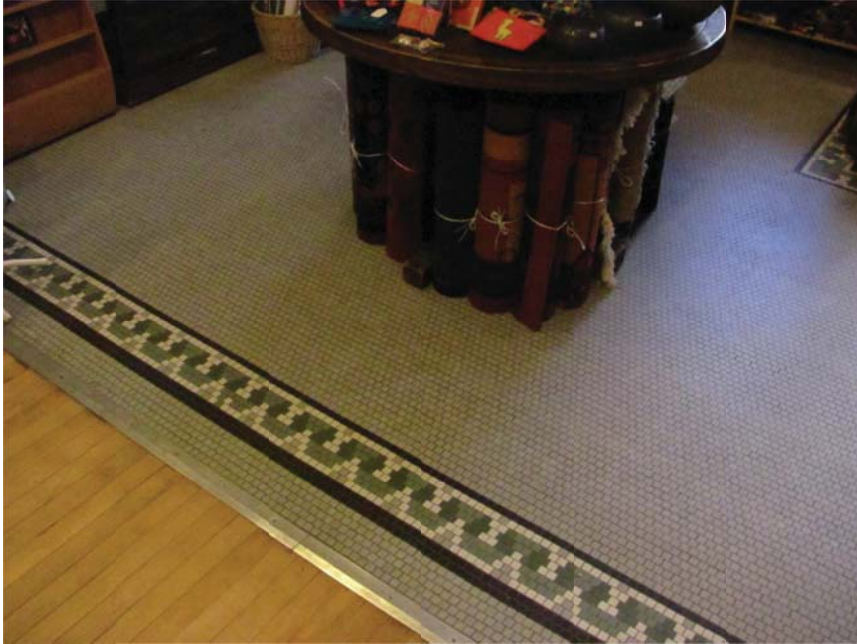
The first floor interior is now used for retail purposes. The finishes installed in the 1921 renovation are largely intact, including hardwood and mosaic ceramic tile flooring, marble wainscot, stained and varnished wood trim, interior doors and hardware, plaster walls and ceiling, and plaster crown molding (Figure 15 and Figure 16).

Figure 15. Hardwood and mosaic ceramic tile flooring in the first floor retail space.

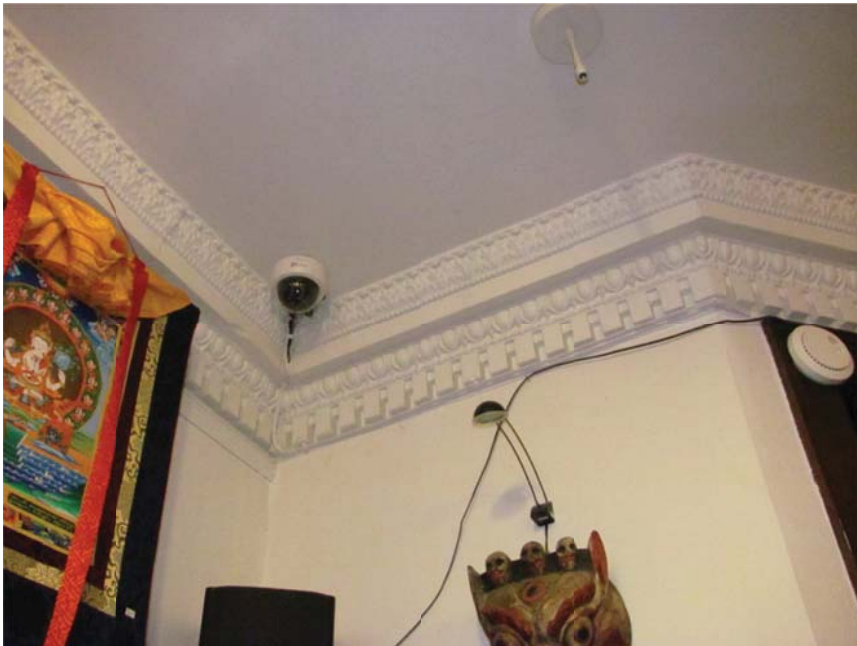
Figure 16. Plaster crown molding in the first floor retail space.

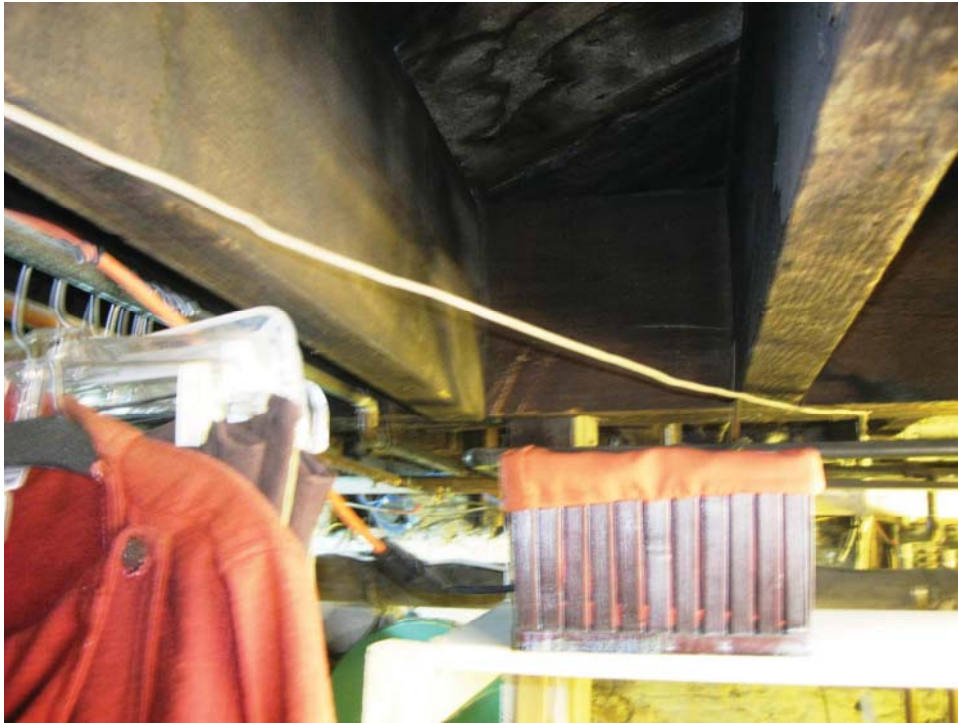
Photo 5 – 1st floor joist framing

The floor is wood framed using 3x12 joists to span 18'. The joist span parallels State Street. A possible stair was filled in along the east side of the space. The columns /beams that frame this abandoned opening are in good condition. The wood joists frame to the header beam at the abandoned opening and are toe nailed for anchorage. The joint is loosening up and should be reinforced with modern day joist hangers. The calculated live load capacity is 65psf versus a present day code required capacity of 100 psf.
