# **Union Corners TID # 37**

## **Report on Blight Determination**

**Prepared by:  
Mid-America Planning Services  
Division of Crispell-Snyder, Inc  
621 N. Sherman Ave.  
Madison, WI 53704  
608-249-2514**

**August 1, 2005  
May 5, 2006**

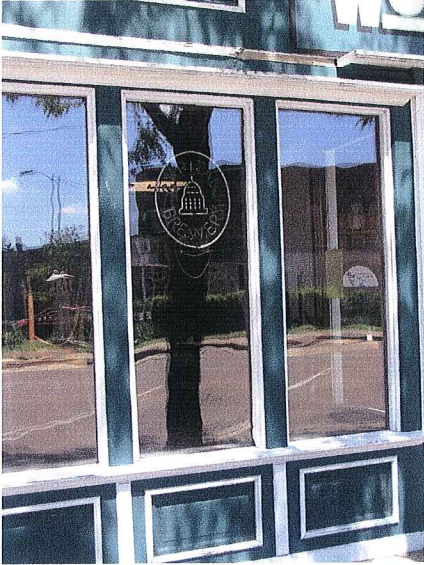
**1980 Atwood Avenue  
Deteriorated Paneling  
Deteriorated Window Frame  
Trim Missing  
May 30, 2005**

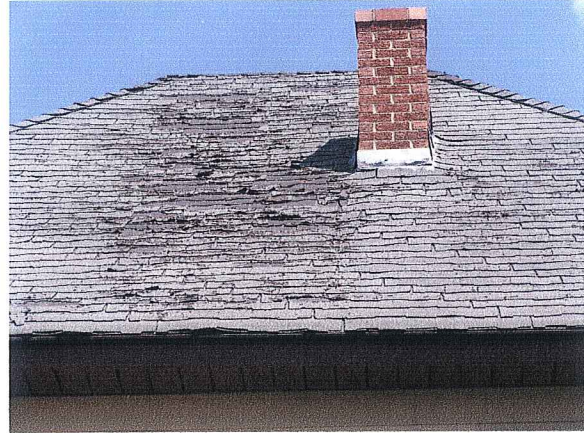
**1833 Winnebago Street  
Deteriorated Shingles  
May 30, 2005**

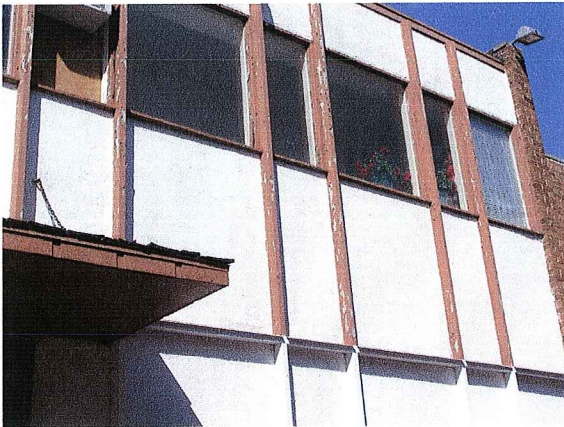
**1915 Winnebago Street  
Deteriorated Window Frames  
May 30, 2005**

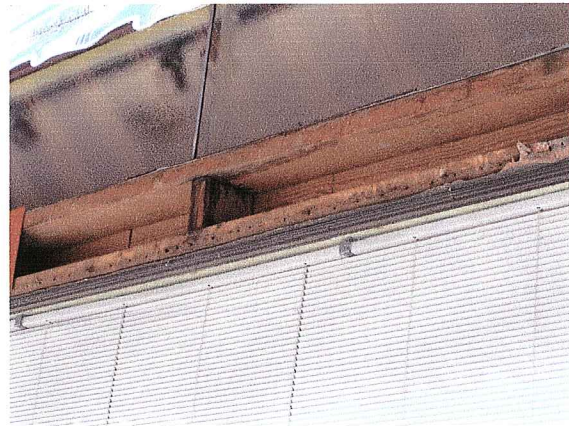
**1947 Winnebago Street  
Panel Missing  
May 30, 2005**

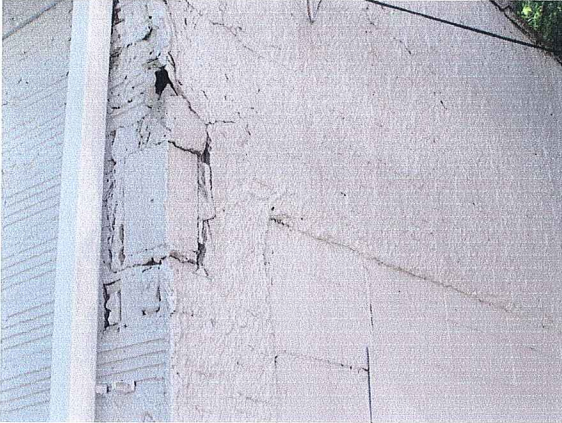
1949 Winnebago Street  
Wall Cracks  
Hole In Wall  
Blocked-up Window  
May 30, 2005

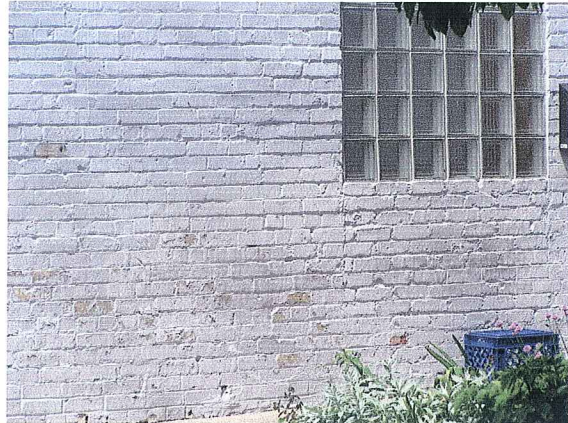
2007 Atwood Avenue  
Deteriorated Bricks  
Blocked-up Window  
June 2, 2005

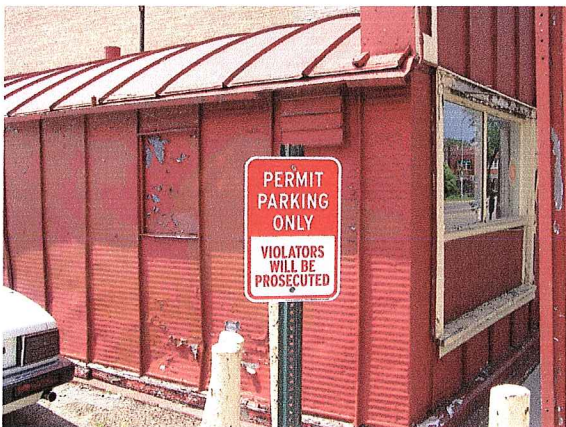
2033 Atwood Avenue  
Obsolete Building  
June 2, 2005

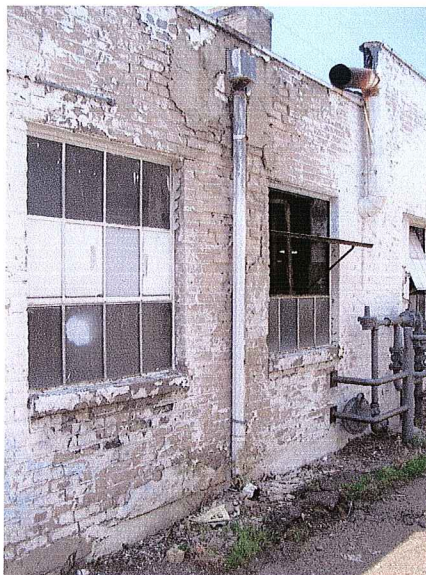
2021 Winnebago Street  
Deteriorated Brick/Wall  
Pieces of Brick on Ground  
June 2, 2005

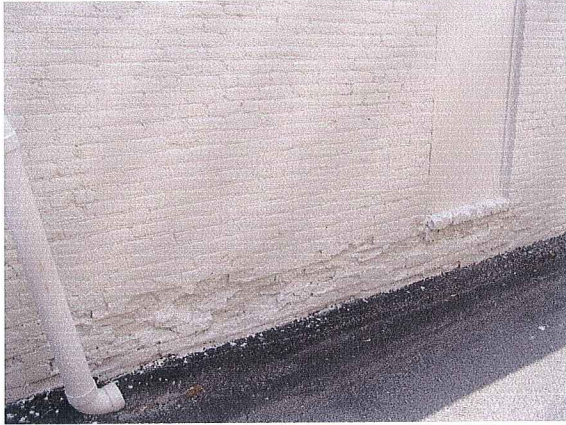
2017 Winnebago Street  
Deteriorated Brick  
Pieces of Brick on the Ground  
June 2, 2005

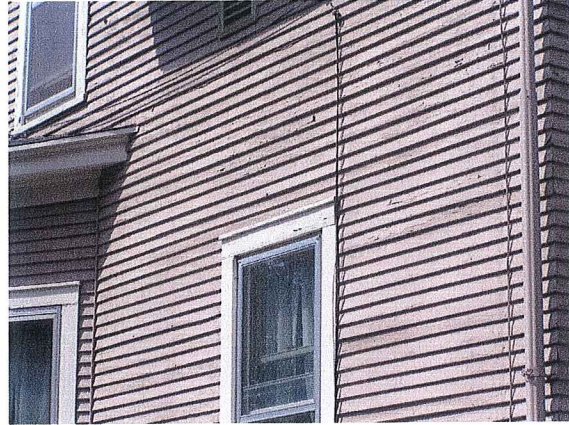
2142 Winnebago Street  
Deteriorated Siding  
Deteriorated Window Frame  
June 2, 2005

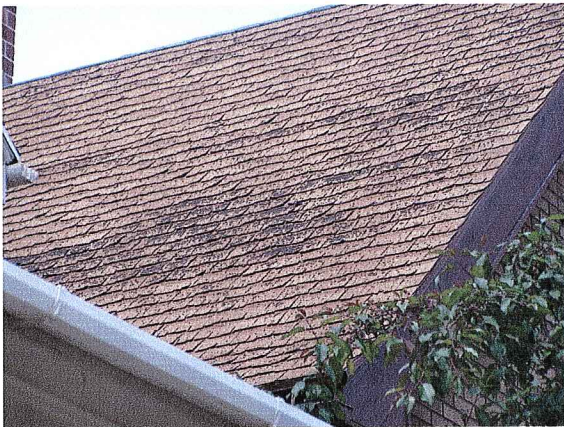
2146 Winnebago Street  
Deteriorated Shingles  
June 2, 2005

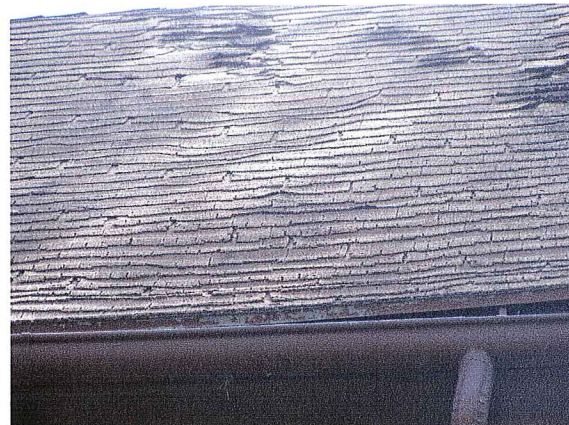
2146 Winnebago Street  
Deteriorated Shingles  
June 2, 2005

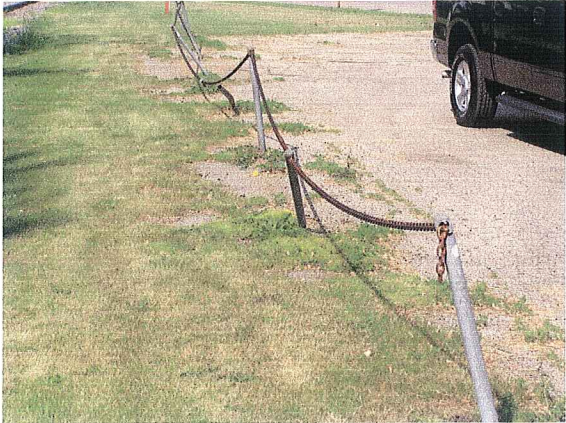
**2240 Winnebago Street  
Broken Boundary Fence  
June 2, 2005**

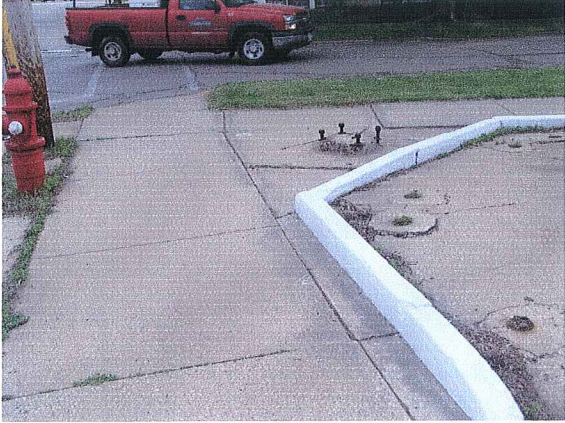
**11 South Fifth Street  
Abandoned Sign Base Inside Walk Area  
With Exposed Electric Wires  
June 2, 2005**

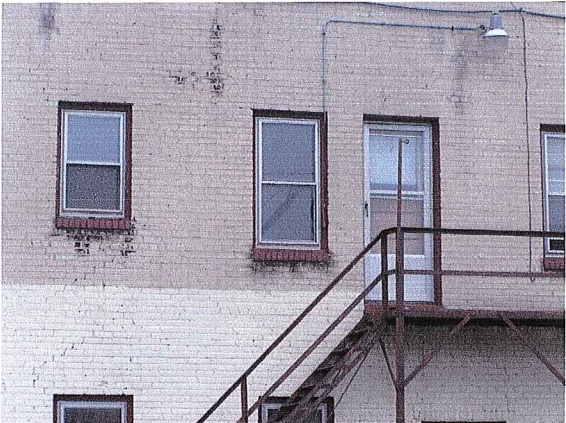
**3820 Winnebago Street  
Cracked Wall  
June 2, 2005**

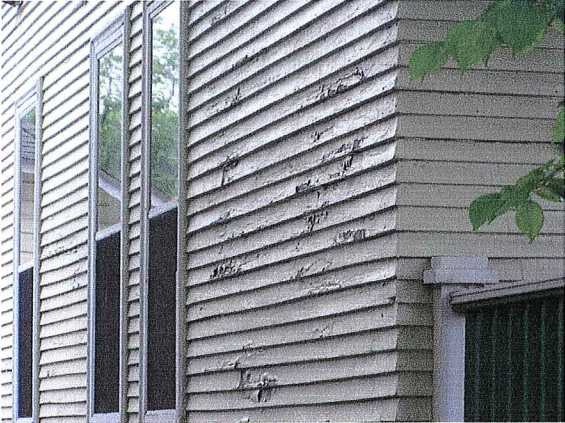
**2303 East Washington Avenue  
Deteriorated Siding  
June 3, 2005**

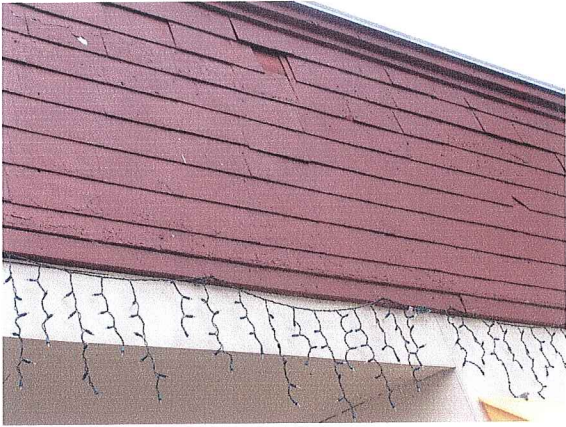
2422 Winnebago Street  
Deteriorated Siding  
Missing Siding  
June 3, 2005

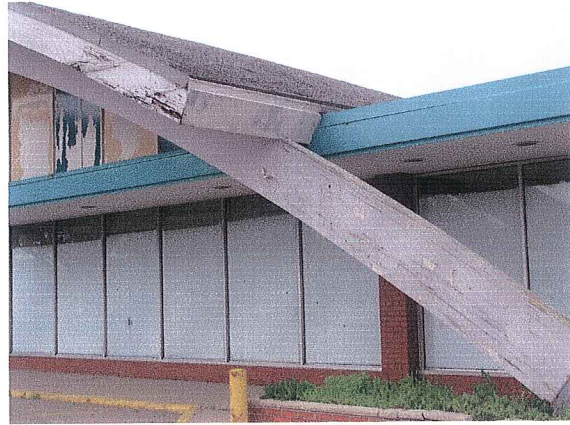
2525 East Washington Avenue  
Deteriorated Fascia  
Deteriorating Load-bearing Element  
June 3, 2005

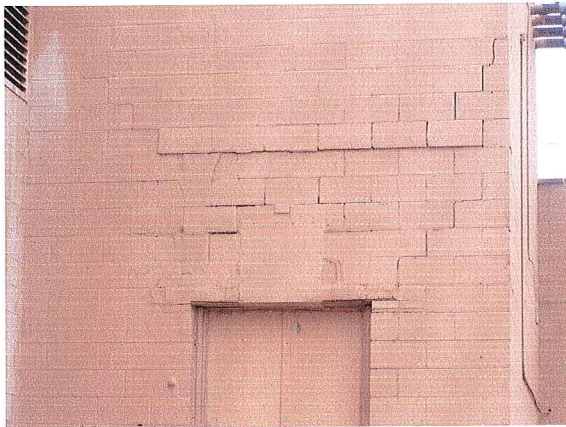
2620 East Washington Avenue  
Deteriorating Brick  
Blocked-up Window  
June 6, 2005  
-or-  
2525 East Washington Avenue  
Cracked Block  
Offset Block  
June 3, 2005

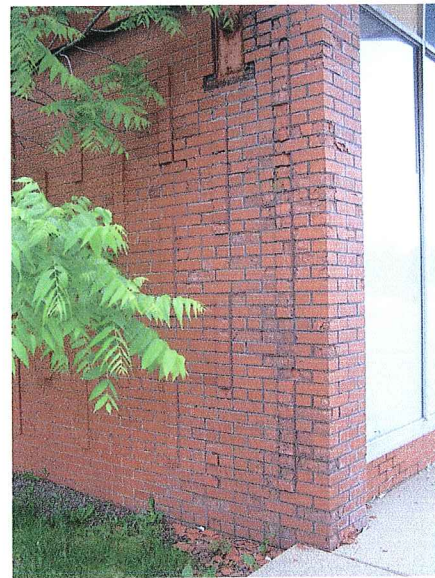
2525 East Washington Avenue  
Deteriorated Brick  
Pieces of Brick Lying on the Ground  
June 3, 2005

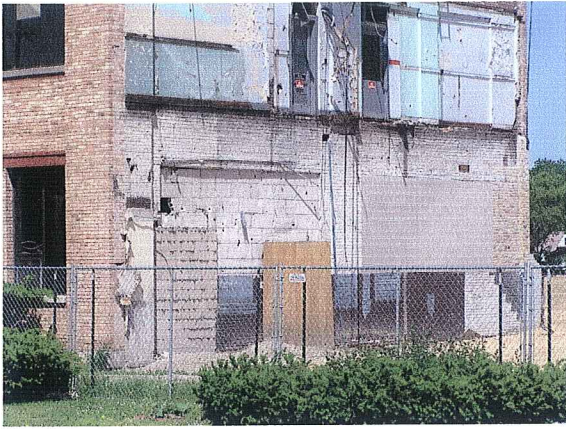
**2317 Winnebago Street**  
**Hole In The Wall**  
**Second Story Door With No Porch**  
**Blocked-up Window**  
**June 6, 2005**

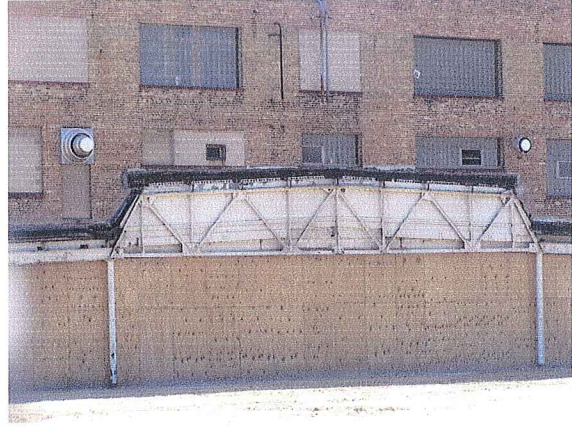
**2317 Winnebago Street**  
**Wall Boarded Up**  
**Blocked-up Windows**  
**June 6, 2005**

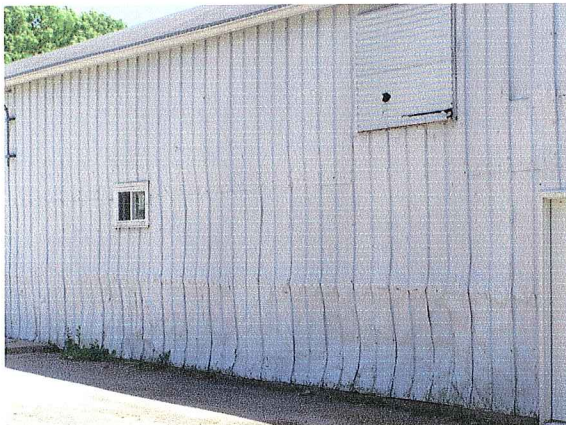
**56 Corry Street**  
**Caved-in Wall**  
**June 6, 2005**

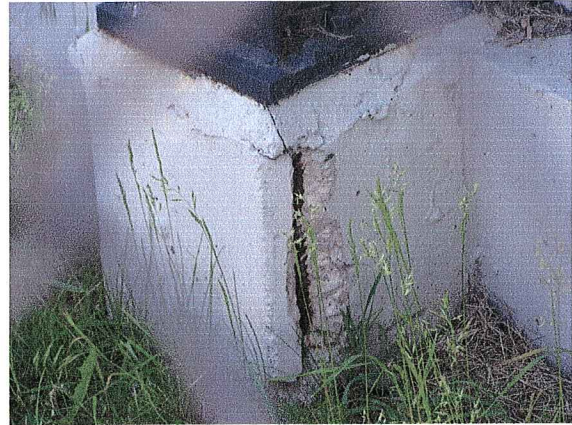
**110 Waubesa Street**  
**Cracked Beam Support**  
**June 6, 2005**

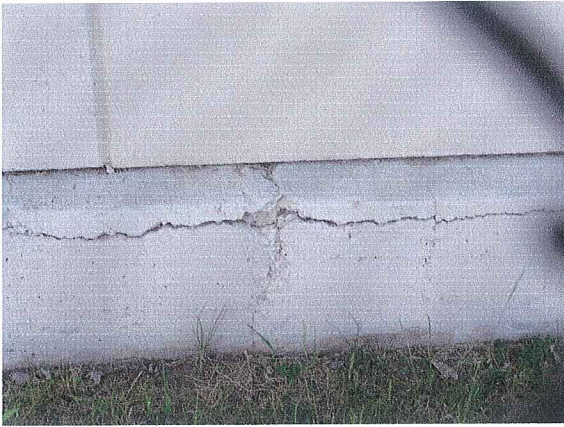
**110 Waubesa Street  
Cracked Wall and Foundation  
June 6, 2005**

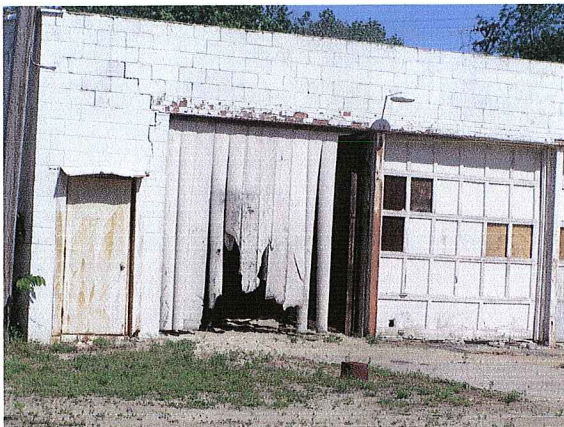
**149 Waubesa Street  
Missing Door  
Windows Missing From Door  
June 6, 2005**

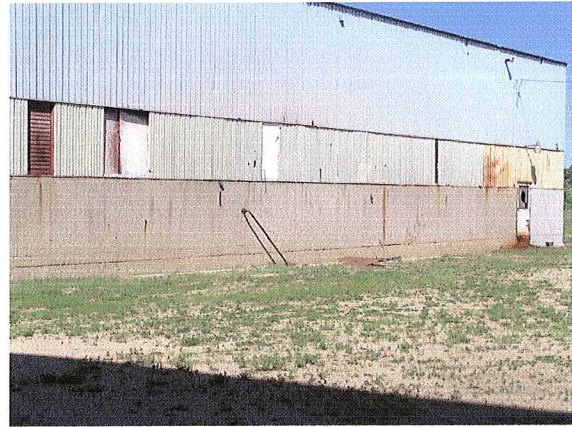
**149 Waubesa Street  
Rusted Siding  
Siding Missing  
June 6, 2005**

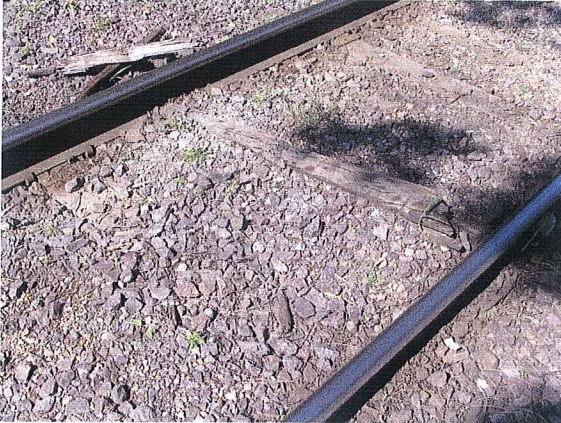
**Between Corry and Winnebago  
Broken Tie  
June 6, 2005**

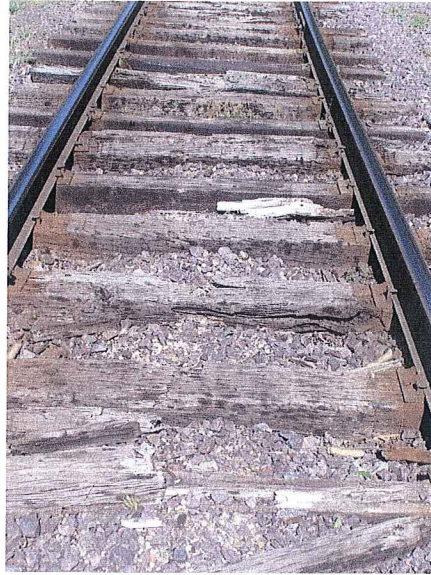
**Between Corry and Winnebago  
Broken Tie  
June 6, 2005**

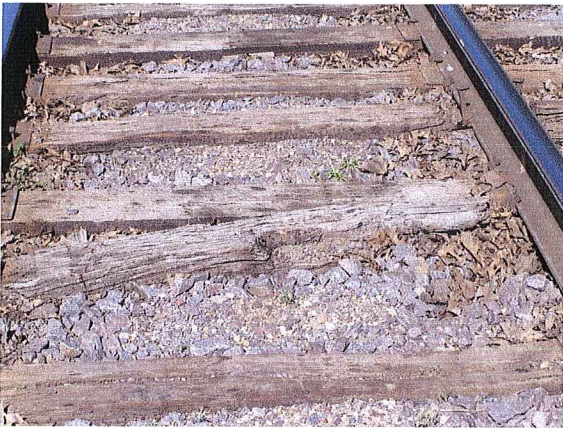
**Between Corry and Winnebago  
Broken Ties  
June 6, 2005**

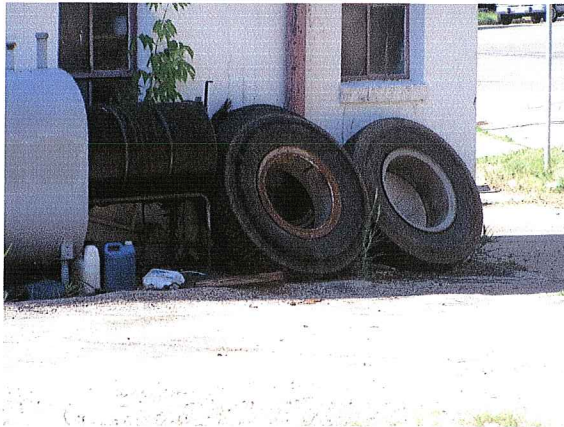
**2305 Winnebago Street  
Old Tires and Trash Visible Outside  
to Traffic  
June 6, 2005**

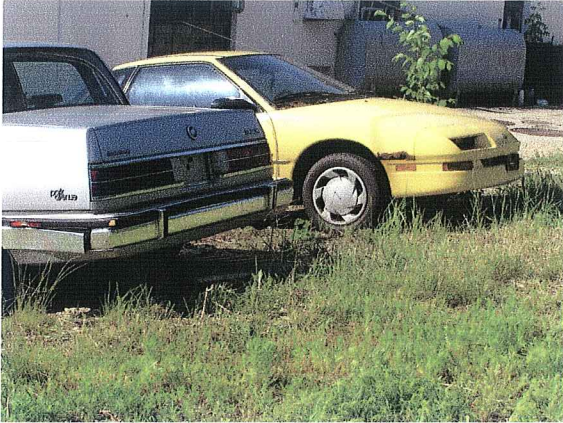
2305 Winnebago Street  
Junk Cars  
June 6, 2005

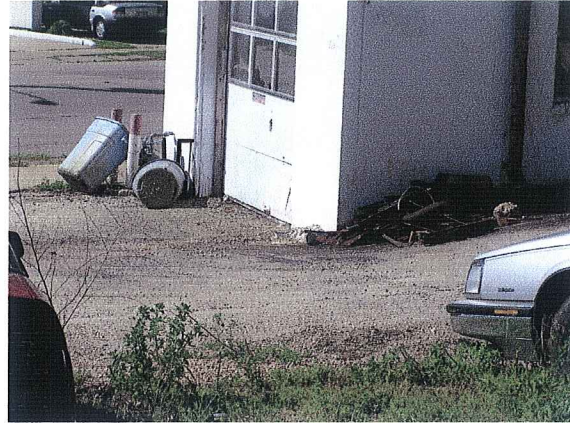
2305 Winnebago Street  
Trash  
June 6, 2005

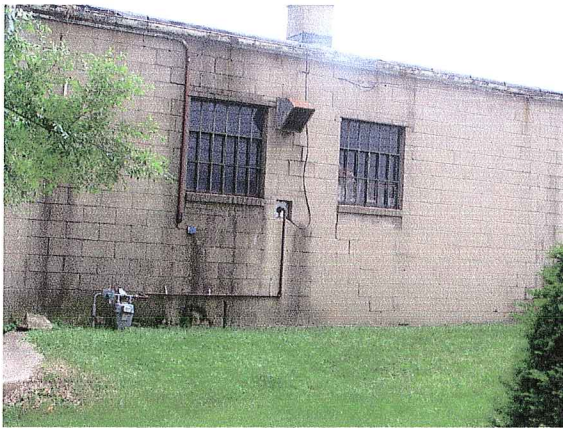
2652 East Washington Avenue  
Cracked Wall  
Water Damaged Wall  
June 6, 2005

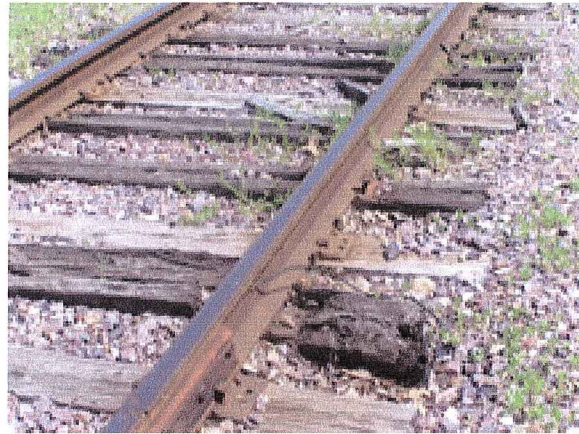
179 South Fair Oaks Avenue  
Rotten ties, broken ties, loose and missing  
spikes  
May 4, 2006

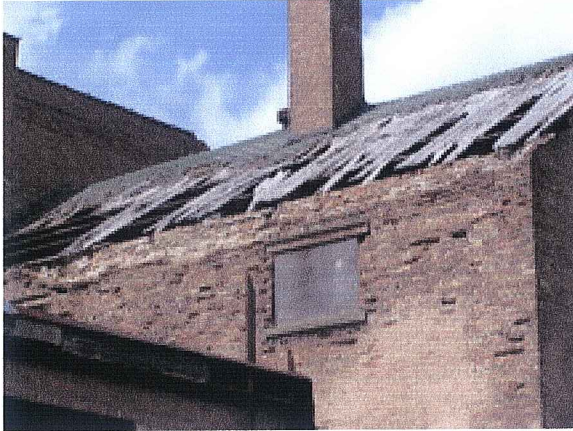
**3244 Atwood Avenue**  
Roof rotted away  
May 4, 2006

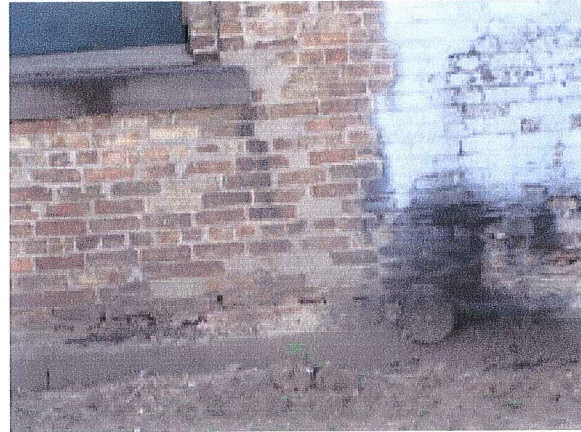
**3244 Atwood Avenue**  
Deteriorated all bricks, cracked wall  
May 4, 2006

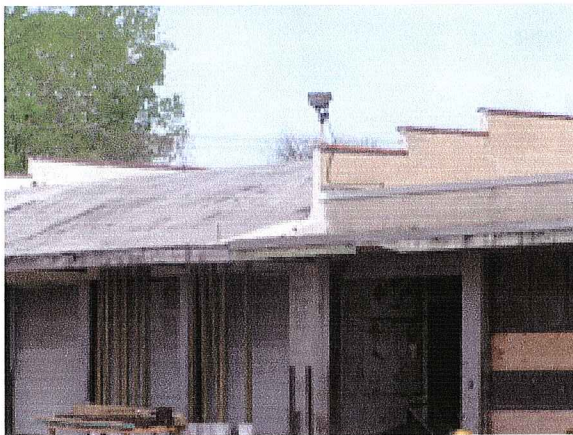
**3030 Gateway Place**  
Deteriorated roofing, cracked wall  
May 4, 2006

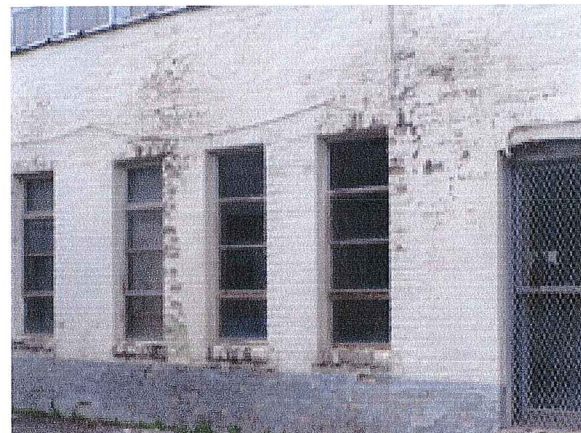
**206 Waubesa Street**  
Deteriorated brick  
May 4, 2006

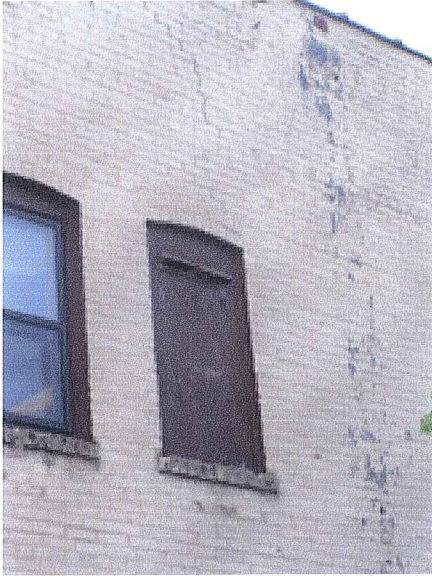
**201 Waubesa Street**  
Cracked wall, blocked up window  
May 4, 2006

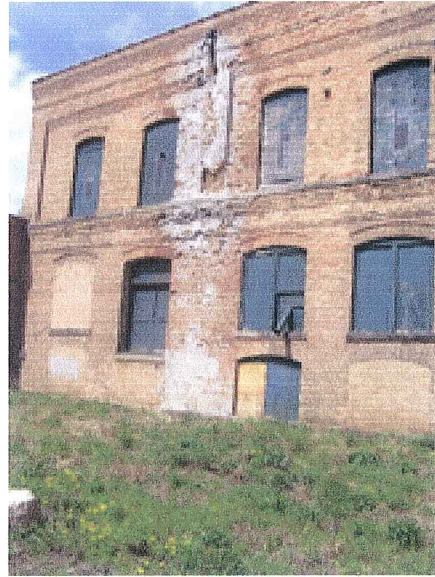
**3244 Atwood Avenue**  
Water damaged wall, boarded up windows,  
broken windows and deteriorated door  
May 4, 2006

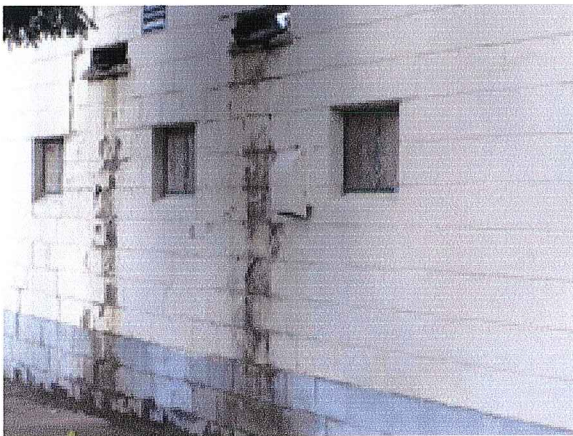
**206 Waubesa Street**  
Water damage and cracked wall  
May 4, 2006

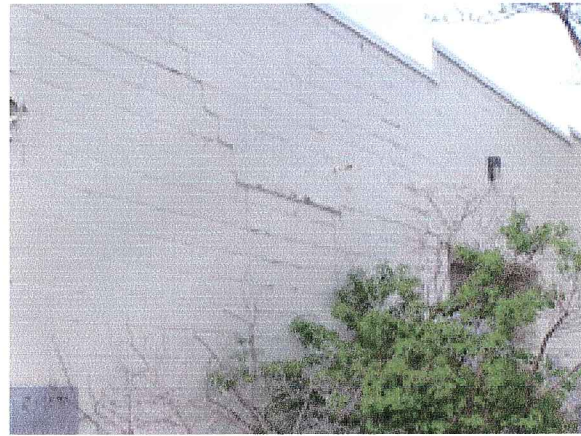
**152 Dixon Street**  
Cracked wall and blocked up window  
May 4, 2006
