2015 East Washington TID 36 Expansion Blight Study

Madison, WI

Prepared by MSA Professional Services, Inc.

January 11, 2016

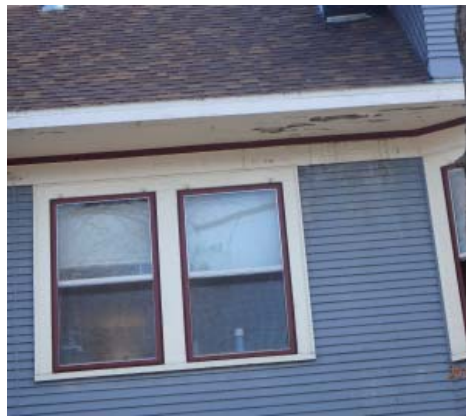
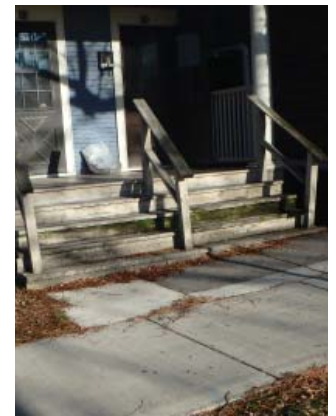
Score: 55.6

Excessive code violations; sections of crumbling foundation, paint peeling and discoloration; paint cracked on window, discolored in some places; signs of rot at bottom of window frames; pieces of soffit missing, cracking, discolored; fascia cracking, holes, discolored; lattice dirty and missing pieces; stairs discolored, warping, stain faded; railing discolored and partially broken.

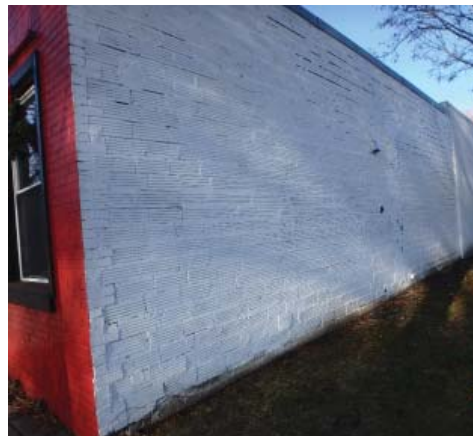
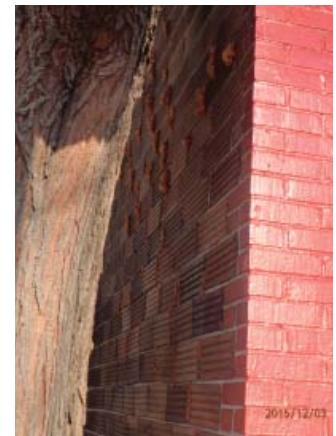
Parcel 25

Score: 58.1

Excessive code violations; not preferred land use, but supports preferred use; excess spray foam insulation on NW wall, missing mortar, paint chipped and mismatched, missing brick; paint peeling on window frames; couple small areas of graffiti.

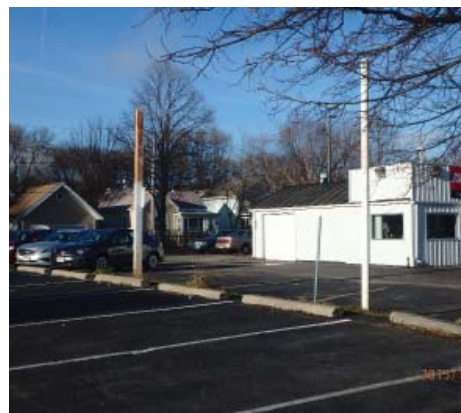
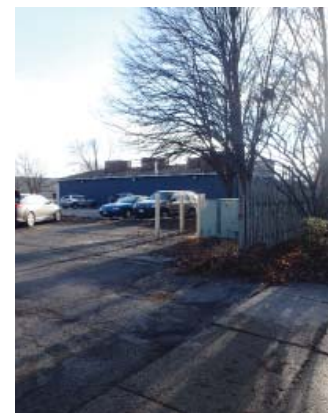
Parcel 28

Score: 49.6

Not preferred land use, but supports preferred use; minimal redevelopment opportunity with current lot size; fence along Curtis Court in poor shape; rusted posts with no signage; Curtis Court missing sidewalk; lack of maintenance - weeds and leaves.

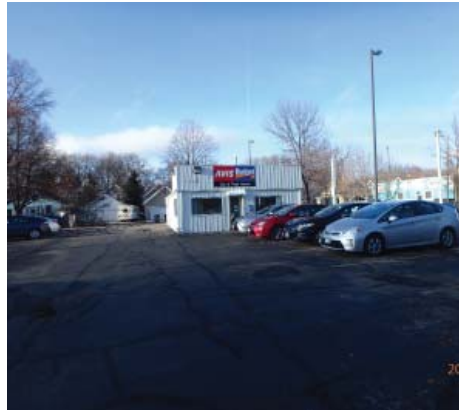
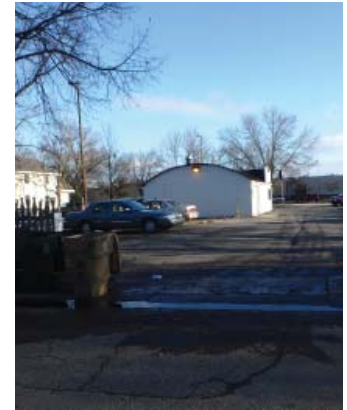
Parcel 29

Score: 58.2

Not preferred land use, but supports preferred use; drip edge bent, discoloration, paint wearing off, roof lifting from wall, seams missing parts; fence along Curtis Court in poor shape; rusted fence poles; discoloration, tarred cracks, uneven sections of parking lot, missing section behind building; Curtis Court missing sidewalk; litter, leaves and tree debris.

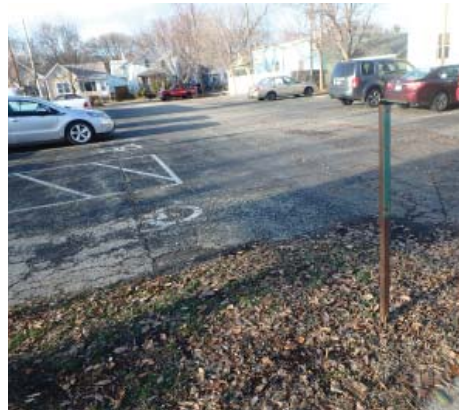
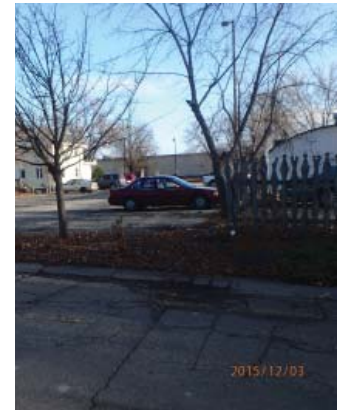
Parcel 30

Score: 54.7

Not preferred land use, but supports preferred use; light poles faded, one missing light fixture; parking cracking, discoloration, weathered, aggregate showing; no sidewalk on Curtis Court, sidewalk aggregate showing in older section; leaves and tree debris, litter, rusted parking post (no sign).

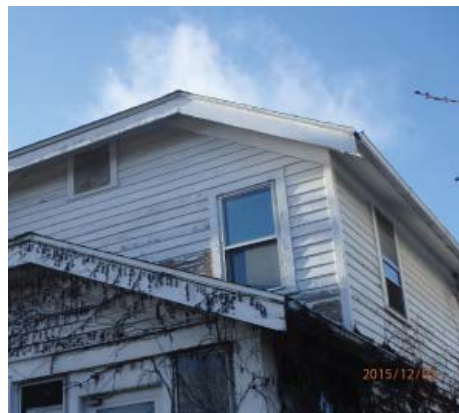
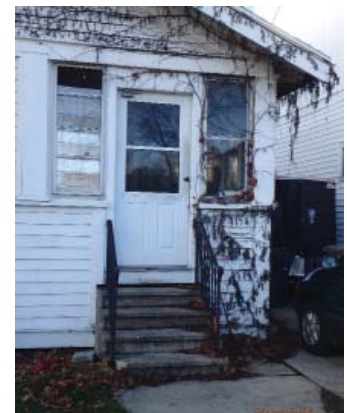
Parcel 33

Score: 56.5

Cladding paint peeling and exposing wood, dirty; paint on window trim cracking and peeling, frame cracked, boarded up window; end cap missing on gutter and downspout disconnected, dirty; rust on step concrete, discoloration, crumbling, spalling, rail rusted; missing piece of door frame; weeds, litter, garbage containers in front lawn and terrace; ladders, bricks, debris on side of home and under enclosed porch.

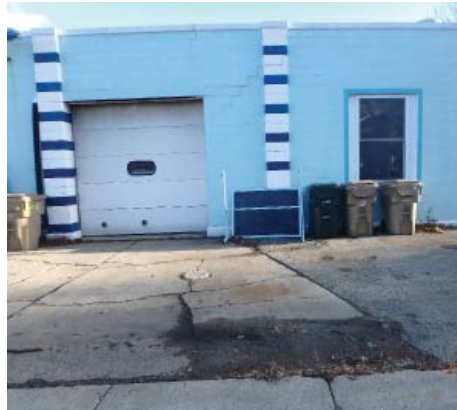
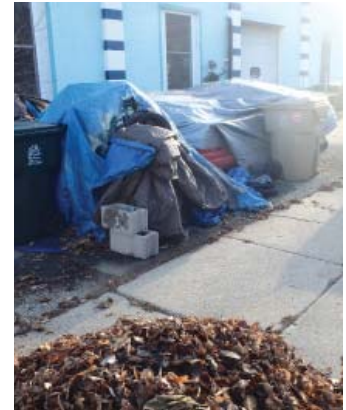
Parcel 35

Score: 47.5

Not preferred land use, but supports preferred use; rust staining on brick, mortar moldy, paint cracking, paint drips; fascia cracked and missing piece, discolored; soffit rusted, paint peeling, garage door dirty; wood fence paint wearing thin; garbage containers not screened; drive/parking cracked, discoloration, potholes, aggregate showing; public sidewalk cracked, discolored, missing near corner of Curtis/Few; dead leaves, dead plants in window boxes; pile of unknown materials covered in tarps; pooling in lot.

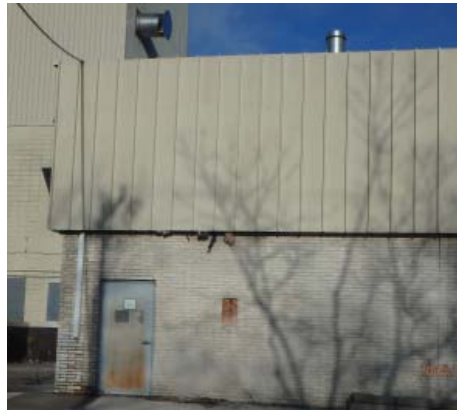
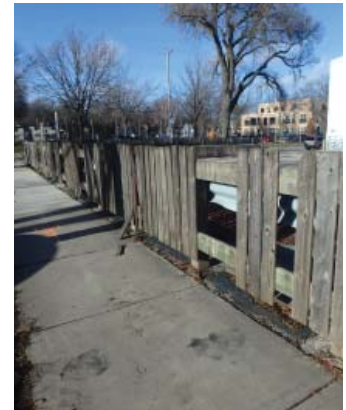
Parcel 36

Score: 45.7

Foundation discoloration and paint peeling on majority; cladding discoloration, paint worn off, rust-stained and mismatched, separating and cracking, insulation hanging under soffit; paint worn off, rusted doors; dock doors mismatch colored materials, dirty; missing and broken fence posts, rusted fence, concrete slabs stained, crumbling; drive/parking cracking, fading, crumbling, aggregate showing; missing concrete sill around electrical box, overgrown landscaping and weeds; graffiti.

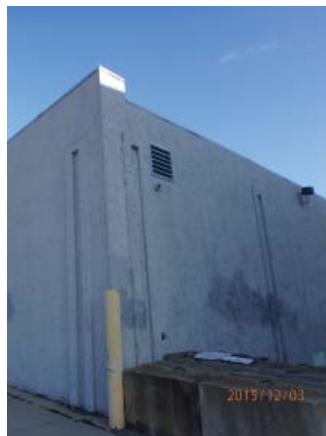
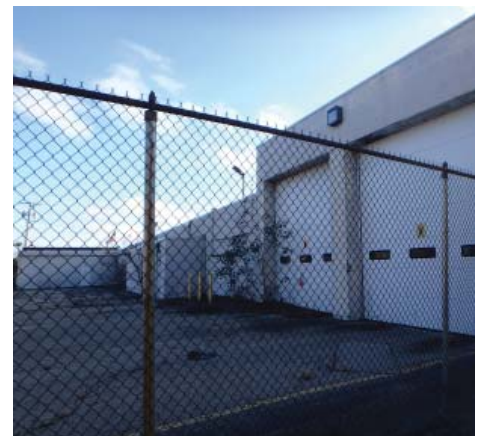
Parcel 37

Score: 41.9

Appears vacant - no activity; stucco cracking, graffiti cover-up mismatch, paint splatter on brick, paint wearing on concrete block, paint wearing, mortar cracks; dock doorway overhangs have rust staining, discoloration, paint wearing off; rusted fence, leaning fence between buildings; drive/parking loose gravel, cracks, discoloration; rusted bollard, litter, dead leaves and tree debris, weeds in cracks.

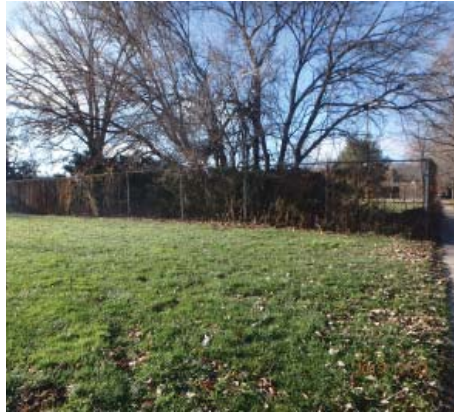
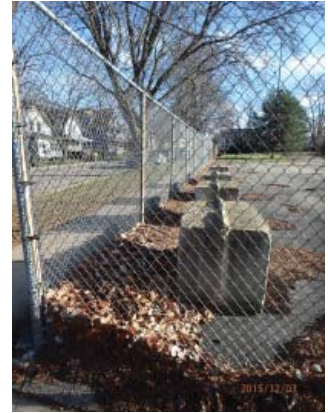
Parcel 39

Score: 51.7

Not preferred land use; chain link fence rusted, bent, discolored in sections; drive/parking cracked, aggregate showing; litter, dead leaves, stained concrete blocks, overgrown bushes/trees, weeds growing in cracks.

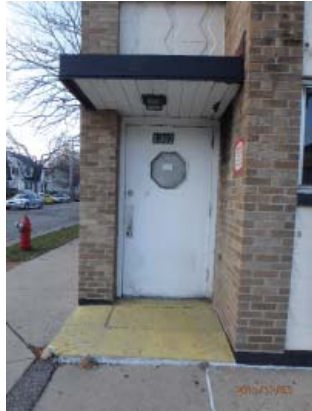
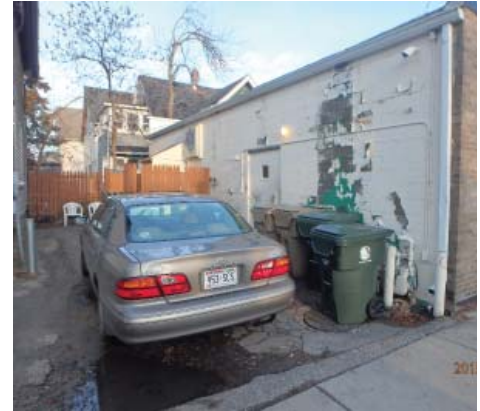
Score: 49.4

Not preferred land use, but supports preferred use; paint peeling on walls, rust-stained, dirty; cornice cracked and discolored; window frames dirty, weathered, paint peeling from frame; side sign paint wearing off, bent metal; front sign dirty, sign support rusted; entry walk cracked, discolored; front entry cracked, crumbling, aggregate showing; pot holes in parking lot.

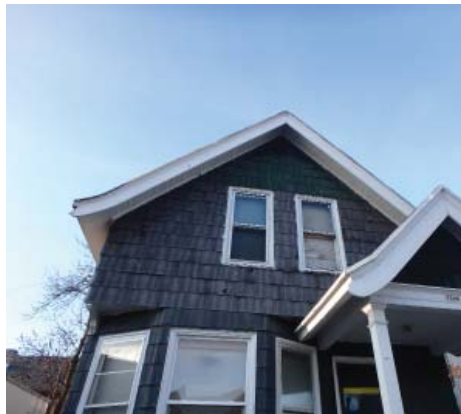
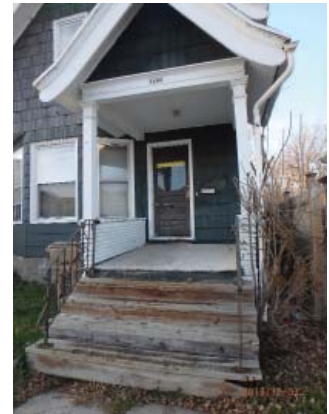
Parcel 7

Score: 45.8

Excessive code violations; discoloration on walls, staining, paint wearing, holes in cladding, paint splatters; paint wearing off and peeling on porch; side wall wood warping/separating; railing rusted; stairs discolored, warping, missing riser section; front walk cracked, discolored; gravel driveway needs maintenance; weeds growing from base of building; interior blinds broken; trash/recycling containers in front yard.

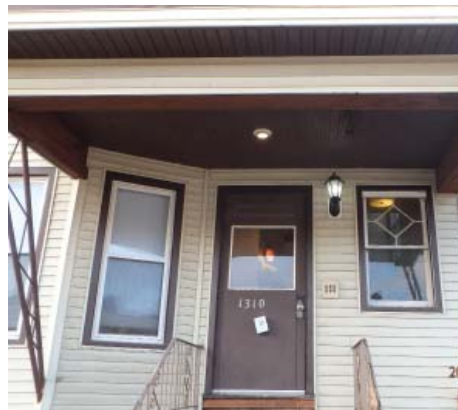
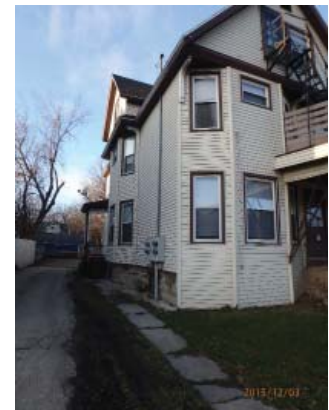
Parcel 8

Score: 54.7

Front stairs chipped, cracked, aggregate showing, rusted railing; side stair stain wearing off; front door paint wearing from frame and off door; lack of paint over past door handle area; driveway cracked, discolored, aggregate showing; walkway cracked, uneven settling, discolored, building not handicap accessible.

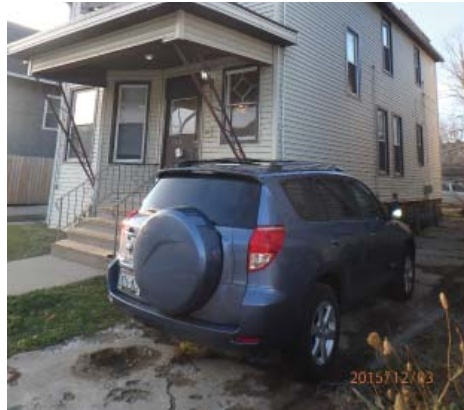
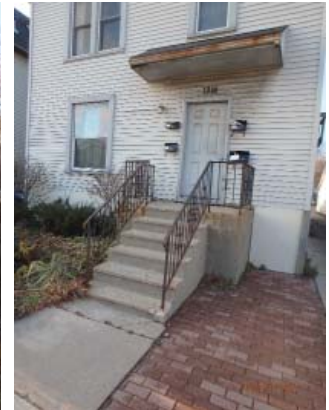
Parcel 9

Score: 58.2

Entry canopy discolored (apparent water damage); original front porch missing, replaced by concrete stoop; railing rusted; concrete steps crumbling, rust stained, aggregate showing; driveway pot holes, cracks, spalling, crumbling; walkway cracks; tree debris in back yard; litter; dead leaves; overgrown landscape; garbage containers left in terrace; building not handicap accessible.

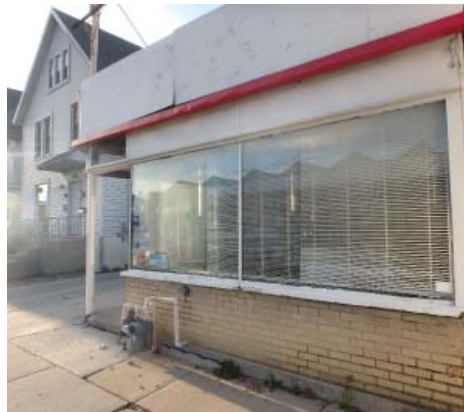
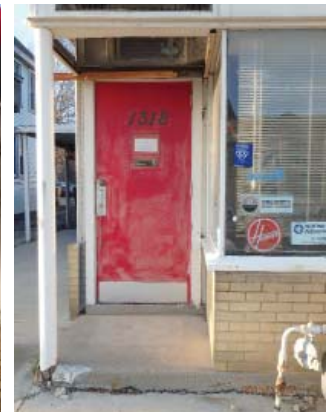
Parcel 10

Score: 44.6

Building vacant; brickwork discolored mortar; wood cladding paint peeling and warped; metal lintel bent; front window metal frame rusted, corroded; window pane stained, cracked; fascia rusted, discolored; brick quite discolored; mortar discolored in areas; rusted pipe vents; crumbling at concrete stoop; front door paint wearing significantly; support pole rust stained; concrete pavement cracking, discolored; asphalt drive and parking cracking, crumbling, potholes; building not handicap accessible.

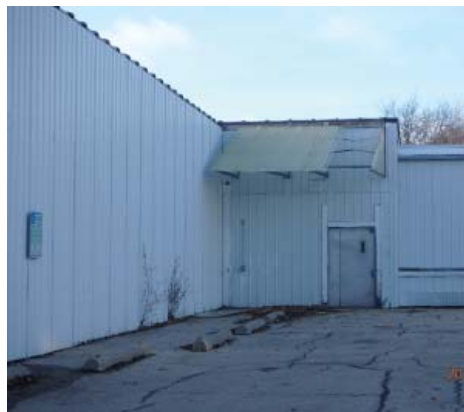
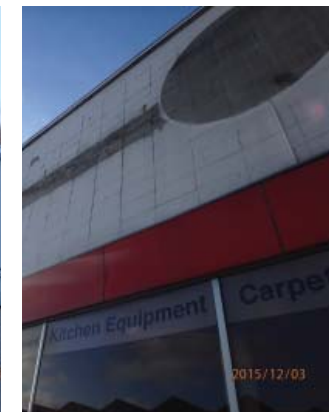
Parcel 11

Score: 43.9

Building vacant; metal cladding rusted, bent; block paint cracked, chipping, missing under previous sign; back wall in poor shape; awning missing piece, bent support; windows lintel rusted, sill paint wearing; weeds growing from base of structure; major pooling in lot; pooling on SW side of building under downspout.

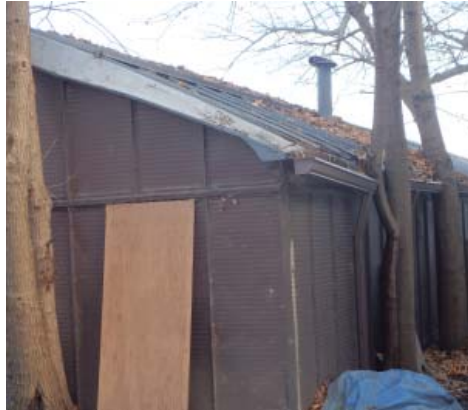
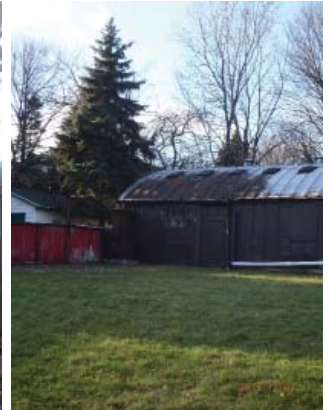
Parcel 16

Score: 13.4

Excessive code violations; building appears vacant; not preferred land use; foundation collapsed, piece missing, cracked; window frame rusted; window stained; metal sheet in window; window cracked on NW side; piece of window missing; dock door dented; door frame warped; NE door severely dented; cracked concrete in front of shed; cracked walkway; loading dock apron crumbling; dead leaves, leaves in gutter; tarp with stuff under it; trees have grown to damage building; bricks piled and falling near base.

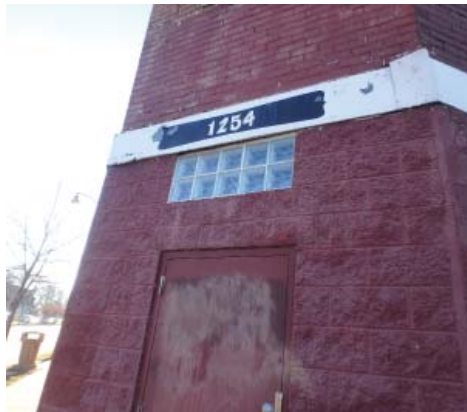
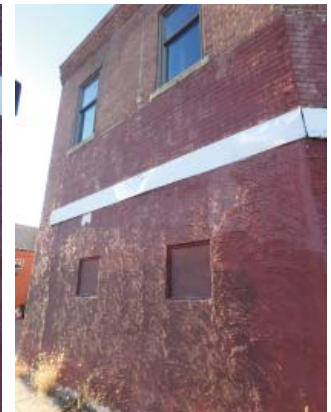
Parcel 21

Score: 53.9

Brick fading paint, staining, discoloration, missing mortar, mismatched bricks, some of first floor brick covered in mortar; metal trim band above first floor in bad shape; rust on window frame, sealant cracked, bars on NE window rusted, boarded up small windows with paint peeling and fading; building not handicap accessible.

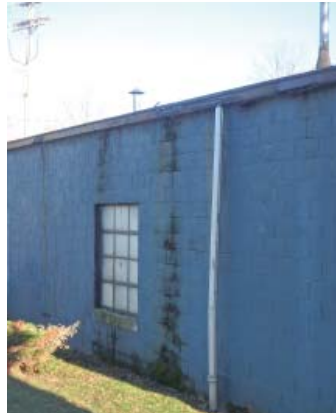
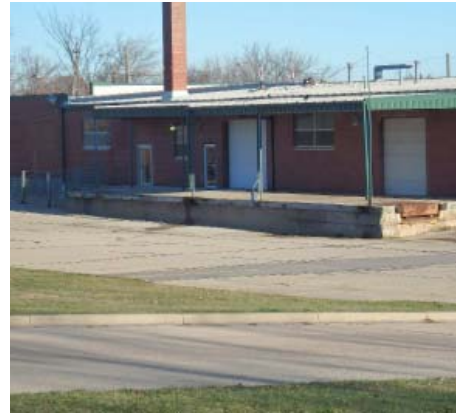
Score: 57.2

Not preferred land use; appears vacant, though a few vehicles indicating activity of some sort; block wall major discoloration, paint peeling; window sills discolored, boarded up; rusted vent; door issue.

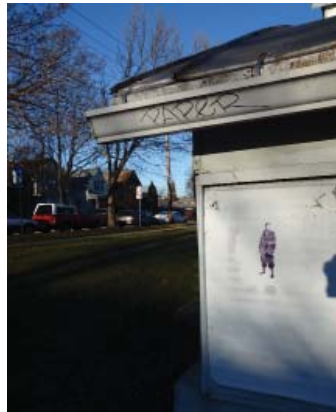
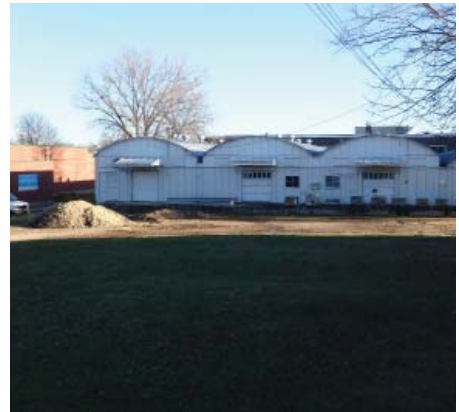
Parcel 3

Score: 44.7

Not preferred land use; wall paint mismatched, chipped and missing, rusted in areas; some rust on roof, bent and uneven roof sheathing; gutter dirty, rusted, bent and disconnected at one location; SW bldg dock door rusted, paint peeling; 1423 bldg rusted roof, boarded up window, poorly covered graffiti; hole in a downspout; pavement covered in dirt on NW building setback yard; gravel area needs maintenance; graffiti; piles of junk on NW side.

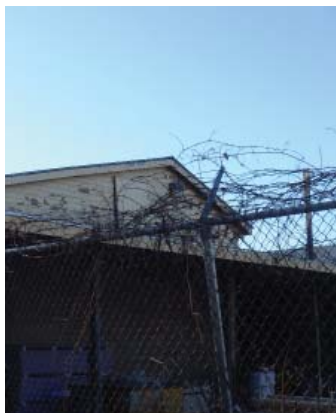
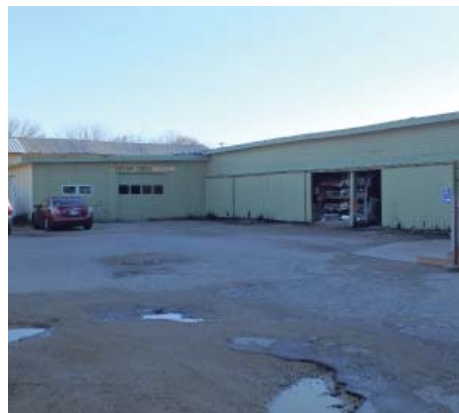
Parcel 42

Score: 34.8

Not preferred land use; foundation discolored, coating wearing off; walls dirty, paint peeling; cladding stained, rotting; paint wearing off chimney; storage bldgs paint peeling off siding and fascia, rusted vents, sagging roof; foundation cracked; fence rusted, bowing out; barbed wire rusted and bent; rusted sign supports; drive/parking stained, cracked, pot holes, crumbling, missing, aggregate showing; weeds; litter; mud and tire tracks in terrace; building significantly larger than adjacent buildings.

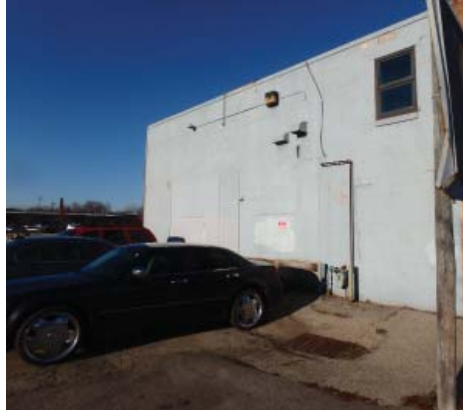
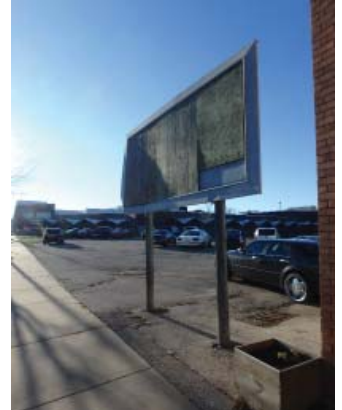
Parcel 46

Score: 52.2

Not preferred land use; SW side paint peeling, missing, mismatched; pole sign paint peeling from poles; bent, boarded up sign face; light on SW side discolored; pavement cracked, aggregate showing, crumbling section.

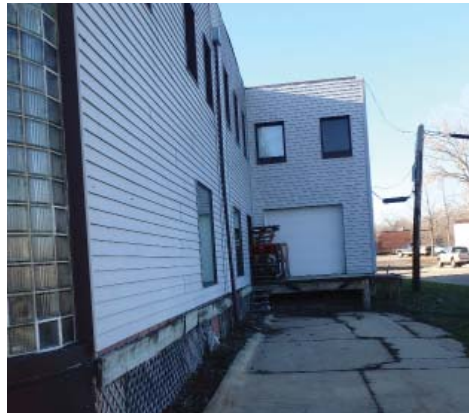
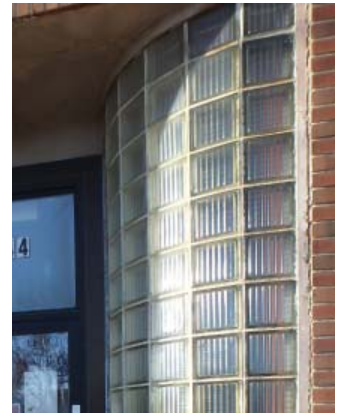
Parcel 47

Score: 53.2

Foundation chipping; loading dock foundation spalling, discolored, rust stained, paint wearing off; entryway ceiling water stained and cracked; dumpster not screened; lattice screening discolored, missing/broken; back paving cracked, uneven settling, stained; loading dock paving cracked, aggregate showing; litter; bricks laying at base; dead leaves, tree debris; stack of pallets on dock; rusted air conditioner in window.

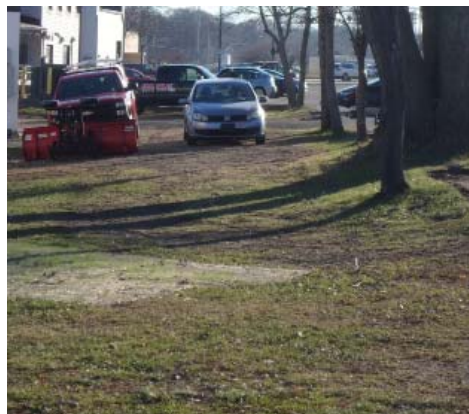
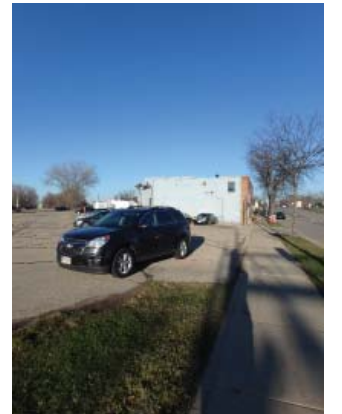
Parcel 49

Score: 56.3

Not preferred land use, though supports preferred use; not developable as a standalone lot; aggregate showing, many tarred cracks; dead grass.

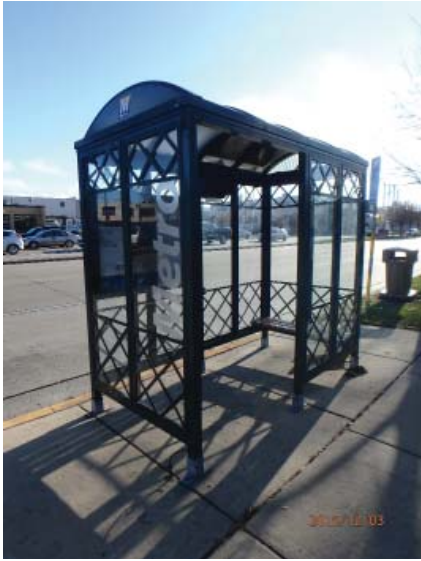
Bus Stop at East Washington and North Ingersoll (paint chipping, graffiti)

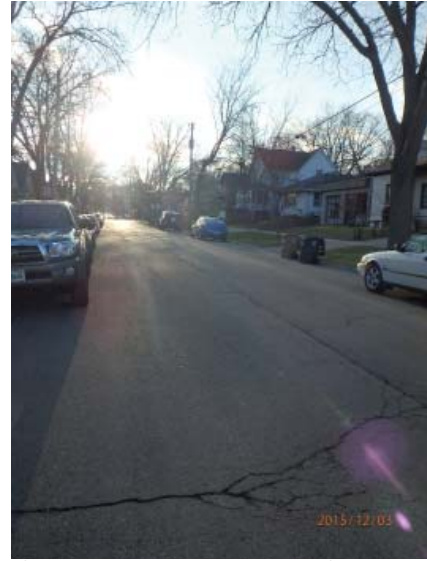
East Mifflin looking southwest (cracking, patching)

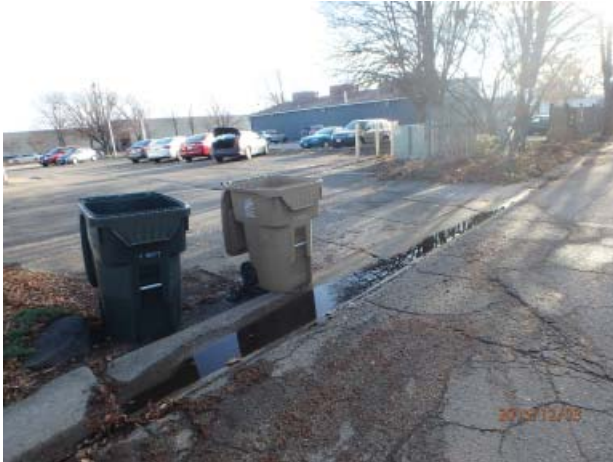
Curtis Court (water pooling in gutter, cracking)

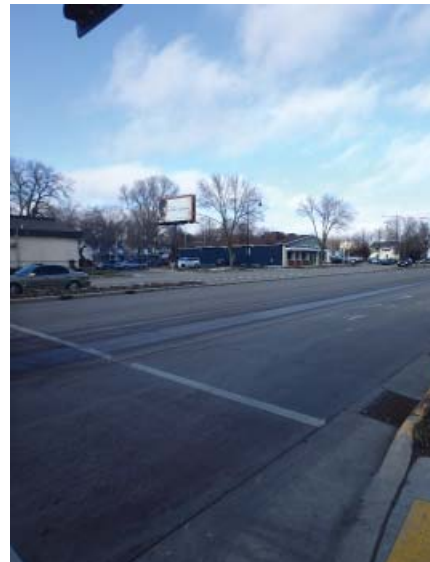
East Washington at South Ingersoll looking northeast (paint faded/worn away at crosswalk, chipping)

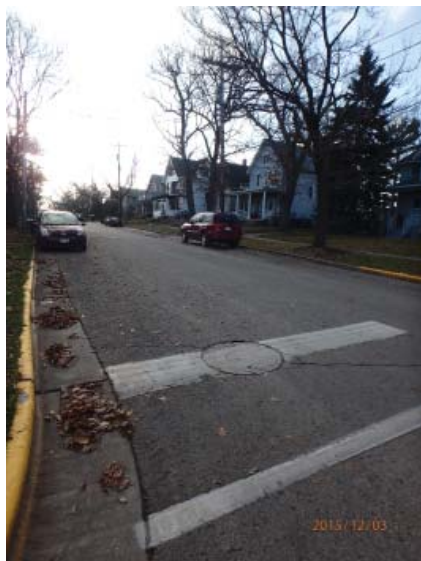
East Dayton looking southwest (cracking, paint chipped, discoloration)

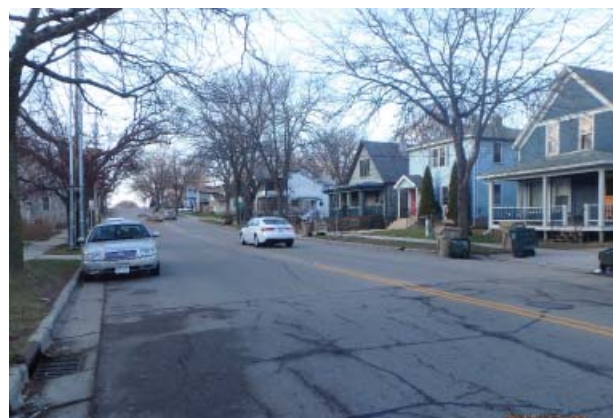
North Baldwin looking northwest (cracks, patching)

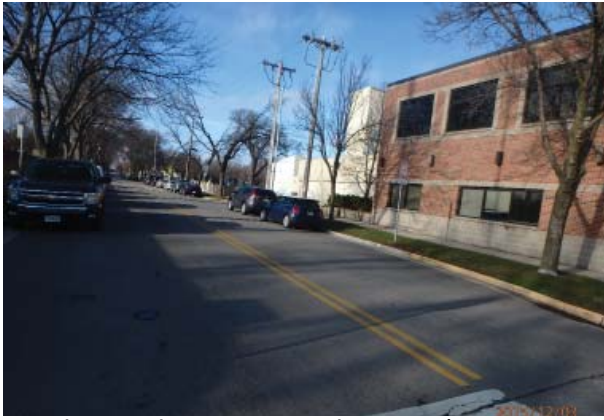
North Brearly at East Washington (paint chipping, pavement chipped)

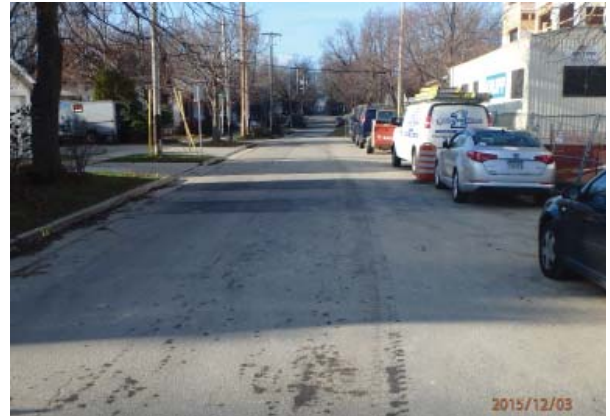
North Few at East Washington looking northwest (cracking, gravel pile on street)

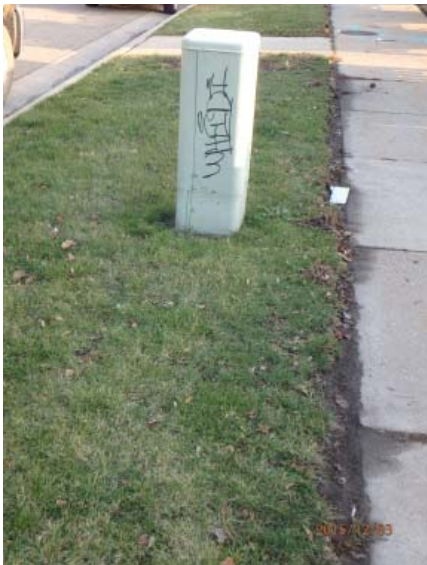
North Dickinson (graffiti, litter)

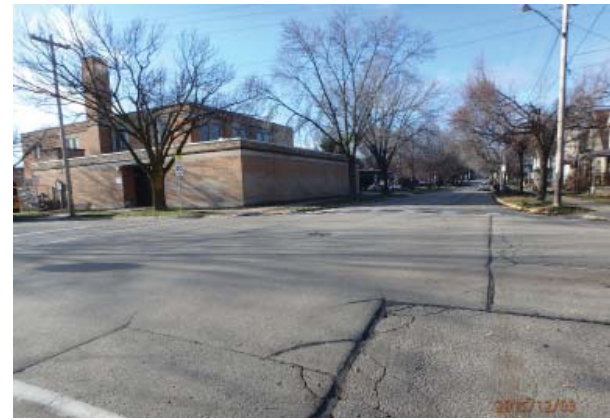
North Ingersoll at East Mifflin (cracking, patching)

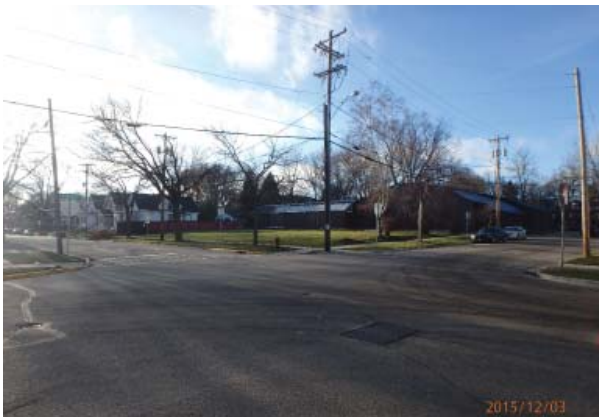
North Dickinson at East Mifflin looking southeast (cracking, patching, paint chipping)

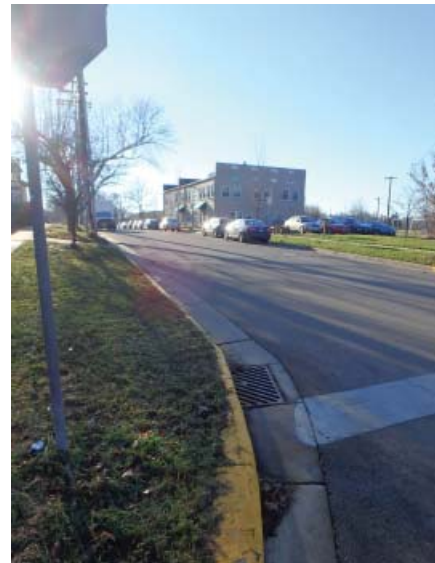
South First at East Main looking southwest (cracking, paint chipping)
