Re: Evaluation of Concrete Cores and Soils from Tree Openings between 329 and 528 State Street, Madison, Wisconsin (STS Job. No. 13068)

State Street Mall Tree Openings, Madison, WI
Concrete Deterioration Report
January 27, 2014
STS Project No. 13068

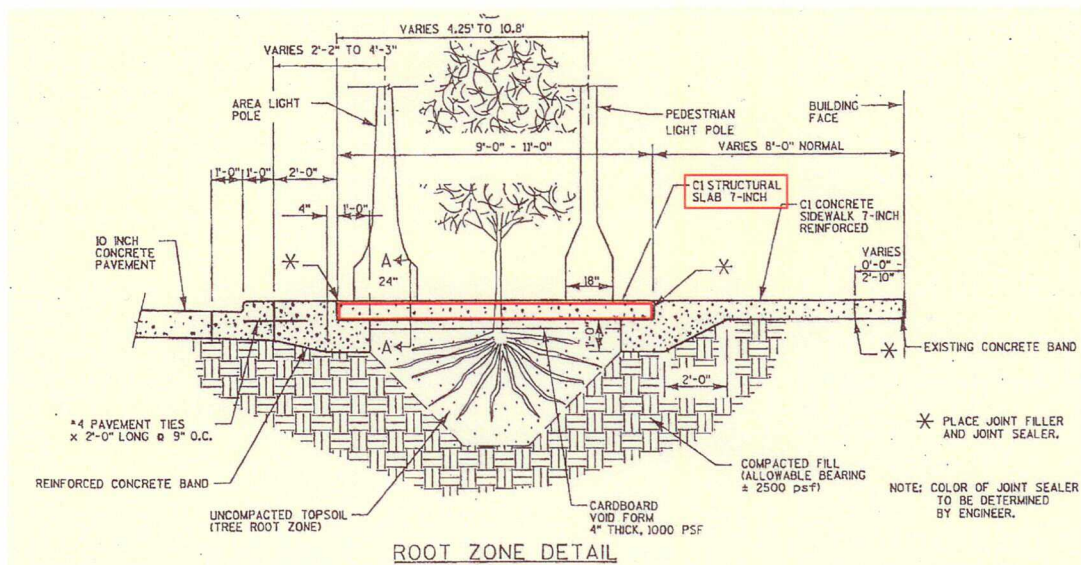
As part of the Phase II reconstruction of the State Street Pedestrian Mall, new tree planters were installed along the 300 to 500 blocks. Figure 1 shows the cross section of the new planter design. The design called for a 7 in. thick structural slab having an exposed (granite) aggregate finish.

Figure 1. Cross-section of planter design showing the concrete slab in question.

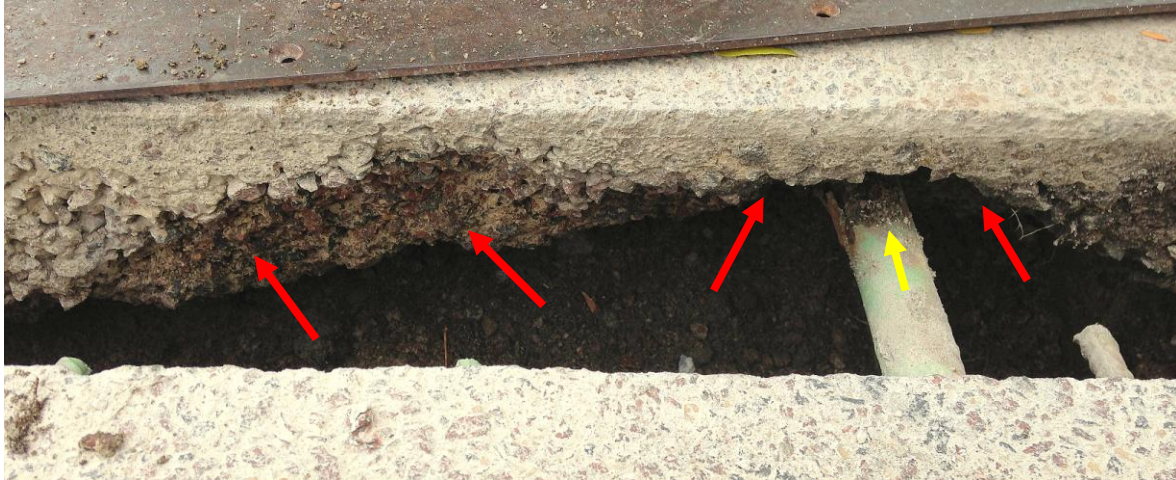
Sometime this past Fall, it was determined that along joints the slabs were deteriorating from the bottom upward (Figure 2). The deterioration is in the form of bottom of the slab cracking and spalling (Figure 2) and joint surface cracking and spalling (Figure 3). The City of Madison contracted CGC, Inc. to take cores of various slabs for testing to determine the cause(s) and extent of the deterioration.

Figure 2. Oblique view of the slab showing deterioration of the slab bottom (red arrows) and corrosion of a dowel bar (yellow arrow).

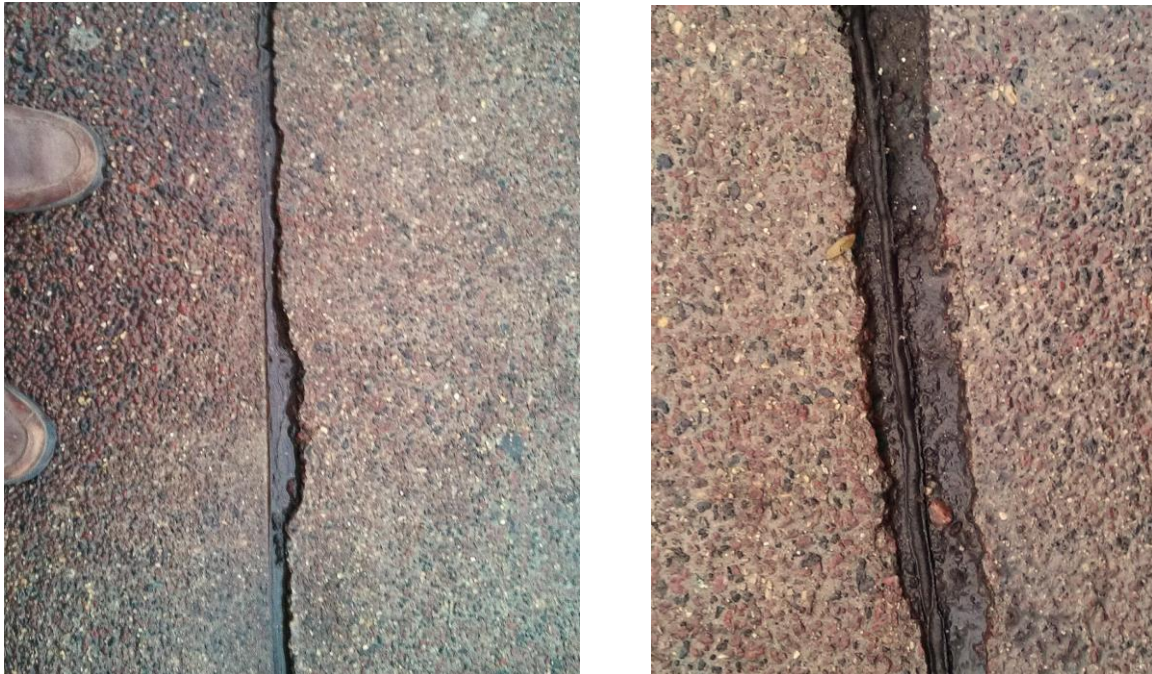
Figure 3. Cracking, spalling and raveling along joints

9. Innocuous, secondary deposits composed of calcium carbonate and ettringite line some of the voids, and which, suggests moisture has migrated into the concrete, likely along the joint, which has a compromised seal (Figure 3). Thus, the joint sealant is not protecting the concrete along the joints against the effects caused by ingress of significant amounts of moisture.

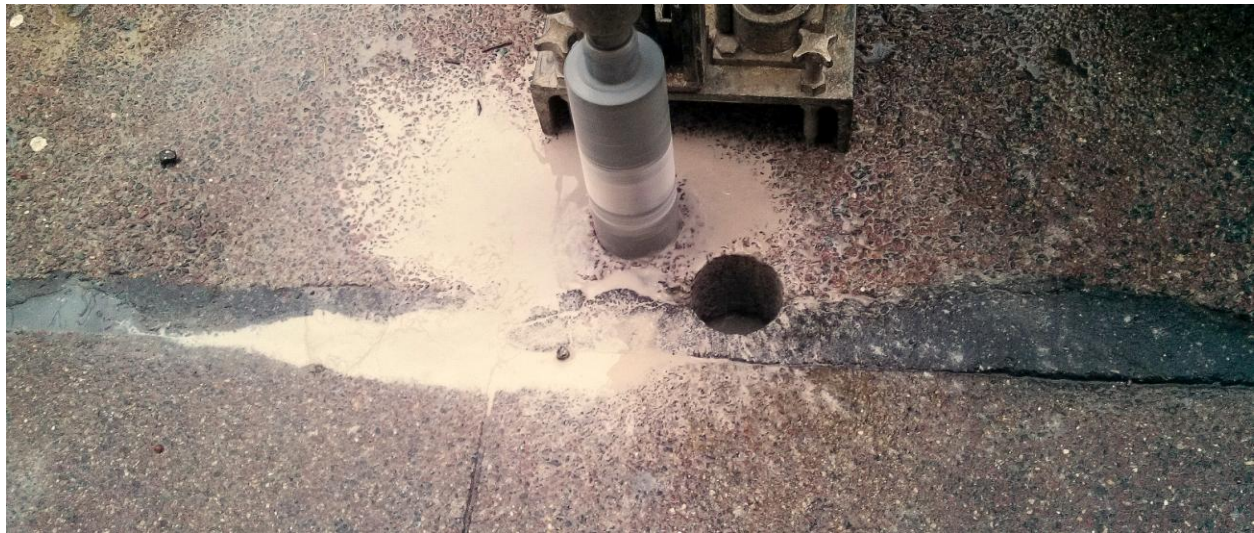
Figure 4. The location of cores showing the deterioration and which were subjected to laboratory testing.

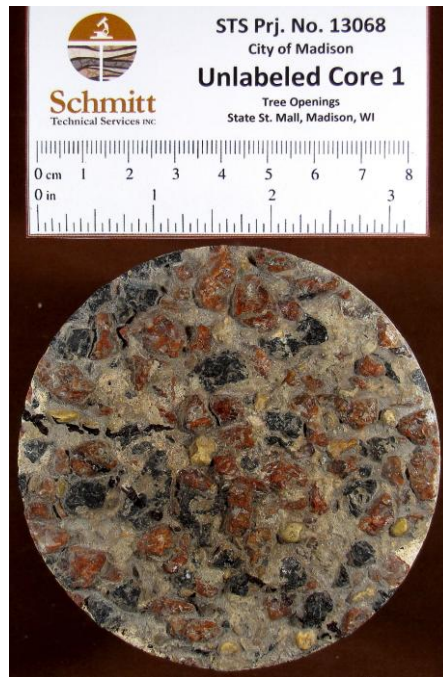
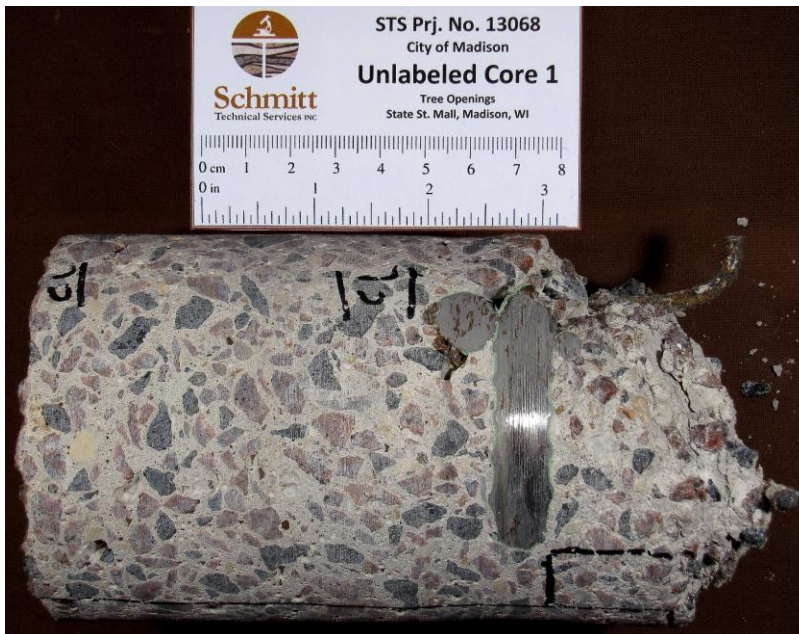
Figure 5. Core 1 as received for laboratory testing. Top scales are in centimeters. Bottom scales are in inches.

The top (wearing) surface has an exposed (granite) aggregate finish that has been coated with a clear shiny substance, presumed to be a sealer or other similar protective treatment (Figure 5a). The bottom surface is an irregular fractured surface. The fractured surface passes both around and through aggregate particles.

(a) Exterior surface.

(b) Core side, exterior surface is to the left.

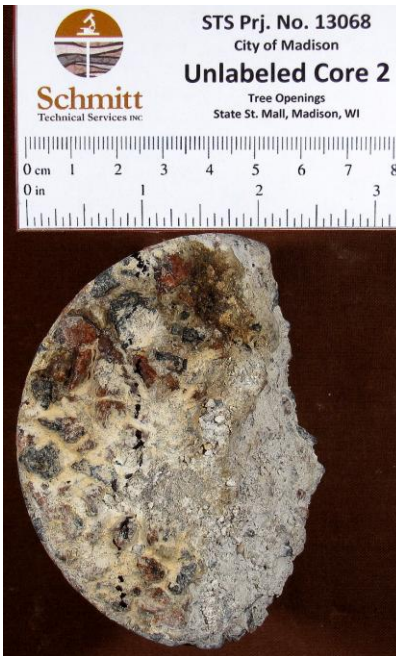
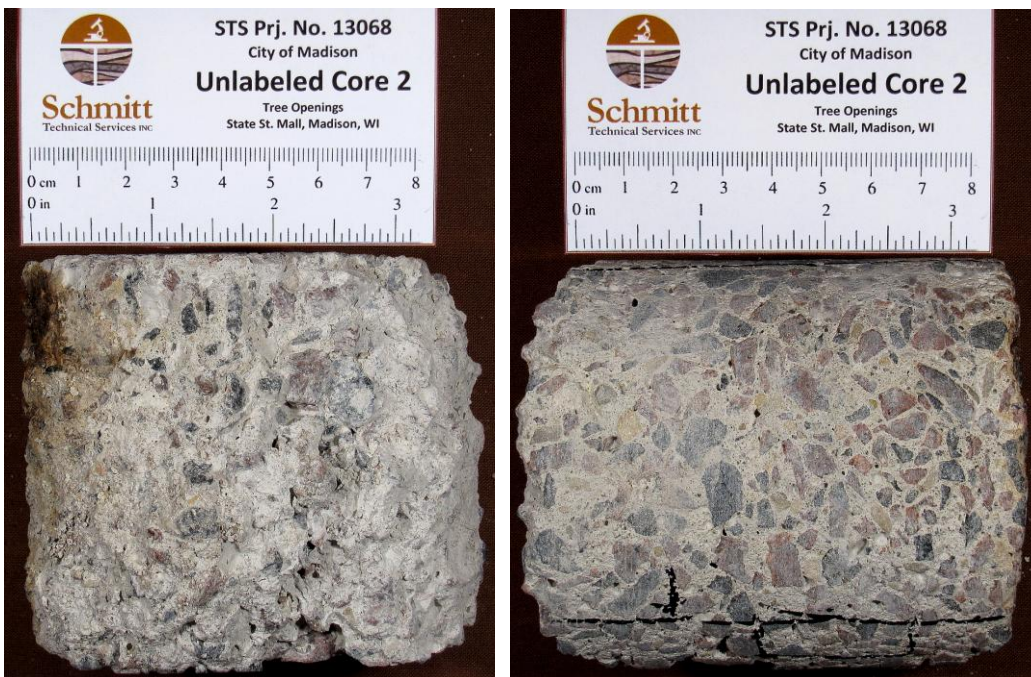
Figure 6. Core 2 as received for laboratory testing. Top scales are in centimeters. Bottom scales are in inches.

(a) Exterior surface.

(b) Core side, exterior surface is to the left in the left photograph and exterior surface is to the right in the right photograph.

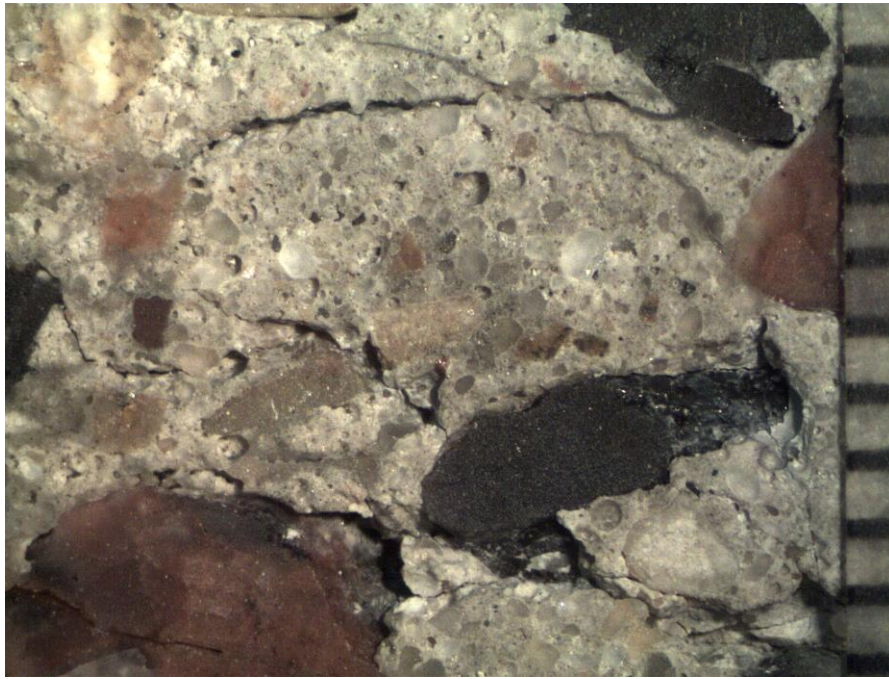
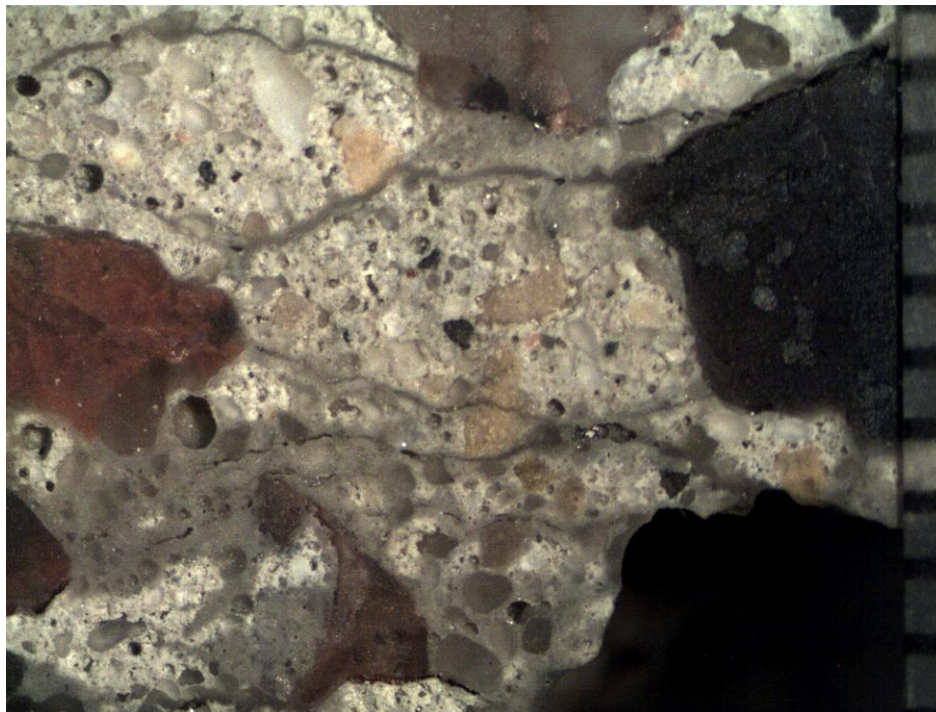
1. Several, semi-parallel, fine (0.15 mm and narrower), cracks occur in the bottom 40 mm (1.5 in.) of the core (Figure 7). The cracks are oriented parallel to the wearing surface. This sort of crack orientation is quite typically seen as a result of freeze-thaw damage. Portions of the bottom of the slab have spalled away along these cracks. The cracks pass around and through granite aggregate particles, suggesting significant tensile force was applied to cause these cracks to form.

Several, semi-parallel, fine (0.15 mm and narrower), cracks occur in the bottom 40 mm (1.5 in.) of the core (Figure 7). The cracks are oriented parallel to the wearing surface. The cracks pass around and through granite aggregate particles, suggesting significant tensile force was applied to cause these cracks to form.

Figure 7. Photomicrographs illustrating semi-parallel, fine (0.15 mm and narrower) cracks occurring in the bottom 40 mm (1.5 in.) of the core. The cracks are oriented parallel to the wearing surface. The cracks pass around and through granite aggregate particles, suggesting significant tensile force was applied to cause these cracks to form. Scales are in millimeters.

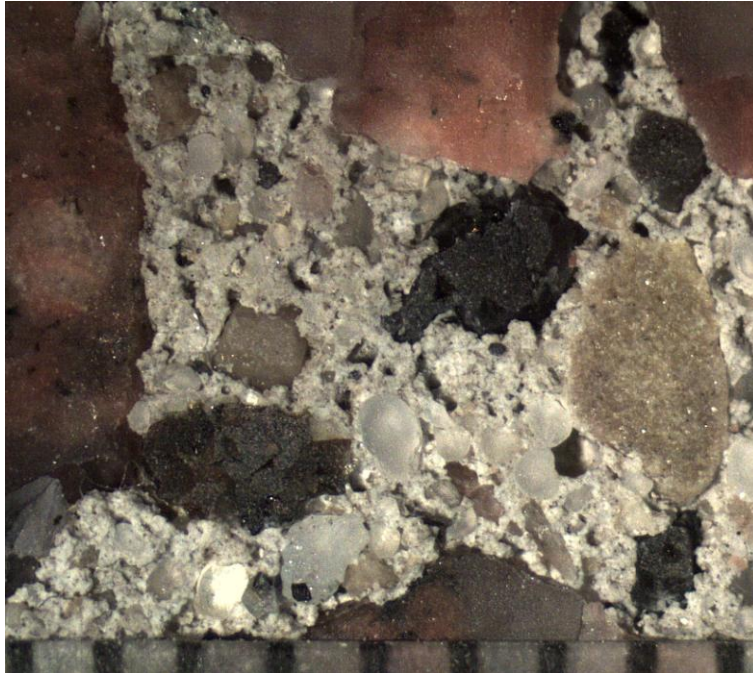
8. These areas of soft, high water-to-cement ratio and high air comprise over 50% of the core area and are not considered resistant to freezing and thawing service conditions.

This variability in water-to-cement ratio, particularly being present as inconsistent masses within the concrete indicates the addition of retempering water followed by incomplete mixing of the retempered water. These soft areas comprise over 50% of the core area and are not considered resistant to freezing and thawing service conditions.

Figure 8. Photomicrograph showing an area of highly porous, very soft and chalky cement paste that has a high water-to-cement ratio (estimated to be in excess of 0.65). These soft areas comprise over 50% of the core area and are not considered resistant to freezing and thawing service conditions. Scale is in millimeters.

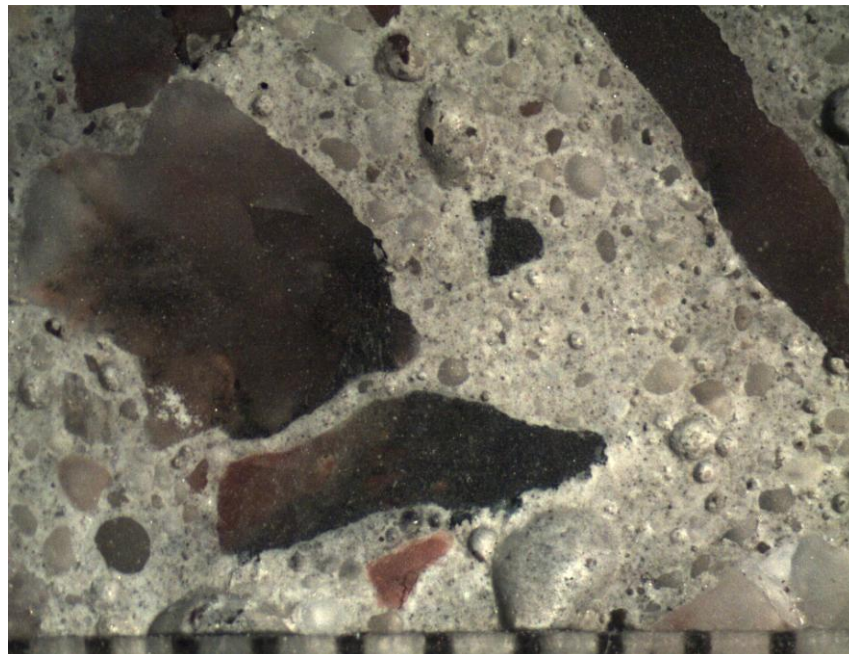
5. Based on paste properties observed, water-cement ratio is estimated to be moderately high and in the range of 0.55-to-0.65, except in the soft, porous areas devoid of normal hydration. In the soft areas, the water-to-cement ratio is high and estimated to be in excess of 0.65.

Figure 9. Photomicrograph along an area of lower water-to-cement ratio paste that is slightly harder, denser and with an estimated water-cement ratio in the range of 0.55-to-0.65. Scale is in millimeters.

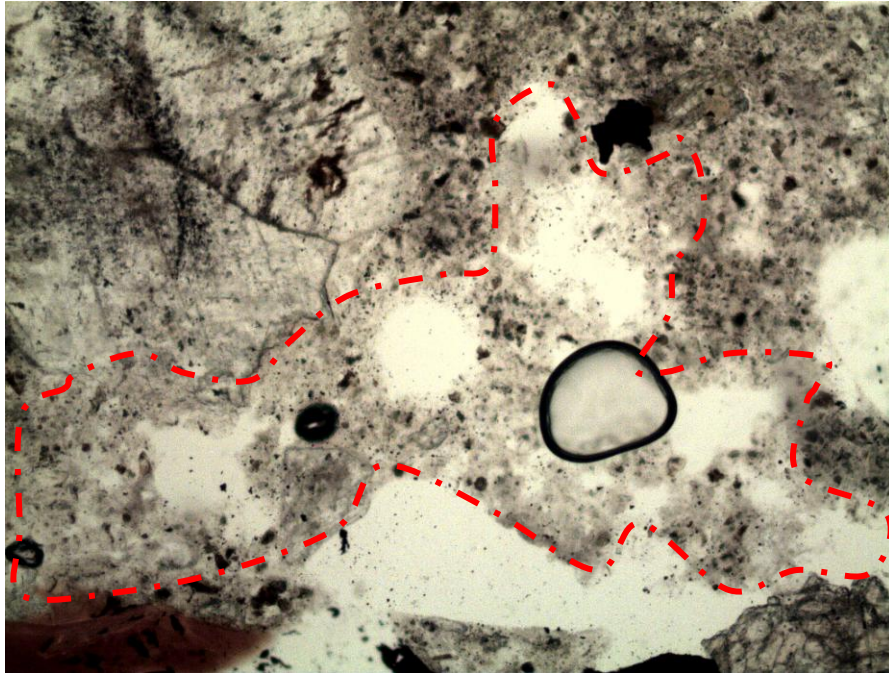
Some areas of the cement paste contain virtually no residual cement particles but contain very large calcium hydroxide masses (Figures 10 and 11). These areas are highly porous, very soft and chalky (Figure 8). In other areas, paste is slightly harder, denser (Figure 9) and residual cement particles are present and are estimated to be 4-to-6 %, by volume of paste. Calcium hydroxide, a normal hydration product, is abundant as very fine crystalline masses and estimated as 12-to-17% of the paste, by volume; Figure 12). No evidence of supplementary cementitious materials was observed.

Figure 10. Thin section photomicrograph showing an area of highly porous, very soft and chalky cement paste that has a high water-to-cement ratio (estimated to be in excess of 0.65). The cement paste contains virtually no residual cement particles and is highly porous (within red dashed circle) compared to surrounding cement paste. 100x magnification. Plane-polarized light.

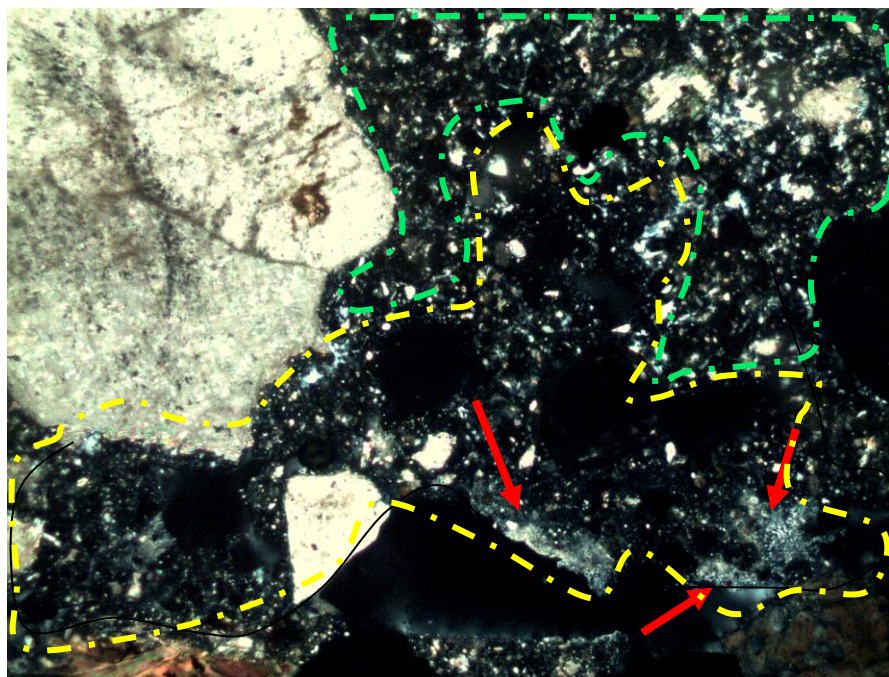
Figure 11. Thin section photomicrograph of the same area as Figure 10, only in cross-polarized light. Red arrows point to very large masses of calcium hydroxide. Area within yellow dashed circle is devoid of normal hydration. Area with green dashed circle shows normal hydration. 100x magnification.

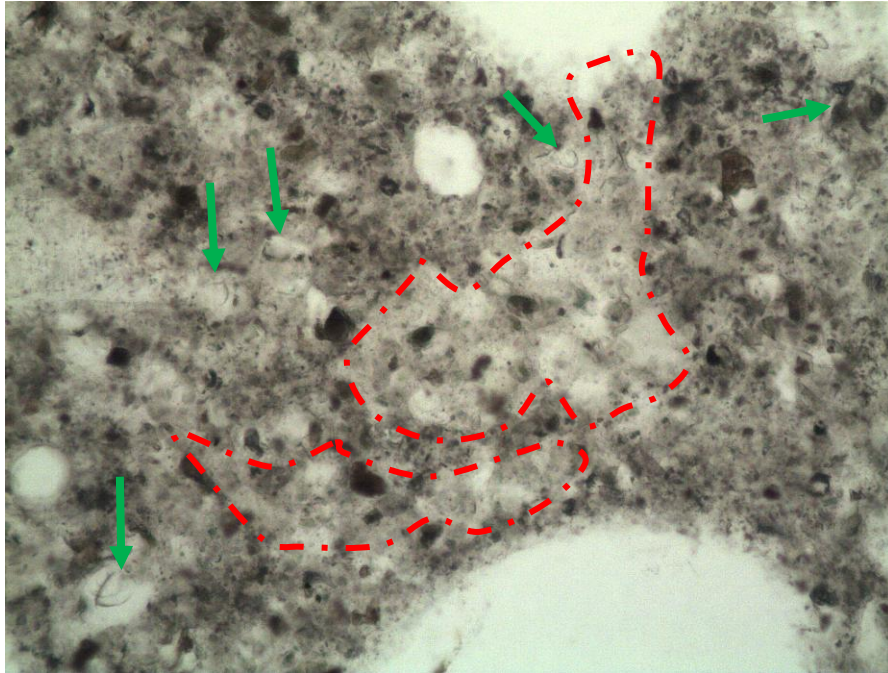
Figure 12. Thin section photomicrograph of an area of lower water-to-cement ratio (in the range of 0.55-to-0.65) where residual cement particles are present (green arrows). Within the red dashed circles are small areas of high water-to-cement ratio. Plane-polarized light. 200x magnification.

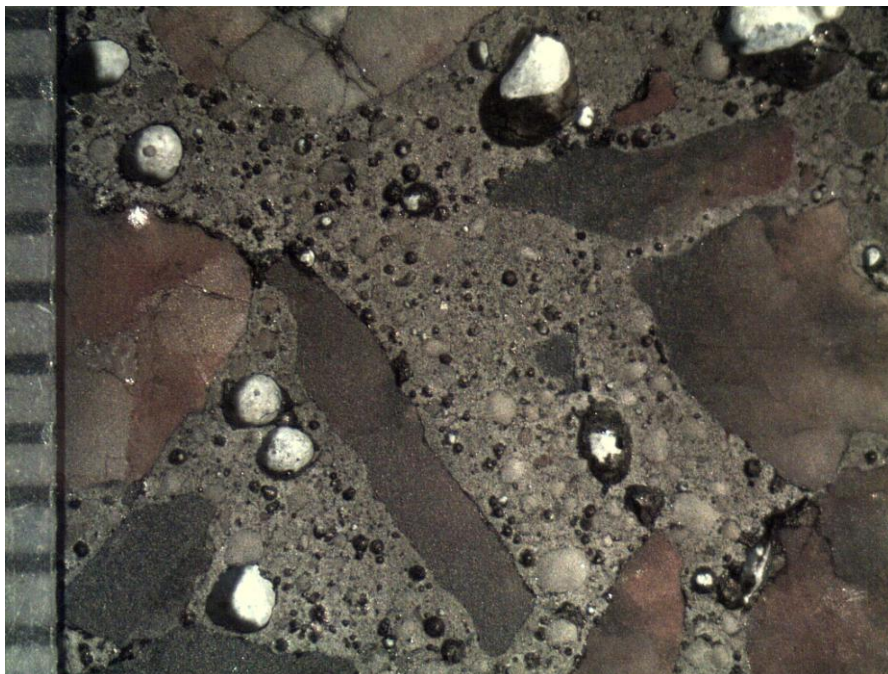
The concrete contains small-to-large and irregularly shaped voids, which are typical of entrapped air and numerous tiny, spherical voids typical of entrained air (Figure 13). Therefore, the concrete is air entrained. However, the air content varies and corresponds to the areas of very high water content. Air content is estimated to be 6-to-7%, by volume of concrete in the harder, denser sections of concrete. But, in the areas of very high water content, there is a very high degree of clustering of air voids and a very high void content, estimated to be 15-to-20% (Figure 14). This high of an air content would also adversely affect the freeze-thaw durability of the concrete.

Figure 13. Photomicrograph along a lapped section of the core that has an estimated water-cement ratio in the range of 0.55-to-0.65. The surface has been dyed black to bring out the air voids. Voids are both large and irregular (entrapped air) and tiny and spherical (entrained air). Air content is estimated to be 6-to-7%, by volume of concrete. Scale is in millimeters.

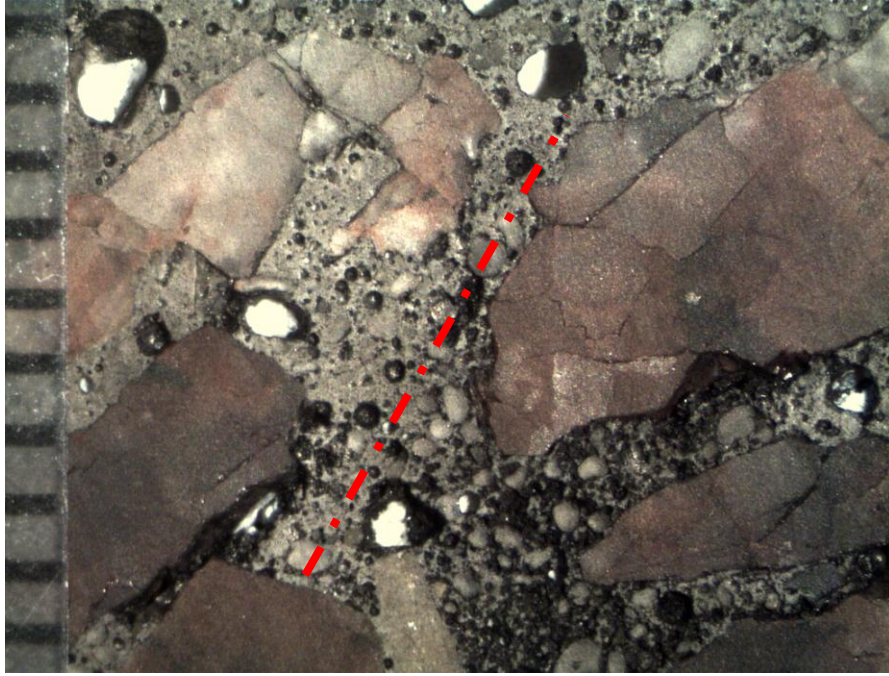
6. Air content varies. Air content is estimated to be 6-to-7%, by volume of concrete in the harder, denser sections of concrete, which is well within the range to provide resistance to freezing and thawing damage in concrete with a 3/8 in. maximum size. But, in the areas of very high water-to-cement ratio, there is a very high degree of clustering of air voids and a very high void content, estimated to be 15-to-20% (Figure 14). This high of an air content would also adversely affect the freeze-thaw durability of the concrete.

7. This variability in water-to-cement ratio and pockets of clustered air voids of high air content, particularly being present as inconsistent masses within the concrete, indicates addition of retempering water followed by incomplete mixing of the retempered water.

Figure 14. Photomicrograph along a lapped section of the core that is on the border of an area that has an estimated water-cement ratio in the range of 0.55-to-0.65 (left of red dashed line) and an area of very high water-to-cement ratio (right of red dashed line). The surface has been dyed black to bring out the air voids. The area of high water-to-cement ratio has an excessively high air content and a significant amount of void clustering, which is typical of retempered concrete. Scale is in millimeters.
