EXISTING BUILDING REVIEW

121-123 State Street

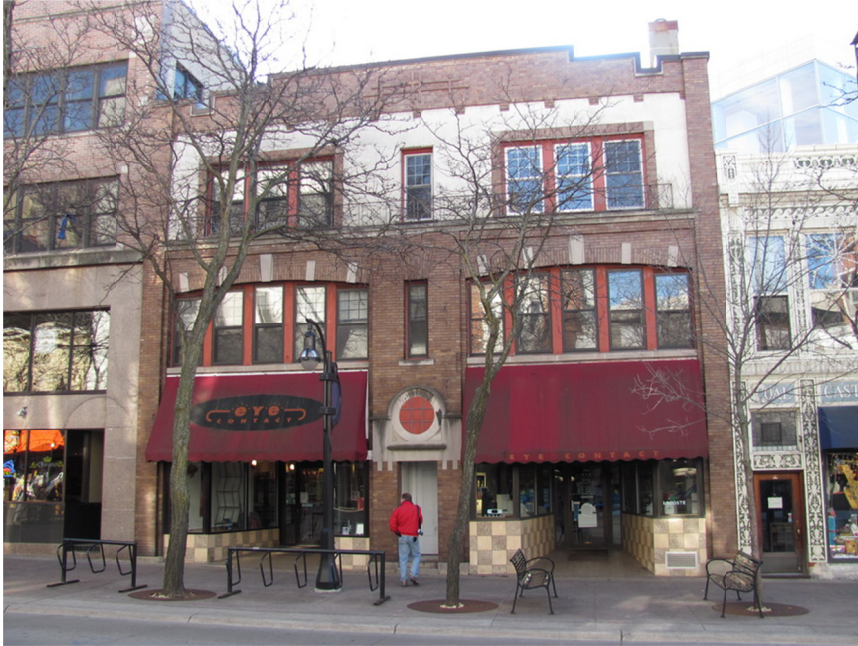
Figure 1. Overall view of the State Street facade.

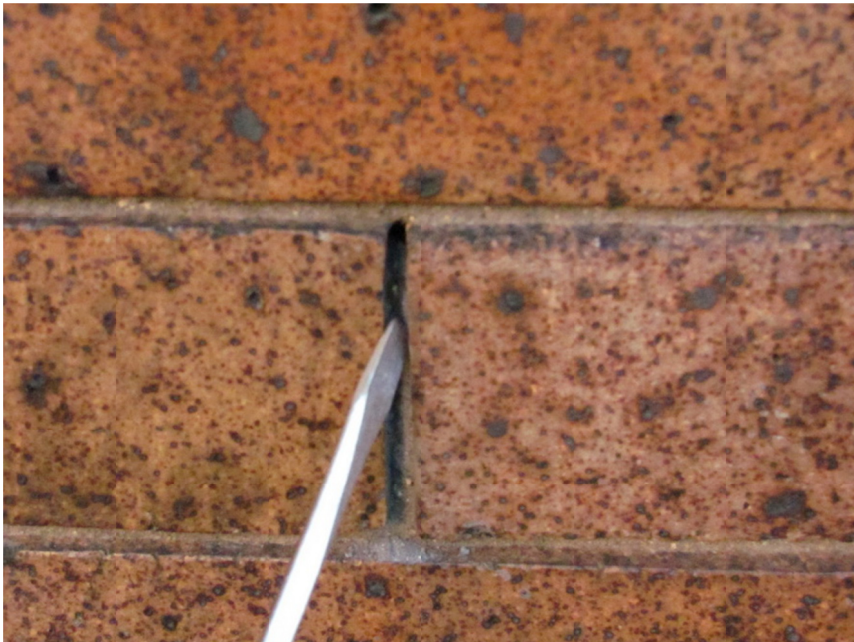
Figure 4. Occasional open mortar joints were observed.

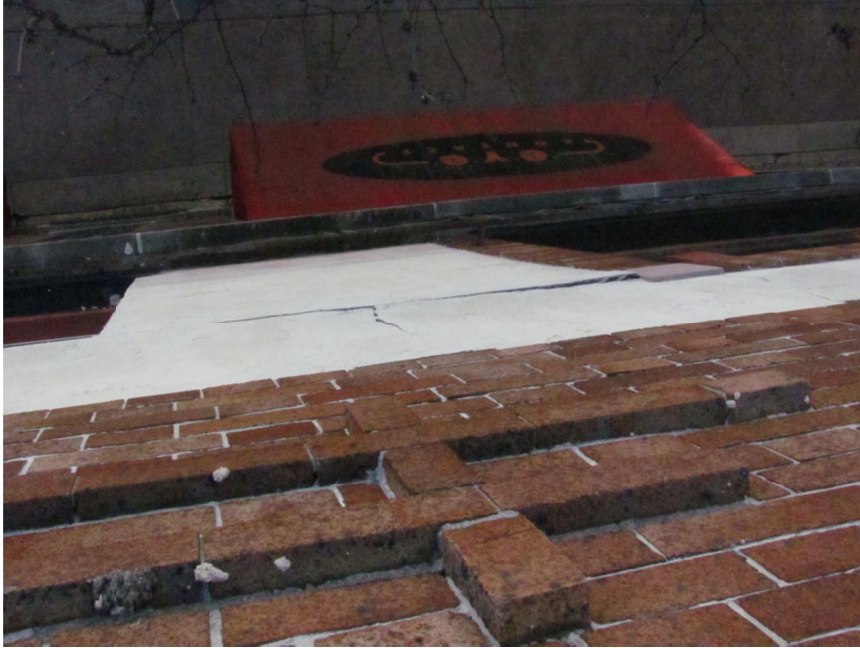
Figure 5. View from the roof of one especially large delaminated area of stucco observed near the middle of the facade.

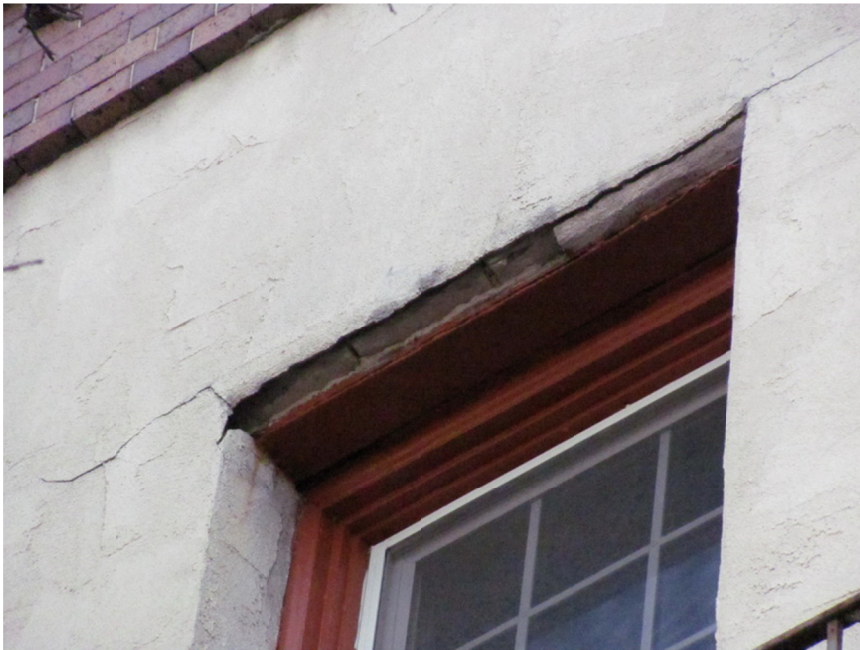
Figure 6. A portion of stucco has previously spalled at the head of the center third floor window.

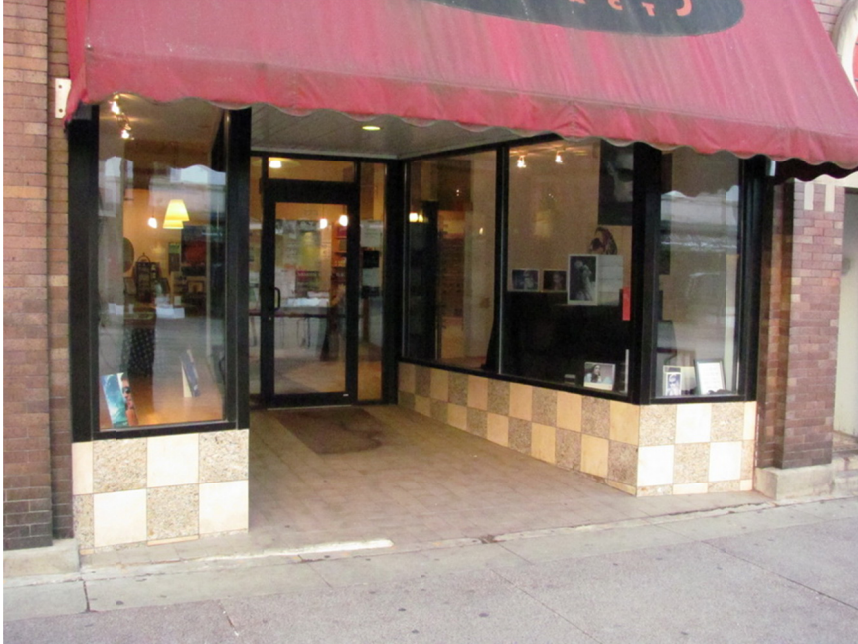
Figure 7. The first floor storefronts are relatively new aluminum-framed windows above a tile-clad knee wall.

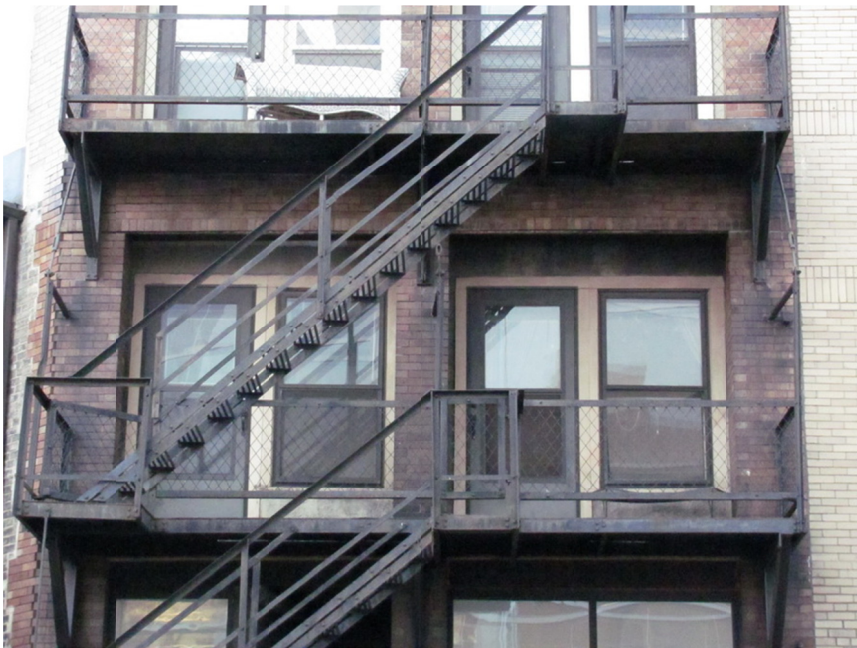
Figure 12. The balconies and fire escapes appeared intact, with areas of paint loss and surface corrosion.

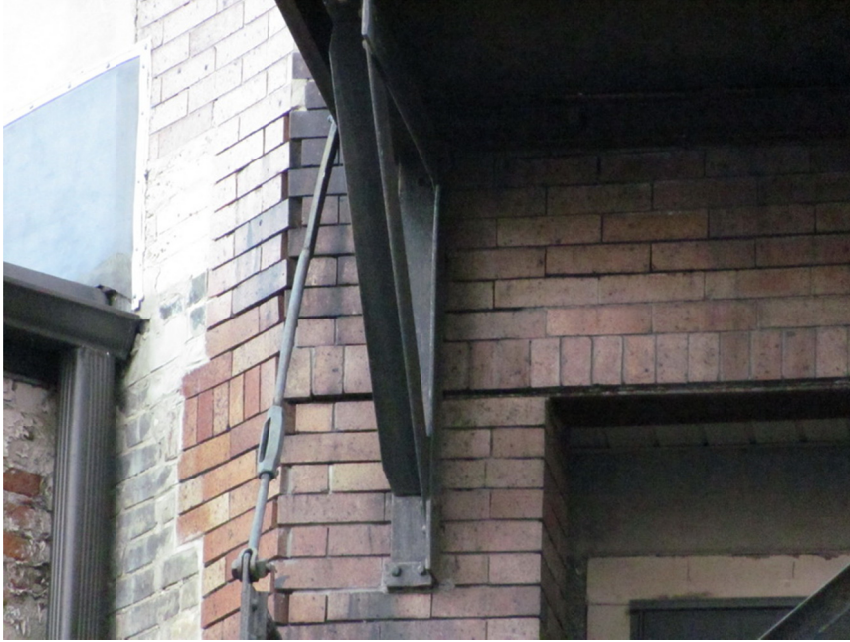
Figure 13. Surface corrosion and minor displacement of masonry associated with the bearing points of the lintels was observed.

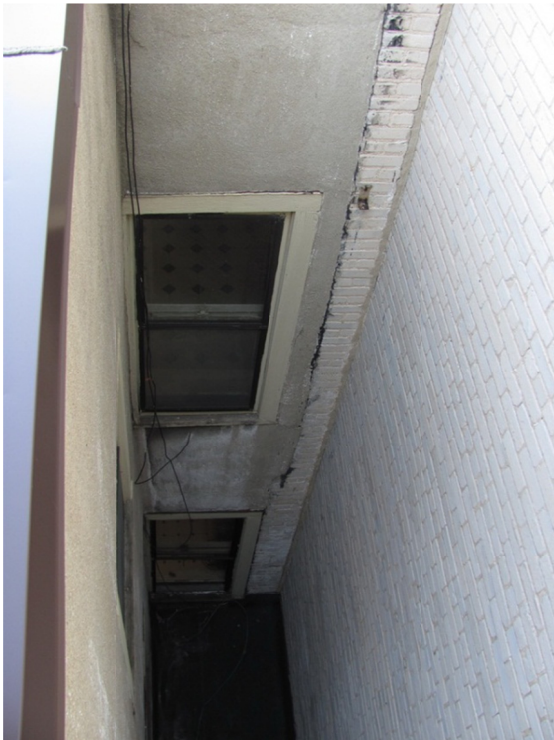
Figure 14. Two-story light well along the east wall of the building.

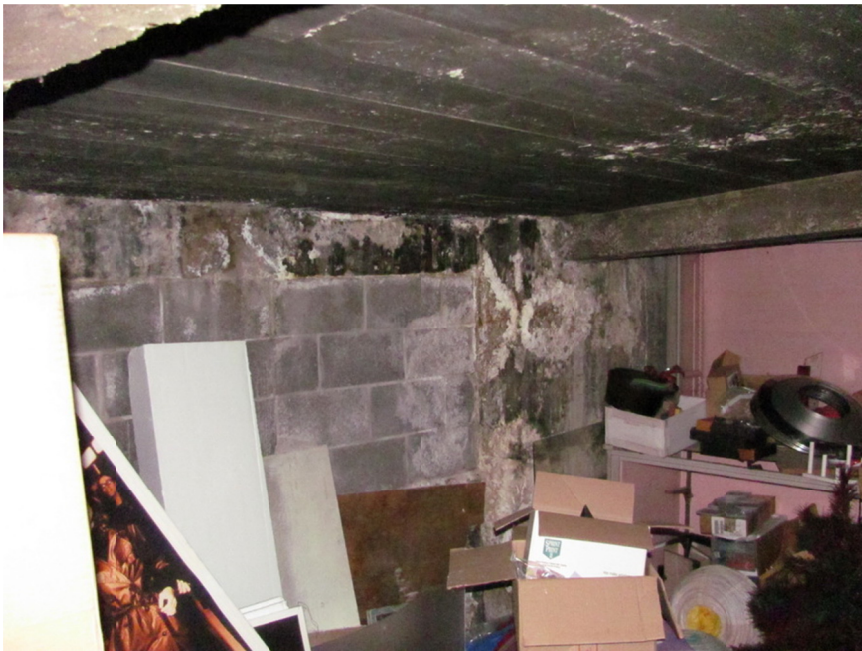
Figure 22. Efflorescence and water staining at the basement level below the entrance storefront.

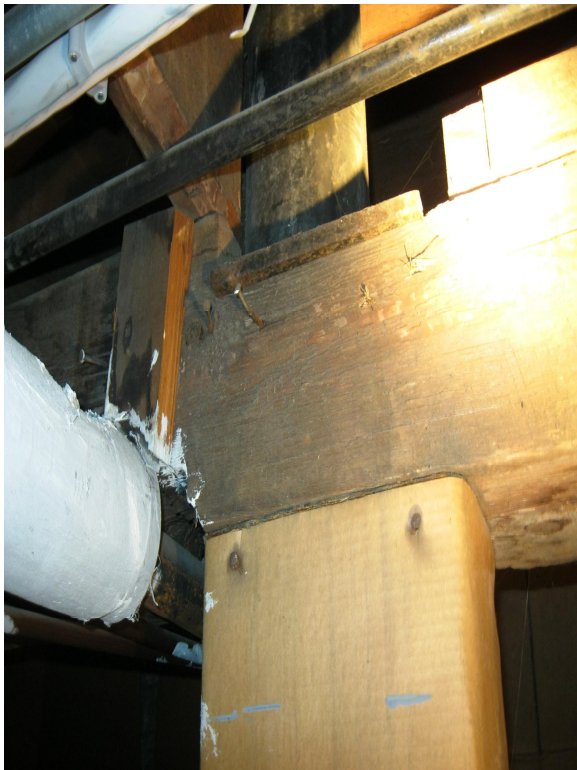
Photo 1 – Notched 1st floor beam requiring replacement

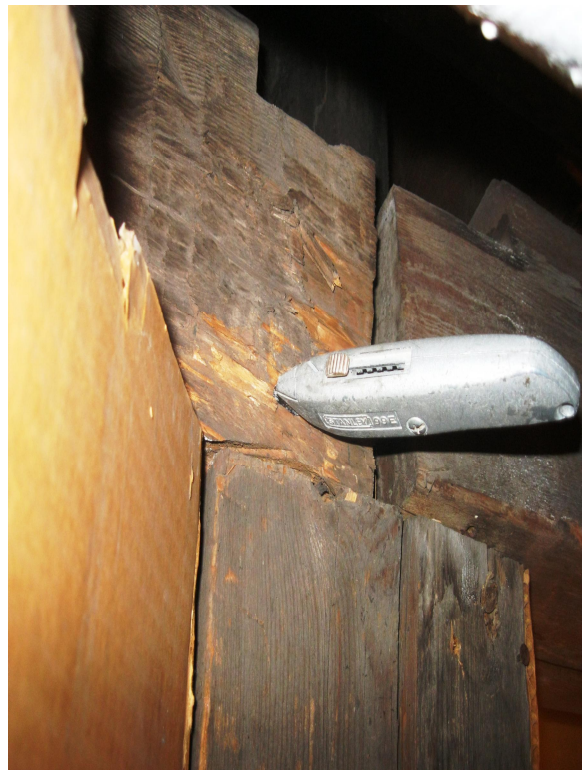
Photo 2 – Poor fit up and wood density at 1st floor beams and column

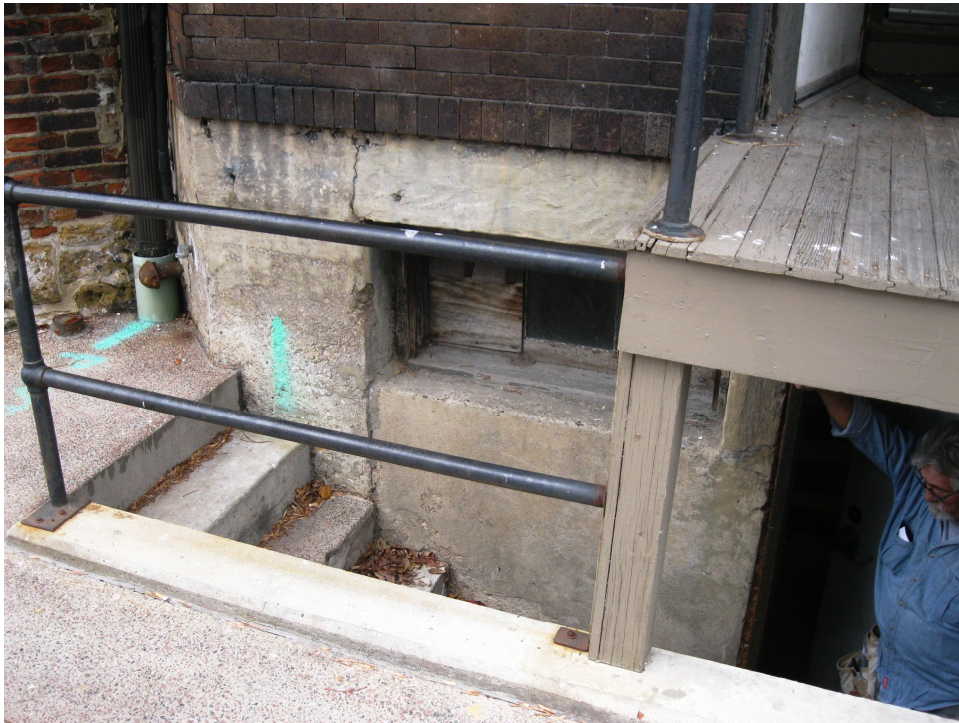
Photo 4 – Stair to basement from Fairchild Street

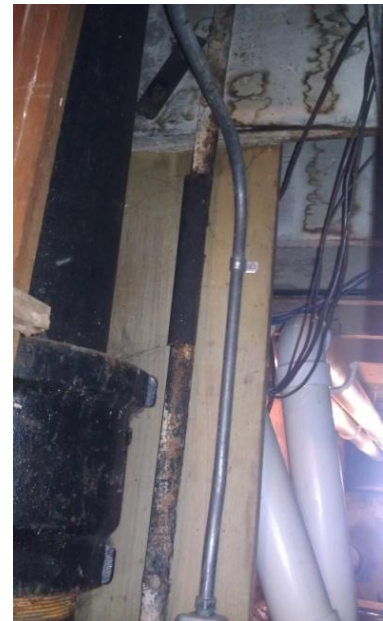
Failing storm main support

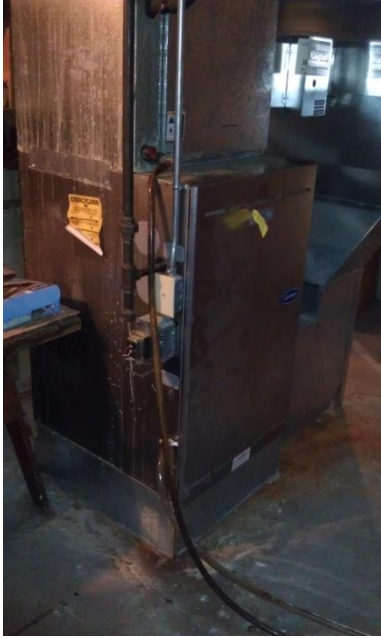
The building does not have a fire protection system.

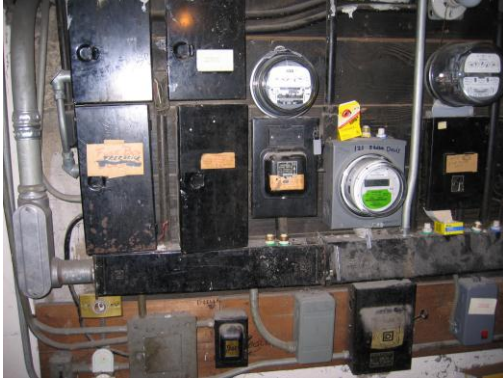
A portion of the older electrical service equipment in the Basement.
