June 3, 2022

Regarding: 629 Spruce Street

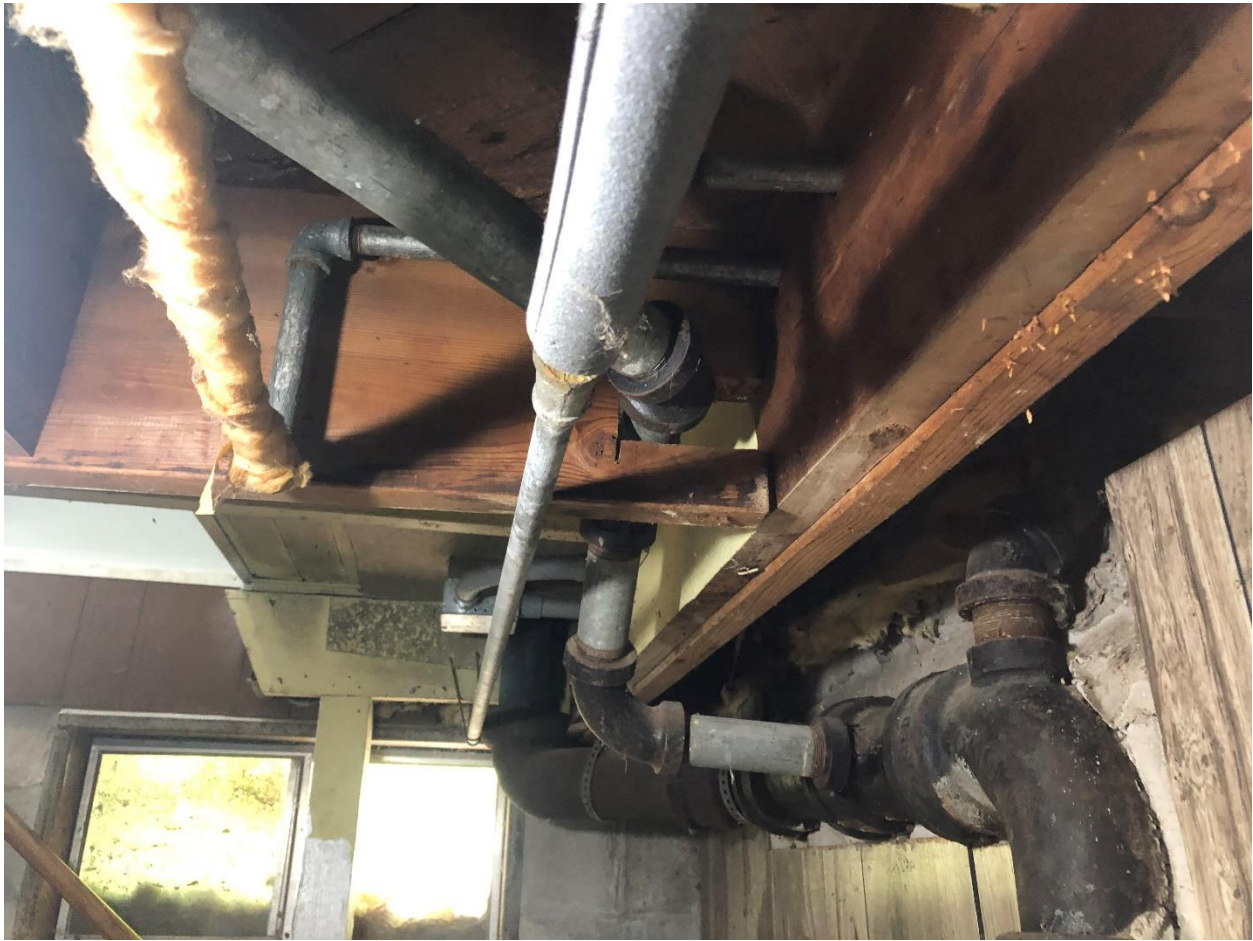
Image showing significant cut out notch at floor header/joist.

The supplemental framing in the basement is lacking some connections. It is important that posts be anchored to the foundations and to the wood framing. Wood columns did not appear to have foundations or base connections. Several notches were noted in original wood framing that should

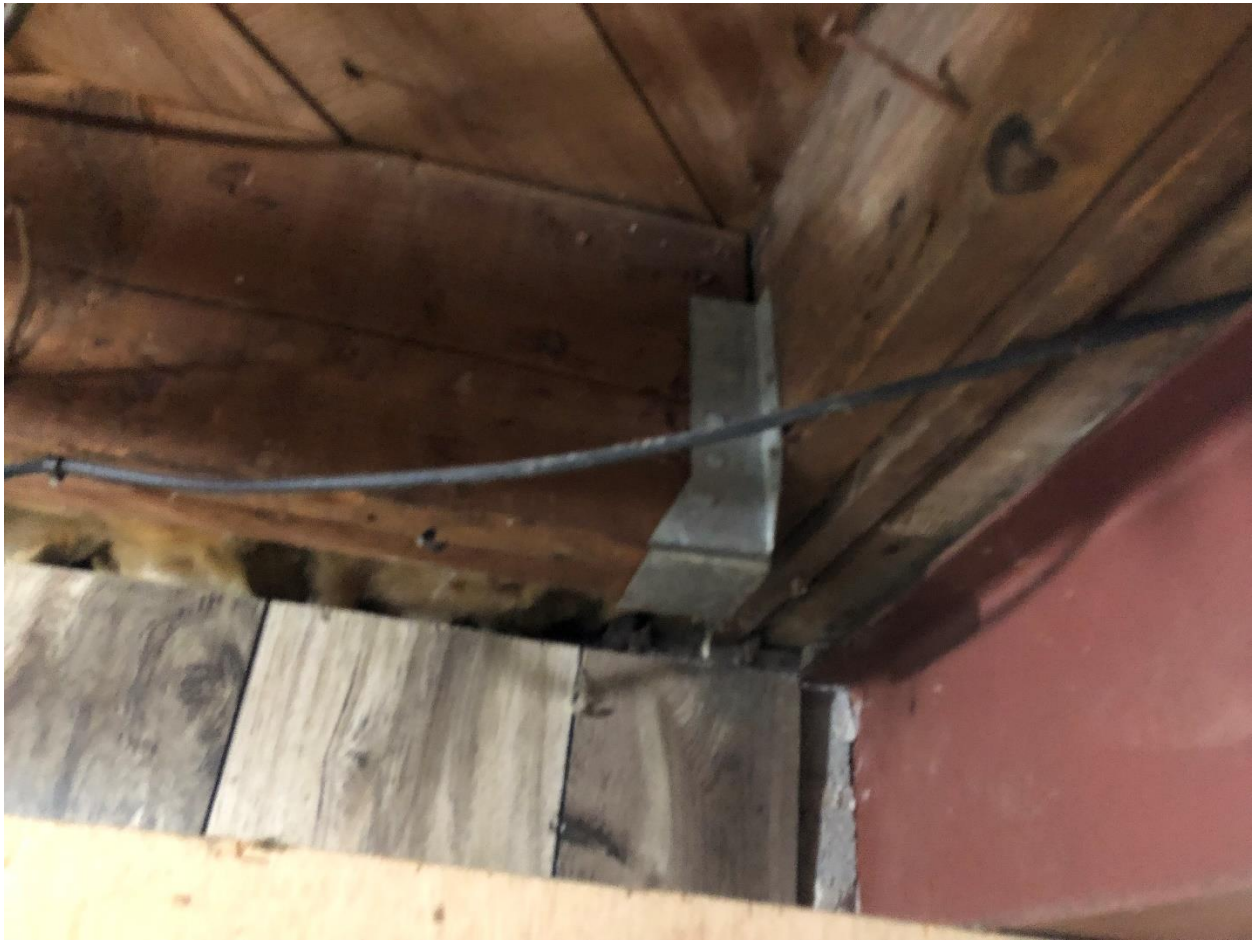
be reinforced. Several supports needed to be addressed because hangers were not properly installed or their supporting members appeared to be insufficient in strength.

Inappropriate connection at hanger to supporting member.

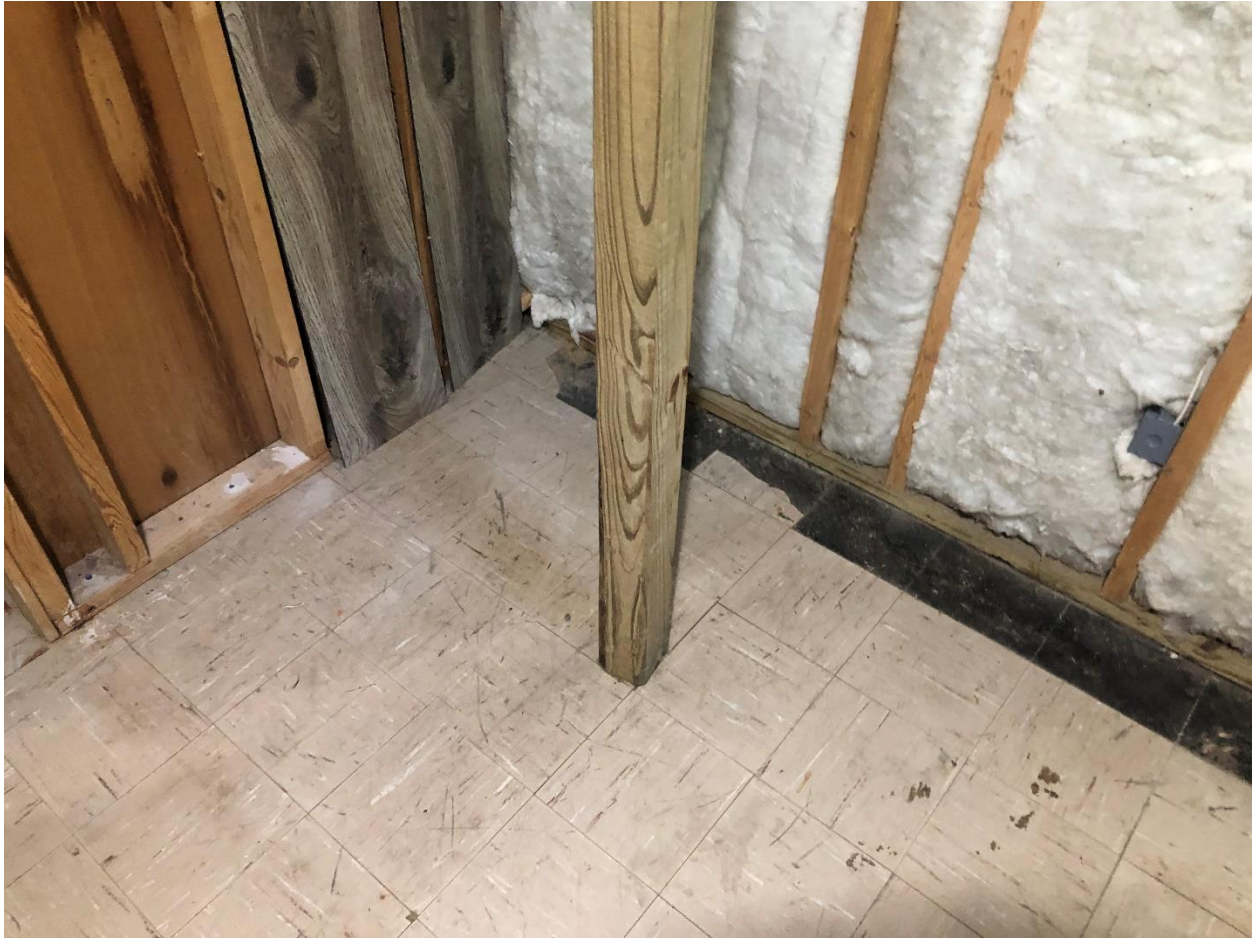
Image showing lack of attachment and lack of foundation at the base of wood columns.

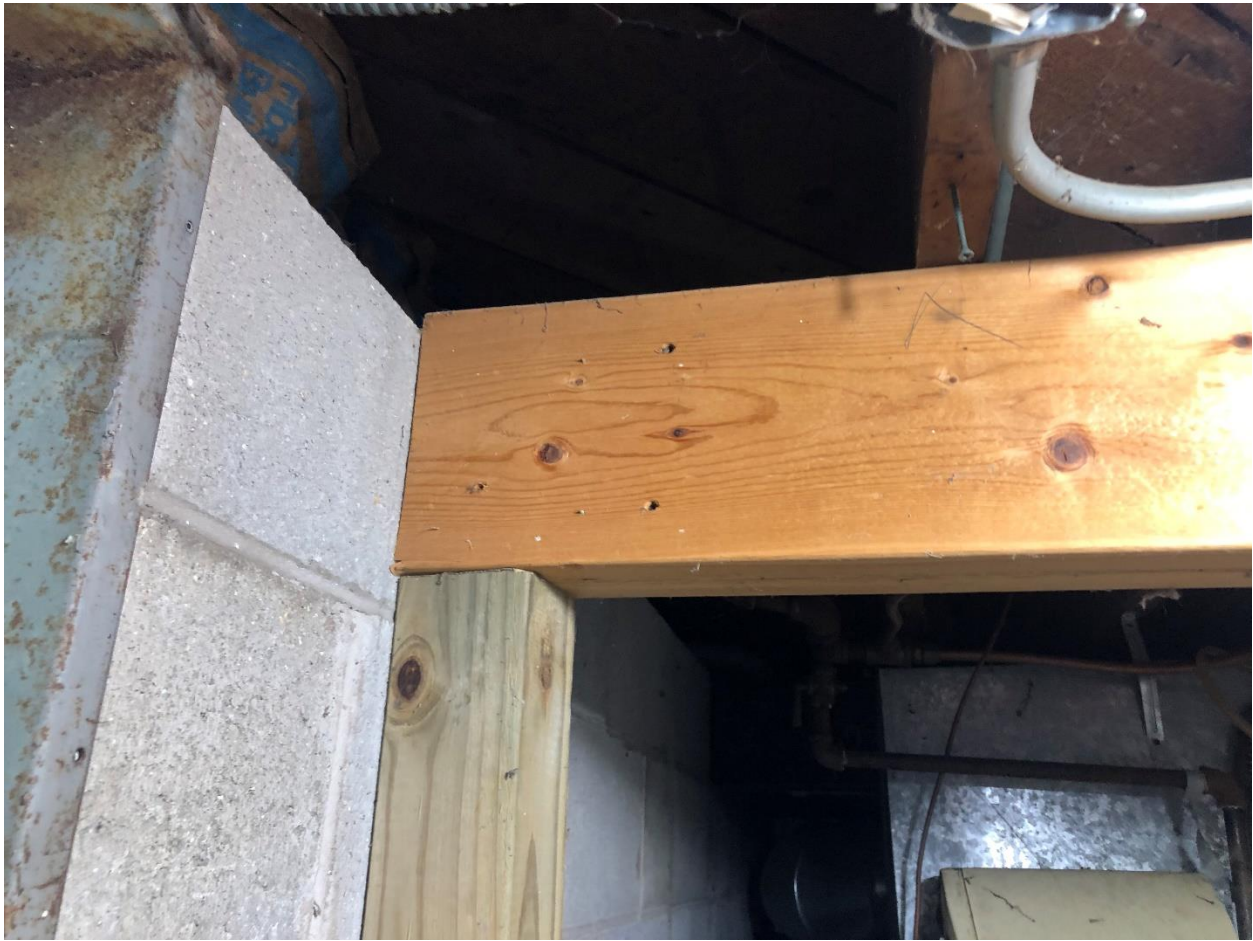
Image showing lack of appropriate structural attachment from the beam to the column. In addition, fastening should also be present at the joist framing to the wood beam.

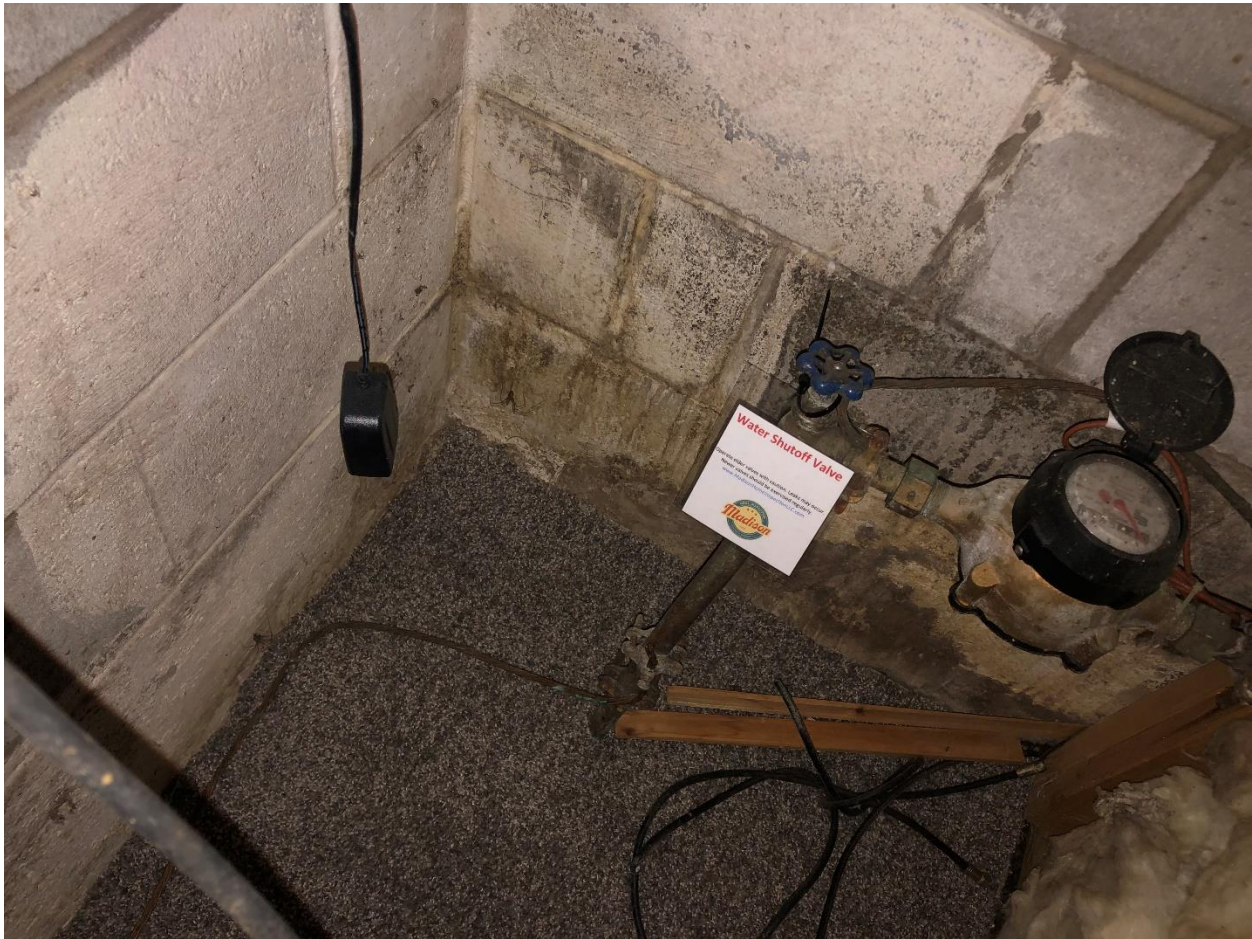
Some past moisture leakage was noted in the CMU walls. Floors were carpeted. We suspect that future leakage could damage recently installed finishes.

Image showing water staining on the base of the exterior foundation wall

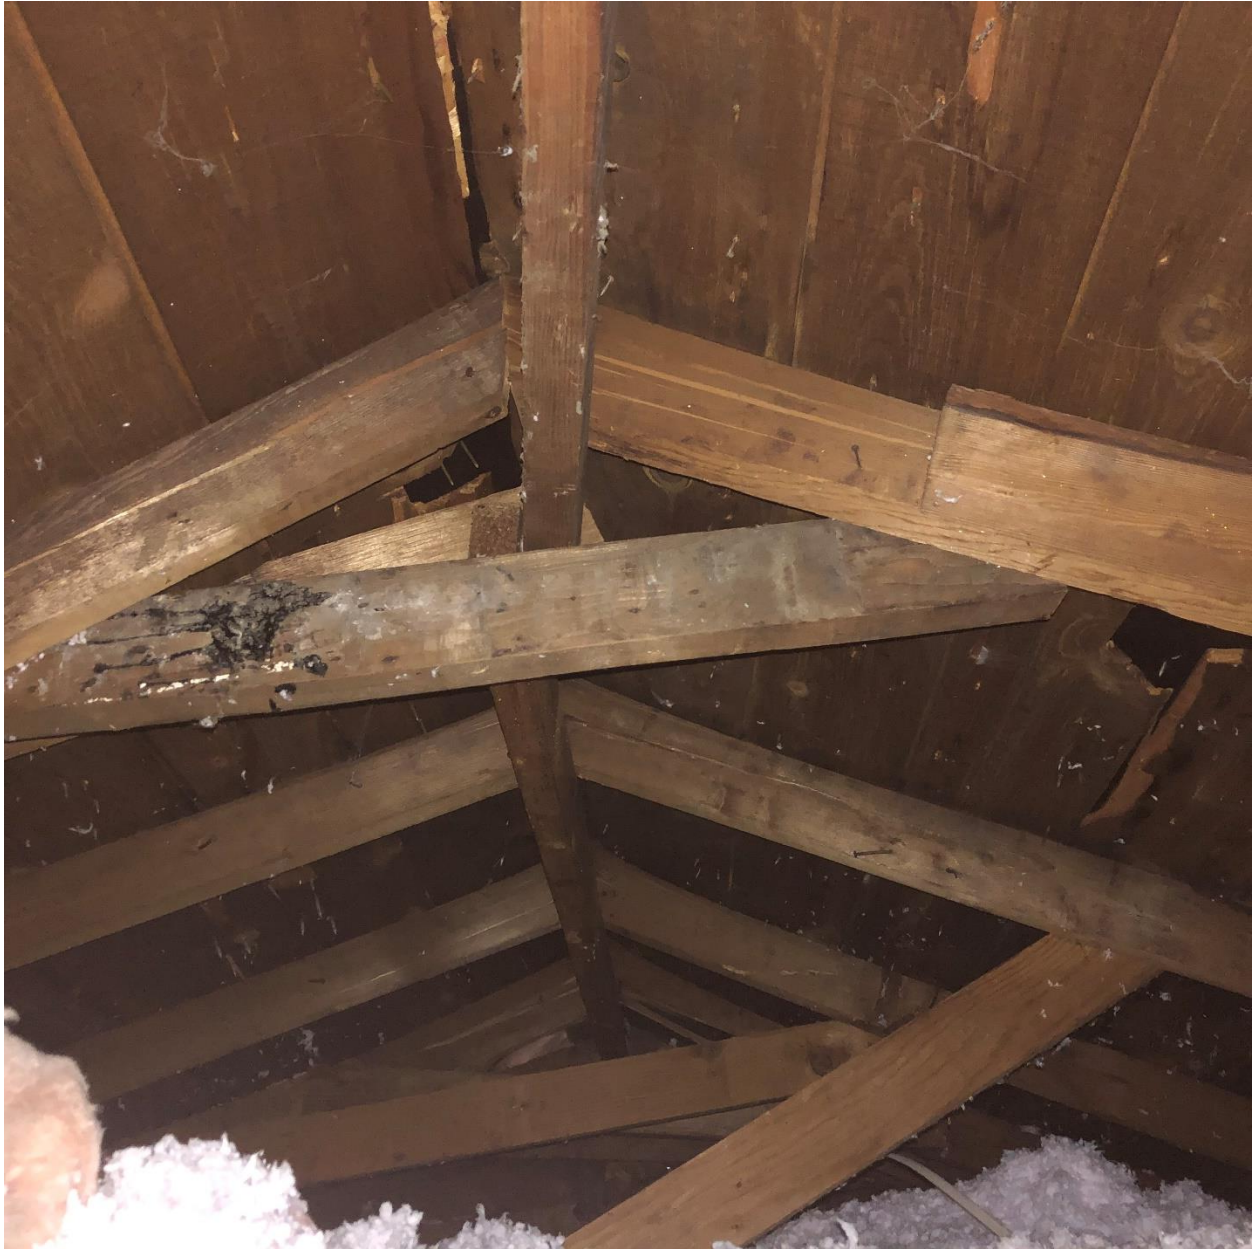
We noted from the access to the attic space that the roof framing was fractured and propped to the walls below with vertical 2x struts. The roof appears to once have been differently configured. We believe that the roof planes had originally extended from the location of the current ridgeline down to the level of the second floor. Some time in its history, the roof planes were changed, swinging the roof surfaces upward and propping the exterior ends with new second story bearing walls, making the roof less steep but attic space converted to space for the bedrooms, hallways and a bathroom. The evidence for this is located at the ridge where rafters meeting only bear against each other with their tips with a pie shaped gap now appearing keeping them from bearing against each other properly. Collar ties have been added to some help, but for the most part, these roof elements likely bear partially on second floor hall walls and load the framing of what was originally attic floor framing. The attic floor framing was not likely substantial; using the framing formally for residential loads may be beyond their safe capacity, not to mention that the framing is also supporting roof loads.

Image showing cracked rafters and cobbled roof framing

- We believe that the roof system is not capable of supporting itself. It should be replaced.
- We believe that the floor of the attic (current second floor) needs to be further evaluated in order to determine if it is strong and stiff enough to support residential loads. It is possible that the floor may need to be reinforced.
- At the very least, the first-floor needs attention to repair joist supports and notches. At the most, the floor system needs further reinforcement to correct possible damage apparent where significant deformations are present. It is likely that some middle ground can be achieved with some additional reinforcement and some understanding that some of the more minor floor sagging can be considered “normal” to older homes.
