**FREIBURGER CONSTRUCTION CONSULTING, Inc.**  
**5438 County Highway M**  
**Fitchburg, WI 53575**  
**(608) 835-0001**

Woodland Montessori School  
1124 Colby St.  
Madison, WI 53715

The following report is based upon observations made at the two school buildings March 21, 2016. The object of the report is to outline the current condition of then two buildings. The final section of the report will list deferred and future maintenance with the object of allowing forward planning for the maintenance of the buildings, modification of the buildings or replacement of the former residential building.

**Photo Log: 114 Van Deusen Street**

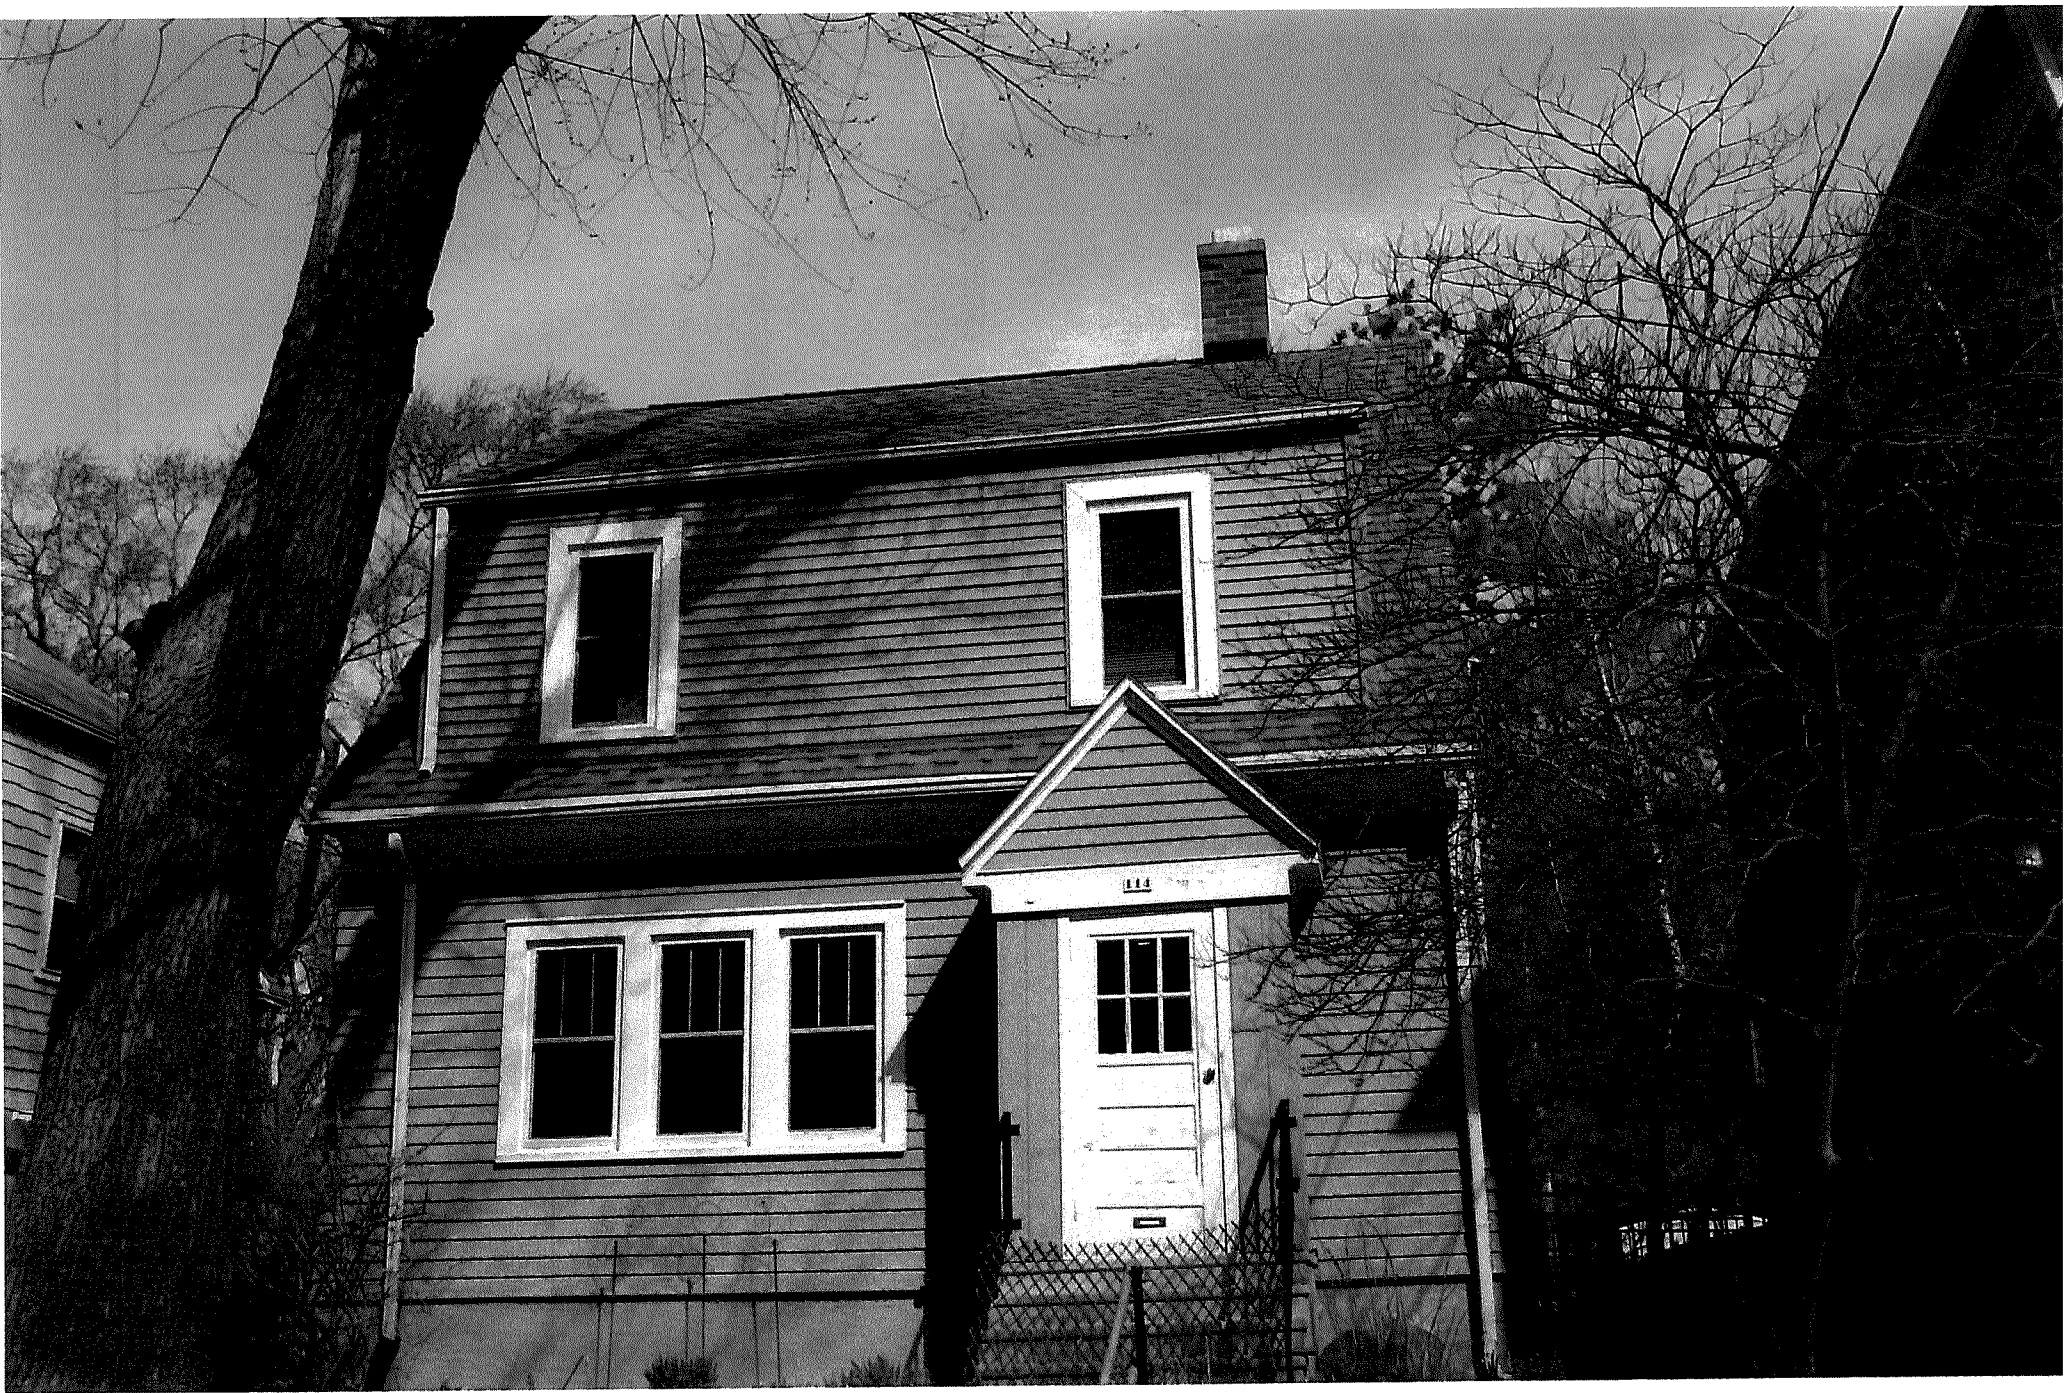
- Photo 37:** Establishing photo of south or front elevation.
- Photo 38:** Entry porch is subsiding. The door lacks the required landing at the top of the steps.

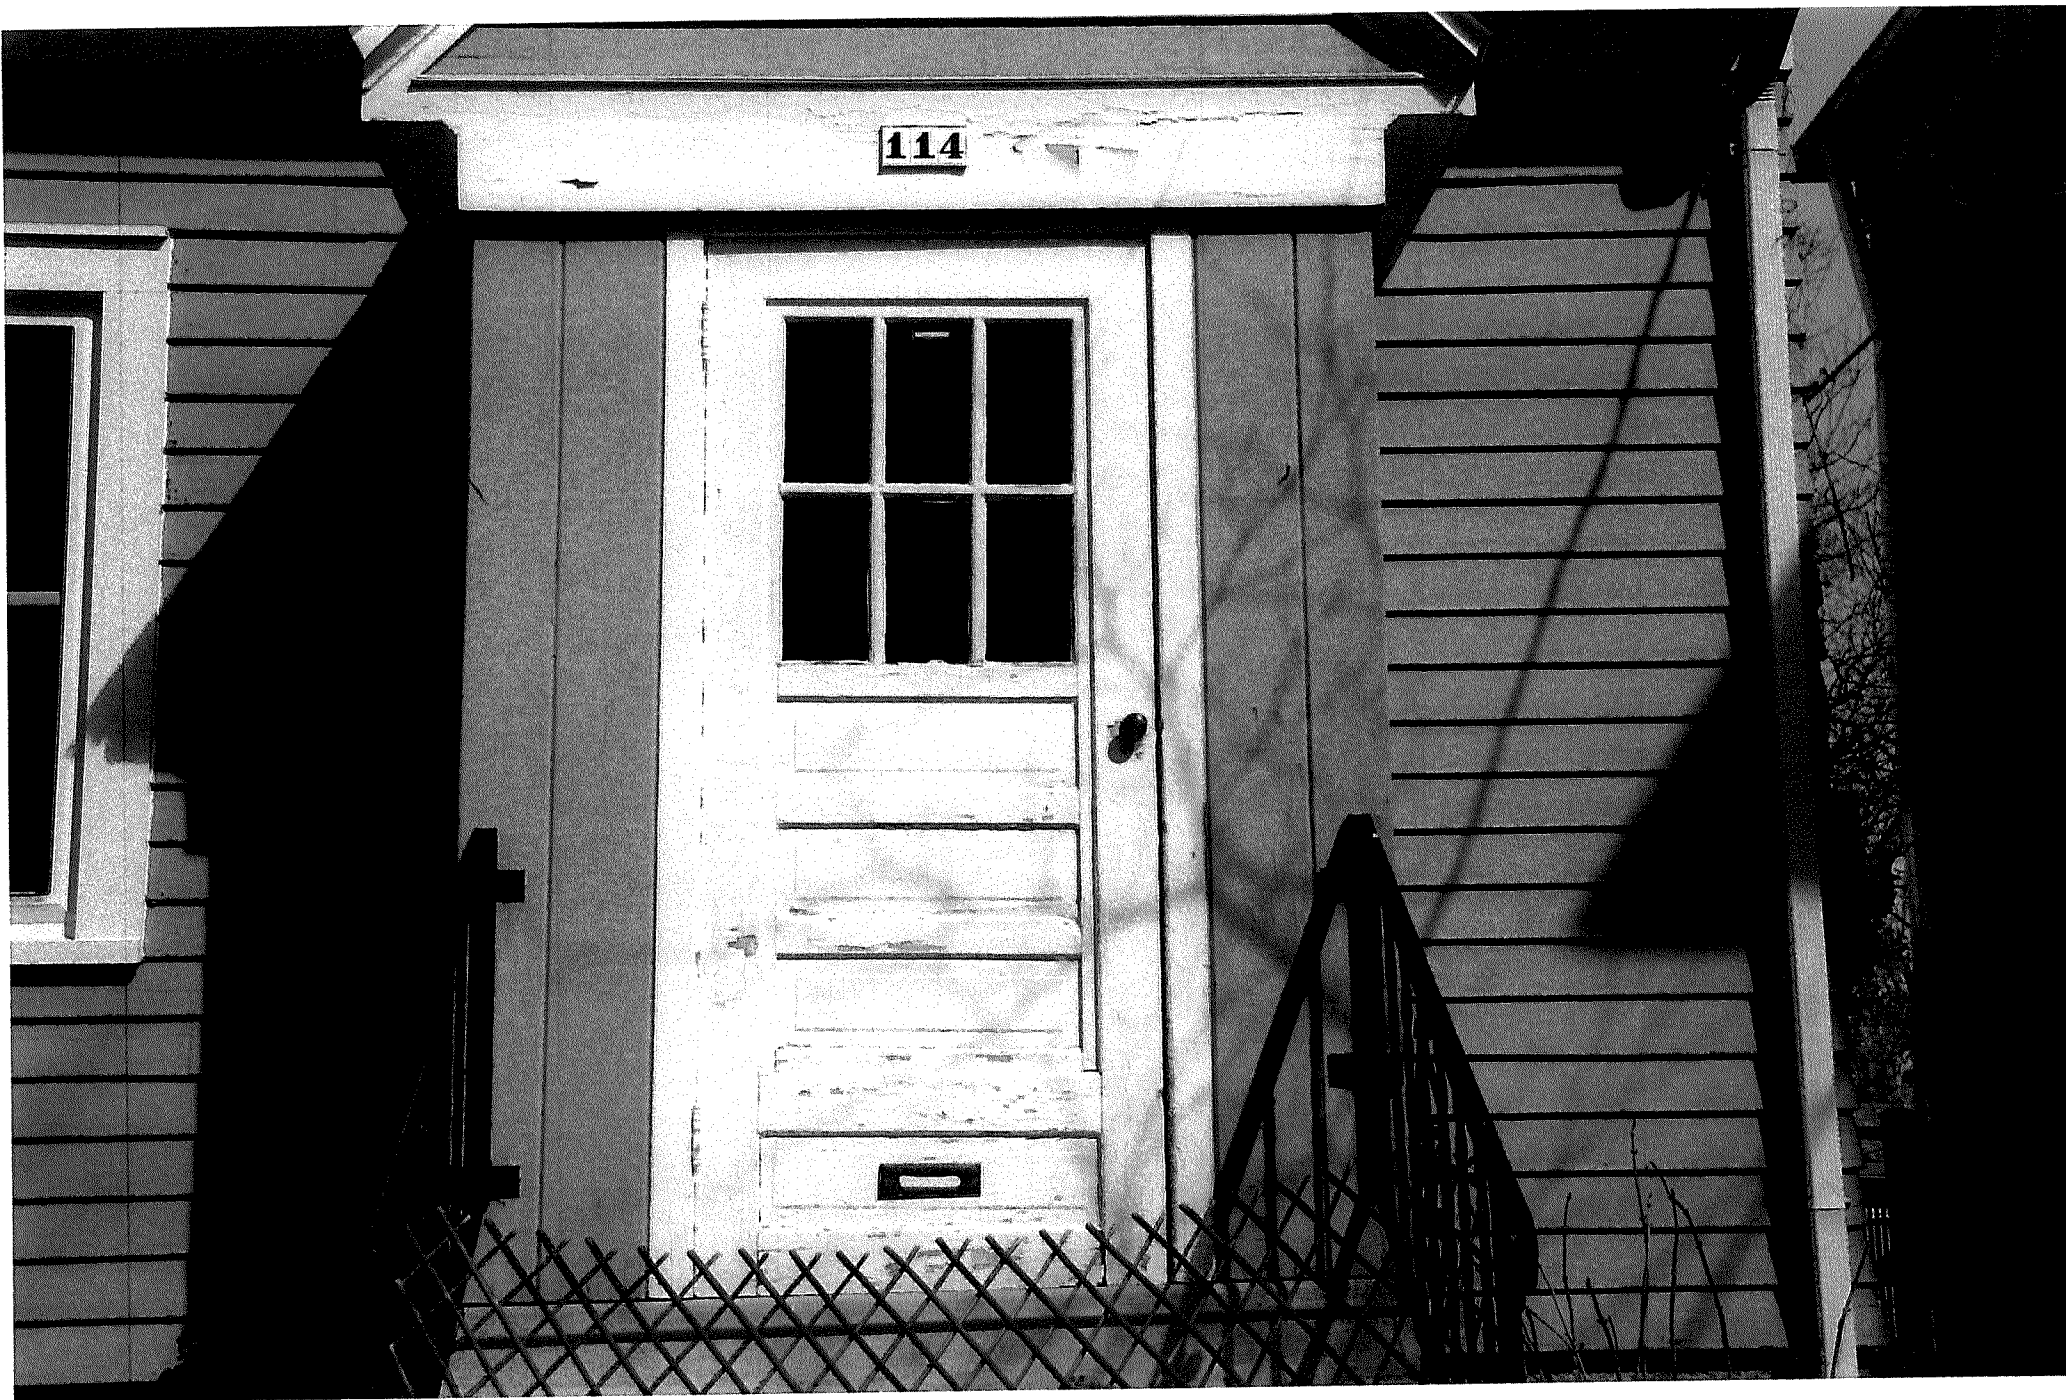
(38)

- 1.4 Porch/entries: The now unused front entry is a poured concrete mass that has subsided over the years. This was once an open area but was enclosed at an unknown date. Now there is no landing at the top of the steps to allow safe access of the door.

Shady setting  
door w/peelings

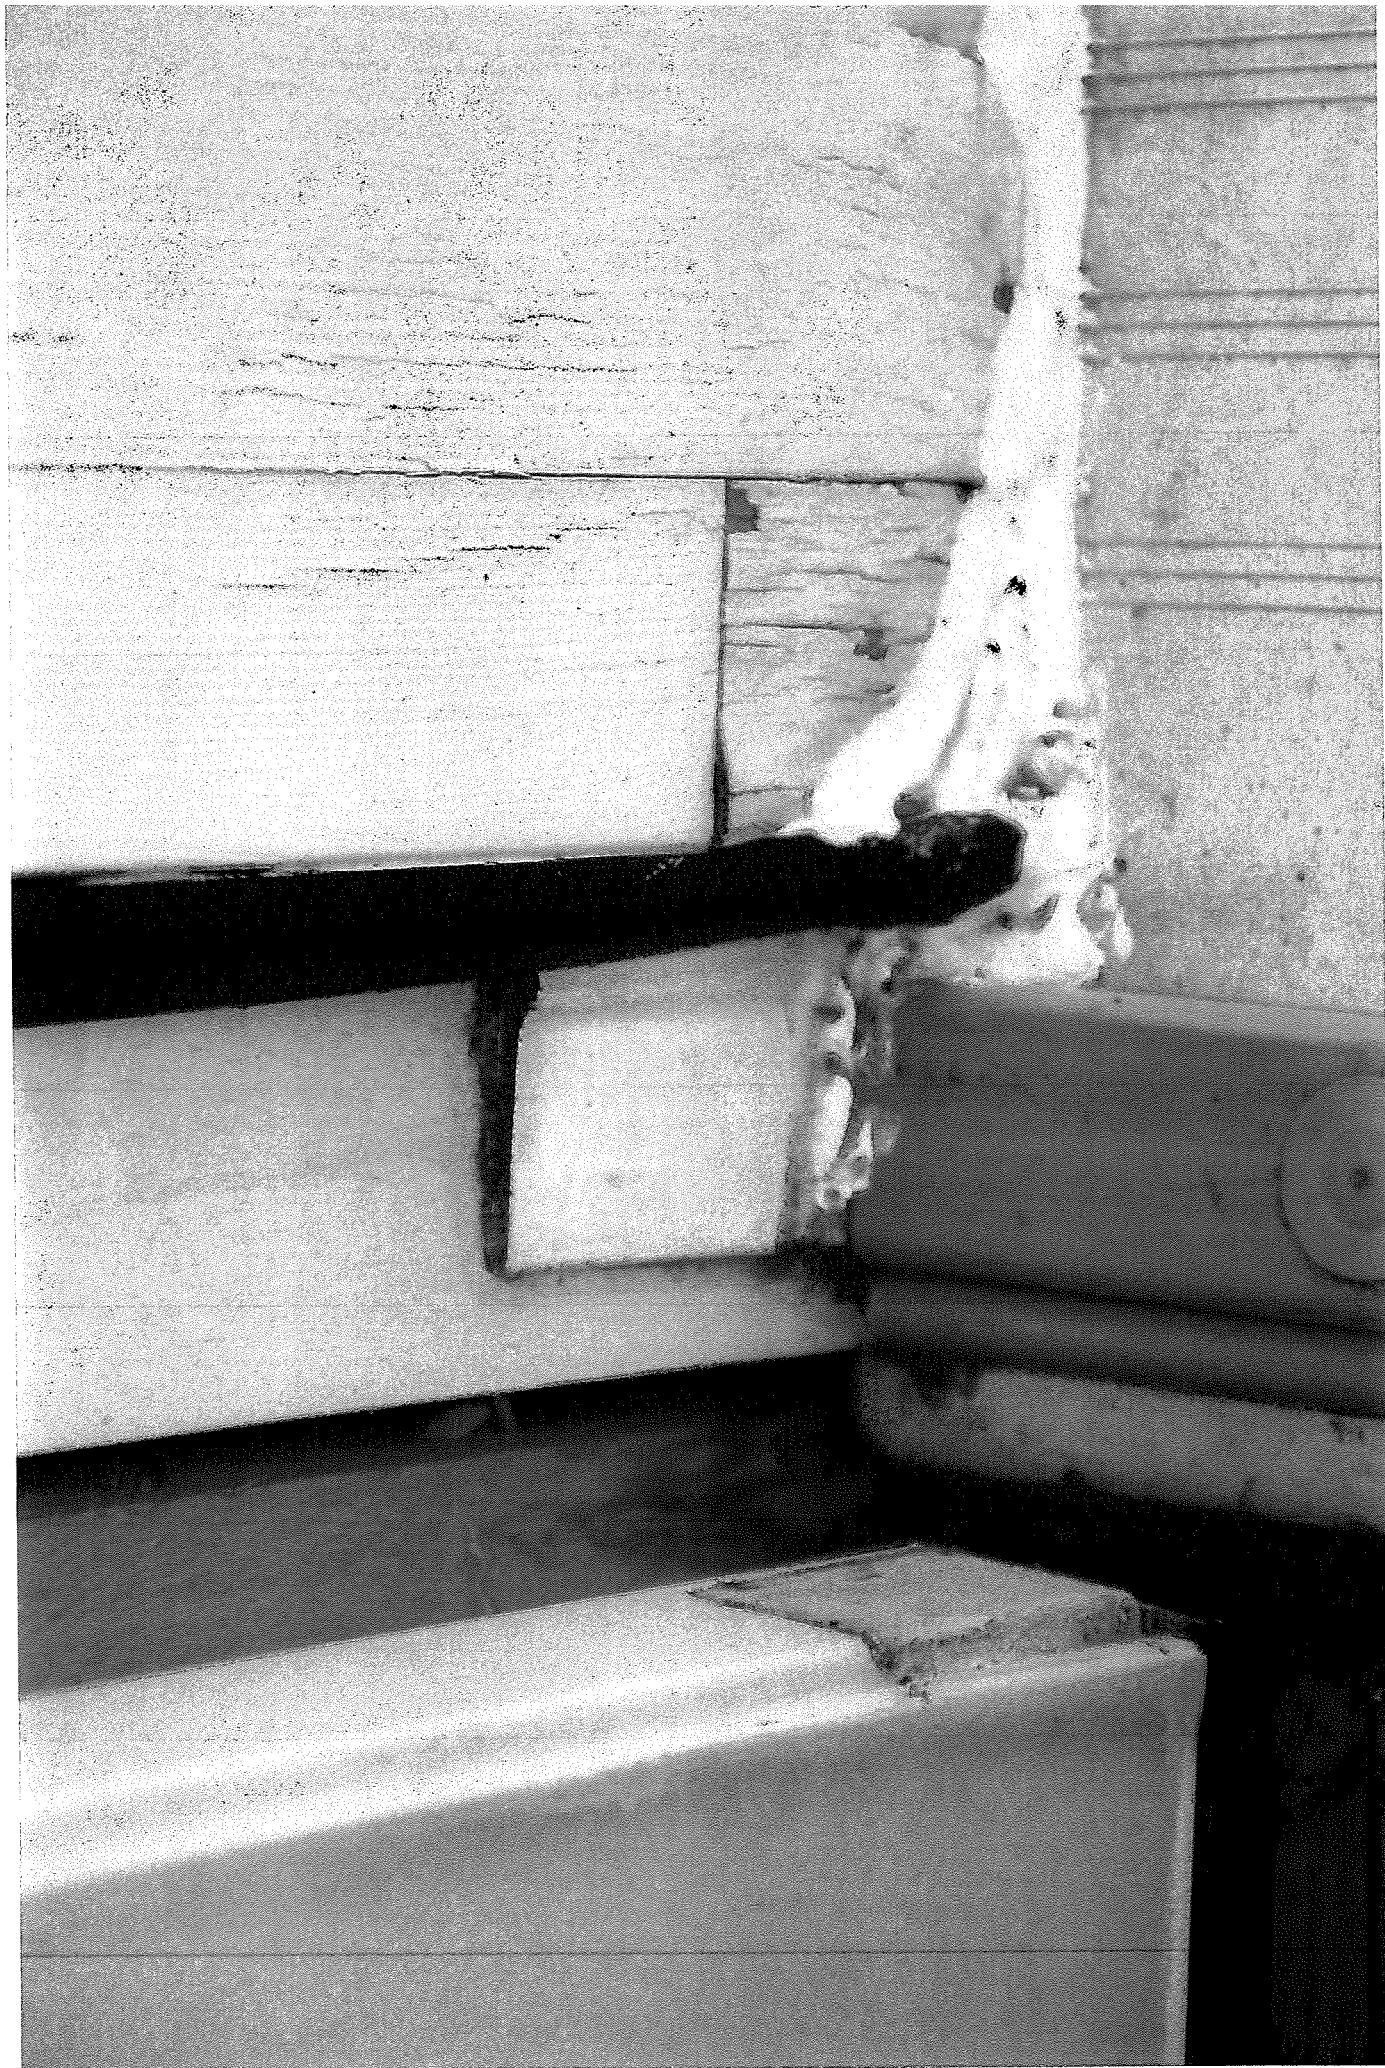
★ (42)

The door added for the second floor jump platform was never completely installed. Open areas exist where water can and does enter the wall system. The stain on the west first floor wall is due to leaking at and around the second floor exist door. This door does not appear to have been correctly flashed and reinstallation or replacement is recommended.

- Photo 41:** Threshold of platform access door where leak exists. Note that jamb is deteriorated.
- Photo 42:** Stain on wall to ceiling interface below platform door leak.

possible mold

- 9.1 Exposed foam: The basement exposed foam needs to be covered. You should also determine if the addition foundation insulation foam is a type allowed by code without a thermal barrier.
- 9.2 Reinstall the second floor platform door with appropriate flashing and casing.
- 9.3 Mount all detectors as required by code in the correct locations.
- 9.4 Plan to replace the west side addition entry structure with a well flashed replacement.
- 9.5 Replace the missing downspout and direct spout discharge as far from the foundation as possible.
- 9.6 Paint all exposed exterior wood where the finish is failing.
- 9.7 Plan to replace the water heater with a modern efficient unit before failure.
- 9.8 Consider an insulation and attic venting plan if the house is to remain in service.
- 9.9 If the house remains in service, study the roof framing and reinforce before insulation is added

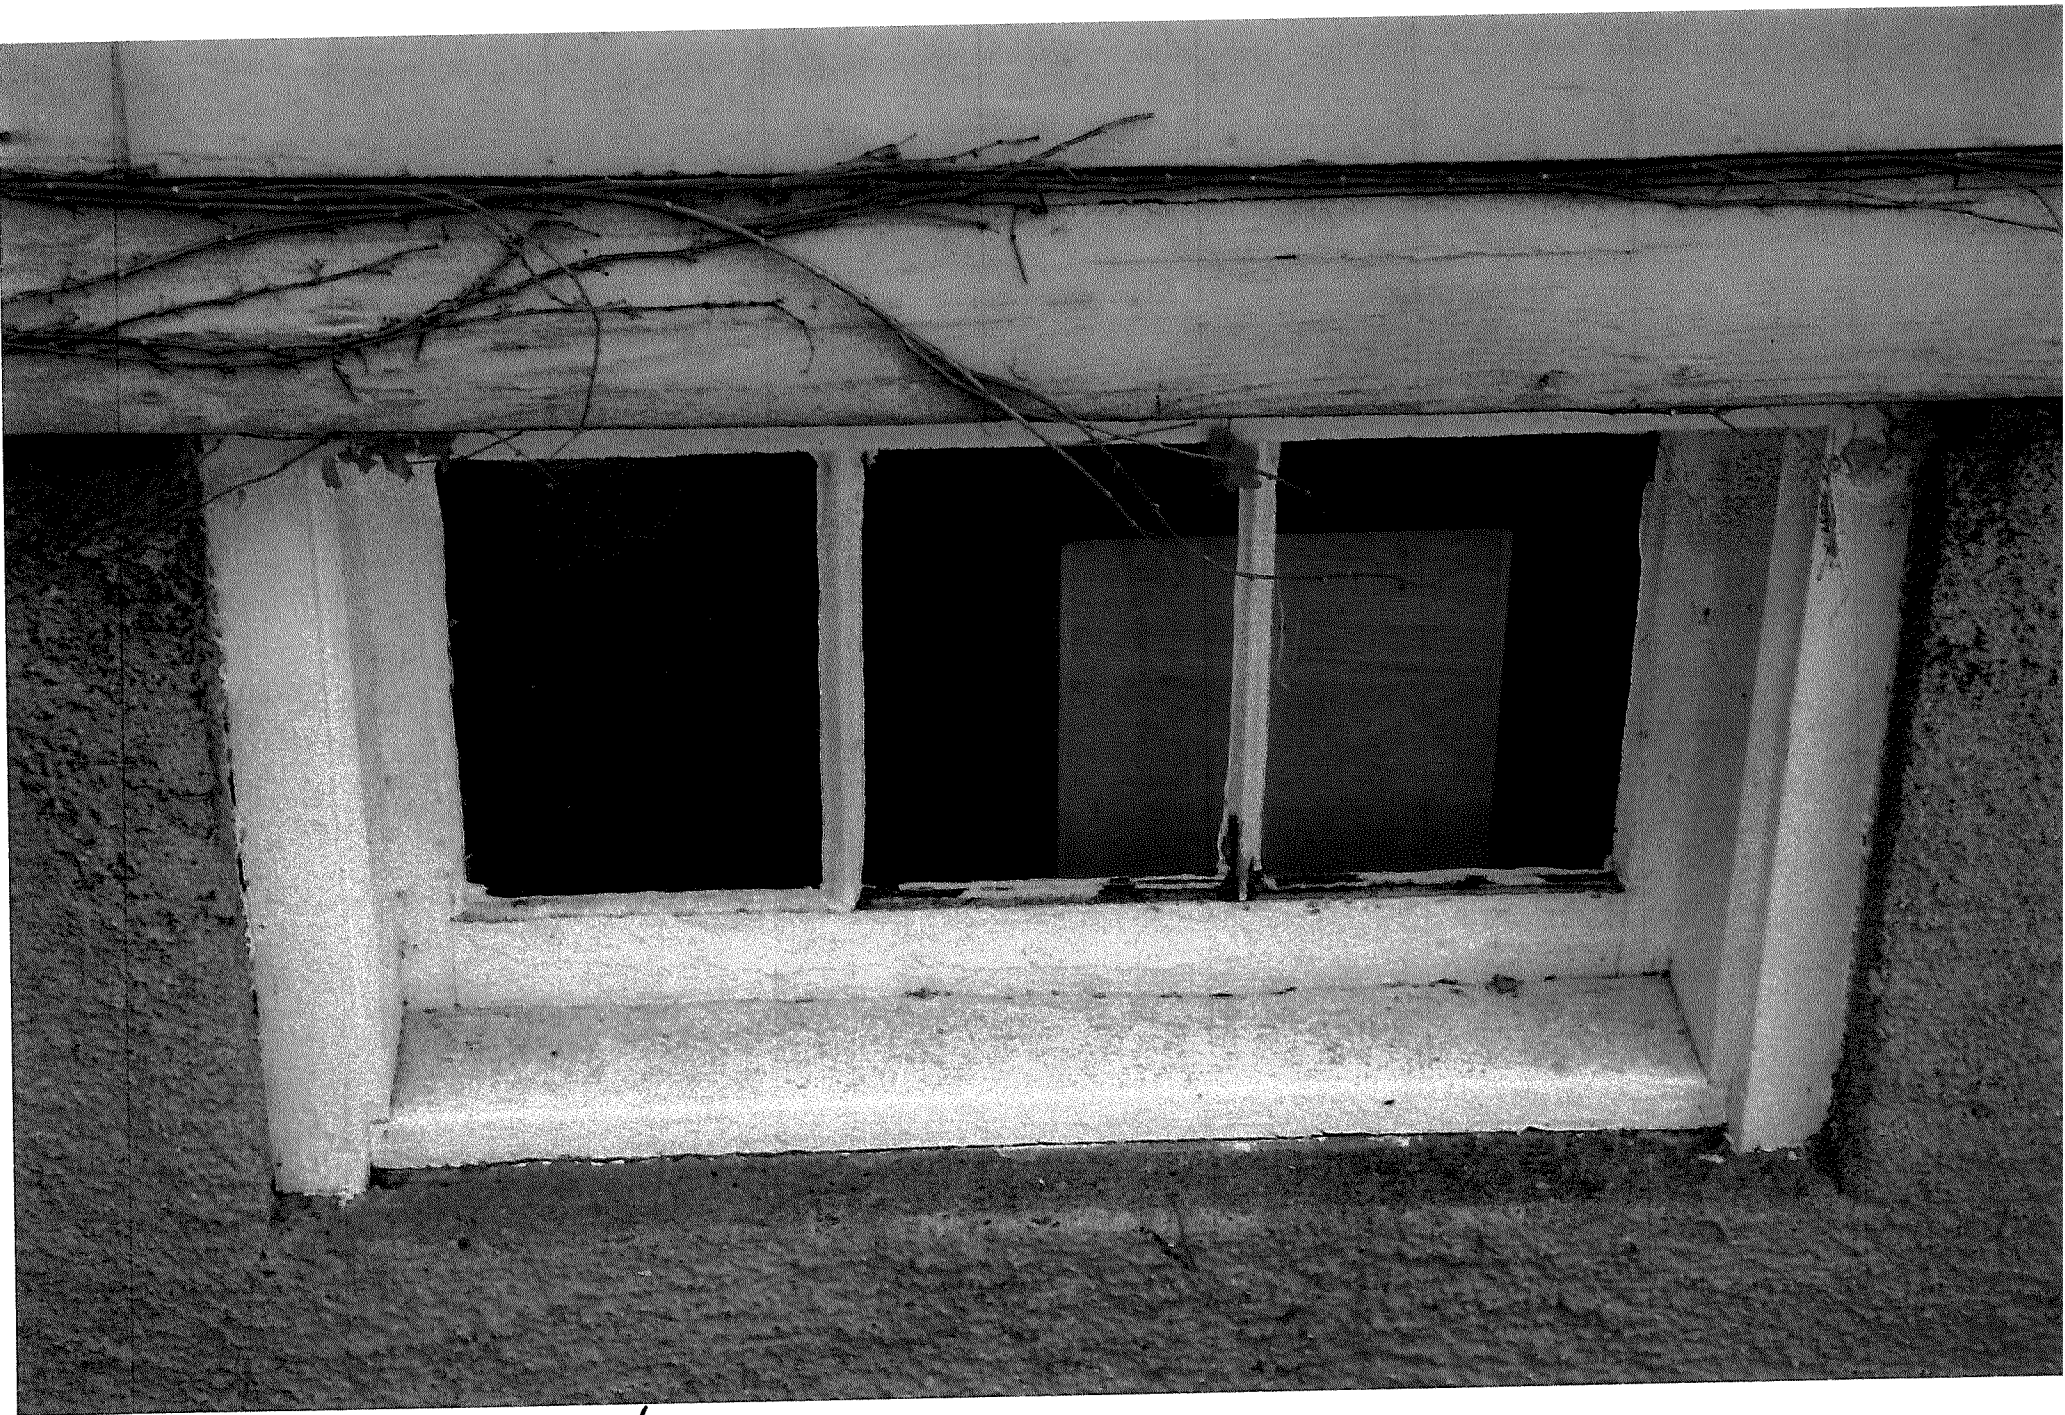
(43)

The basement windows are single glazed wood units. Cracked glass was noted at one of these windows.

- Photo 43:** Basement window that need glazing, paint and a storm.
- Photo 44:** Missing downspout on north second floor elevation.
- Photo 45:** Ice damming damage on second floor north of Toddler House.

*needs a storm*

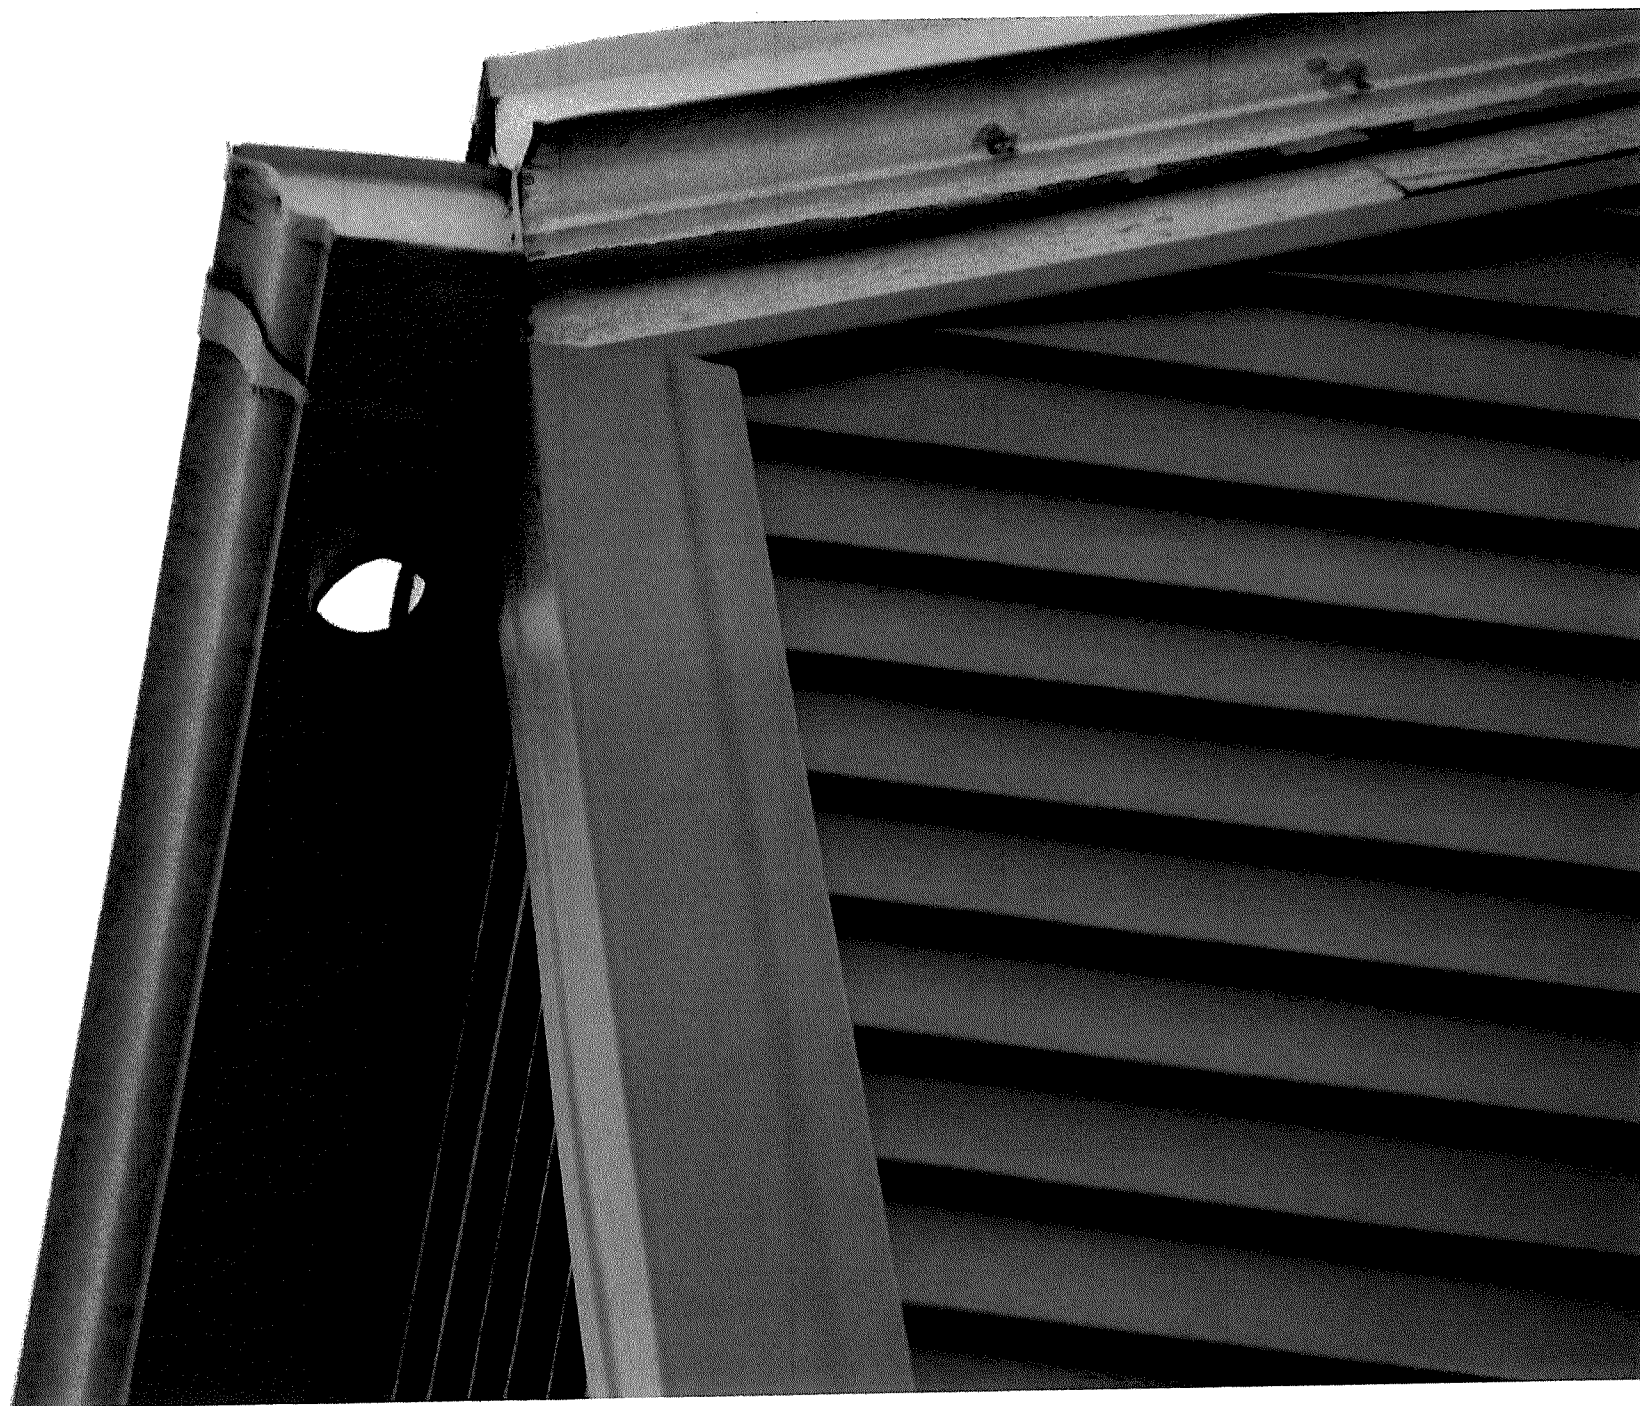
missing downspout

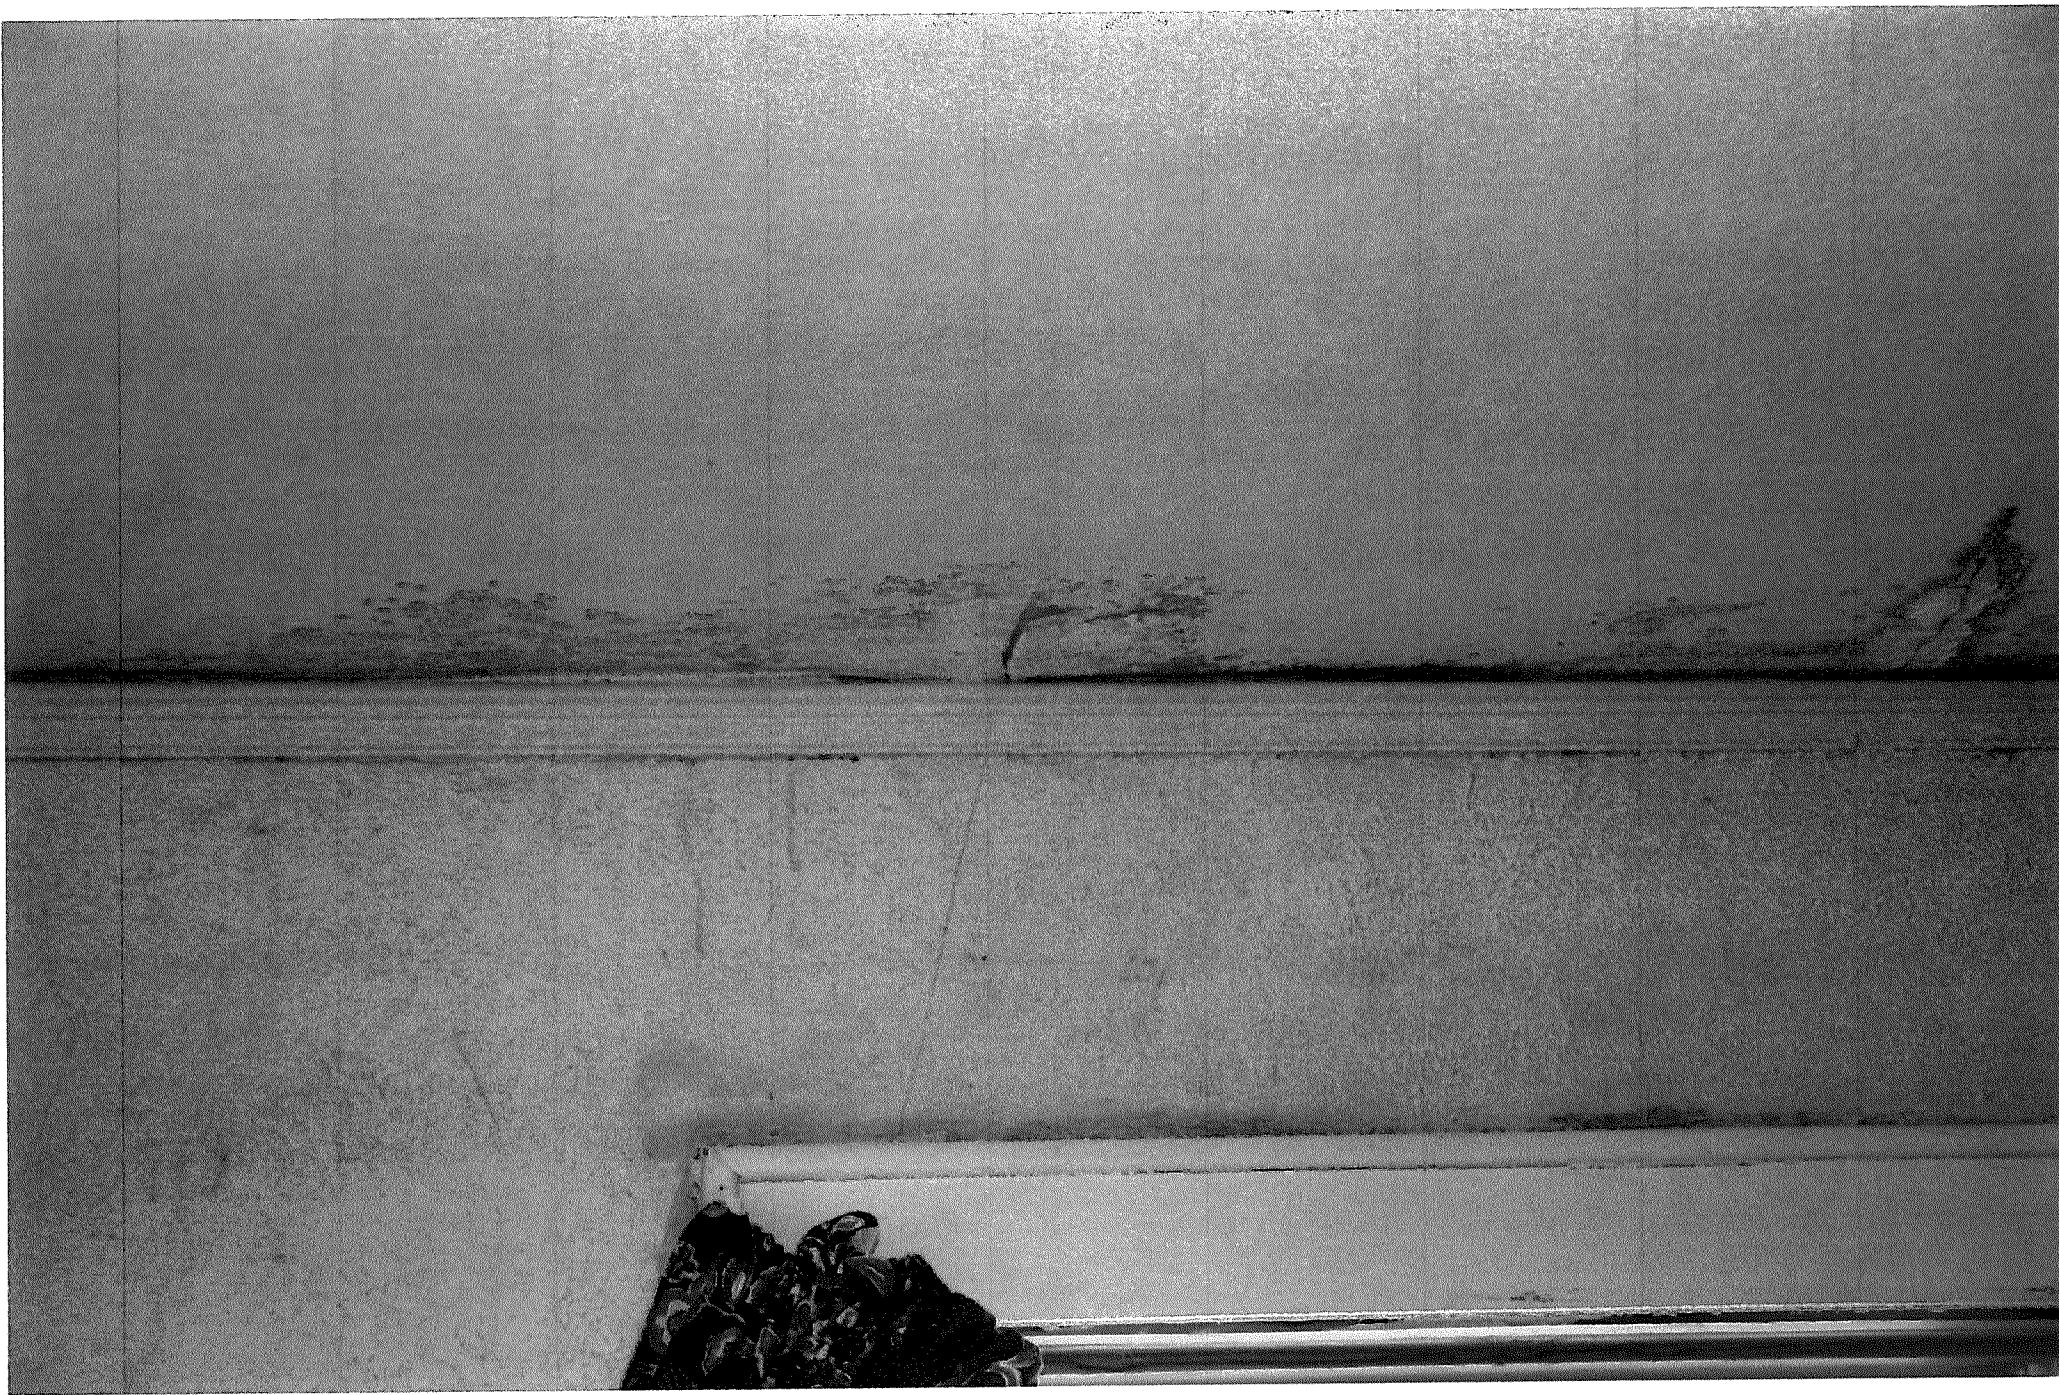
(45)

- 8.2 The kitchen cabinets are in fair to poor condition with damage to the doors and poorly functioning doors.
- 8.3 The finish on the wood floors in the original dwelling is very worn. The vinyl plank flooring in the addition is in much better condition.
- 8.4 Stains were noted on the second floor where the wall meets the ceiling. These are most likely ice dam caused. The age of the stains is not known.

ice damming

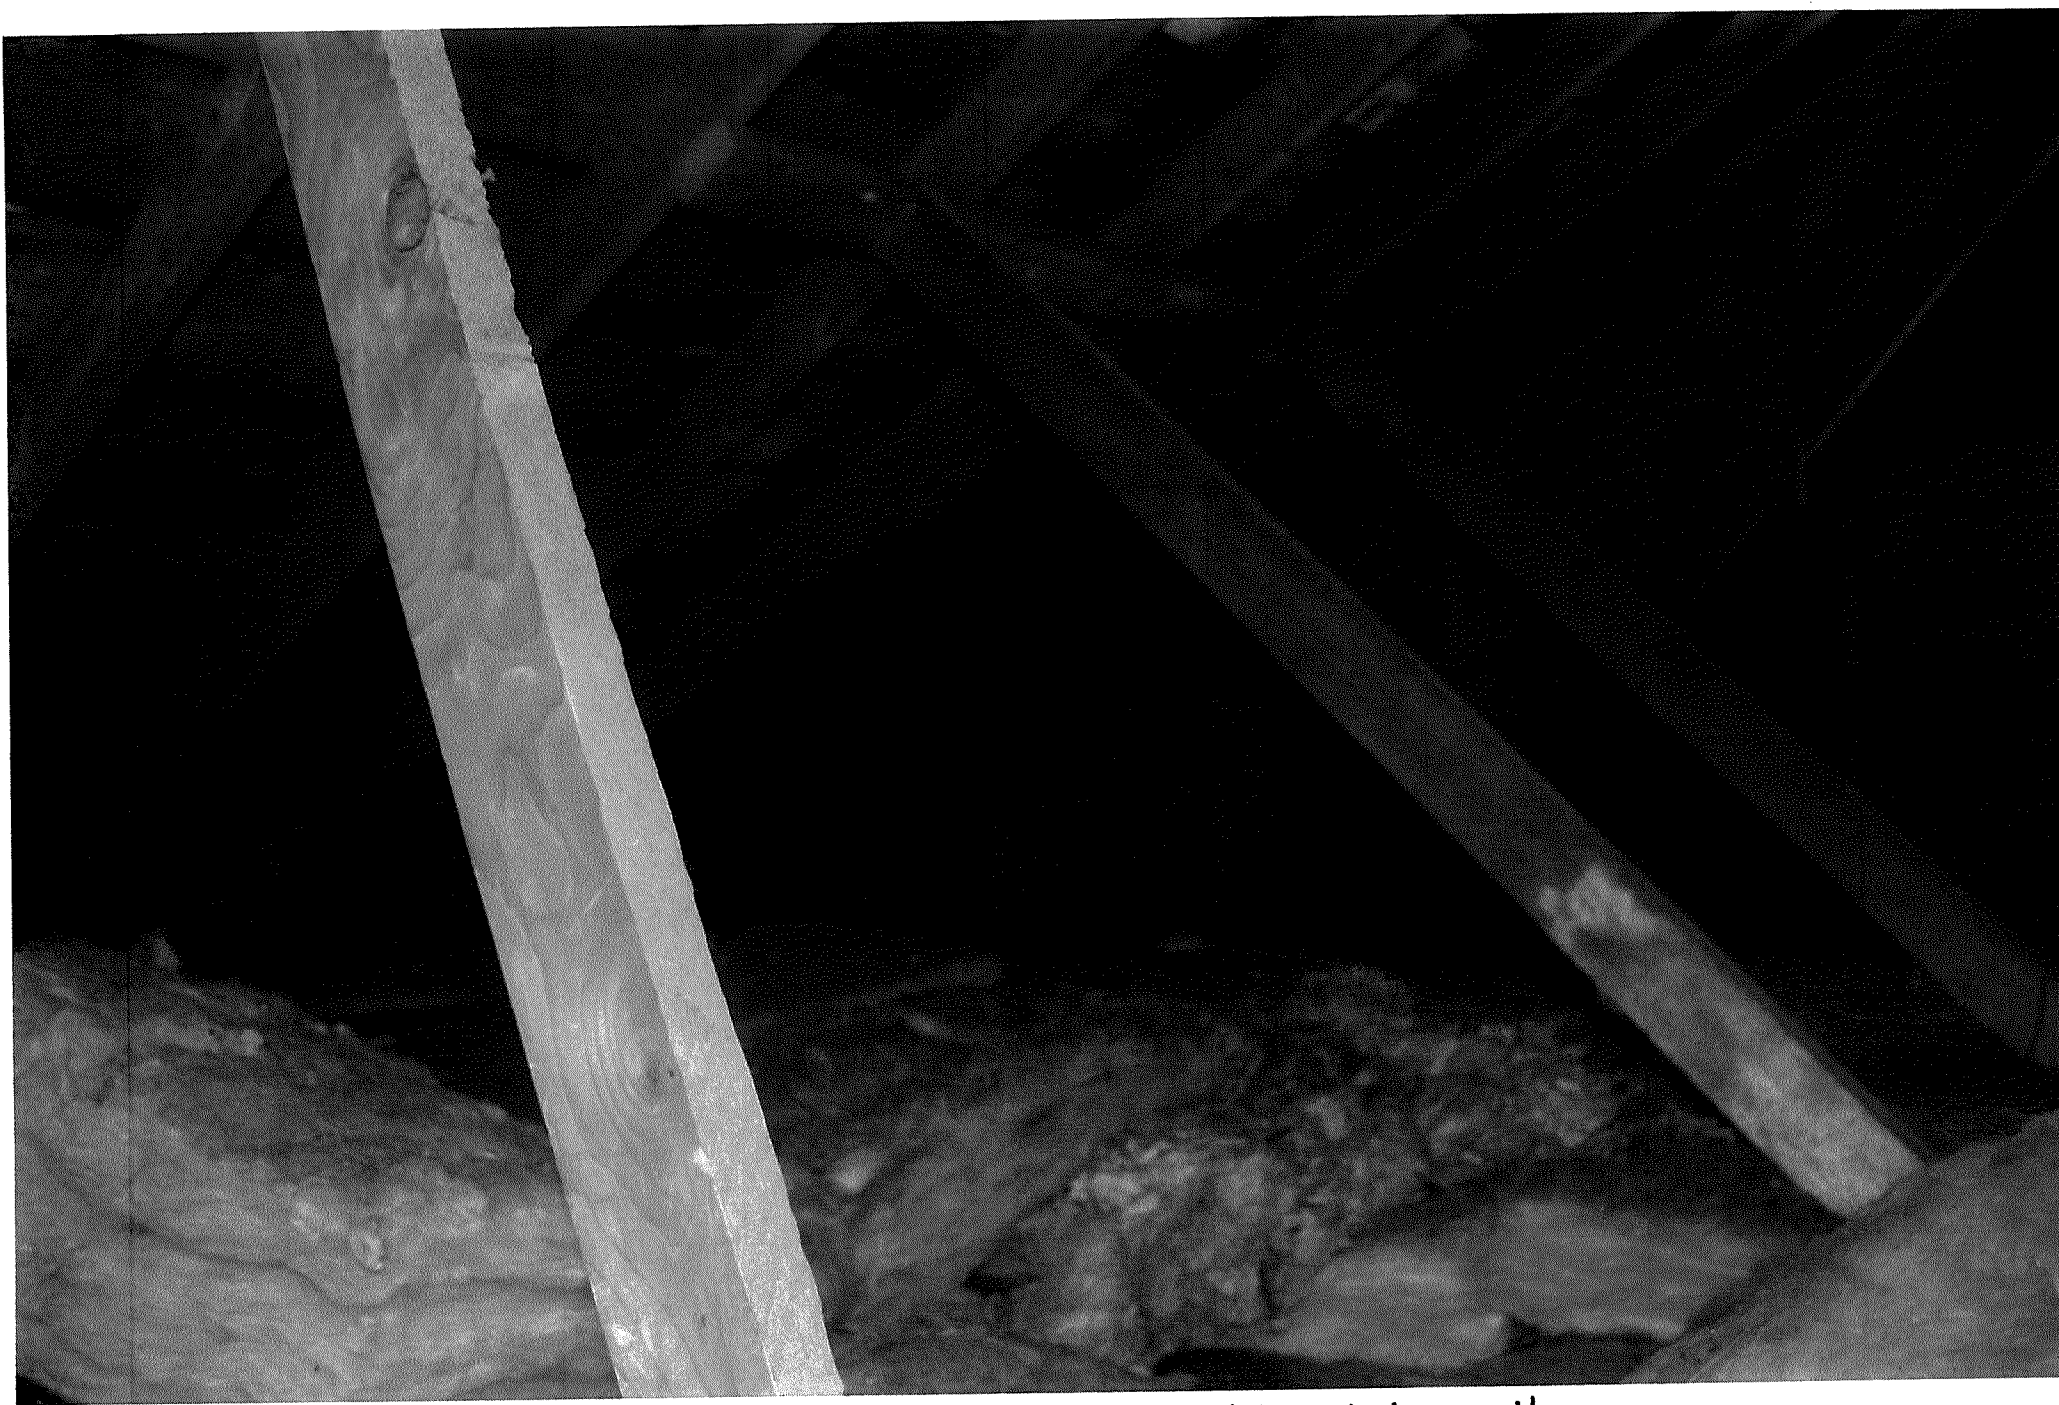
(46)

- 1.3 Framing: The floors are framed in a typical residential manner and no deflection due to dead or live loading was noted. The house attic was entered to view the lightly constructed house roof. The rafters are only two by fours and fairly long spans. Bracing has been added to reduce the deformation of the roof. This bracing causes roof loads to develop onto the house framing and main basement beam. We consider the house framing to be structurally serviceable, but if the house is retained for more than a few more years, further study is recommended.

- Photo 46:** Braced two by four rafters constitute a weak system. Note irregular insulation.
- Photo 47:** Condensation staining on rafters in attic.
- Photo 48:** Condensation staining on sheathing due to inadequate attic venting.

not challenging load capacity  
roof framing crappy
