**FREIBURGER CONSTRUCTION CONSULTING, Inc.**  
**5438 County Highway M**  
**Fitchburg, WI 53575**  
**(608) 835-0001**

Woodland Montessori School  
1124 Colby St.  
Madison, WI 53715

The following report is based upon observations made at the two school buildings March 21, 2016. The object of the report is to outline the current condition of then two buildings. The final section of the report will list deferred and future maintenance with the object of allowing forward planning for the maintenance of the buildings, modification of the buildings or replacement of the former residential building.

**Photo Log: 114 Van Deusen Street**

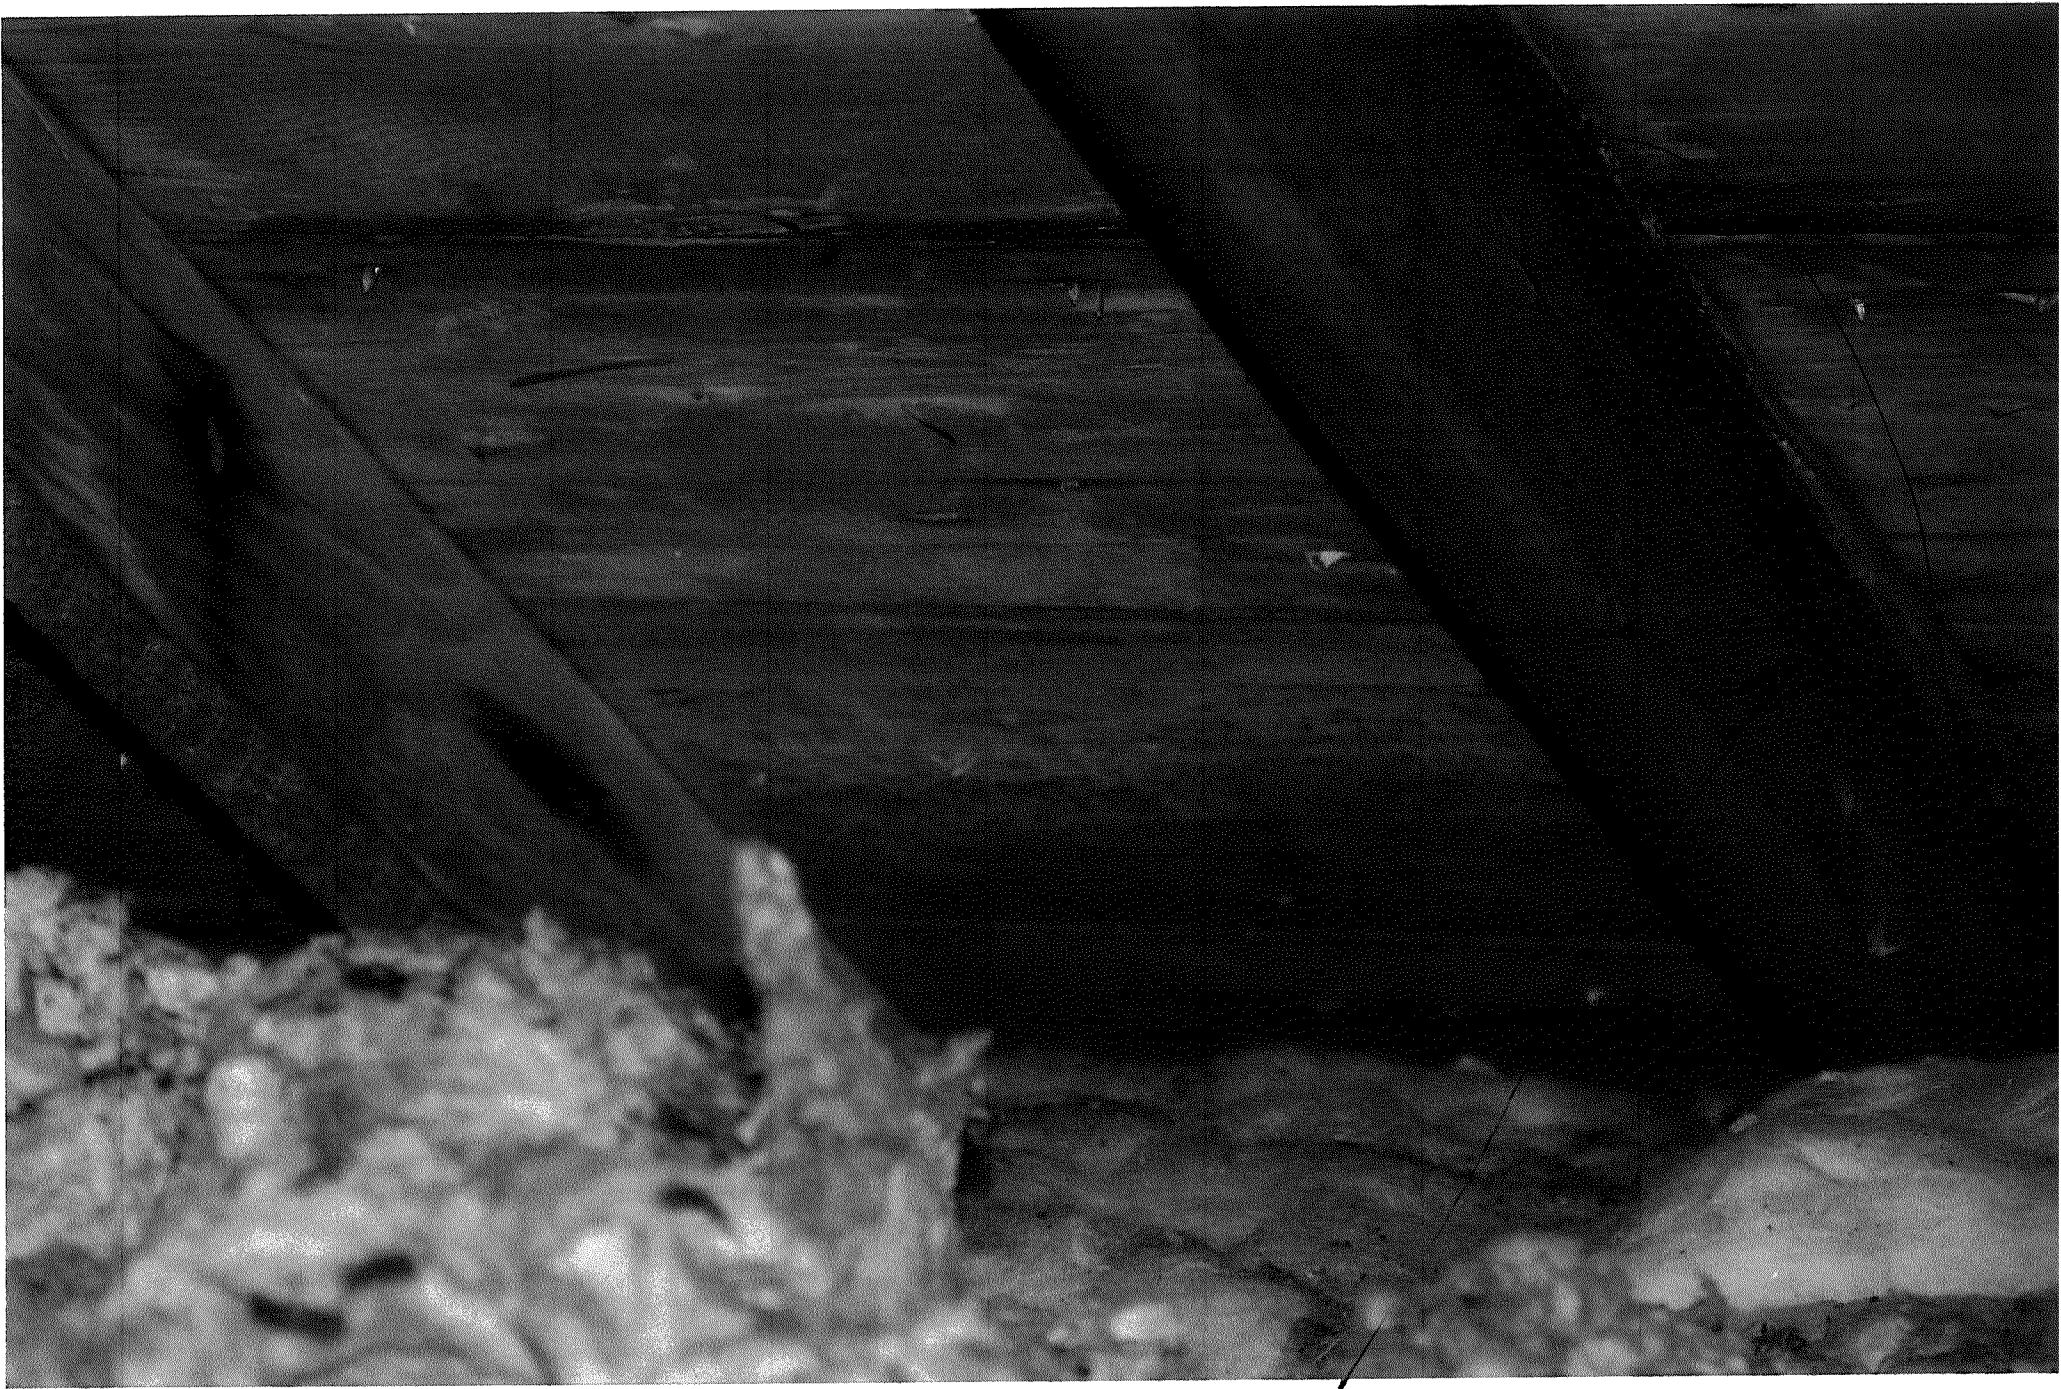
(47)

- Photo 46:** Braced two by four rafters constitute a weak system. Note irregular insulation.
- Photo 47:** Condensation staining on rafters in attic.
- Photo 48:** Condensation staining on sheathing due to inadequate attic venting.

Condensation

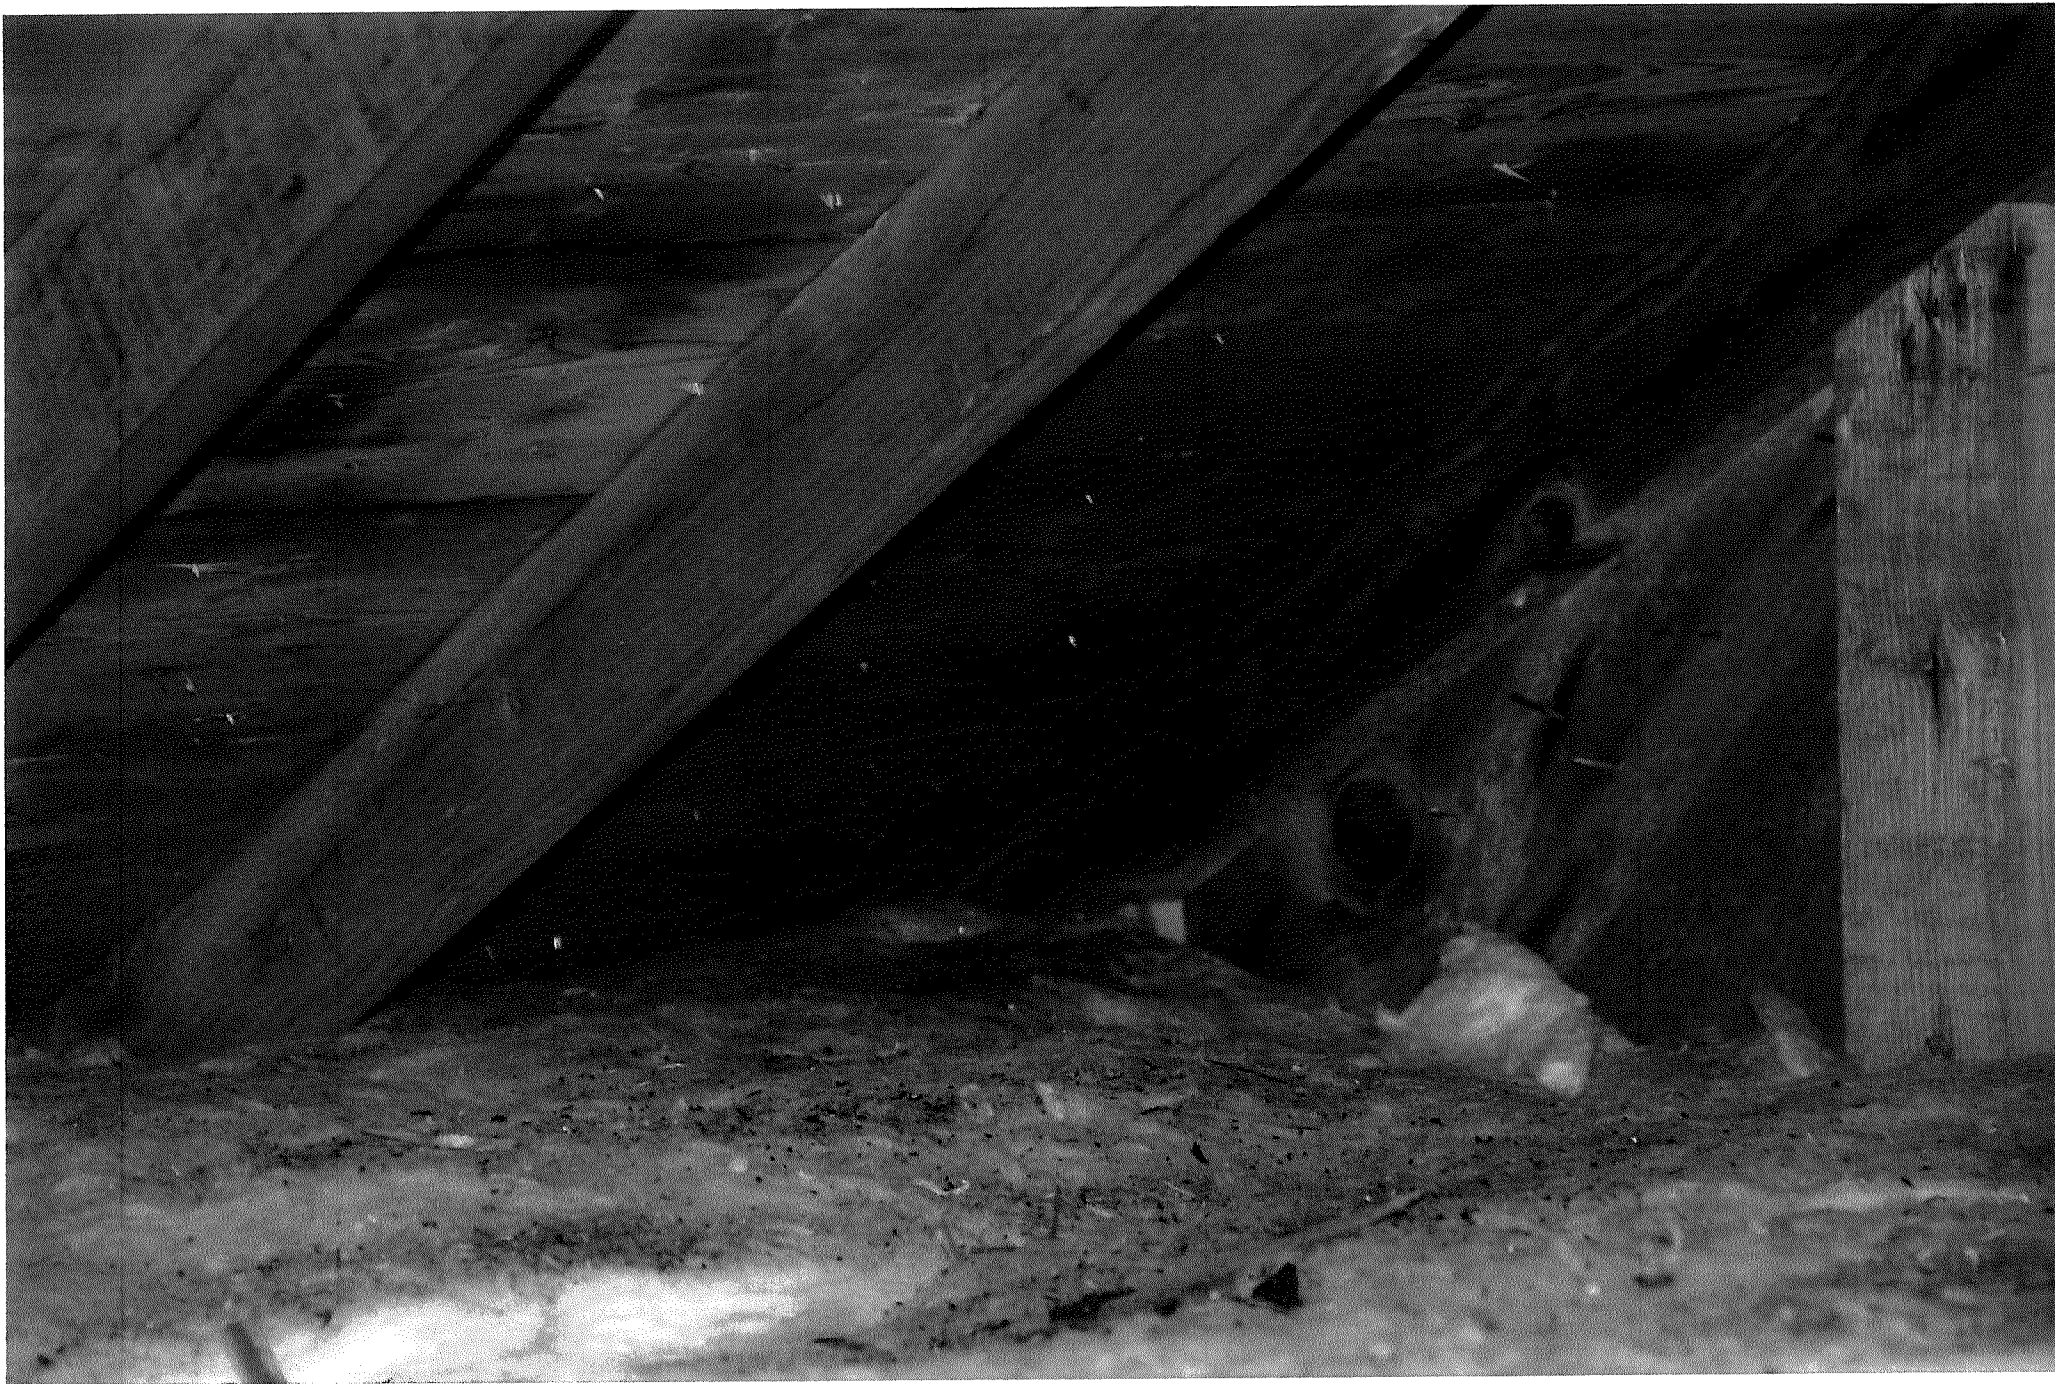
(48)

Weak  
Structure

mold + mildew - needs new roof total new roof  
25-30 thousand

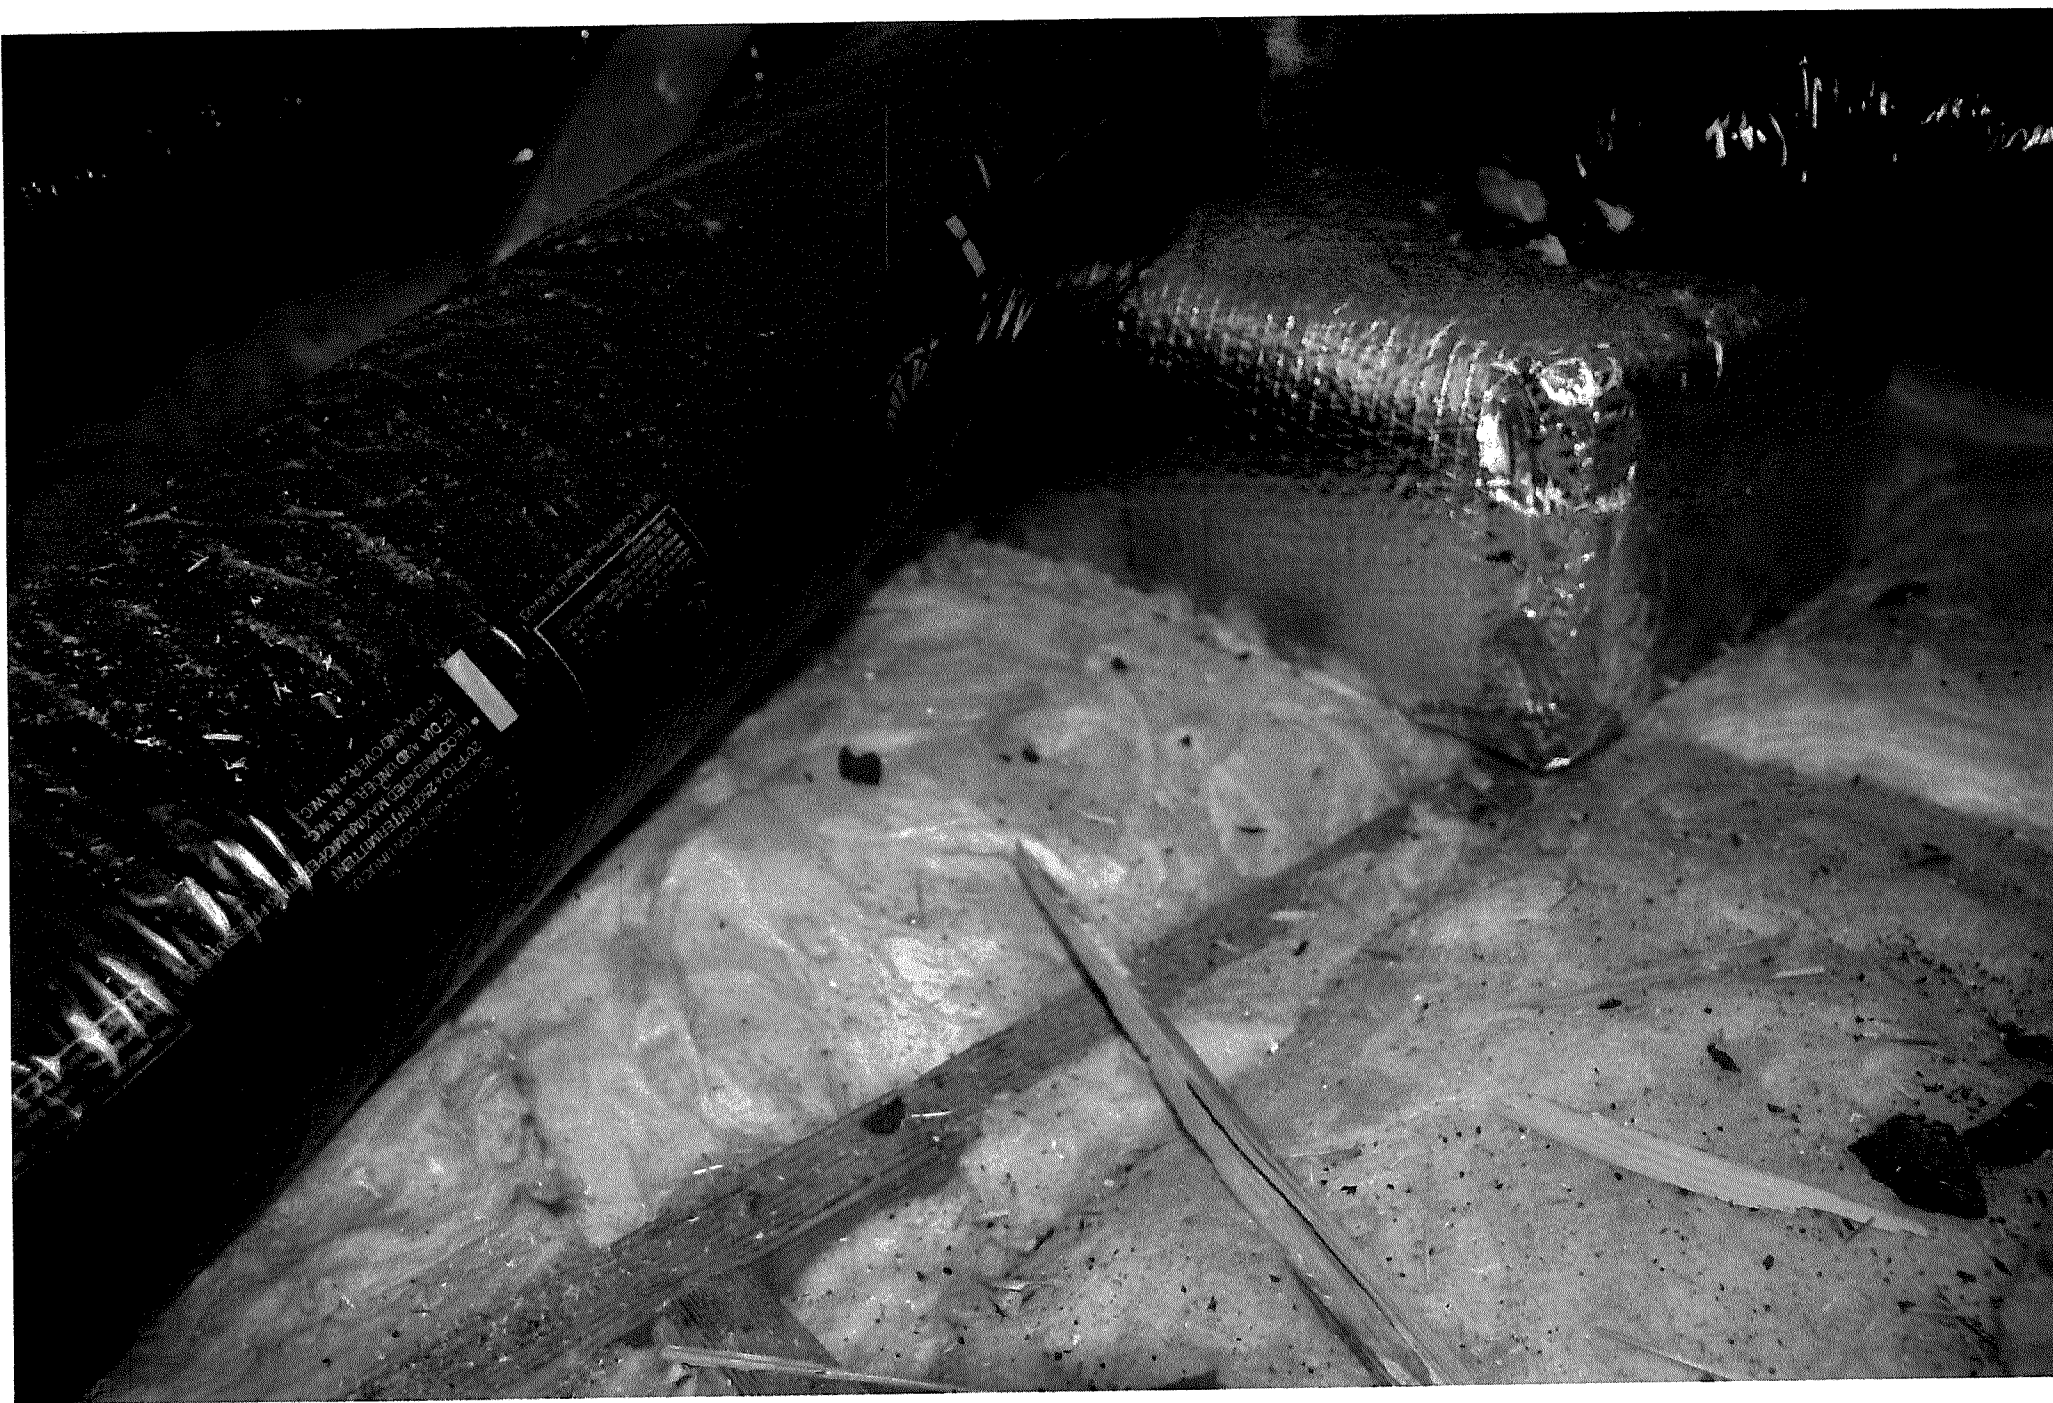
49

- 4.1 Attic insulation: The attic is poorly insulated with fiberglass. There are also heat ducts run in the attic and they have the minimal R-5 insulation covering. The attic insulation allows significant heat loss, which can cause ice damming. If the building is to be kept in use, a retrofitted air sealing, venting and insulation plan should be devised.

- Photo 49:** Poorly insulated heat runs in the attic contribute to heat loss and ice damming.
- Photo 50:** View of a portion of the west elevation of Toddler House at addition.

needs insulated - heated attic → melts snow → leaks air

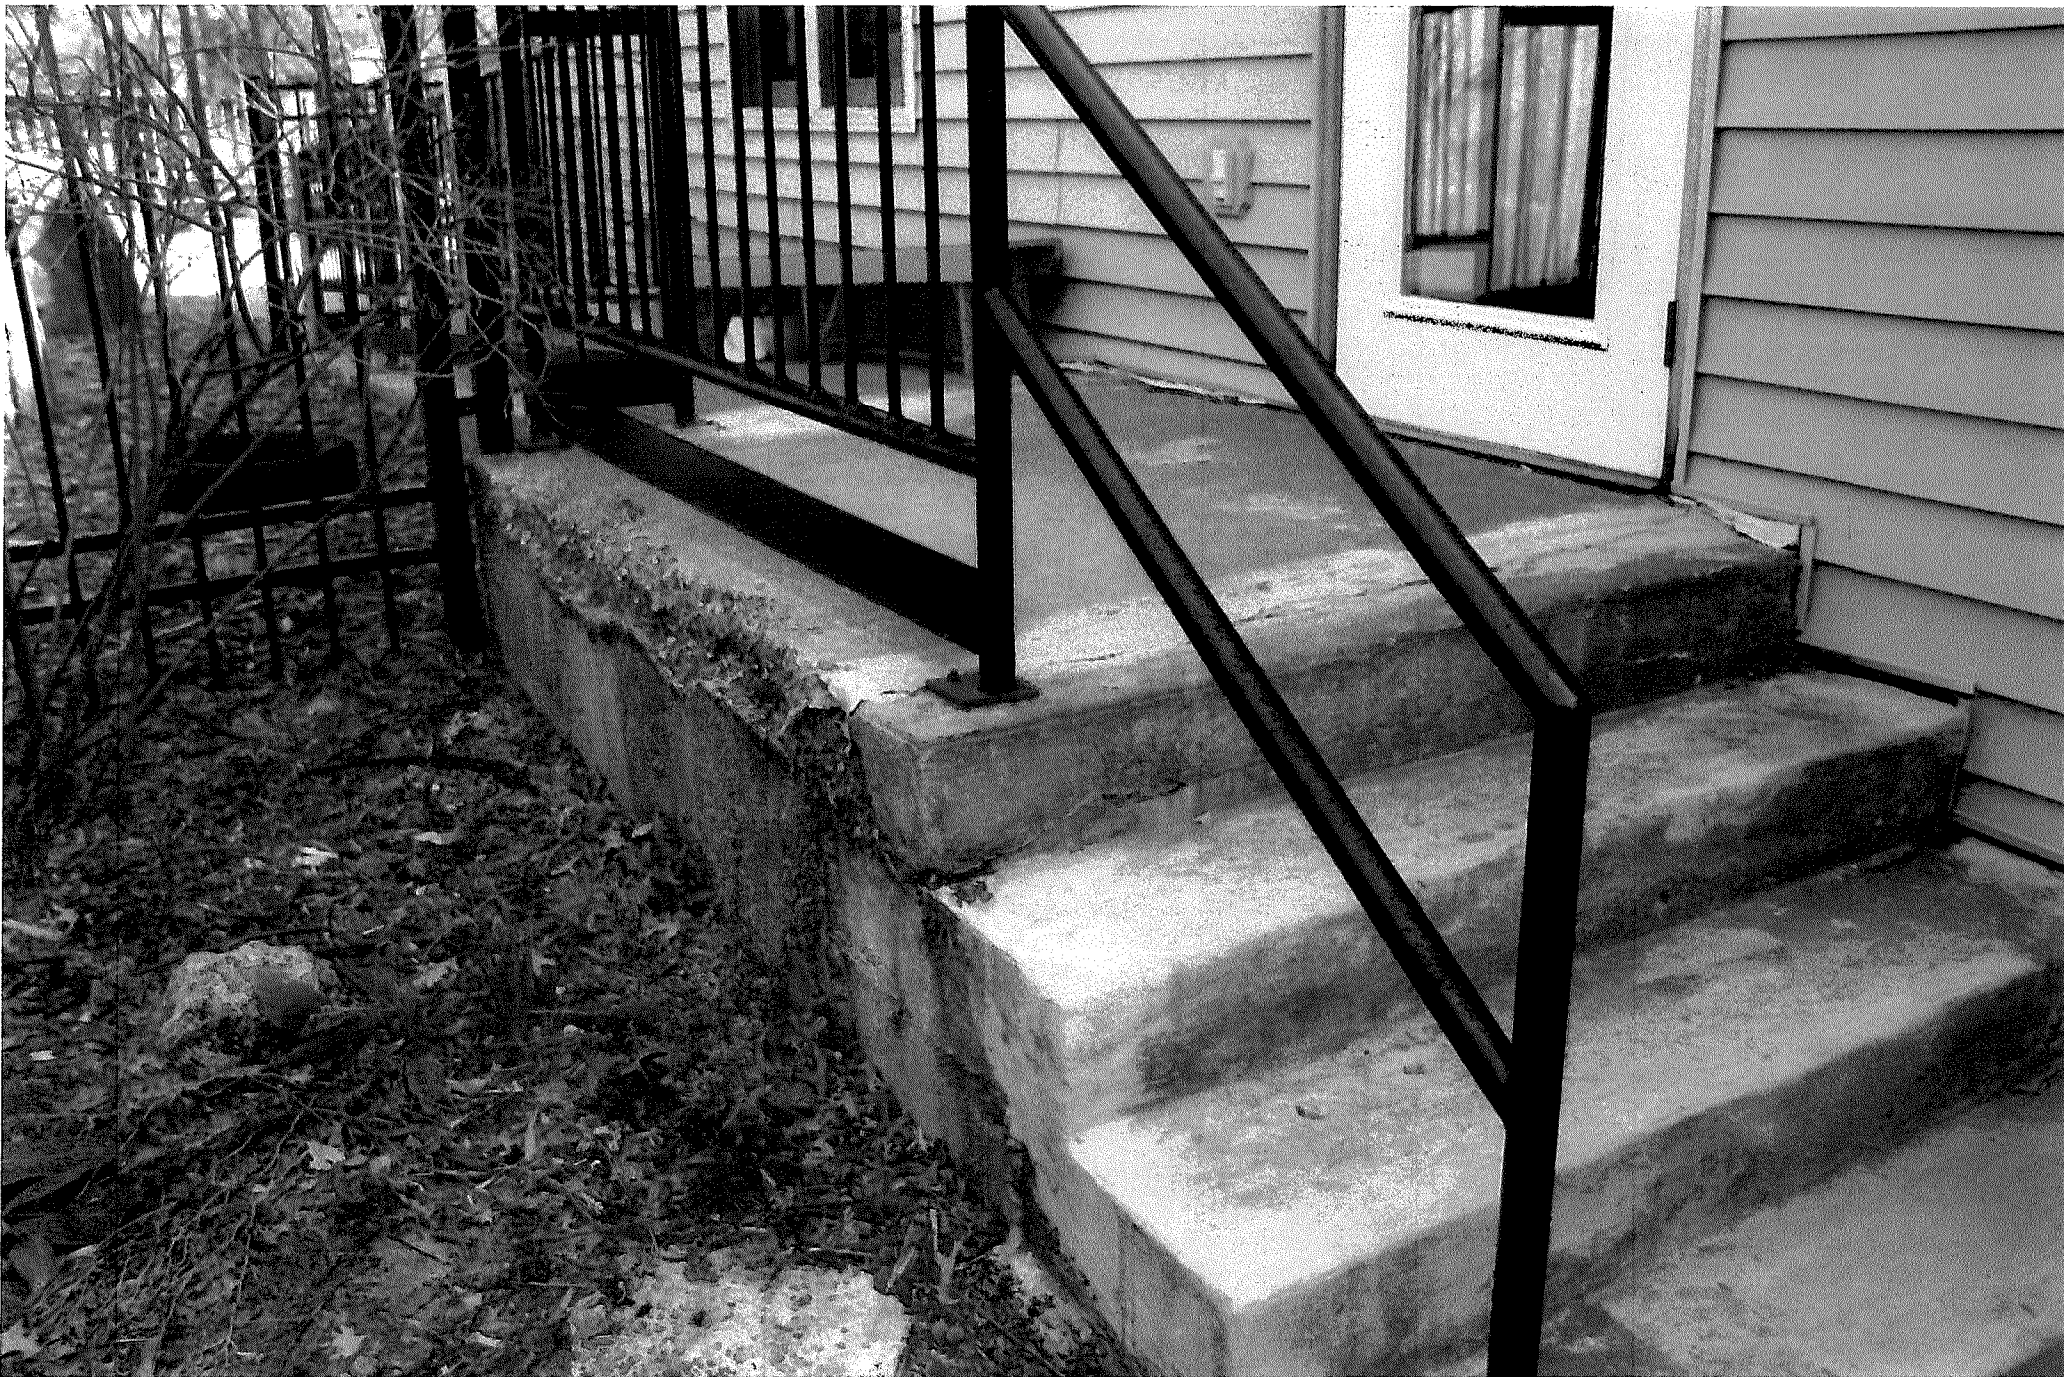
(51)

The addition has a poured concrete steps, landing and ramp system that is deteriorating. The concrete is badly spalled and the long cracks may indicate rust jacking by corroding reinforcement bar. The entry has a limited future life. It may also have been poured up to the level where un protected or inadequately protected framing and sheathing exist on the west exterior wall.

- Photo 51:** Deterioration of concrete entry structure.
- Photo 52:** Corrosion of door jamb due to salt and water. Replacement will eventually be required.

patch every 5 years

\$45,000 - replace stairs

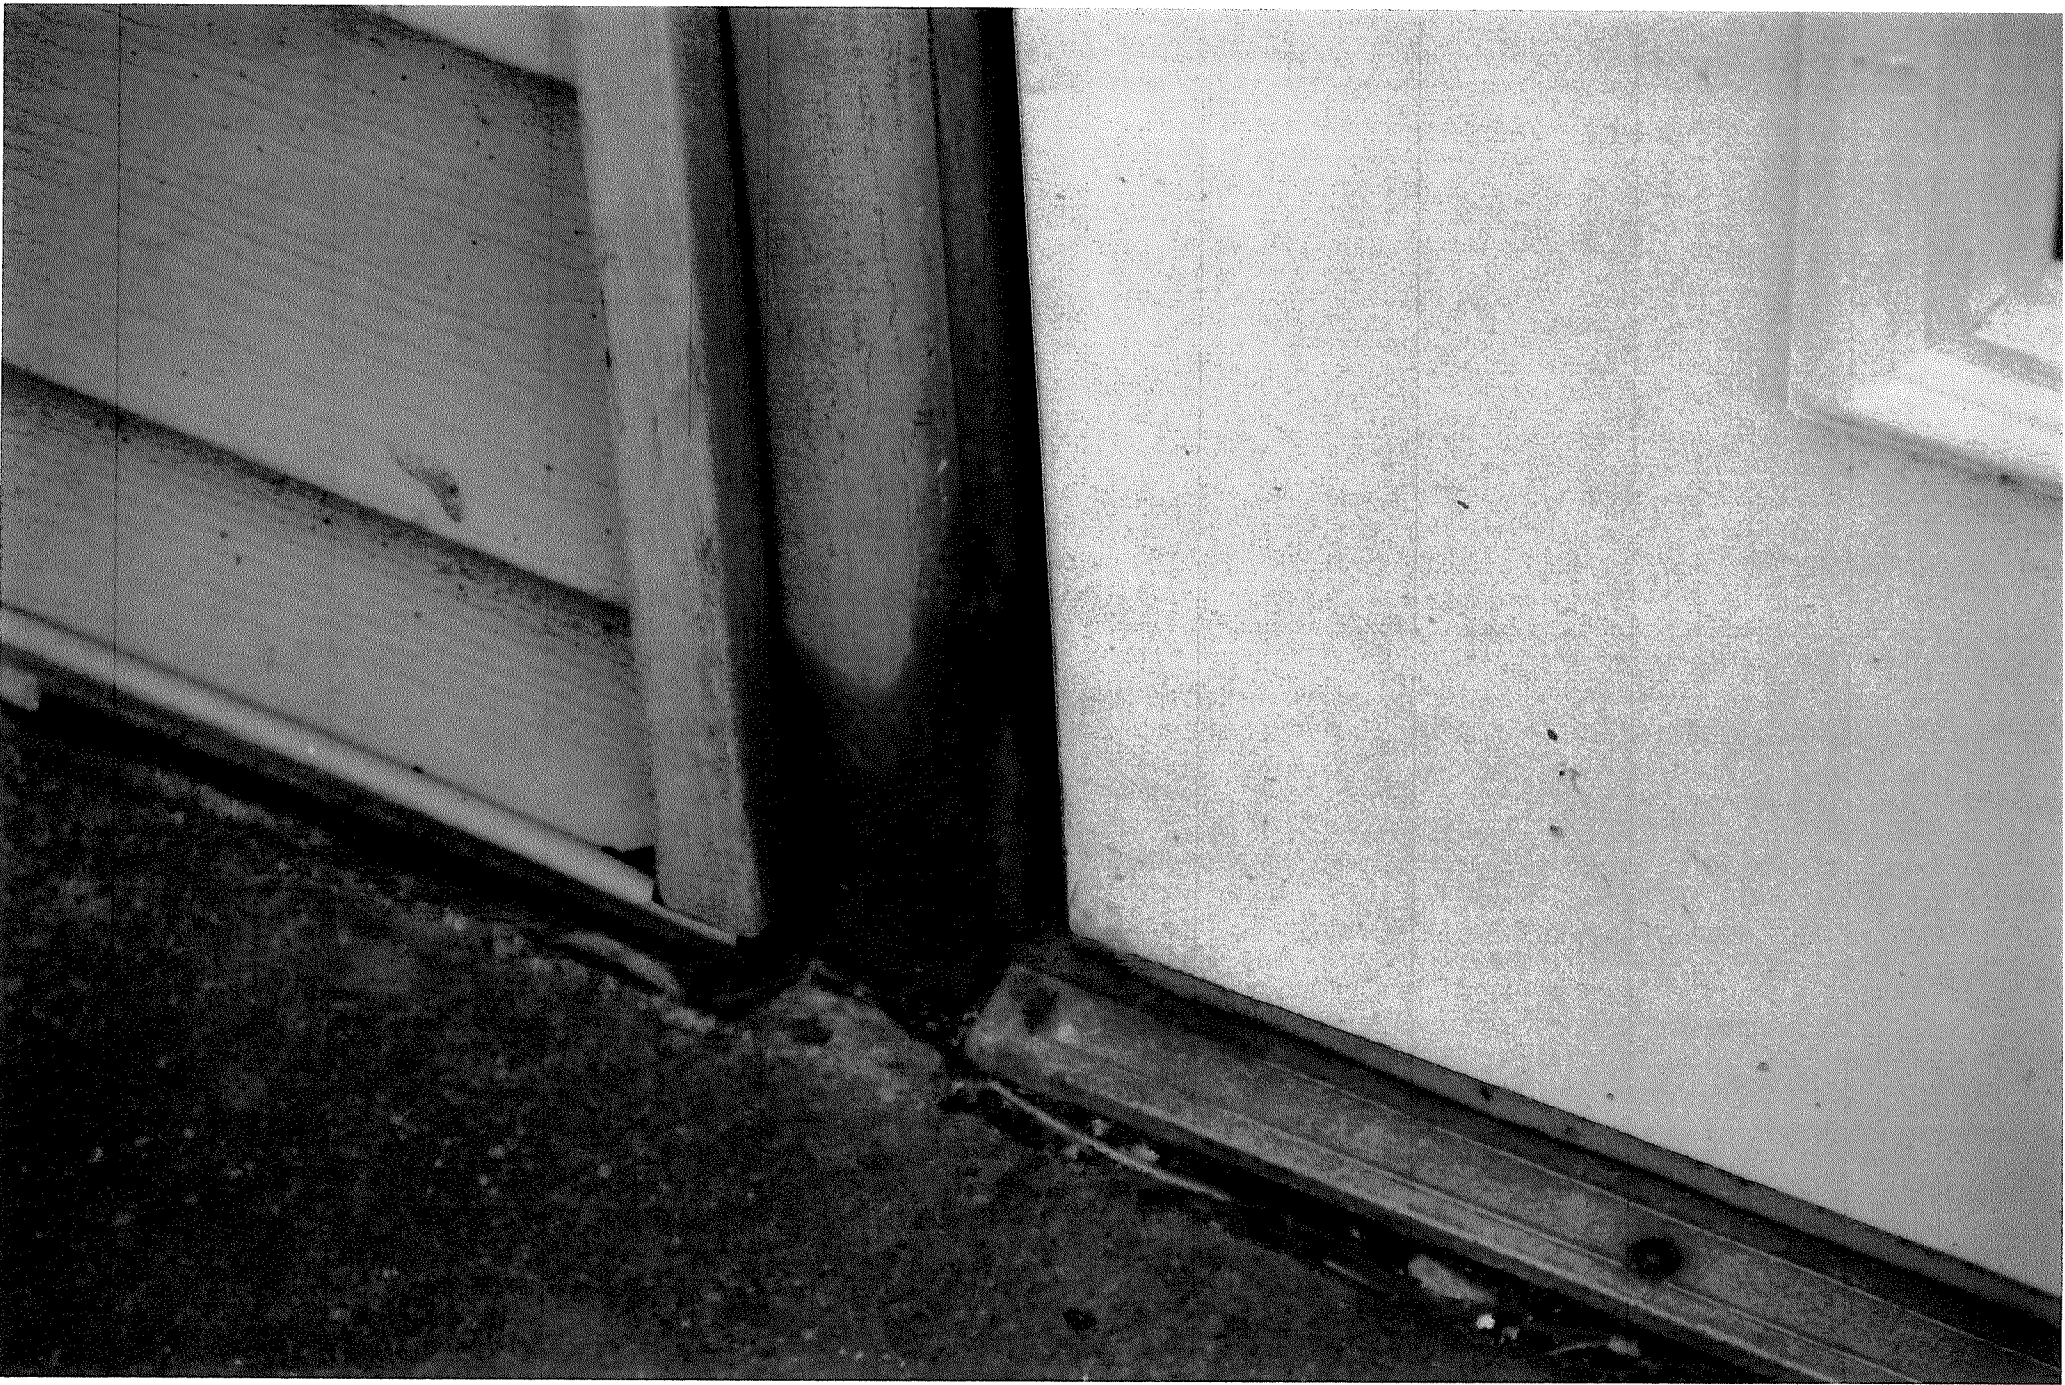
- 3.2 Doors: The metal frames of the exterior doors at each side of the building are deteriorating at the base of the jambs. Moisture collecting at the landings and salt used to melt ice are contributing to this deterioration. Replacement rather than repair will be required.

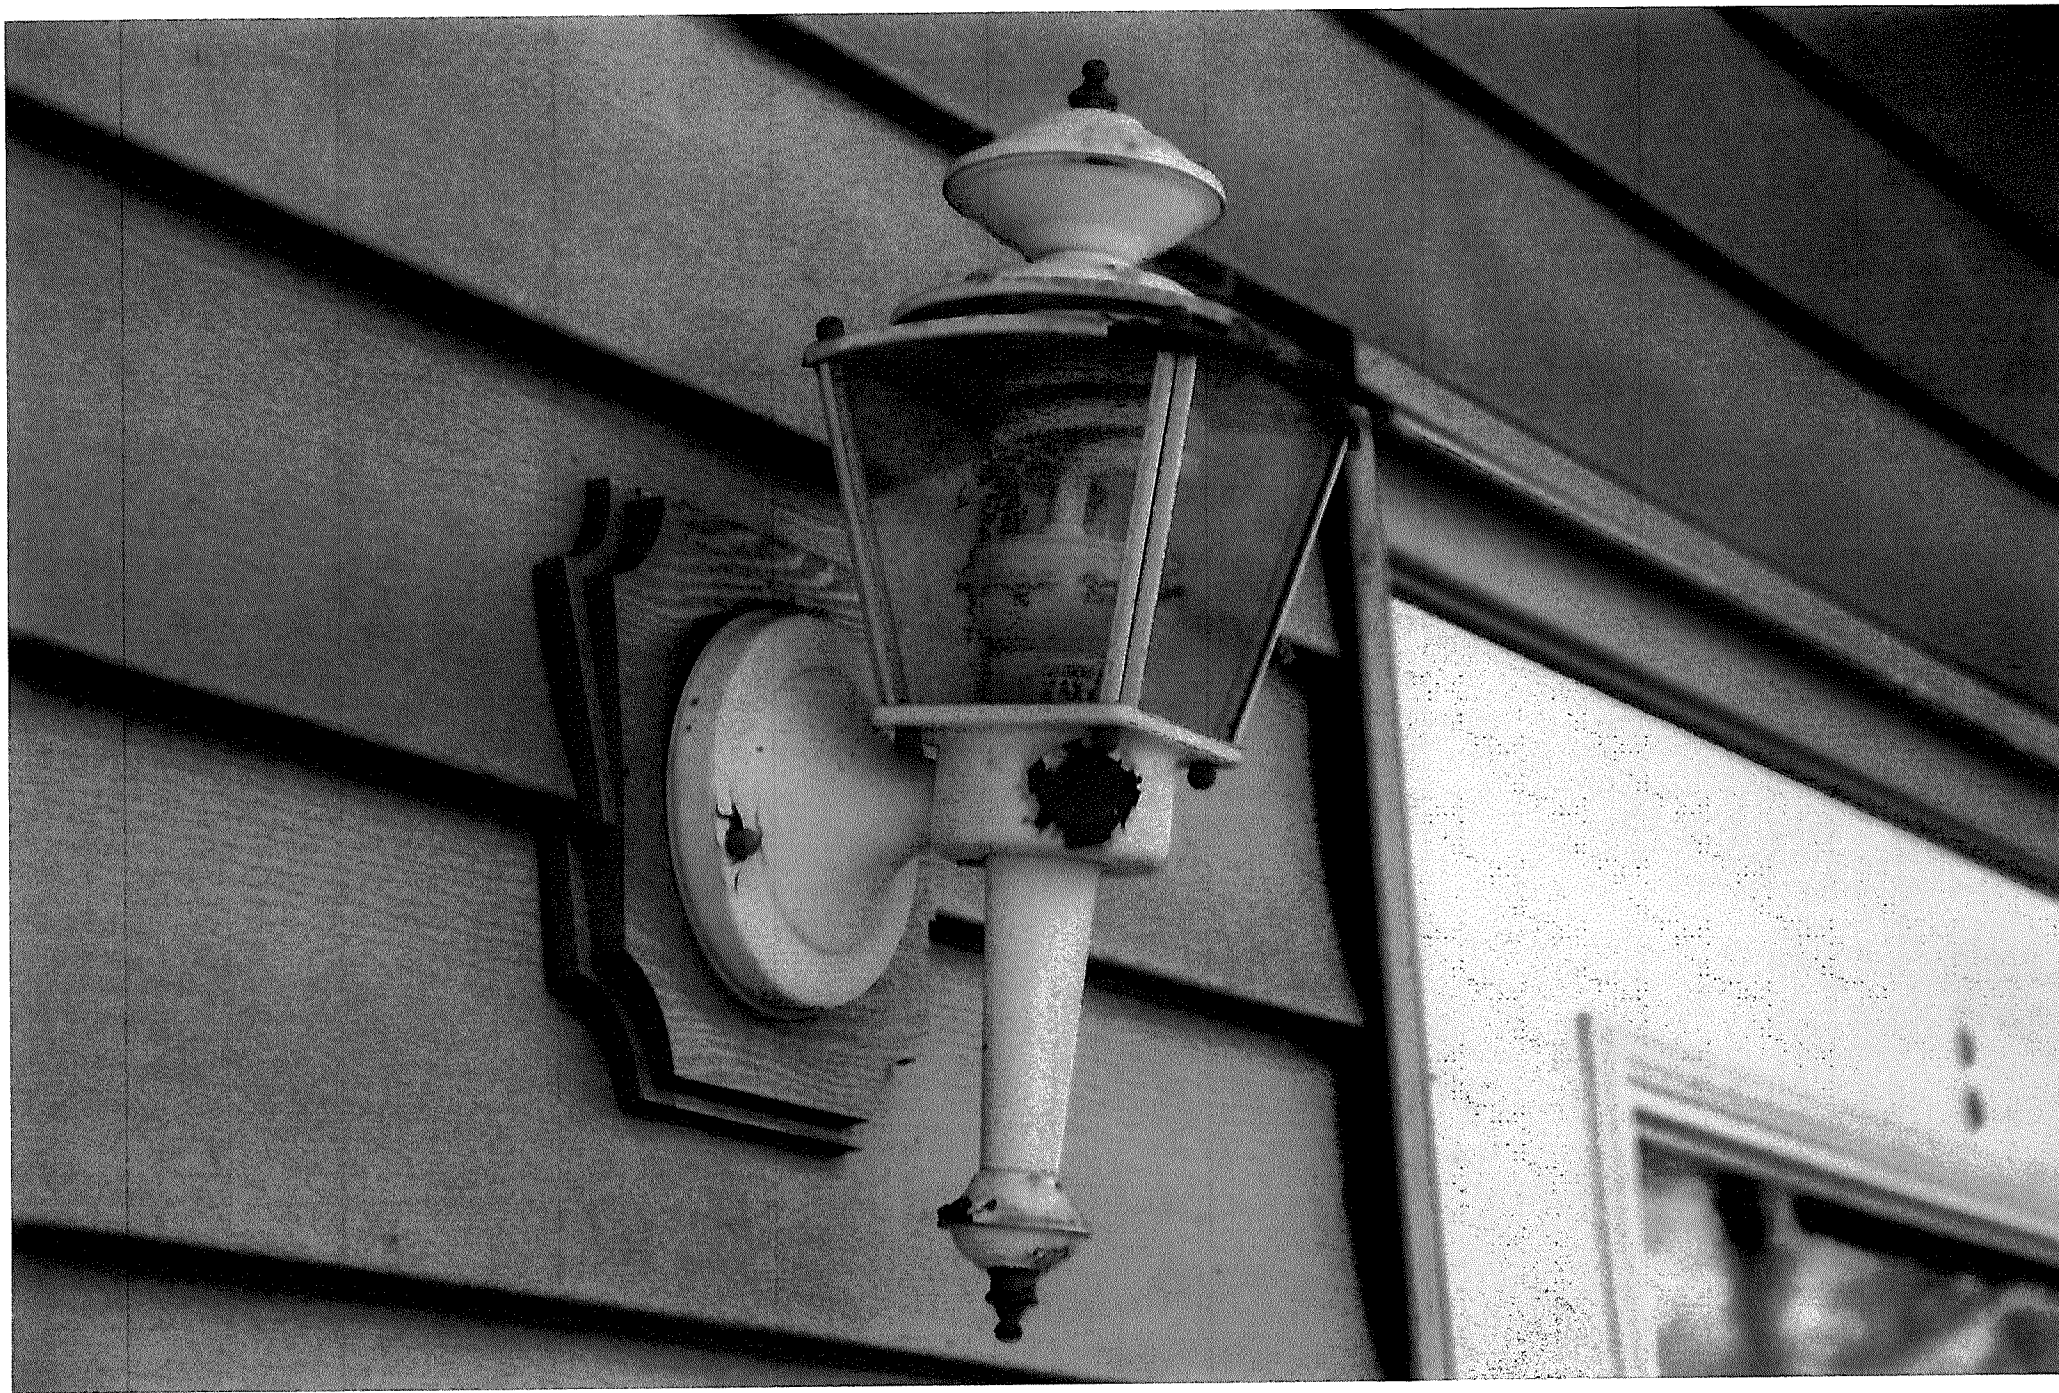
- Photo 53:** Corroded light fixtures should be replaced. Weather tight fixtures are recommended.
- Photo 54:** Missing drywall thermal barrier for basement insulation.

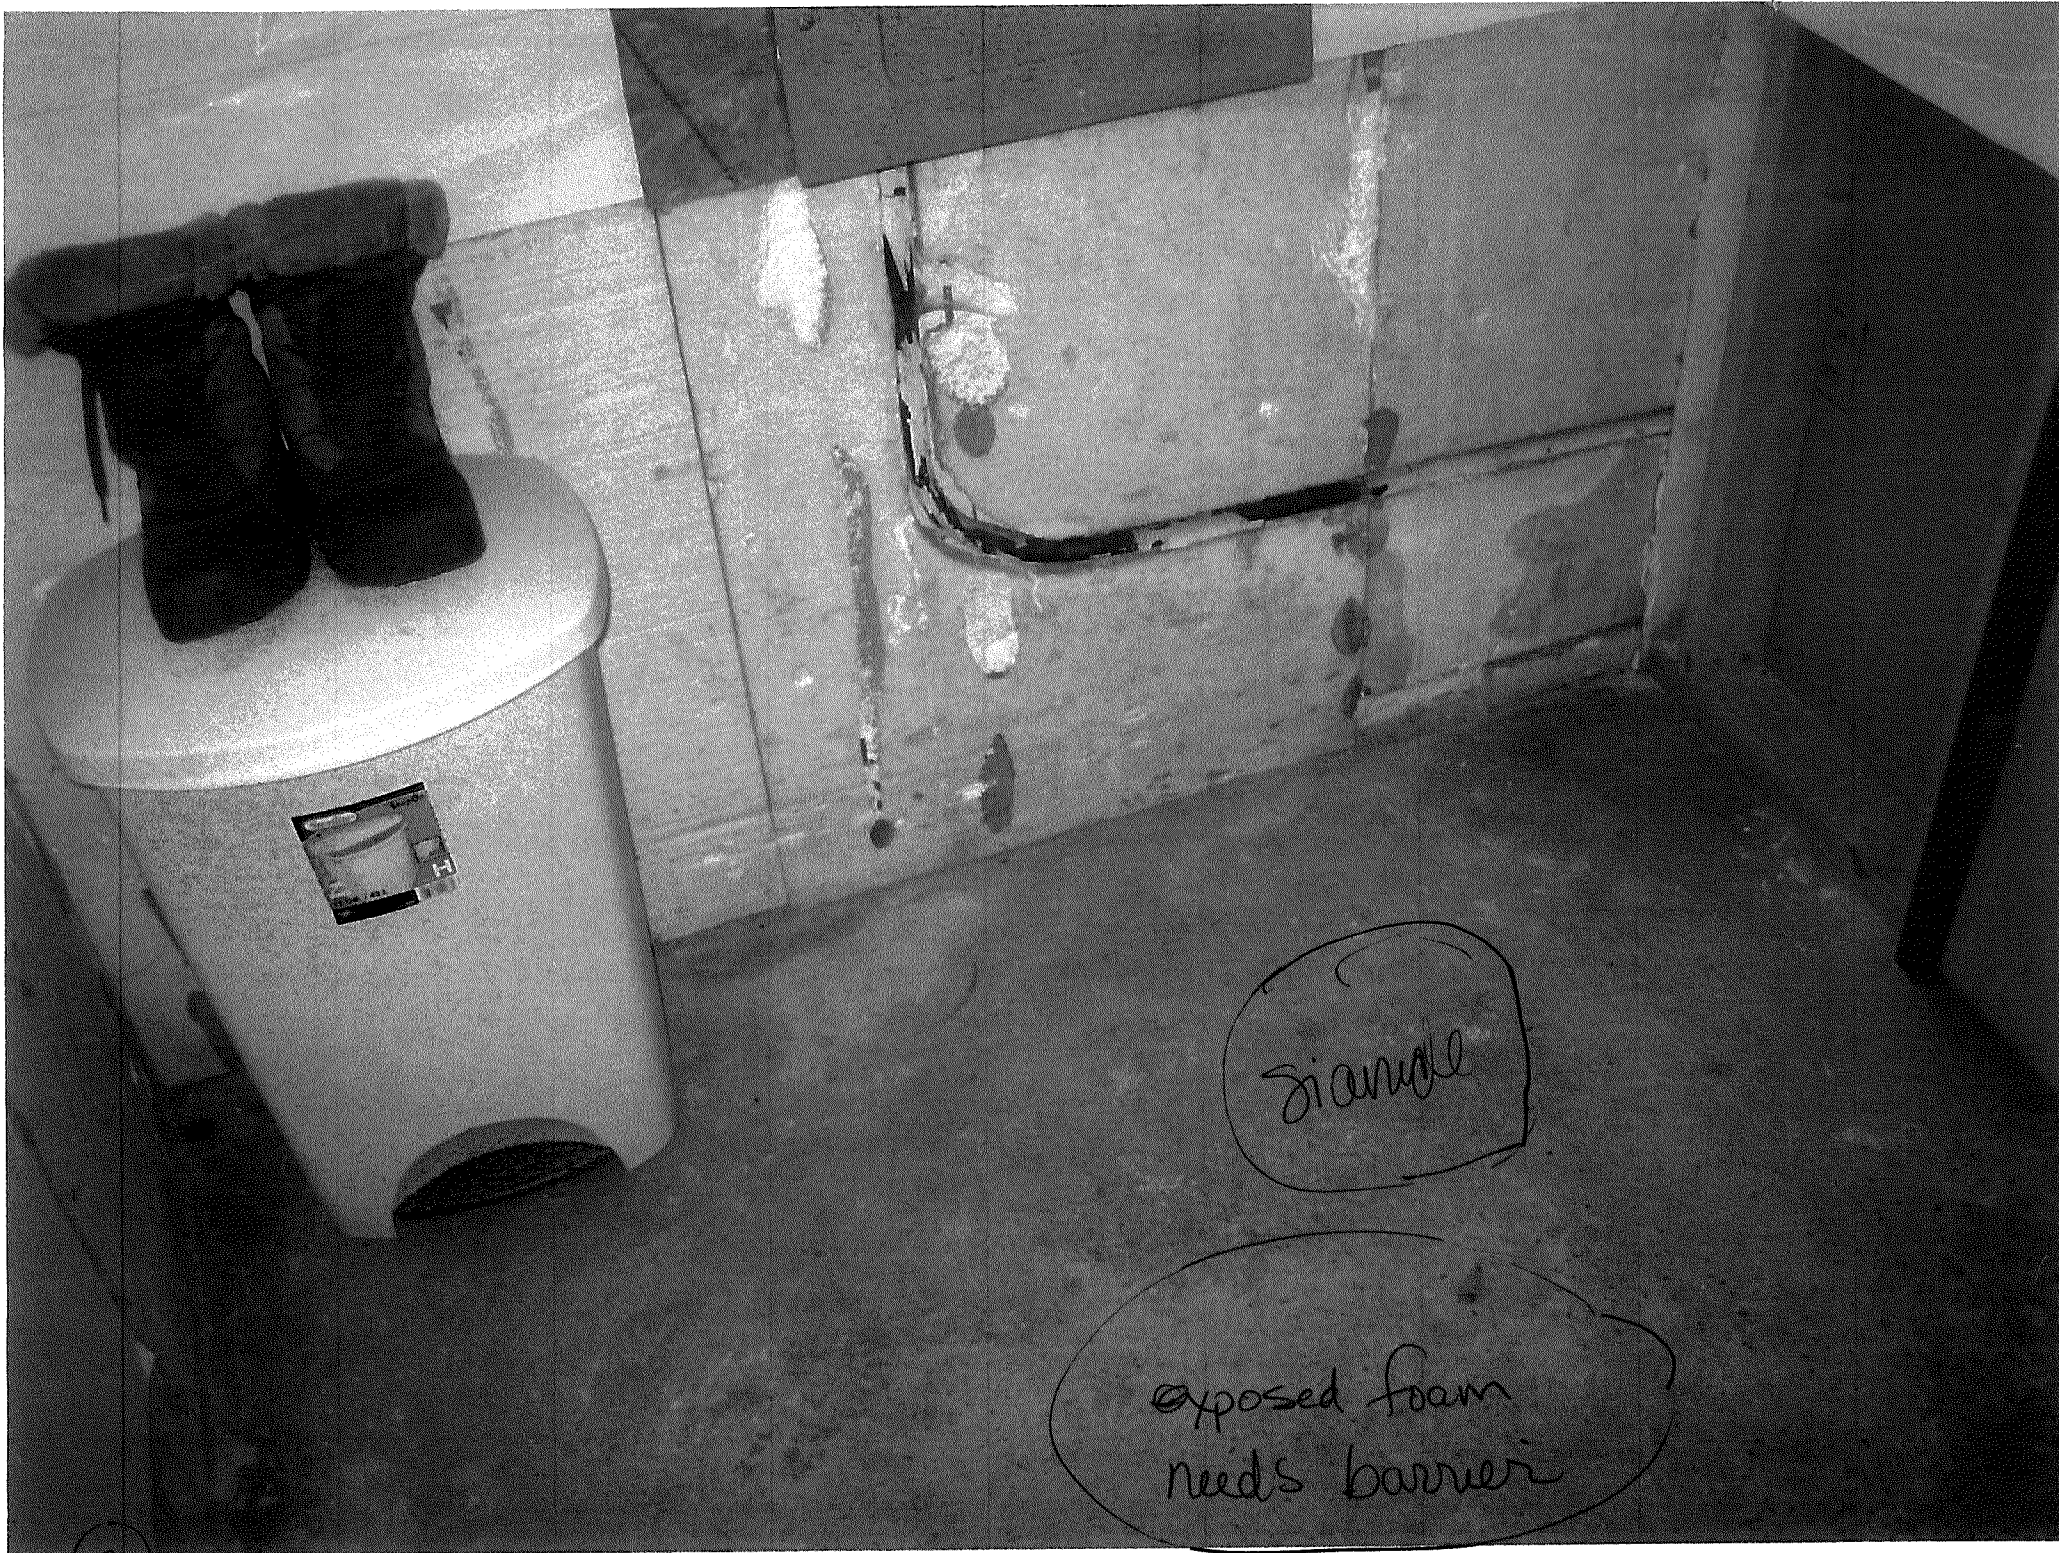
The basement had foam insulation applied which was covered with drywall to meet the flame spread code. Due to seepage, it appears some of the drywall was removed, causing a non-compliance situation.

exposed foam  
needs barrier

- 9.1 Exposed foam: The basement exposed foam needs to be covered. You should also determine if the addition foundation insulation foam is a type allowed by code without a thermal barrier.
- 9.2 Reinstall the second floor platform door with appropriate flashing and casing.
- 9.3 Mount all detectors as required by code in the correct locations.
- 9.4 Plan to replace the west side addition entry structure with a well flashed replacement.
- 9.5 Replace the missing downspout and direct spout discharge as far from the foundation as possible.
- 9.6 Paint all exposed exterior wood where the finish is failing.
- 9.7 Plan to replace the water heater with a modern efficient unit before failure.
- 9.8 Consider an insulation and attic venting plan if the house is to remain in service.
- 9.9 If the house remains in service, study the roof framing and reinforce before insulation is added
