BREESE STEVENS REPAIRS

MADISON, WI

FOR CITY OF MADISON PARKS

SHEET TITLE: PARTIAL PLAN A1-G4

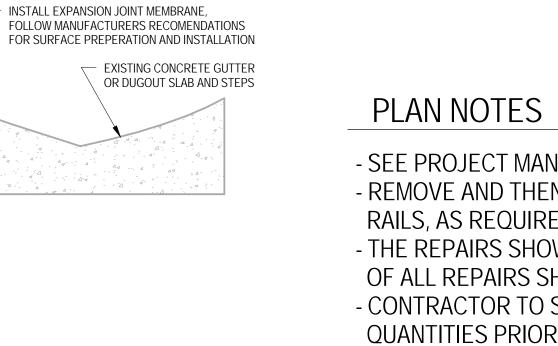
WALL BASE JOINT DETAIL

EXISTING CONCRETE FIELD WALL

REMOVE EXISTING PAINT COATING AND INSTALL NEW
