Ref: 127 W. Gilman St

At your request, I have visited the referenced building to evaluate its condition. This structure is a three-story wood framed rooming house containing a total of thirteen dwelling units. At the time of my site visit, not all rooms were accessible for inspection.

127 W. Gilman St.
Madison, WI 53703

Conceptual Budget/Recommendations Report

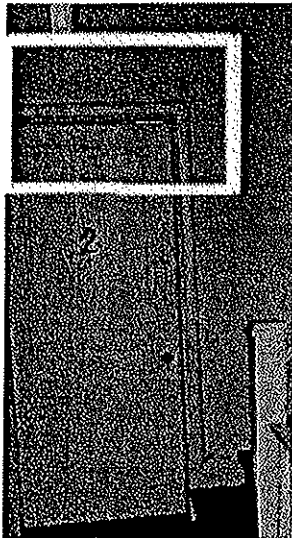
(Figure 1)

Per your request, I have thoroughly inspected your building at 127 W. Gilman St. with the hopes of renovating it. The purpose of my inspection was to create an estimate for the amount of work required to make the units habitable. However, once I began going through the building, I realized that it would be extremely costly to renovate this building. Typically, if a building has good mechanicals and a sound structure, we can gut the finishes and start over. However, this building has inadequate mechanicals as well as many structural problems in various areas. Several areas within the building have settled so much, that there are 1" or more gaps between the door slabs and the door frames (See figure 1 below.) Also, a fire that swept through the attic of the house has severely compromised the integrity of the existing roof structure (See figures 2 & 3 below.)
