# Park Drake Blight Study - Proposed Redevelopment District

February 14, 2013

City of Madison,  
Wisconsin

PREPARED BY MSA PROFESSIONAL SERVICES, INC.

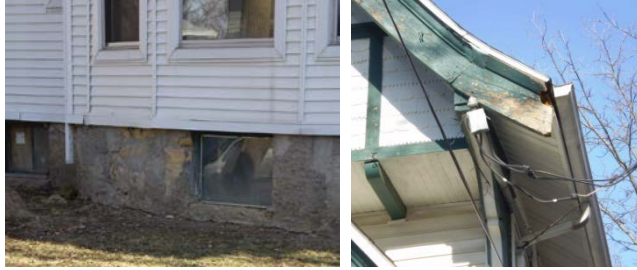
Siding dirty with poor patchwork on left side; rotting wood fascia with pieces missing; boarded windows on second floor and basement; porch and overhang sagging slightly; gutters separating from roof with downspout missing; concrete steps cracked with pieces missing; walk has significant cracks and is heaving; construction material occupying drive; vacant

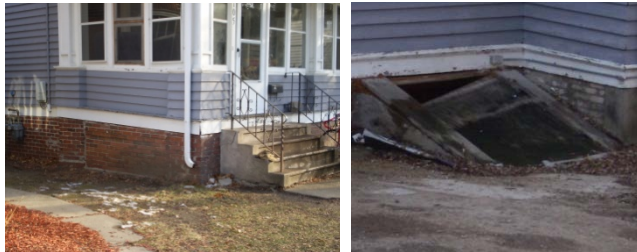
#### ***Parcel 66***

Foundation is cracked with poor patchwork; warped and loose siding boards; windows mismatched with chipped paint; porch sloping and sagging; rear porch broken railing; missing gutters with existing gutters twisted and rusting; cellar door broken and a safety hazard; missing lights

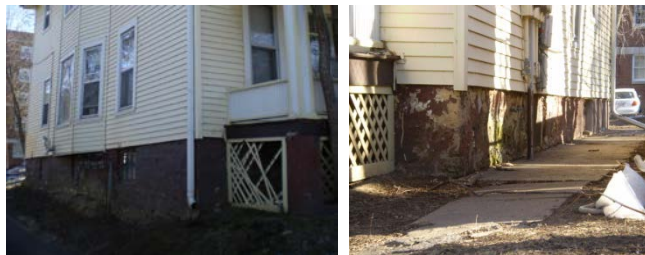
#### ***Parcel 296***

Front porch missing lattice pieces, chipping paint and worn floor boards; foundation peeling and moldy; gutters rusted; graffiti covered with mismatched paint; sidewalk heaving with exposed aggregate; vacant

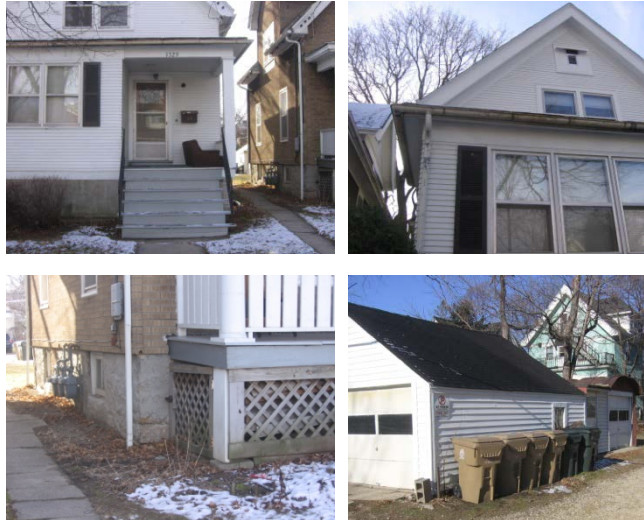
This parcel is comprised of two houses, the east house (pictured on top) has dirty, stained and missing siding, chipping paint, and the garage has two different door styles and walkways heaving. The west house (bottom) has a poorly patched foundation, a window too small for opening, a leaning porch, front gutters hung improperly with missing sections, walk missing chunks and exposed aggregate.

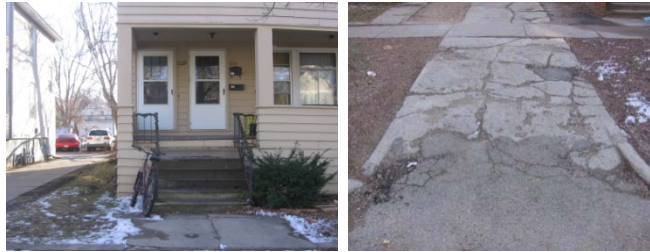
Dirty and stained siding, damaged shingles, chipped paint on fascia, two story porch not level with unfinished wood, poorly patched chimney, front steps cracked and pieces missing, column on garage leaning, and driveway is severely cracked, heaving and poorly patched.

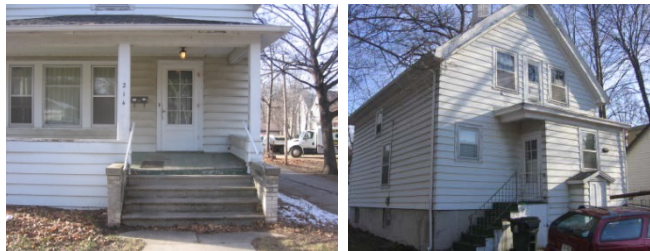
#### ***Parcel 35***

Cracked and patched foundation, damaged siding, chipped paint on fascia, porch floor boards are worn, chipped and uneven, stained front stairs, and missing railing for second floor balcony a safety hazard.

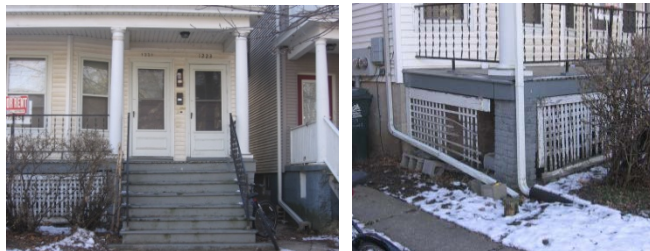
#### ***Parcel 45***

Chipped paint on fascia, front porch boards decaying, broken lattice, rear porch missing lattice, mold on front stairs, garage doors have gap, walk is cracked and heaving enough to create a trip hazard.

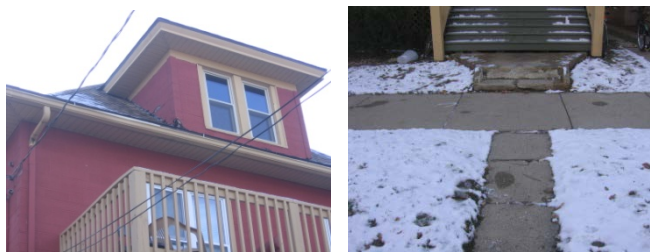
#### ***Parcel 144***

Siding missing in places; bent gutters; concrete steps in front cracked and spalling; garage missing door and roof faded and dirty; front walk cracked, chunks missing; indoor furniture on porches; foundation flaking near ground

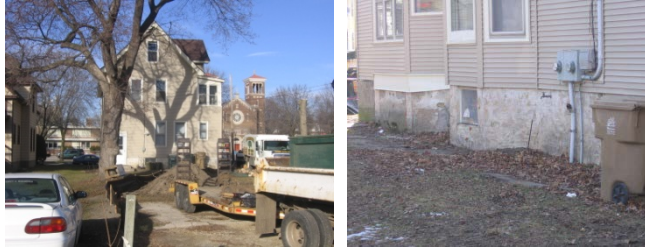
**Parcel 246**

A few shingles are loose or damaged; front porch unfinished wood, mold, broken lattice; no gutters; missing mortar on chimney; sidewalk has missing chunks; scattered litter and debris around structure

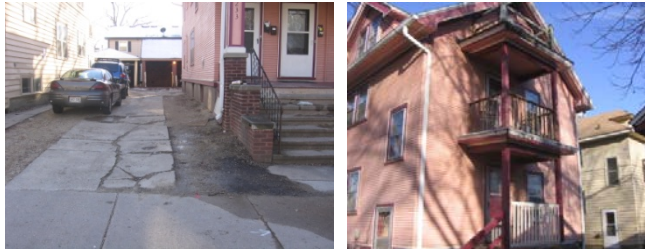
**Parcel 304**

Foundation dirty and stained with holes near side door; back porch stairs worn paint, rotting, sagging; side door insulated with spray foam remnants visible; mismatched paint color on doors; garage has loose brick, missing mortar; driveway severely cracked.

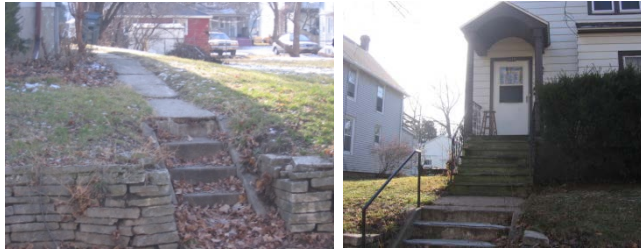
Siding stained, patched window; chipping paint on window frame; porch has unfinished wood with signs of rotting; bent gutters; front wood stairs unfinished, worn, mold, very dirty; retaining walls loose and shifting, missing pieces; suckering tree, overgrown shrubs, large weeds surrounding house

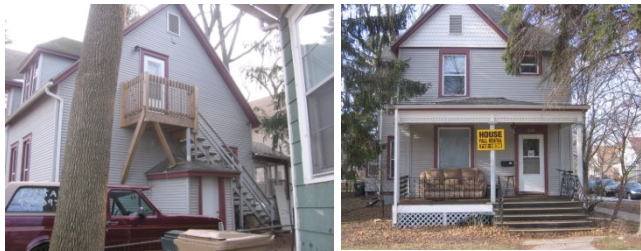
#### ***Parcel 151***

Foundation cracked and bulging with chipping paint; shingles have signs of mold; poor patchwork on chimney; front stairs carpet dirty and improperly cut; back stairs worn with mold and chipping paint; driveway poorly patched with chunks still missing; litter around house and debris in gutters; indoor furniture on porch

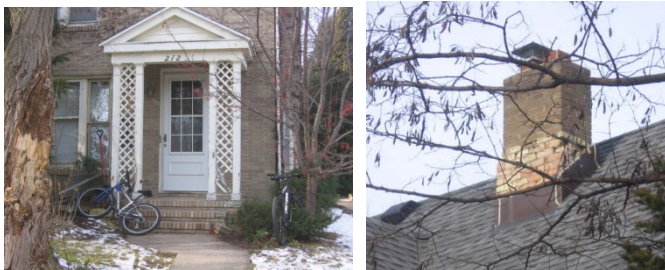
#### ***Parcel 152***

Windows dirty/stained with chipped paint; aluminum foil over front windows; lattice has chipped paint, broken pieces; back balcony chipped paint and unfinished wood; gutters dirty; chimney bricks mismatched; brick stairs have broken corners; concrete stairs leaning; retaining walls shifting with missing bricks; walk heaving; vines covering house

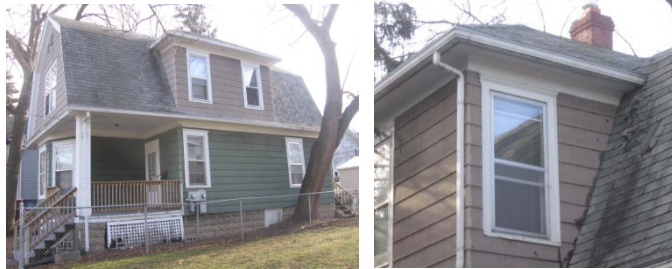
**Parcel 283**

Foundation has poor patchwork; different colors on upper and lower parts of house; damaged shingles; chipping paint on window frames; lattice loose and broken with chipped paint; railing wood unfinished; porch has worn boards with chipping paint; concrete stairs have significant cracks, chunks missing, and are poorly patched

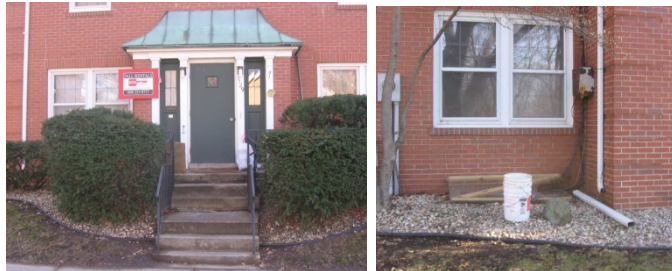
**Parcel 305**

Brick siding has poorly patched mortar; the soffit is separating from the fascia; gutters dirty and stained with pieces not connected; both sets of stairs have pieces missing and are dirty; railings do not match; asphalt driveway is faded, cracked and has exposed aggregate; copper roofs over doors dirty and rust-stained

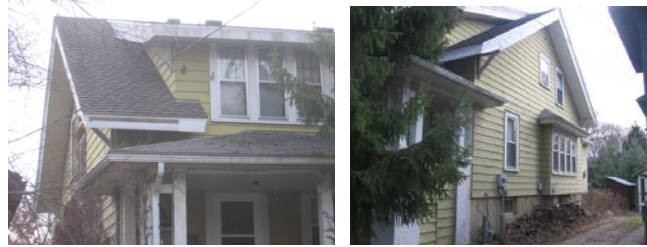
Mismatched shingles; fascia trim missing; porch boards worn, chipping paint, dirty; back stairs unfinished; exterior stairs wood worn with chipping paint; front door peeling paint; shed is made of unfinished plywood; walk and driveway are cracked, shifting and heaving; bare spots in terrace; rotting wood along side of house.

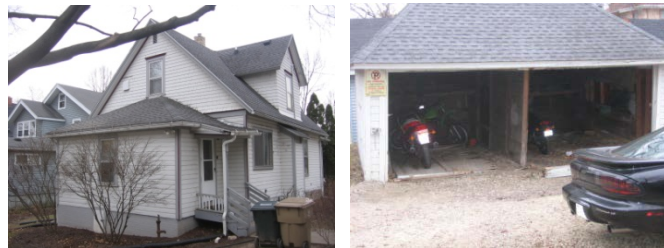
#### ***Parcel 84***

Foundation stained; walls have chipped paint, broken siding pieces and water damage; discolored window; front porch sagging, chipped paint; back porch not level with overhang and showing signs of rot; front stairs worn with chipped paint; back and side stairs not level; garage chipping paint, no doors, broken support in center.

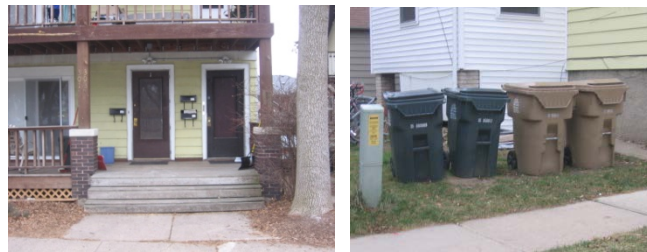
#### ***Parcel 106***

Siding dirty, especially under porches, mismatched on back addition; porches/balconies have unfinished floors, mold, partial lattice, chipped paint; missing downspouts, chimney has rust spots; walk is cracked and heaving; foundation is dirty; shingles faded; piles of debris behind garbage bins; indoor furniture on porch.

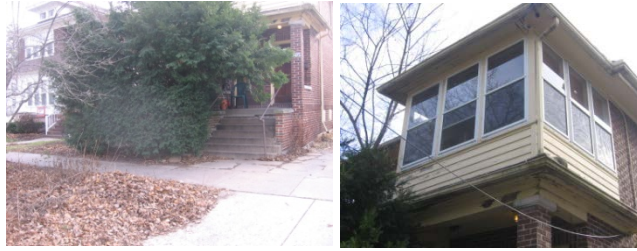
**Parcel 126**

Brick siding is dirty, has efflorescence, missing mortar and some mortar patchwork; brick separating in columns; gutters bent; mortar patchwork on chimney; concrete stairs stained with broken brick and concrete; mismatched doors; driveway is cracked and heaving; shrubs and trees in front extremely overgrown.

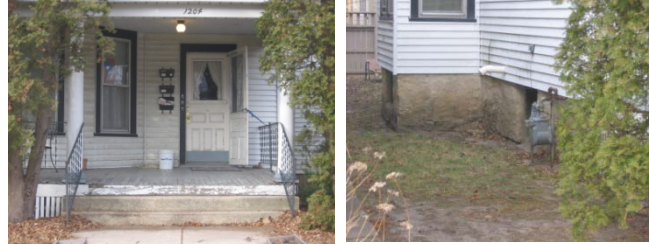
Foundation is dirty, cracked, flaking and chunks missing; walls dirty under porch; porch floor worn, chipped paint, railing rusted; gutters loose, dented and twisted; chimney poorly caulked and discolored; side wood stairs chipped paint, very dirty and worn; screen door chipped paint, loose screen.

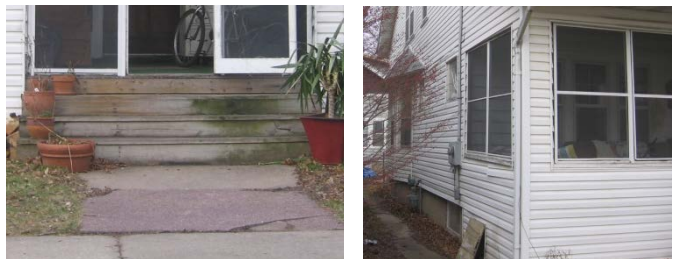
Discolored siding around rooflines; roof discolored around downspout; screen windows on porch missing trim; window trim paint chipped and left side window broken; porch has unfinished wood and dirty carpeting; balcony wood wall sloping; poor patchwork on chimney; stairs have unfinished wood with mold; sidewalk is heaving; front walk cracked and discolored; indoor furniture on porch.

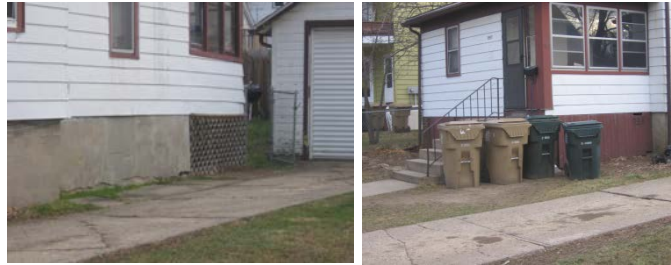
Foundation resurfaced poorly in places; dirt and rust stains on siding, missing pieces; broken screens in windows; chipping paint on window trim; front porch boards stained and pieces broken off; back porch sagging with unfinished lattice; missing downspouts; front door mismatched color; garage dirty, chipping paint; driveway cracked and pieces missing

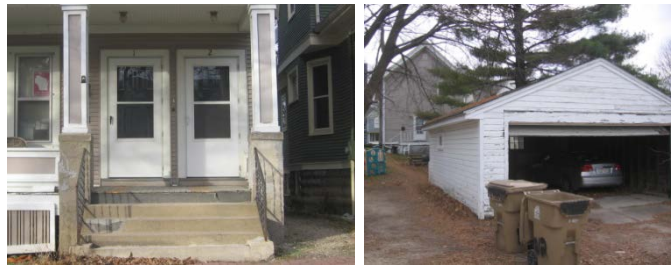
**Parcel 264**

Porch has unfinished floor boards with chipped paint, uneven skirt and columns poorly patched; chipped paint on window trim; significant damage to bricks in chimney; concrete steps poorly patched; garage has signs of rot on siding and chipped paint; uneven settling of brick walkway; railing rusting on porch

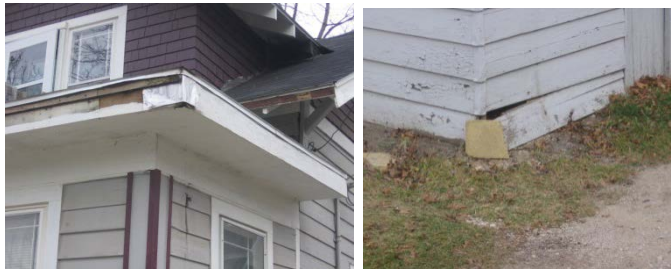
**Parcel 293**

Paint splatter on foundation; chipped paint on siding with broken board in front; roof is dirty and stained, shingles are peeling up; missing fascia board; screen broken on basement window; left overhang different color than roof; front porch is sloping, balcony has unfinished wood; front stairs unfinished and molding; ruts in driveway; debris across yard

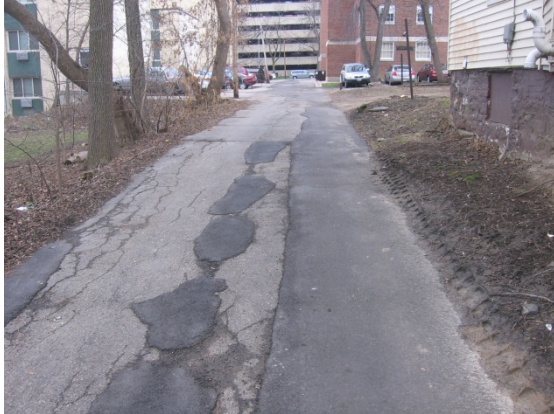
Asphalt problems in Sections B Alley  
*(poor condition)*

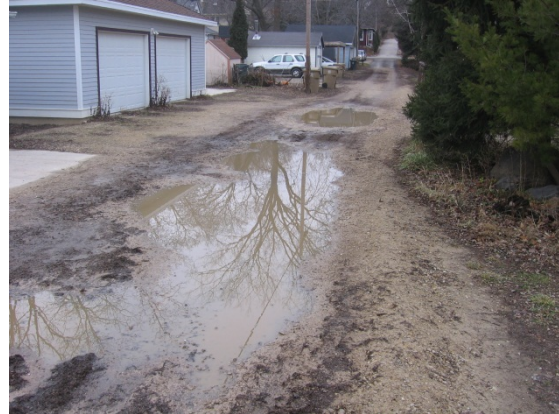
Water pooling issues in Section G Alley  
*(poor condition)*

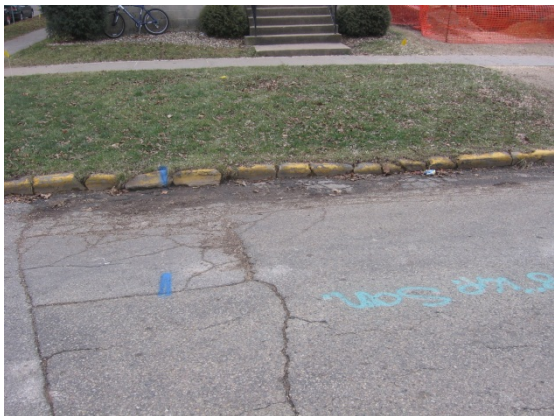
Mound between Orchard and Charter  
*(curb and road in poor condition)*

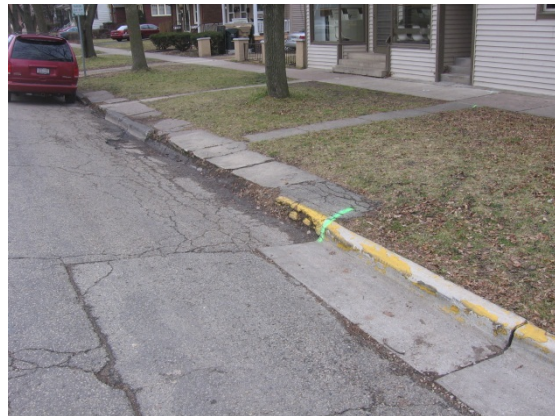
Mound between Orchard and Randall  
*(curb and road in poor condition)*
