City of Madison

**Madison Municipal
Building
Conceptual
Schematic
Design Study**

November 2013

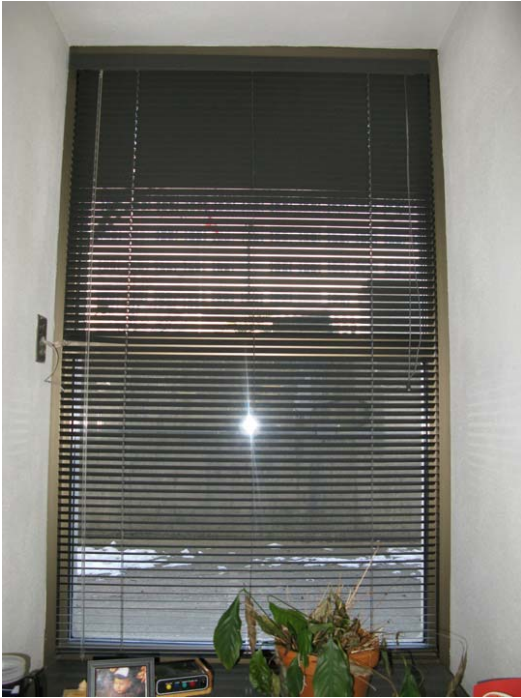
Figure 15 – Aluminum Framed Replacement Windows are Located on the Lower and First Floor Levels

Standard two inch, commercial grade, bronze colored, aluminum framed, fixed, storefront windows with tinted insulated glass were installed as replacements to the original steel windows located on the lower level and first floor within the stone openings. The replacement units attempt to resemble the original design intent however they fall very short because the frame, glass and muntin inserts vary in color, reflectance and size.

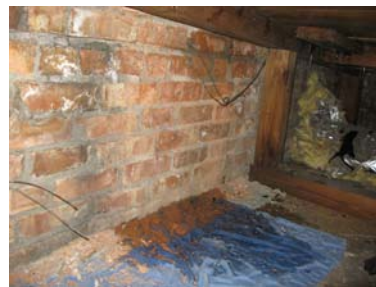
Like other buildings of the era and type, the majority of building issues at MMB reside in the construction and detailing of the parapet and roof systems. Water is finding its way through the roof flashing and deteriorated mortar joints in the parapet and cornice. The distance of travel for moisture to reach occupied interior spaces is too great but there are signs of water infiltration in the interstitial space between the roof deck (concrete) and the roof system (wood and asphalt.)

Figure 19 – Water Infiltration is occurring at the Raised Wood Roof Level.

There are areas where more water is penetrating the system and it appears most of the moisture is migrating to and staying in the stone, the brick back-up and the joints. Signs of water saturation in the stone and joints occur on all elevations of the building. Most water infiltration has not caused damage to the stone other than staining but damage to the stone due to freeze and thaw within the saturated stone can be found in portions of the west and southwest parapet and cornice.

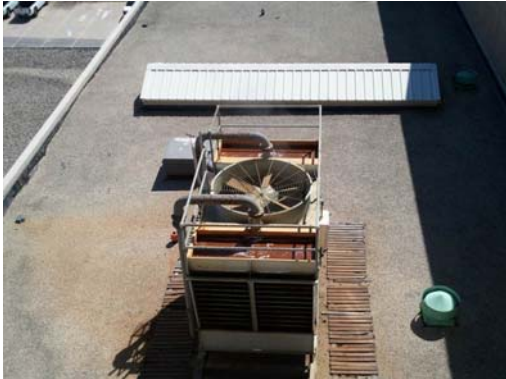
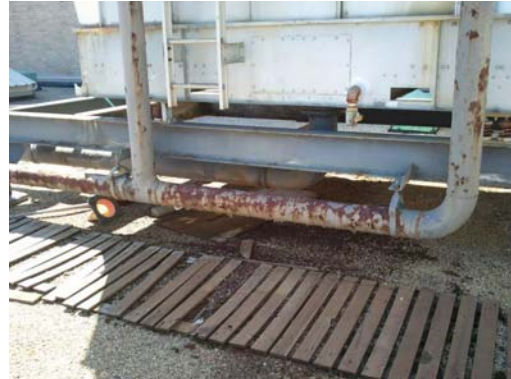
A draw through cooling tower is located on the single story roof and serves both chillers located in the lower level mechanical room. The cooling tower was installed during the 1979 renovation, and is nearing the end of its usable life. Both figures below show the current condition of the cooling tower and associated condenser water piping. In the last five years there have been multiple leaks in the condenser water piping that have been temporarily patched. The cooling tower does not operate the majority of the year, due to the heat reclaim chiller.

Figure 31 – Cooling Tower Condition

Figure 32 – Cooling Tower Condition

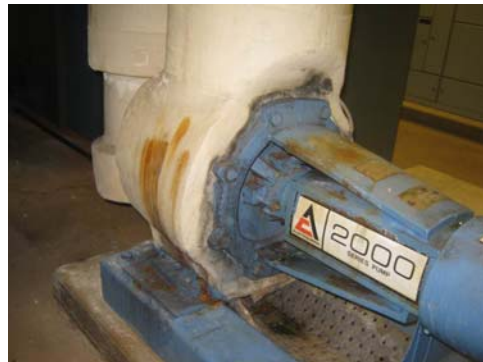
In the lower level mechanical room, there are a heating water primary and secondary pumps, chilled water primary and secondary pumps, and condenser water pumps. All pumps were installed during the 1979 renovation and are nearing the end of their usable life. Below is an example of the typical rust and water damage that is present on many of the pumps. The pumps require additional regular maintenance including seal replacement, bearing replacement, etc. due to their age.

Figure 33 – Rust on Pump Header

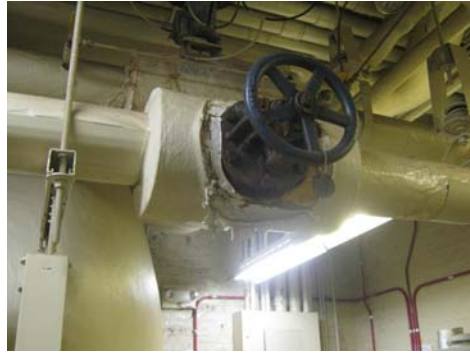
Many of the valves located in the lower level mechanical room are rusting and show signs of water damage to insulation.

Figure 34 – Leaking Valve and Damaged Insulation

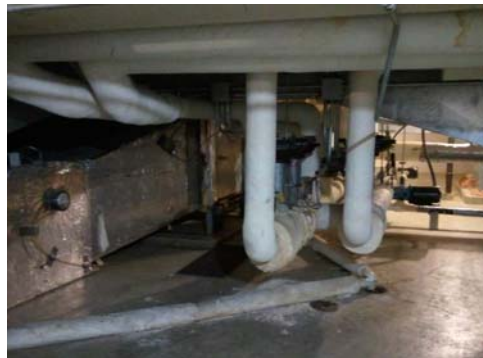
Ventilation air is provided to lower level and first floor through a 100% outside air unit located in a crawl space on first floor. The ventilation unit is currently very difficult to provide maintenance because of the limit dimensions of the crawl space.

Figure 38 – Ventilation Air Unit for Lower Level and First Floor

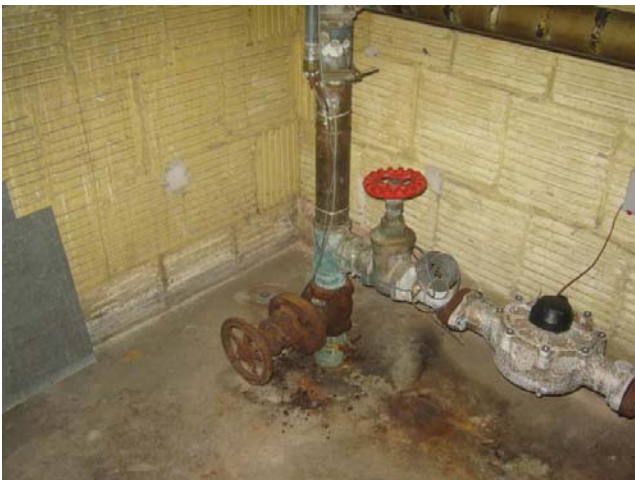
A 3” combination domestic water and fire protection service provides water to the building for the plumbing system. The 3” fire service splits off upstream of the water meter and feeds the remainder of the building; see fire protection system description below for details. Within the water entry room the domestic water system is metered and a building isolation valve is installed. The combined plumbing and fire protection service also shows significant rust and water damage within the water entry room.

Figure 39 – Incoming Combined Plumbing and Fire Protection Service

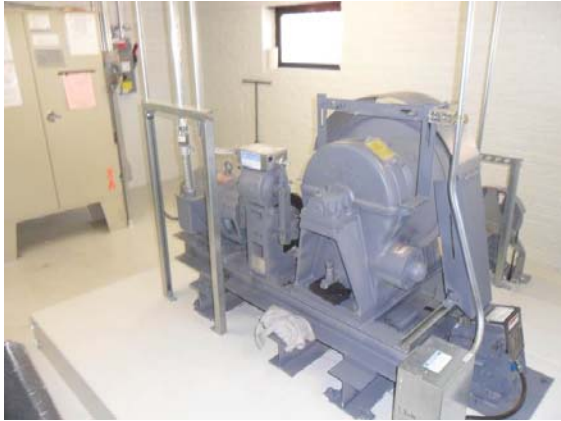
The building also has an elevator, which has undergone some changes since the original building. It appears to still be served from the original exposed motor located in the penthouse equipment room. The inspection dates looked current and the elevator appears to be in good working condition. The elevator cab itself has had at least one recent upgrade, and so have the button interfaces on each floor.

Figure 52 – Exposed Elevator Motor

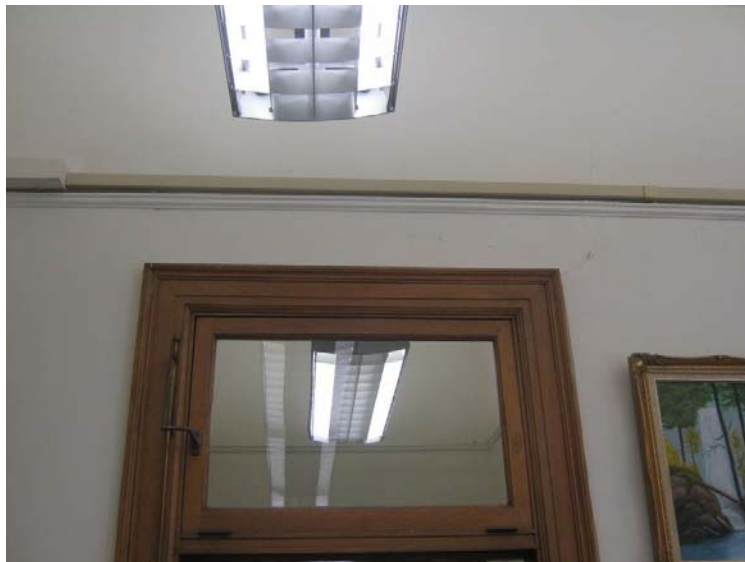
Figure 57 – Plaster Cracking at Corners of Third Floor Door

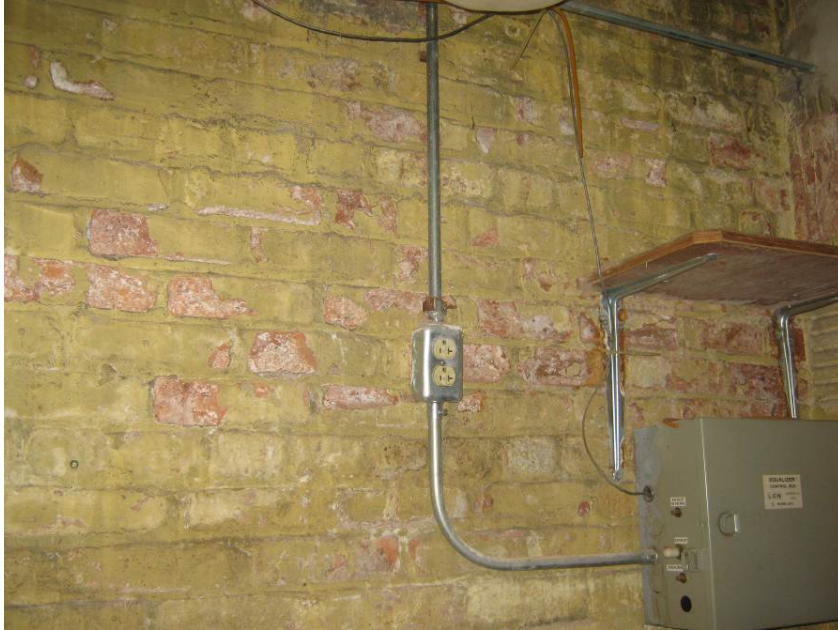
Figure 58 – Existing Brick Basement Wall Water Damage
