AmeriSpec Home Inspections
2829 Perry Street Suite 100
Madison, WI 53713
Ph#: (608) 276-8060

SUMMARY ITEMS

Client Name: Louis Fortis

Dwelling Address: 906 Williamson Street
Madison, WI 53703

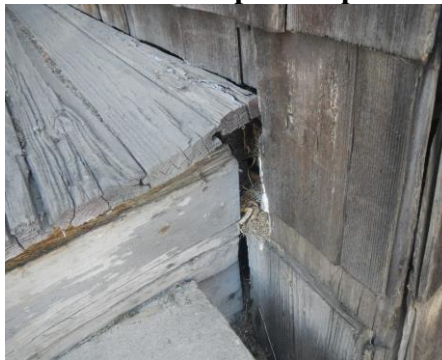
| 1121. | Porch | Defect. Wood. Wood deterioration observed. Structure of the front porch is starting to fail, porch structure may need completely rebuilt. Suggest review by a qualified contractor for repairs/replacement, as needed. |

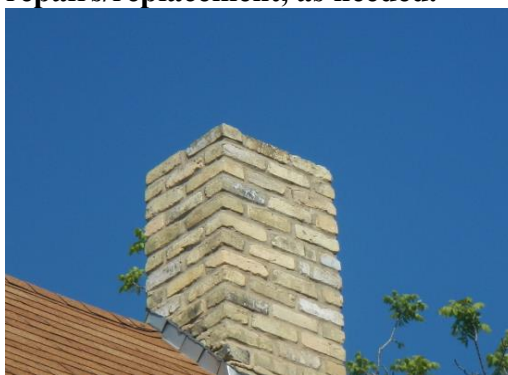
Step #	Component	Comment
1201.	Methods Used To Inspect	The roof was inspected from top of a ladder.
1202.	Material/Type	Gable; Asphalt composition shingle.
1203.	Number of Layers	One layer of shingles.
1205.	Exposed Flashings	Defect. Flashing appears to be improperly installed. Suggest review by a licensed roofer prior to closing for repairs/replacement, as needed.

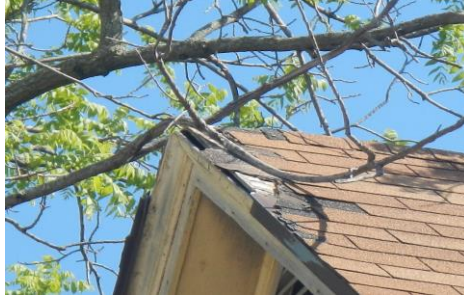
1209. Conditions **Defect. Damaged shingles observed. Recommend review by a licensed roofer for repair or replacement, as necessary, prior to close.**

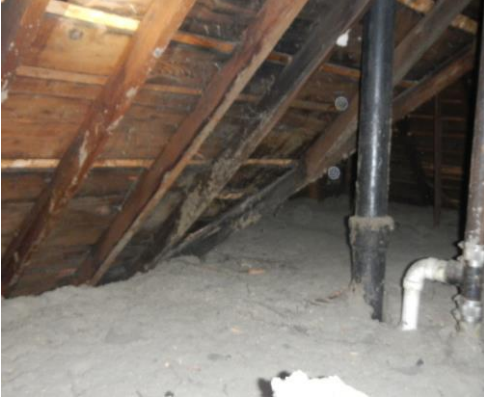
1352. Framing **Defect. Rafters. Severe bowing and cracking of almost every rafter. Years of heavy snow and too many layers of shingles have taken their toll on the roof structure. Recommend review by a structural engineer or other qualified professional for repair or replacement, as necessary, prior to close.**

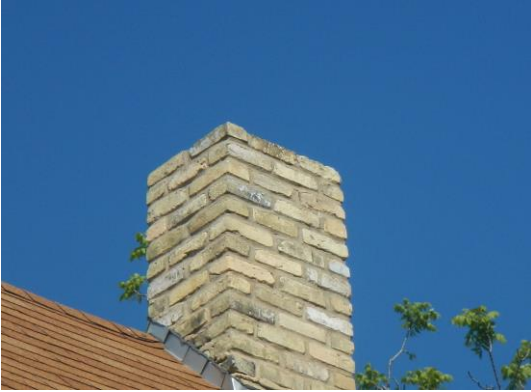
1403.	Chimney Flue	<p>Defect. The chimney stack appears to have an unlined flue. Chimney flue liners are a fire safety feature which the client should consider installing to enhance safety. Regular cleaning of the chimney is recommended to ensure safe and efficient operation.</p>

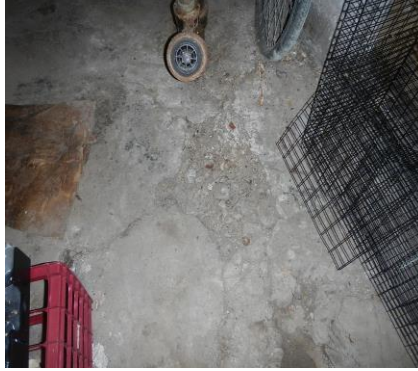
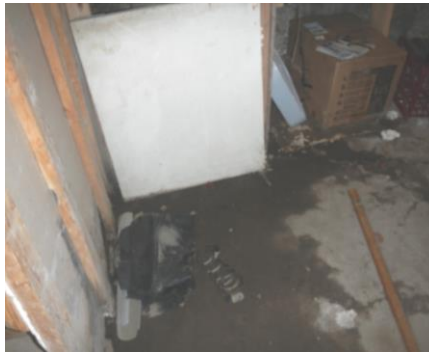
1603. Floor **Defect. Concrete. Active leaks observed at the time of inspection. Cracks/deterioration observed. In the Inspector's opinion, the floor is near the end of its useful life. Recommend review by qualified professional for repair or replacement, as necessary.**

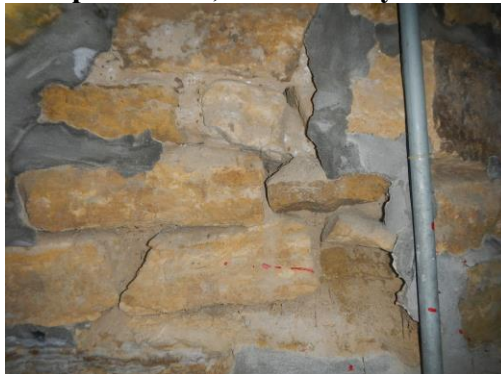
1604. Walls **Defect. Stone. Damaged/deteriorated mortar observed; suggest tuck pointing, as necessary, to prevent further damage. Active leaks observed at the time of inspection. Recommend review by licensed professional for repair or replacement, as necessary.**

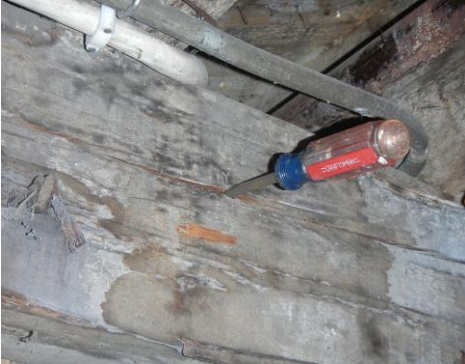
1608. Joists **Defect. Conventional 2 X 10 framing. Sagging observed in floor framing. Wood deterioration observed to floor framing members. Review is needed by a licensed contractor for repairs, as needed, prior to close.**
1609. Sub Floor **Defect. Wood rot, moisture damage observed. Review is needed by a licensed contractor for repairs, as needed, prior to close.**
1610. Support Posts / Columns Serviceable. Concrete; Wood.
1611. Beams **Defect. Wood. Beams are sagging and rotten; review by licensed building contractor is needed for corrections prior to close.**

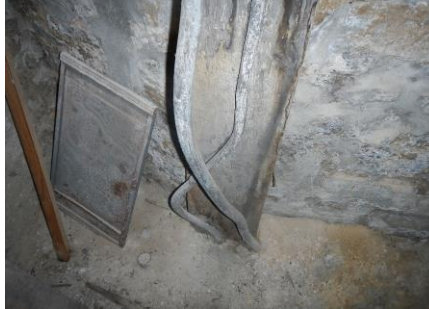
1620. Visible
Plumbing

Defect. Old lead and steel pipes noted. Improper and poorly done repairs noted. Extensive corrosion observed; no leaks visible at time of inspection. Recommend review by a licensed plumber for repair or replacement, as necessary, prior to close.

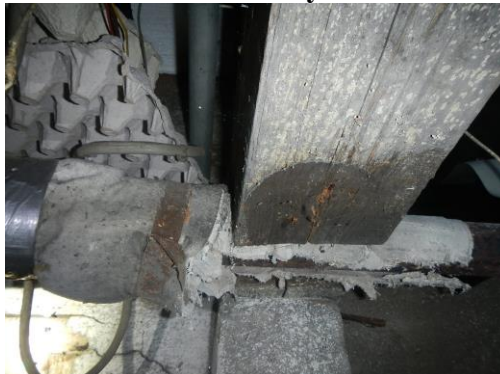
Defect. Pipes/Radiators. Possible asbestos materials observed. The materials were torn, ripped, or damaged at the time of inspection. This is a possible safety hazard. Suggest further review by a licensed asbestos testing lab be performed prior to closing for repairs/replacement needed to ensure safety.

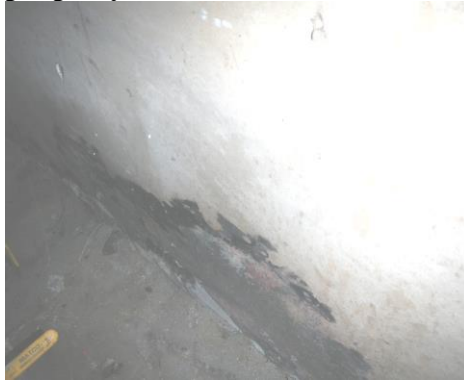
1626. Basement
Comments
- Defect. Stains, discoloration, growth and/or evidence of moisture observed. These conditions may indicate mold and/or fungus growth and were discovered during the home inspection. Because certain types of mold may be toxic and result in adverse health effects, we recommend further review by a specialist so proper repairs and clean-up are made. Limited review due to personal property.**

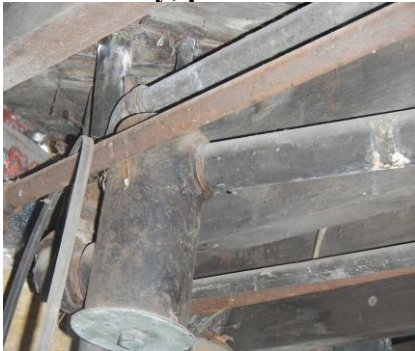
1703. Supply Lines **Defect. Copper. Lead supply pipes observed. While environmental concerns and other chemical testing are beyond the scope of the inspection, your inspector's experience leads him to suspect that the materials used on the main water service lines may contain lead. Lead can be hazardous to your health; therefore it is recommended that a water chemical test be performed prior to closing to determine if your water supply system meets proper and safe health standards. Due to safety concerns client should consider future replacement of the lead pipes. In the Inspector's opinion, the supply pipes are near the end of their useful life due to age, poor materials and poor repairs. Recommend review by a licensed plumber for repair or replacement, as necessary.**
1704. Waste Disposal System The waste disposal system appears to be connected to public sewer systems.
1705. Drain Waste Lines & Vent Pipes **Defect. PVC; Cast iron; Galvanized. Most of the plumbing is older and/or original & will likely need ongoing maintenance/replacement. Older drains are metal/cast iron which deteriorates over time, having hidden damage, root problems, which can affect drainage or water flow. Extensive corrosion observed; no leaks visible at time of inspection. Recommend review by a licensed plumber for repair or replacement, as necessary, prior to close.**

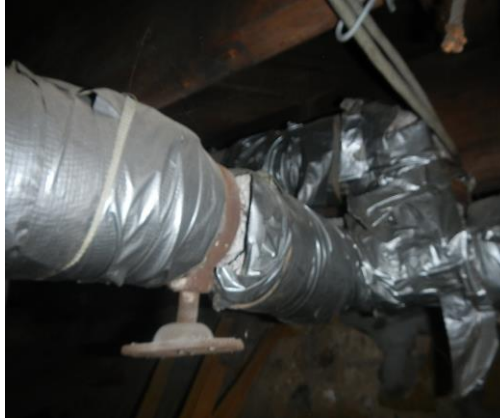
1909. Distribution / Ducting **Defect. Pipes/Radiators. Possible asbestos materials observed throughout the house. The materials were torn, ripped, or damaged at the time of inspection. This is a possible safety hazard. Suggest further review by a licensed asbestos testing lab be performed prior to closing for repairs/replacement needed to ensure safety.**

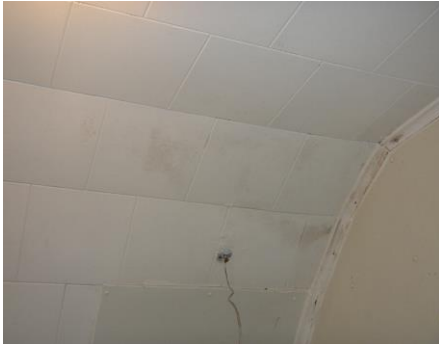
2302. Walls **Defect. Stains, discoloration, growth and/or evidence of moisture observed. These conditions may indicate mold and/or fungus growth and were discovered during the home inspection. Because certain types of mold may be toxic and result in adverse health effects, it is strongly recommended that a mold inspection be performed by a qualified professional to determine the presence of, and types of, mold in the house and that corrective measures be taken to limit moisture inside the home.**

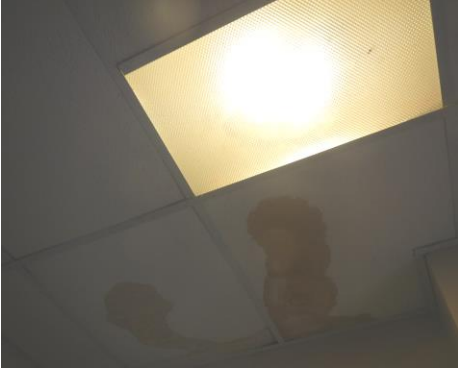
2403.	Ceiling	<p>Defect. Evidence of past water penetration observed. Recommend review Seller Disclosure Statement or have it reviewed by licensed professional for repair or replacement, as necessary.</p>
