# City of Madison Landmarks Commission

Project Title / Description: Demolition, fill-in, and replacement with green space

At your request we have inspected the residential building located at 929 Williamson St. Madison, Wisconsin, and have compiled the following report. This report is for your information and is not to be construed as a warrantee of any mechanical system, nor does it guarantee any portion of the building against subsequent failure.

# 929 Williamson St Freiburger Consulting Review

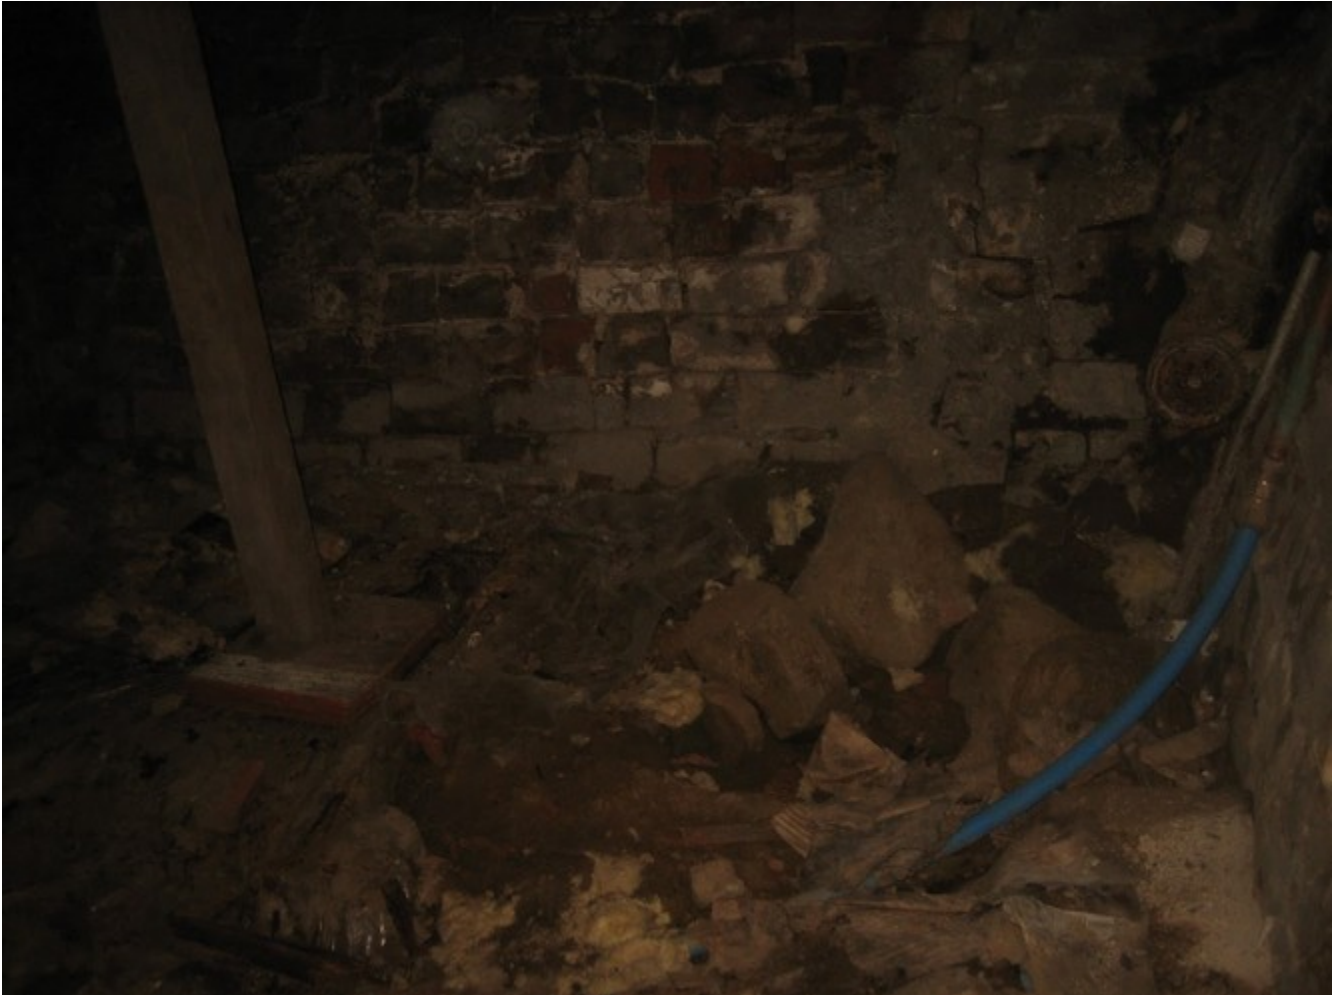
## 01. Brick foundation

- 1.2 There is a small basement with a brick foundation under a portion of the center section of the structure. (Photo 1) The headroom clearance in this area is limited at 5'. The balance of the center section and the sections towards the front and rear of the property are supported on what appear to be shallow stone or other masonry foundation walls with inaccessible crawl spaces.

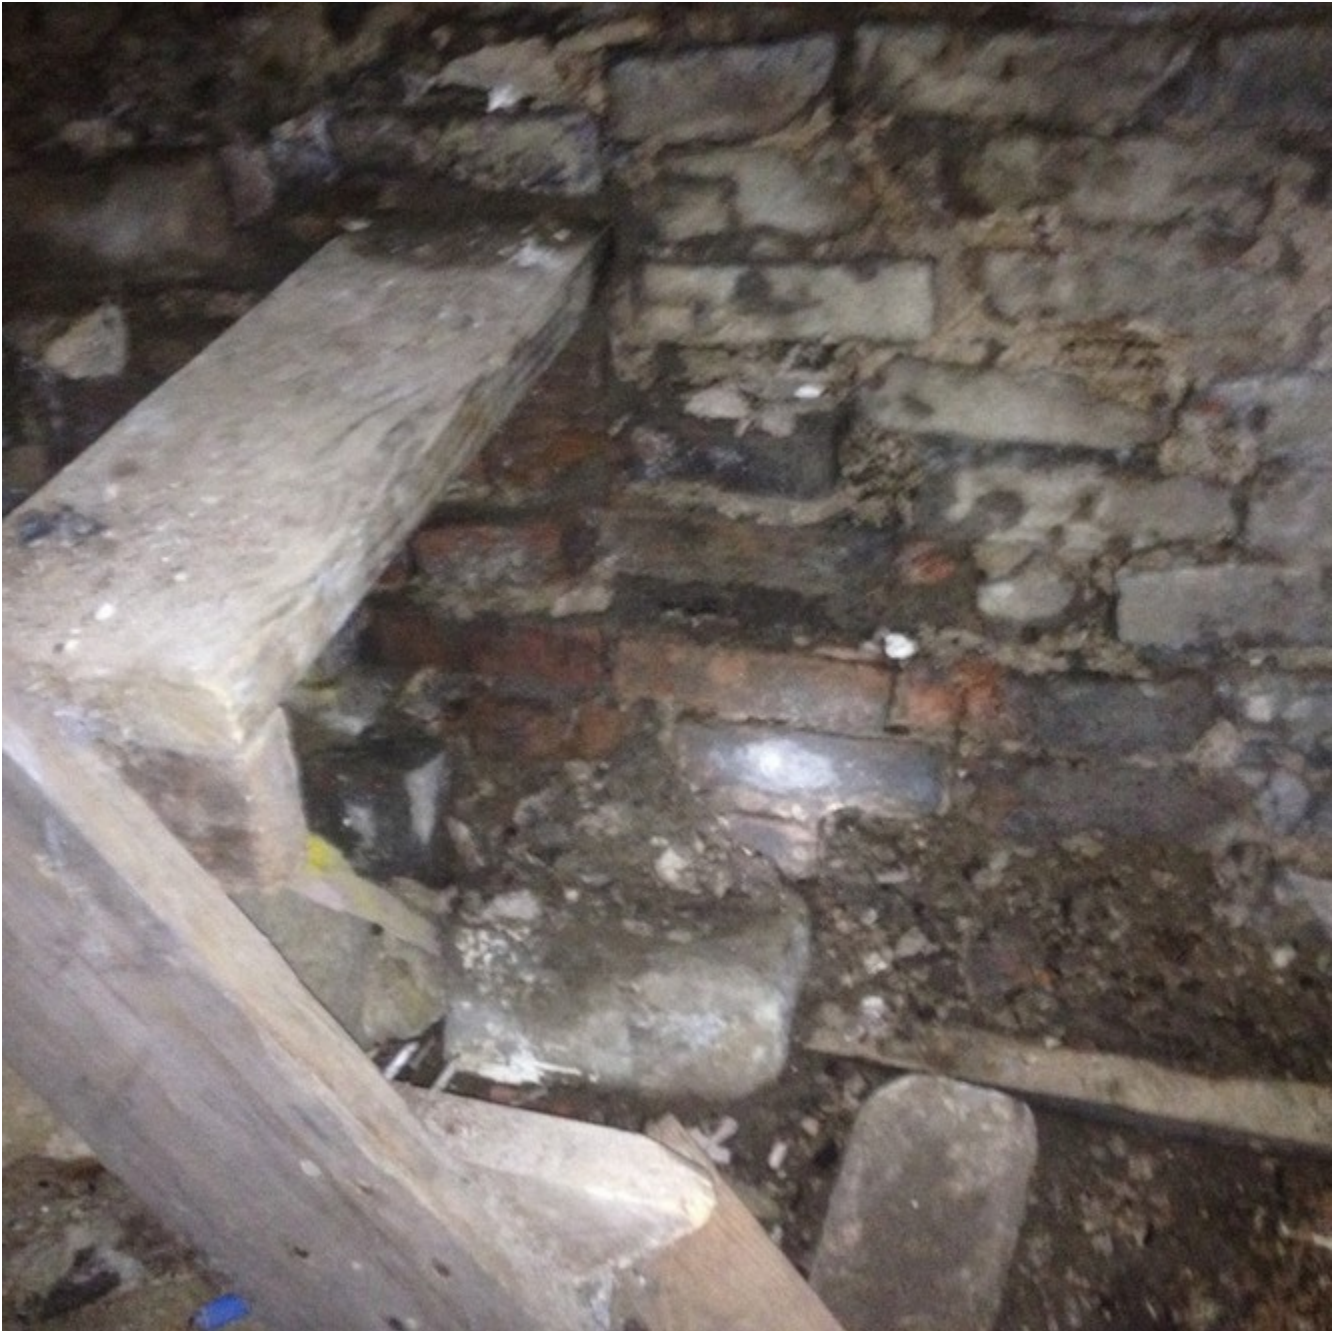
## 02. Deterioration of Brick Foundation.

- 1.3 There is some deterioration to the brick foundation where moisture infiltration has occurred. Eroded mortar joints and spalled brick were noted in several locations. (Photo 2) In another area portions of the foundation wall were removed to provide access to part of the rear crawls space to allow for installation of plumbing pipes. (Photo 3) The basement area has an earthen floor.

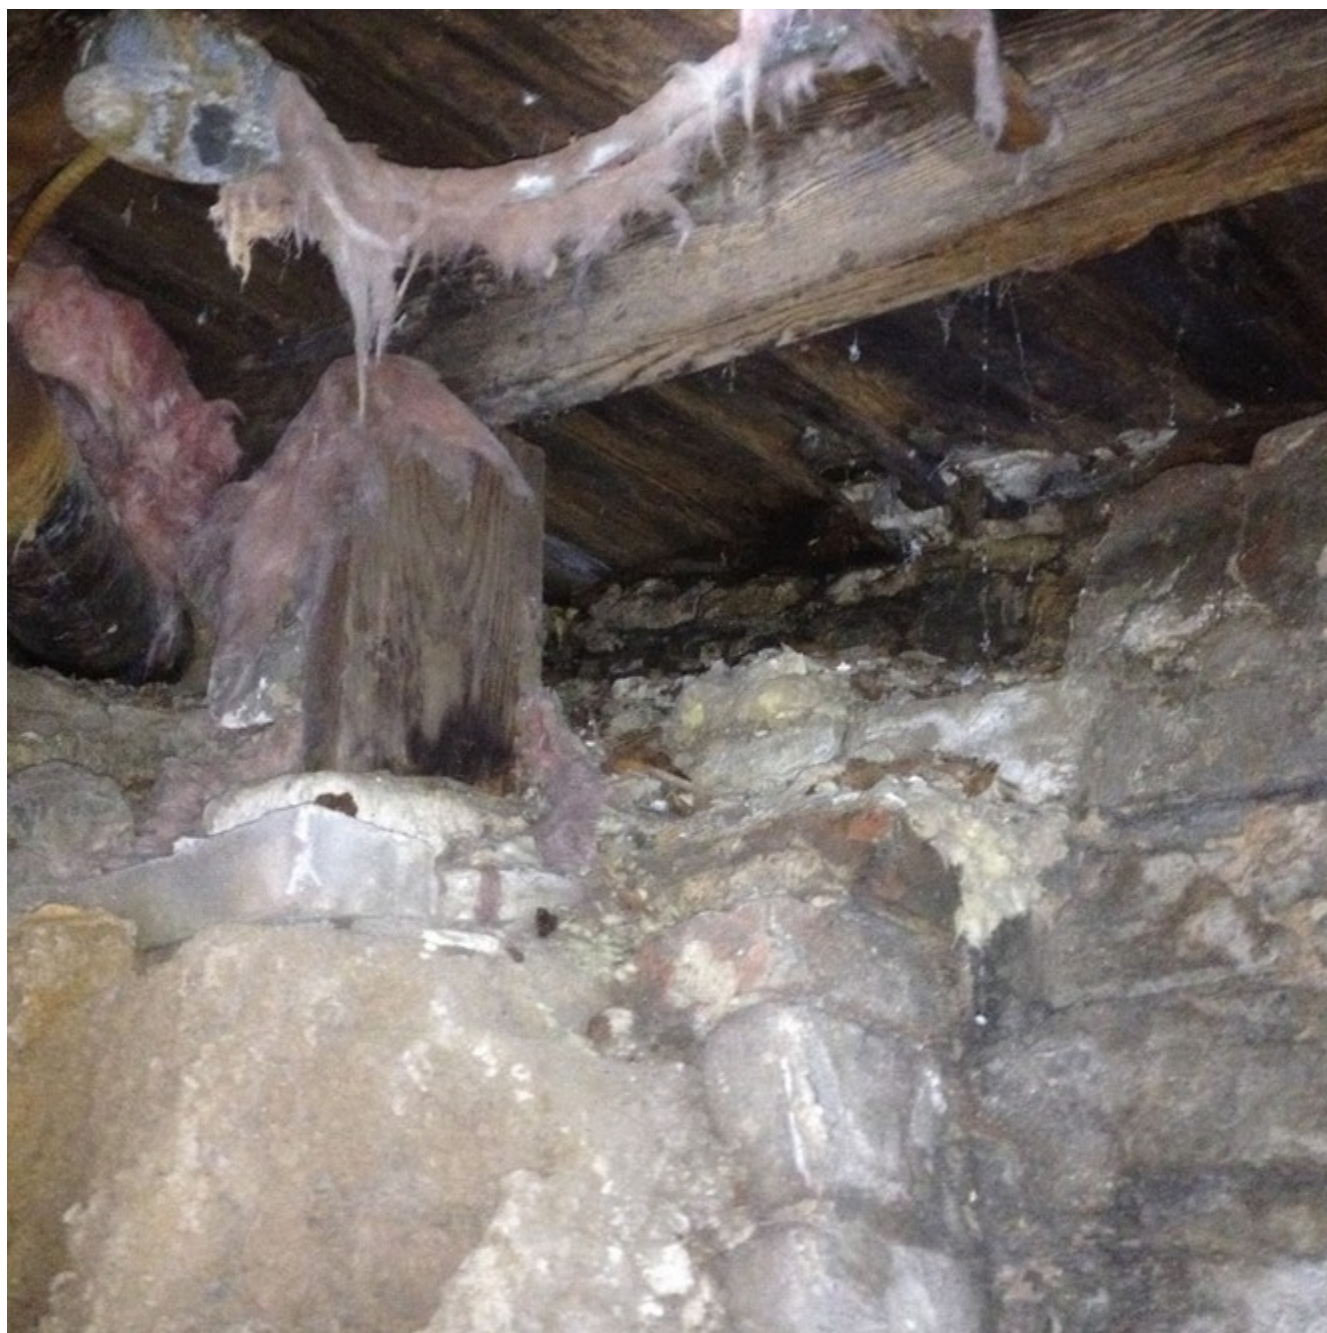
#### 04. Wood framing deterioration at perimeter

- 1.4 The wood framing set on top of the brick foundation is severely deteriorated. (photos 4 & 5) A probe could be fully inserted into the wood in many locations. Other portions of

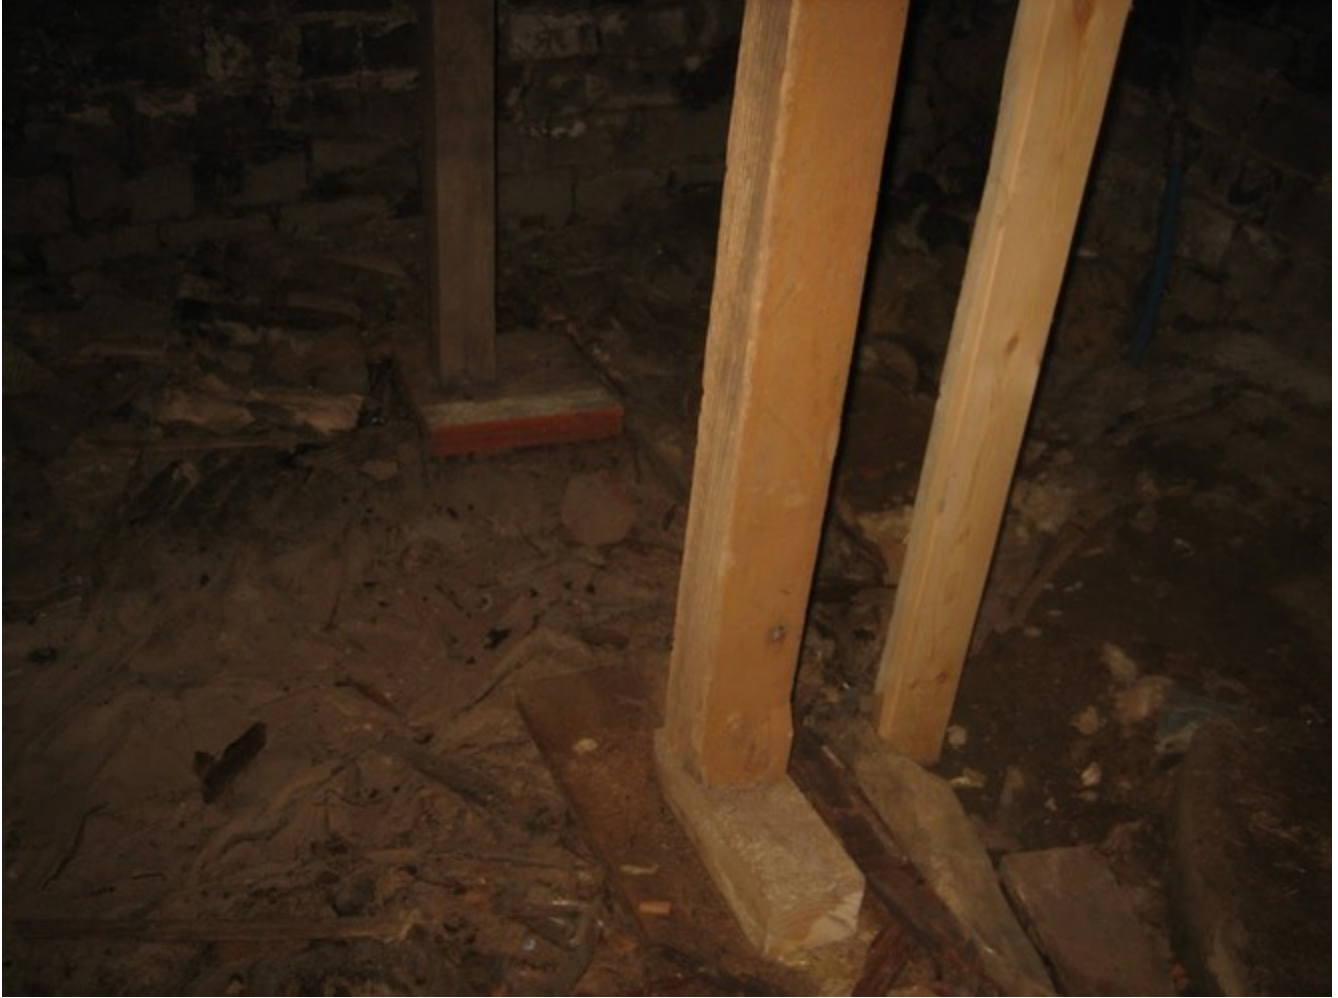
## 06. Supplemental posts, inadequate bearing

the wood framing are also deteriorated due to excess moisture. Supplemental posts have been installed under portions of the floor framing in numerous locations without proper support or protection from deterioration at the base. (Photo 6 - 8) In other locations supplemental blocking bears directly on soil. (Photo 9)

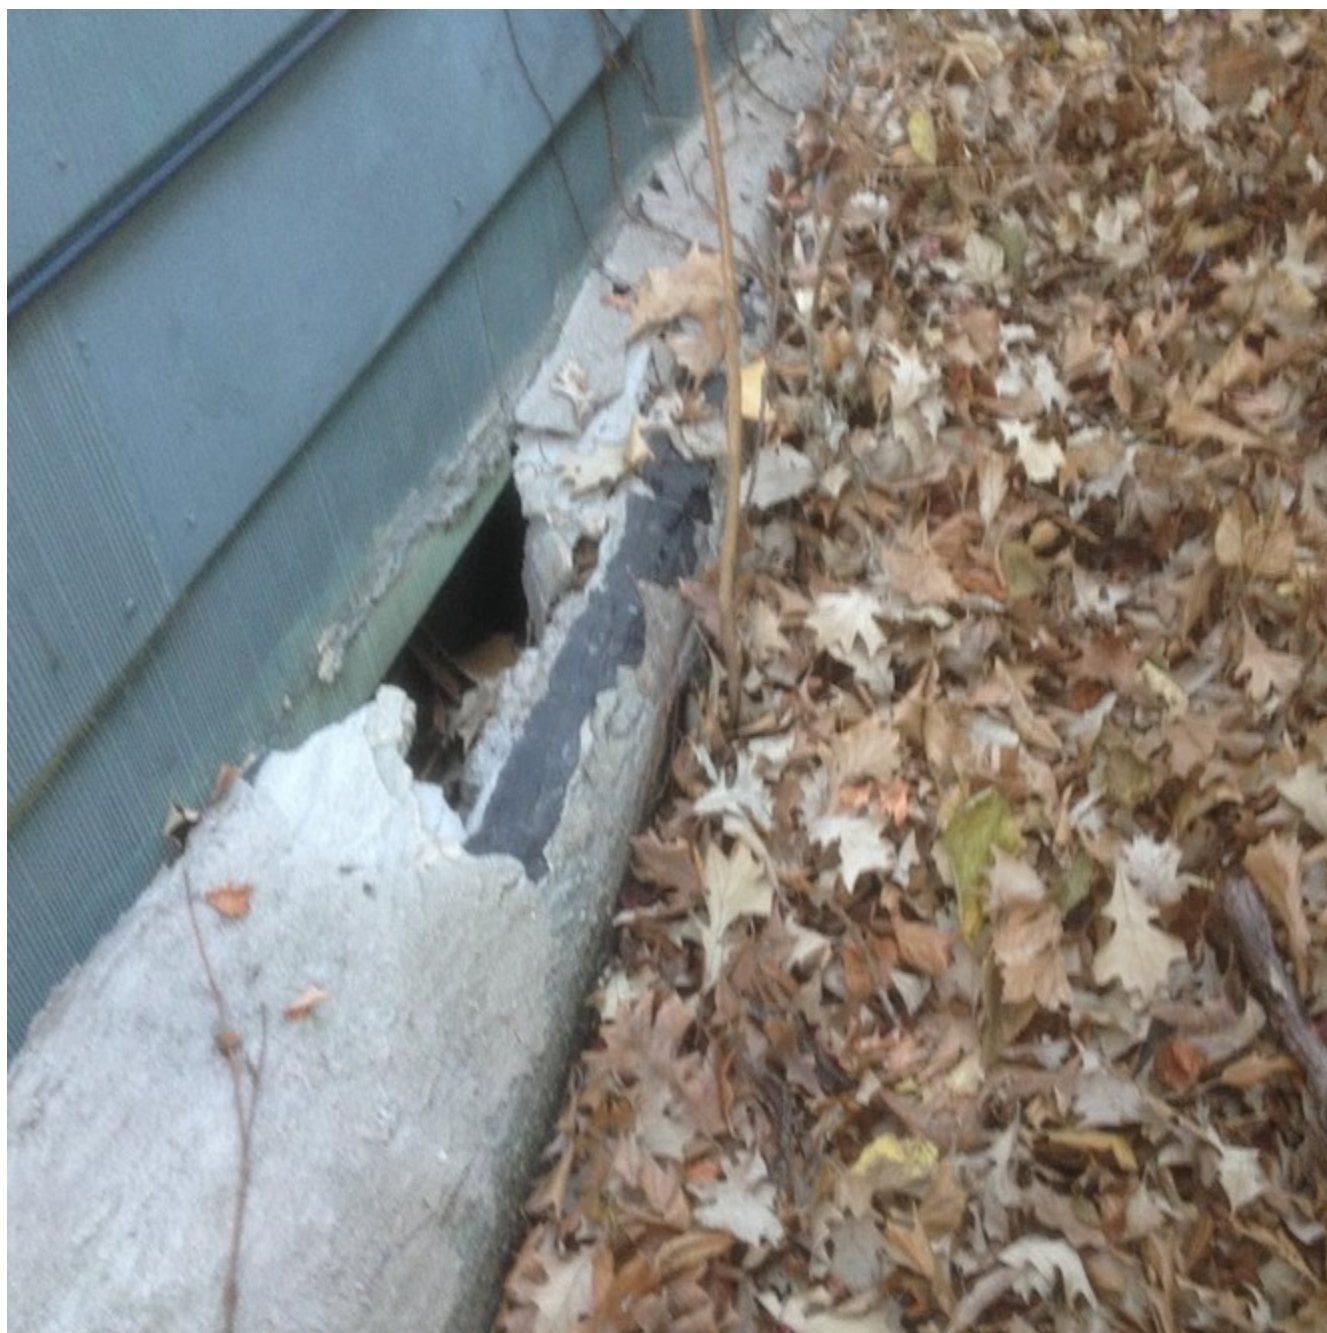
## 10. Masonry barrier against dwelling

- 1.5 Around the exterior perimeter where the wood framing could be accessed the wood framing is noted to have deteriorated. At the front section of the dwelling a parged masonry barrier was constructed around the base of the structure. This masonry concealed the wood floor framing setting on the crawl space foundation. (Photo 10) The intent was apparently to close off the crawl space. Where this masonry has fallen away the wood framing is visible and is seriously deteriorated.

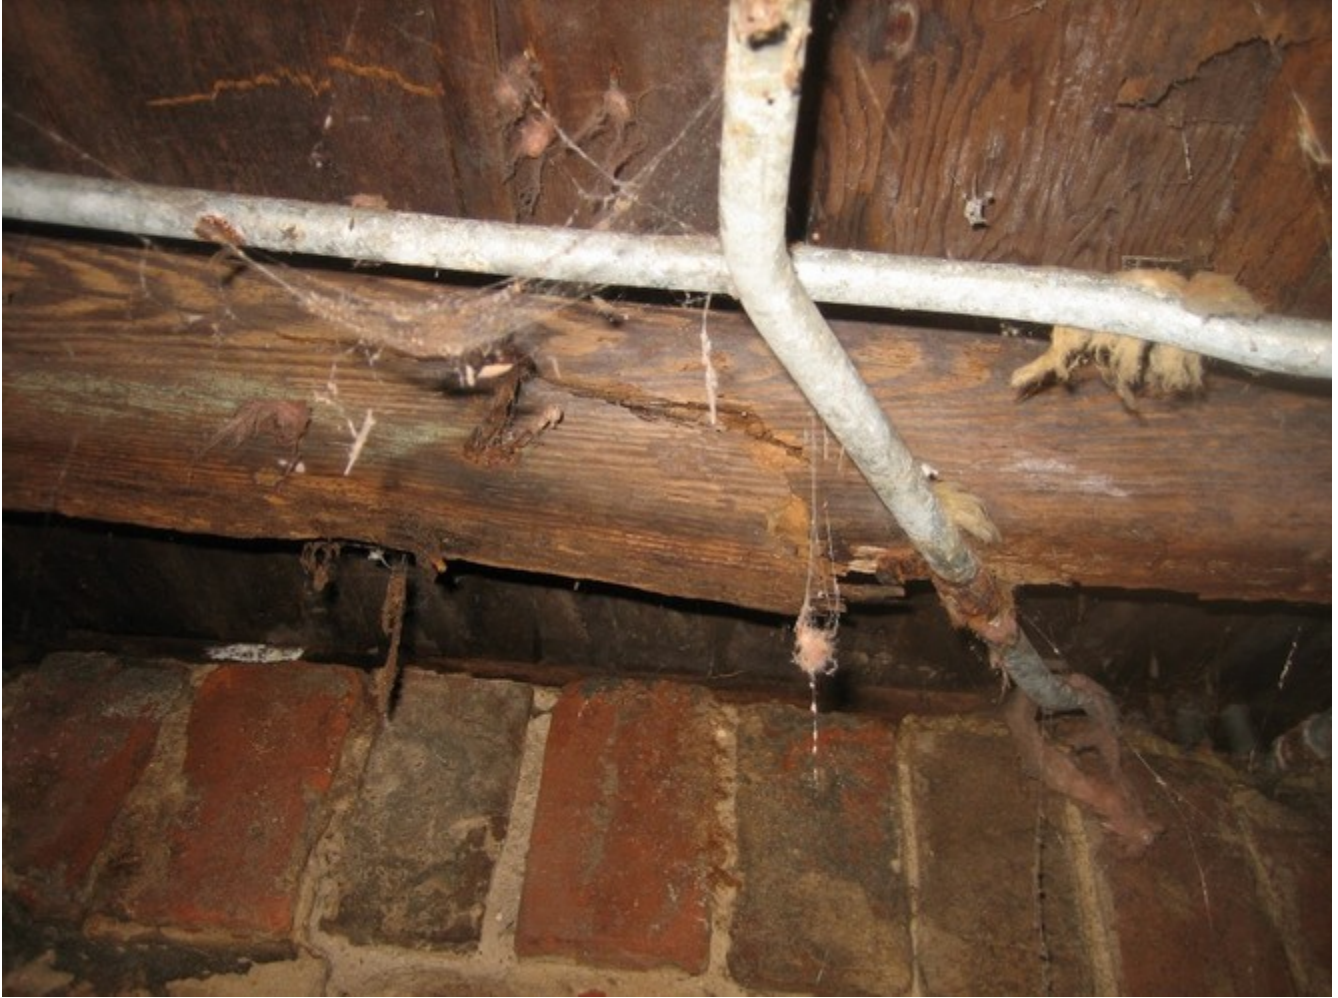
## 11. Cracked floor joist

- 1.6 The floors within all of the rooms are uneven and slope reflecting the deterioration of the framing and foundations. In some locations the slope is over 1" across 2'. Cracked or deteriorated floor joists were noted in several locations. (Photos 11 & 12) In the bathroom the legs of the claw foot tub have pushed thru the flooring. (Photo 13)

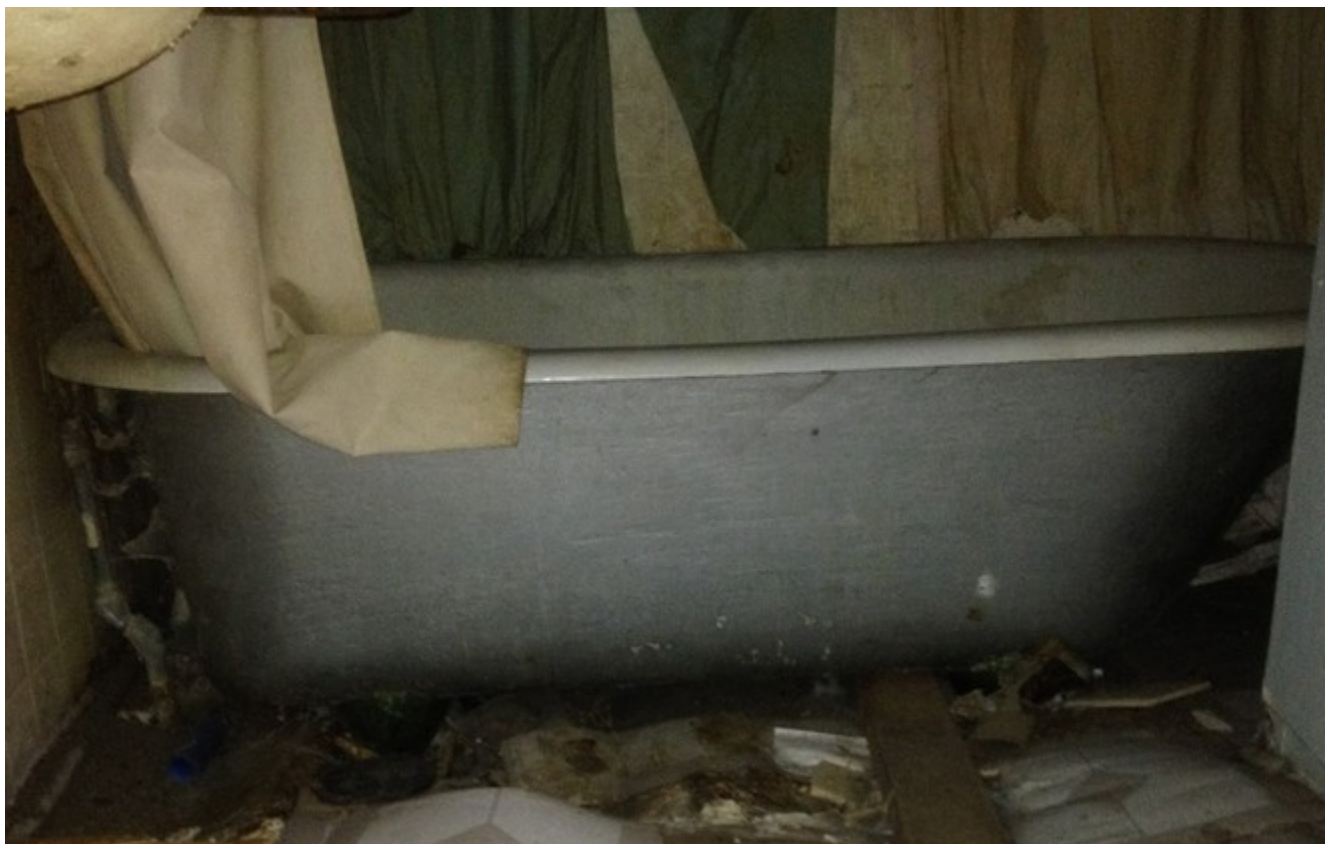
### 13. Legs of tub thru floor

6.3 As noted above the bath tub has subsided a couple of inches through the floor. It is likely that this has resulted in damage or breaks in the associated plumbing pipes.

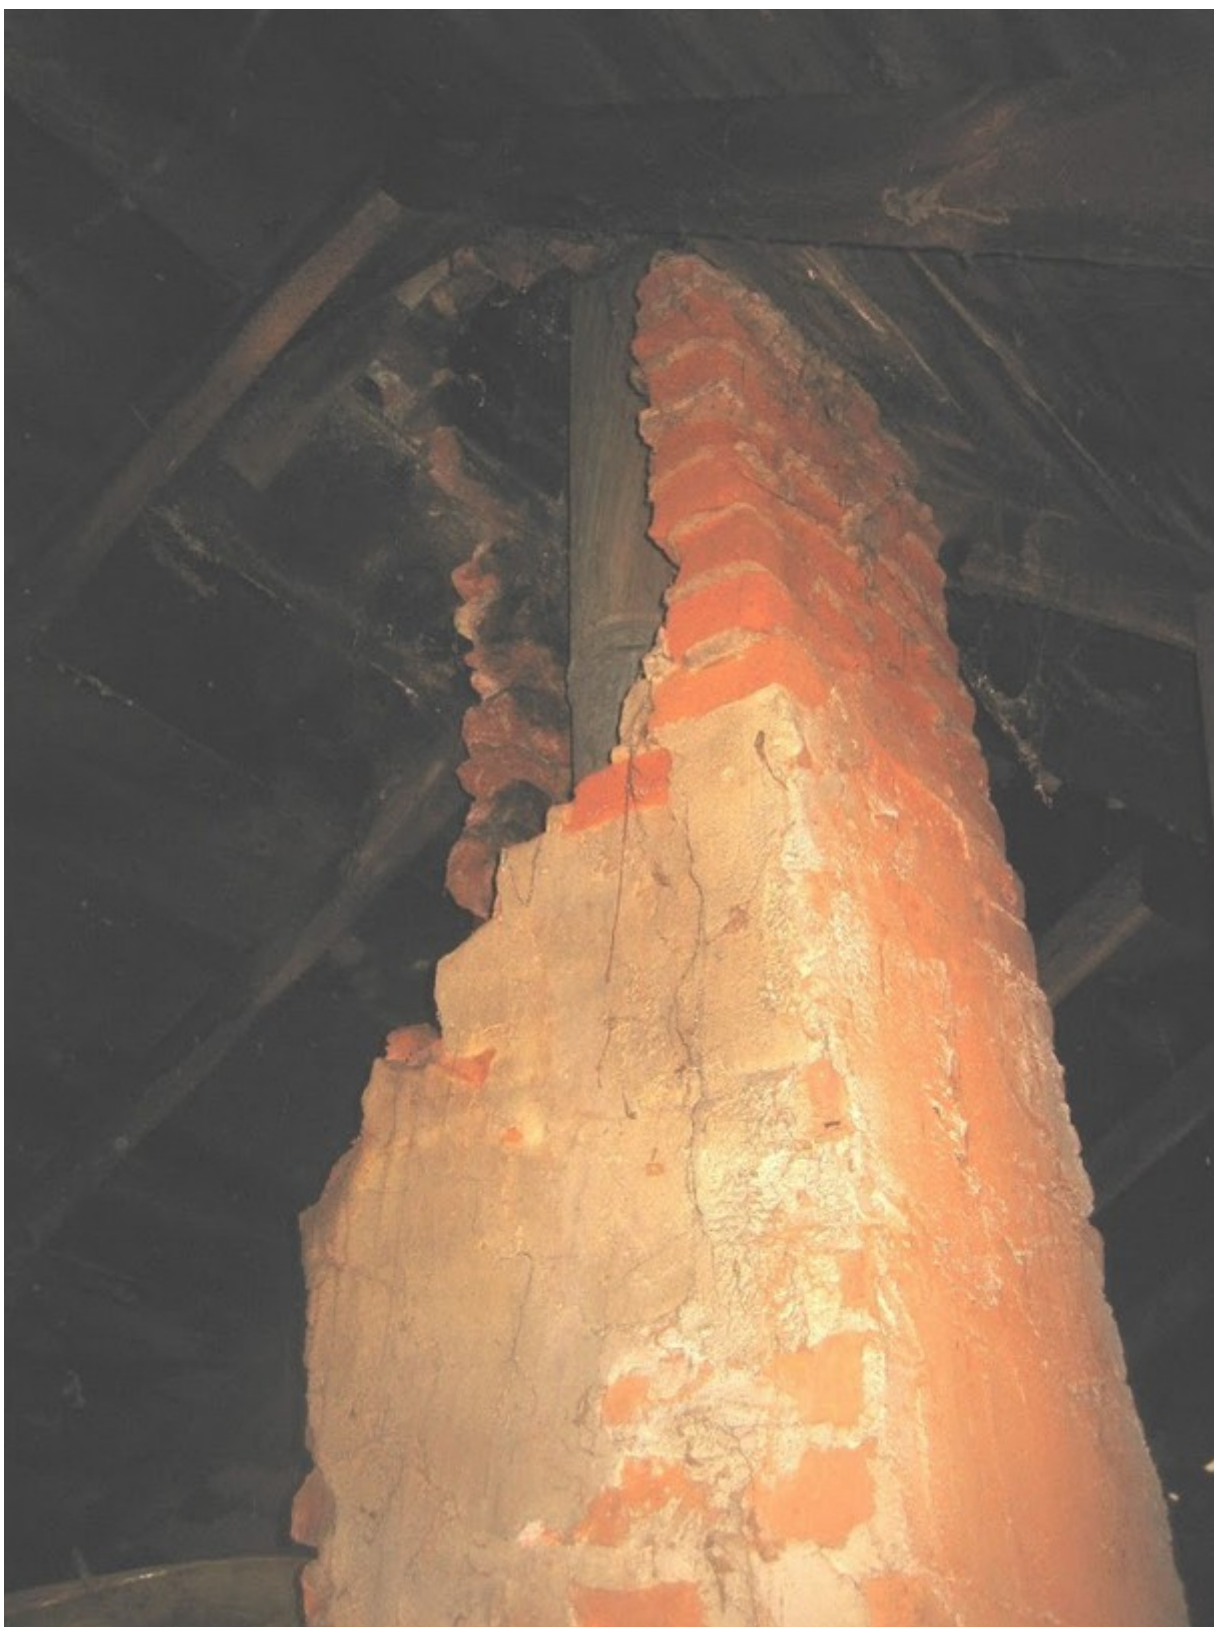
#### 14. Collapsed chimney in attic

- 1.7 There is a single wythe brick chimney in the center of the structure which extends up through the roof. Within the attic the brick on two sides of the chimney have collapsed. (Photo 14) The chimney above the roofline should be considered unstable since it does not have support at all sides.

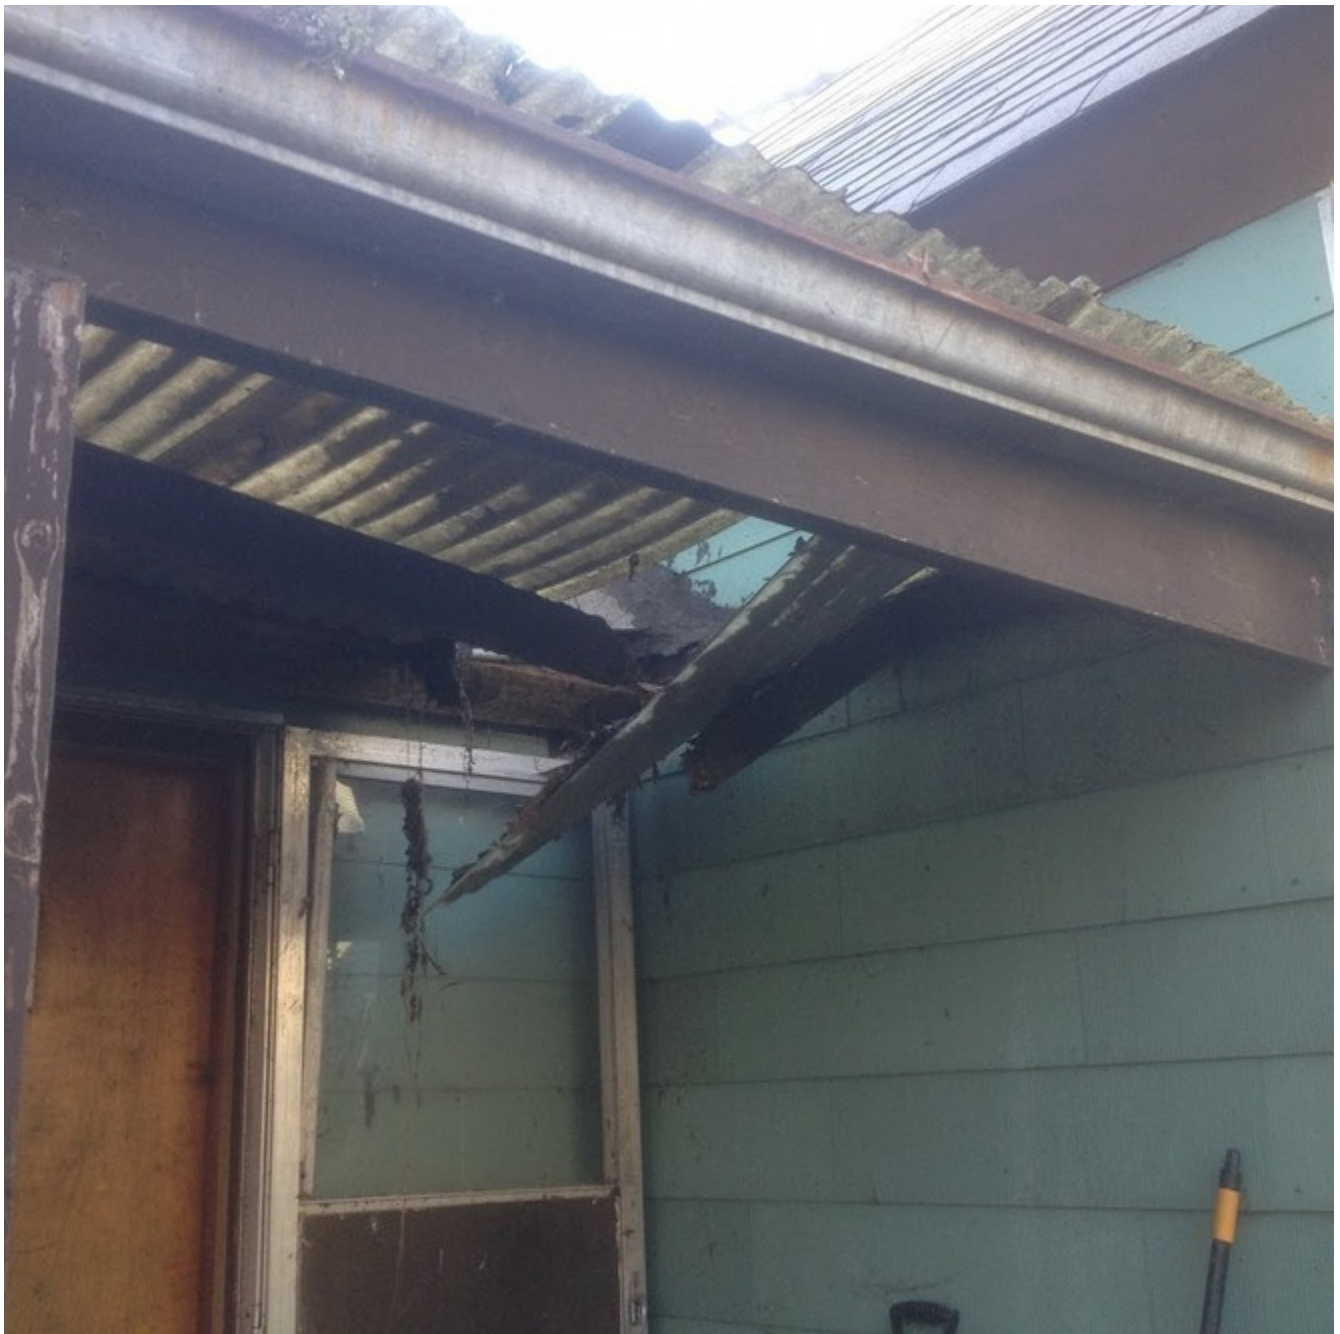
## 15. Collapsed entry roof

- 1.8 The wood framing for the roof over the rear entry landing has rotted and collapsed. (Photo 15)

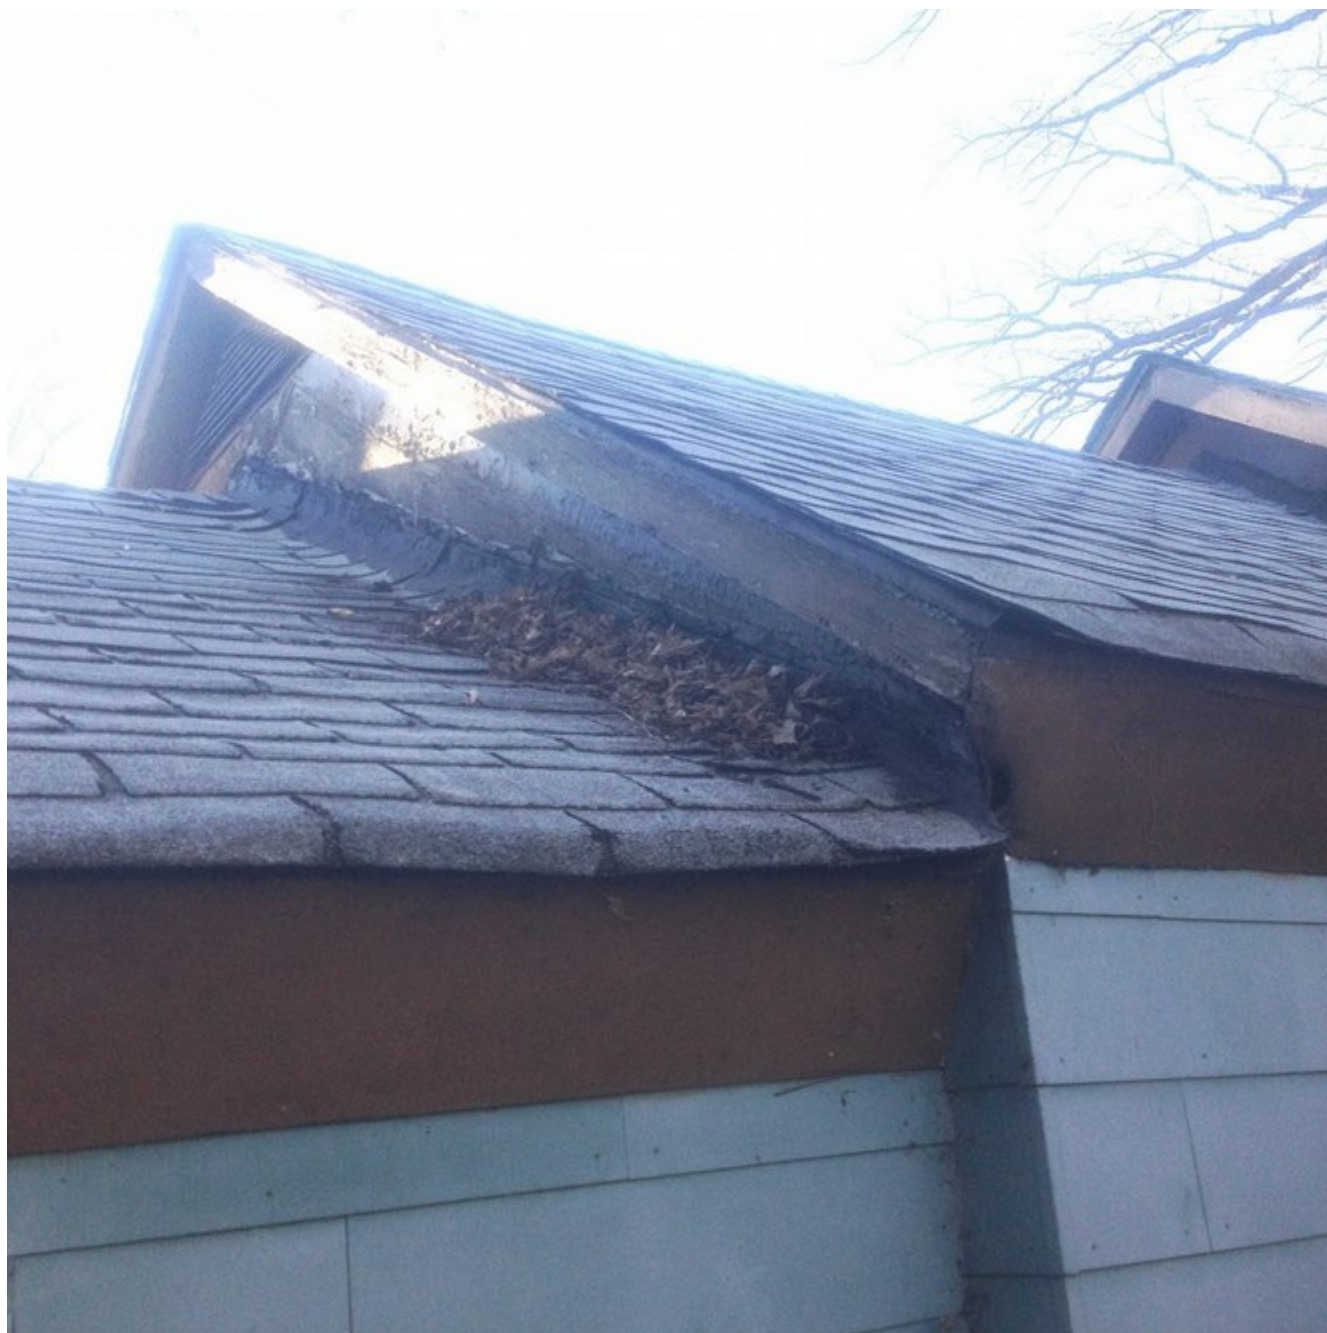
## 16. Roof to wall detail

- 2.1 The asphalt shingles on the roof are nearing the end of their useful life. Where the shingles abut an exterior wall the detailing was not completed in a professional manner. Roofing mastic has been lapped up onto the siding or wood trim and some sections are pulling away creating a point of moisture entry. (Photo 16)
- 2.2 There are multiple layers of shingles on the roofs. In at least one location there appears to be three layers of shingles. Roof structures are typically designed for no more than 2 layers of asphalt shingles.
- 2.3 There are no gutters or downspouts on this structure.

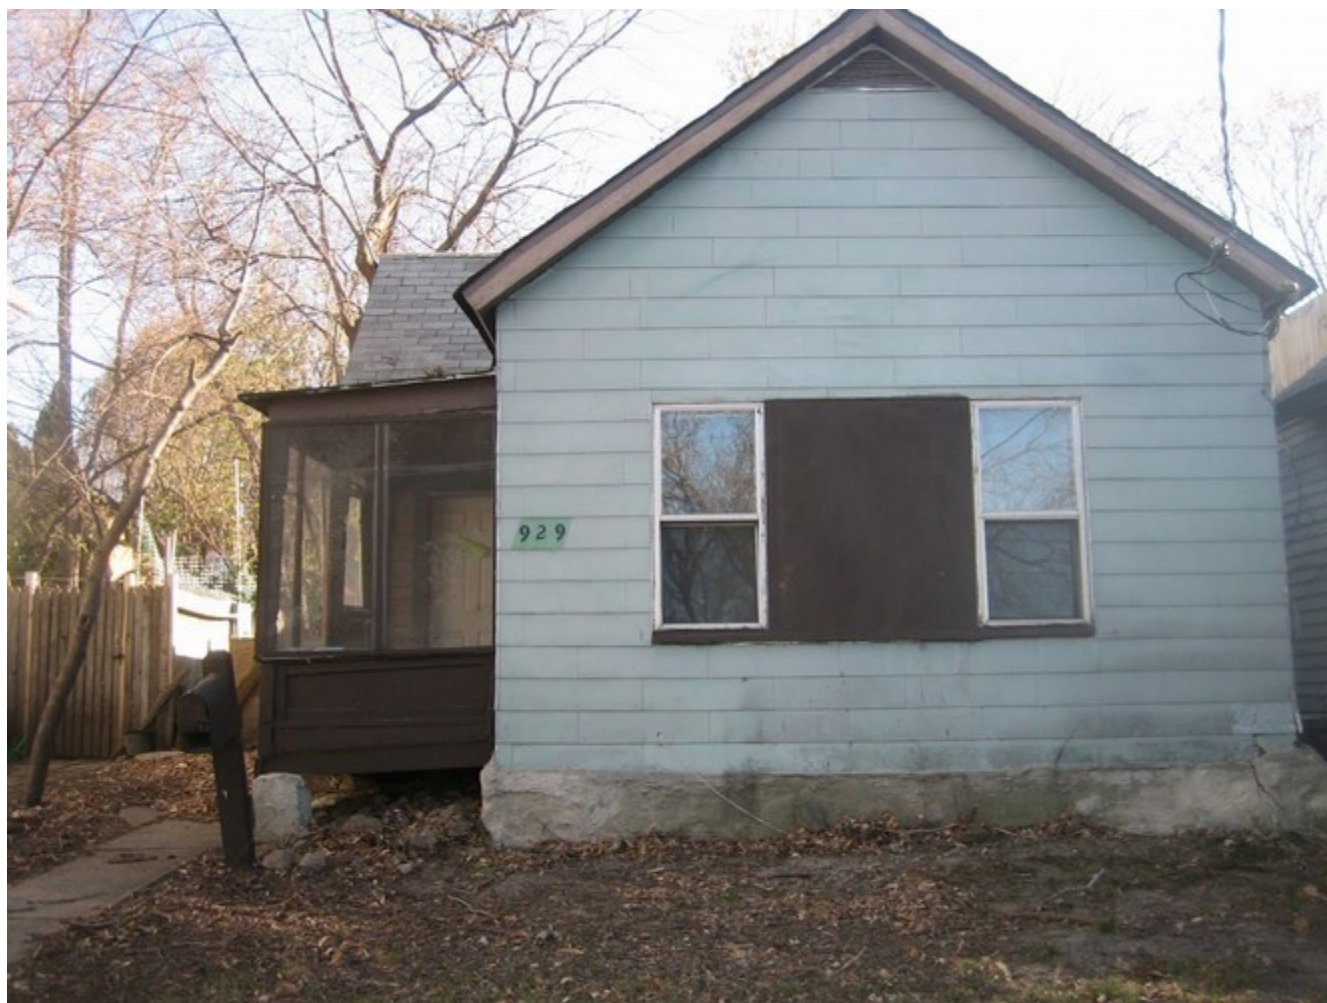
## 17. Window opening infilled

- 3.1 The wood frame double hung windows are single glazed. Random windows that were tried did not operate smoothly. Some of the wood frames and glazing are deteriorated. There are aluminum frame combination storms and screens at the windows that are in poor condition. Screens or storm windows are missing in a number of locations.
- 3.2 The windows do not appear to be original to the dwelling. Replacement jamb liners have been installed. At some locations the installation was never completed with interior trim. At the front of the dwelling the space between two windows that likely was a picture window has been filled in with painted plywood. (Photo 17)
- 3.3 The wood exterior entry doors are in poor condition and not original to the dwelling. The door at the front entry is a door intended for interior use. At the rear entry the door

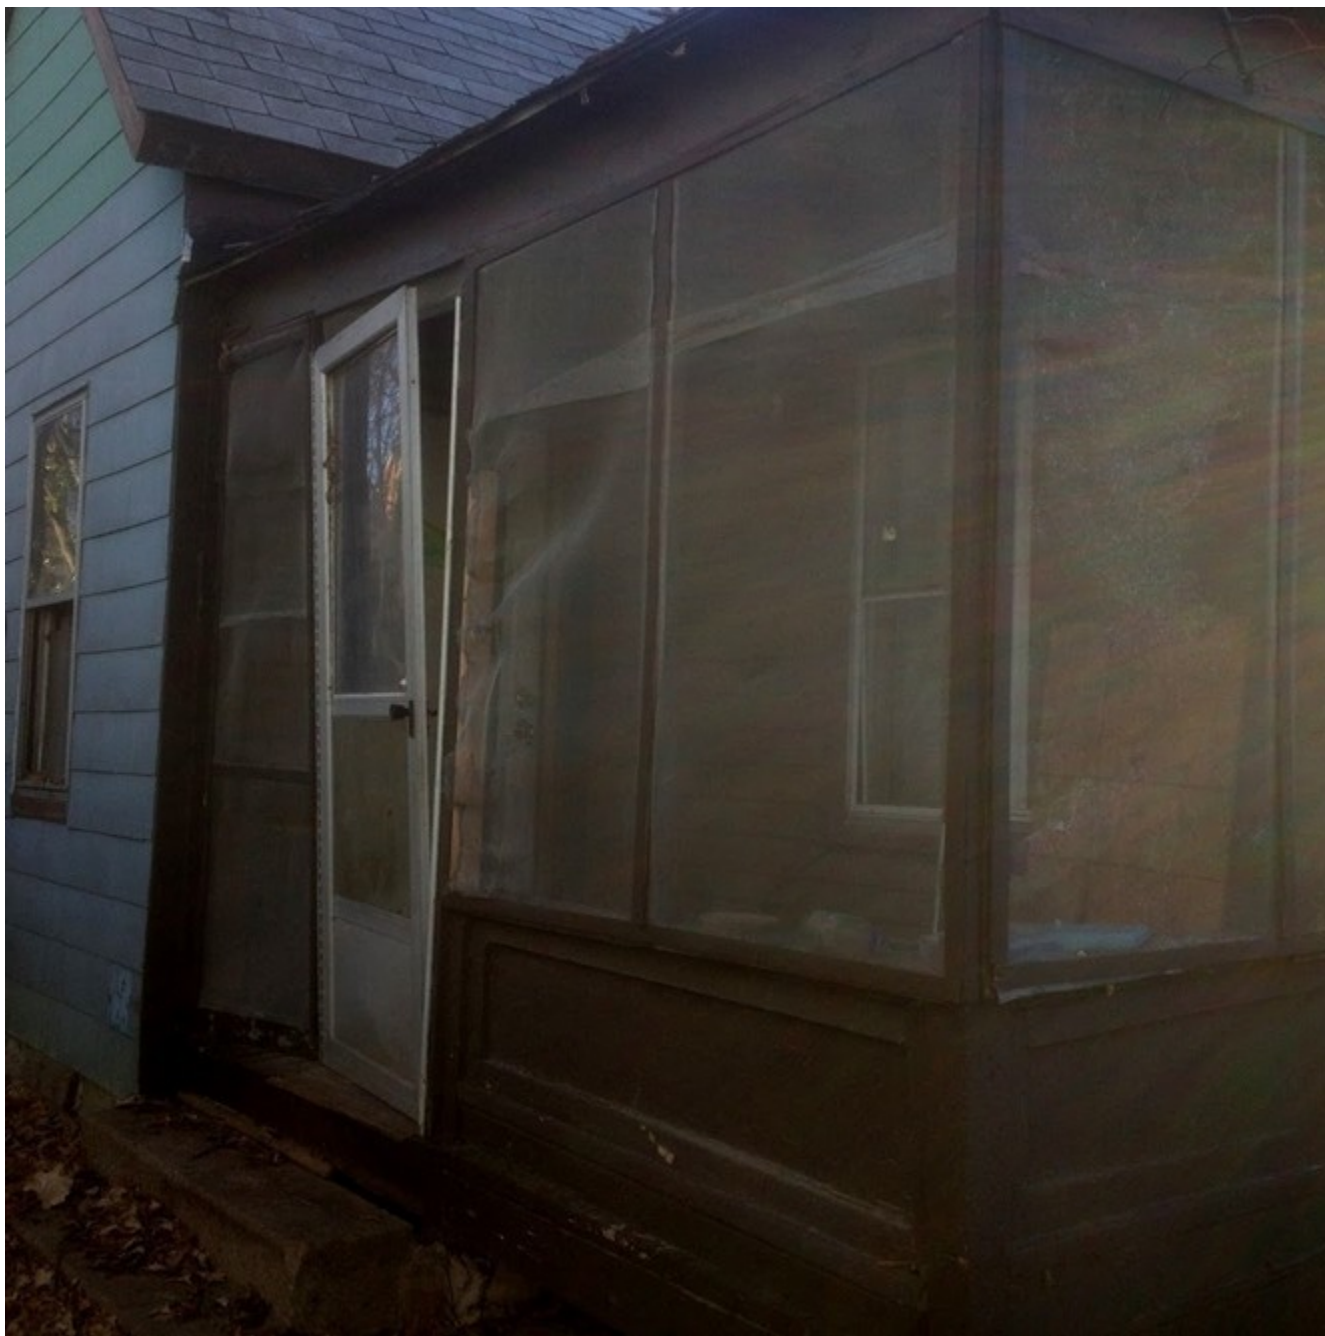
## 18. Front porch

3.4 At the front porch the framing supporting the screen door has been dislodged making operation problematic. (Photo 18) The screens at the porch are in poor condition.

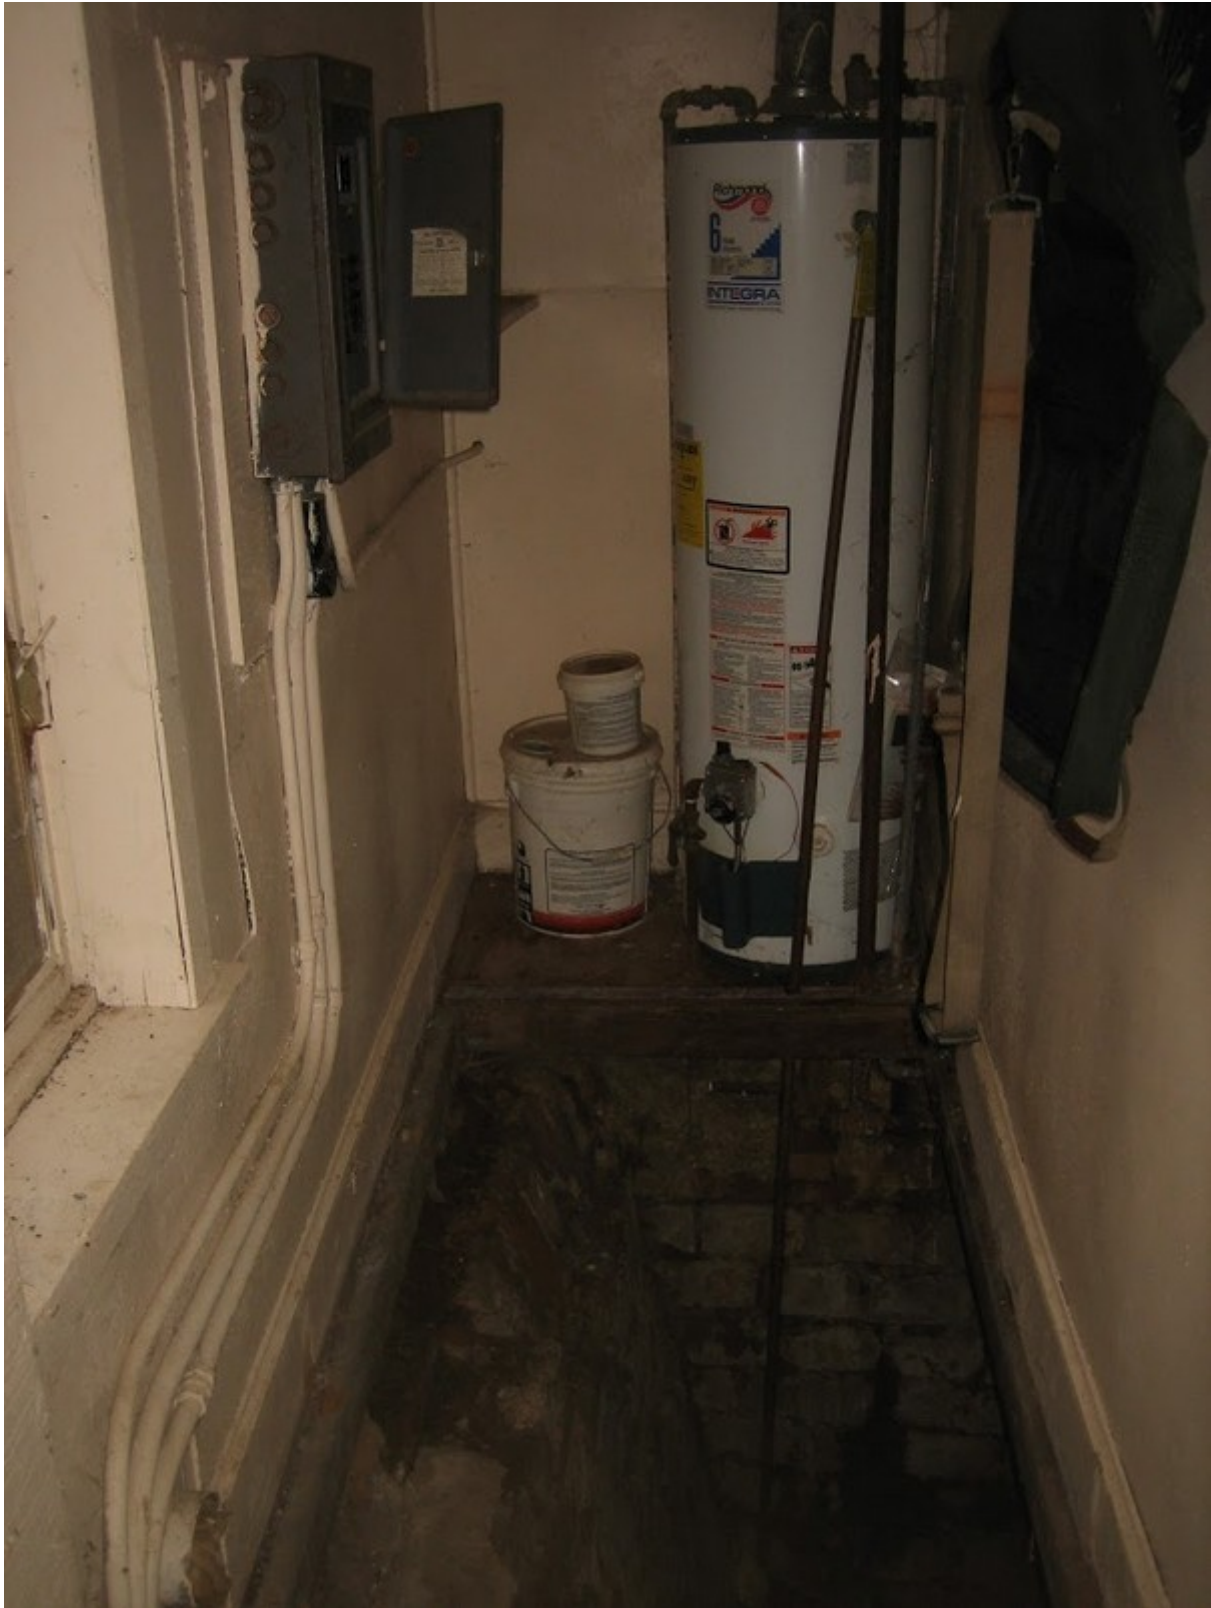
## 19. Lack of work space at electrical panel

- 7.2 In the basement area the metal electrical conduit is corroded due to the high moisture levels.
- 7.3 There are no smoke detectors or carbon monoxide detectors in this dwelling.
- 7.4 The current electrical system does not meet current code requirements in a number of areas including; the main service panel is located over the stairs without an appropriate working area, the limited number of receptacles in most rooms and lack of ground fault protection. (Photo 19)
