# City of Madison Landmarks Commission

Project Title / Description: Demolition, fill-in, and replacement with green space

At your request we have inspected the residential building located at 929 Williamson St. Madison, Wisconsin, and have compiled the following report. This report is for your information and is not to be construed as a warrantee of any mechanical system, nor does it guarantee any portion of the building against subsequent failure.

# 929 Williamson St Freiburger Consulting Review

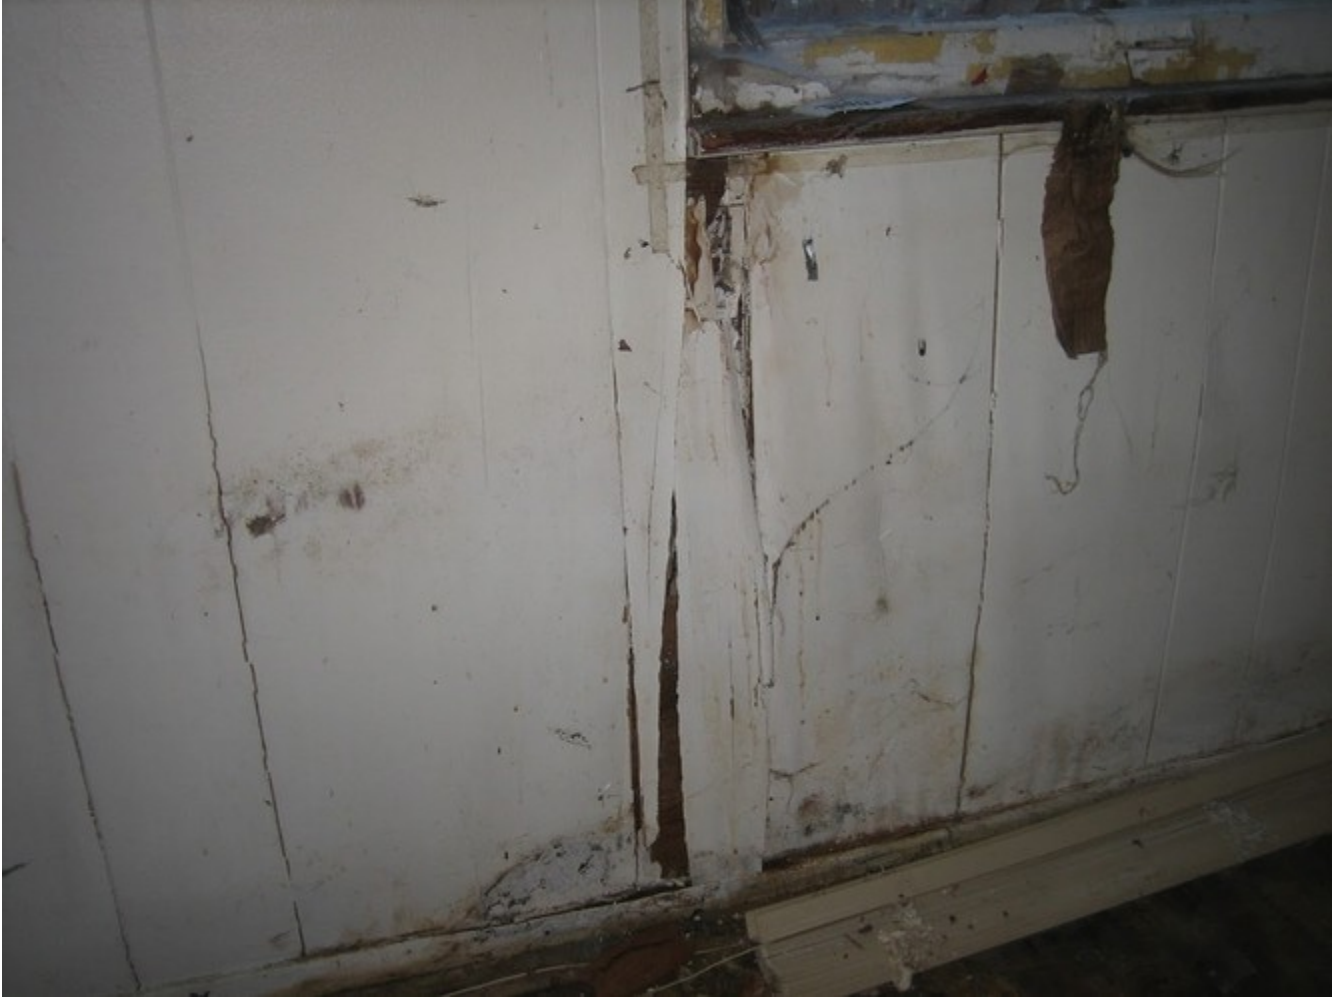
## 20. Water damaged interior wall

- 8.1 The interior finishes are in poor condition. Wall paneling has moisture damage and is deteriorating. (Photos 20 & 21) Gypsum board walls have cracks and holes. The ceilings have fiberboard tiles which are water stained and deteriorated in several locations. Floor coverings are worn, cracked or missing. Cabinetry and countertops are damaged.
- 8.2 The stairs to the basement are steeply pitched, very narrow and the bottom tread is missing. (Photo 22) There are no handrails or guardrails at these steps. Installing a code compliant set of steps would require reconfiguring the stairway opening and moving walls within the dwelling.

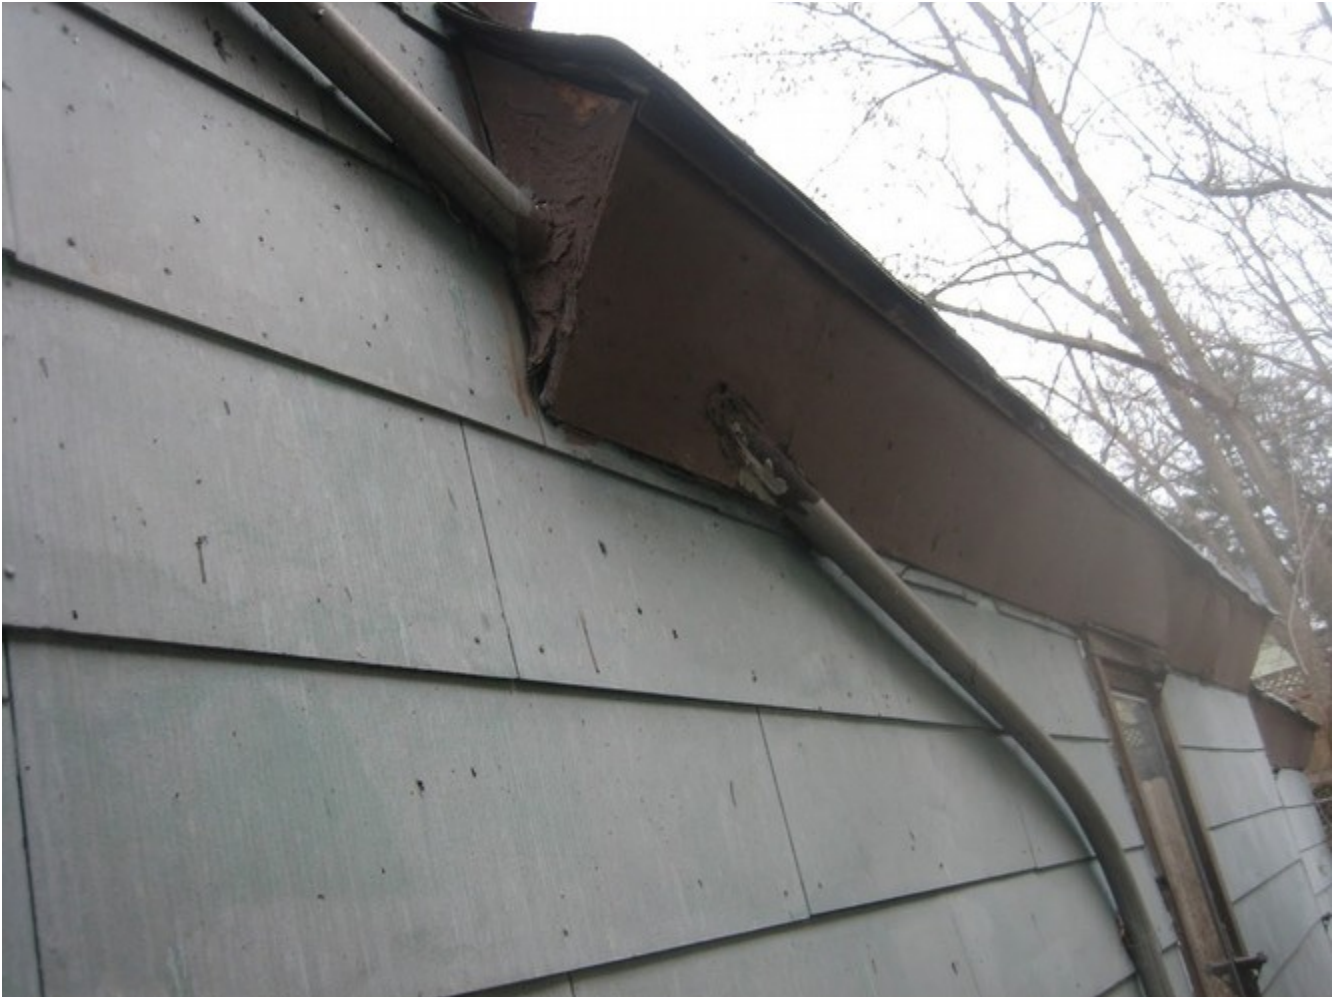
## 23. Board covering fascia & soffit

- 9.1 The exterior of the building is clad with a cement board siding of the type which may contain asbestos. A Certified Asbestos Tester can take a sample to provide definitive information. Removing or cutting the siding will require special precautions if the siding contains asbestos. The siding is generally intact, though there are a few cracked or missing pieces.
- 9.2 Apparently there was damage to the soffit and fascia in several areas. At these locations a board has simply been installed to close off this area rather than actually making repairs to the damaged components. (Photo 23) In one location a section of this board cracked and fallen away.
- 9.3 There is wood trim at windows and the porch which is in fair condition. At the fascia the paint finish has deteriorated and the wood is cracked or rotted in places.

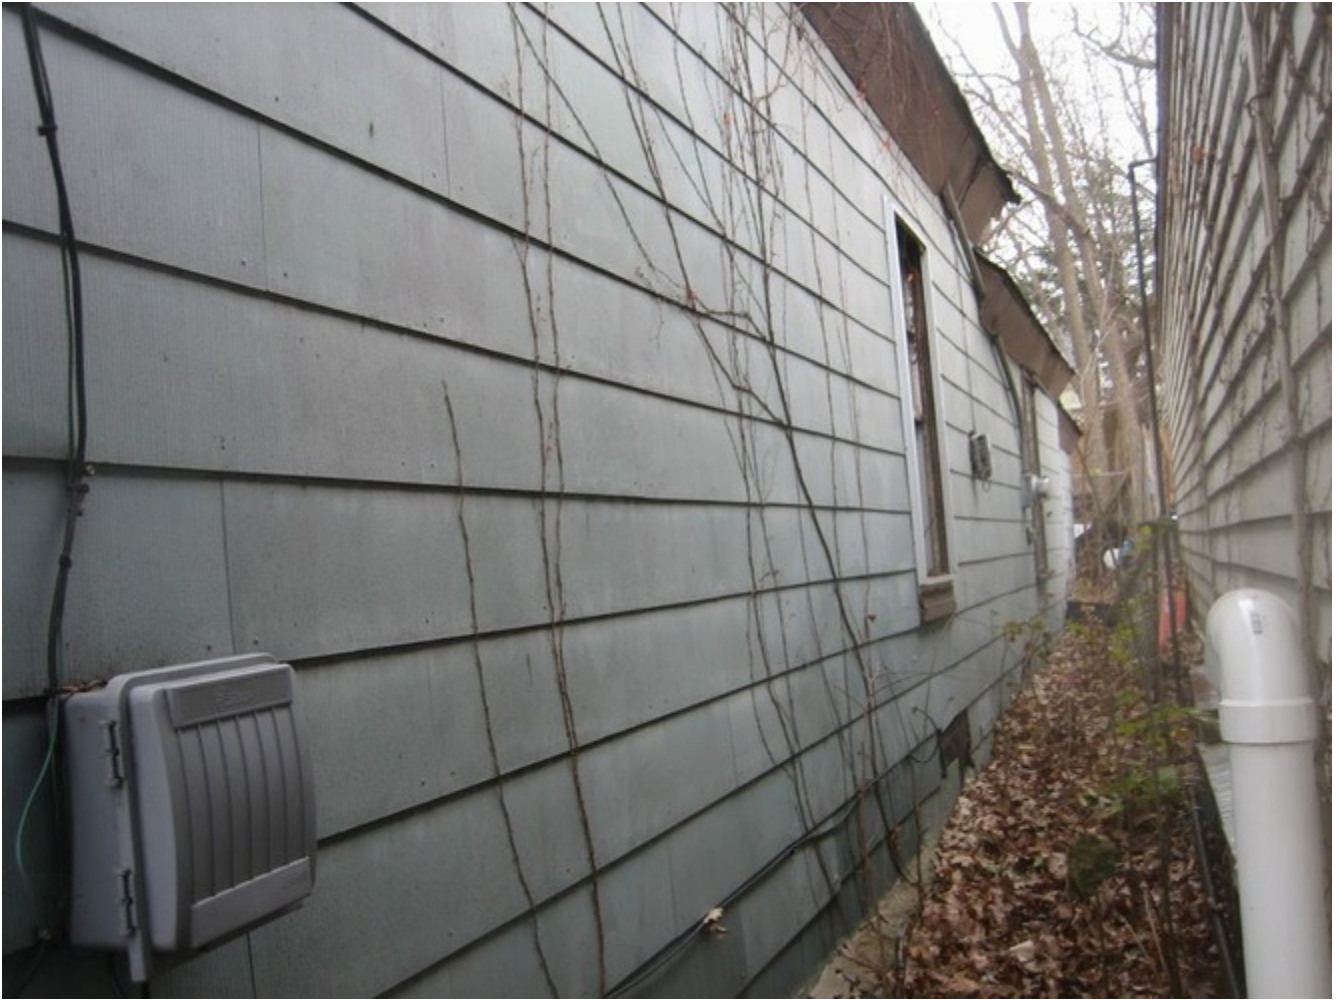
## 24. Limited separation to adjacent building

- 10.4 The plumbing, heating and electrical systems will need to be completely replaced to provide adequate comfort, safety and code compliance.
- 10.5 The building is located very close to the west side lot line. The adjacent property is also close to the lot line. Only 3' separates the two buildings. (Photo 24) During any reconstruction there will likely be issues of fire separation and limits on size and number of openings in this wall. Currently a bedroom and bathroom have windows along this wall.
