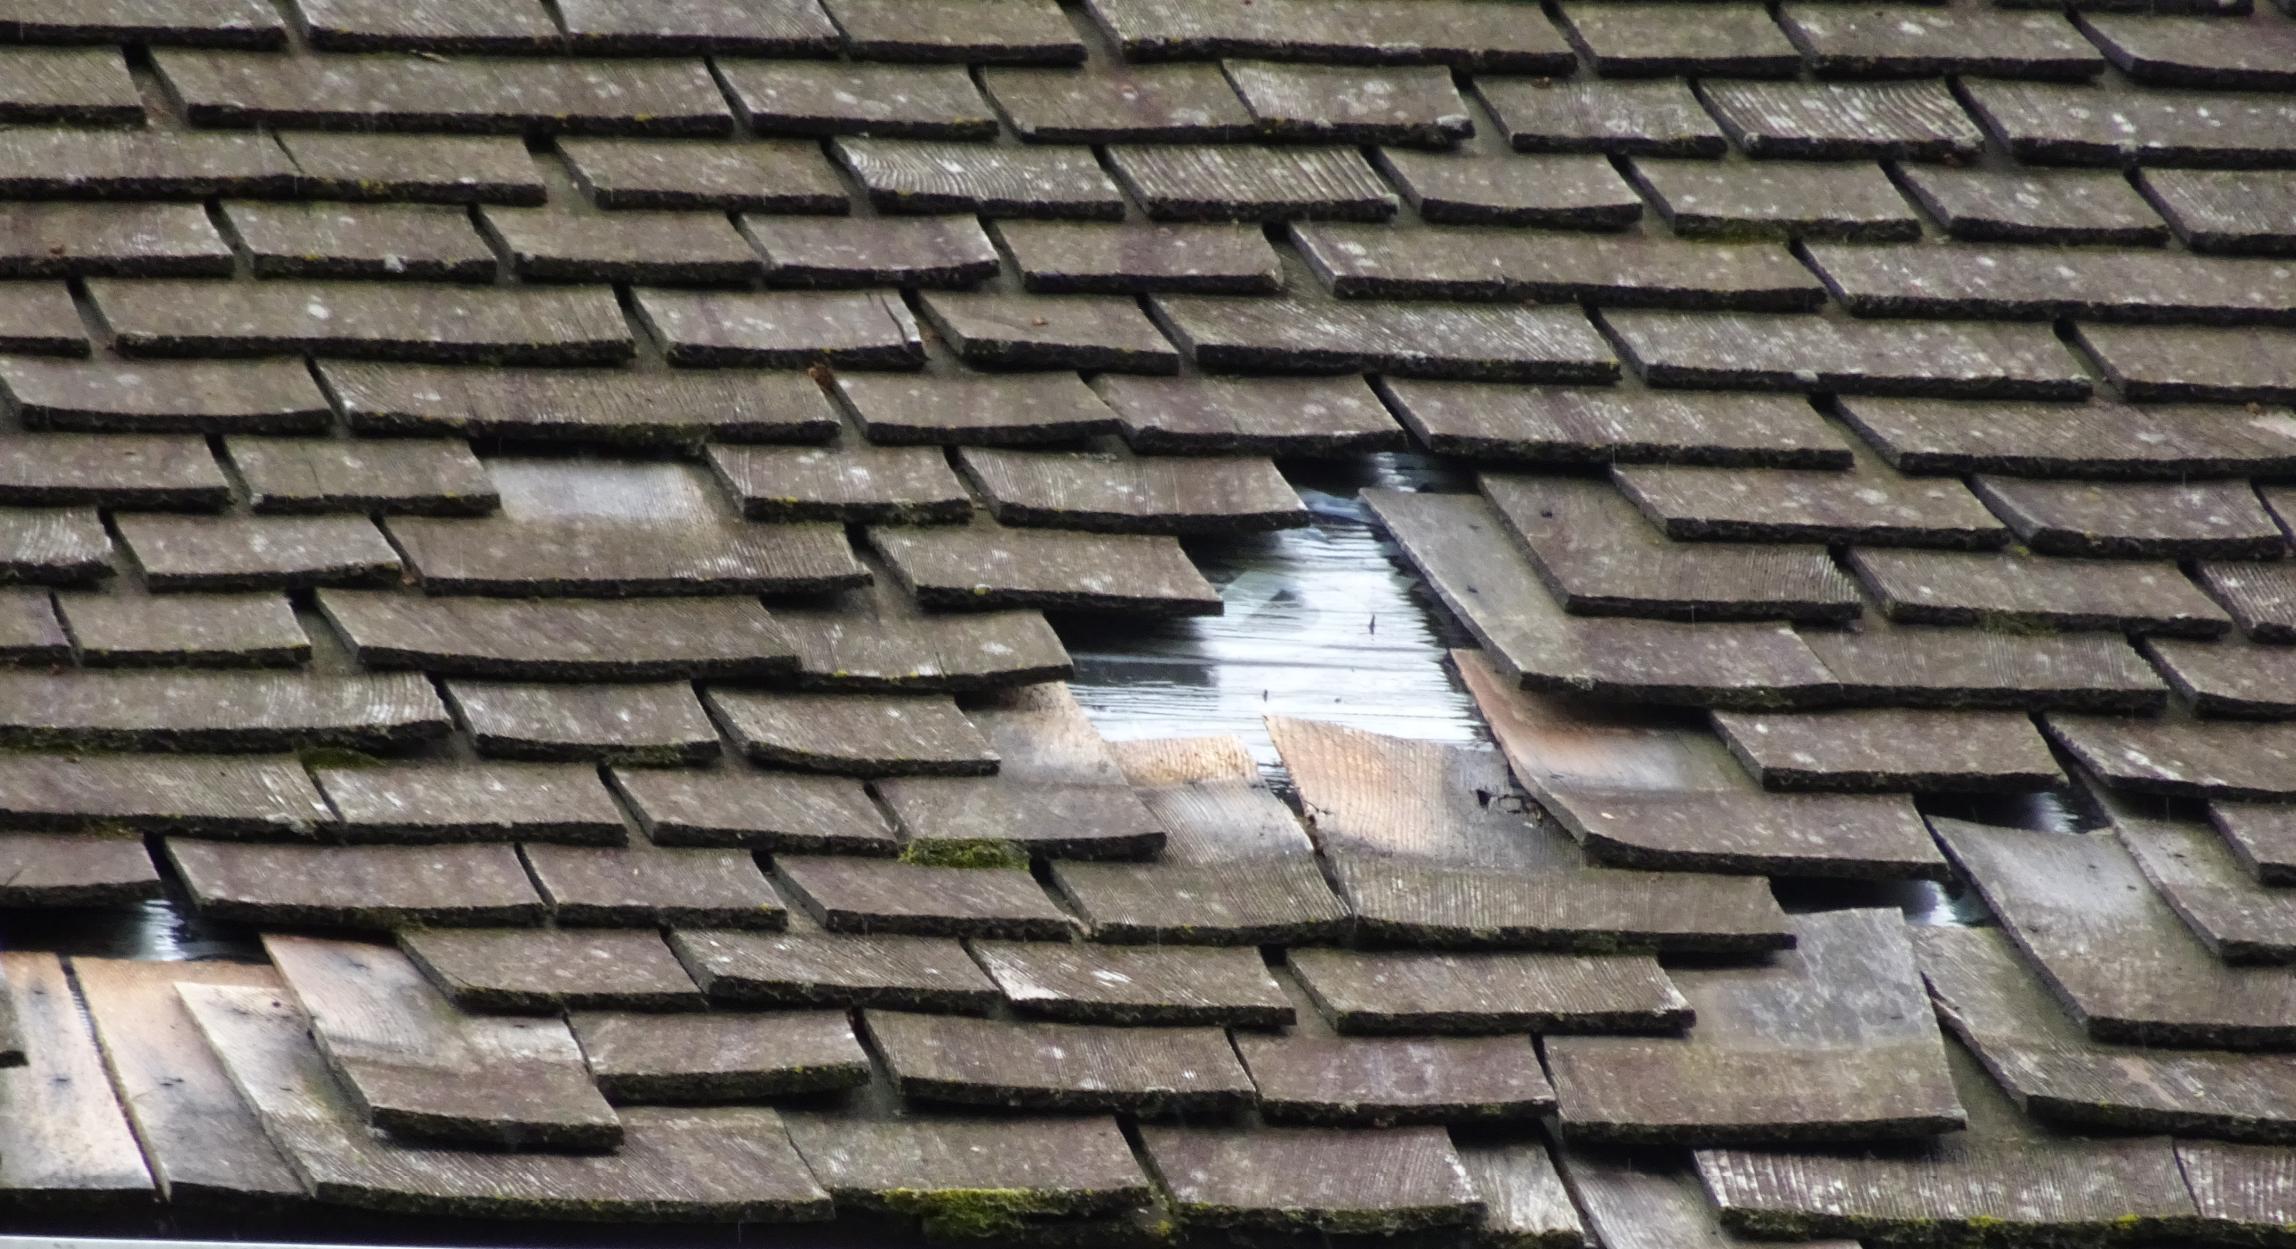
Up on closer investigation around the damage areas, it was found that the cedar shingles were installed with electro galvanized roofing nails that were not compatible with the shingles. The majority of the nail heads had rusted off and the surrounding shingles were loose and could be easily lifted off of the roof with very little effort. Thus, the scope of the repair work was expanded by face nailing every one of the shingles on the roof.
