Project Title / Description: Stormwater Improvements Glenwood Children's Park

**RAILROAD ARCH CULVERT
PRELIMINARY ASSESSMENT
GLENWOOD CHILDREN'S PARK
MADISON, WISCONSIN**

Railroad Arch Culvert Preliminary Assessment

June 5, 2018

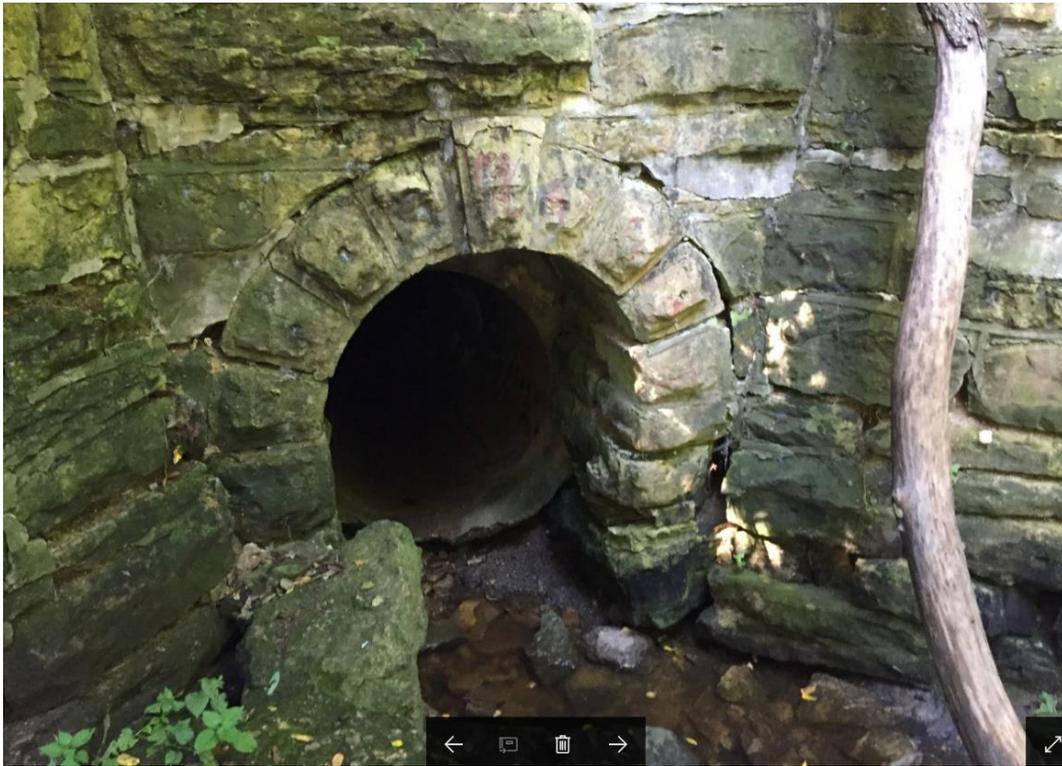
Existing Limestone Railroad Arch Summer 2017

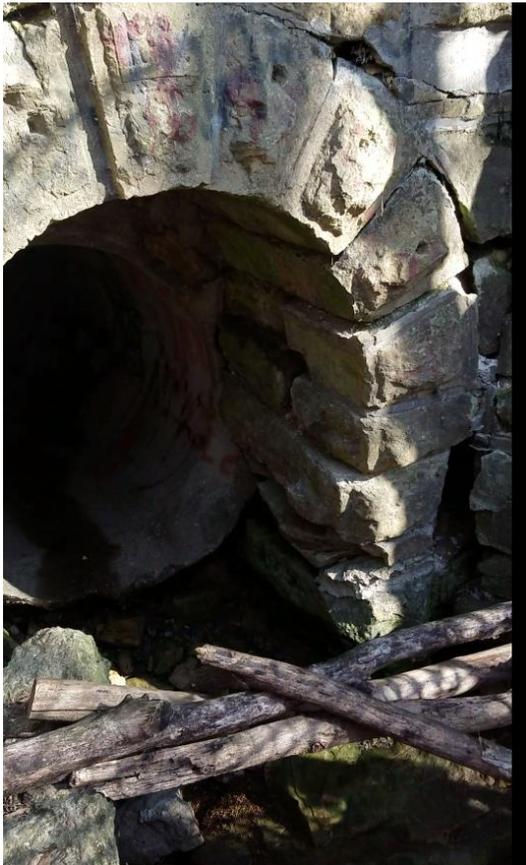
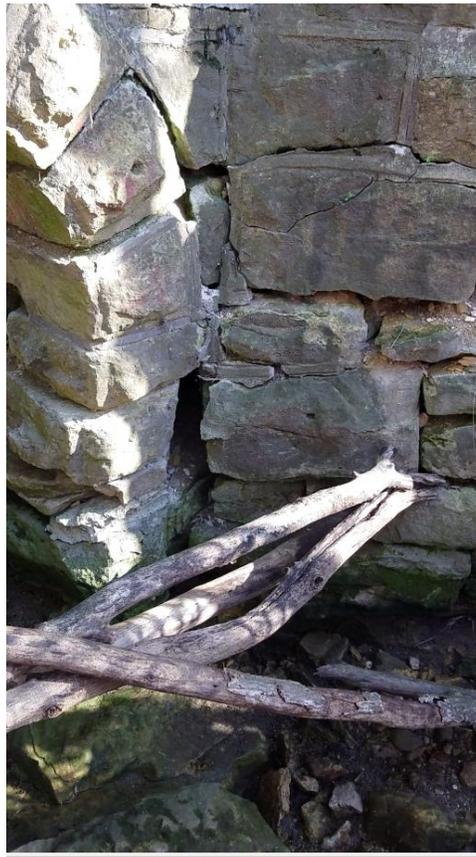
Existing Limestone Railroad Arch Spring 2018

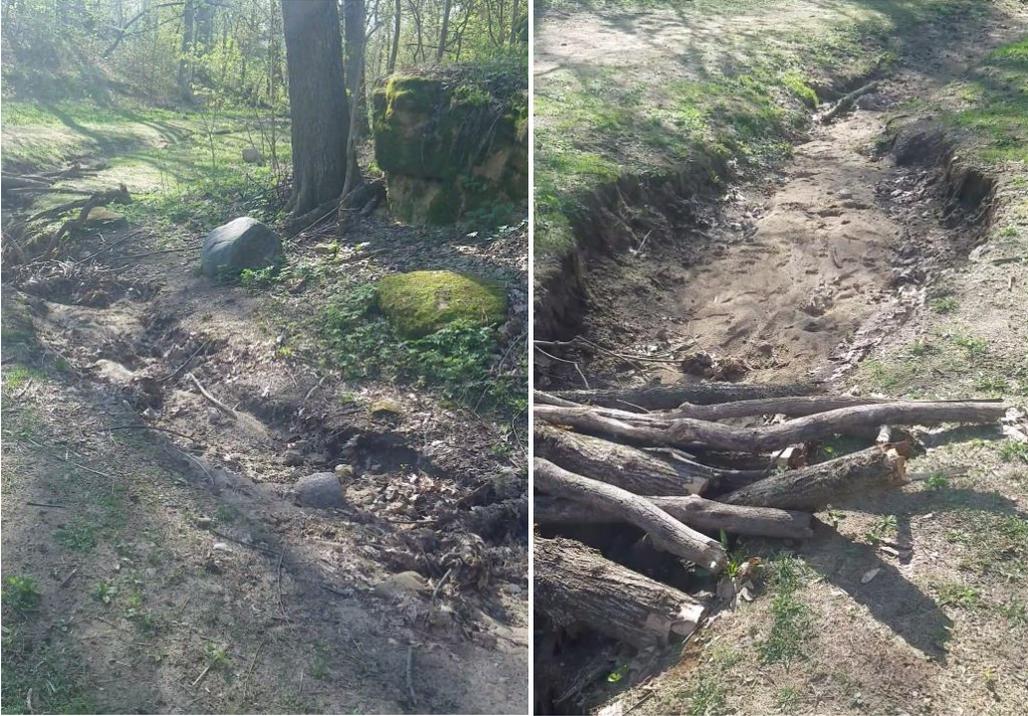
Erosion Downstream of Existing Inlet

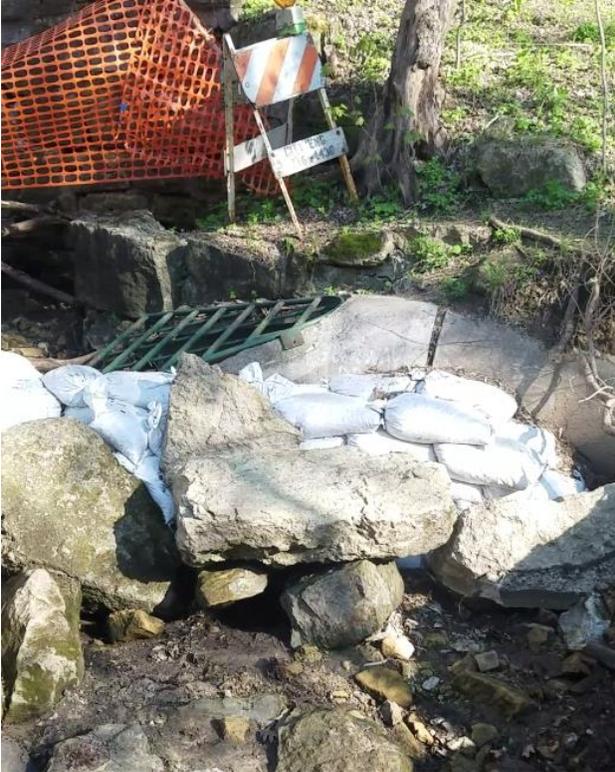
Erosion at the upstream storm sewer caused by failure of the diversion wall

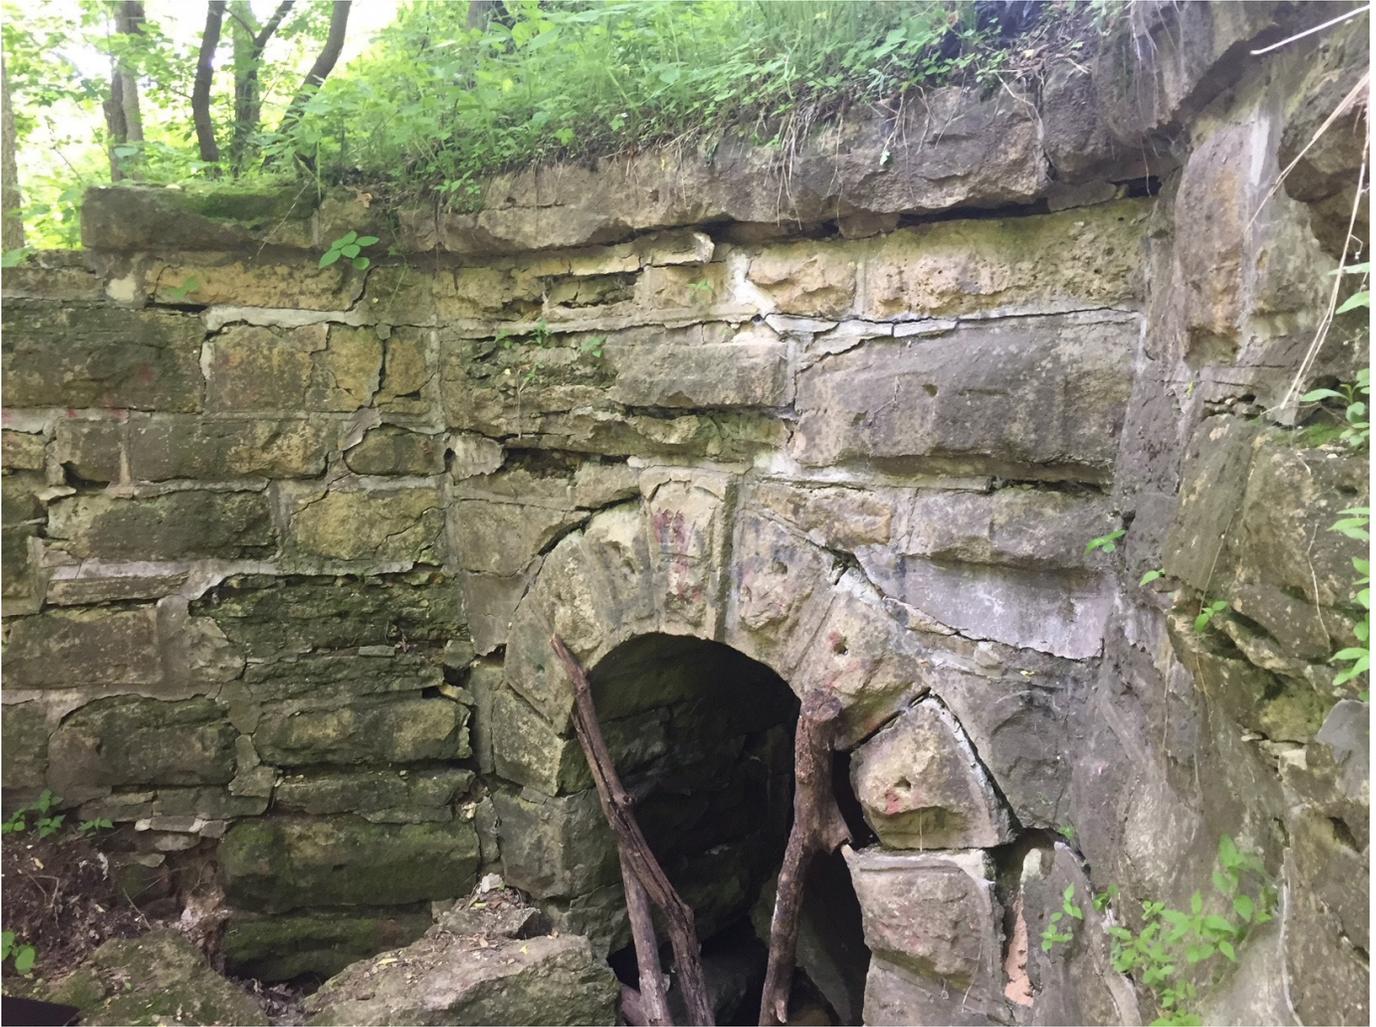
Figure 1: Height of arch and overburden above.

Height varies maximum ~8-9'

Central arch wall width varies: ~ 7' at base, ~13' at top

Wing-walls (splay backwards going up) at base: ~15' w.

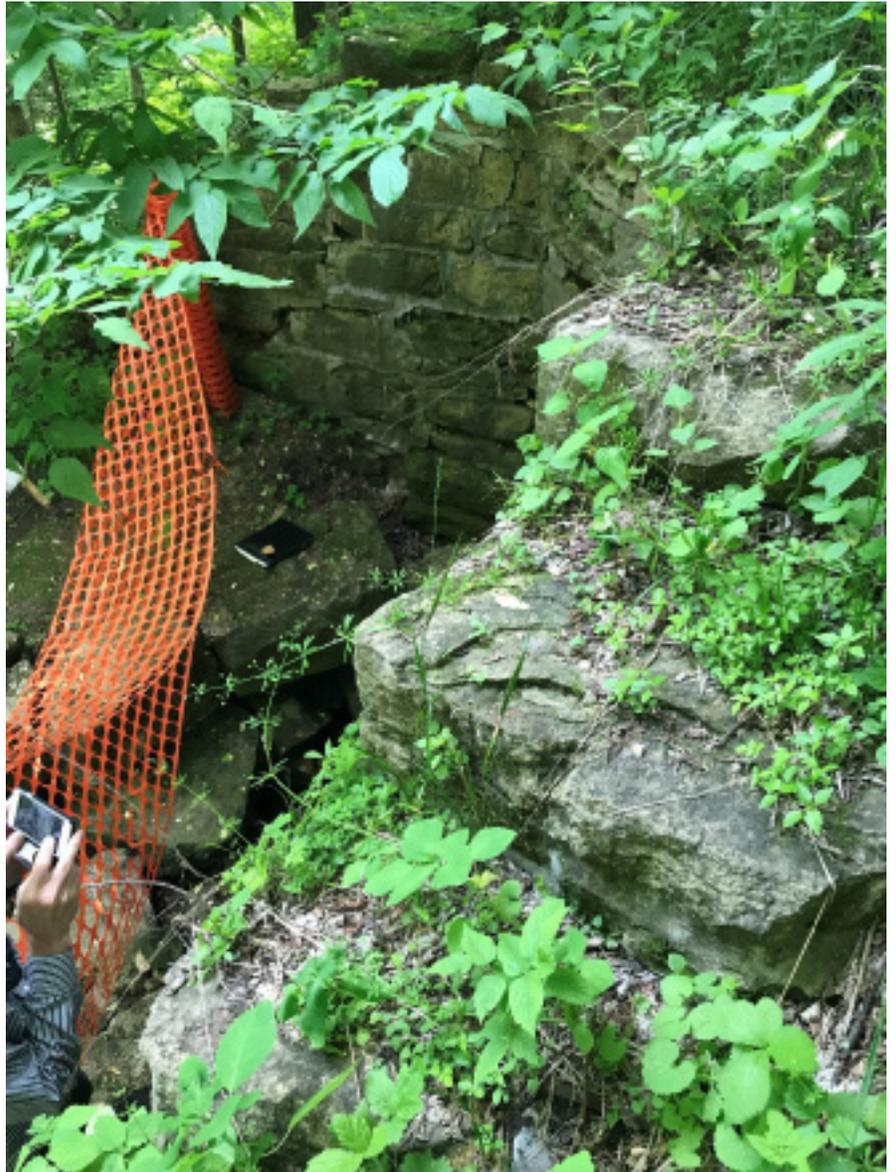
Figure 2: View of capstones and minimal overburden above the wing walls (additional soil over the ventral arch wall.)

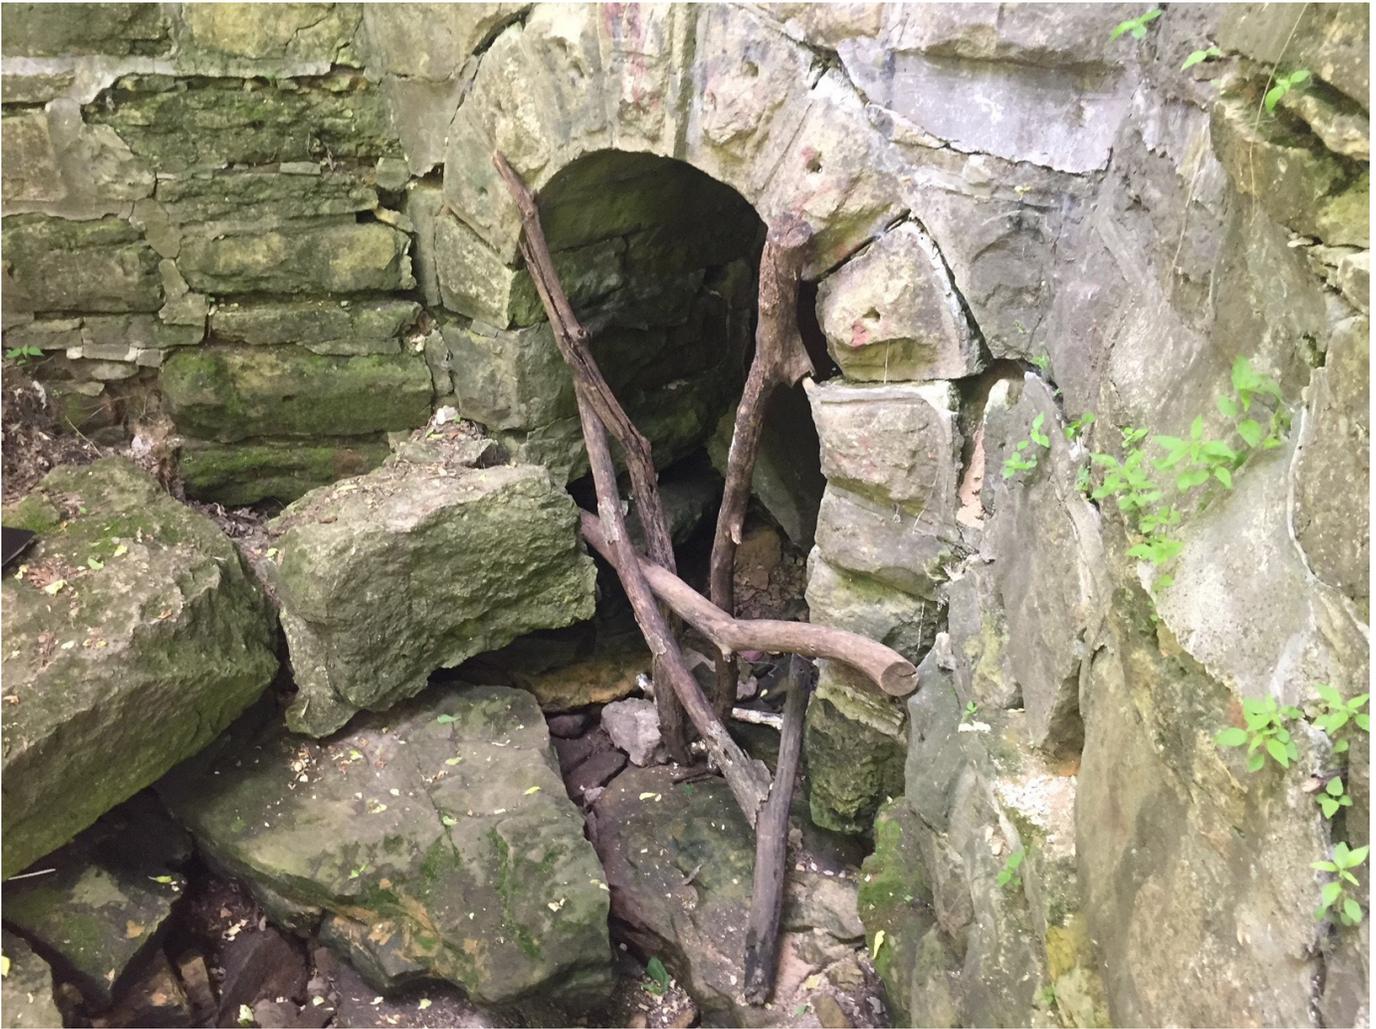
Figure 3: Overall view of arch.

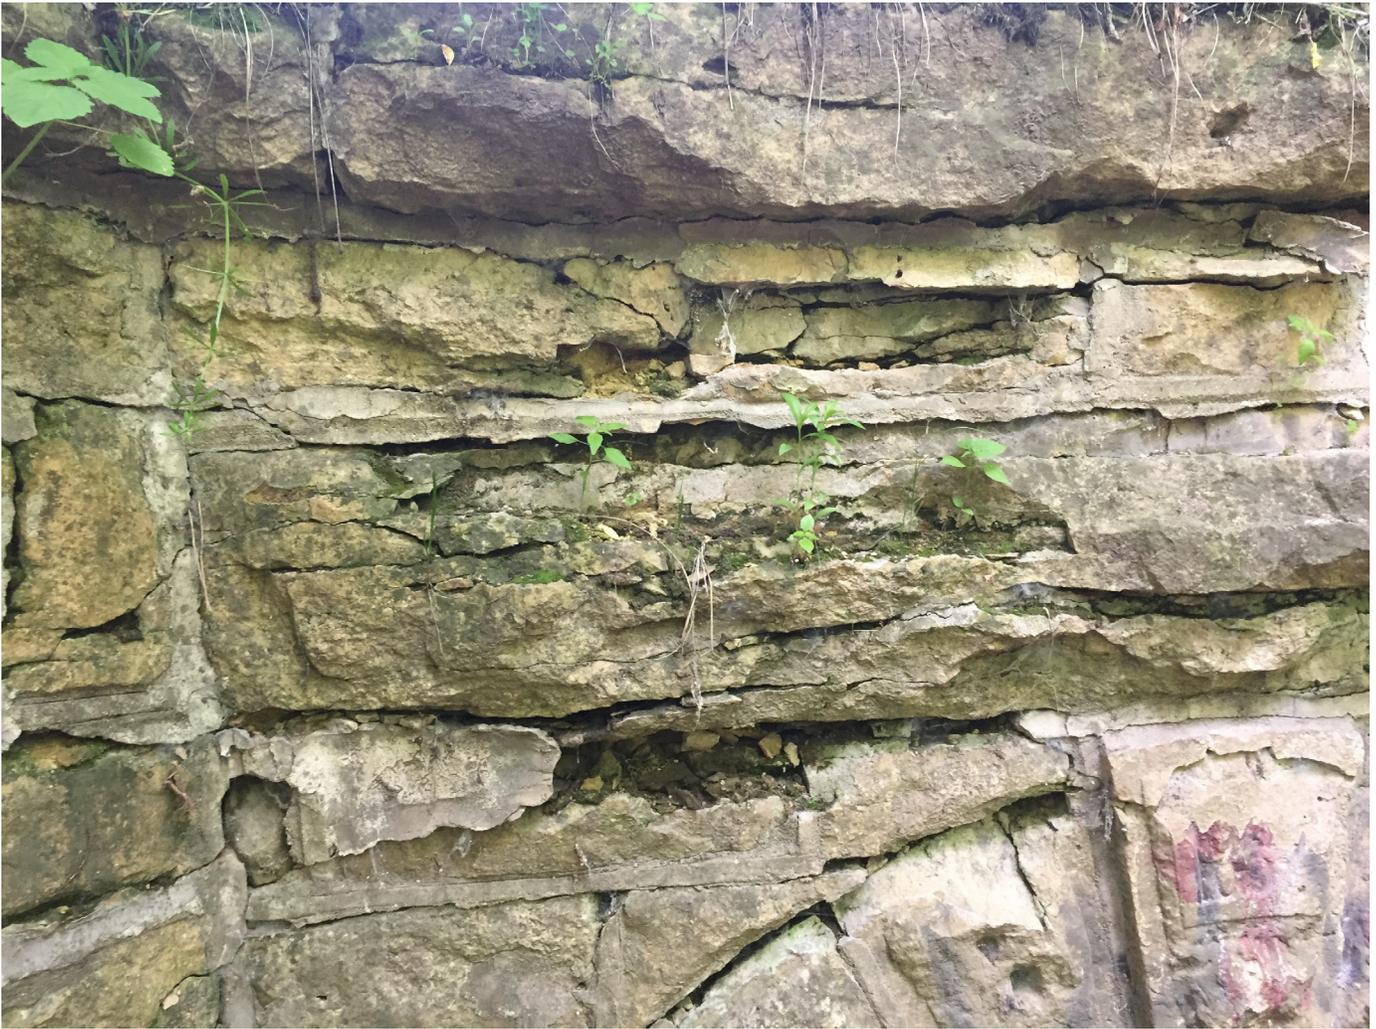
The settling and degradation of the base and surrounding stone is causing misalignment of the inner arch. Many of the surrounding stones are disintegrating so rapidly that only the mortar left suspended in space outlines where the stone head and bed faces had been.

Figure 4: General disintegration of stone above the arch.

The conclusion is that the entire masonry structure must be deconstructed and rebuilt in strict accordance with the Secretary of the Interior's Standards for the preservation of the historic elements of the arch and retaining wall. This should occur as soon as funds are available. The stones of the inner arch are in good enough condition to be used as templates to fabricate replacements (as required). The face rustication includes the original lifting holes which add interest and still might be usable in disassembly.

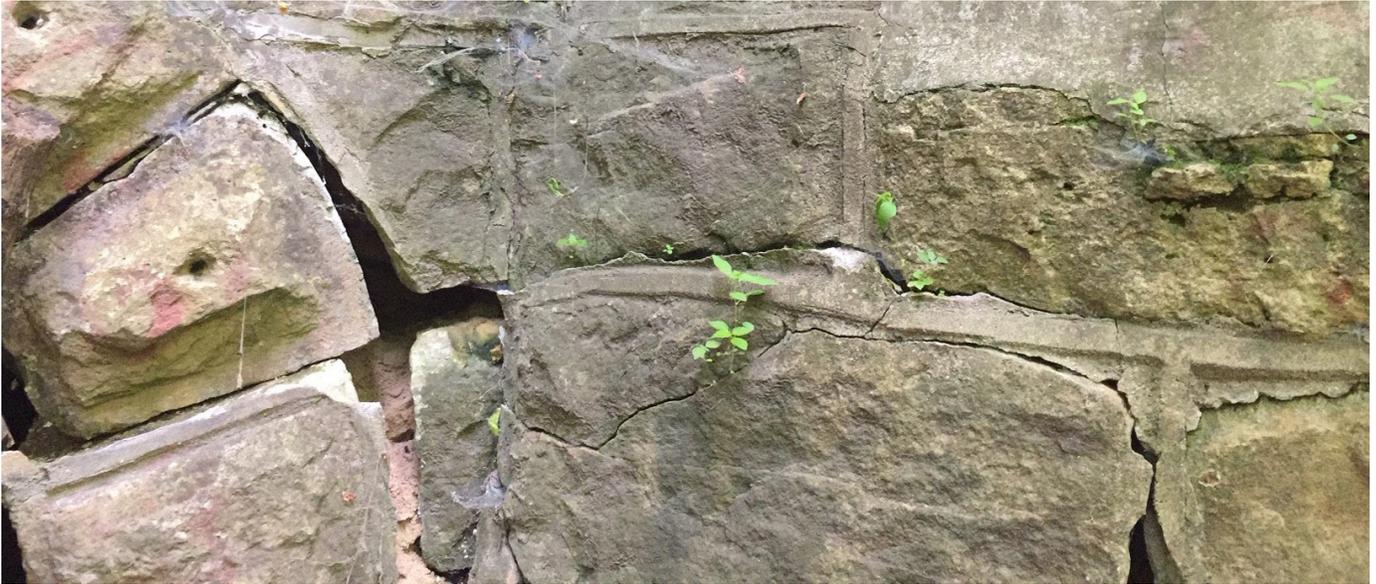
Figure 5: Right side of arch deflection and beginning of collapse.

Immediate Recommended Action: As part of any effort to mitigate stormwater run-off into the park through the culvert terminated with the historic sandstone area, we recommend a temporary stainless steel frame be constructed to hold the existing stone masonry in place. This would allow the stones to continue in their current position until a full restoration can take place. The cost for this work will be from \$10,000 - \$25,000 and will provide the stabilization required for the deferral period.

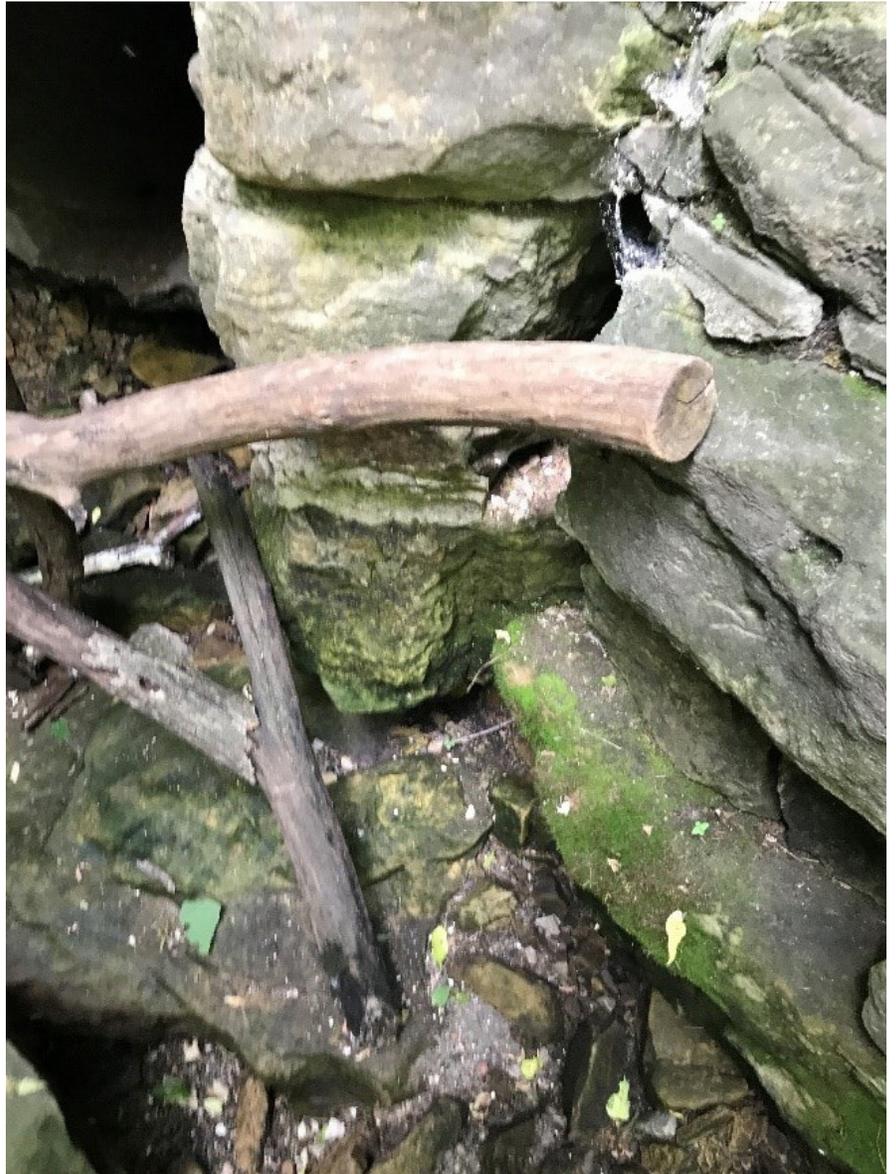
Figure 6: Arch bearing condition at right.

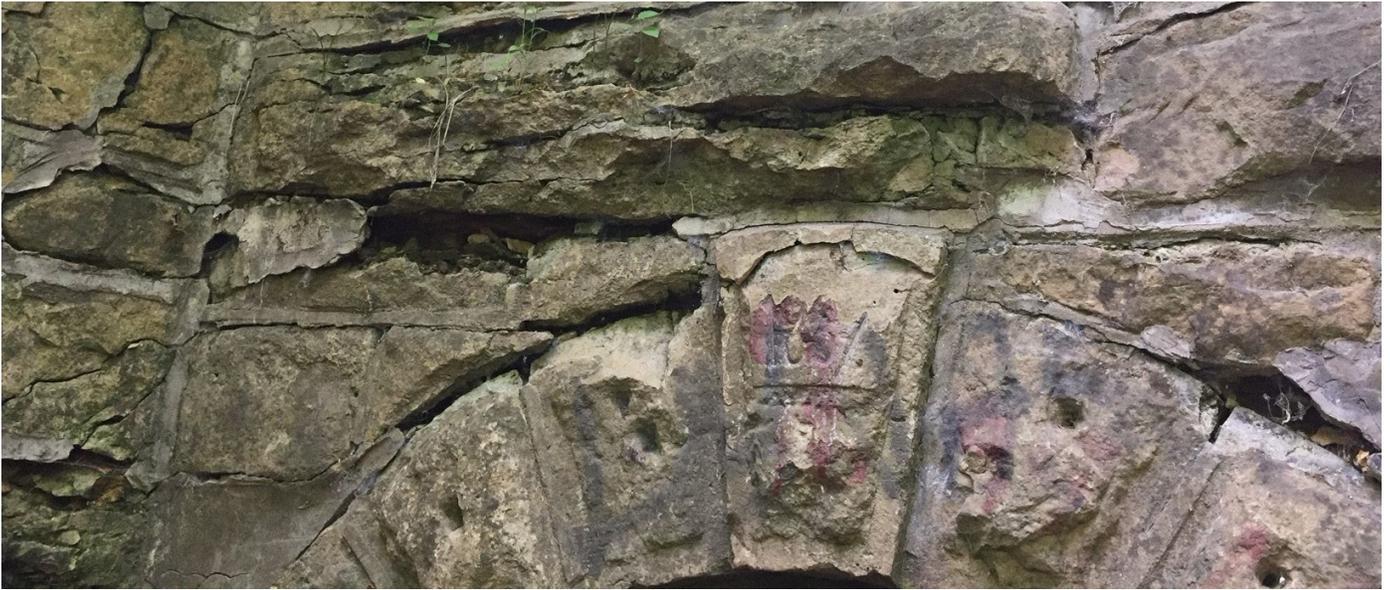
Figure 7: Defaced Keystone needs to be deciphered.

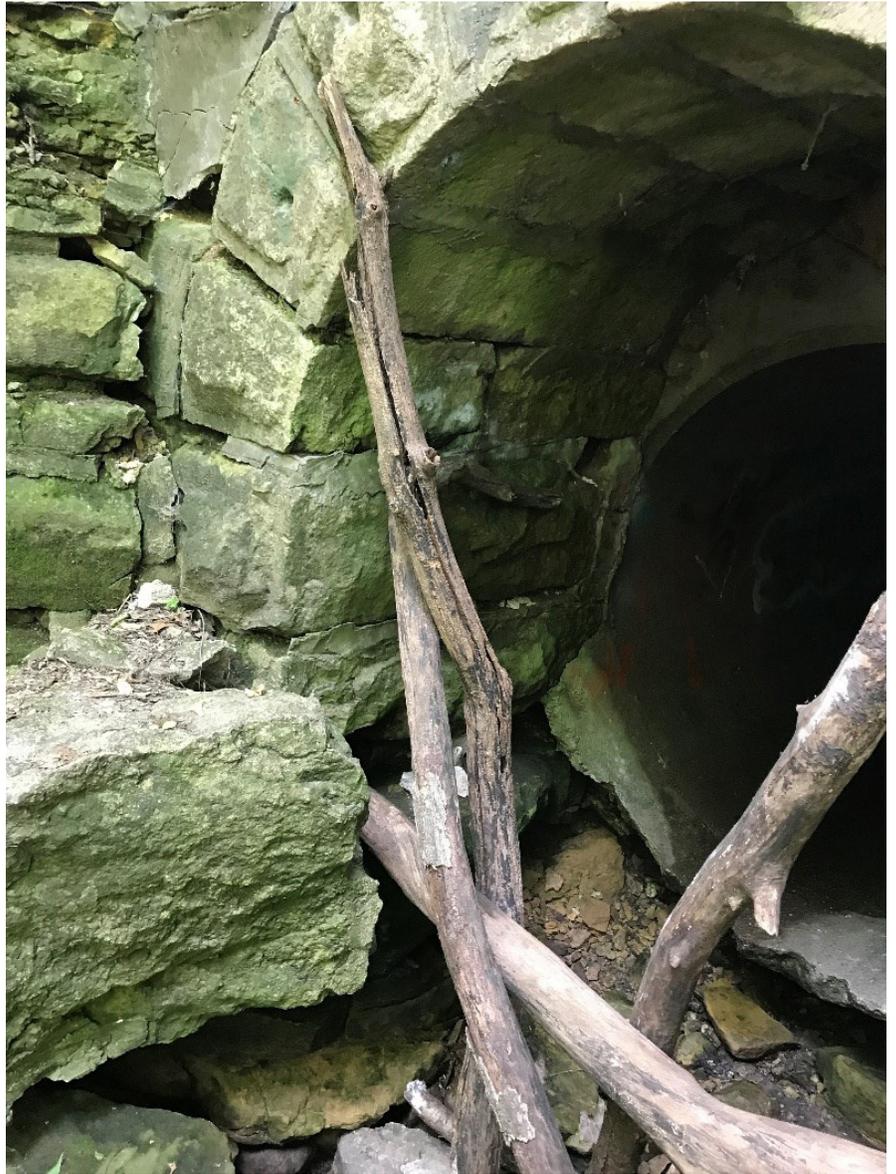
Figure 8: Undercutting of the arch at left and 2-3' stone construction depth to the intact concrete culvert that conveys stormwater under the bike path.

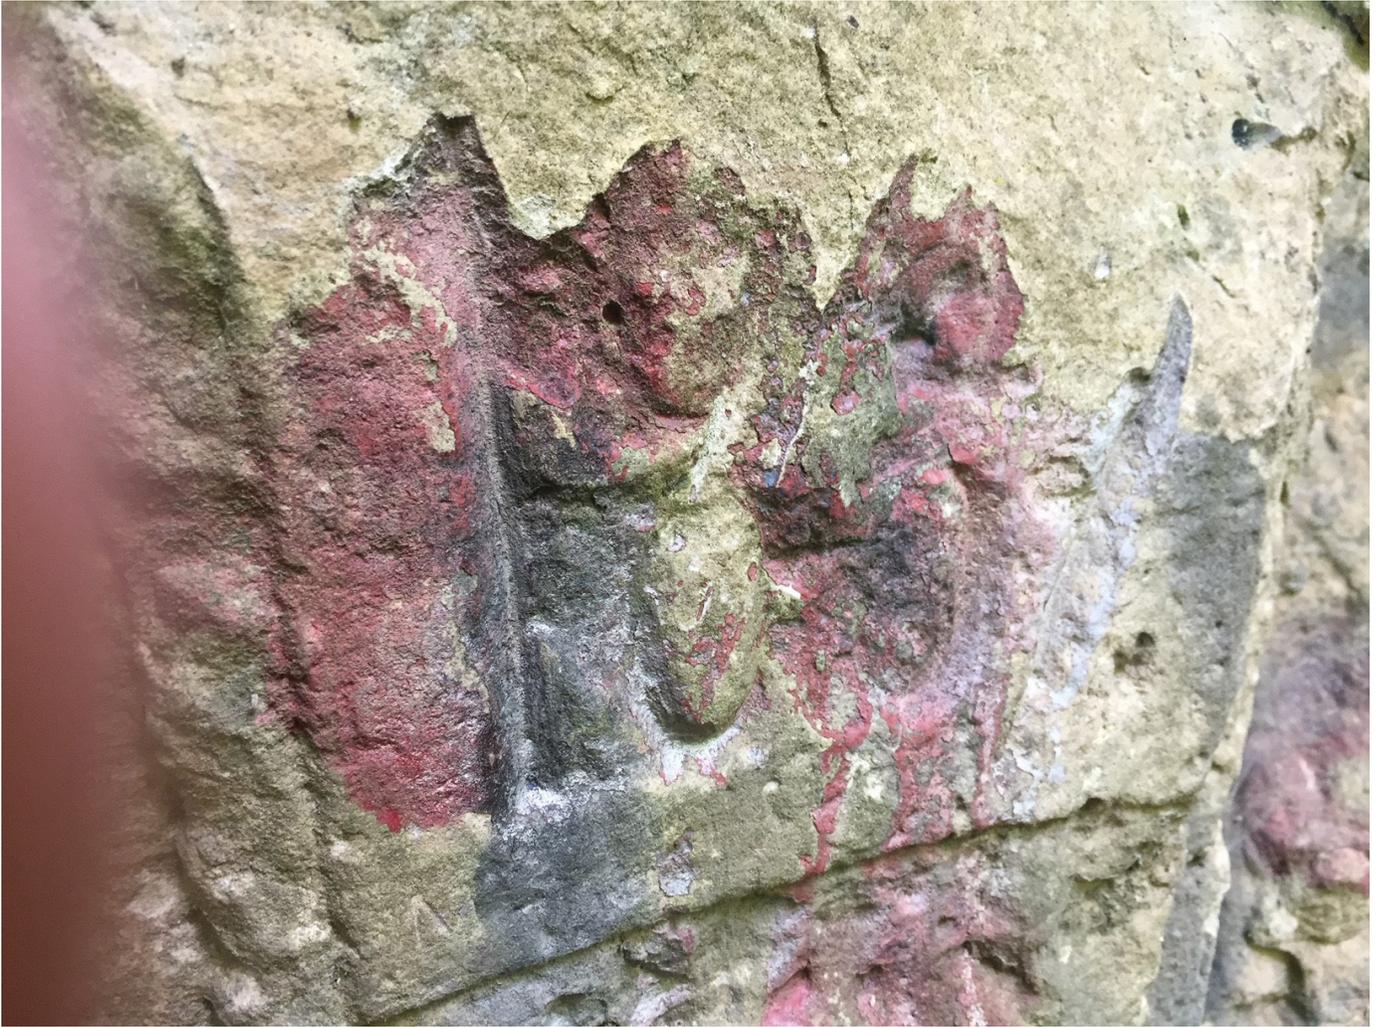
Figure 9: Defaced keystone needs to be deciphered.

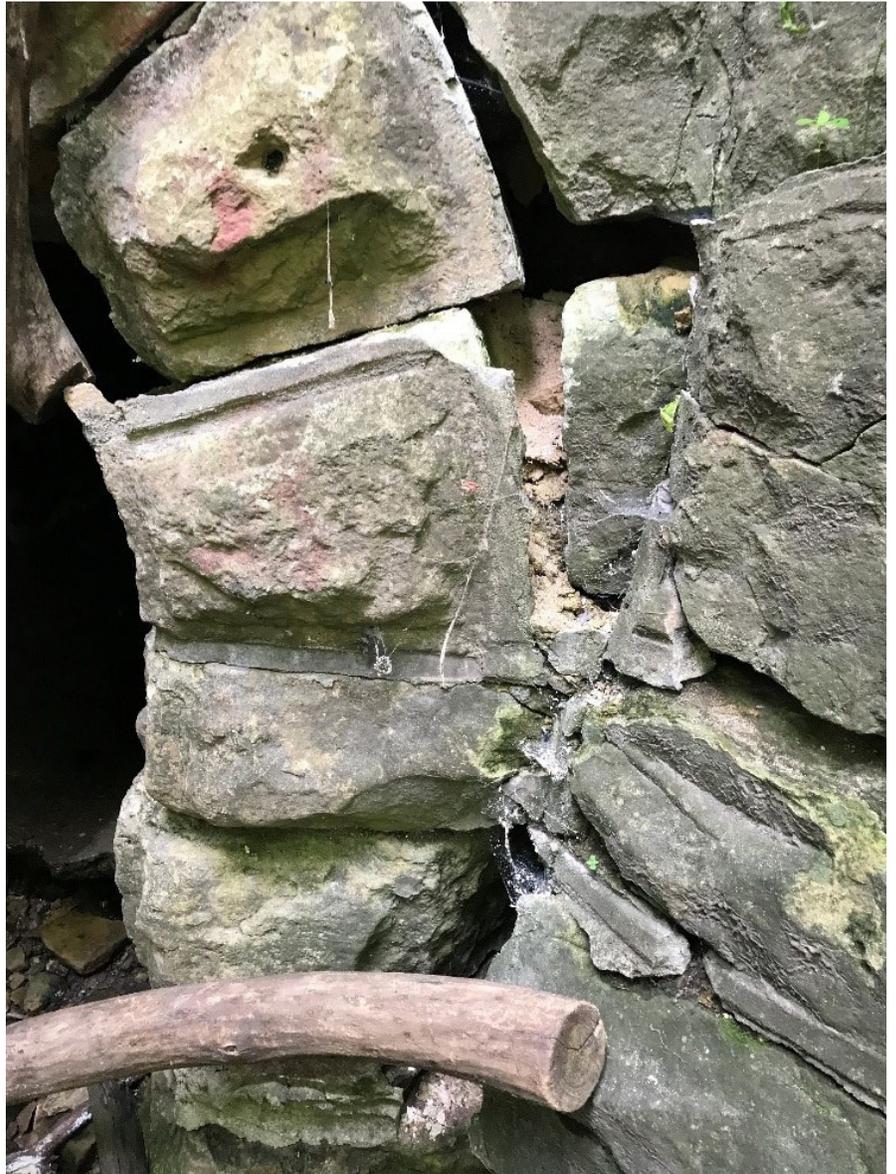
Figure 10: Degradation of the sandstone at the wing walls is most advanced at the face.

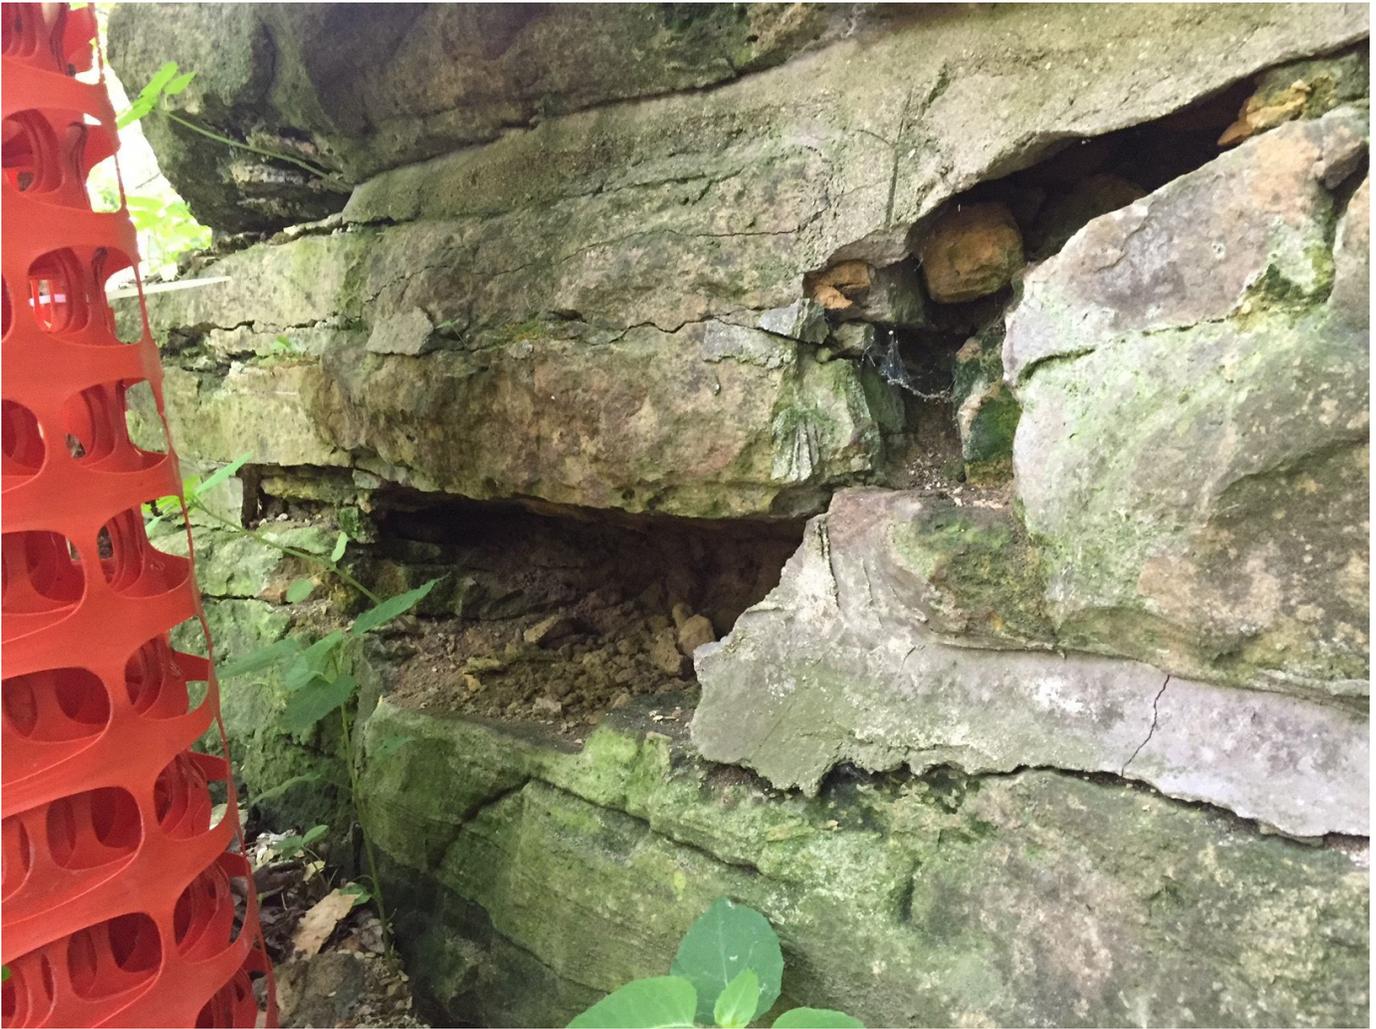
Figure 11: Degradation of the sandstone at the wing walls is most advanced at the face.

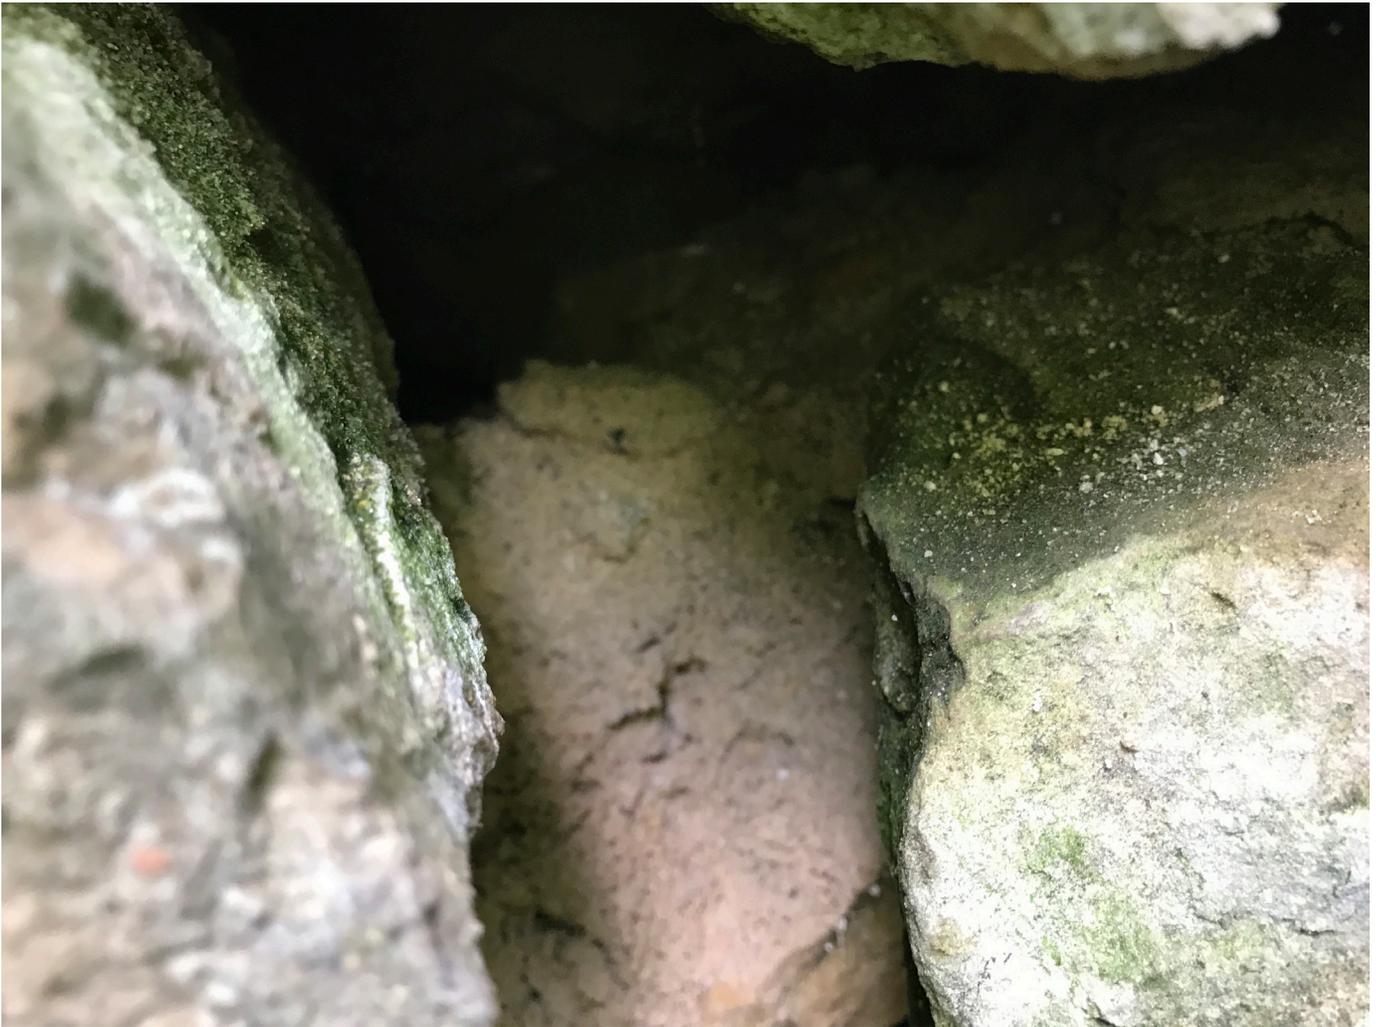
Figure 12: Degradation of the arch stones deeper in the wall is visible from the open joints where the arch has come out of alignment due to settling at the base at the right.
