JUNE 2020

ENVIRONMENTAL CONTAMINATION ON THE FORMER OSCAR MAYER PROPERTY AND SURROUNDING AREA IN MADISON, WISCONSIN

MIDWEST ENVIRONMENTAL ADVOCATES

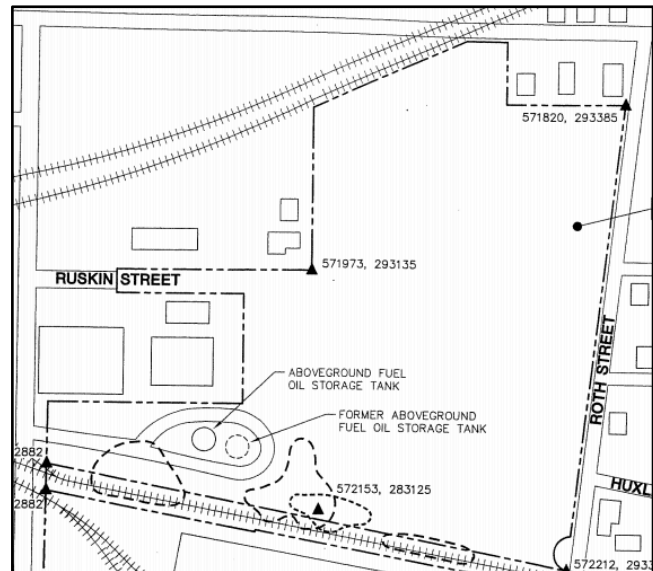
HARTMEYER PROPERTY

The Hartmeyer Property located at 2007 Roth Street in Madison, Wisconsin has been the subject of at least four BRRTS Activities beginning in 1989. The property is adjacent to the former Oscar Mayer facility located at 910 Mayer Avenue in Madison, Wisconsin and was leased by Kraft Heinz (which owns Oscar Mayer) from the John Hartmeyer Estate until November 2019. As relevant here, Oscar Mayer installed two above-ground fuel oil storage tanks on the eastern portion of the property and piping associated with those tanks leaked and released thousands of gallons of fuel oil into the environment that contaminated both soil and groundwater on and off the property. Oscar Mayer also stored coal on the property, placing it directly on the ground with no liner or other protective barrier, which resulted in soil contamination. One activity related to this contamination has been closed, one activity has been closed with continuing obligations, and two activities remain open. Since two activities remain open and to avoid confusion, all activities are listed under Open Sites and this subheading.

[BRRTS Activity #31300053](#) – On February 17, 1989, DNR was first notified of a hazardous substance discharge on the Hartmeyer Property. There was an initial emergency response to the spill, but a site investigation work plan was not prepared until August 2001, after which actions

[BRRTS Activity #213579045](#) – On March 7, 2017, DNR was again notified of a hazardous substance discharge on the Hartmeyer property located at 2007 Roth Street in Madison, Wisconsin. The substance spilled was diesel fuel and seems to be related to the above-ground fuel oil storage tanks that were located on the property. A letter to responsible parties was sent on March 13, 2017, but no further actions have been taken since and the case remains open.

[BRRTS Activity #213580328](#) – On April 10, 2017, DNR was again notified of a hazardous substance discharge on the Hartmeyer Property located at 2007 Roth Street in Madison, Wisconsin. In anticipation of the lease terminating in November 2019, an environmental engineering firm called Ramboll US Corporation (Ramboll) was retained to conduct an Environmental Site Assessment. Ramboll conducted subsurface investigations in April and September 2019 to evaluate soil conditions and determine whether any state soil cleanup standards have been exceeded. Soil sampling taken during those investigations revealed elevated levels of benzo[a]pyrene and arsenic on the eastern portion of the property. On November 25, 2019, Kraft Heinz submitted a request to DNR for technical assistance and to determine the extent of Kraft Heinz's liability to clean up the property. The case remains open.

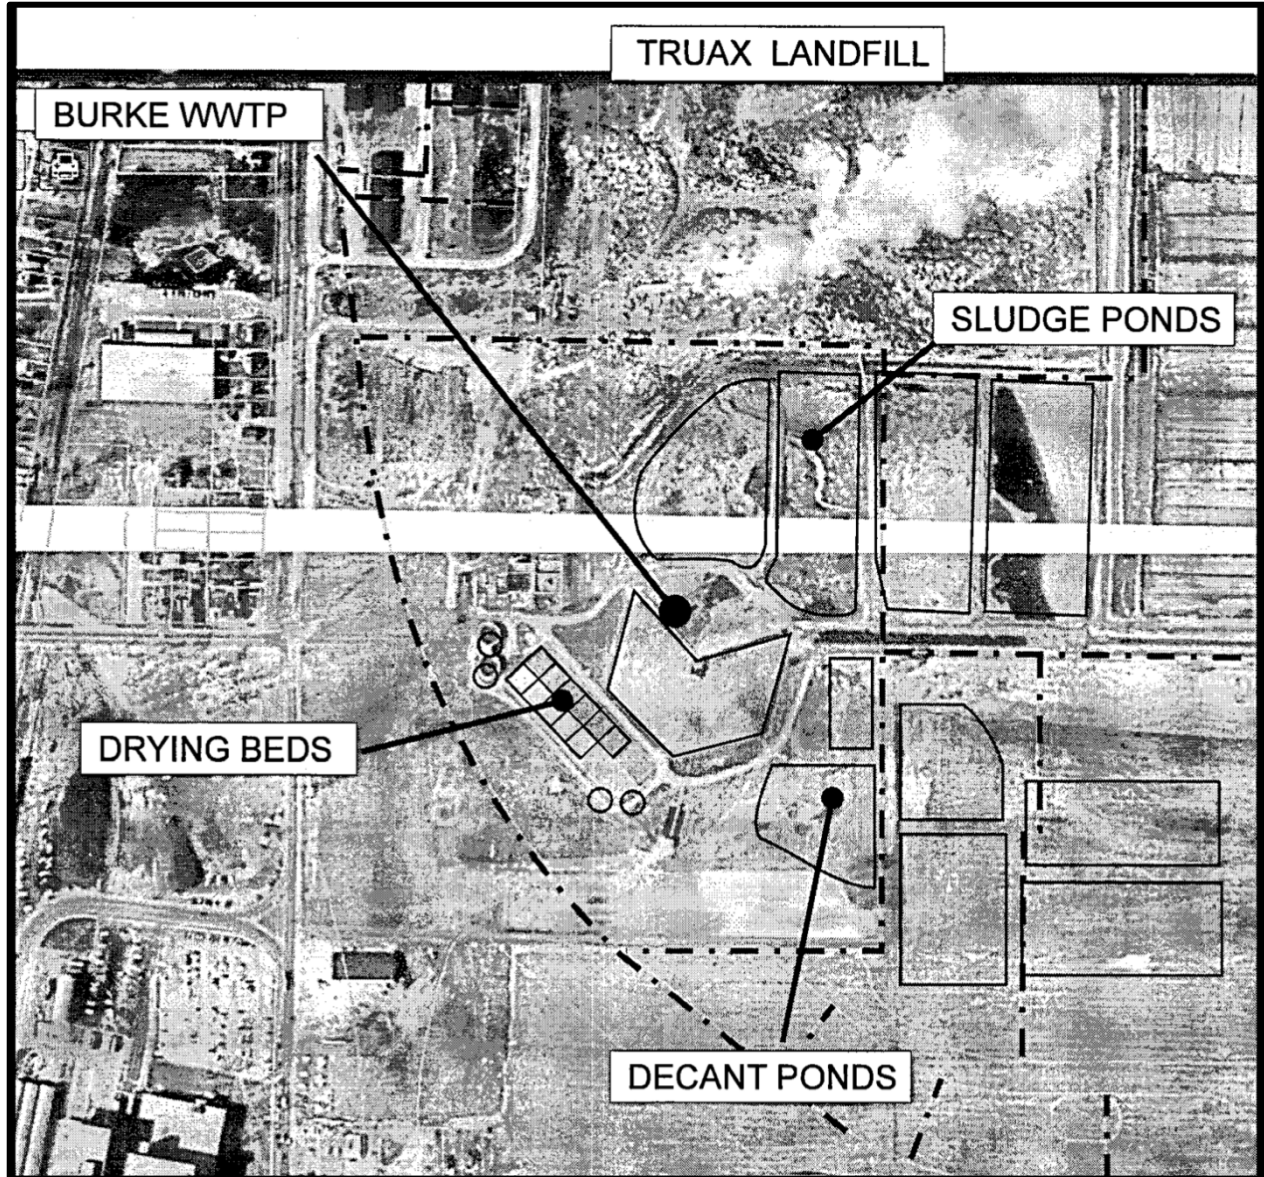
In addition, the former wastewater treatment plant was located adjacent to the former Truax Field Landfill, which was an open burning dump in the 1930s and a landfill for the U.S. Department of Defense and the City of Madison from 1942 to 1972. Groundwater contamination and methane gas intrusion from the former Truax Field Landfill to the wastewater treatment plant property occurred, resulting in the commingling of the two contaminant plumes.

On-site sampling of sludge in the lagoons, soils near the wastewater treatment's outfall near Starkweather Creek, and soils around the drying beds was conducted in the late 1980s and early 1990s. The sludge sample showed petroleum hydrocarbons and volatile organic compounds such as methylene chloride, 1,1,1 trichloroethane, trichlorofluoromethane, and toluene. Soil samples near the outfall showed petroleum hydrocarbons, lead, mercury, and volatile organic compounds such as methylene chloride, 1,1,1, trichloroethane, ethylbenzene, and toluene. Heavy metals, including arsenic and lead, in excess of state groundwater standards were also identified. Soil samples from the drying beds showed several volatile organic compounds, including petroleum-related compounds and halogenated organic compounds. Surface water samples taken from a former sludge lagoon and a drainage ditch connecting the lagoons to Starkweather Creek were also taken. No contaminants were detected in the sample taken from the sludge lagoon, but the sample from the ditch contained petroleum hydrocarbons and

tetrachloroethene. Groundwater samples on the western part of the property were also taken, which showed lead, chromium, and cadmium. Additional sludge samples taken from the sludge lagoons on the northeastern and southeastern portions of the property showed elevated levels of arsenic, cadmium, copper, lead, and zinc.

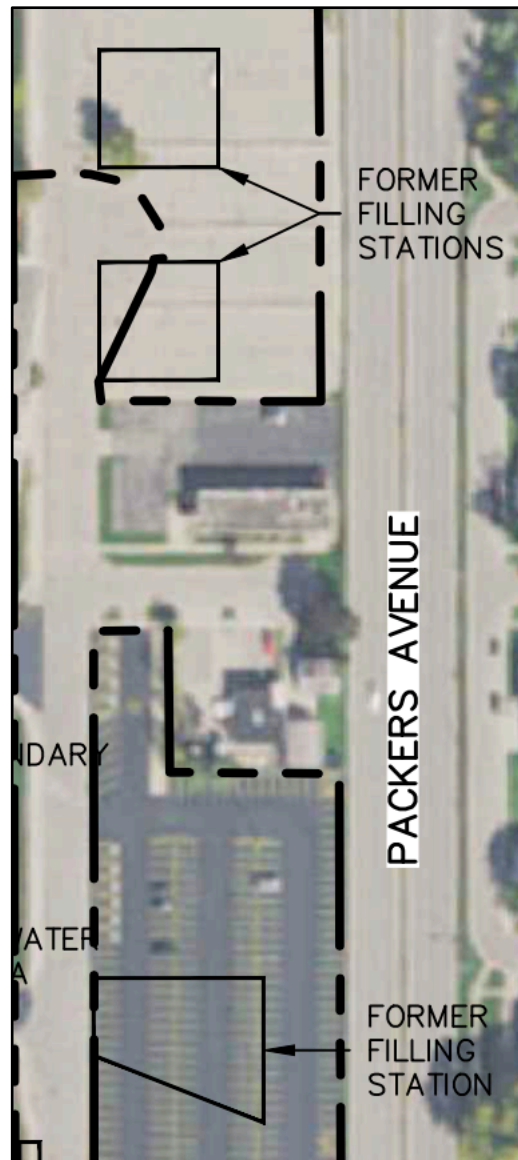
[BRRTS Activity #213580722](#) – On December 01, 2017, DNR was notified of a hazardous substance discharge at former gasoline filling stations located on the eastern portion of the former Oscar Mayer facility located at 910 Mayer Avenue in Madison, Wisconsin. The notification was provided after environmental site assessments conducted in October 2017, revealed contamination of soil and groundwater with petroleum, volatile organic compounds, polycyclic aromatic hydrocarbons, and lead. The contamination appears to be from the historical use of the site as three gasoline filling stations near the eastern edge of the property between 1958 and 1967. These filling stations were completely destroyed and the area was paved over for use as parking by 1968. Records of the exact number of underground storage tanks and/or their subsequent removal are unavailable. However, a geophysical survey of the site did not indicate the presence of underground storage tanks at the former filling stations.

On January 11, 2018, DNR sent letters to parties responsible for remediating the contamination. A site investigation plan was developed in October 2018 and options for determining the extent of groundwater and soil contamination were analyzed. The proposed monitoring program involved installing thirteen groundwater monitoring wells and taking soil samples. Field work was scheduled to be completed from November 2018 to January 2019, although a site investigation report, which should have included data from groundwater and soil sampling, was never uploaded to BRRTS on the Web. It is also not clear what remedial actions, if any, took place, but the locations of the former filling stations have been paved over and are currently used as parking lots, creating impervious surfaces like those that are typically used as a cap to reduce migration of contaminants through infiltration of precipitation from the surface. Nevertheless, on May 19, 2020, DNR received a request for case closure. That request was denied on May 27, 2020, with DNR pointing out that the monitoring wells need to be filled and sealed in compliance with applicable regulatory standards. As such, the case remains open. When the case is approved for closure, continuing obligations will apply due to remaining contamination.
