## 5. EXISTING CONDITIONS

## CURRENT USE ANALYSIS

The current use analysis provides an overview of the current conditions of facilities at Vilas Park. These uses are examined in these sub-section; Structures, Playgrounds and Other Activities, Drinking Fountains, Historic Stonework, Annie Stewart Fountain, Roads and Parking, Bridges, Paths, Signs and Wayfinding, Edible Landscape, and Children’s Memorial Benches. Some of these facilities are at the end of their expected life and should be considered for repair or replacement and others are in good condition and may last for some time. This analysis is based on visual inspection coupled with background information provided by the City.

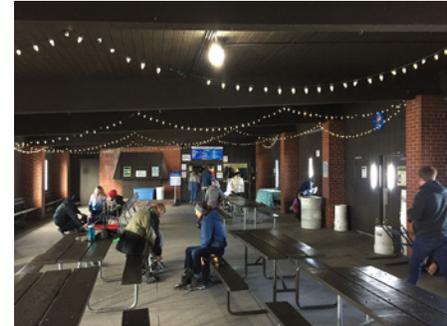
Figure 5.6. Inside Shelter as Warming House

Ponding of rainwater is evident from aerial views of the building (Figure 5.4). The roof will need replacement in 3 to 5 years. The building provides a covered open-air picnic and gathering space in the warm months and a warming house in winter for ice-skating on the neighboring lagoon (Figure 5.5). Temporary wood doors are placed between columns in the winter to create an enclosed space. The doors need replacement. There is a concession stand within the building that is only open in the winter (Figure 5.6). There are old restroom facilities and two unused fireplaces in the building. The shelter has electrical, water and wastewater services as well as access to propane from an adjacent tank. The electrical system could be updated to be more efficient. There have been requests for improved lighting in the building. The plumbing fixtures and pipes are well past useful life but functioning. Fixtures are not water saving models. The building has HVAC which needs frequent repair and will need full replacement soon. The surrounding pavement connects to paths and the parking lot. The asphalt has been patched and is cracked, a PASER of 6.

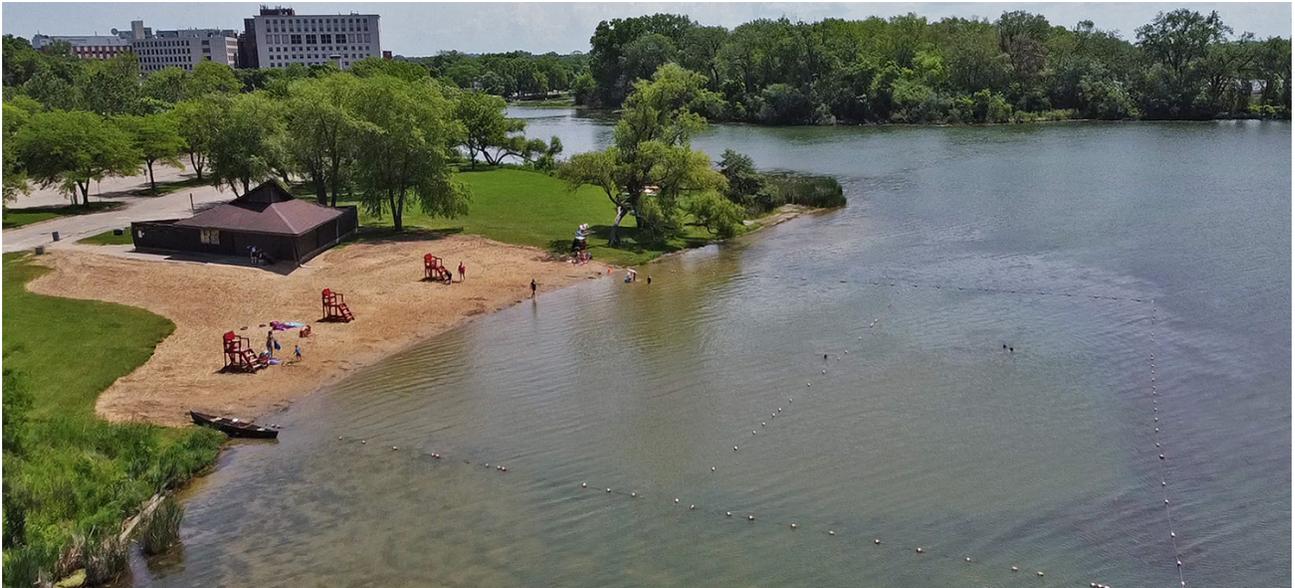
Figure 5.7. Beach Bathhouse and Beach

wood and is in relatively good shape structurally, however functionally the facility does not meet the needs of the current beach operations. Overall, the roof, doors, electrical and plumbing are in good condition. The bathhouse is connected to Vilas Park Drive and to parking with an asphalt path (Figure 5.10). There are potential accessibility concerns. The remainder of the site has bike parking racks on a concrete pad on the north side of the building and beach access on the Lake Wingra side.

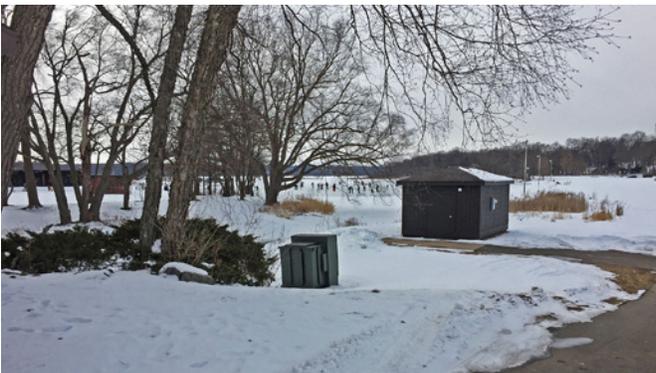
Figure 5.11. Pump House in Winter

The pump house was built in the 1990's to provide a water source for winter maintenance of the lagoon for ice-skating. The structure was recently replaced with a new building (Figure 5.11). The pump house is wood clad, on a concrete slab and is in good condition. The building is connected to the asphalt path running north-south through the park (Figure 5.12).

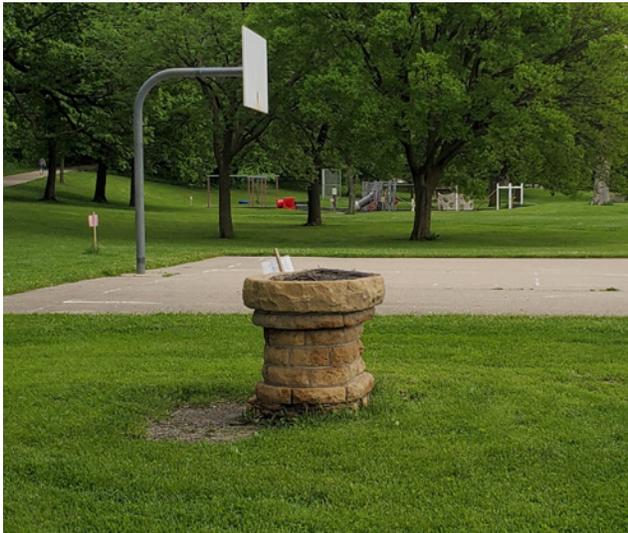
Figure 5.27. Historic Drinking Fountain

There are a few remnant stonework elements from the initial construction of Vilas Park. The John L. Burke drinking fountain is a limestone fountain that was constructed in 1931 (Figure 5.27). It is located near the basketball court and is not operational, but the stone is in good condition. Near the Burke fountain is a stone step system (Figure 5.28). These located west of the tennis courts along the woodland edge near the multi-use trail. The stone is in good condition, but the steps have shifted and become uneven. Vegetation is also overgrowing the steps which creates unsafe conditions.

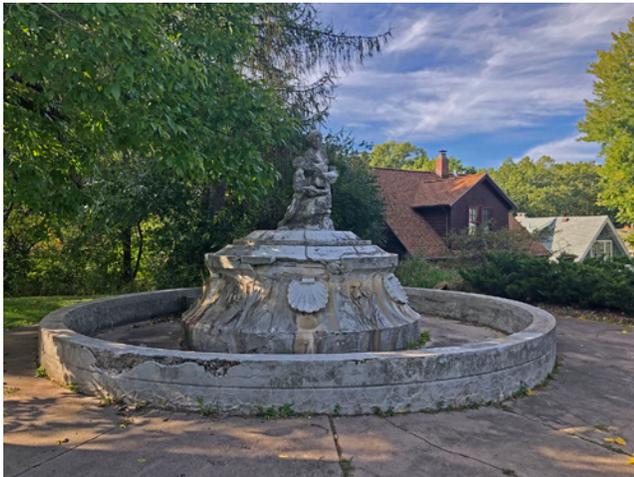
Figure 5.29. Anne Stewart Fountain in Summer

The Annie Stewart Fountain was completed in 1925 for the pedestrian entrance to the park addition at Erin Street. The fountain was heavily vandalized in 1931. The fountain is constructed of marble and concrete and has significantly deteriorated (Figure 5.29 and 5.30). The fountain has not had flowing water for most of its existence. The fountain is connected to the park and city walk system in the Greenbush Neighborhood. A preservation report was completed in 2017<sup>67</sup> that outlines the steps needed to preserve the fountain. The report noted much of the fountain needs to be replaced and it is unexpected that it will ever function as a fountain again. The City has started a separate planning effort to determine the future of the fountain.

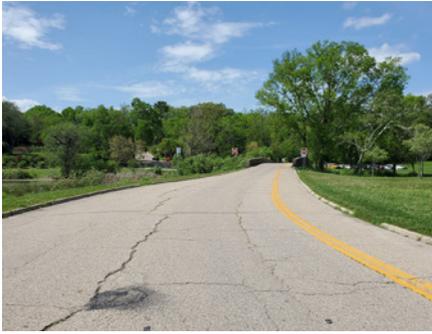
As Vilas Park Drive extends eastward toward the zoo and beach, there are linear parking lots where parked vehicles must back directly into the drive lane when exiting the parking space. The asphalt continues to show longitudinal and transverse cracks with asphalt patches. Ponding of stormwater is found along Vilas Park

Figure 5.31. Longitudinal Cracks

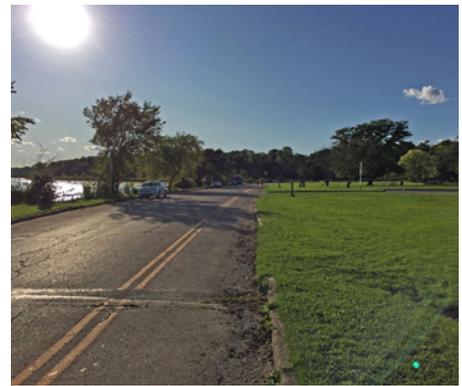
Figure 5.36. VPD Curb

Vilas Park Drive extends most of the length of the park along Lake Wingra. There is a short segment of Edgewood Drive that enters the park and intersects with Vilas Park Drive. The pavement of Edgewood Drive is in fair condition and the City does not have a PASER for that road segment. The Vilas Park Drive asphalt is cracked and patched (Figure 5.31). The entire length of Vilas Park Drive received a 2 to 4 PASER in 2018, meaning potential reconstruction. The asphalt surface drains to lawn areas, asphalt trenches leading to Lake Wingra and some storm sewer pipes (Figures 5.32, 5.33, and 5.34). The edge of the road has a segmented concrete curb that has shifted in places or has been removed altogether (Figure 5.35). Overall, the curb is in poor condition (Figure 5.36).

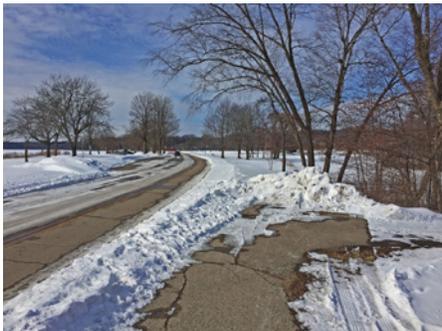
Figure 5.37. VPD in Winter

Drive near the south parking lot and zoo edge. The profile of Vilas Park Drive is flat with significant rutting and has drainage issues during winter snow removal and freeze/thaw conditions (Figure 5.37).

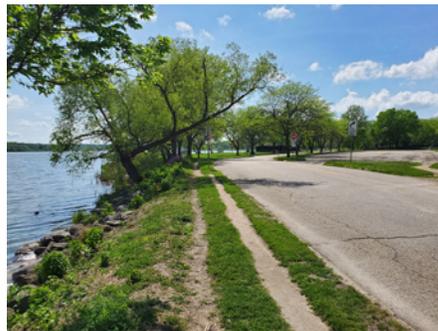
There is a pinch point along Vilas Park Drive at the zoo where the cross section of the road leaves little space for pedestrians. The curb and pavement show damage from heavy vehicles using the zoo service entries along Vilas Park Drive. The pavement is showing signs of transverse, longitudinal and slippage cracks and the asphalt pavement and curb are in poor condition extending to the intersection of Orchard Street and the edge of the park (Figures 5.38 and 5.39).

Figure 5.38. Transverse Cracks

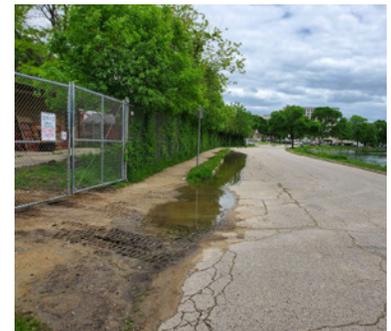
Figure 5.39. Slippage and Longitudinal

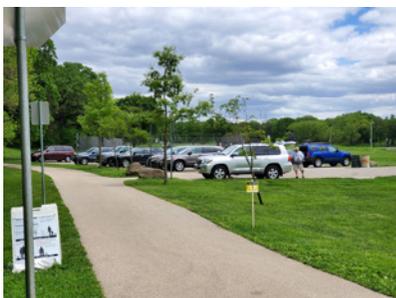
Figure 5.43. West Parking Lot

The west parking lot near the tennis courts is in fair condition with a PASER of 7.5 (Figure 5.43). There are no major cracks. The parking lot is connected to the multi-use trail but does not have any paved connections to the tennis courts. There is no curb at this parking lot and runoff flows south directly to the lawn toward the lagoon.

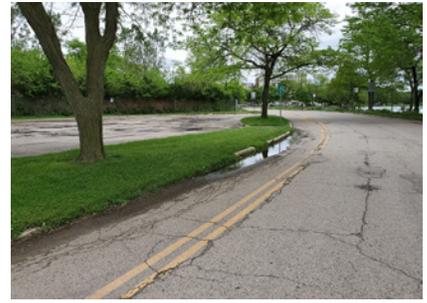
Figure 5.48. Drainage issues at South Lot

The parking lot near the south entrance to the zoo is in poor condition (Figure 5.48 & 5.49). The pavement has many patches and is oversized for a typical parking lot design (Figure 5.50). The parking lot received a very low PASER of 2. The lot near Orchard Street is also in poor condition with cracking and has a PASER of 4 (Figure 5.51). Both parking lots have failing curbing along most edges. Both lots also have connections to walks.

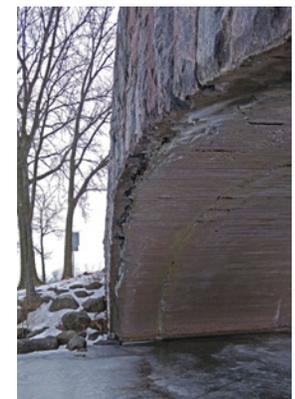
Figure 5.54. Bridge Structure

A structural load rating analysis for the historic bridge at the west end of Vilas Park Drive was performed by Strand Associates in 2012. The bridge was constructed in 1915 and has a wood pile foundation (Figure 5.52). The Strand analysis estimated a load capacity of approximately 11.1 tons (capable of safely supporting a bus) for the bridge. The stone façade of the bridge is in good condition, but the masonry joints need tuck pointing (Figure 5.53). The concrete arch support has several cracks and gaps also in need of masonry work (Figure 5.54).

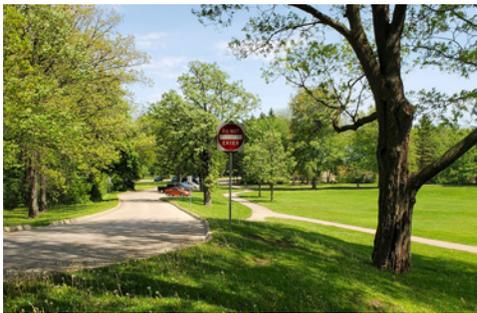
Figure 5.60. Path along North Exit Road

The asphalt path that is parallel to the exit road from the north parking lot to the intersection of Grant and Drake Streets is in good condition (Figure 5.60). The PASER is an 8 for this walk.

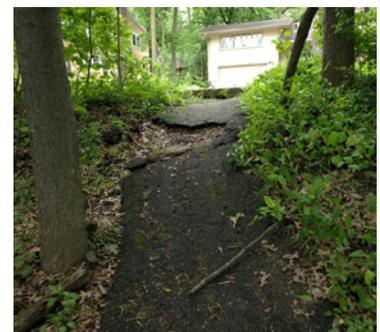
Figure 5.65. Informal Path Example

Avenue along the route. The main connection is directly across from the Van Buren Street intersection with Vilas Avenue. There are also several informal connections through the woodland edge of Vilas Avenue to the multi-use trail (Figure 5.65). These connections range from asphalt to dirt paths. They are in poor condition and mostly non-ADA compliant.

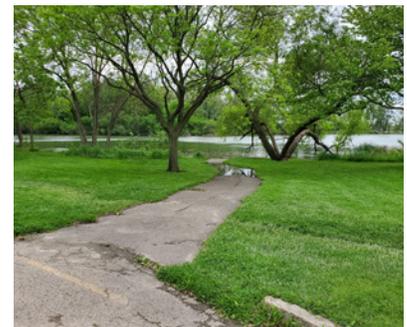
Figure 5.75. Path to Kayak Launch

There are three short asphalt paths connecting the south zoo entrance, the beach and the kayak launch to Vilas Park Drive (Figures 5.73 to 5.75). These paths provide accessible connections to use areas but are in poor condition. There has not been a formal assessment of these paths. The south zoo connection is the only link maintained in the winter.
