Lustron Home Model 02, Serial No.02470	EXHIBIT - A	"as-altered"	
--	-------------	--------------	--

REMARKS and CONCLUSIONS

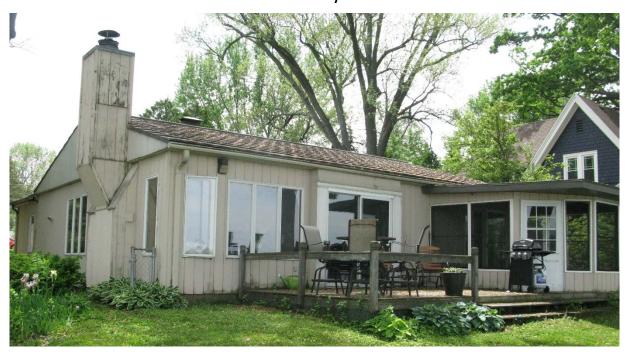
FRONT ELEVATION - Current View at Lakeshore (same view)

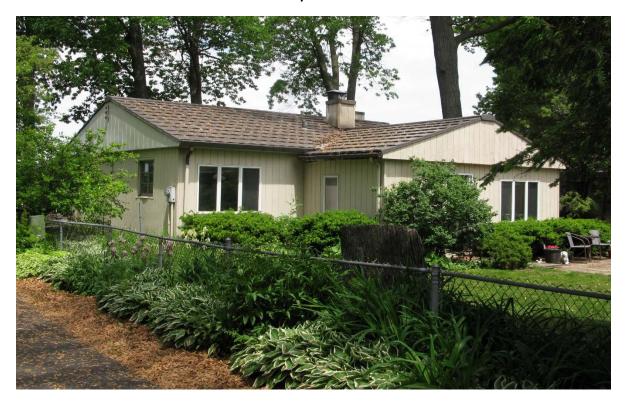
REAR ELEVATION - Current View at From Street

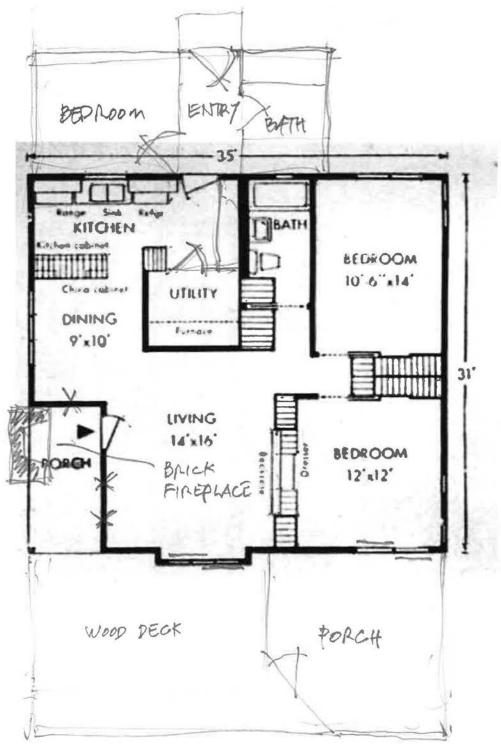
Floor Plan as Altered

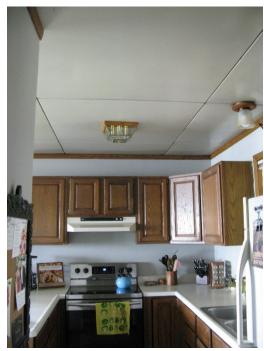
Kitchen – original ceiling

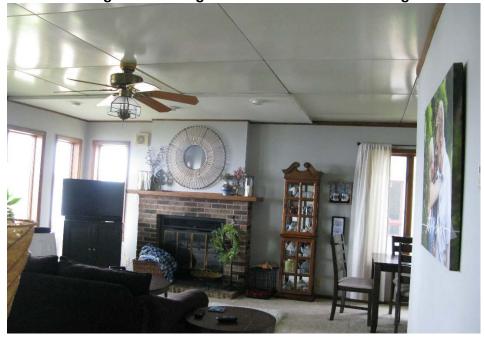
Living Room — note ceiling drop where porch was enclosed to enlarge room and add brick fireplace.

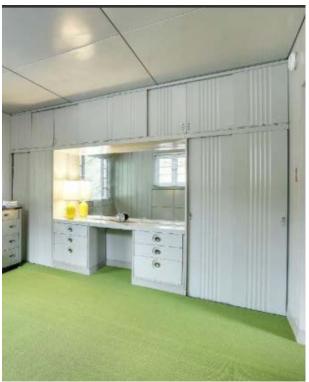
Current Alteration
