BRICK BUILDING AT THE CORNER OF REGENT AND N CHARTER

PROJ. #:	20001-01
© SKETCHWORKS

**EXISTING CONDITIONS -EXTERIOR**

**EXISTING CONDITIONS -INTERIOR**

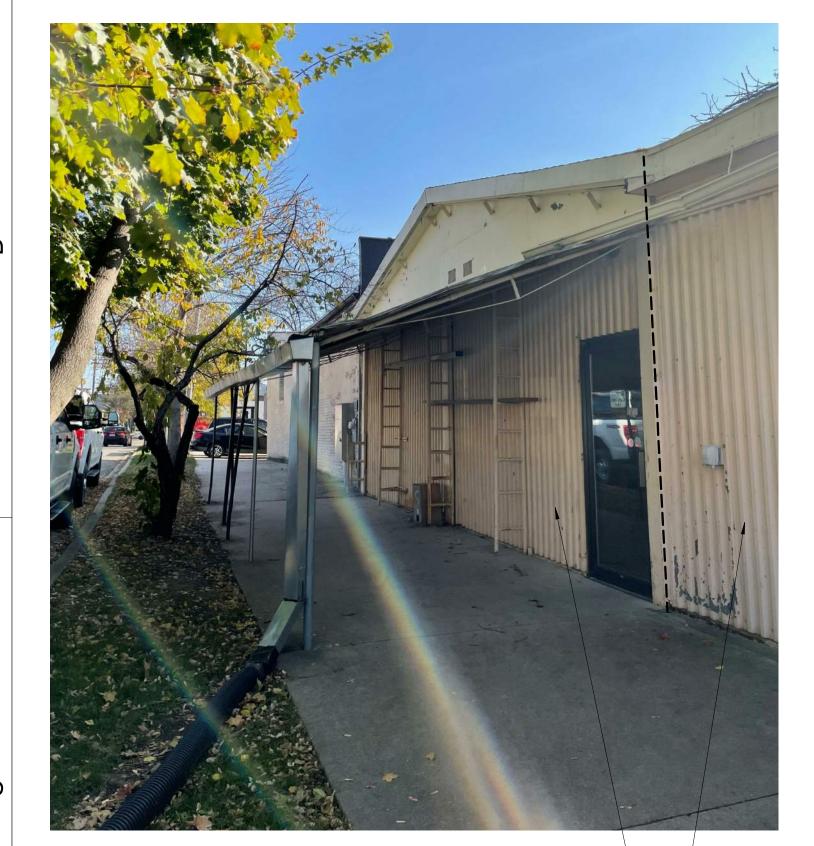
NORTH SIDEWALK AND CANOPY

WEST BAY TO BE DEMOLISHED

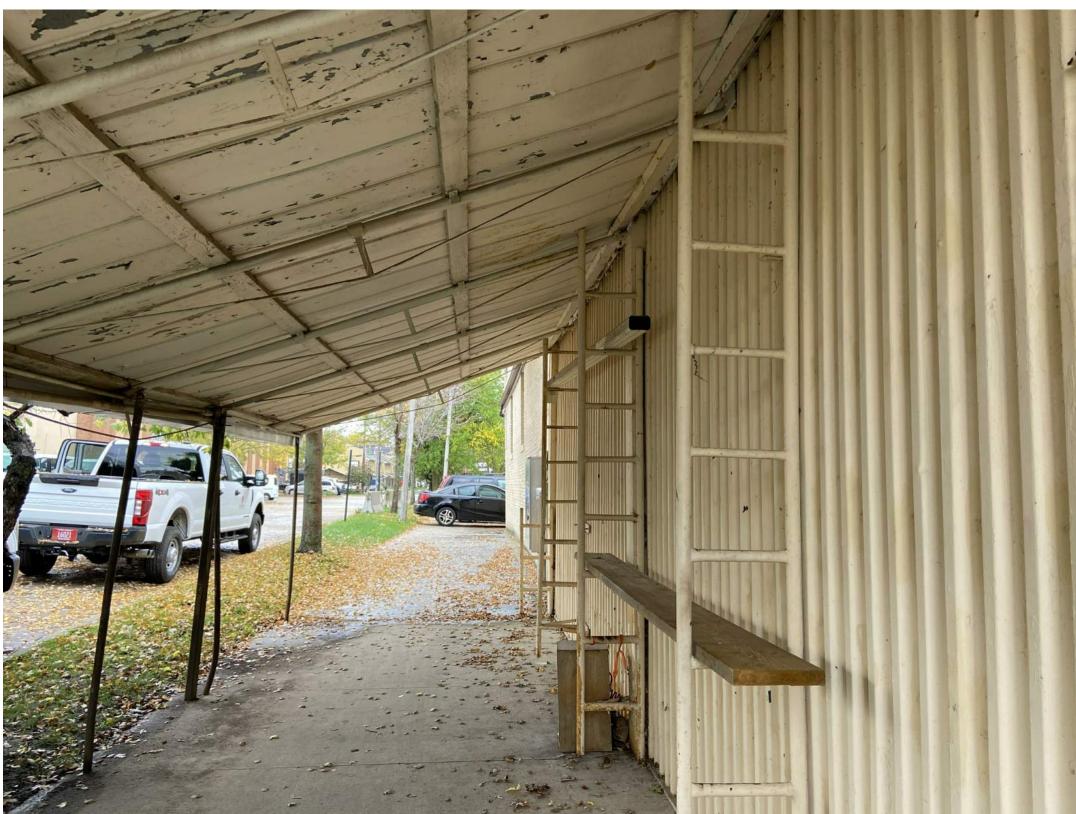
VIEW UNDER CANOPY TOWARD PARKING LOT

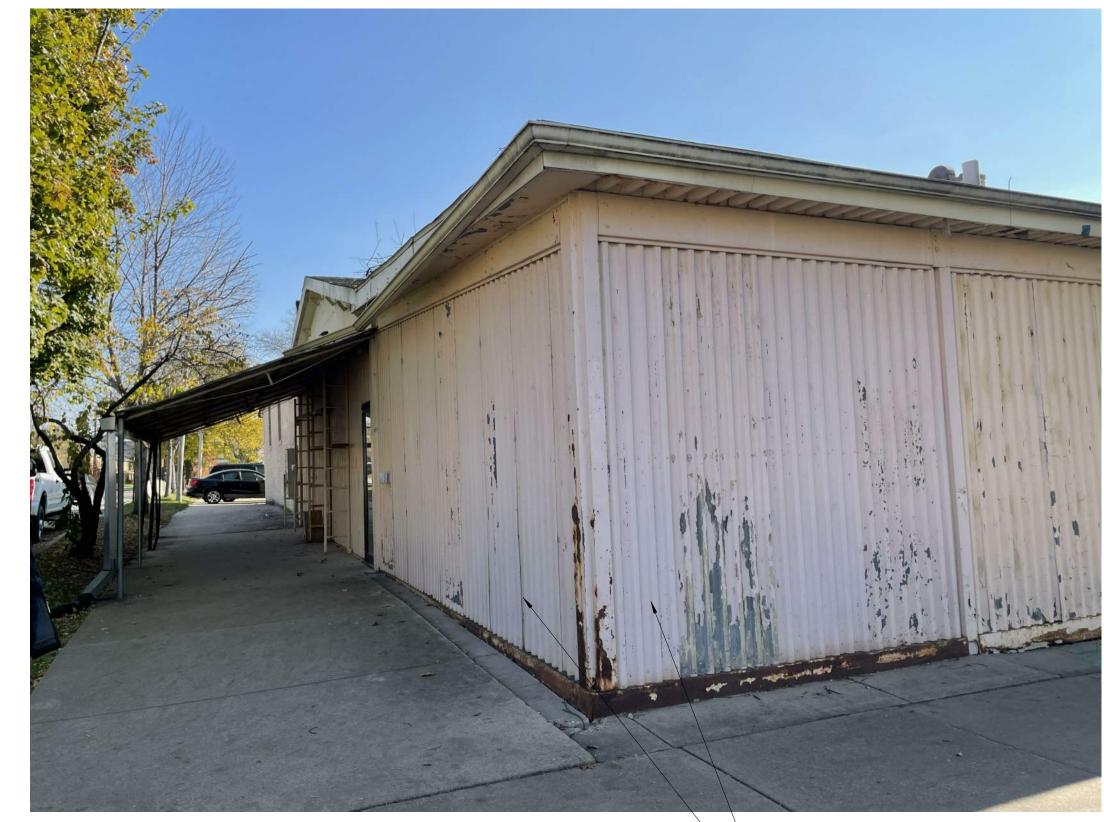
NORTHWEST CORNER

WEST BAY TO BE DEMOLISHED.

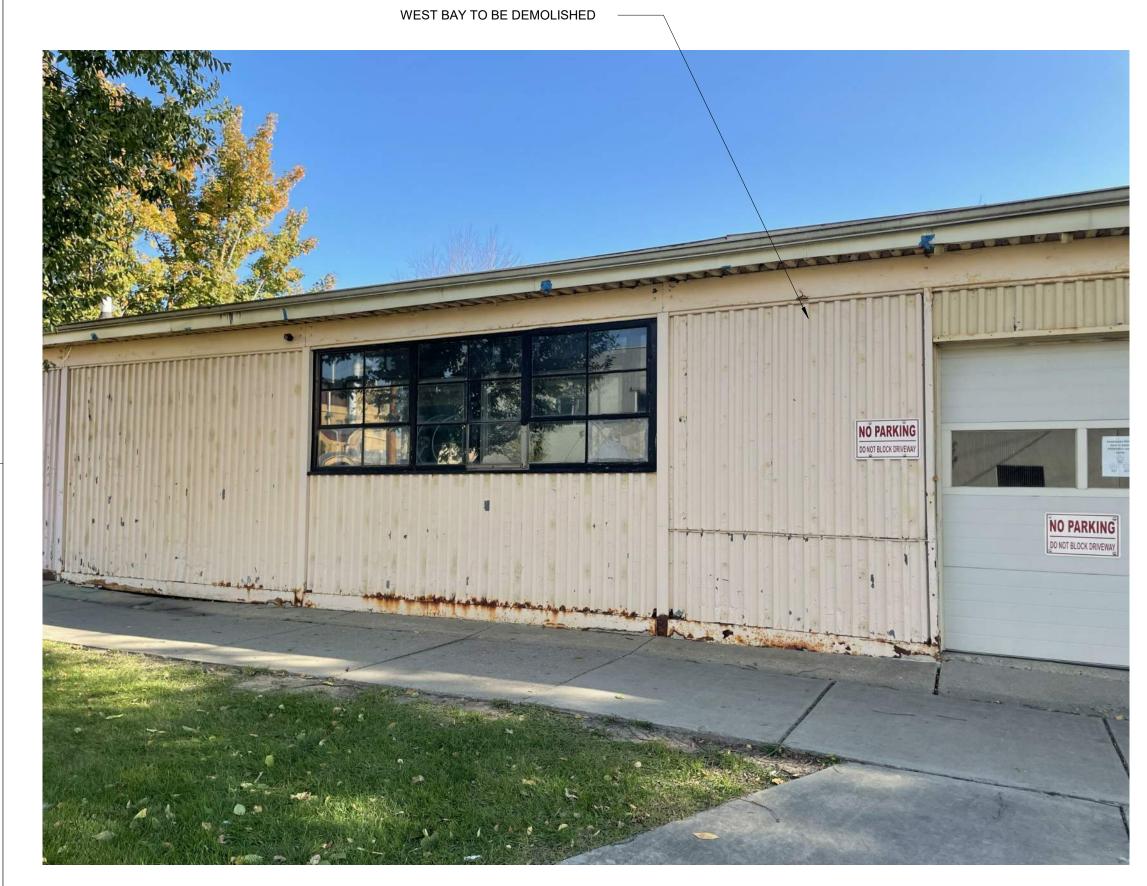
WEST FACADE, VIEW FROM N CHARTER STREET

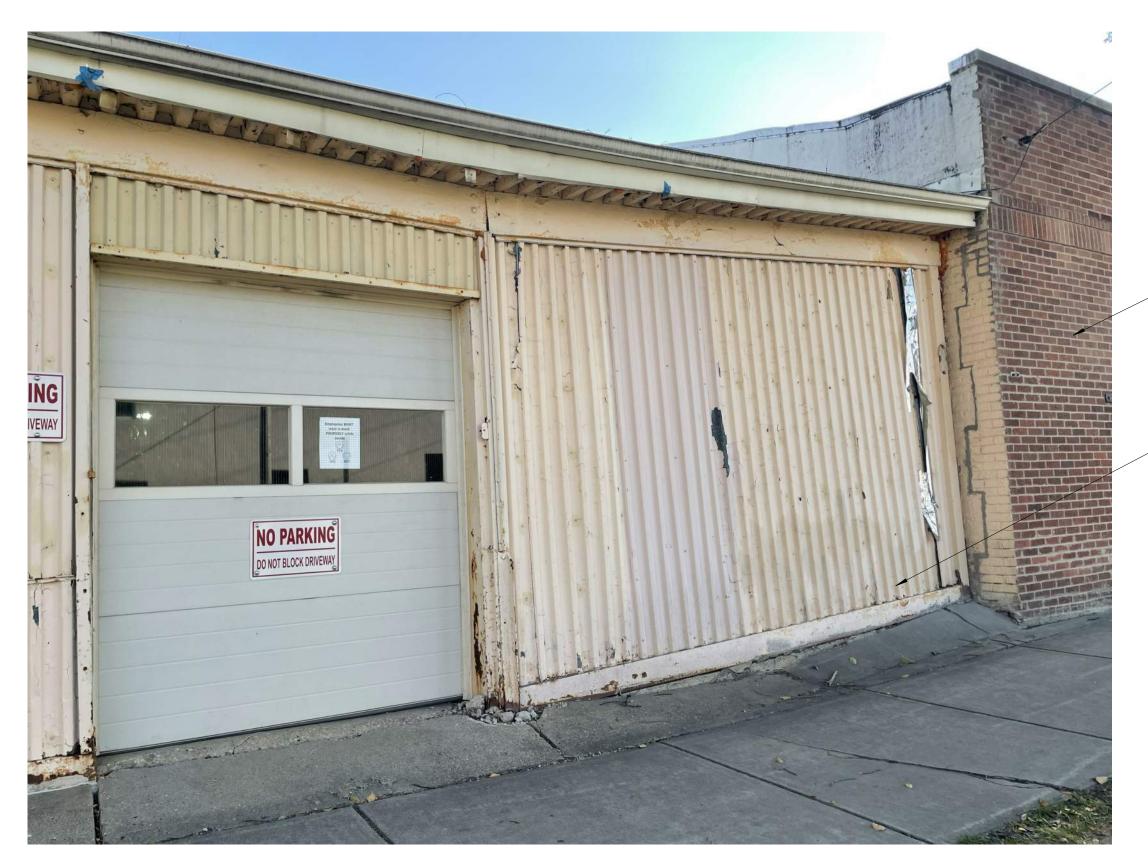
**VIEW OF WEST FACADE**

STRUCTURAL INSTABILITY RESULTING FROM POOR SOIL CONDITIONS -PORTION OF THE BUILDING (WEST BAY) TO BE DEMOLISHED.

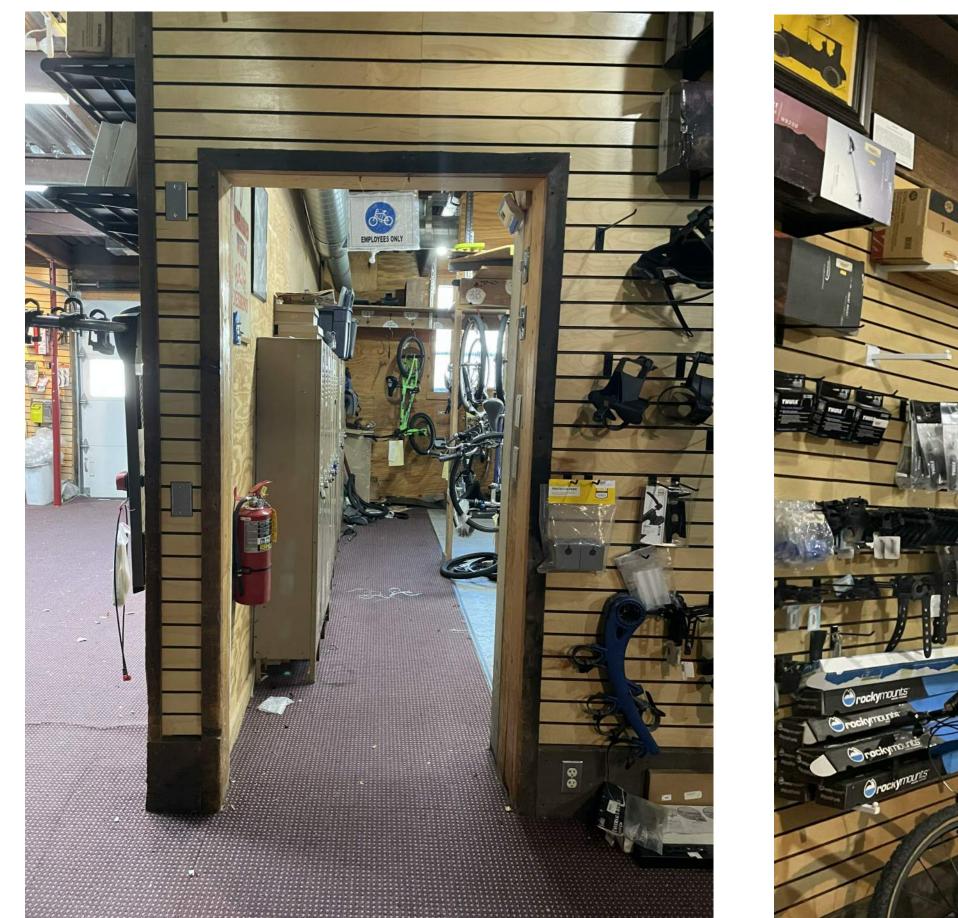
**INTERIOR PARTITIONS**

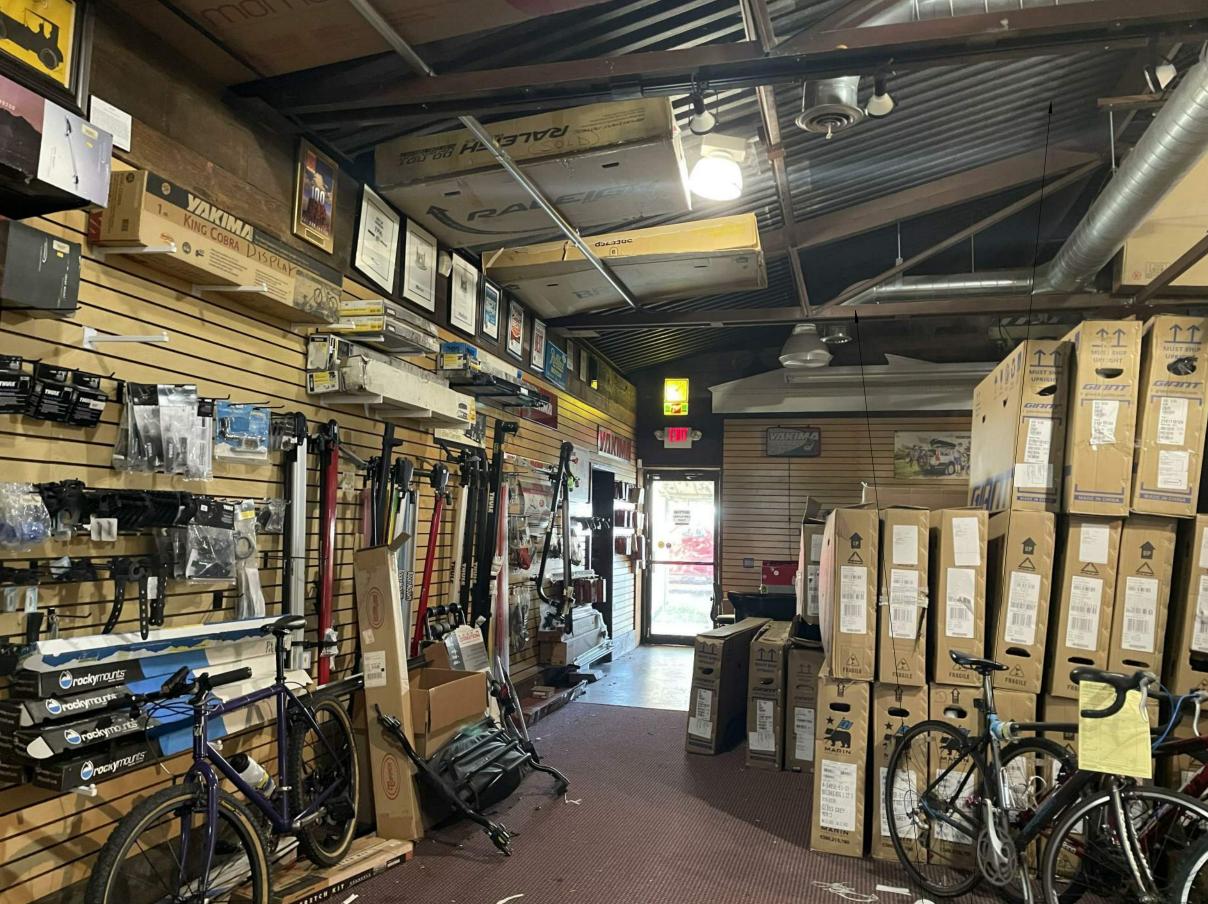
**EXISTING GABLE TRUSSES**

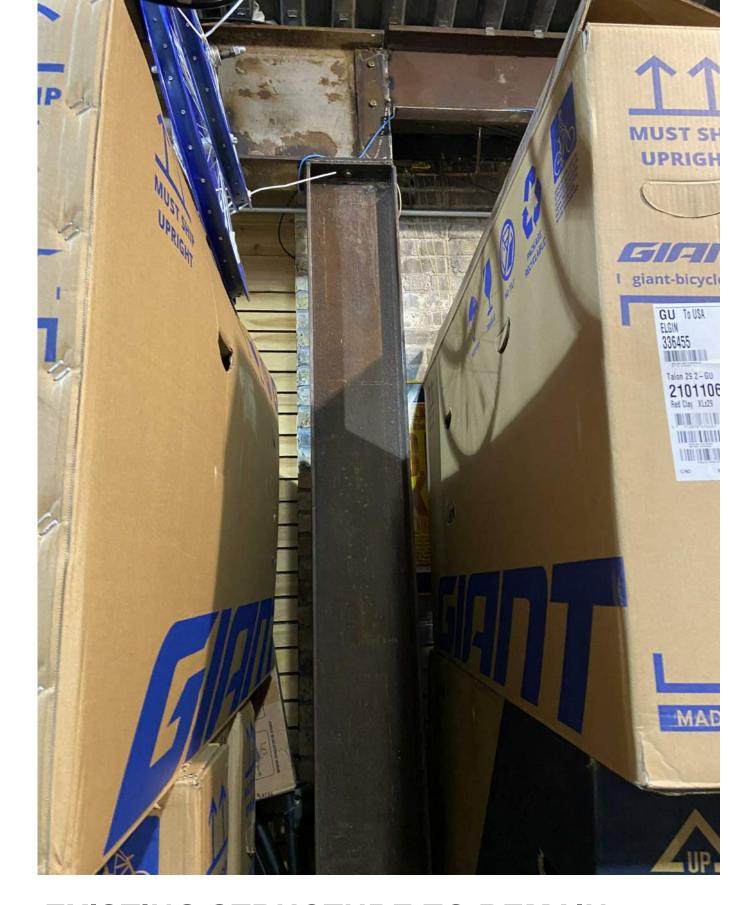
**EXISTING STRUCTURE TO REMAIN**

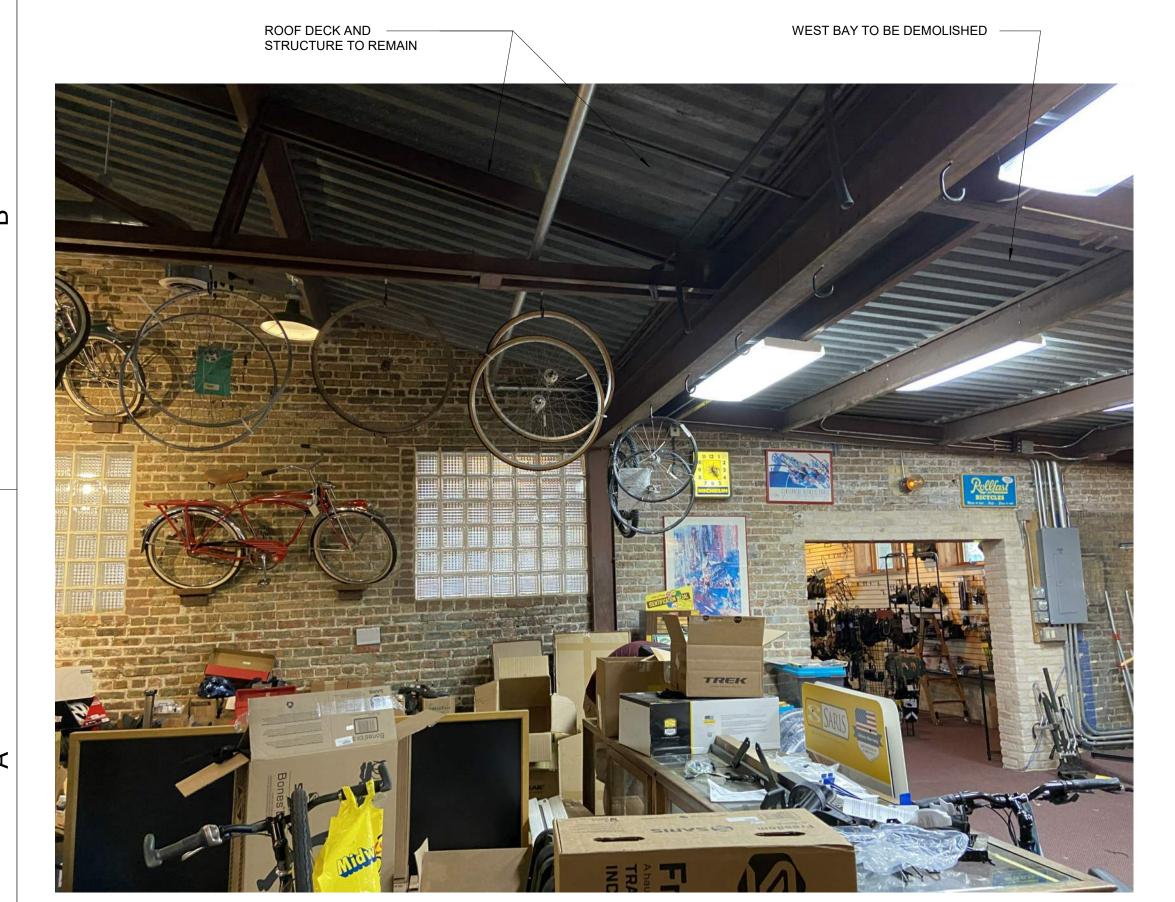
**GABLE STRUCTURE AND WEST BAY**

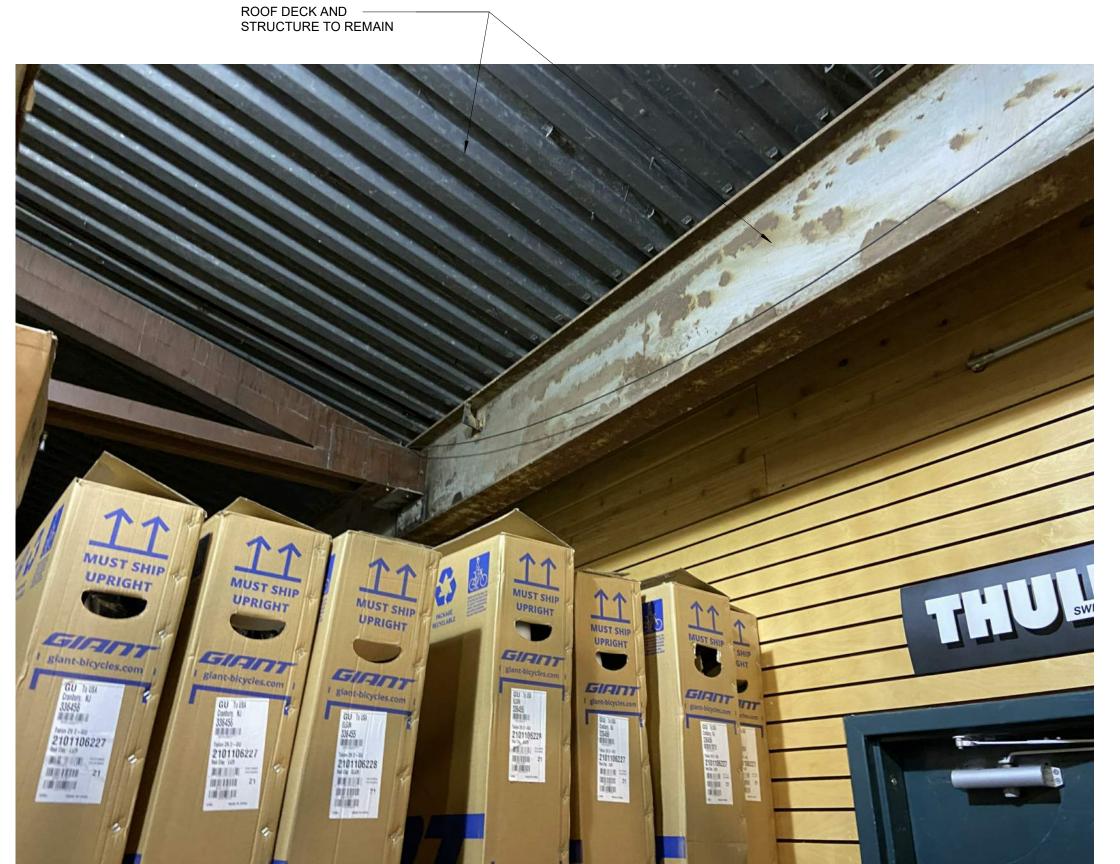
TRUSSES TO REMAIN

FRONT FOUR BAYS OF ROOF DECK TO REMAIN

**EXISTING ROOF DECK AND STRUCTURE**
