Project Name & Address: 946 Spaight Street
Application Type(s): Certificate of Appropriateness for exterior alterations
Legistar File ID # [76445](#)
Prepared By: Heather Bailey, Preservation Planner, Planning Division
Date Prepared: February 28, 2023

Project Applicant/Contact: Henry Doane
Requested Action: The Applicant is requesting that the Landmarks Commission approve a Certificate of Appropriateness for the replacement of a patio wall.

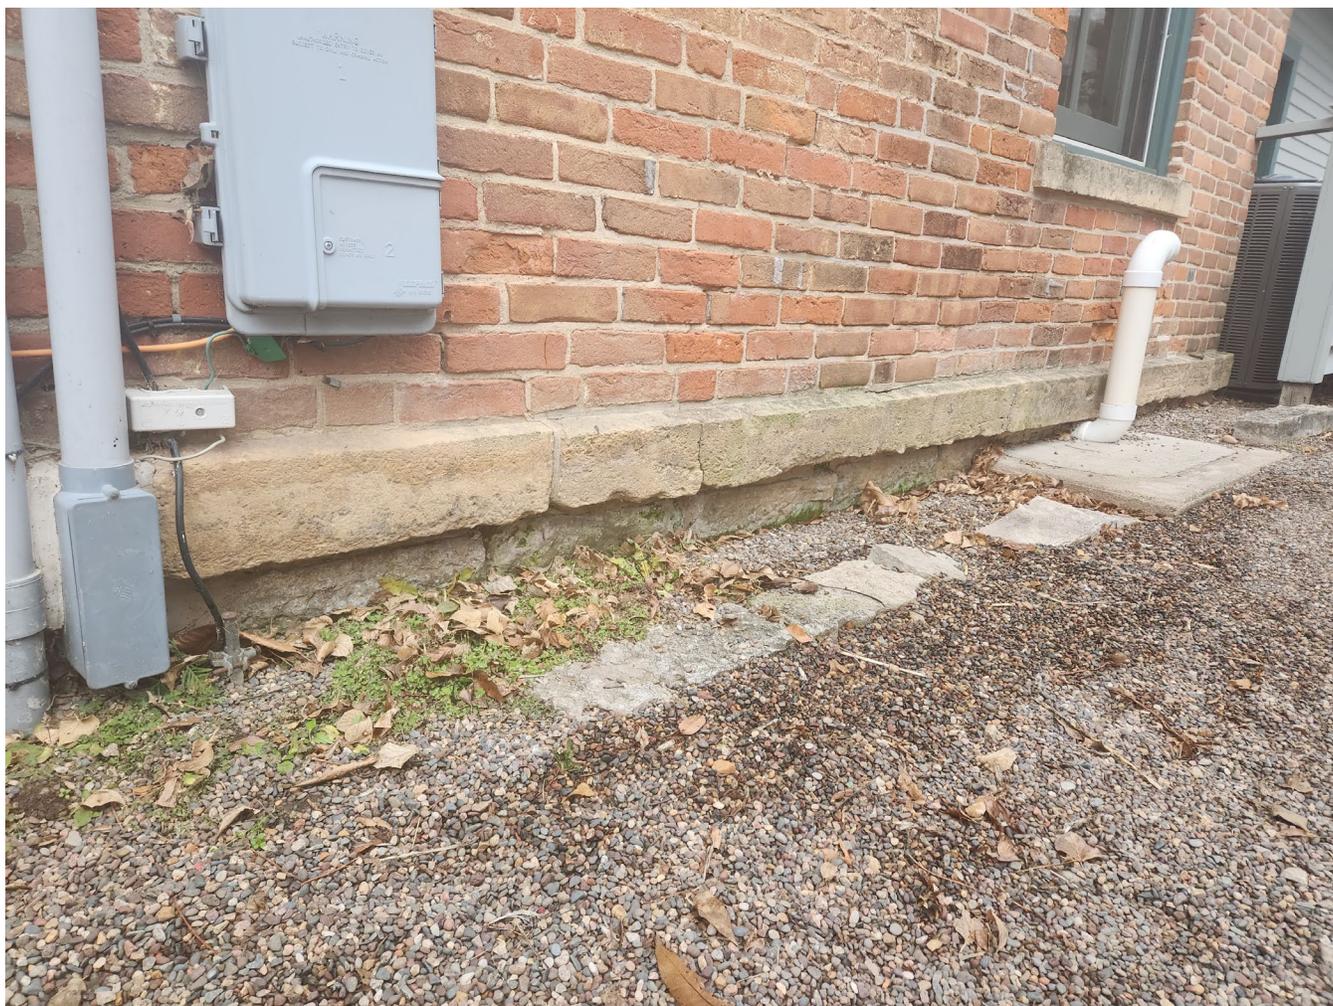
Staff photo of side of structure from 12/7/22. The limestone foundation is constructed of finely tooled, regularly coursed stone blocks, not a randomly coursed, rubble construction with untooled stone.

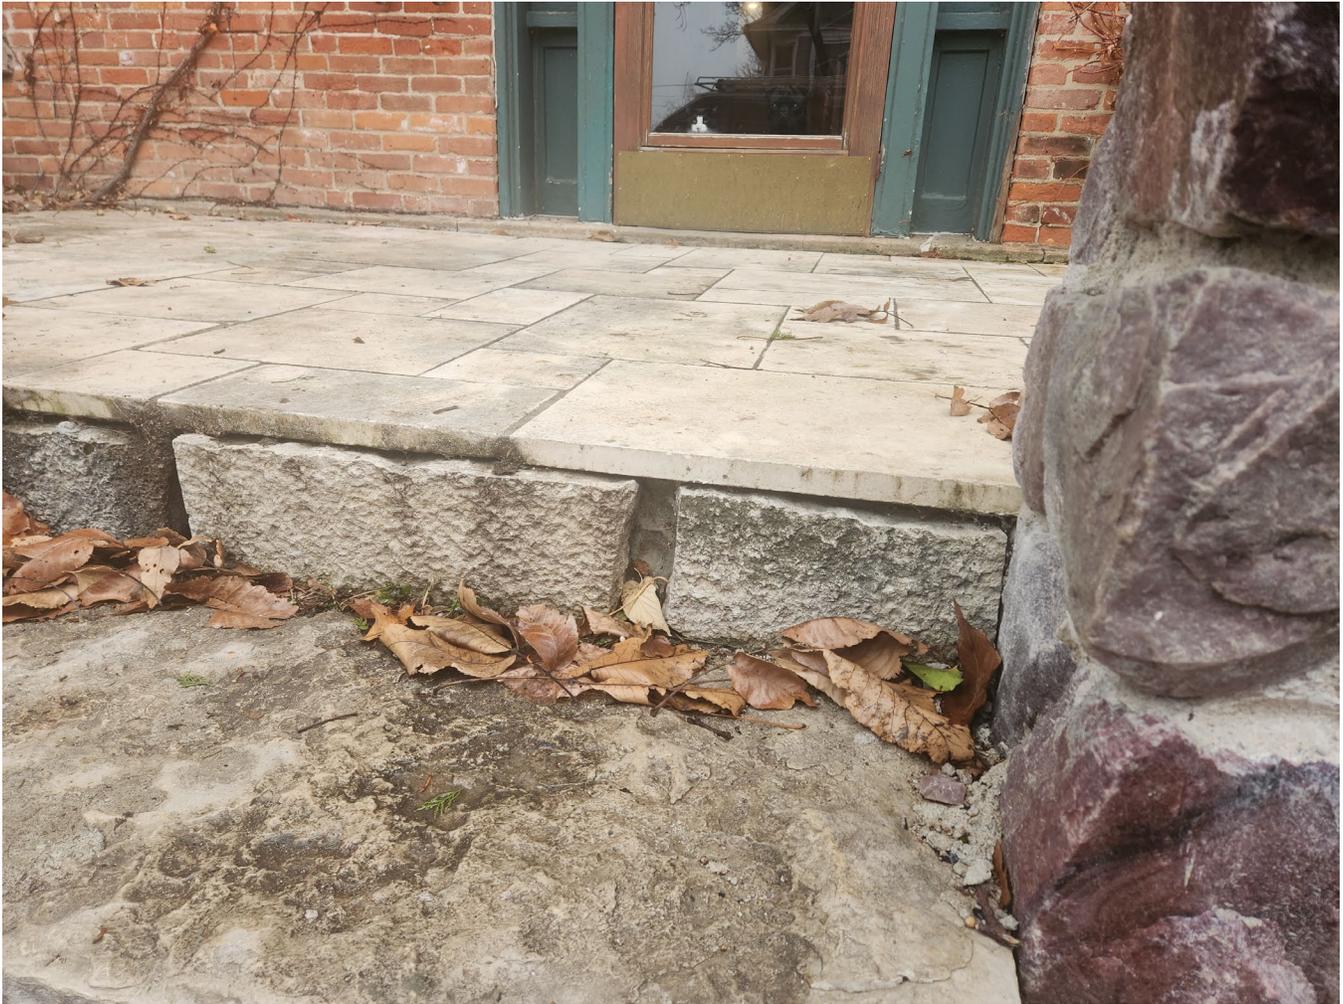
Staff photo of existing conditions from 12/7/22. The stone cladding on the front of the concrete stoop looks compatible with the limestone foundation. The stone tiles on top of the concrete stoop are also new. Google Streetview shows this previously being topped with brick pavers.

4. The previous conditions of the front stoop had not acquired historic significance in its own right.
5. The distinctive materials of this site are the simple limestone and red brick of the structure. The introduction of the very contemporary tiles on the front stoop and the purple rubble wall out front detract from those distinctive materials and types of craftsmanship.

Staff believes that the standards for granting a Certificate of Appropriateness could be met and recommends the Landmarks Commission refer this item to the April 3 meeting with a request that the property owner submit updated plans that meet the standards.
