Normal Hall Rehabilitation
Landmarks Commission Letter of Intent
February 4, 2026

Normal Hall

Project Description

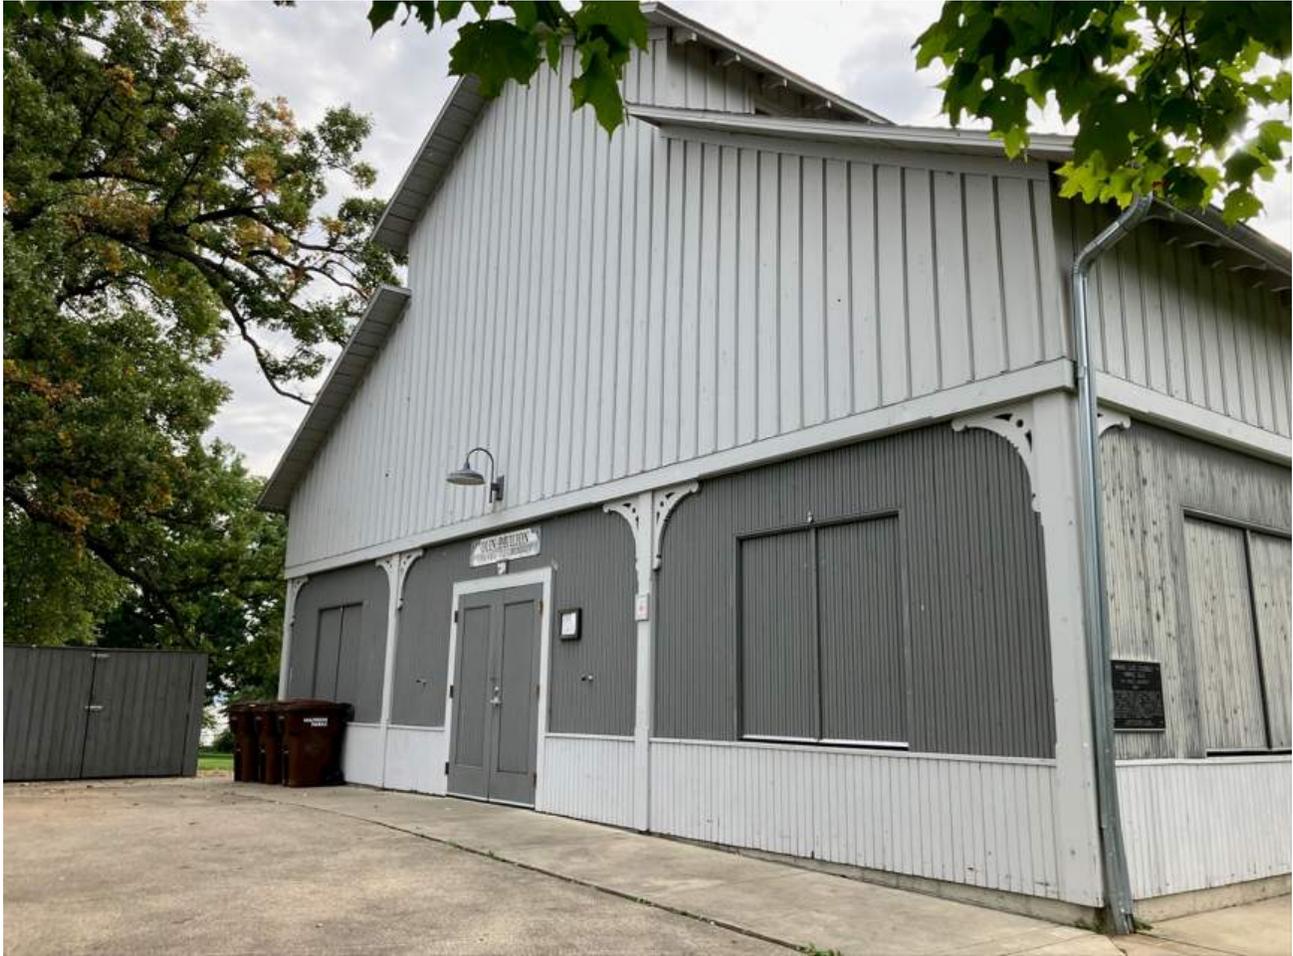
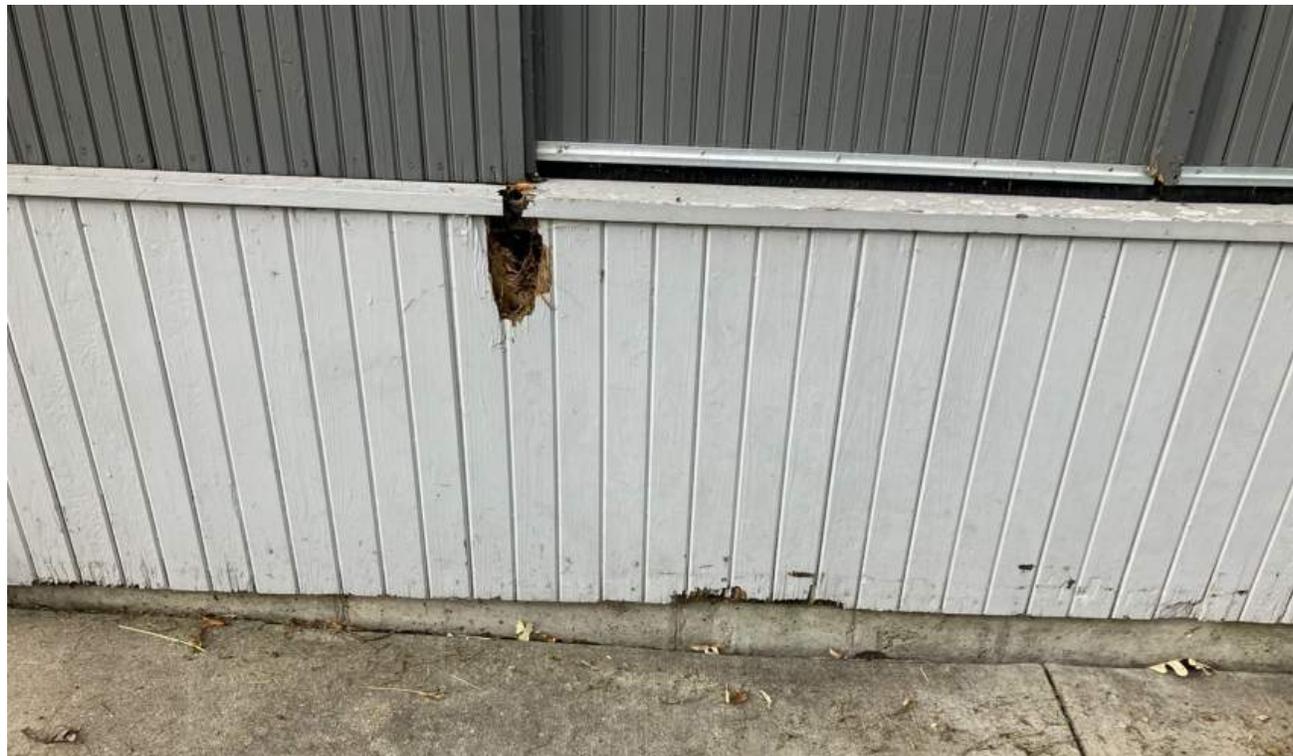
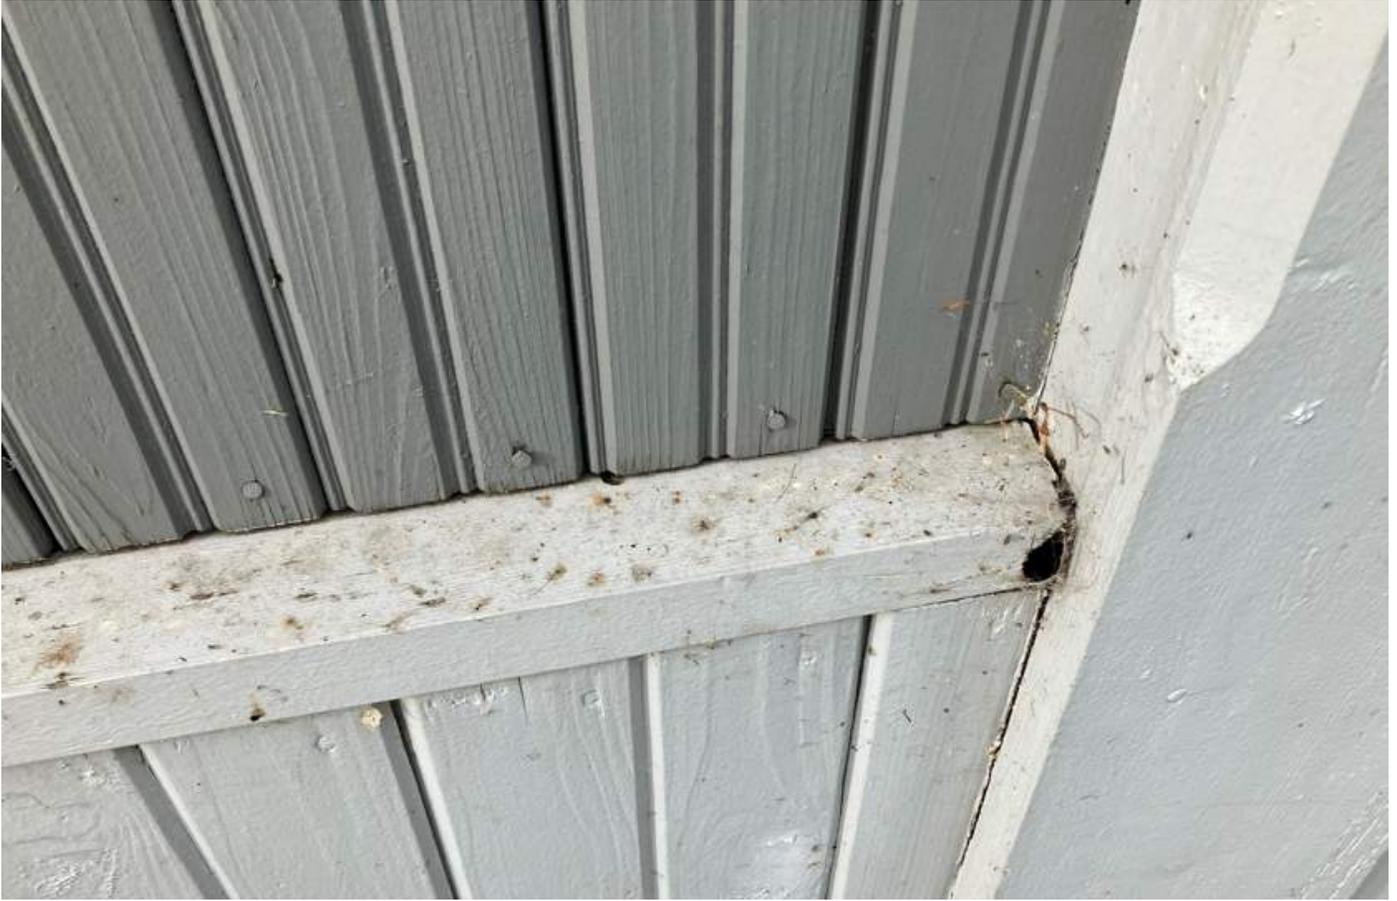
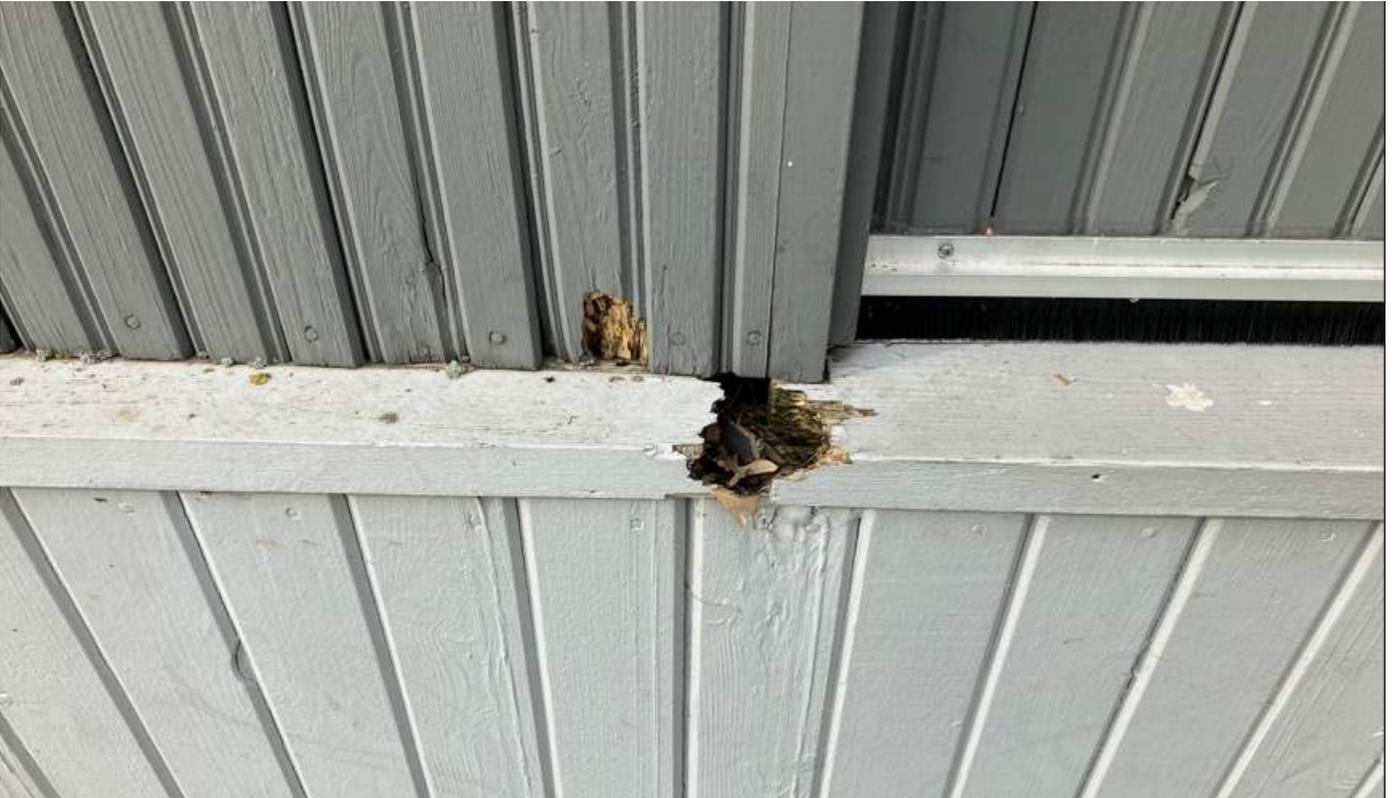
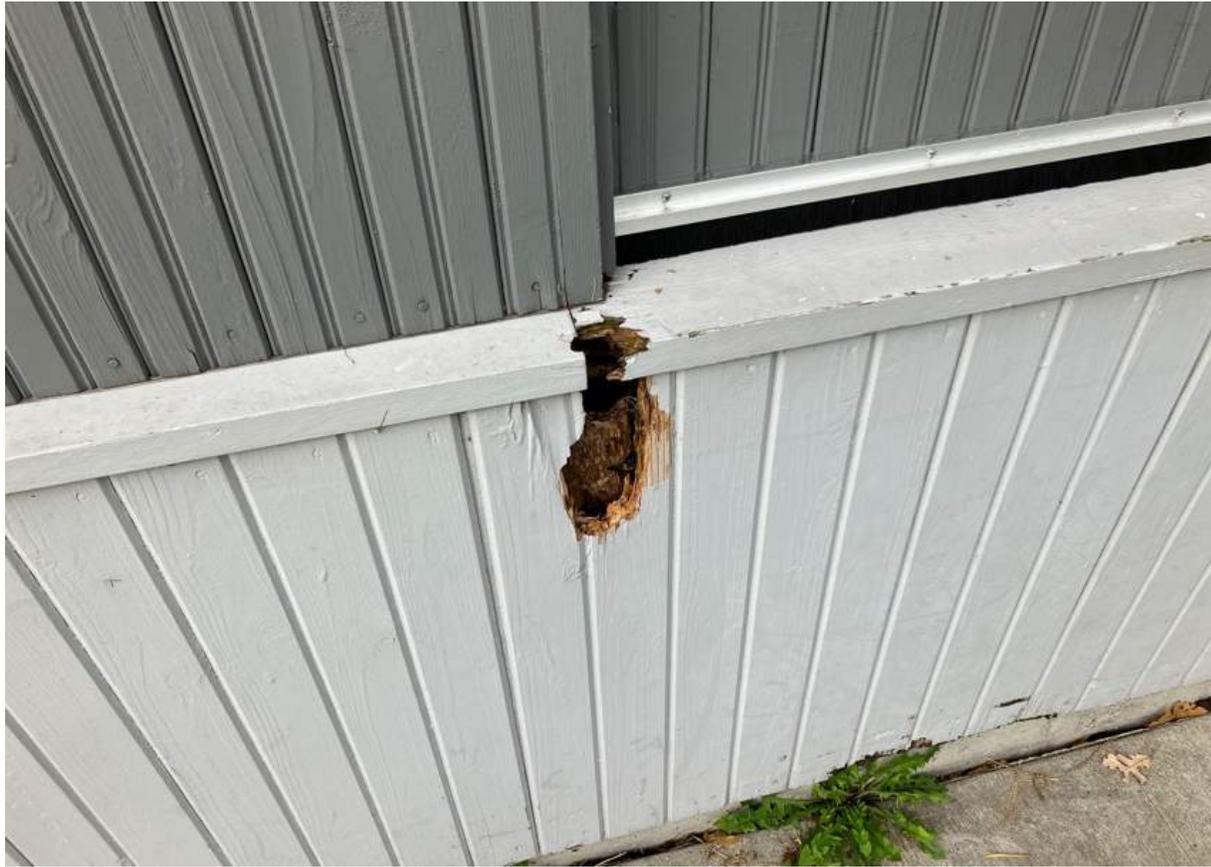
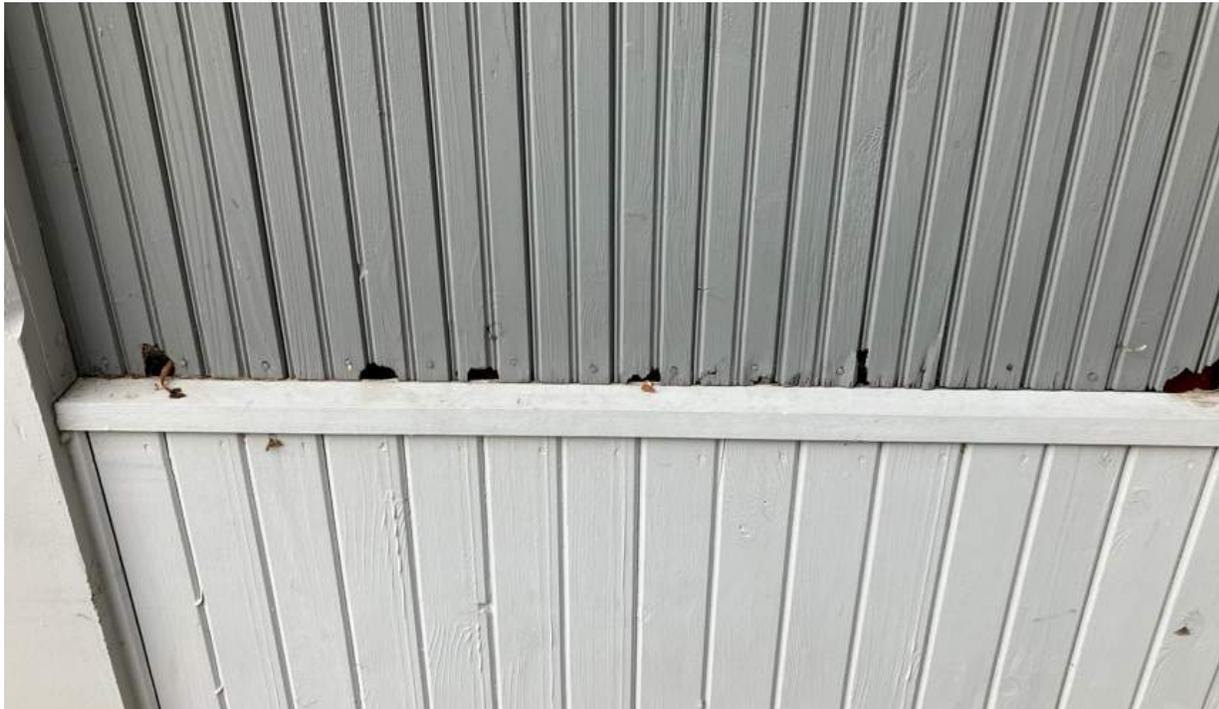
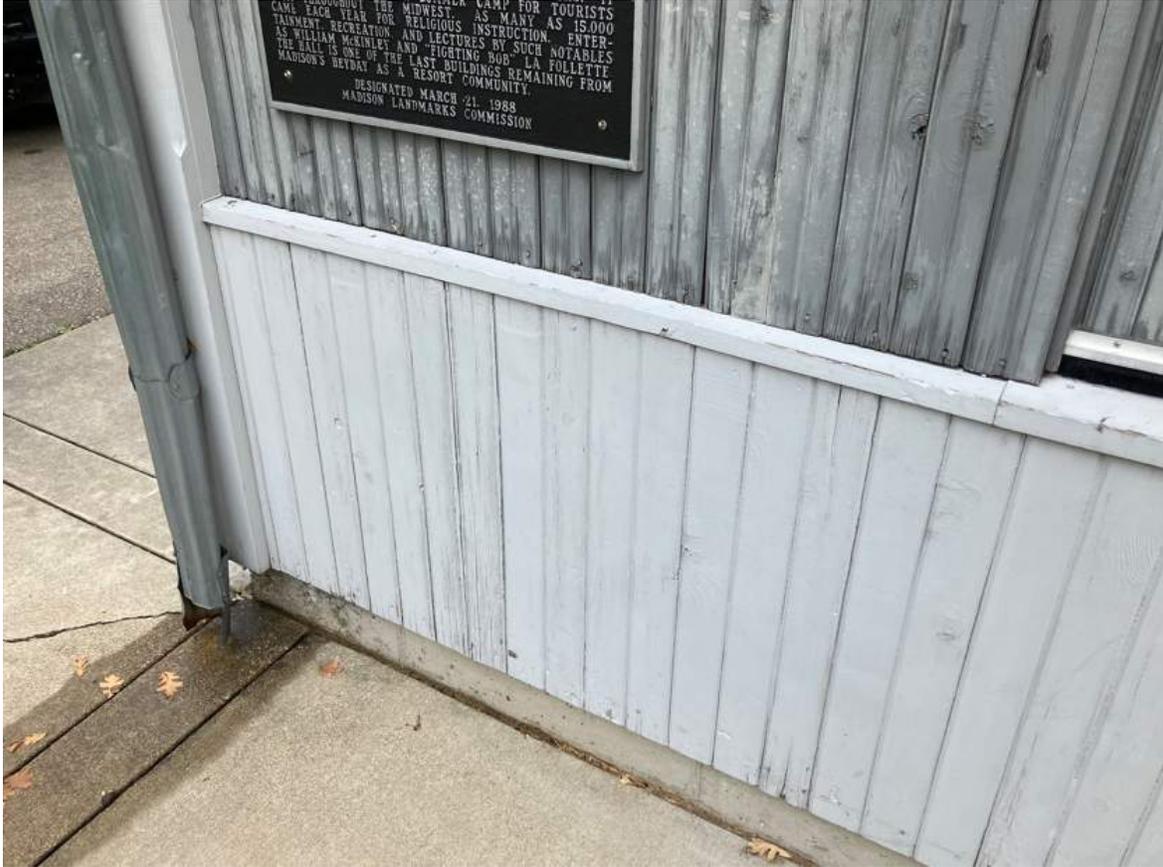
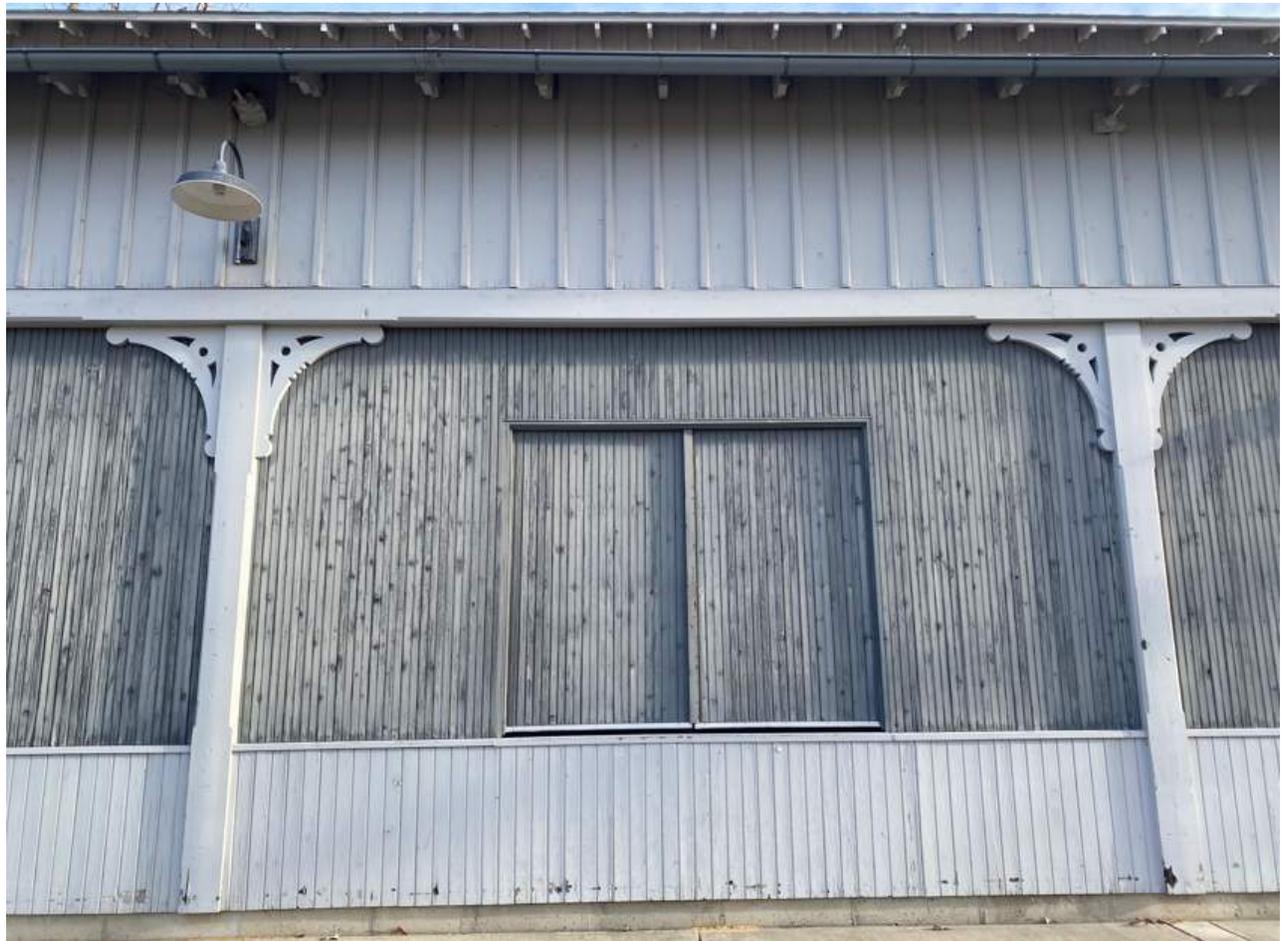
Current conditions of existing structure:

In the 2000 renovation, the infill material was provided to add stiffness to the frame and allow angled structural bracing to be hidden from view and installed between interior and exterior paneling. The siding was renovated to match the original beaded board rails and the shutters were designed to be frameless. The doors required frames for structural stability, but they remain as plain as possible. Clerestory windows were added to match the original design, which were gone. The original vertical board siding was also restored. The roofing was replaced with a fiberglass shingle that approaches the look of wood shingles. In addition, the entire floor system was removed and replaced with a continuous concrete perimeter footing and foundation wall where wood I-joists at 16" on-center, span from a ledge at the foundation wall to perpendicular LVL beams. The interior floor is hardwood floor over tongue and groove plywood subfloor. The LVL beams and wood I-joists are deteriorating due to extended water intrusion and improper ventilation of the crawl space.

The existing sill or top of railing, has significant rot, therefore we propose a new wood sill be added that has a stronger slope to direct positive drainage away from the building instead of sitting on the flat board and wicking into the end grain of the vertical wood panels (see photo of existing sill condition).

Replace damaged exterior beaded paneling and 1x4 groove paneling that has deteriorated over the last 25+ years from exposure to exterior elements. Paneling will be replaced in kind.

We also propose a new 1x5 board be horizontally installed above new sill, flash in plane with beaded paneling above. This board will proactively prevent water from wicking up the vertical beaded panel end grains and allow for more existing bead board material to be reused.
