City of Madison Landmarks Commission

Project Address: 1014 WILLIAMSON ST. Aldermanic District: 6th

Project Title / Description: REPLACEMENT OF EXISTING WINDOWS ON SECOND AND THIRD FLOOR

Reference: Window Review

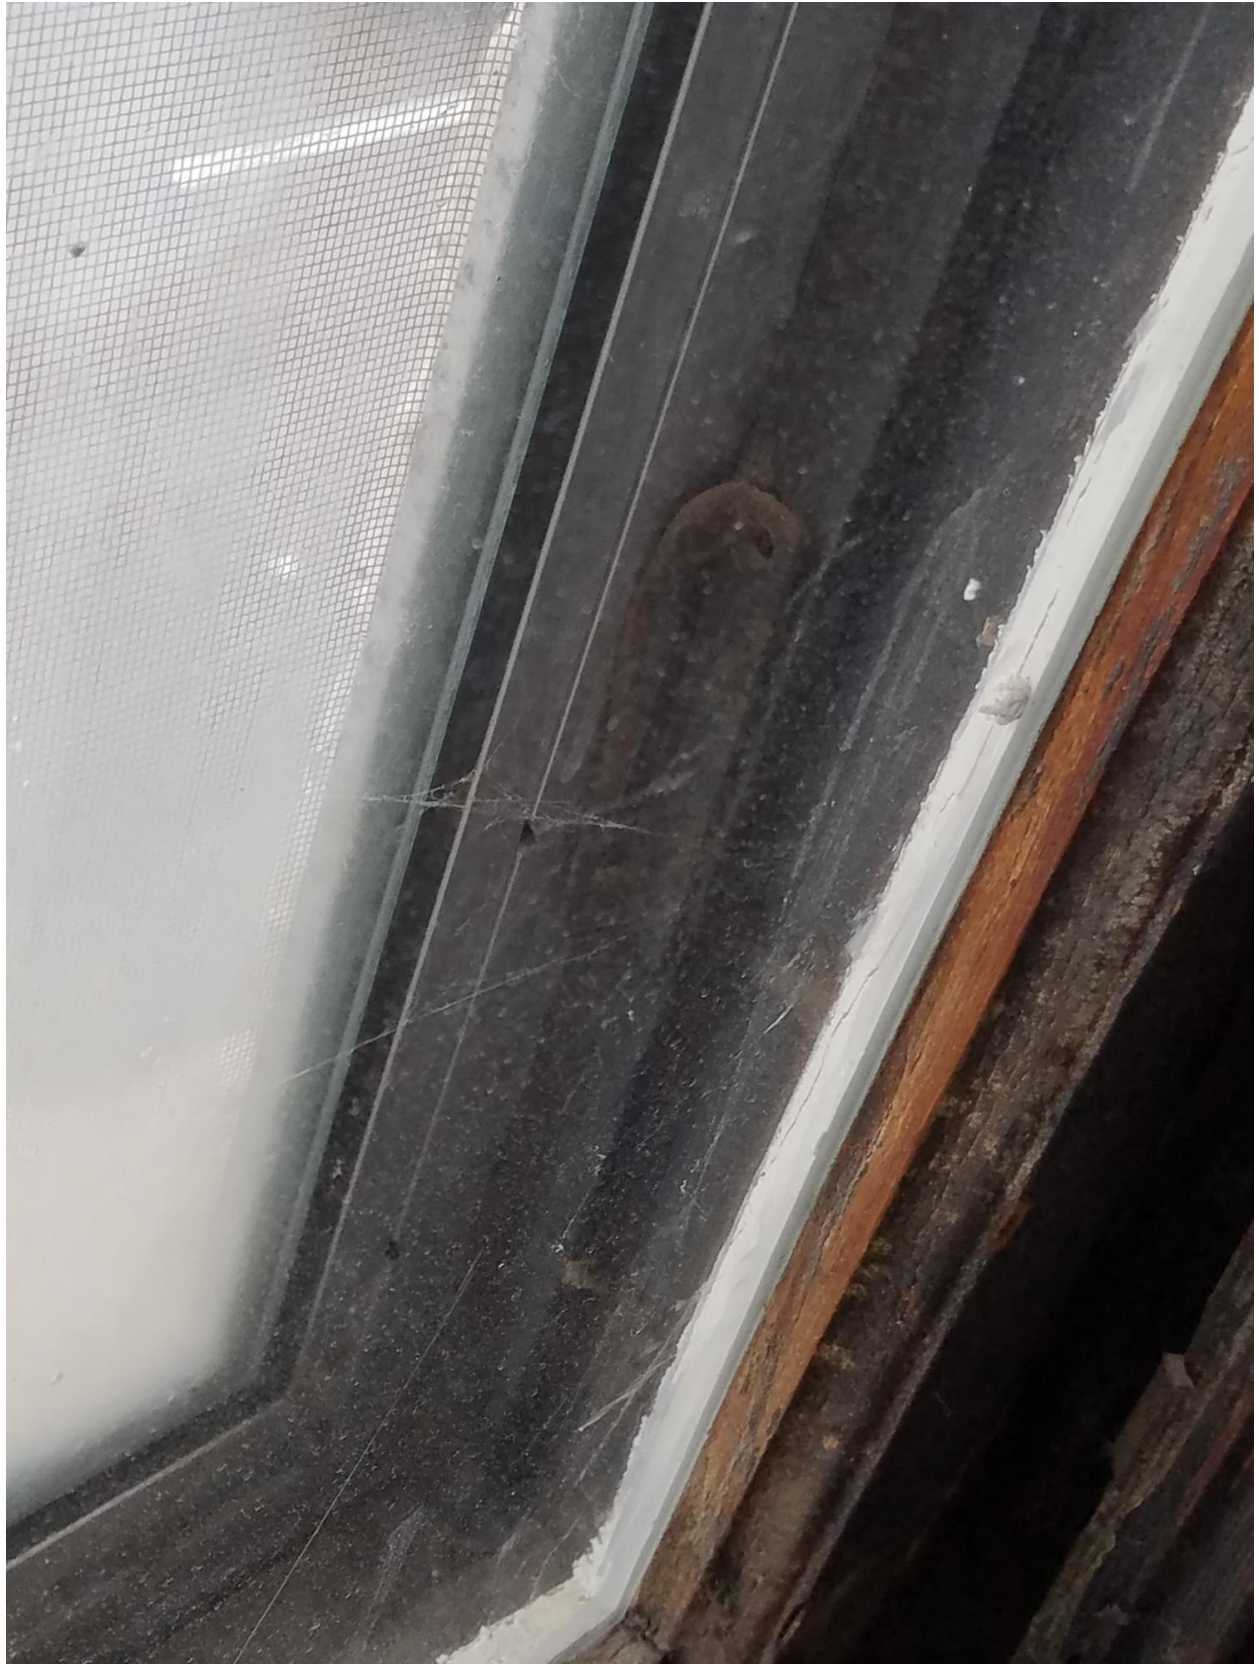
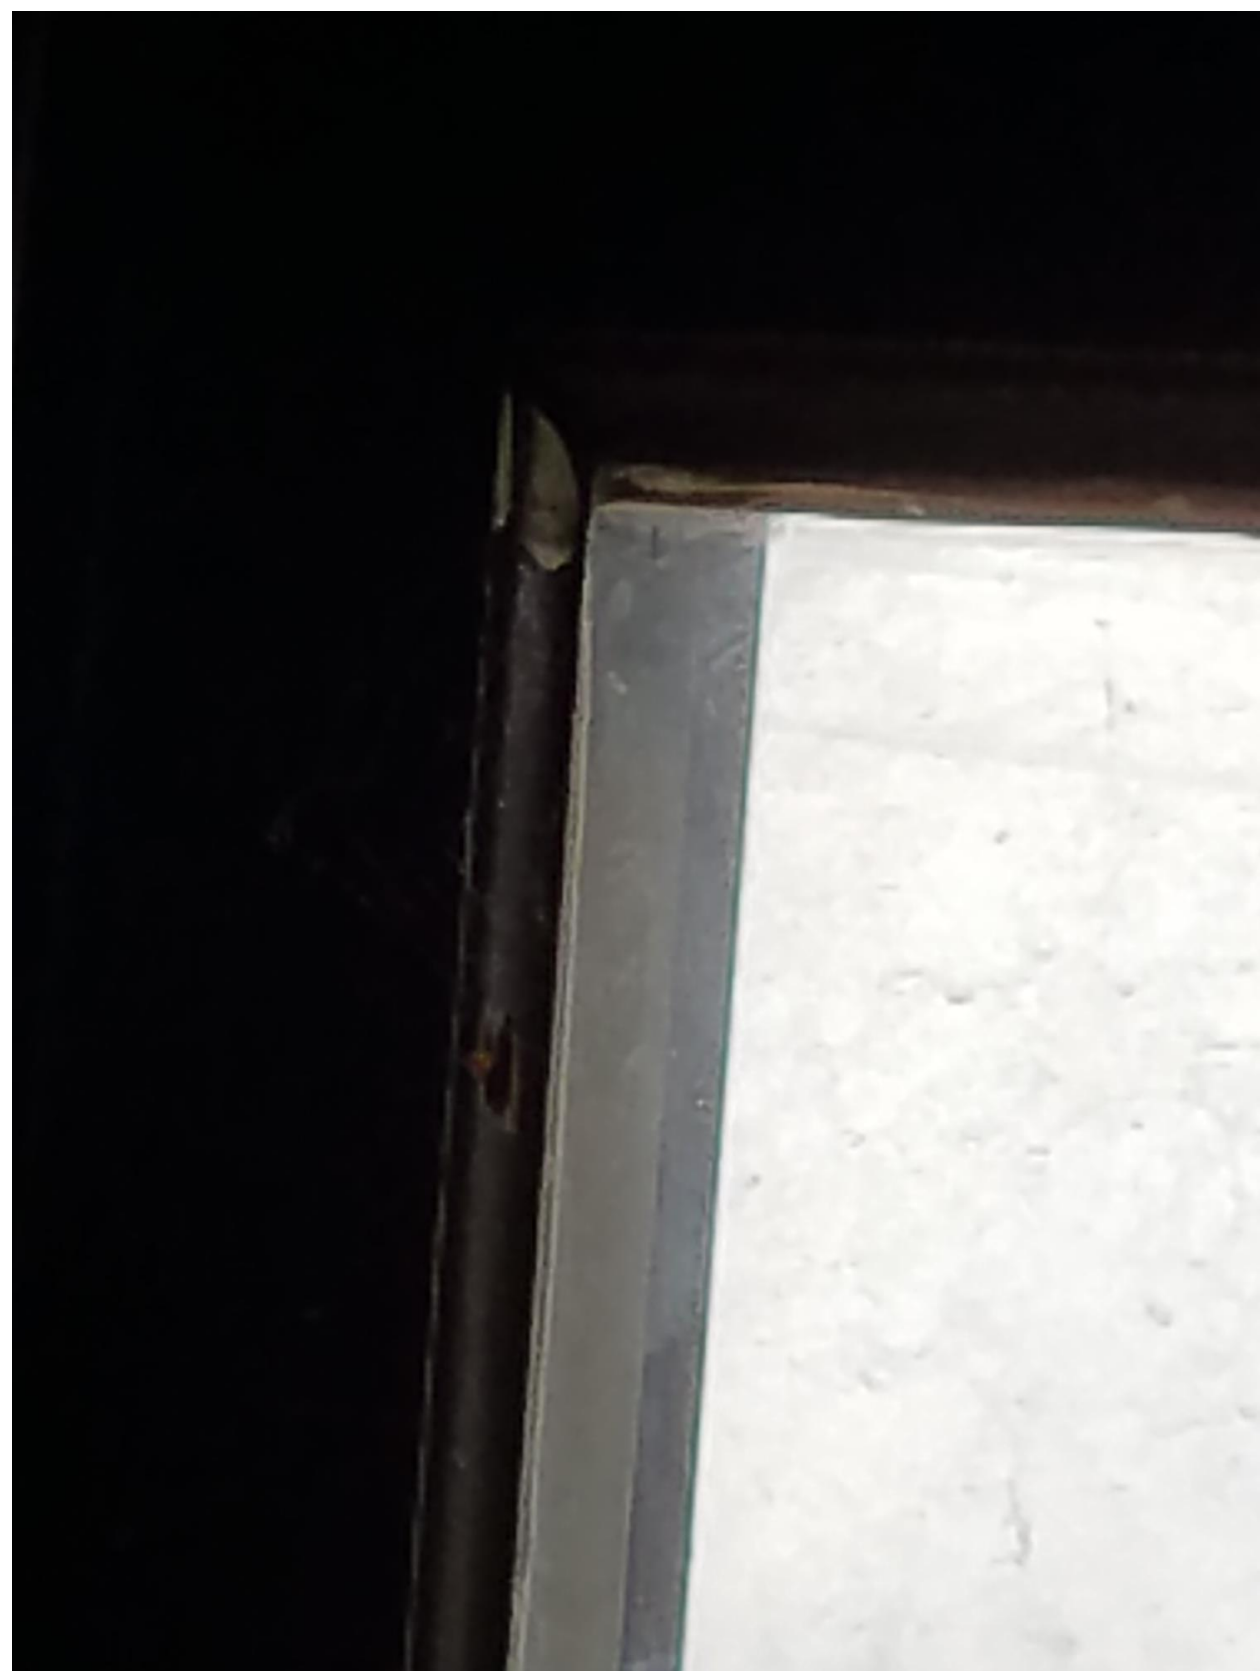
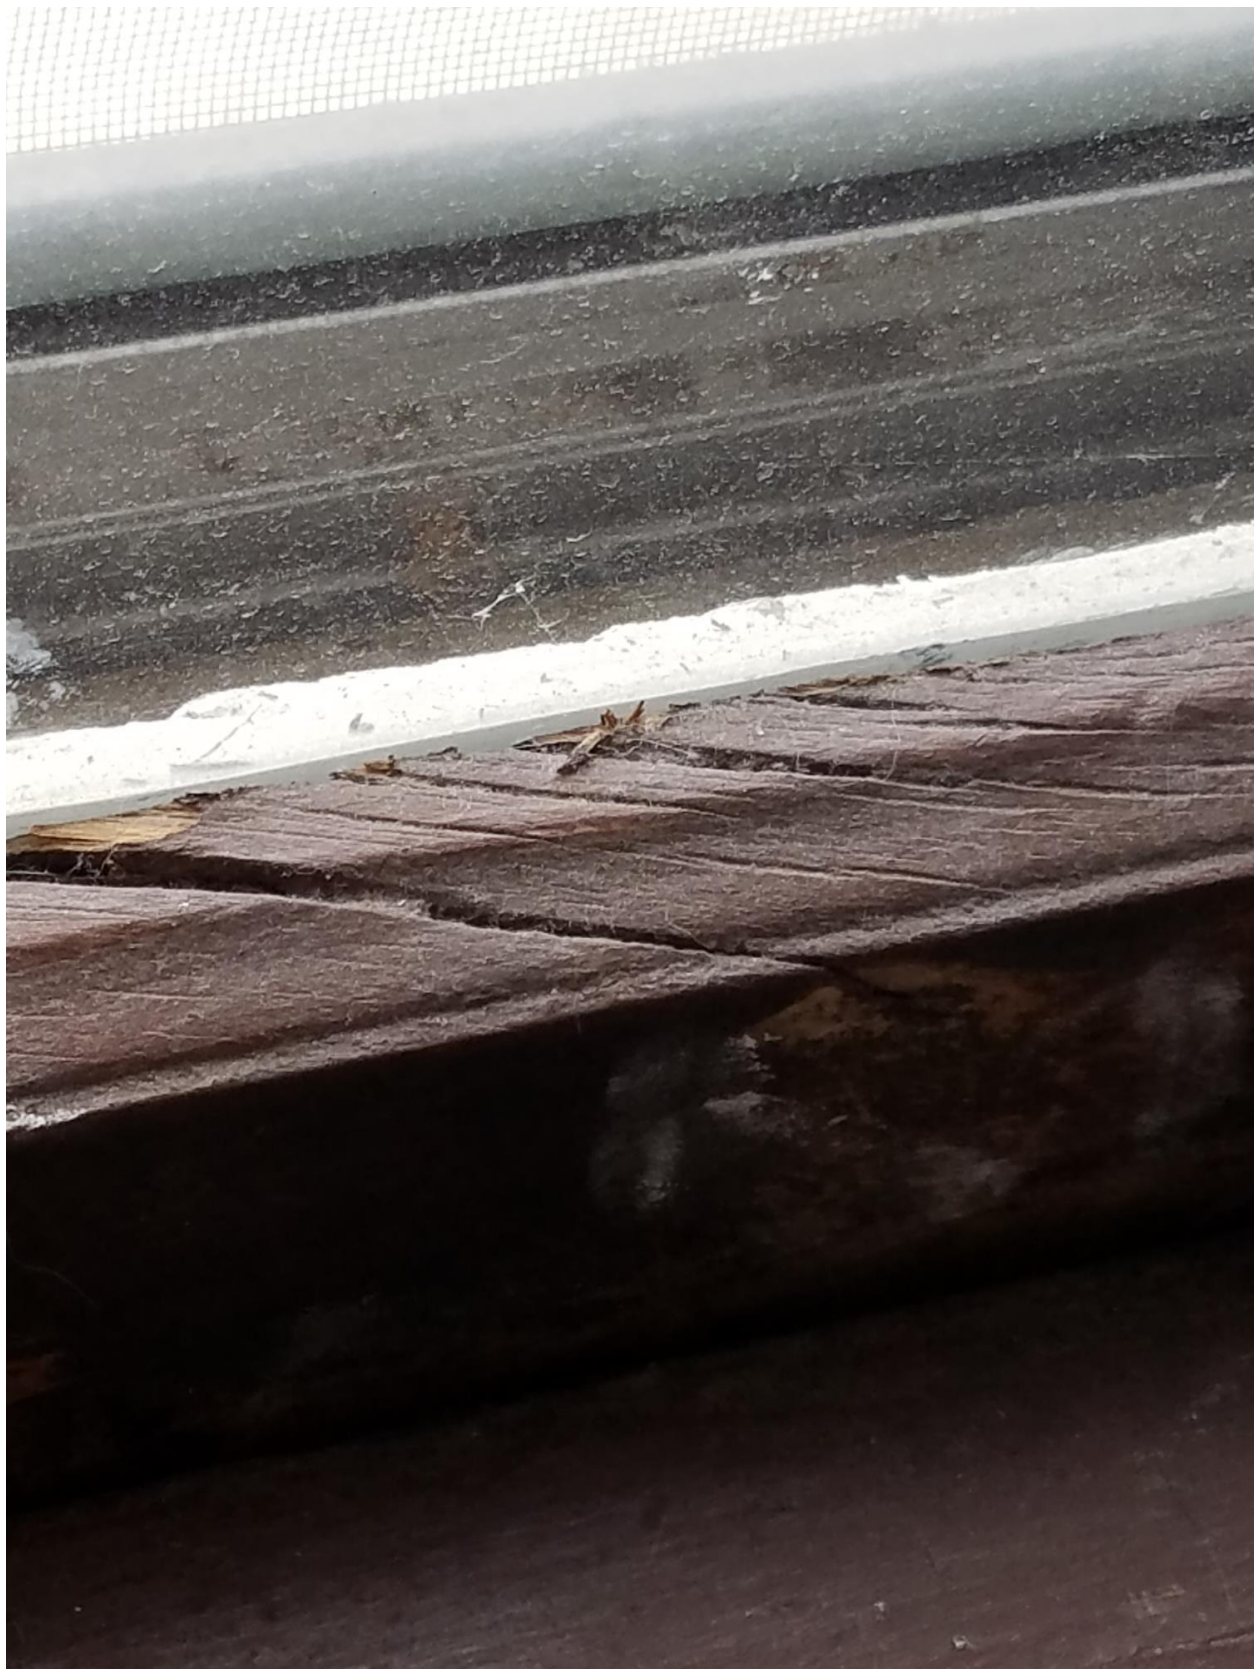
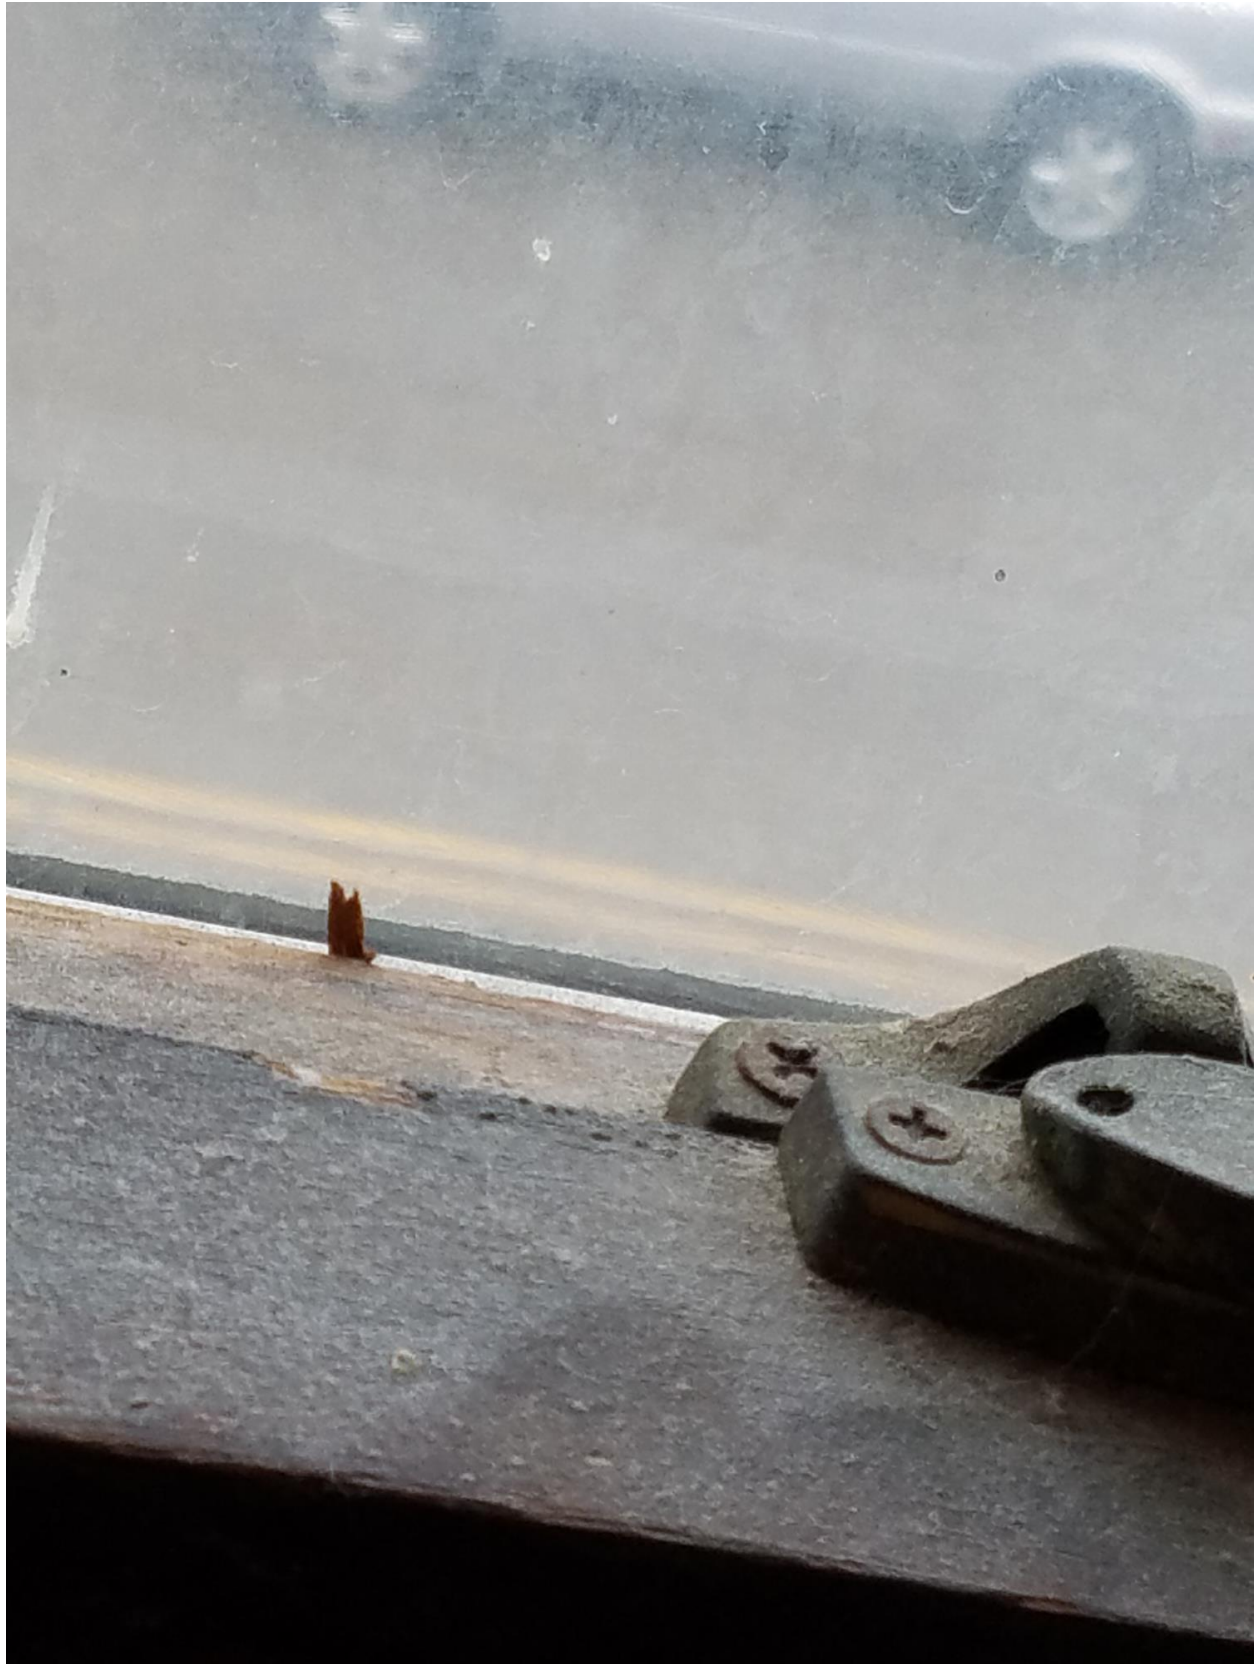
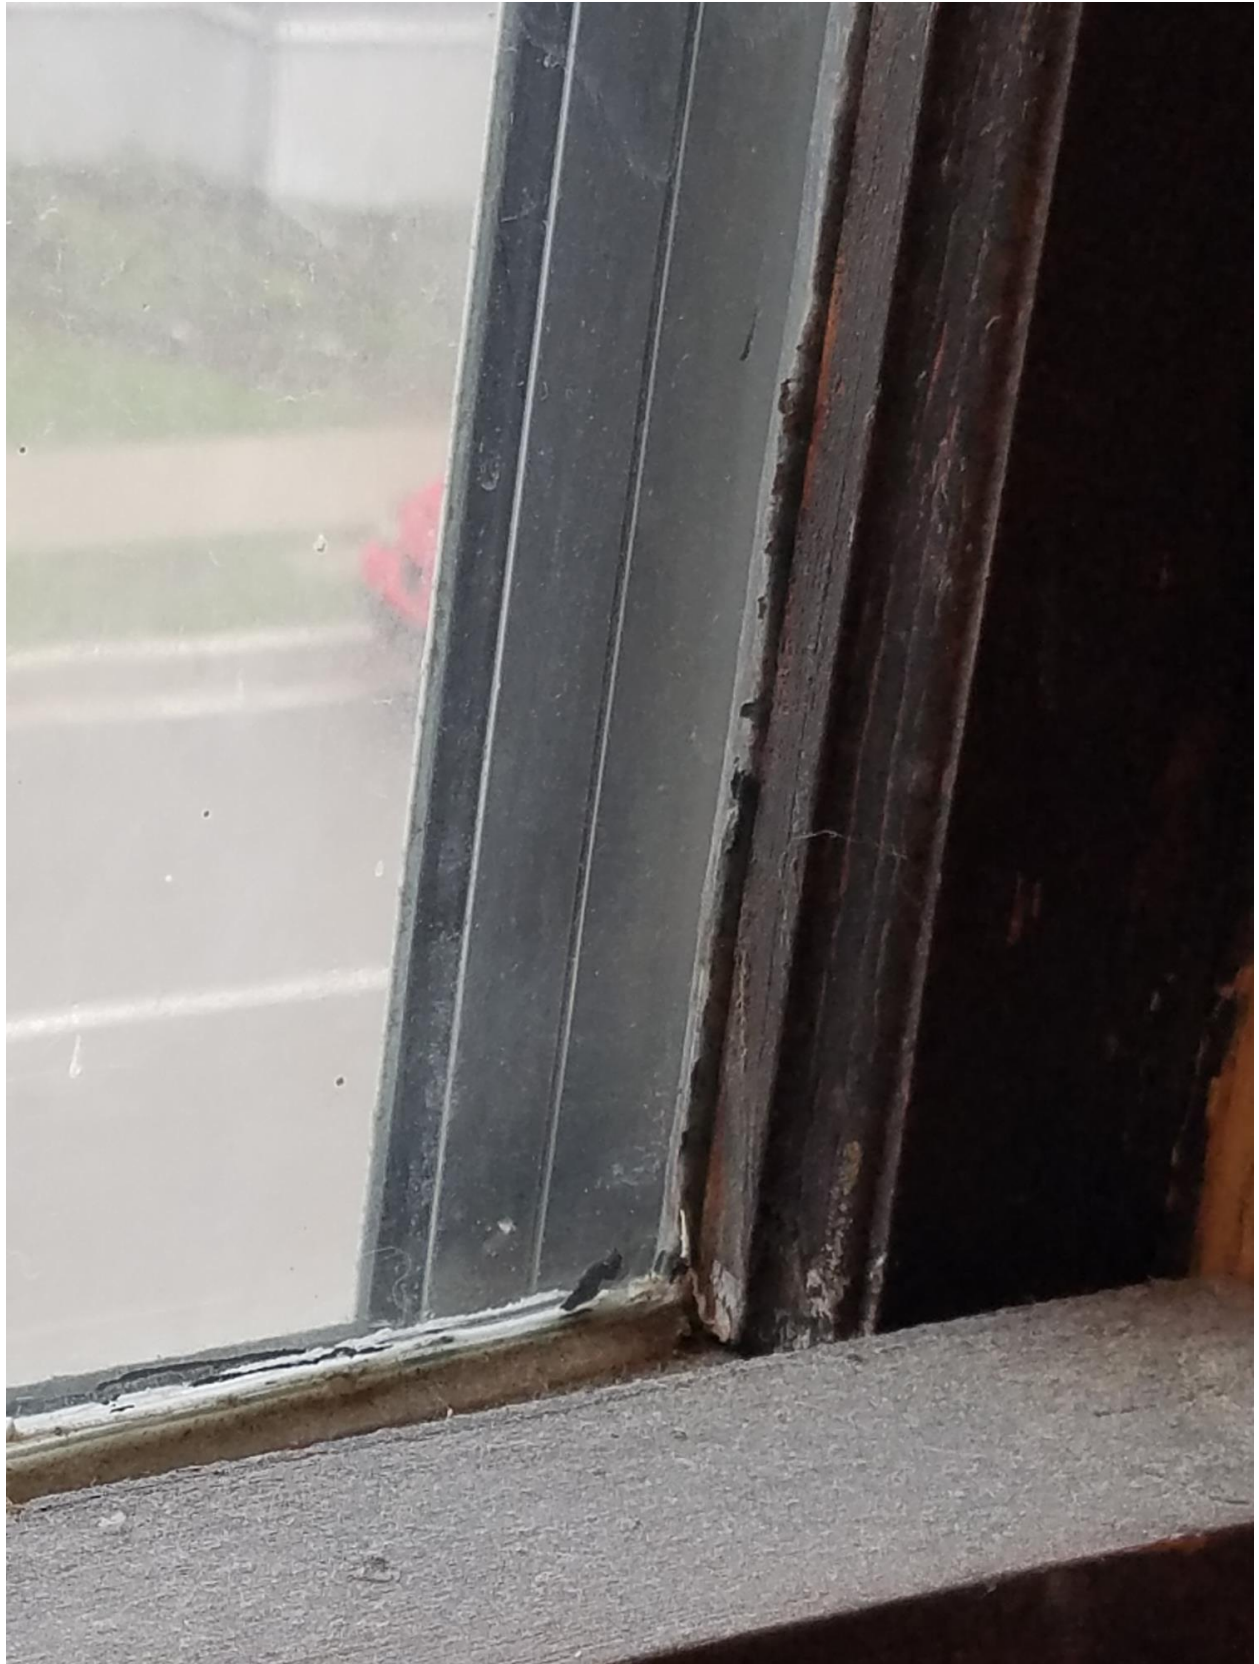
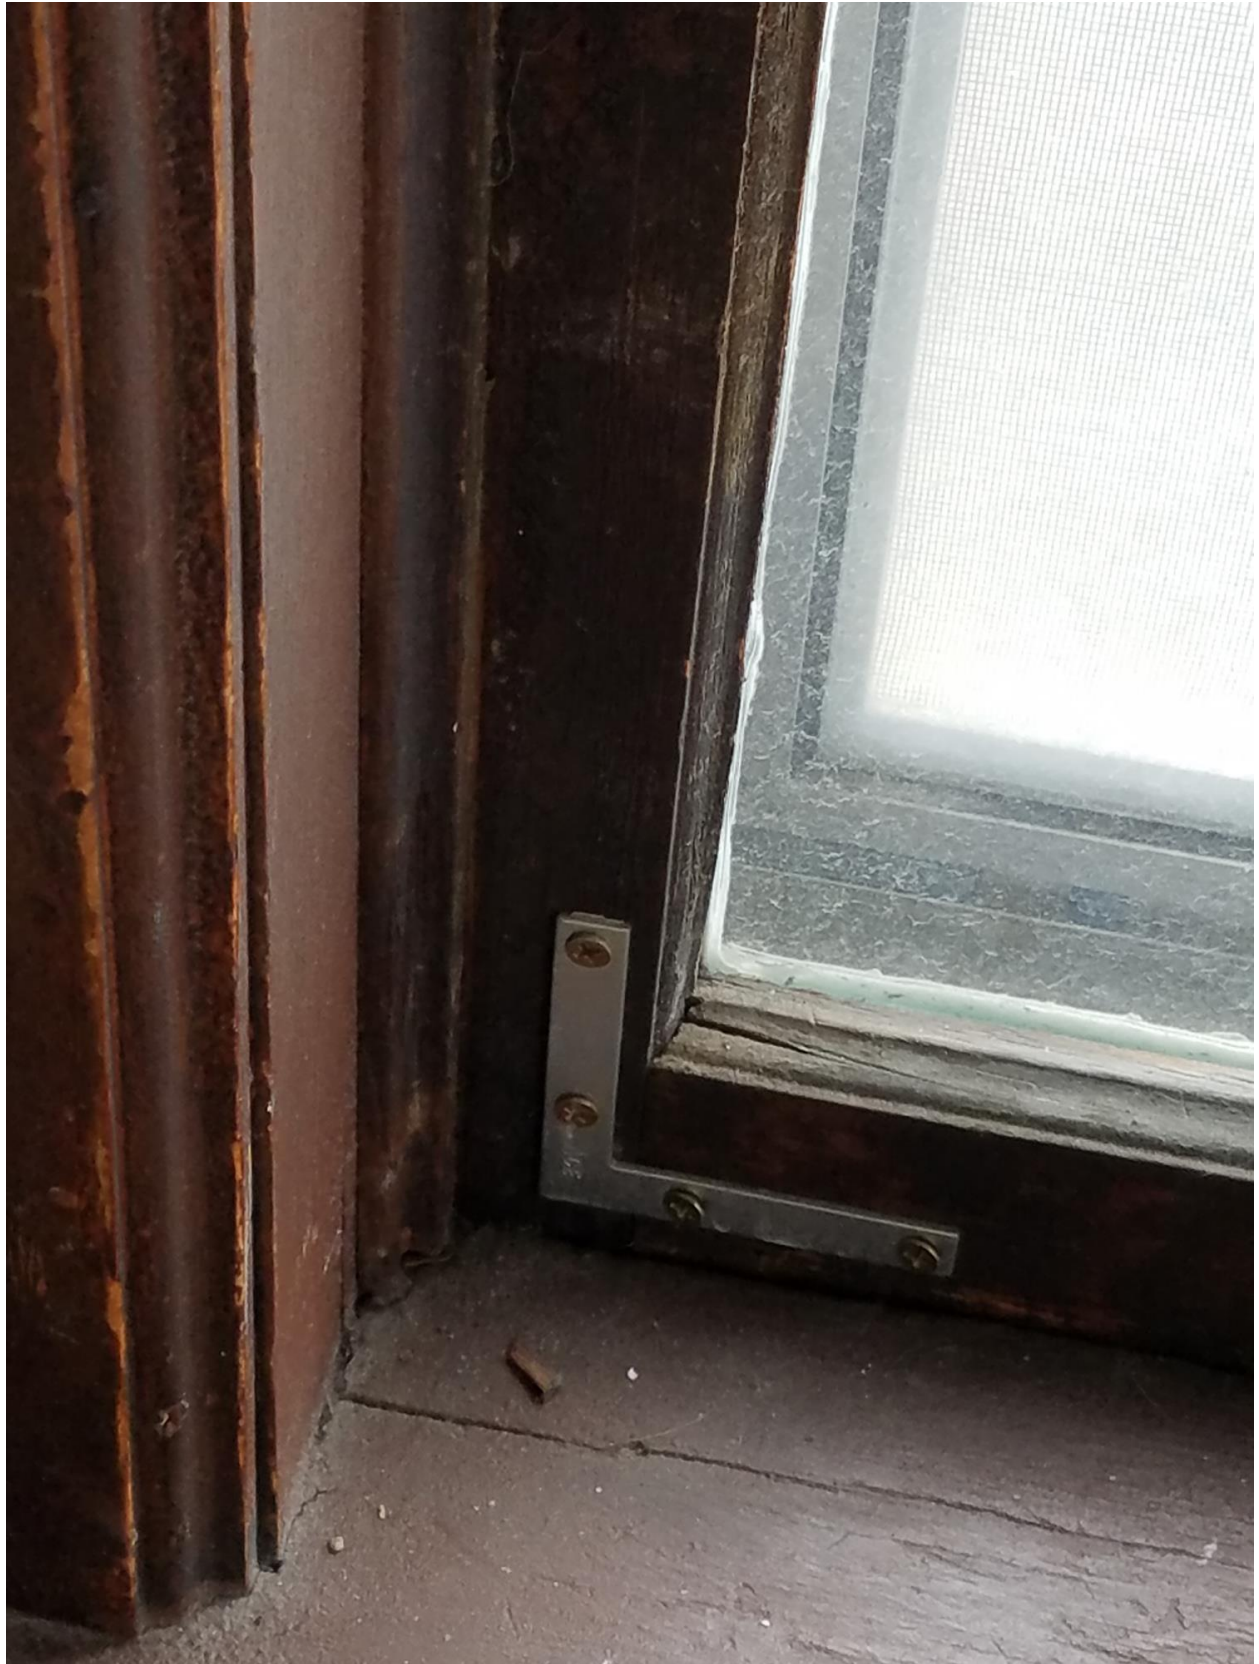
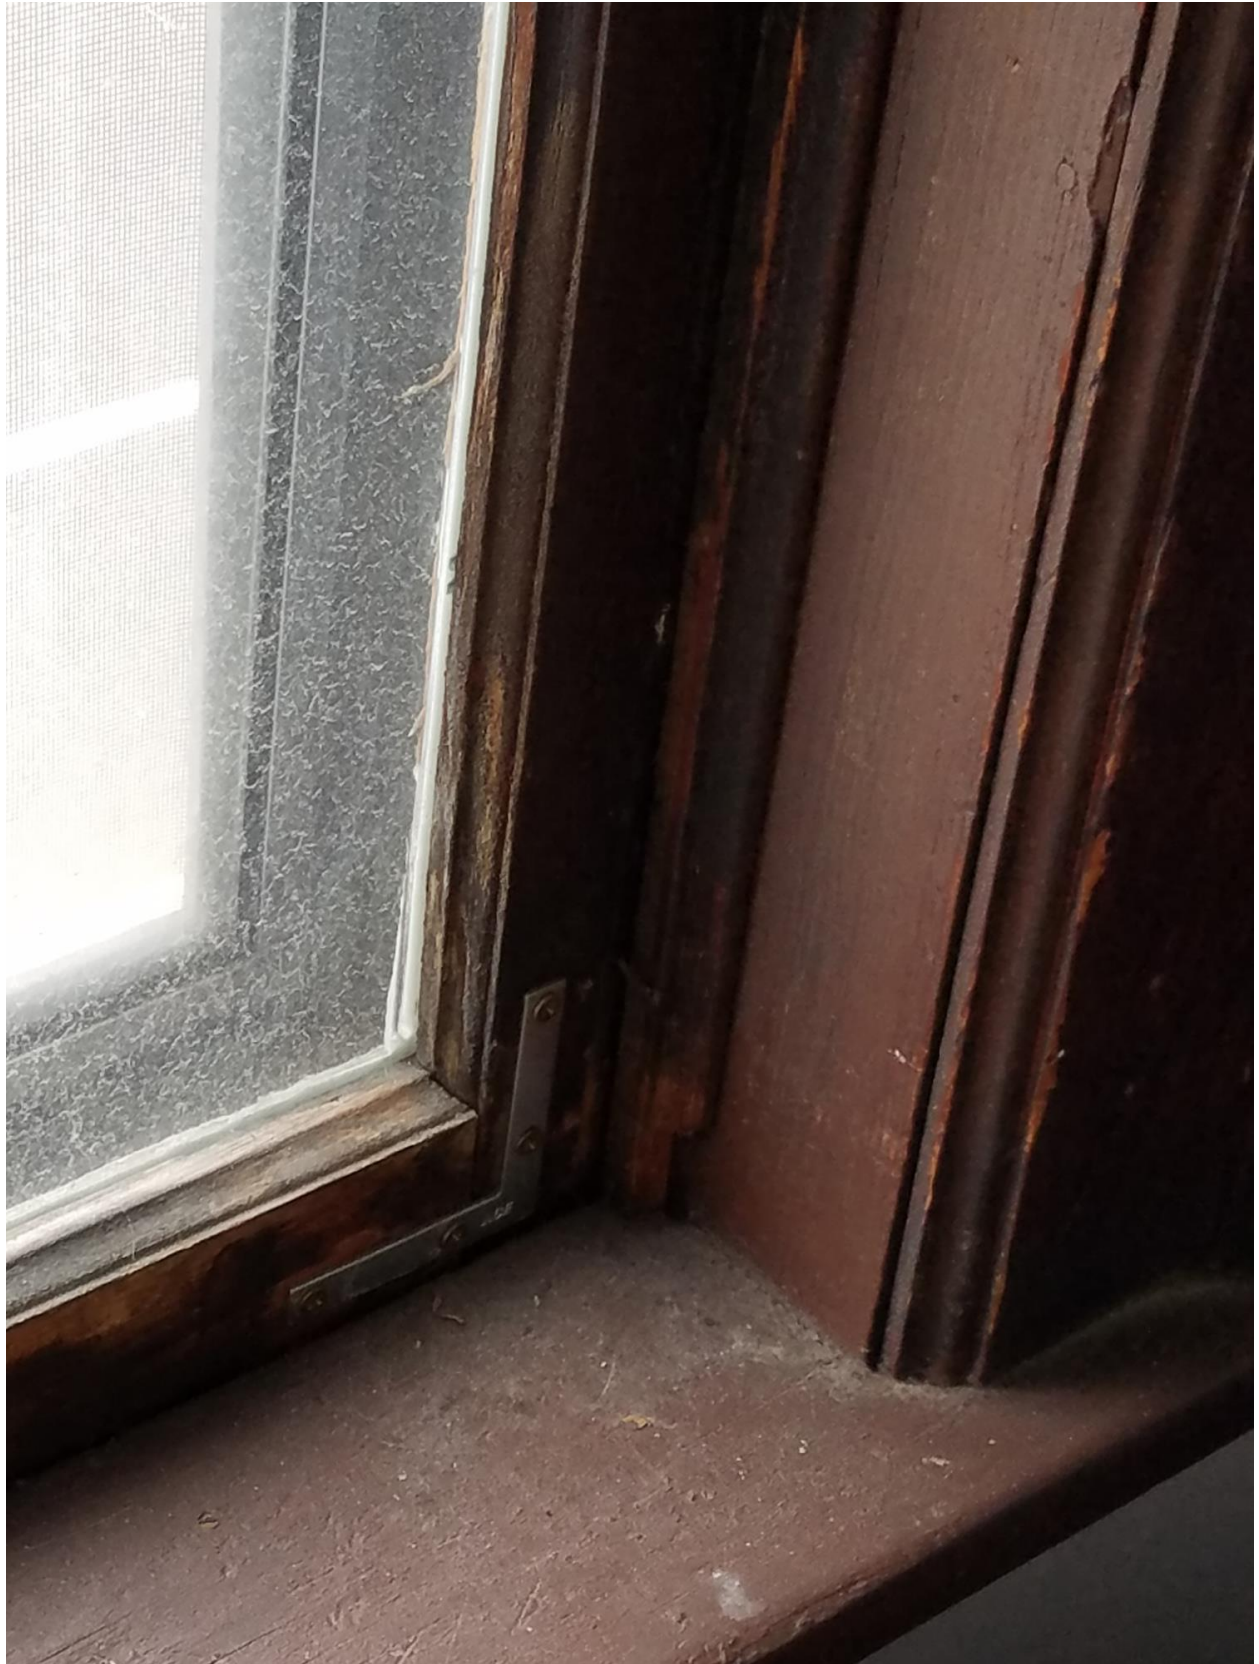
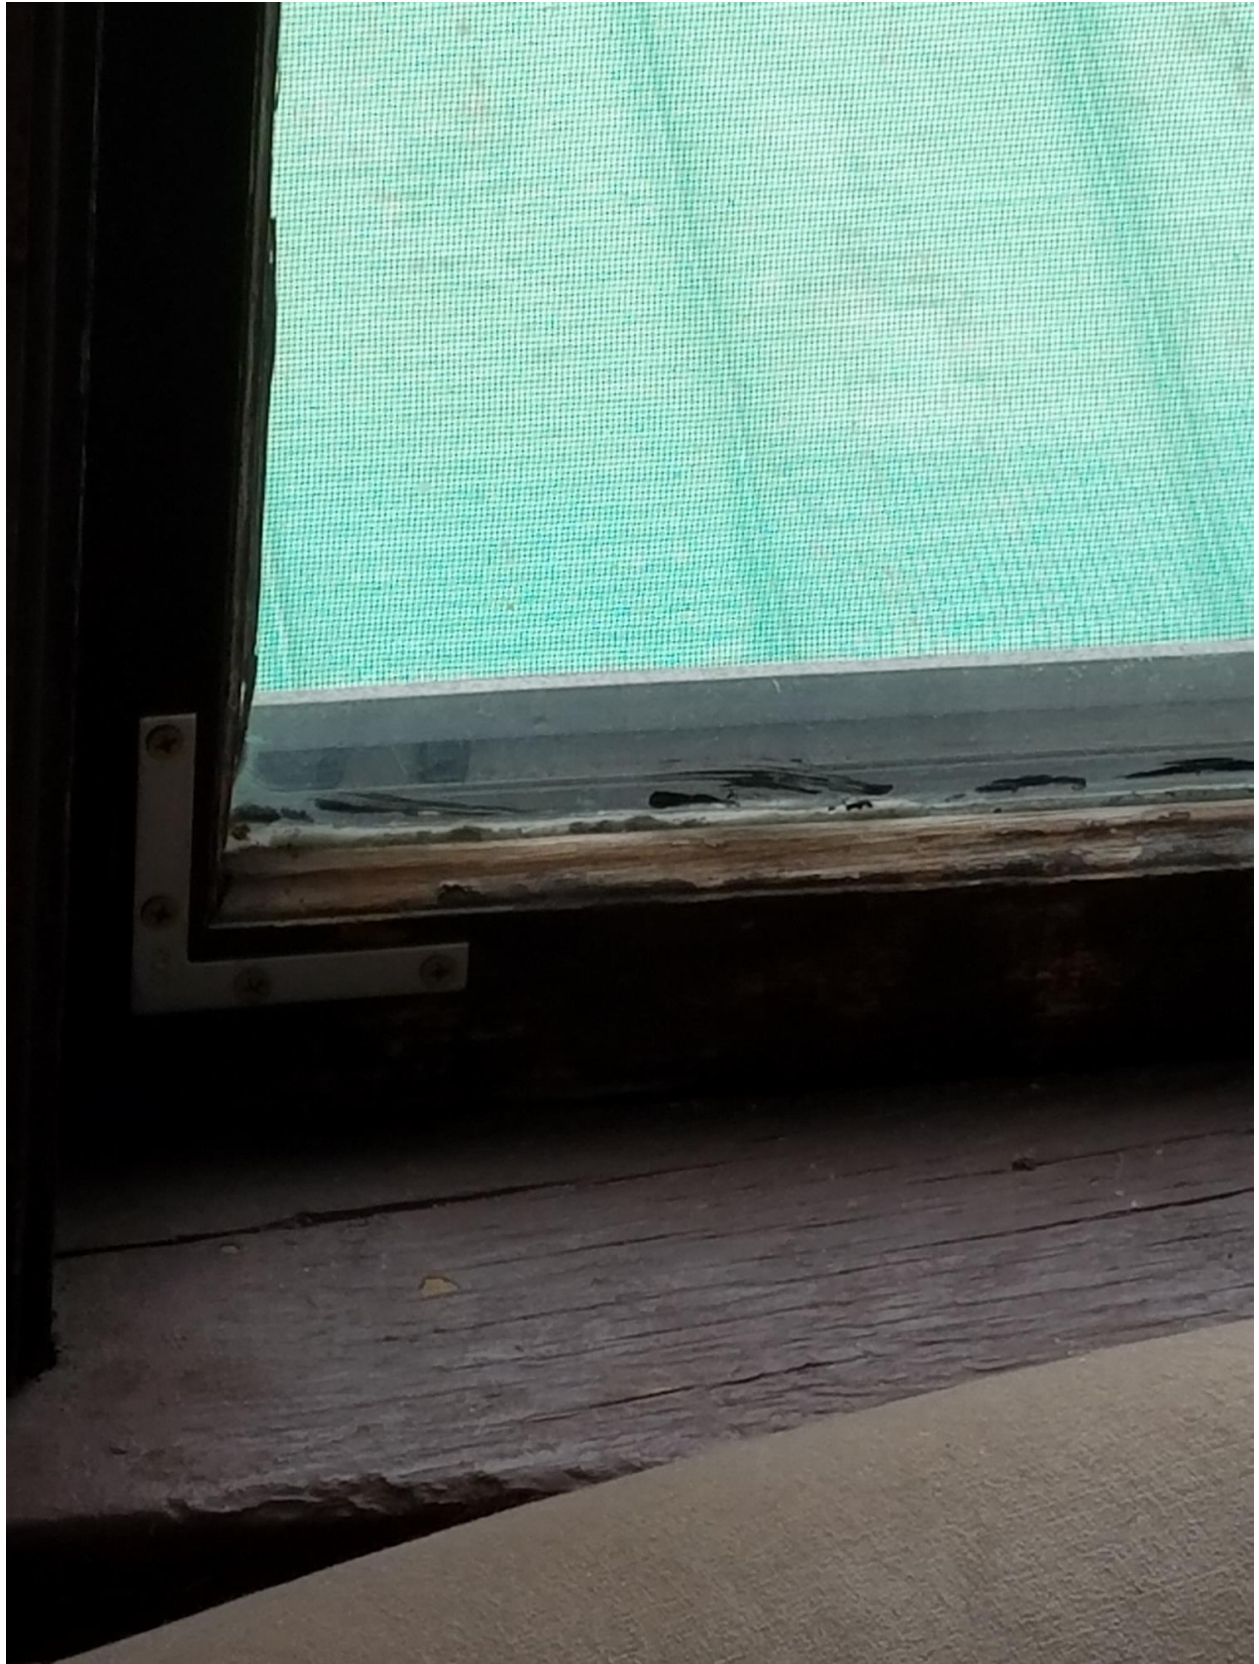
As you will see from my pictures of the interior of the windows, there are plenty of rotted areas as well as areas that have been repaired. Some of the photo's show where weather stripping has been added to keep out the drafts. You will also be able to see in one of the photos that these are the old windows with the rope and weights. There are also several windows with the original glass and sash that we are going to salvage and donate to the Habitat for Humanity ReStore. We will also be saving all of the ropes and weights for donation.

- **Windows on the 2<sup>nd</sup> and 3<sup>rd</sup> floor are badly deteriorated in all aspects.**
  - Exterior brick mold shows extensive wood rot
  - Sashes demonstrate extensive wood rot and stability issues. The sashes structural condition is severe
  - Both exterior and interior finish conditions are poor
  - Hardware is in poor condition or missing
  - Weather stripping in the original form does not exist on the windows
  - Storm window have been added to the exterior (aluminum)
  - Weights, pulley hardware should all be saved or donated to historic related businesses
  - Glass has been replaced in the majority of window openings. The few remaining sashes with original glass should be saved or donated to historic related businesses

- **The conditions of the current windows lead me to recommend replacement.**
  - Repair is not an option for any of the windows
  - Benefit of replacement is the exterior window view will be very similar to the original windows.
  - Additional benefits include energy efficiency, exterior color retention, and historic appearance on the interior with similar locking hardware.
