**RE: LAKE PARK APARTMENT HOMES
DEMOLITION ASSESSMENT
451 W. WILSON AND 315 S. BASSETT**

EXHIBIT A

**Photos of Buildings to Demo
Building A - 315 S Bassett Street**

EXHIBIT B

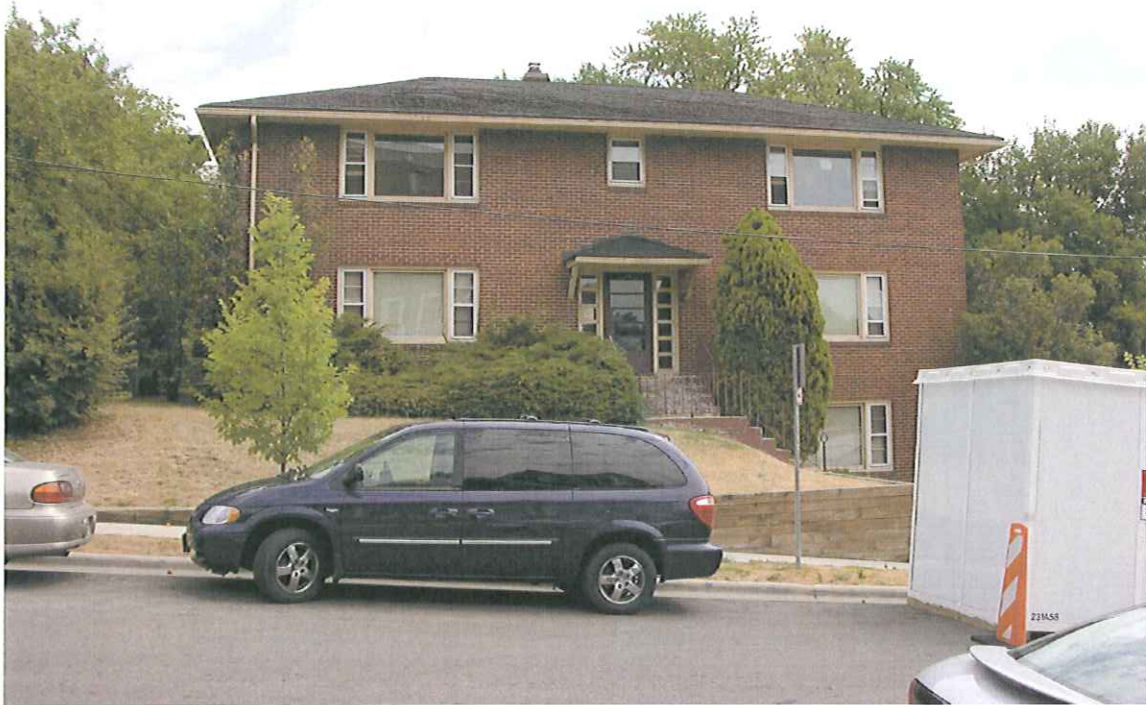
315 S. Bassett St.

This building was originally built in 1954. It is a 2-story brick structure with walk-out basement and contains five identical 1-bedroom apartments. There is a central stairway with two apartments on each floor. The basement level is split into two halves – one side containing utility/mechanical and storage space and the other a basement apartment that walks out to the exterior. There are wood decks off the back side of the building for the four upper apartments.

The four upper apartments have wood floors in the bedroom and living area and vinyl flooring in the kitchen and bathroom. There is insufficient storage – only one closet in each unit. The kitchens are in poor condition and have the original cabinets and countertops which were not of high quality when originally installed. Each kitchen has a refrigerator and an 18-inch range – there is no dishwasher in any of the units. The bathrooms contain original plumbing fixtures for the most part, and do not have ventilation fans. There is also typically significant rot around the bathtub. The HVAC system is a baseboard radiant hot water system with no air conditioning. There is minimal sound separation between units.

The building itself is in need of a new roof and the wood decks have reached the end of their useful life and are rotting and in need replacement. The parking lot is asphalt and needs to be replaced (especially after this winter). There is a retaining wall along the railroad corridor property line and it is listing at about 15 degrees – there are concerns that it could fail in the near future. There is also a timber retaining wall along the sidewalk that should also be replaced in the near future – it is showing some signs of bulging and rot. The building is not very energy efficient and probably lacks adequate insulation. Storm windows were added to some of the windows but the large “picture windows” in each unit are just single panes of glass. The front stoop is a concrete structure and needs constant caulking to prevent water infiltration into the basement apartment (which has flooded twice due to this defect).

In general, this building is need of substantial repairs and would require significant remodeling to get it into a marketable condition.

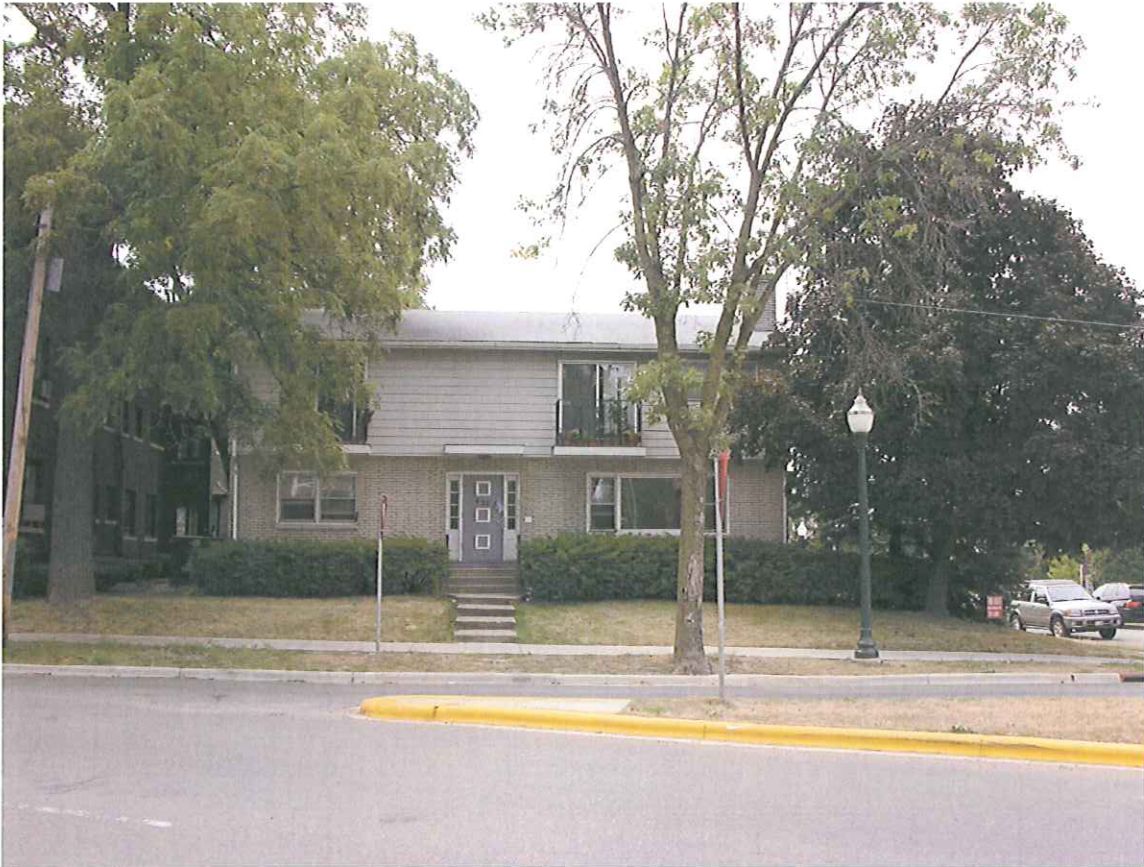
451 W. Wilson St.

This building was originally built in 1962. It is a 2-story brick/aluminum siding structure with an attached two-car garage. It contains a large 4 bedroom flat on the first floor and three 1-bedroom apartments upstairs. The basement is split into a mechanical/storage/utility area and the other part is connected to the first floor flat. A three season porch was added above the garage and is connected to the first floor apartment.

The apartments have multiple flooring products – all in very poor shape. There is insufficient storage. The kitchens are in poor condition and have the original cabinets and countertops which were not of high quality when originally installed. Typically, each kitchen has a refrigerator and an 18-inch range – there is no hood fan or dishwasher in any of the units. The bathrooms are in very poor shape. The HVAC system for the upper three apartments is a baseboard radiant hot water system with thru-wall air conditioning units. The first floor apartment has a forced air system. There is minimal sound separation between units.

The building itself is in need of a new roof. The three season porch is in very poor condition and the small projected balconies on upper floor facing Wilson Street are also in poor condition. There is a small parking lot and its asphalt is in poor condition. The building is not very energy efficient and probably lacks adequate insulation.

In general, this building is need of substantial repairs and would require significant remodeling to get it into a marketable condition.
