## REZONE REQUEST

**6101 Mineral Point**  
DEMOLITION APPLICATION  
University of Wisconsin-Madison Facilities Planning & Management  
P:\MAJOR\PROJECTS-ACTIVE\Vet Med Expansion - 18H2H\Building Removal\5707 MineralPointRd

## BUILDING DEMOLITION REQUEST FORM

Name Charmany – Vet Diagnostic Lab 0677 Institution Madison Campus, CALS  
 (Identification of Structure) (Bldg No.)  
 Location Charmany/Vet Med, 5801 Mineral Point Rd, Madison, Request Date: 07/17/2020  
WI 53705  
 (Address)

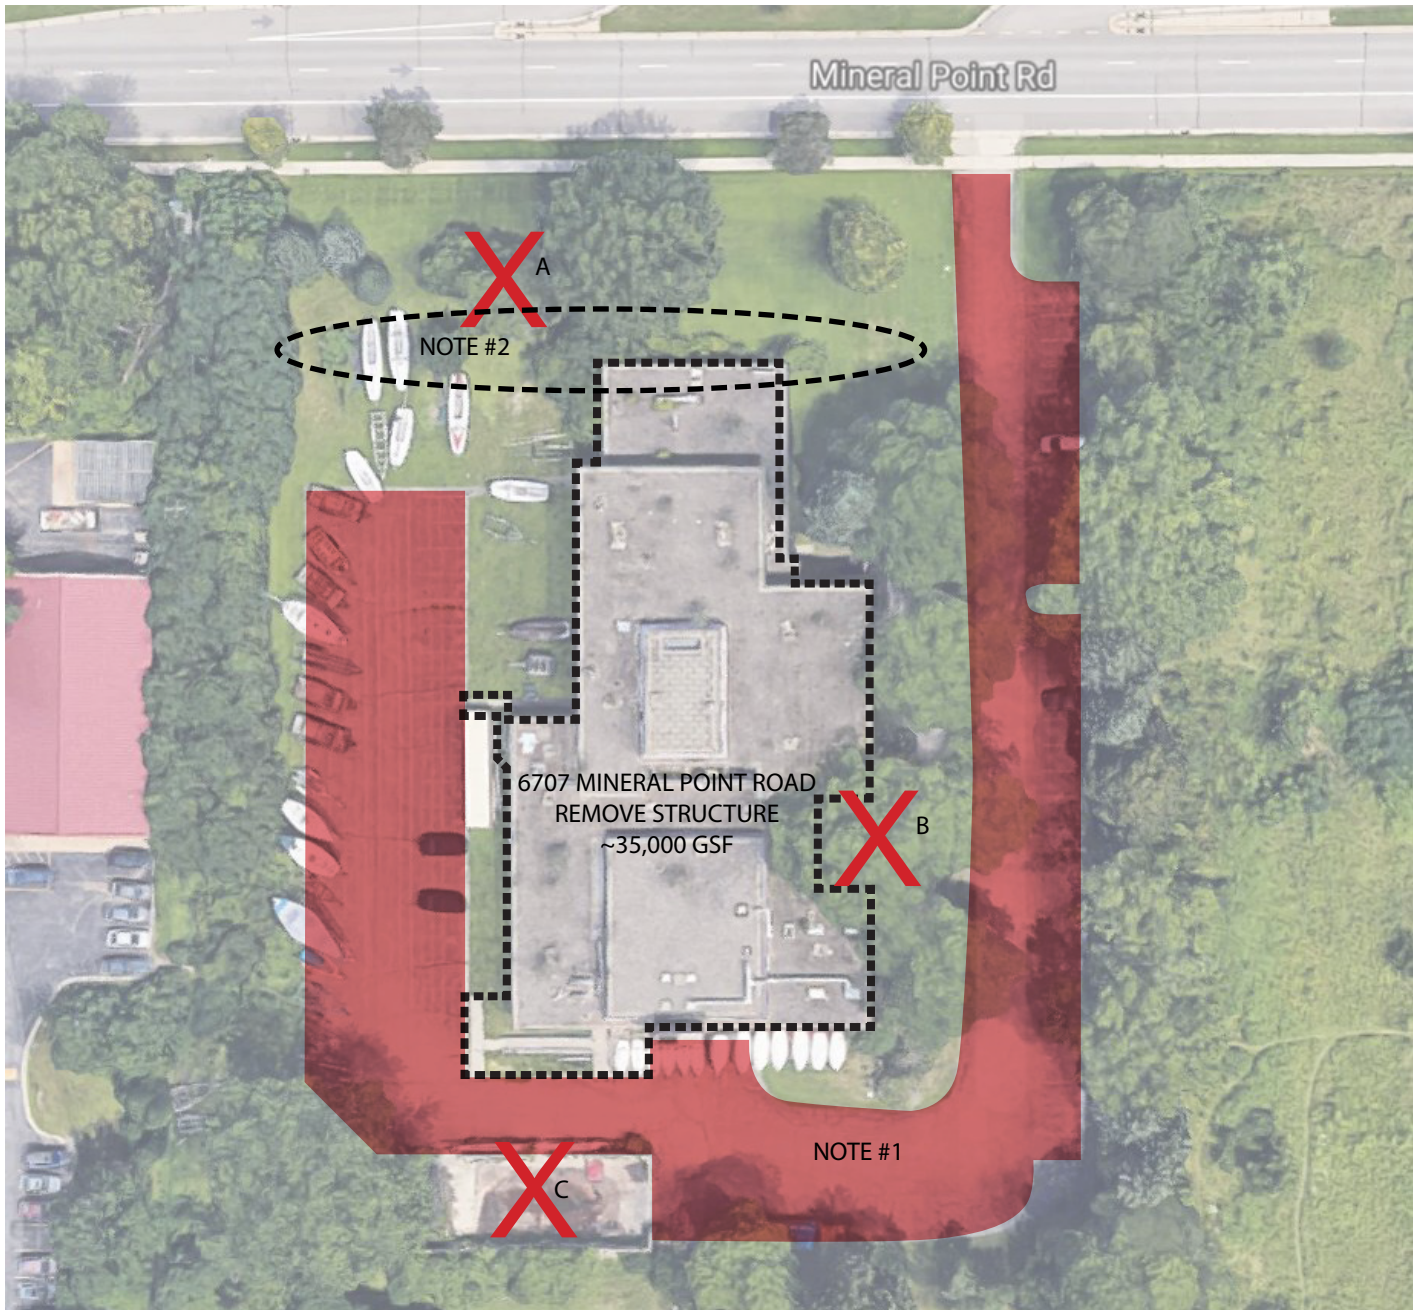
## SITE PLAN

NOTE #3:  
Remove decling ash (A), honeylocust close to building (B), walled open-air trash area (C)

NOTE #1:  
Mill and overlay existing asphalt parking lot. Retain parking in temporary near term condition until relocation is available.

NOTE #2:  
Add evergreen screening vegetation.
