5707 Mineral Point DEMOLITION APPLICATION

University of Wisconsin-Madison Facilities Planning & Management
P:\MAJOR\PROJECTS\ACTIVE\Vet Med Expansion - 18H2H\Building Removal\5707 MineralPointRd

BUILDING DEMOLITION REQUEST FORM

Name Charmany – House 0656 Institution Madison Campus, CALS
 (Identification of Structure) (Bldg No.)
 Location Charmany/Vet Med, 5801 Mineral Point Rd, Madison, Request Date: 07/17/2020
WI 53705
 (Address)

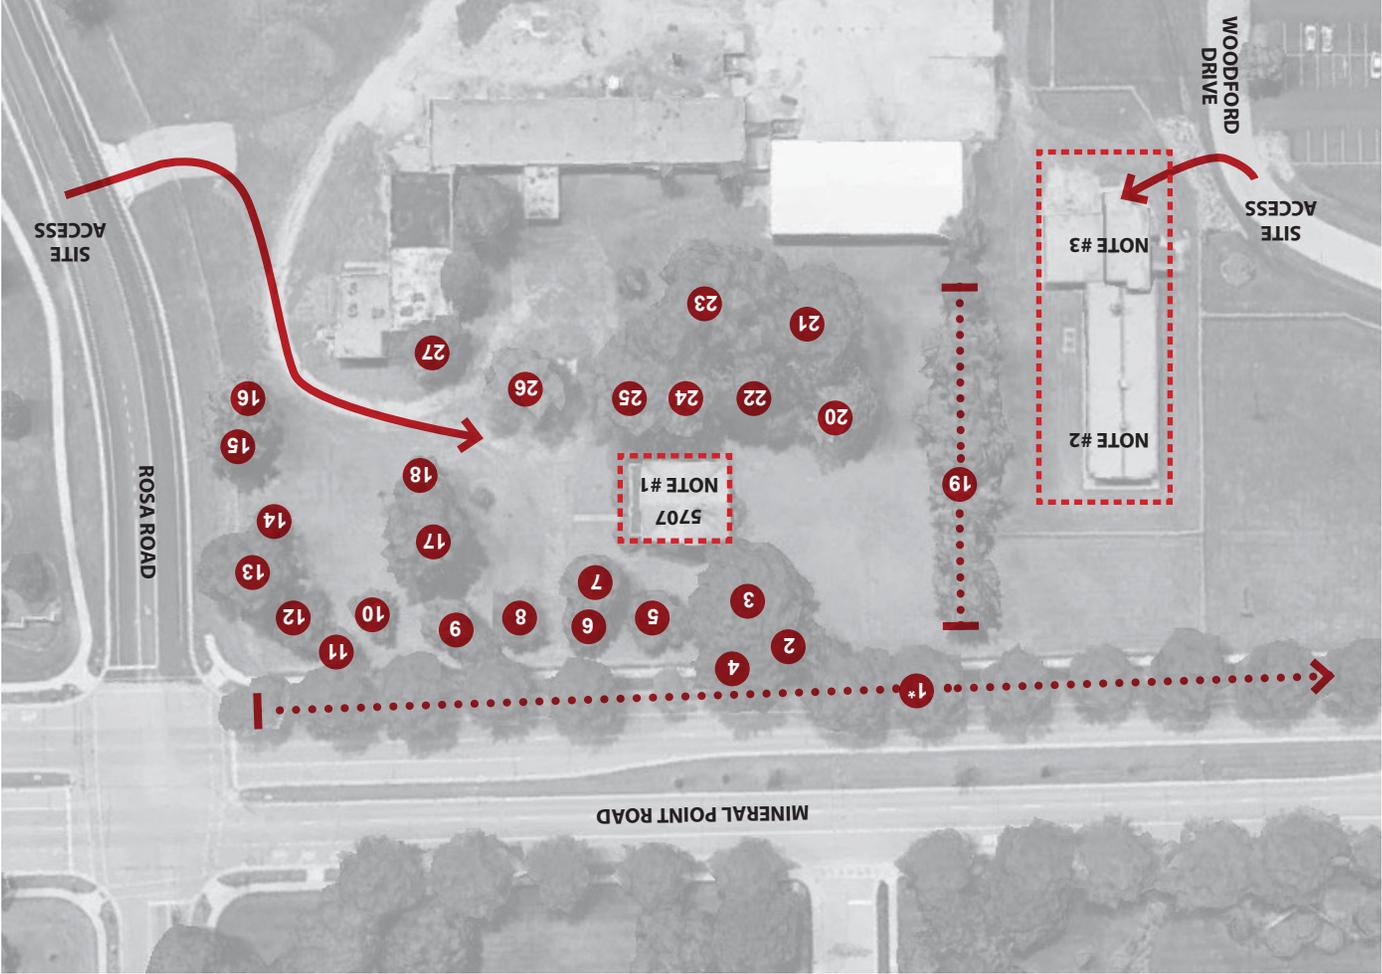
NOTE #1
5707 Mineral Point Road
School of Veterinary Medicine (SVM) Charmany House
Structure to be removed
Access via Rosa Road through gate

NOTE #2
5707 Mineral Point Road
School of Veterinary Medicine (SVM) Storage Building 1
Structure to be removed
Access via Woodford Drive (Charmany Instructional Facility)

NOTE #3
5707 Mineral Point Road
School of Veterinary Medicine (SVM) Storage Building 2
Structure to be removed
Access via Woodford Drive (Charmany Instructional Facility)
