Version/Date: LAND USE PHOTOS 180316 04.09.18 Printed by: m.t. ADDITION / REMODEL WRIGHTS Page Size: <u>11 × 17</u>

2 of 9

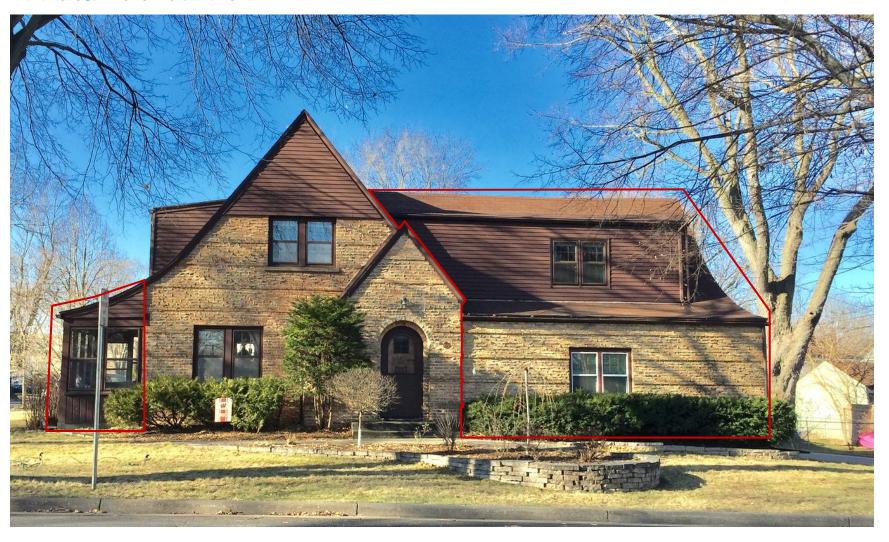
1980'S (?) ERA ADDITON TO BE REMOVED - INCLUDES GARAGE AND MASTER SUITE TINY ENCLOSED PORCH TO BE REMOVED

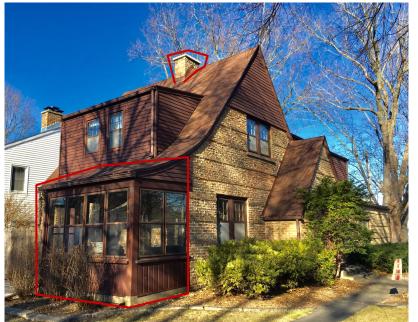
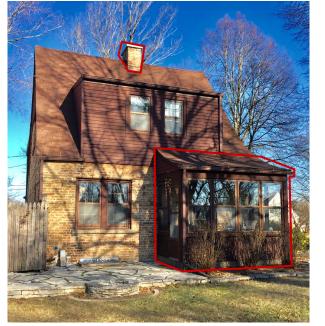
TINY ENCLOSED PORCH & CHIMNEY TO BE REMOVED

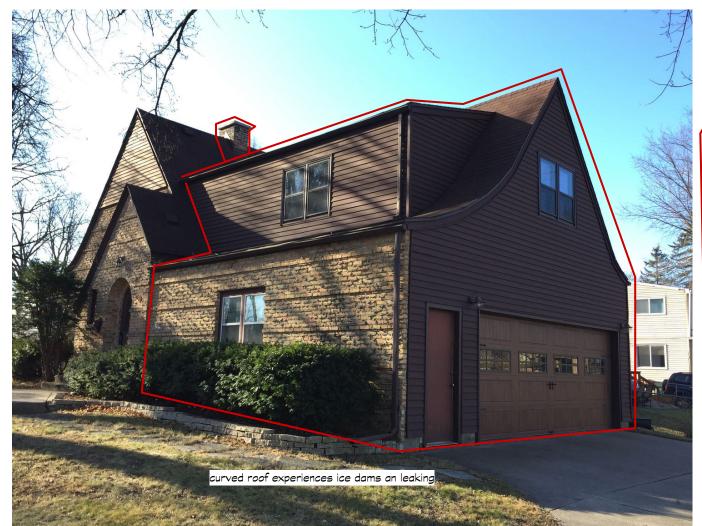
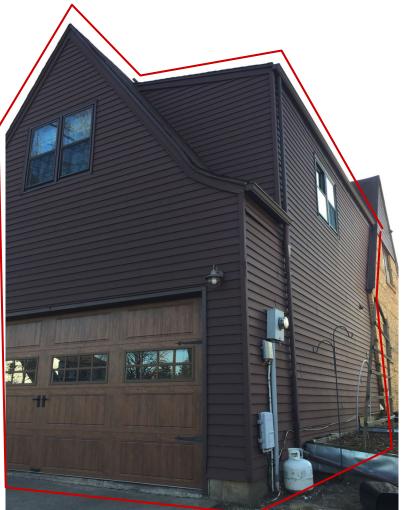
1980'S (?) ERA ADDITON TO BE REMOVED - INCLUDES GARAGE AND MASTER SUITE

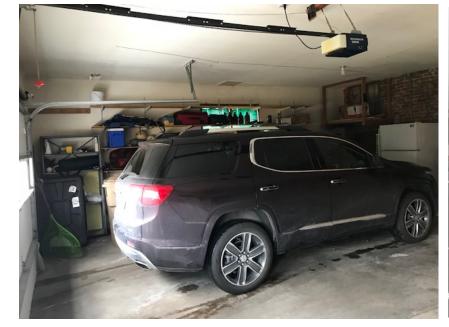
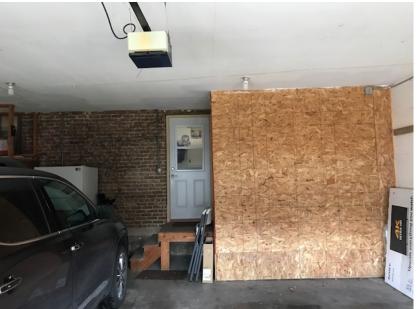
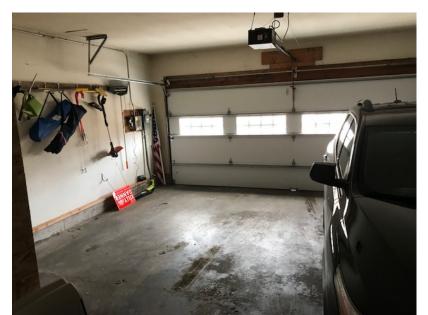
GARAGE INTERIOR

steps up form garage to house is challenging for everyday living

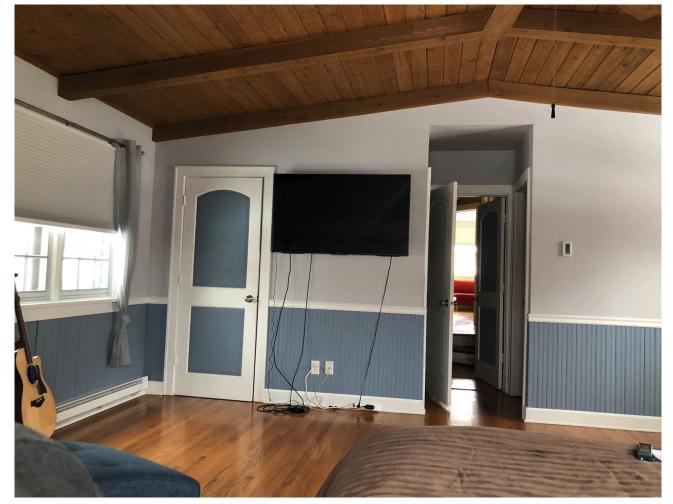
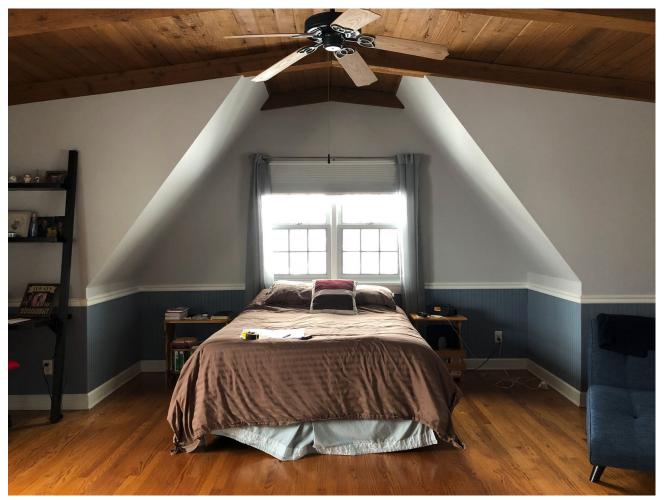
MASTER SUITE INTERIOR

(electric baseboard heat, no AC, insufficient insulation to garage below, awkward and unsafe transition off staircase winder treads)

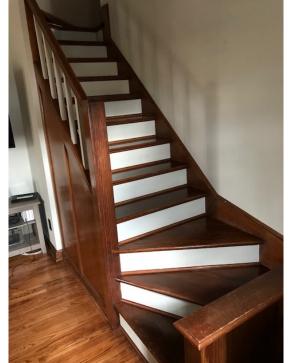
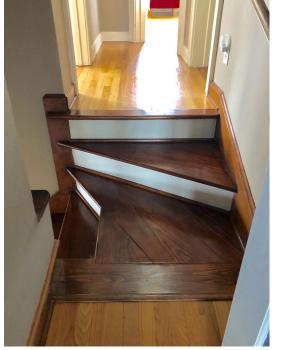
THE WAY IN WHICH THE 1980'S ERA ADDITON WAS ADDED TO THE HOUSE CREATED AN UNSAFE CONDITION AT THE EXISTING WINDER OF THE STAIRCASE
