Madison Landmarks Commission APPLICATION

Project Address: 1124 Spaight Street Aldermanic District: 6

Project Title / Description: Repair/Replace front proch

May 20, 2014

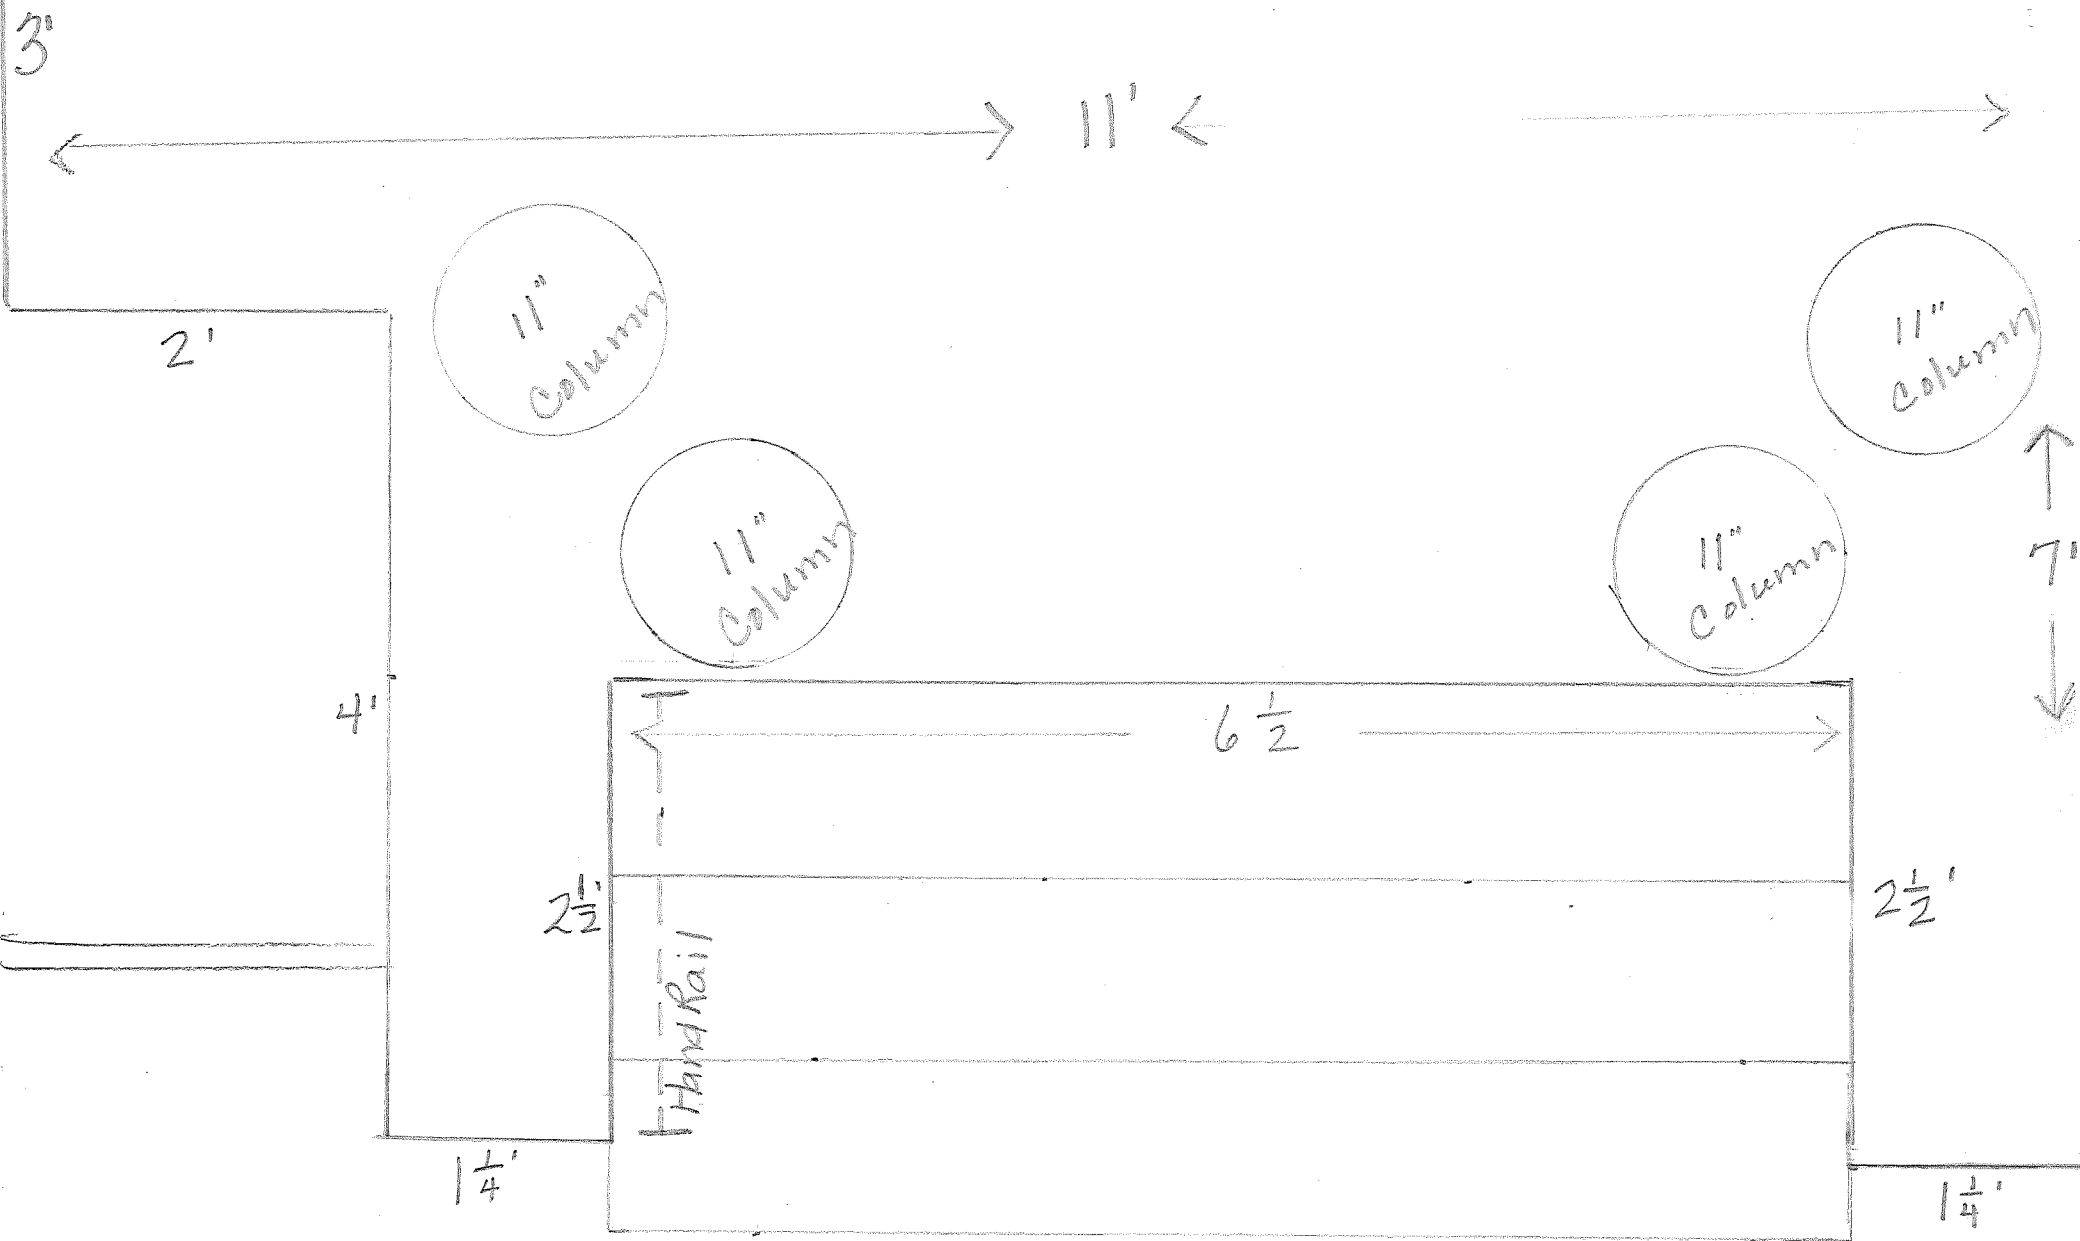
Scale 1" = 1' 2 1/2' elevation

The concrete flat work and stairs of the porch will be replaced and will have the same overall footprint, 11' X 4.5'. The rise, 14", and fall, 8", of each step will match the existing stairs. Since the existing porch concrete is painted brick red, tinted concrete will be used to eliminate the painted surface. The black wrought iron handrail will be inset into the concrete for stability.

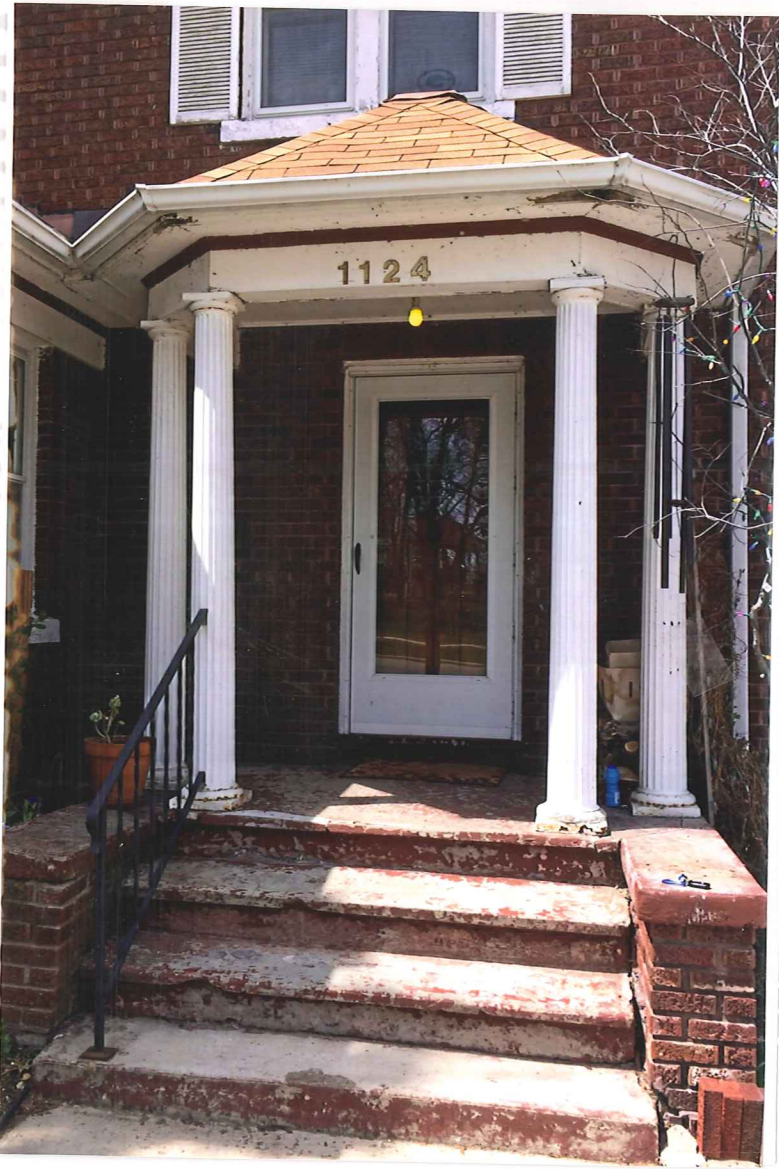
Stoop

This project will repair or replace the entire front stoop that currently has crumbling steps, a cracked cement floor, rusted and unstable decorative metal columns and water-damaged woodwork, soffits and fascia, on the underside of the porch overhang. Due to water and ice damage, the brick side walls on either side of the stairs have shifted, tilted and become unstable, some bricks are actually loose. The cement slab at the base of the steps has shifted and cracked in multiple places. The asphalt shingles on the porch roof are in need of replacement. The flat rubber roof on the front sun porch has deteriorated and needs to be replaced, as well as the tuck flashing where the exterior porch and the sun room roof lines meet. 25 LF of rain gutter will be replaced to accommodate heavy run-off from a steeply pitched roof, and will include one downspout.

A new foundation will be laid under the entire footprint of the porch. The crumbling concrete slab directly in front of the stairs will be replaced and aligned to allow for proper drainage of rain and melting snow. Previously, no foundation existed under the brick sidewalls.

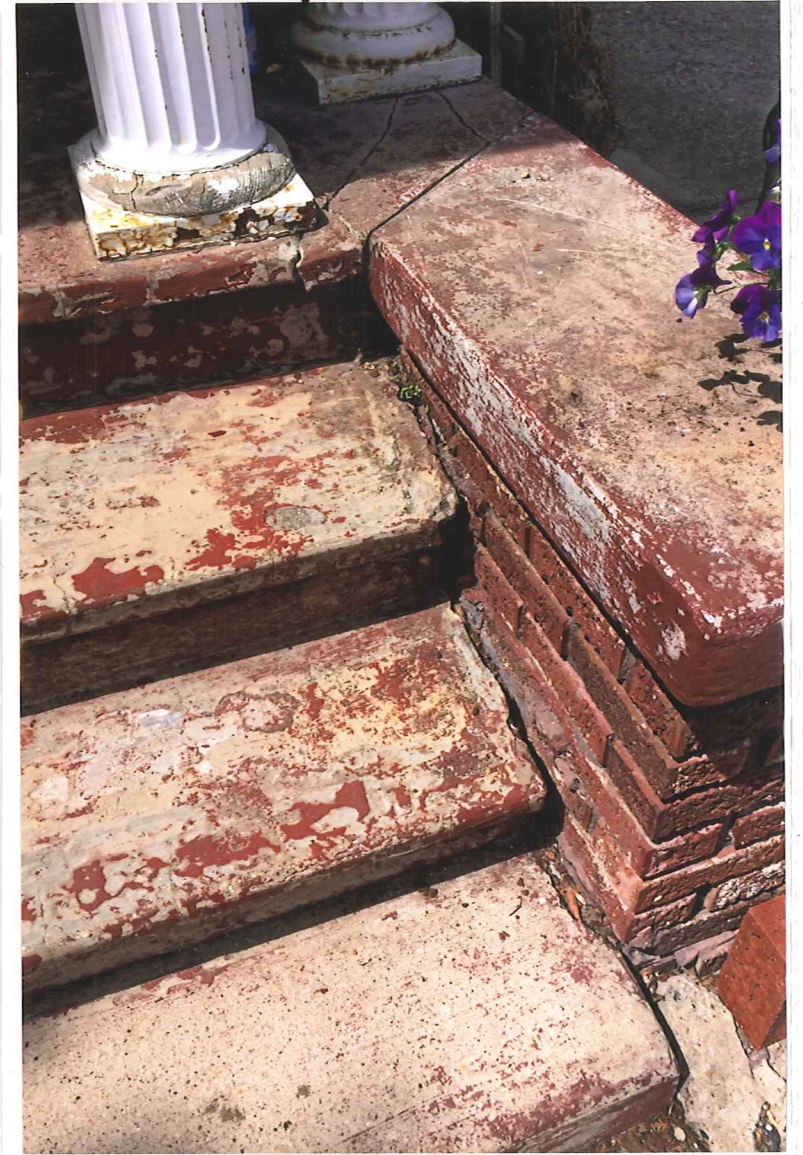
Column ± 3
+ ± 4

The metal columns will be removed, restored and reset in place. Each of the columns is a 7.5 foot fluted Doric tapered round design, starting at 25" circumference and tapering to 21". Each round profiled base and cap measures 3" and each column height is 84" for a total height of 90". Each base is an 11" square at the bottom and 9" square at the top. Each cap is circular with a diameter of 11" at the bottom and 9" at the top. Three bases are original and one was previously replaced with wood. Each of the 4 column bases and caps may need to be replaced, but will remain the same dimensions as the original. Because of the significant amount of deterioration, erosion and rust, at the bottom and the top of each of the columns, the repair and rebuild to a smooth lasting finish may not be possible. If this is the case, each column will be replaced with a new aluminum fluted Doric tapered column. The old will be removed, new base mounts and caps of the same dimensions as the existing will be built and installed, and new 84" columns will be set. The overall dimension will remain 7.5'. These will have a better finish and will look like the columns did when they were new.

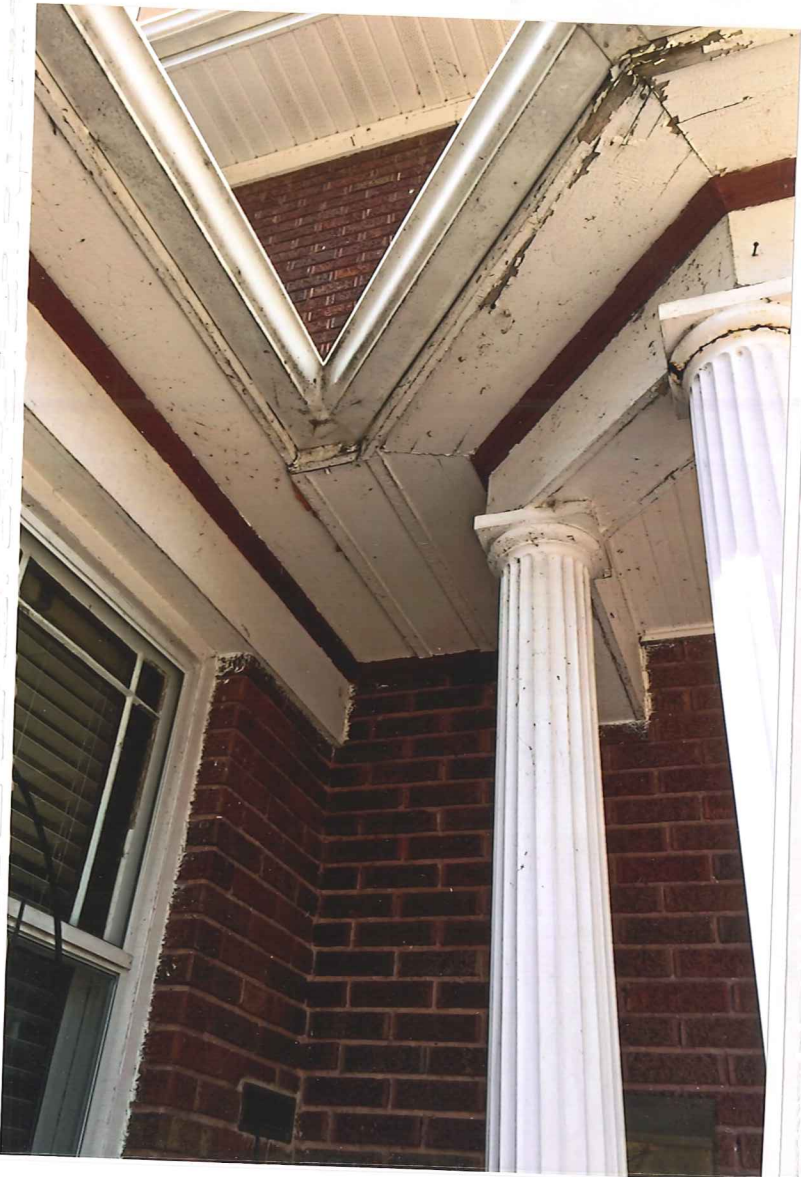
#1 + #2

Soffit

All damaged wood on the underside of the porch overhang will be replaced. Existing Burnt Sienna asphalt shingles will replace existing terra cotta as it is a color more closely matching that of the existing main roof shingles.

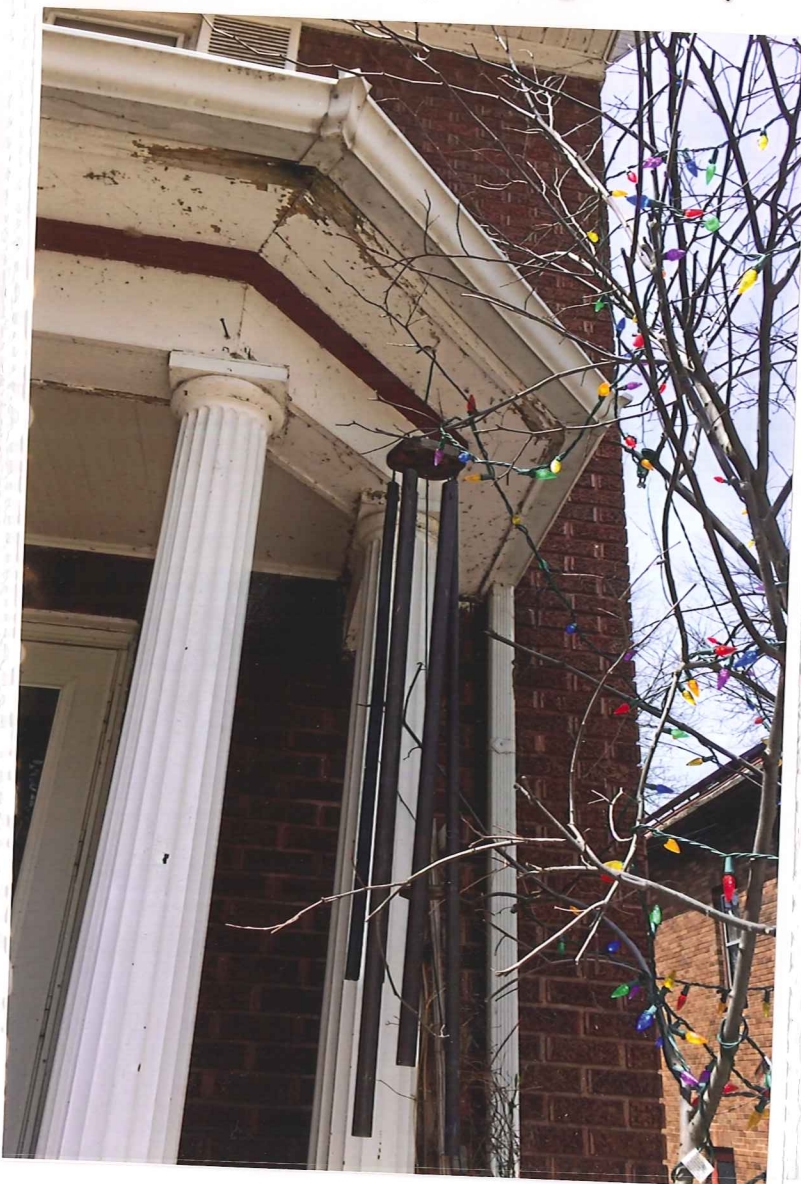
#3 + #4

Soffit
