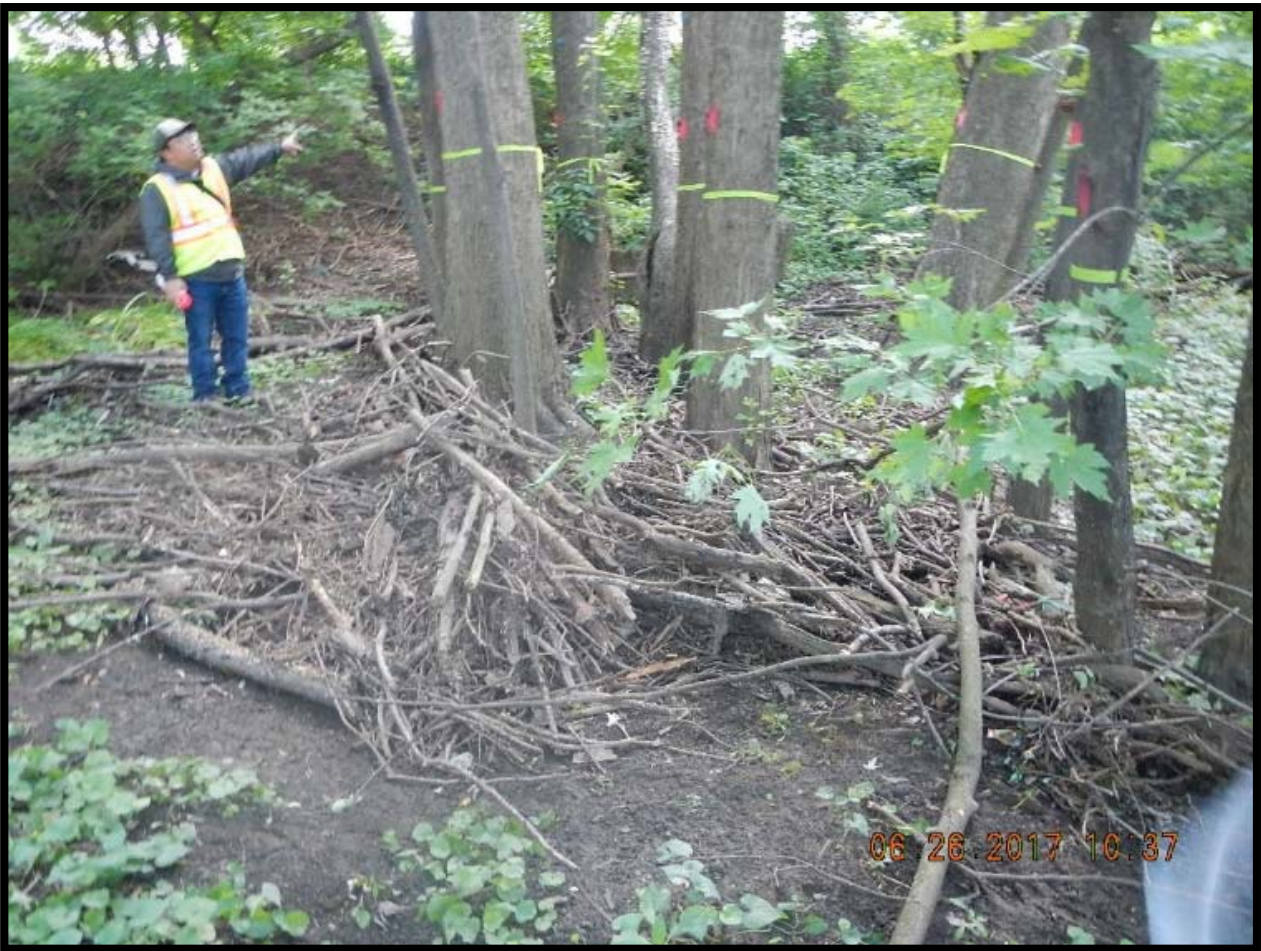
Figure 3: Silver maples cause large quantity of debris in channel.
